Subject **Notice of Violation, Transmittal of Inspection Report of June 7, 2023
Inspection of Mendocino County Assessor's Parcel Number 012-620-61-00**

FACILITIES INSPECTION REPORT

June 7, 2023 Anderson Inspection Report
Map and Photo Appendix
CIWQS Inspection ID 52033254

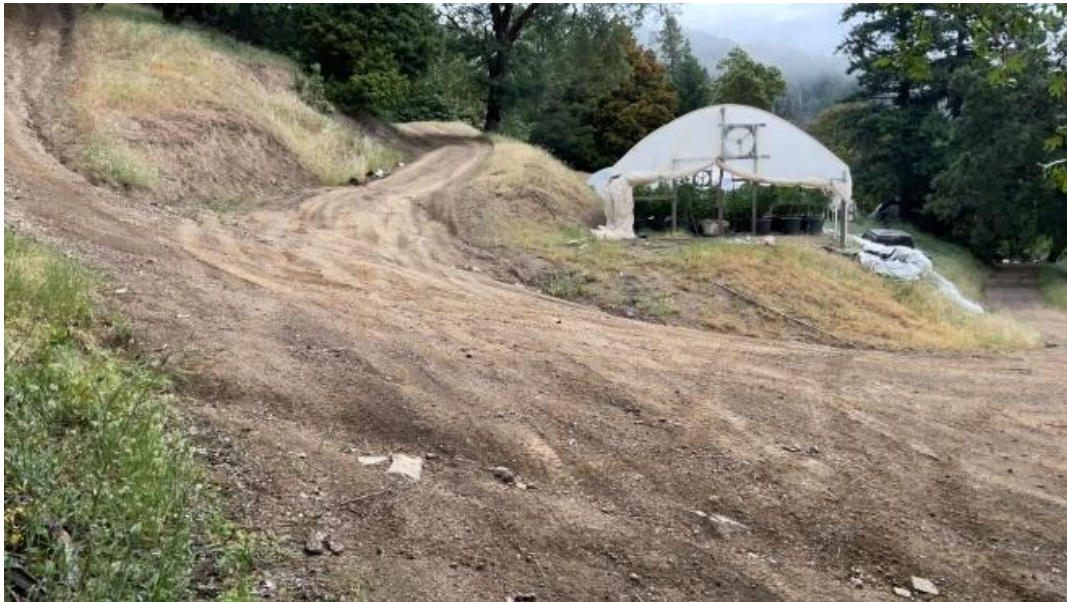
Class III stream crossing X1 (39.838125, -123.535522) is an earthen ford. Road sediment delivery. Fill from CA2 greenhouse pad is placed at downstream end of stream crossing. CA1 is three greenhouses totaling ~5000 sq ft.

Figure 5. Cultivation area CA1 near stream crossing X1. CA1 consists of two greenhouses on graded flats (photo facing NW).

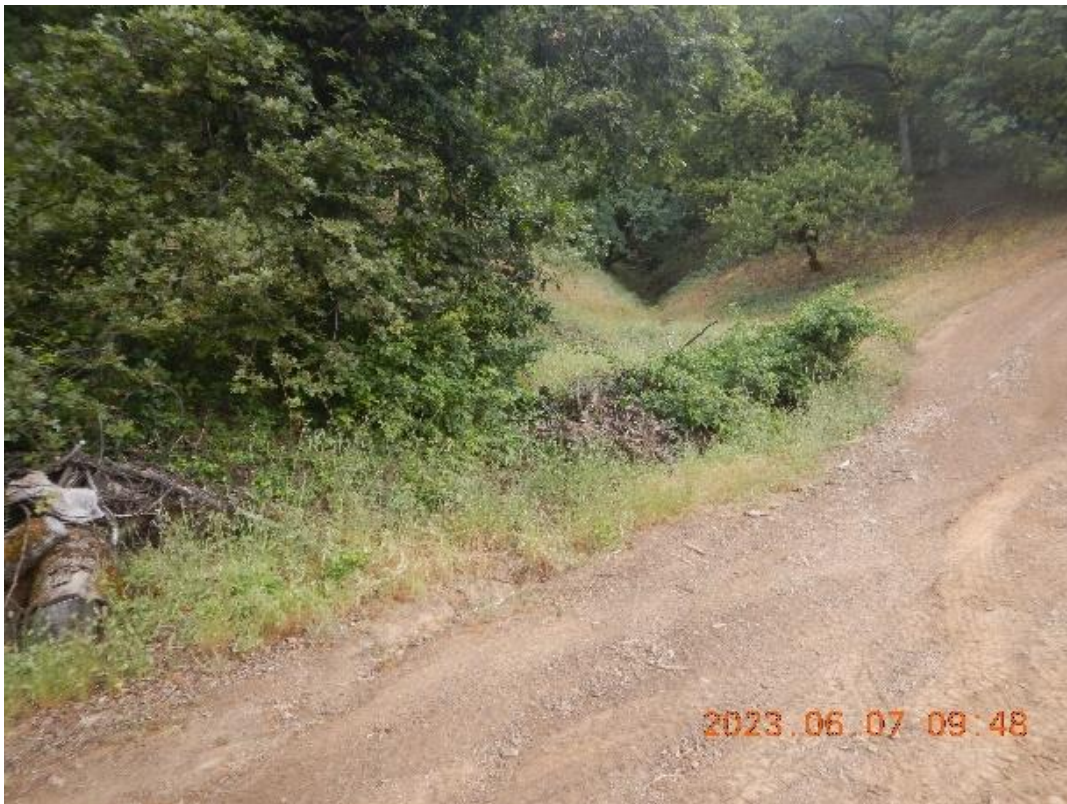
Figure 6. X1 upstream channel.

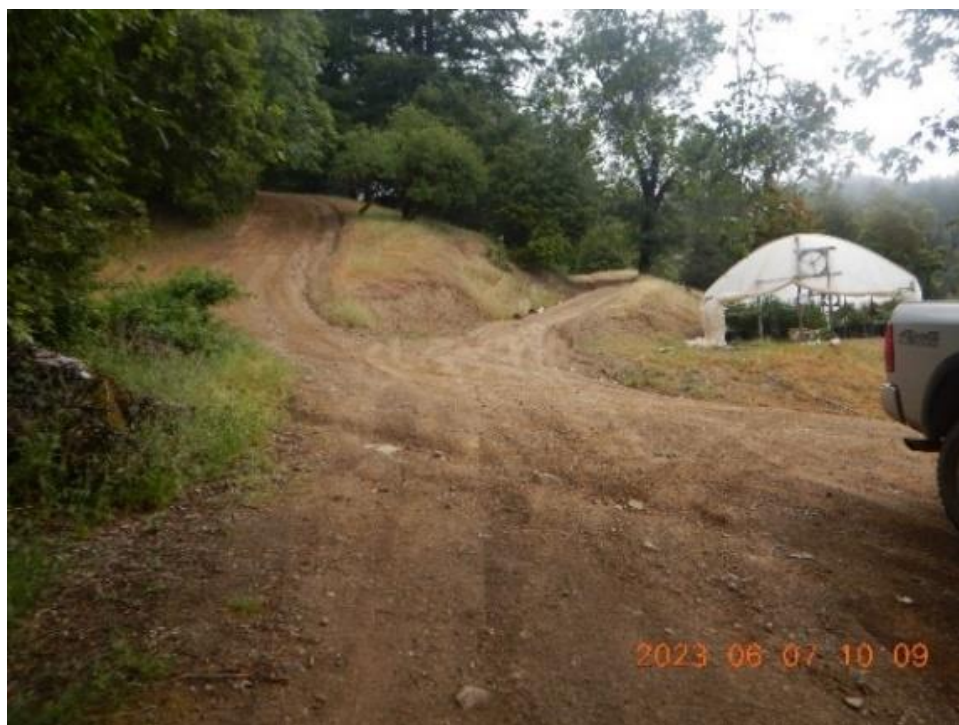
Figure 7. X1. Road sediment delivery from two upslope road segments. CA1 is cultivation area near X1.

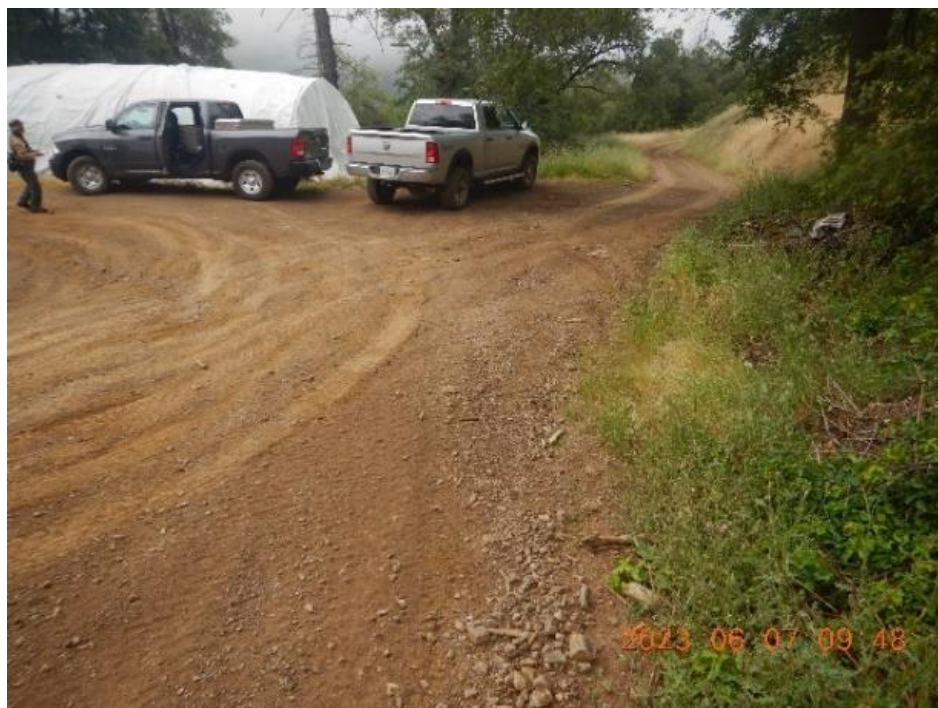
Figure 8. Road runoff flows past greenhouses and delivers to the watercourse downslope of the crossing at X1.

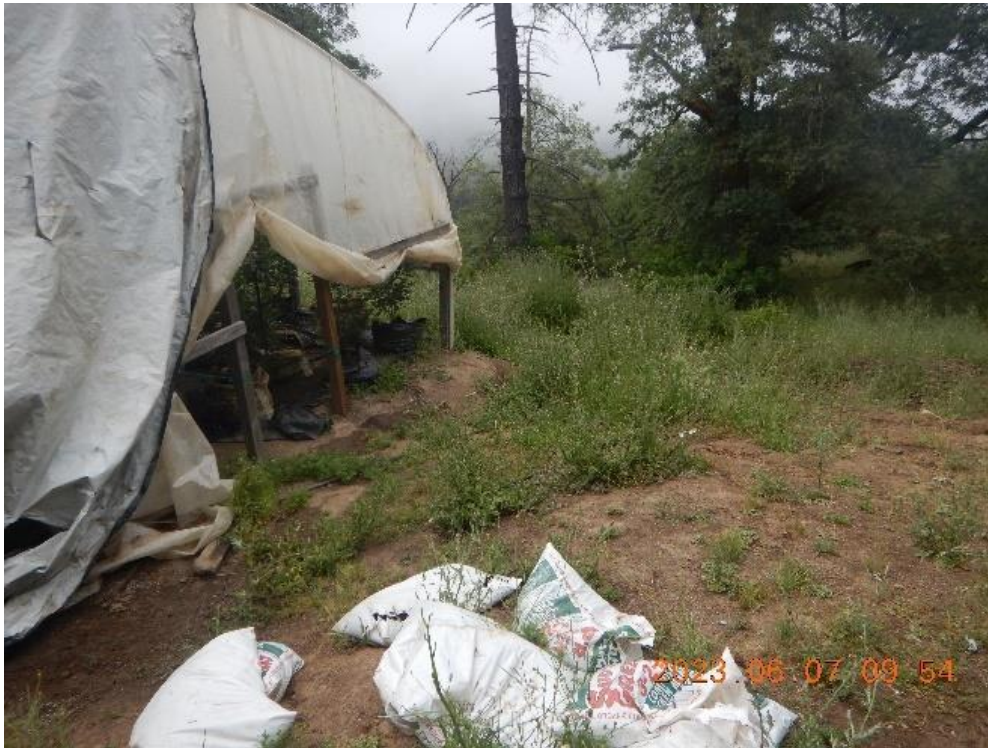
Figure 9. Greenhouse at the downstream end of X1.

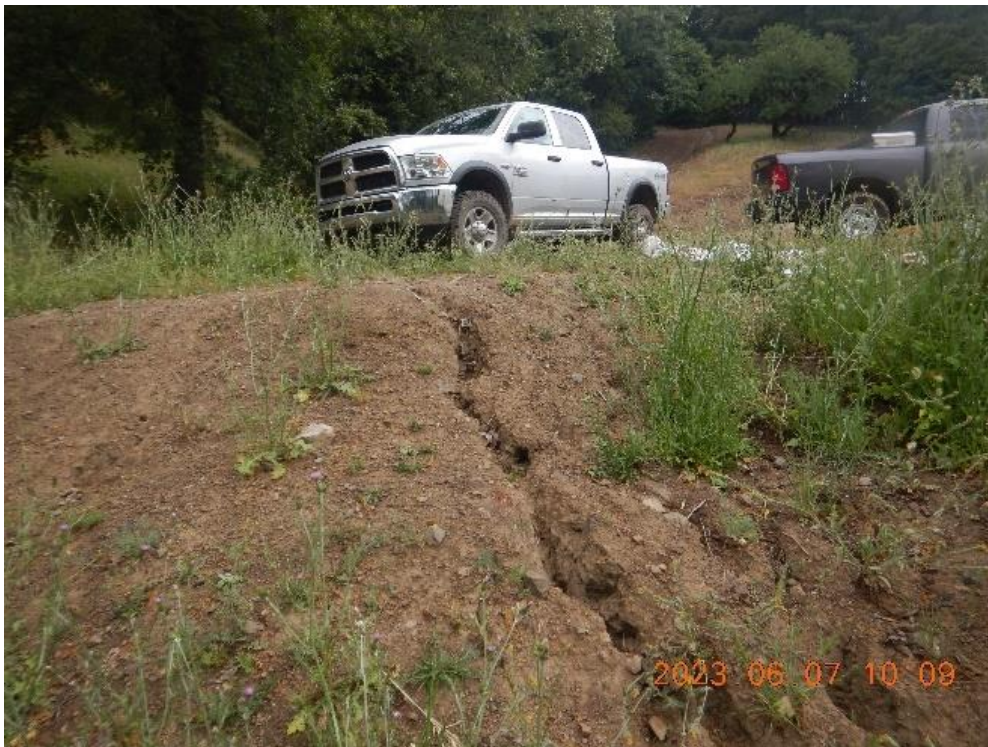
Figure 10. Eroded fill slope below X1, with delivery to the class III watercourse.

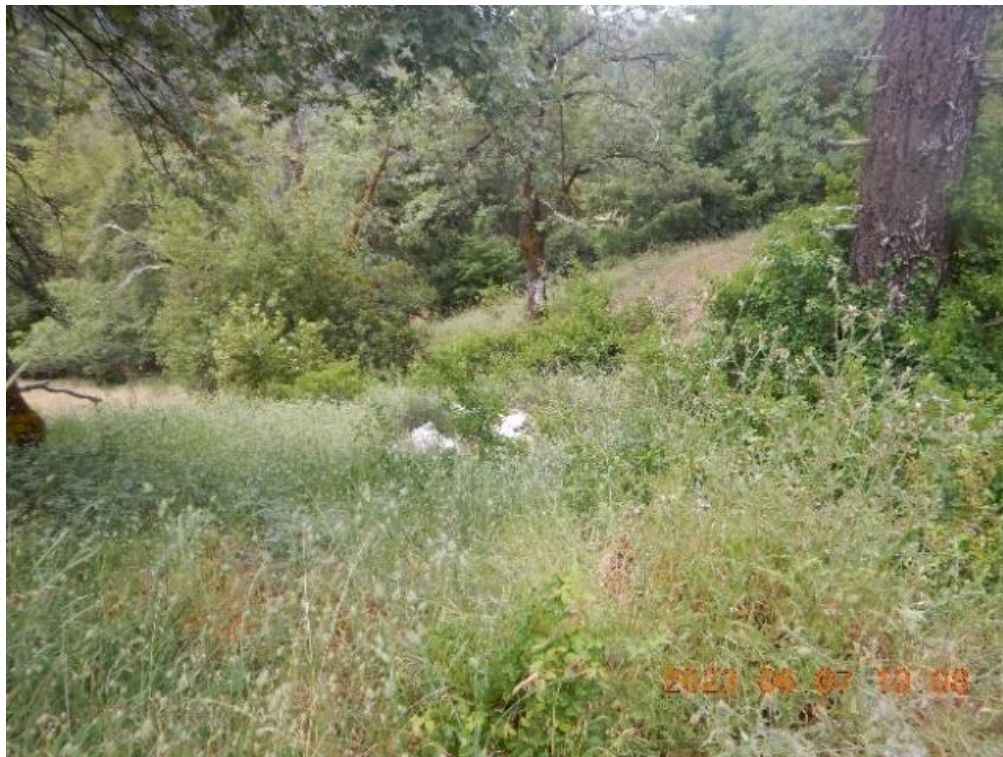
Figure 11. Watercourse channel downstream of X1, with old grow pots in watercourse.

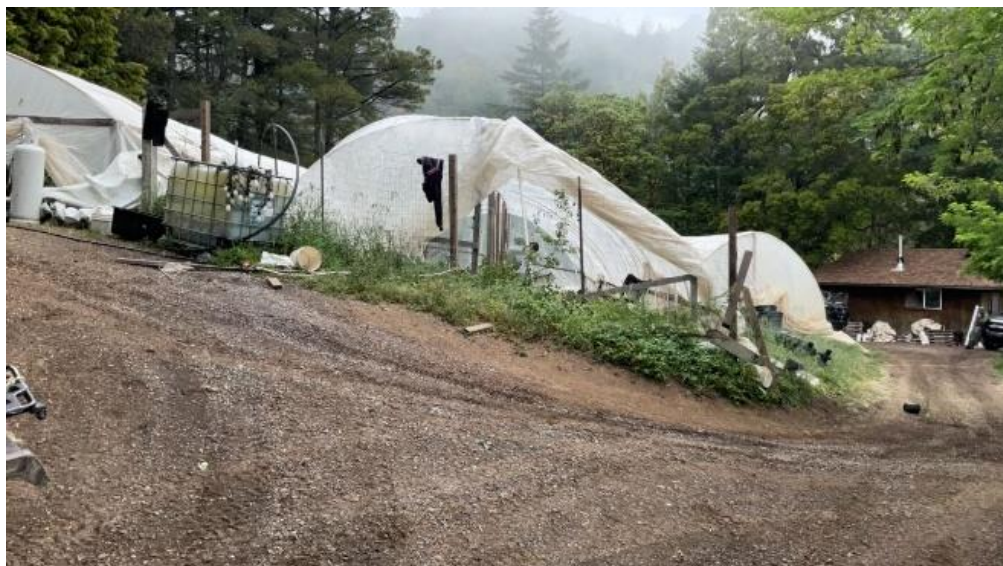
Figure 12. CA2.

CA2 (39.838217, -123.534526) greenhouses.

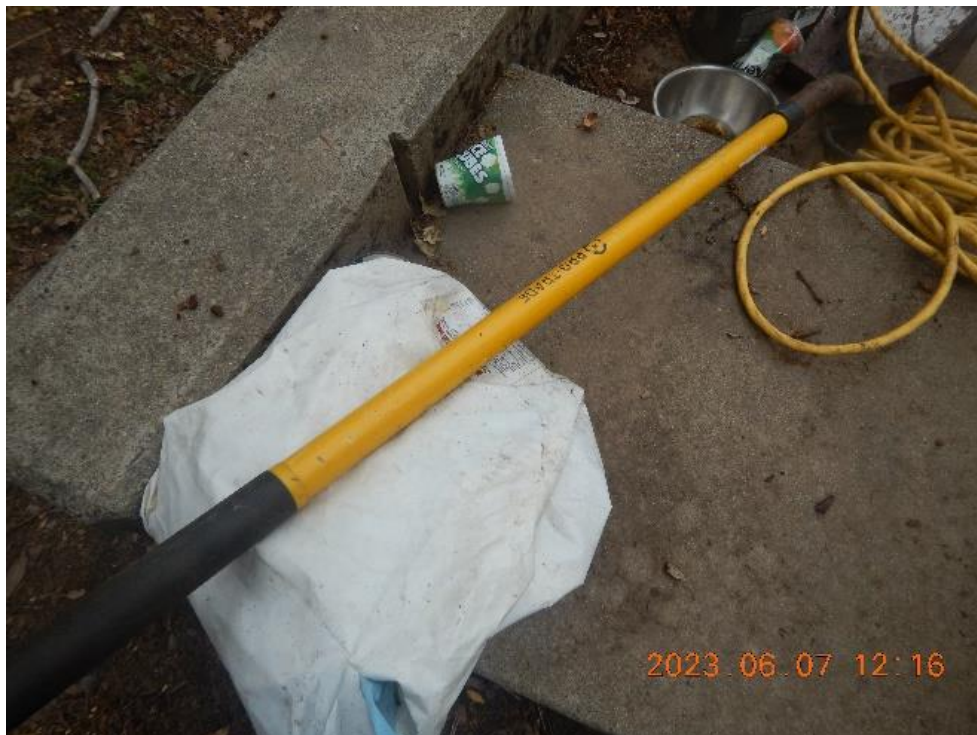
Figure 14. High concentration water soluble fertilizer near residence.

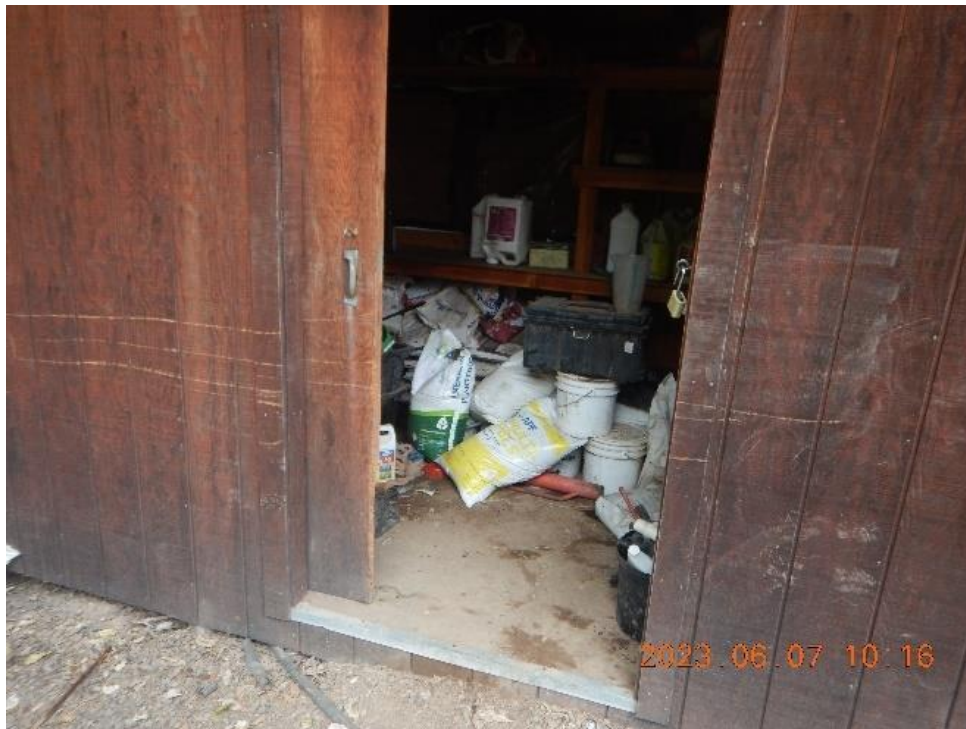
Shed (39.838537, -123.534275) with fertilizers & pesticides.

Figure 15. Shed storing fertilizers and pesticides.

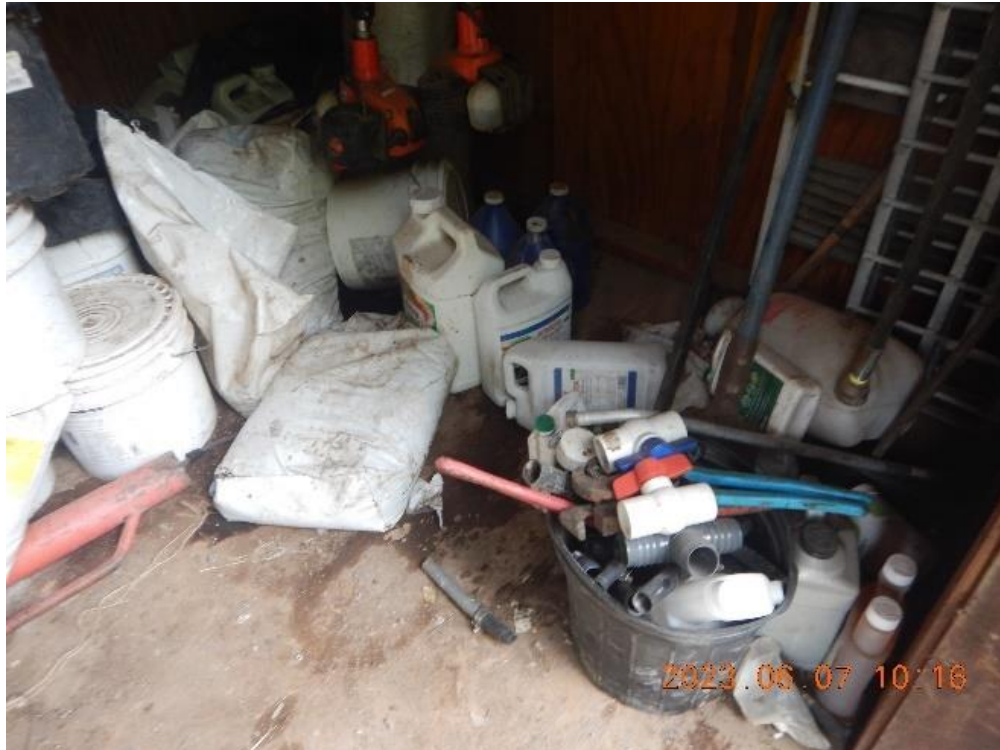
Figure 16. Contents of shed.

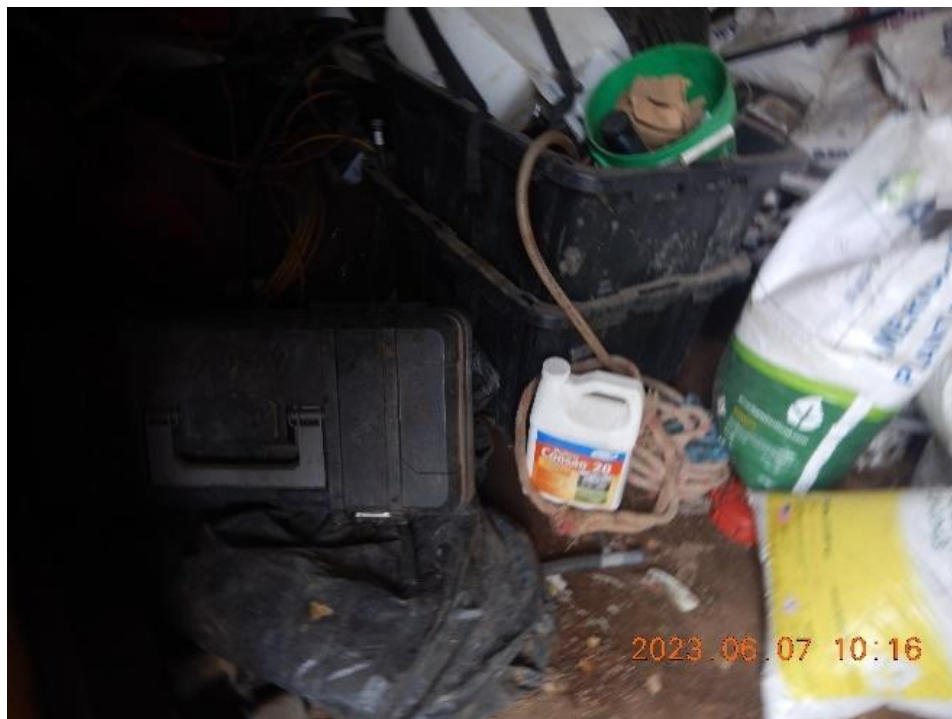
Figure 17. Highly concentrated garden and household fungicide/algacide.

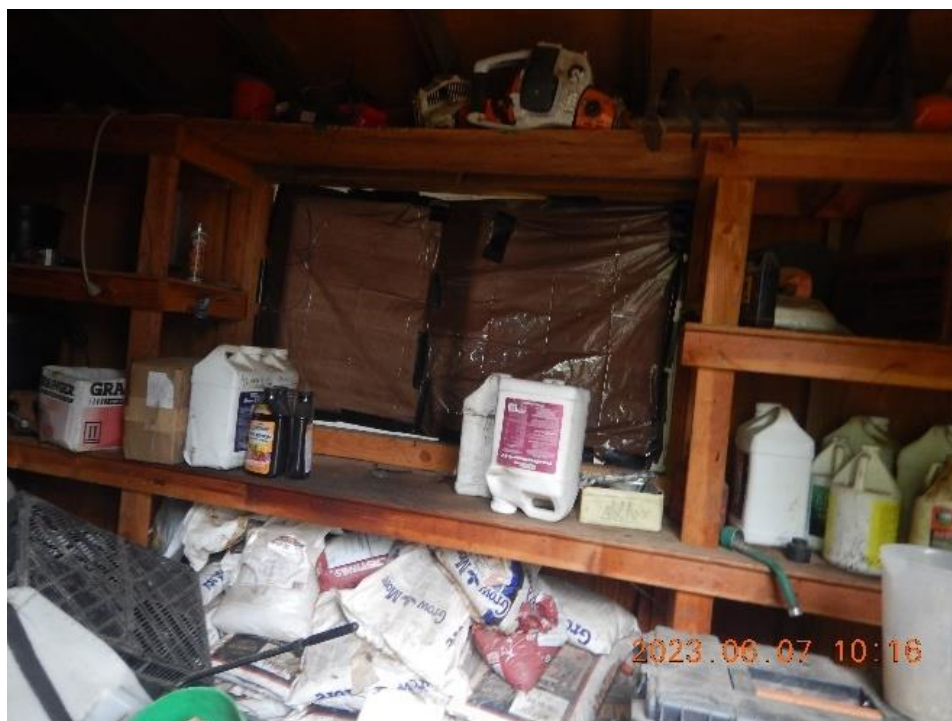
Figure 18. Spectracide Malathion Insect Spray.

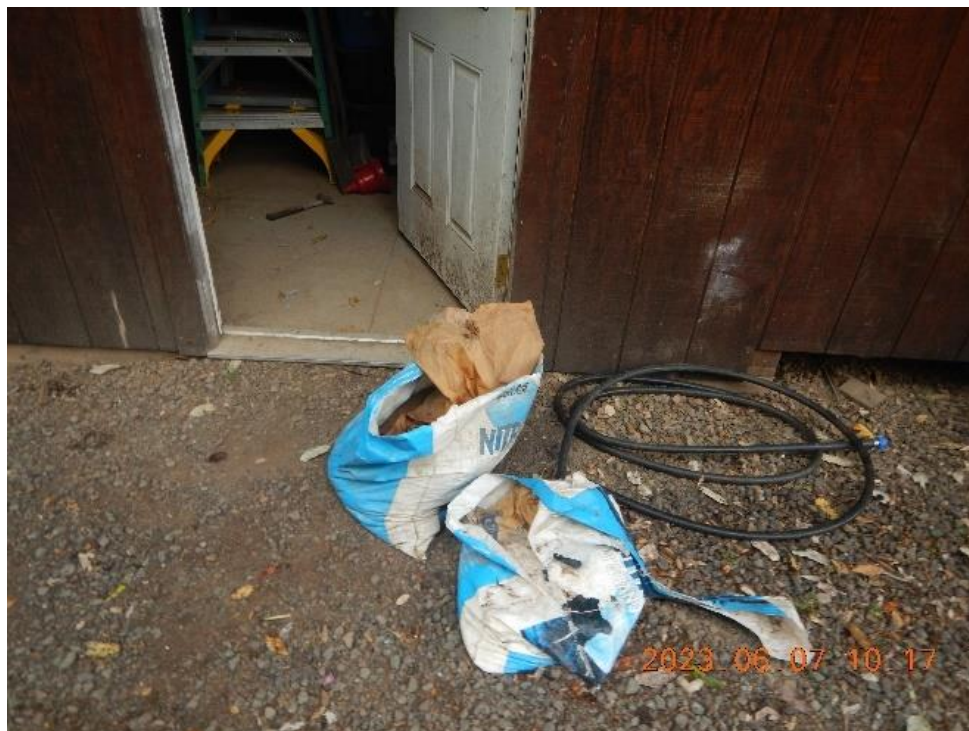
Figure 19. Fertilizer on ground outside of shed.

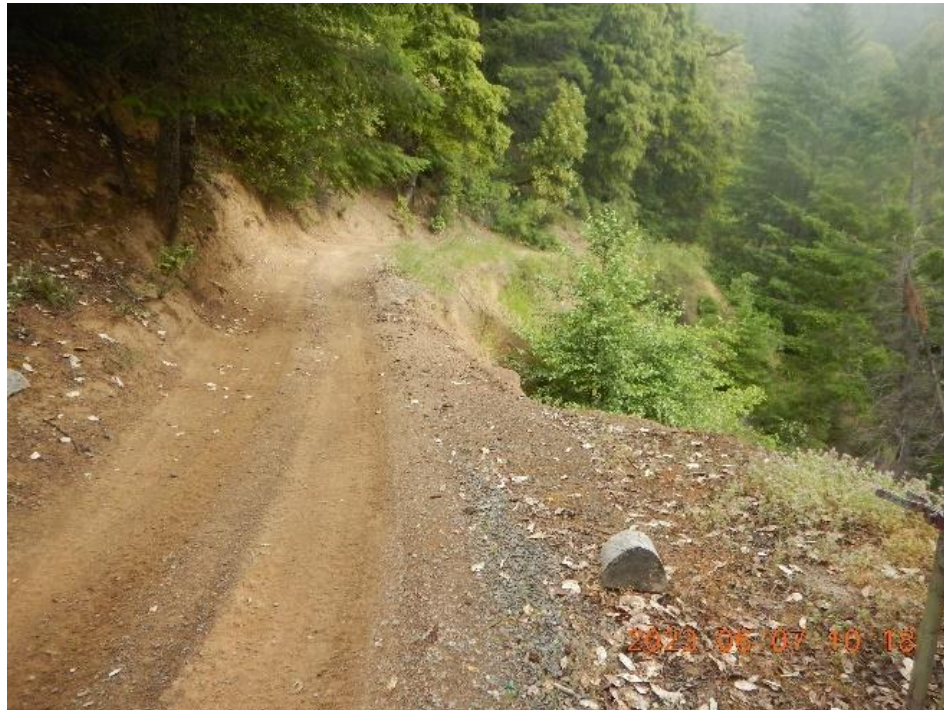
Slide (39.838589, -123.534256). Low slope access road built across a blue line watercourse (X2). Slopes below road to watercourse have failed, are overly steepened, devoid of vegetation, and a chronic source of sediment to stream.

Figure 20. Slide associated with the failed slopes of the access road. Approximately 400 feet of road on the right bank of the watercourse is impacted by unstable slopes leading directly to the blue line watercourse.

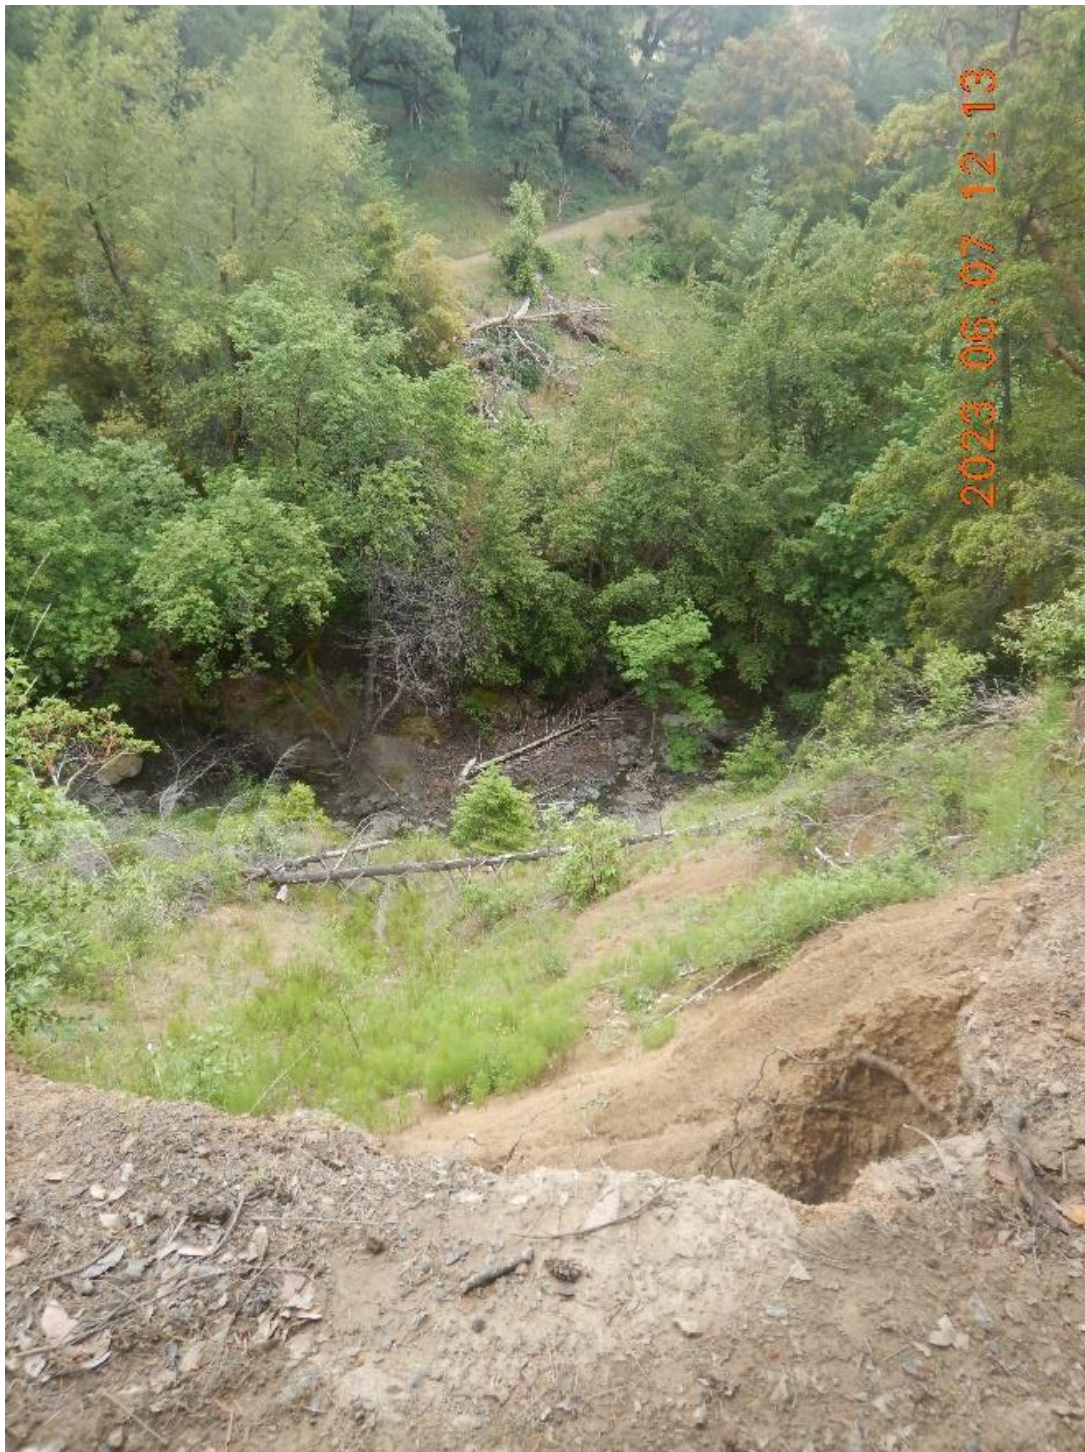
Figure 21, Road related slide delivery to the blue line watercourse.

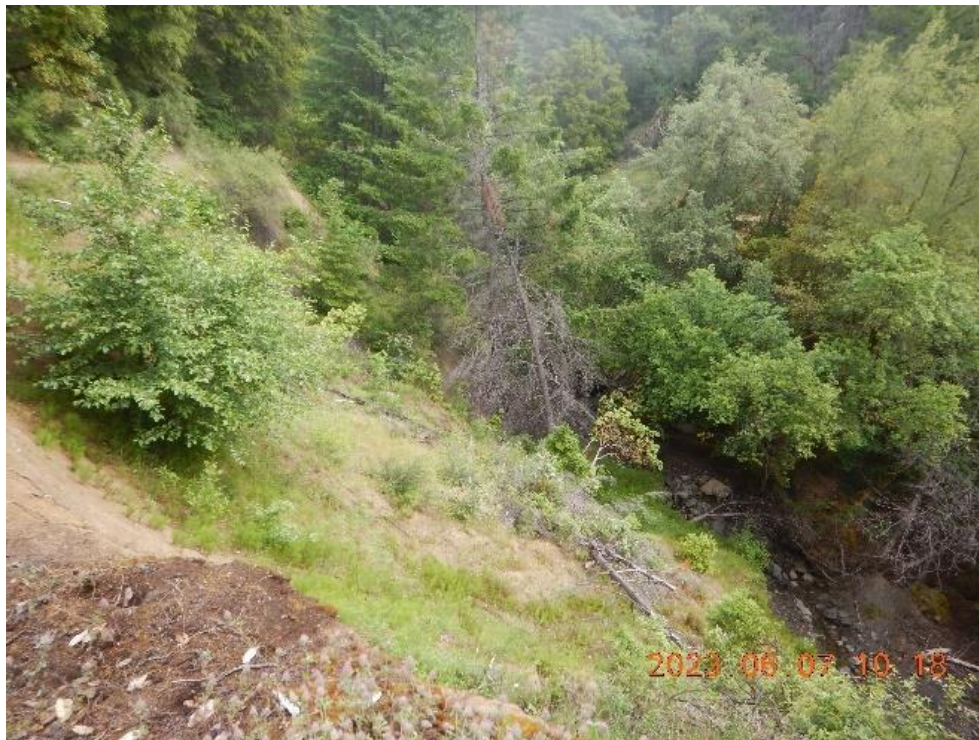
Figure 22. Unstable slope leading directly to watercourse.

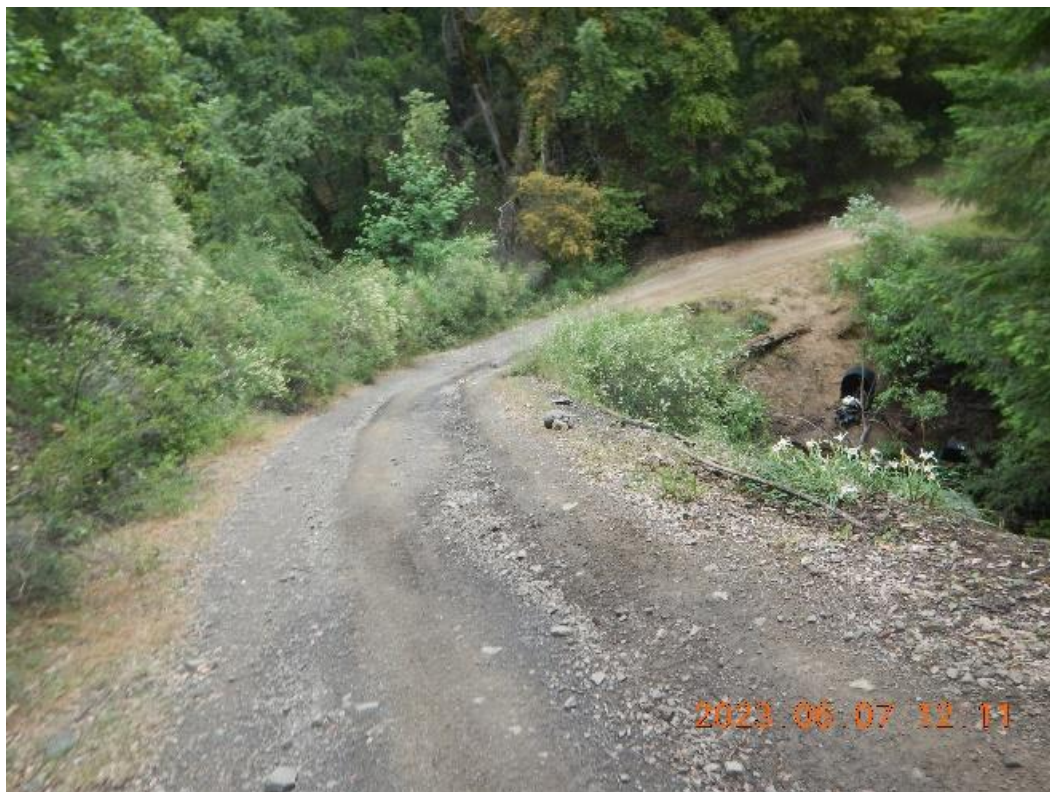
Figure 23. Outlet of X2 stream crossing and debris in stream.

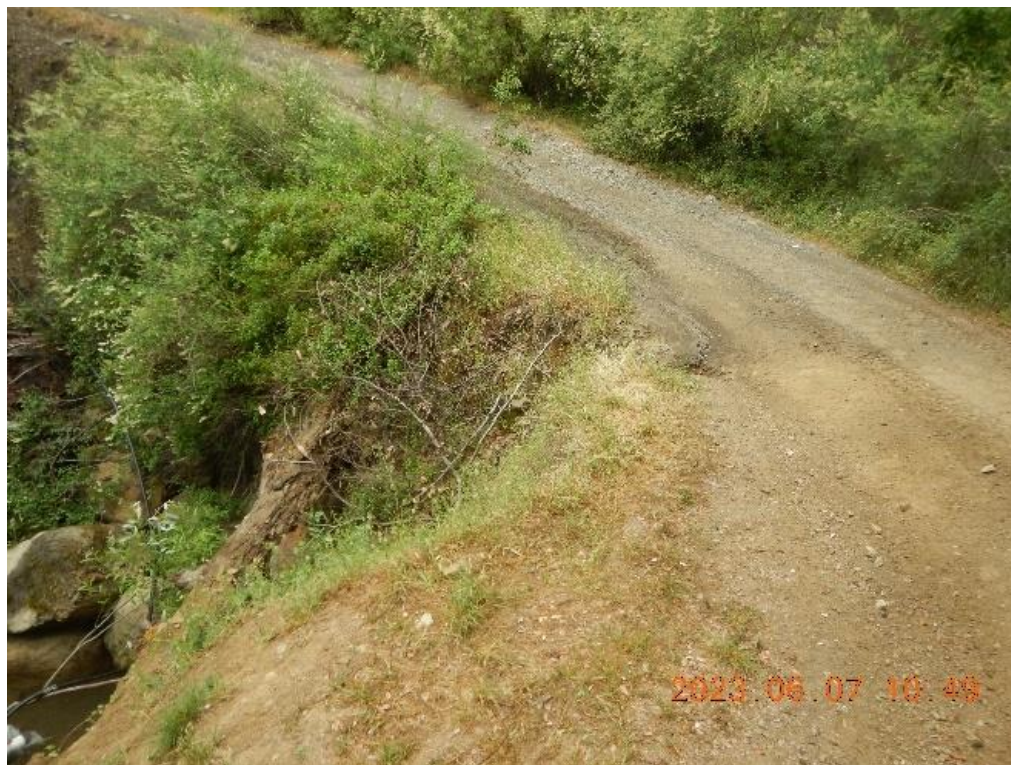
Figure 24. The road surface concentrates water and discharges stormwater to the watercourse at the outlet of X2.

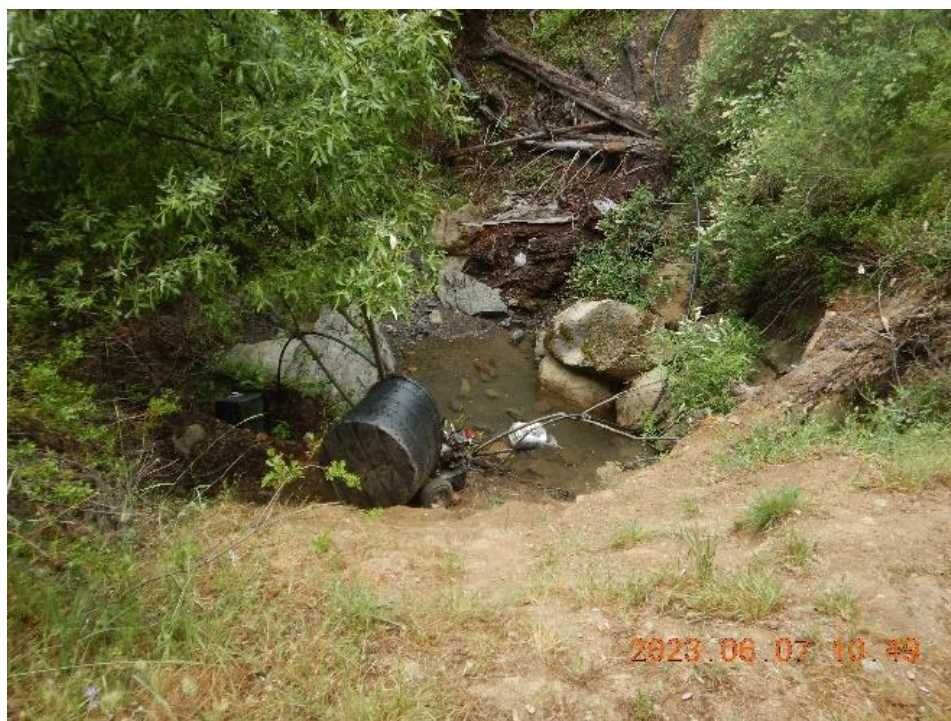
Figure 25. View downstream of X2 from road surface, with debris in stream.

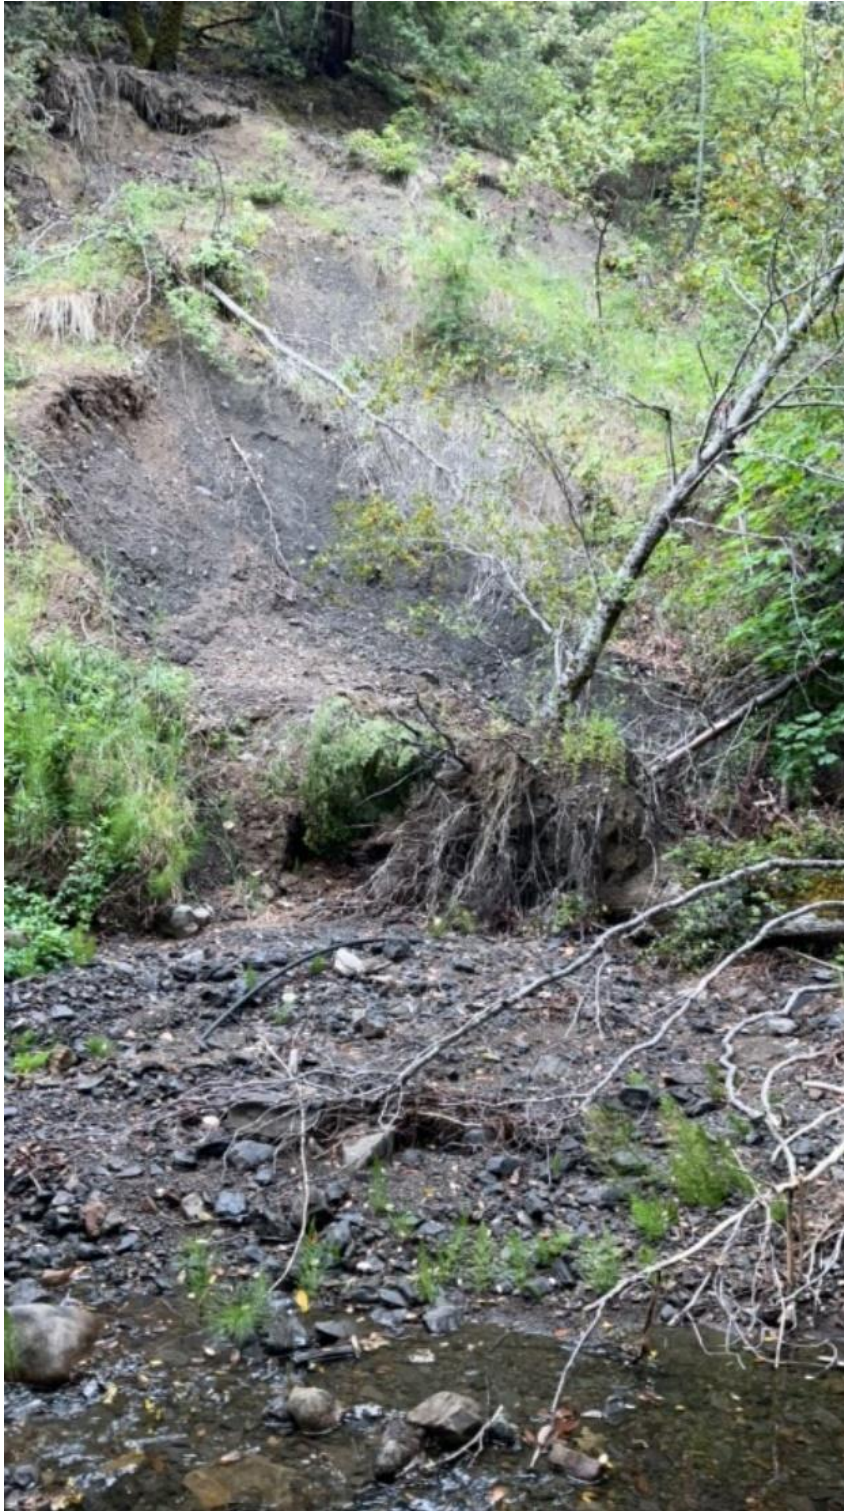
Figure 26. Slide located on the right bank upstream of X2 inlet.

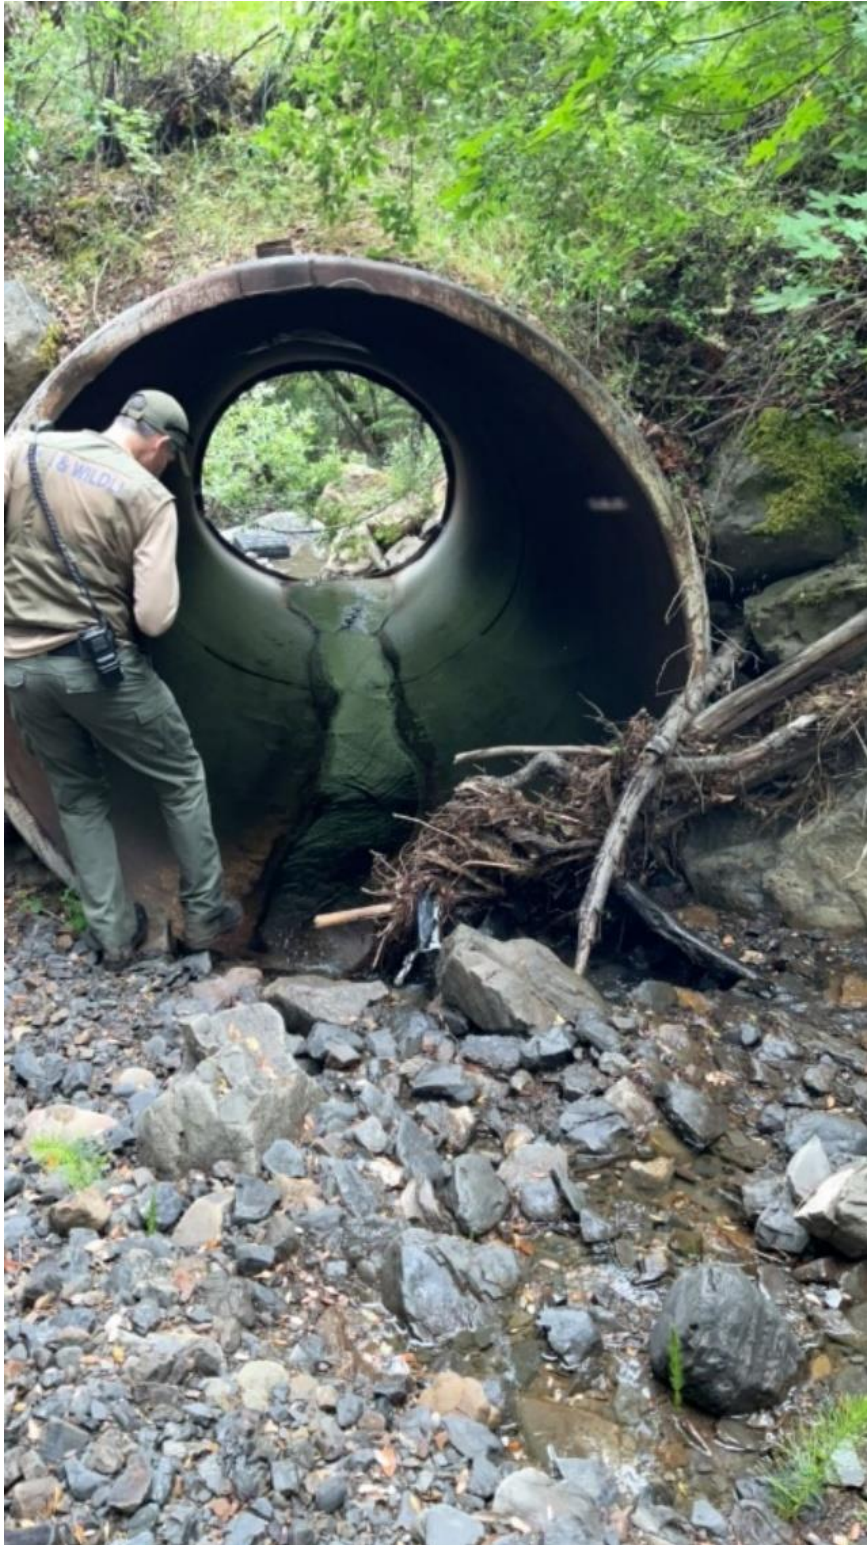
Figure 27. X1 looking downstream.

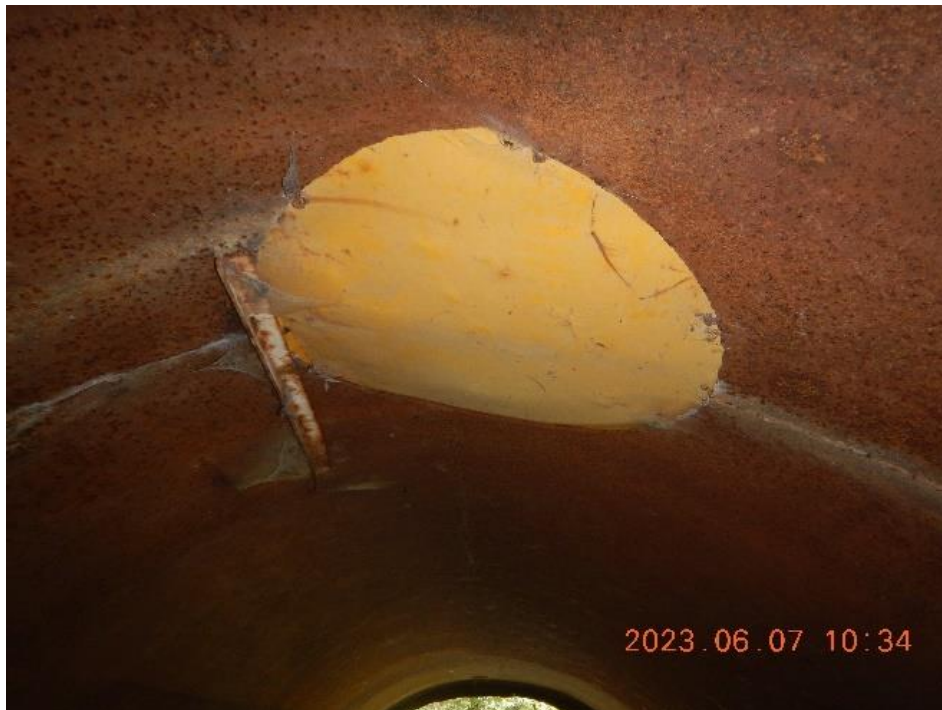
X2 (39.839423, -123.534125) The culvert is an 8-foot diameter fabricated culvert with seam in the middle. A water diversion Pump (39.839226, -123.534303) was at the outlet of X2 on the stream bank. I observed a sheen on the water associated with the petroleum pollution.

Figure 28. X2 culvert is fabricated from two metal cylinders with a seam in the middle and an opening that is patched with fiberglass.

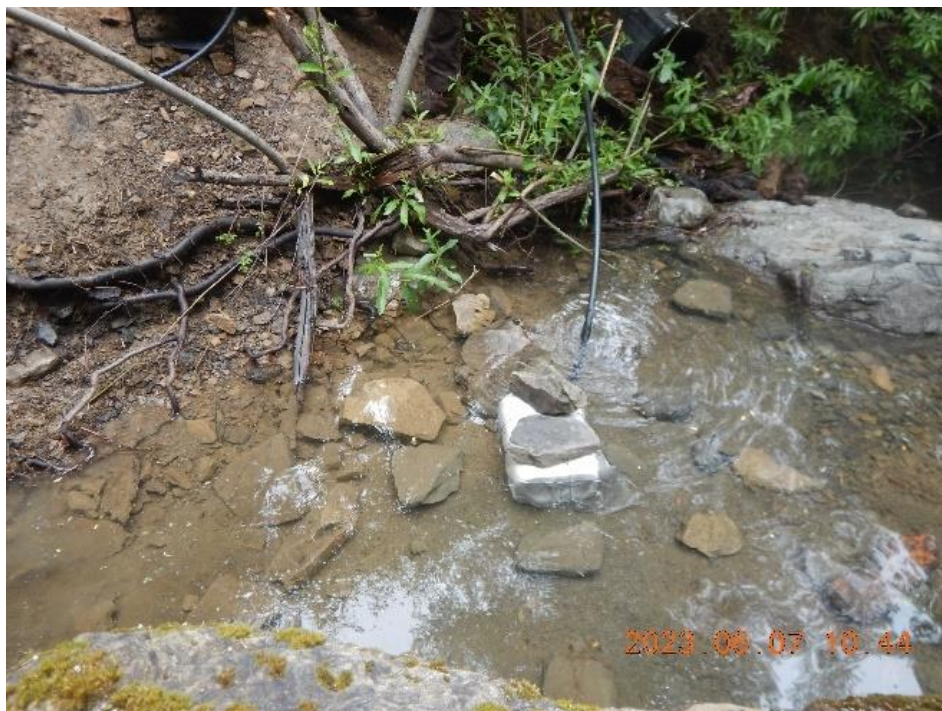
Figure 29. Diversion line at X2 culvert outlet.

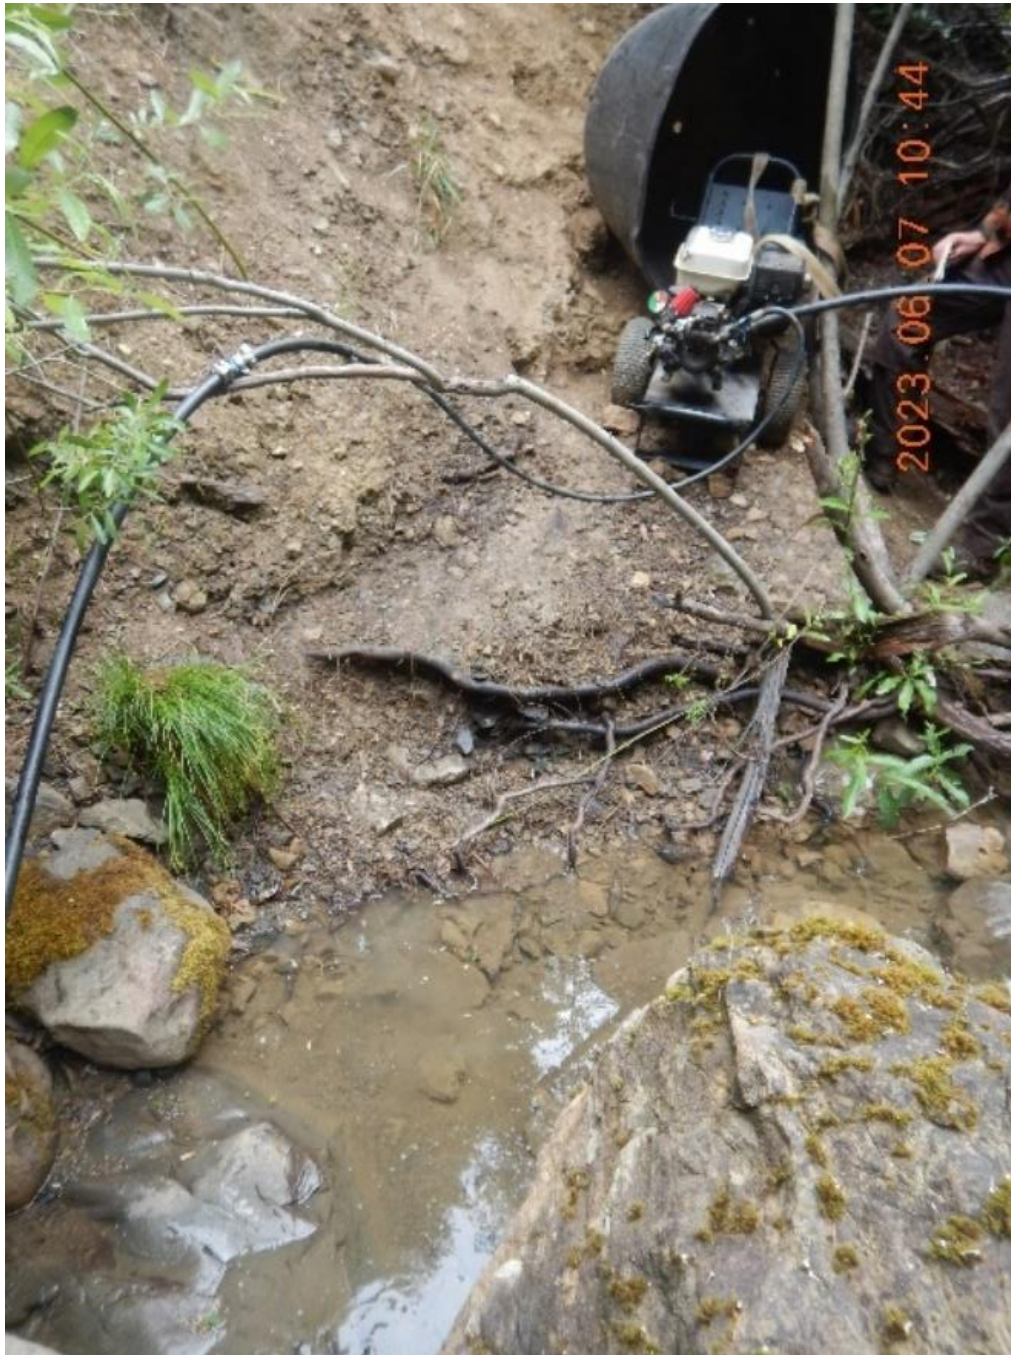
Figure 30. Pump at outlet of X2 culvert.

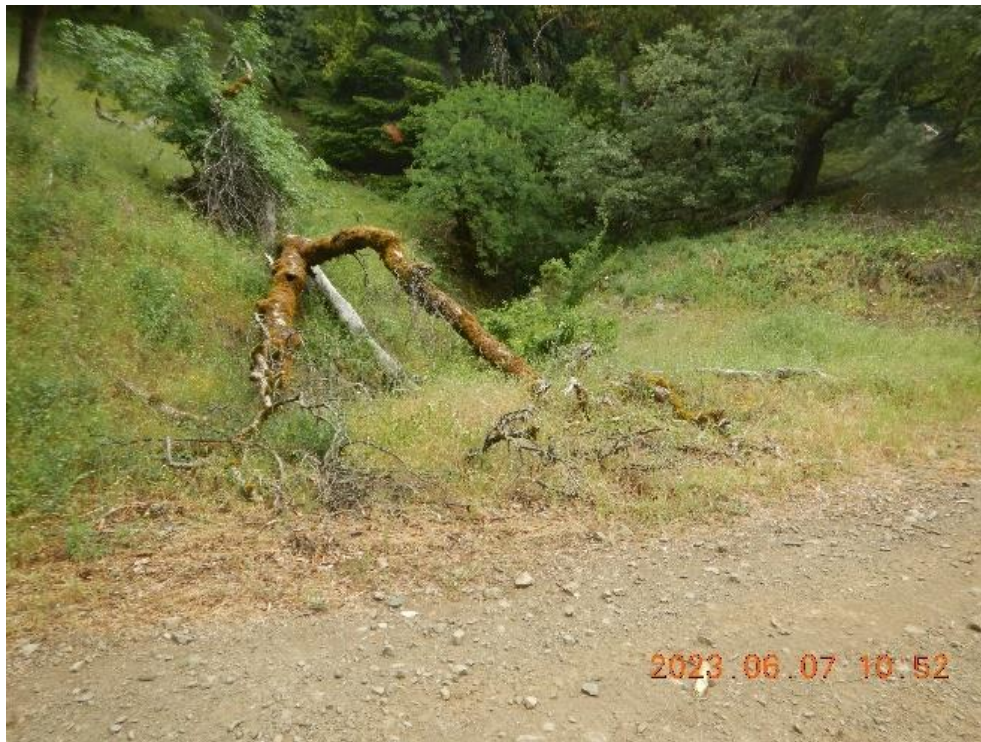
Figure 31. Watercourse channel upstream of stream crossing X3.

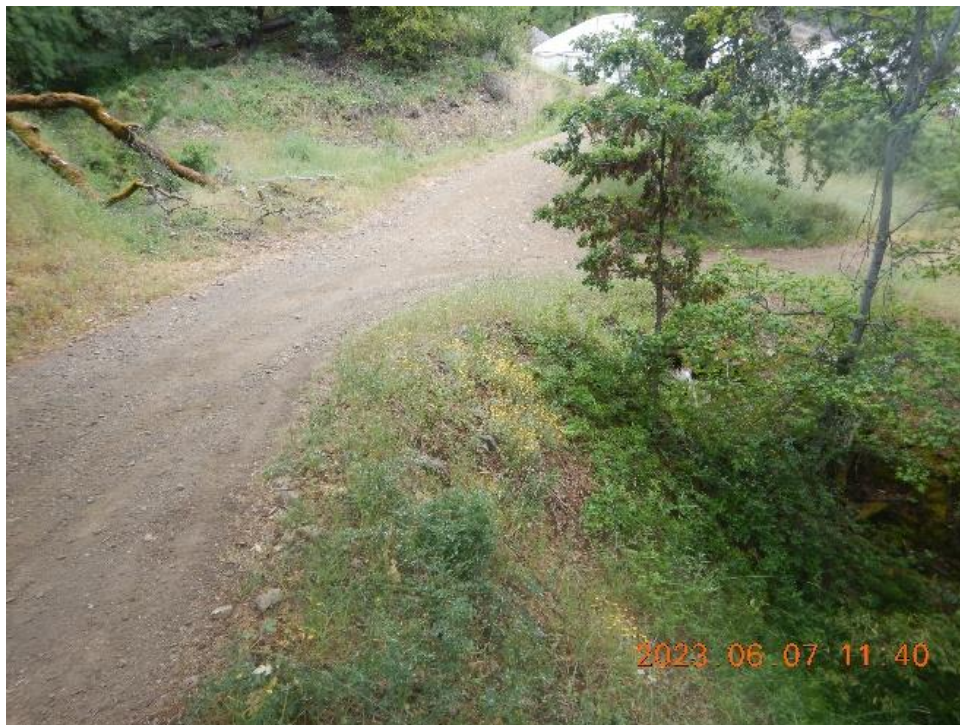
Figure 32. Road over stream crossing X3.

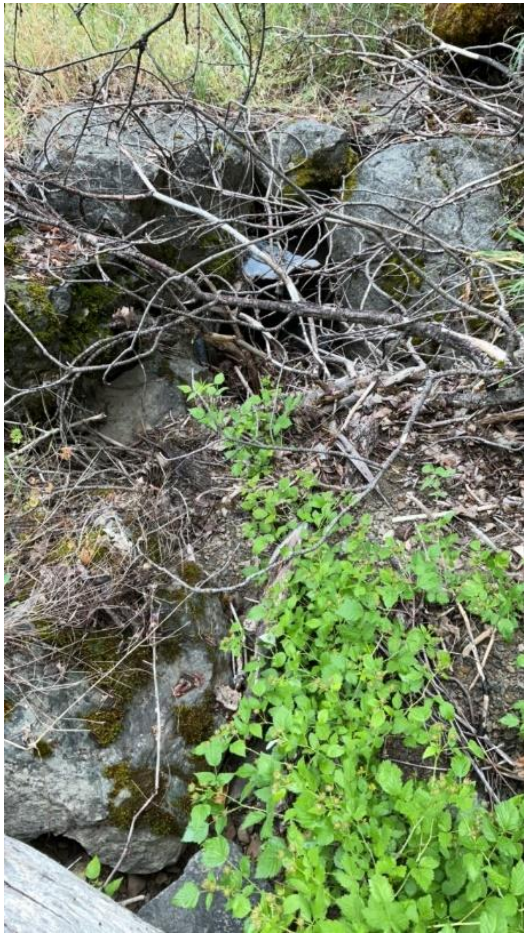
X3 (39.838269, -123.532296) is a crossing of 24 in diameter and is undersized compared the Class II stream.

Figure 33. Inlet x3, undersized culvert
