Subject **Notice of Violation, Transmittal of Inspection Report of June 7, 2023
Inspection of Mendocino County Assessor's Parcel Number 012-620-61-00**

FACILITIES INSPECTION REPORT

June 7, 2023 Anderson Inspection Report
Map and Photo Appendix
CIWQS Inspection ID 52033254

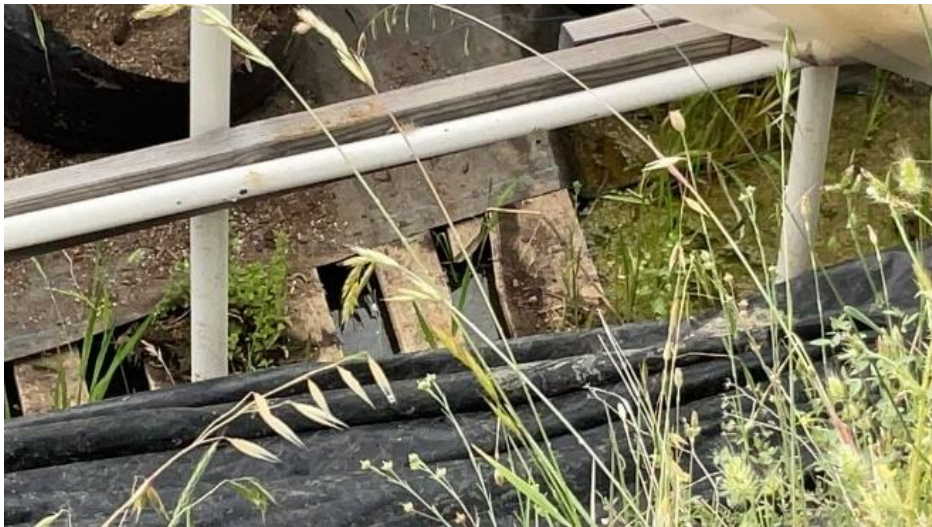
CA3 (39.838869, -123.532306). Greenhouse on a cultivation flat constructed with cut and fill. Within the greenhouse, I observed standing surface water and a trench constructed to divert surface water down the access road to the Class II watercourse at X3.

Figure 34. Standing water in greenhouse at CA3 with pallets on top.

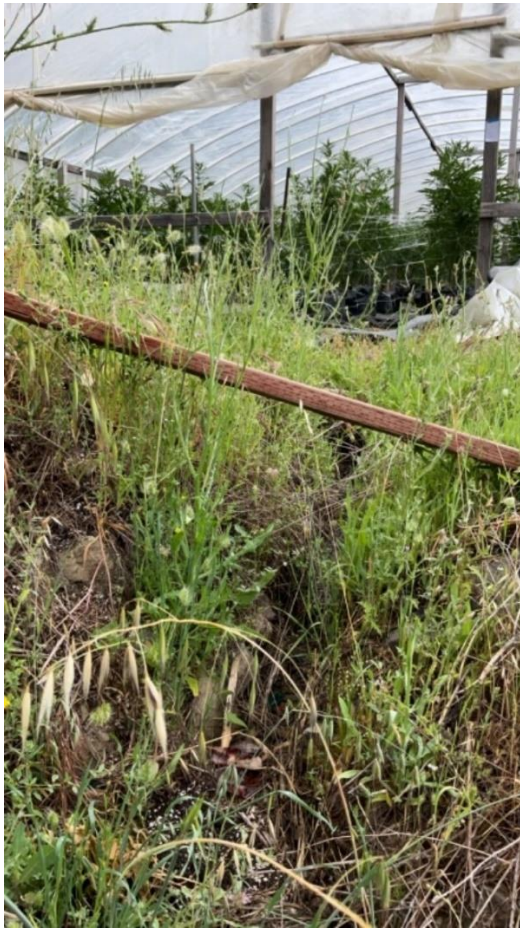
Figure 35. Trench in CCA3 greenhouse drains seep water from greenhouse to watercourse at X3.

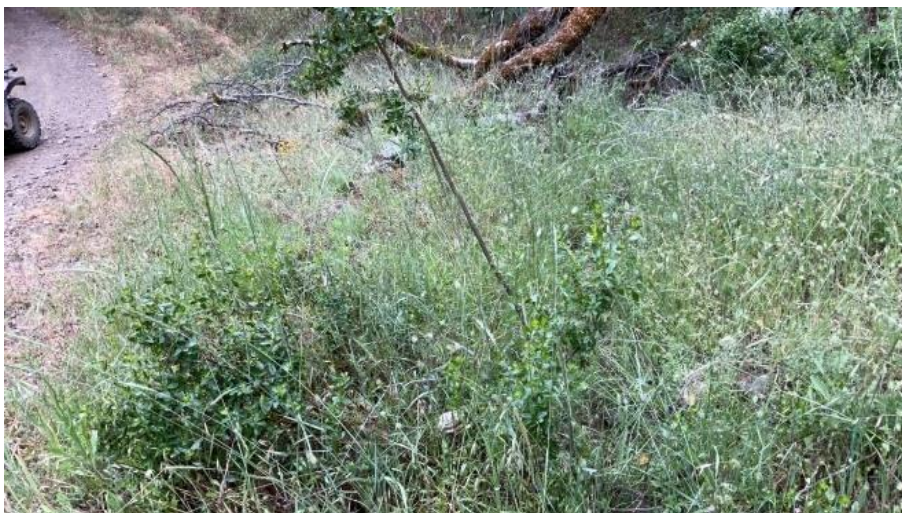
Figure 36. The trench from CA3 leads directly to the watercourse at the upstream end of X3.

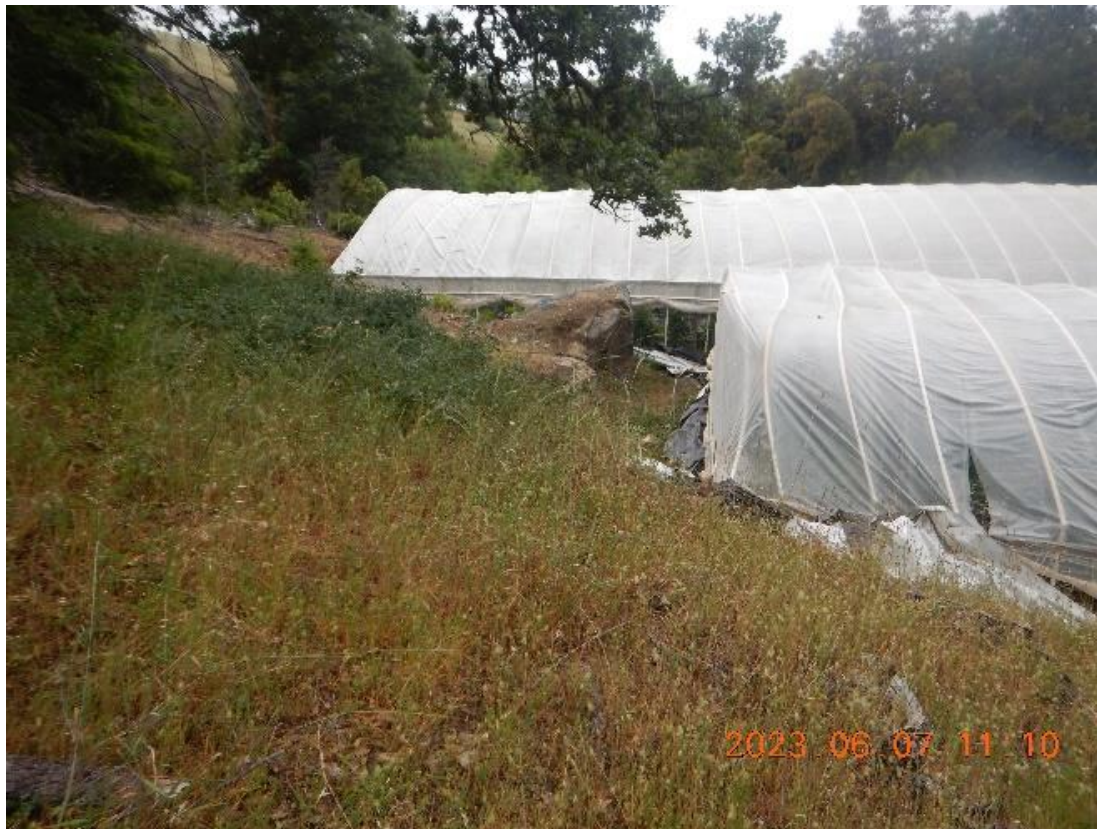
Figure 37. Upslope of CA3, the cut bank appears to have failed.

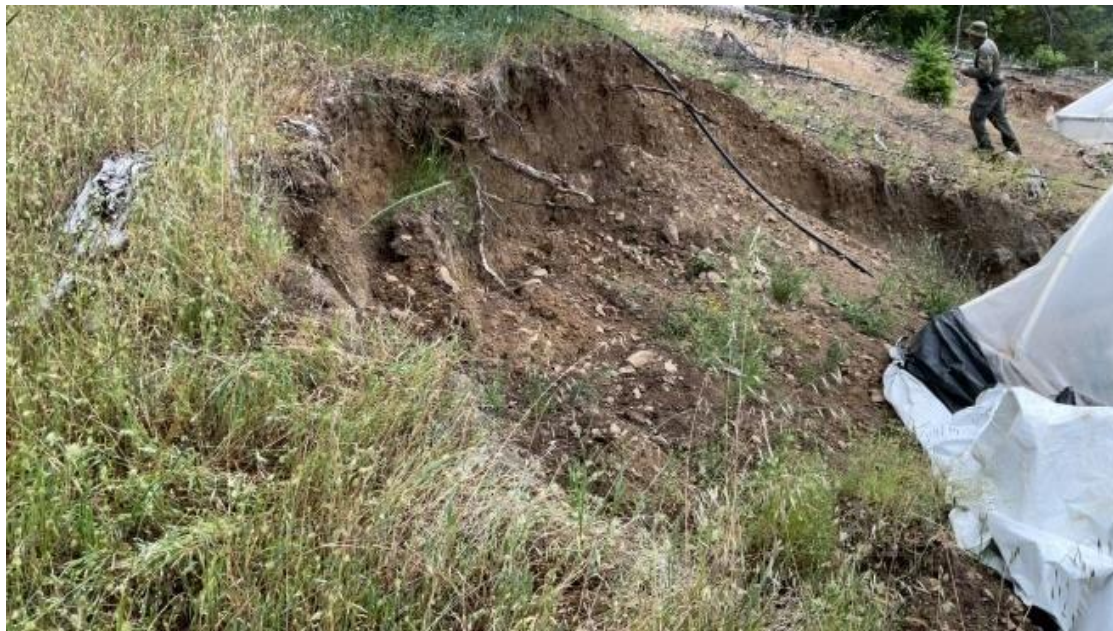
Figure 38. Cut bank failure associated with CA3.

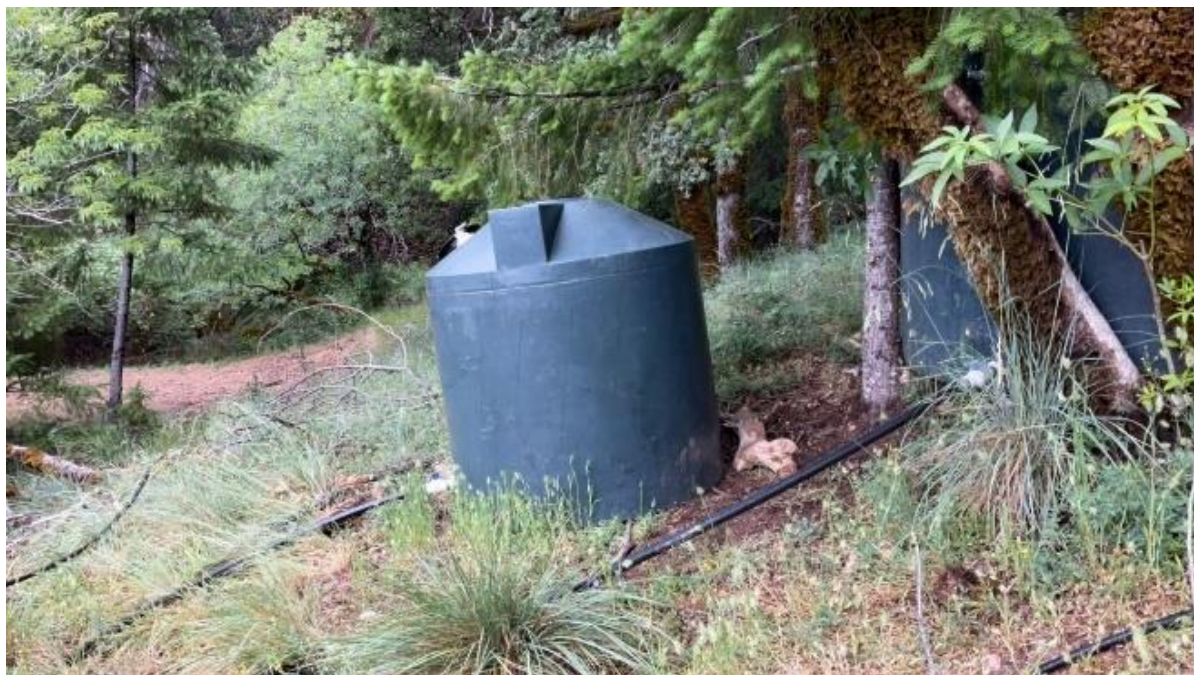
Figure 39. Tanks upslope of CA3.

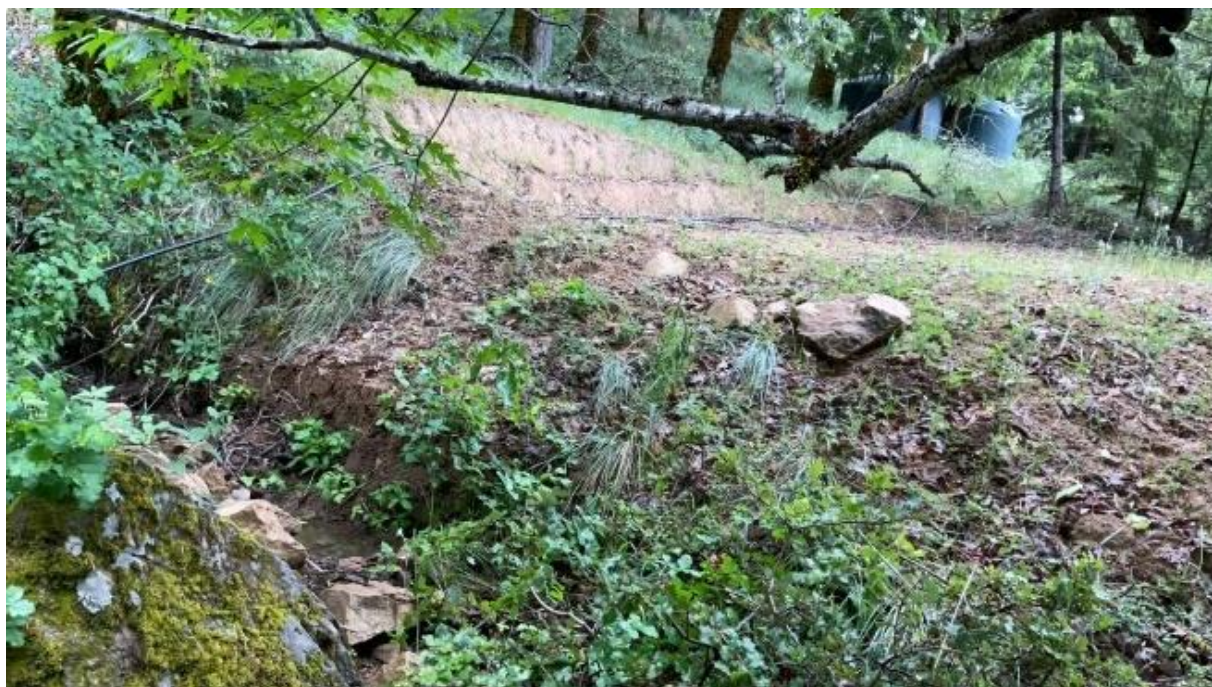
Graded (39.838255, -123.531678). A cleared graded area is extends from stream bank and is a sediment source.

Figure 40. Graded area next to Class II watercourse has disturbed the stream bank and resulted in sediment delivery to the watercourse.

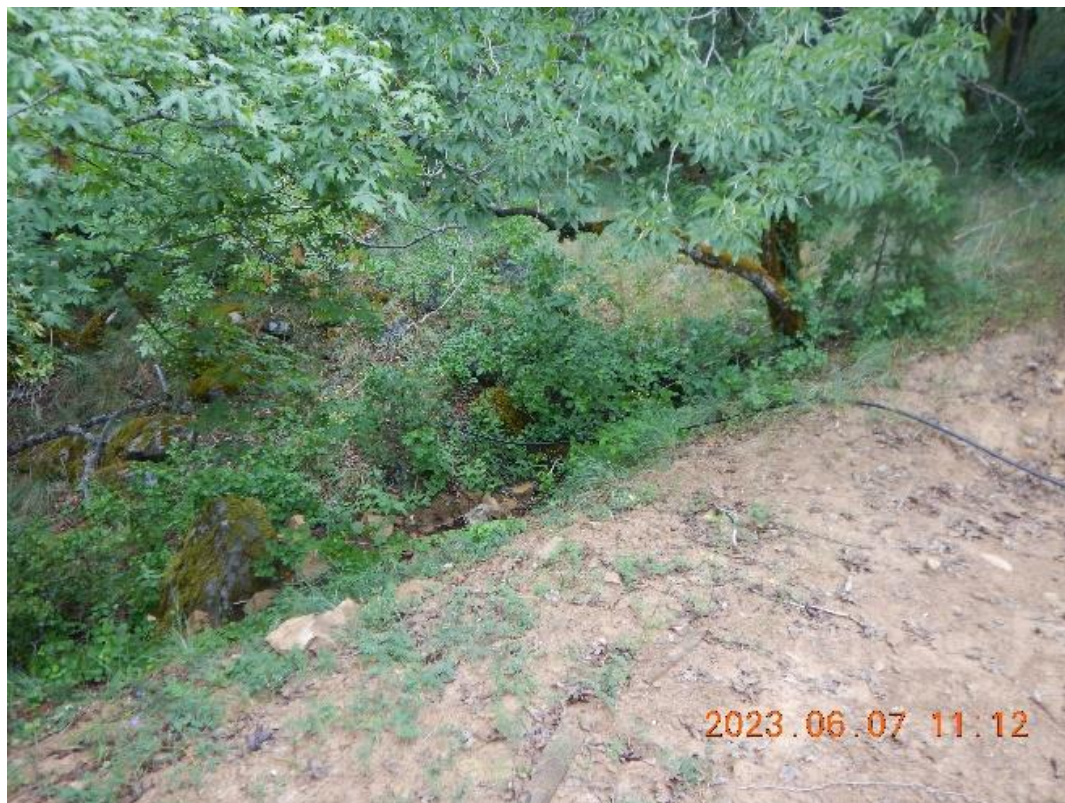
Figure 41. Graded area on Class II watercourse.

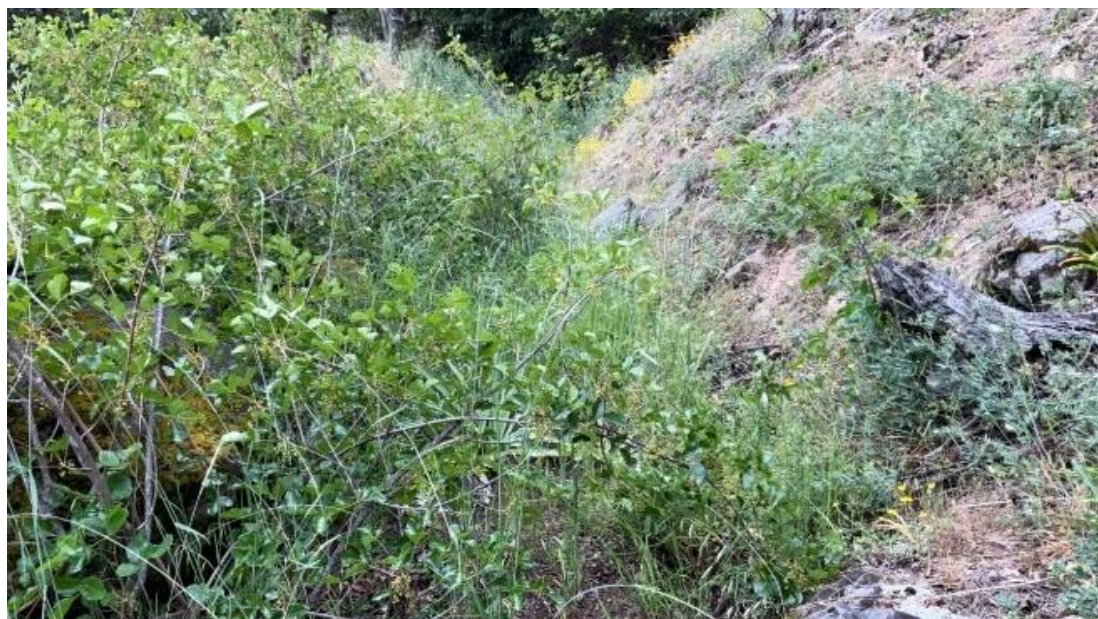
Diversion Creek (39.838250, -123.531973). Upslope of CA3, a watercourse is diverted from its natural flow path to the Class II watercourse to go around CA3.

Figure 42. Alteration of stream upslope of CA3, diverts creek to Class II watercourse. Photo is facing south and is downstream of natural channel.

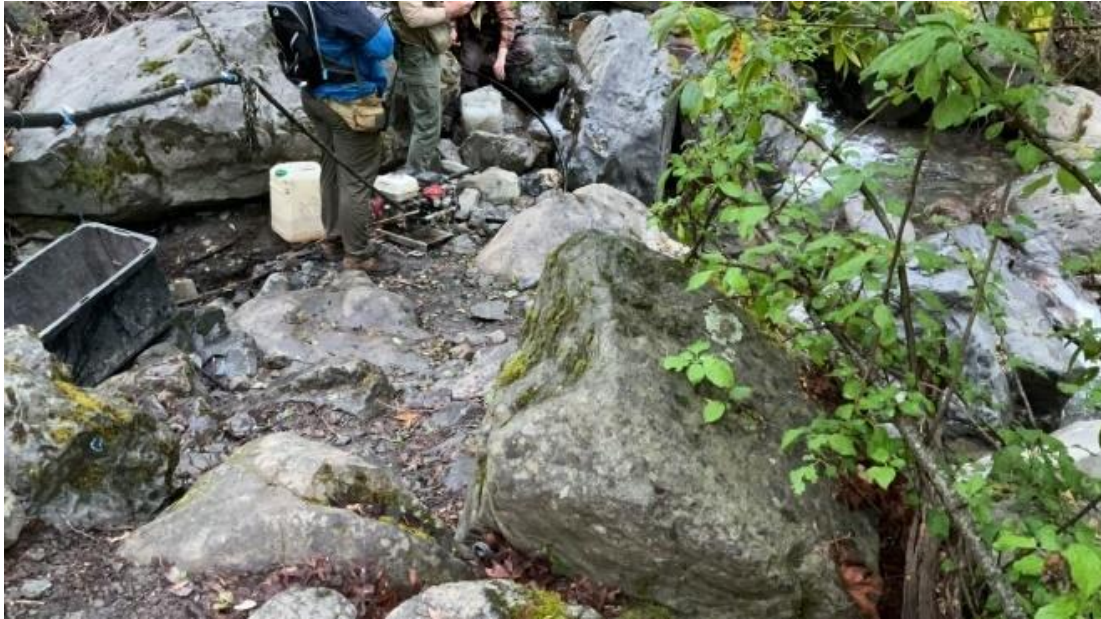
Pump 2 (39.837661, -123.531629) located on stream gravels.

Figure 43. Below CA3, Pump 2 was located on the gravels of a blue-line stream, posing threat of discharge of petroleum products.

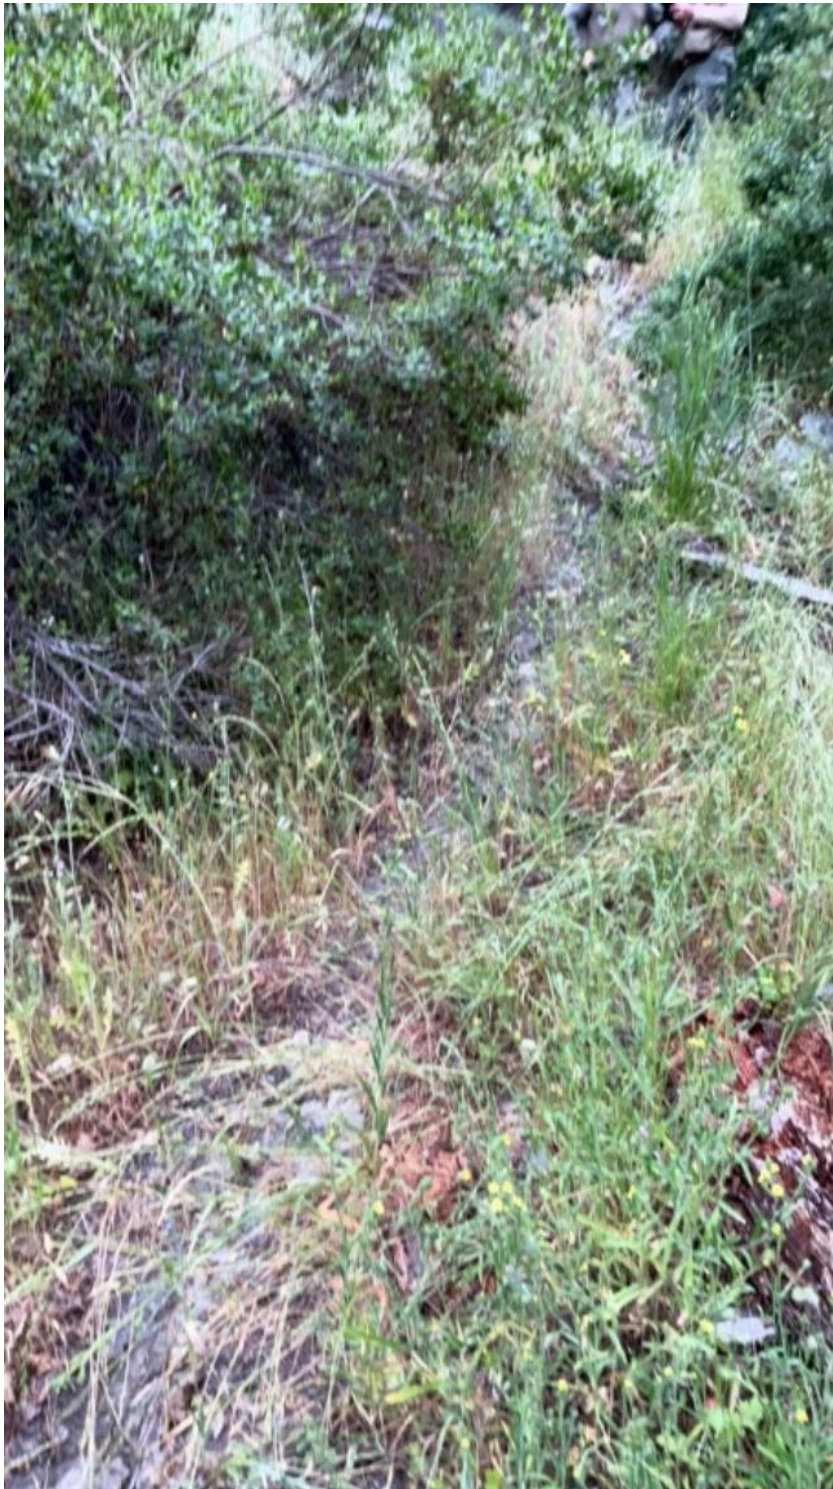
Sed Del (39.837680, -123.531813) to blue line stream from road runoff.

Figure 44. Below CA3, a steep road segment is undrained and surface erosion has resulted in sediment transport and delivery to the blue line watercourse.

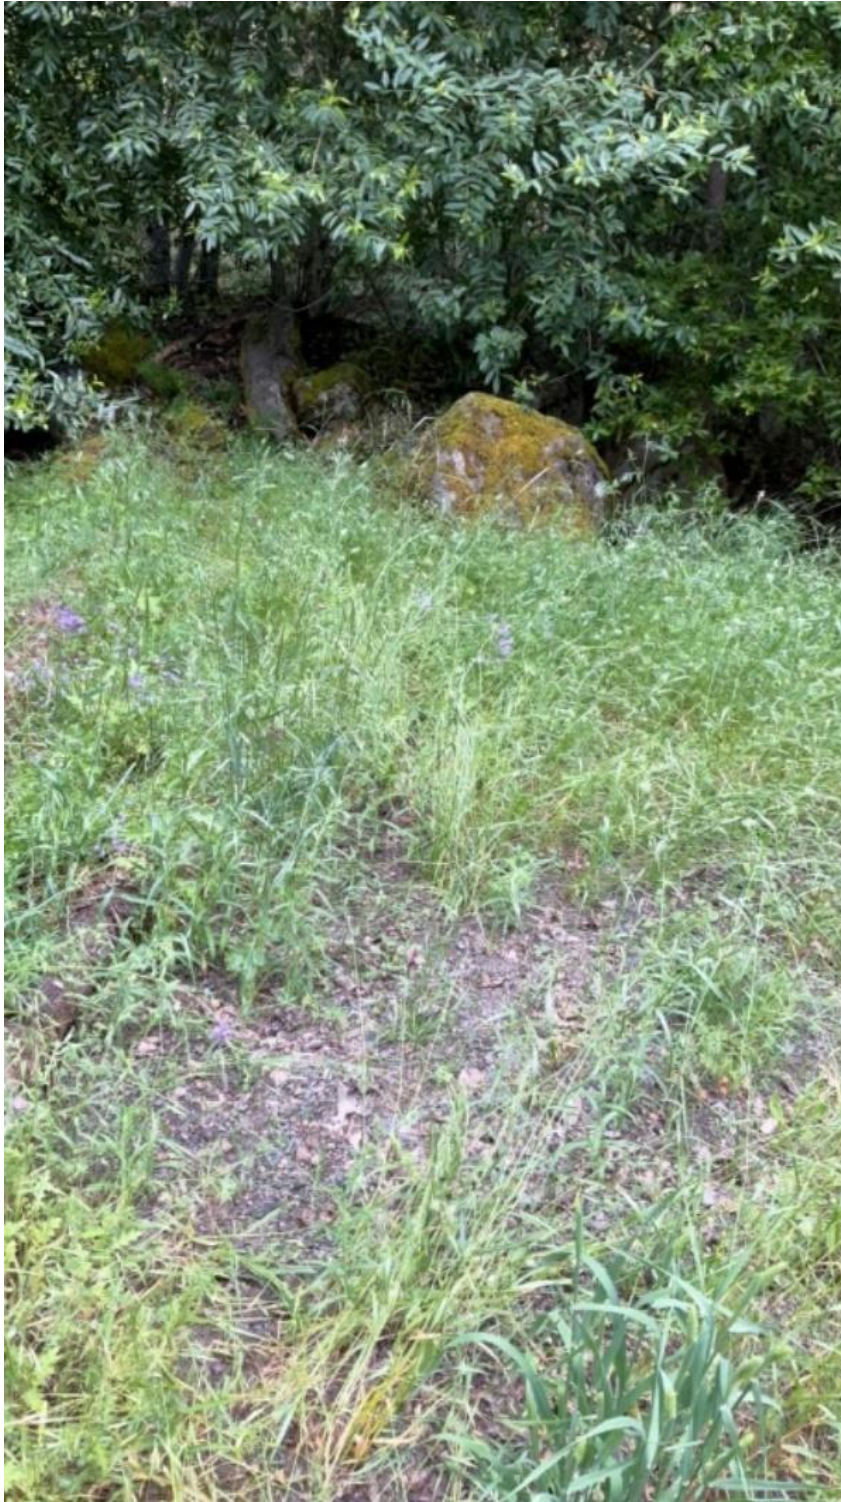
Figure 45. The sediment deposition path was evident to the edge of the vertical slope above the blue line watercourse.

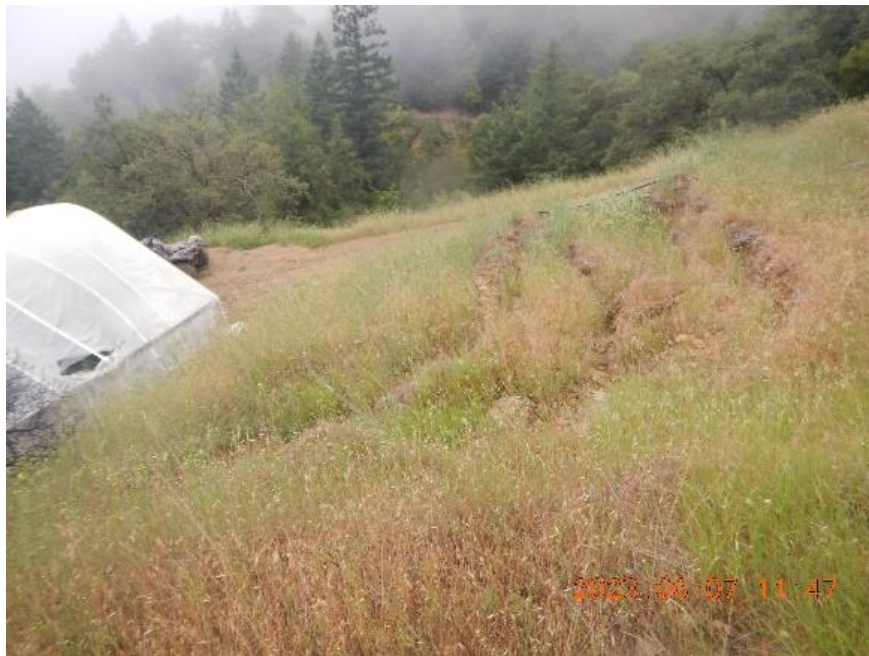
Figure 46. Concentric scarps associated with cut bank of CA4.

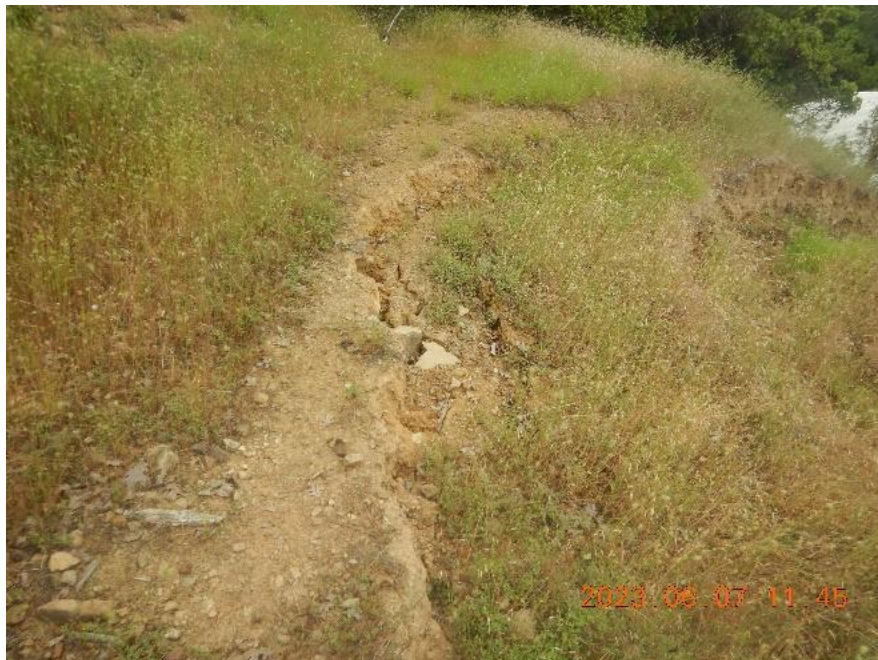
Figure 47. CA4 scarp.

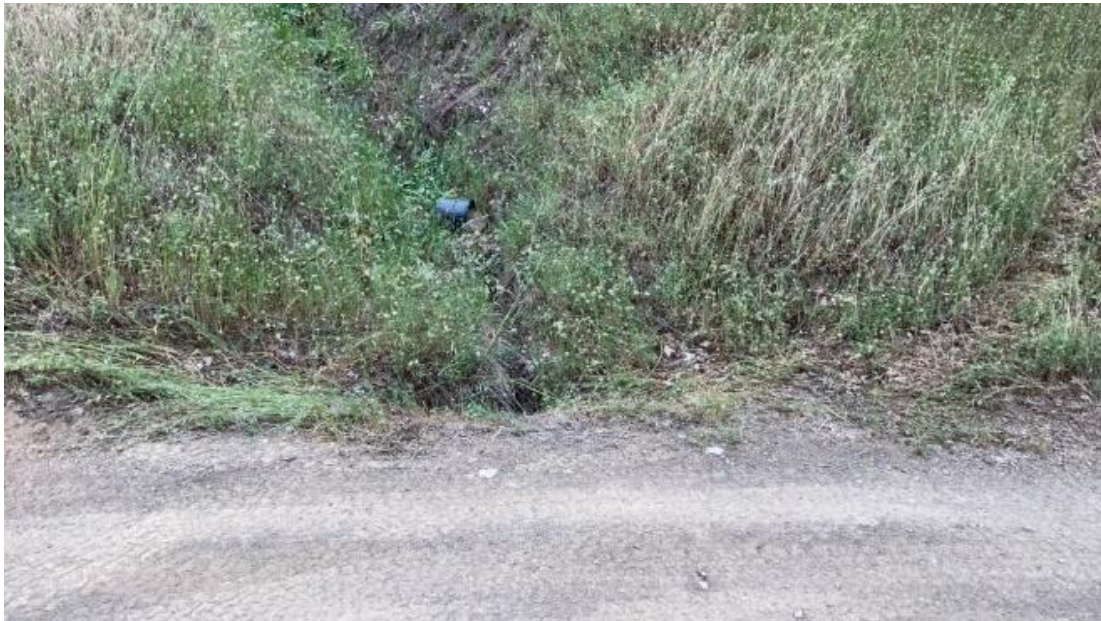
X4 (39.837228, -123.534511) and X6 (39.837167, -123.535020) are undersized culverts with road sediment delivery.

Figure 48. X4 inlet (facing SW). Undersized pipe, road sediment delivery.

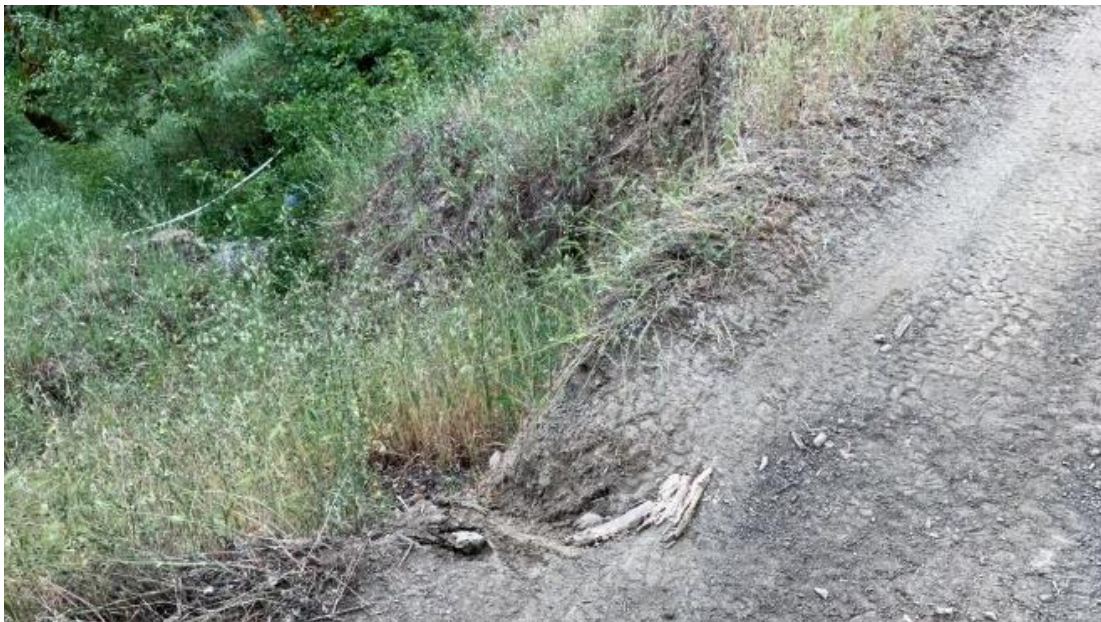
Figure 49. outlet of X4 crossing (facing E).

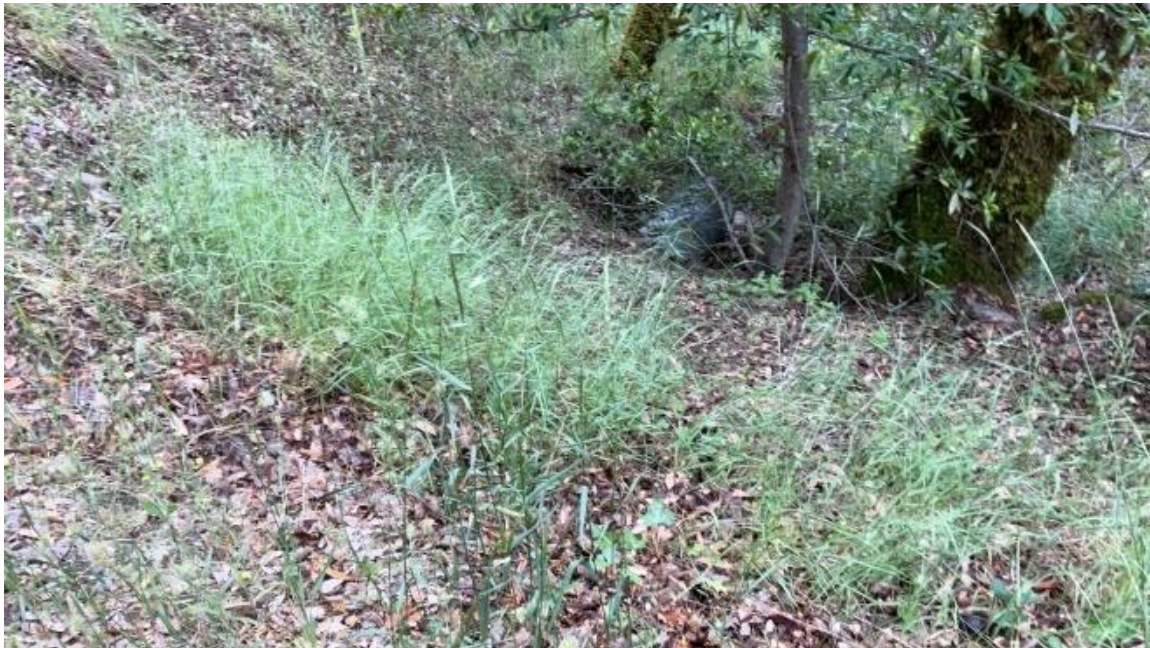
Figure 50. X6. 18 inch culvert perched 20 feet, undersized for channel, with road sediment delivery.

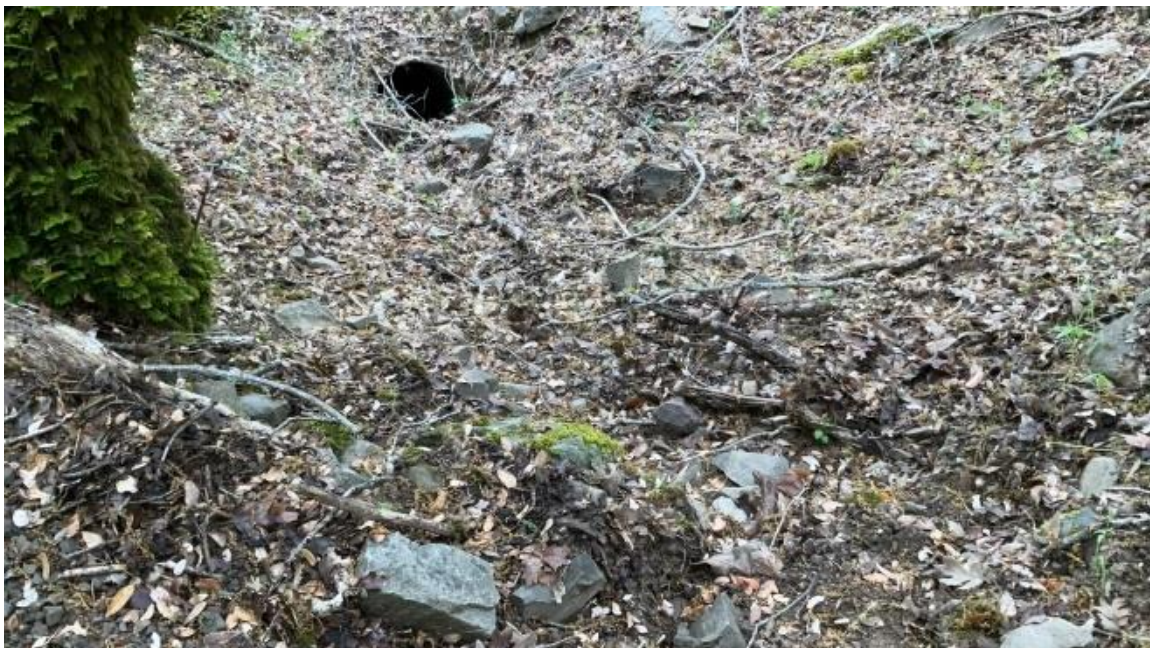
Figure 51. X6 inlet.

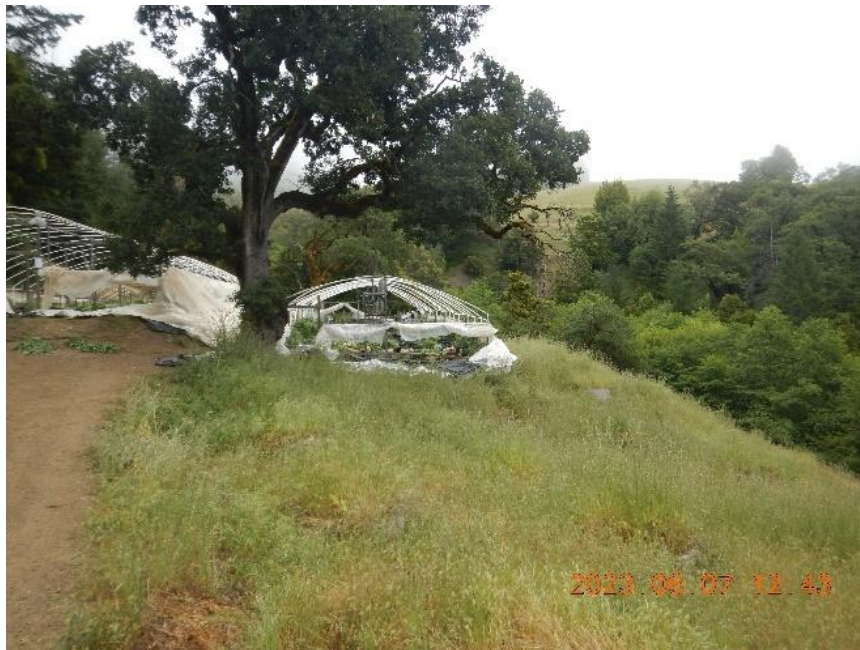
Figure 52. CA5.

CA5 (39.837534, -123.533843) built near swale.

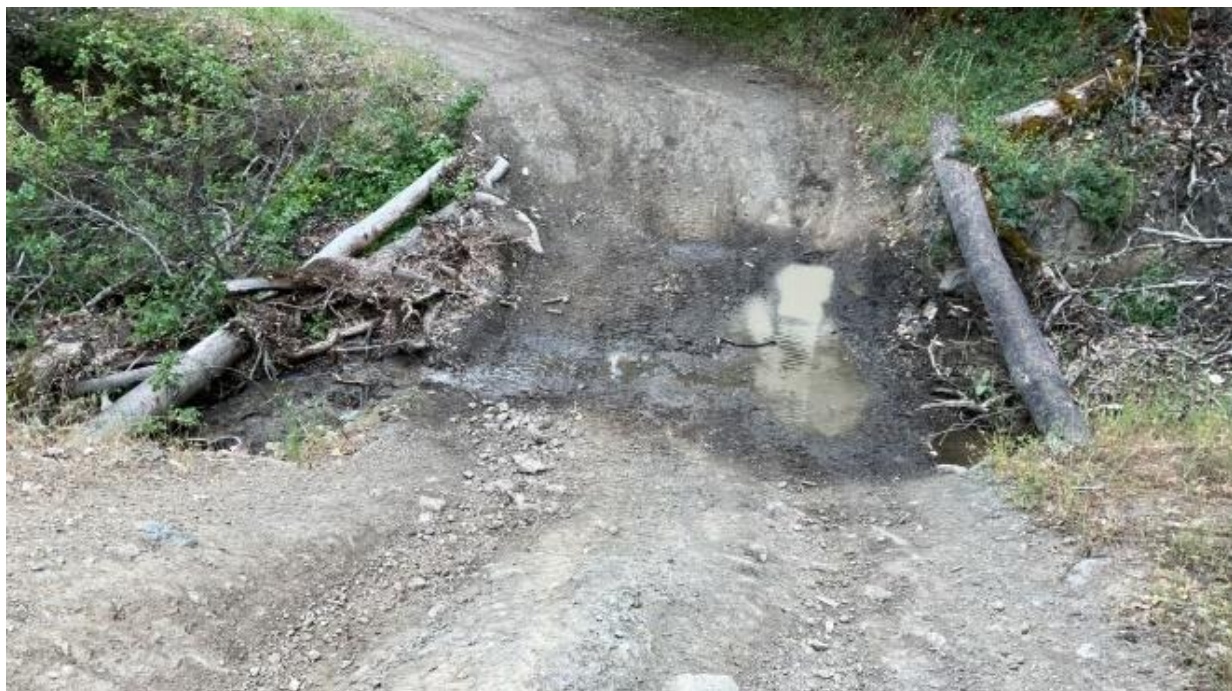
X7 is an earthen ford on a blue line stream with much debris in watercourse, and rutted mud tracks from crossing.

Figure 53. X7. Ford over a blue line Class II watercourse with debris in channel and rutted mud tracks. Presence and use of the crossing result in sediment discharge. View facing SE, from left bank, downstream to left of photo.

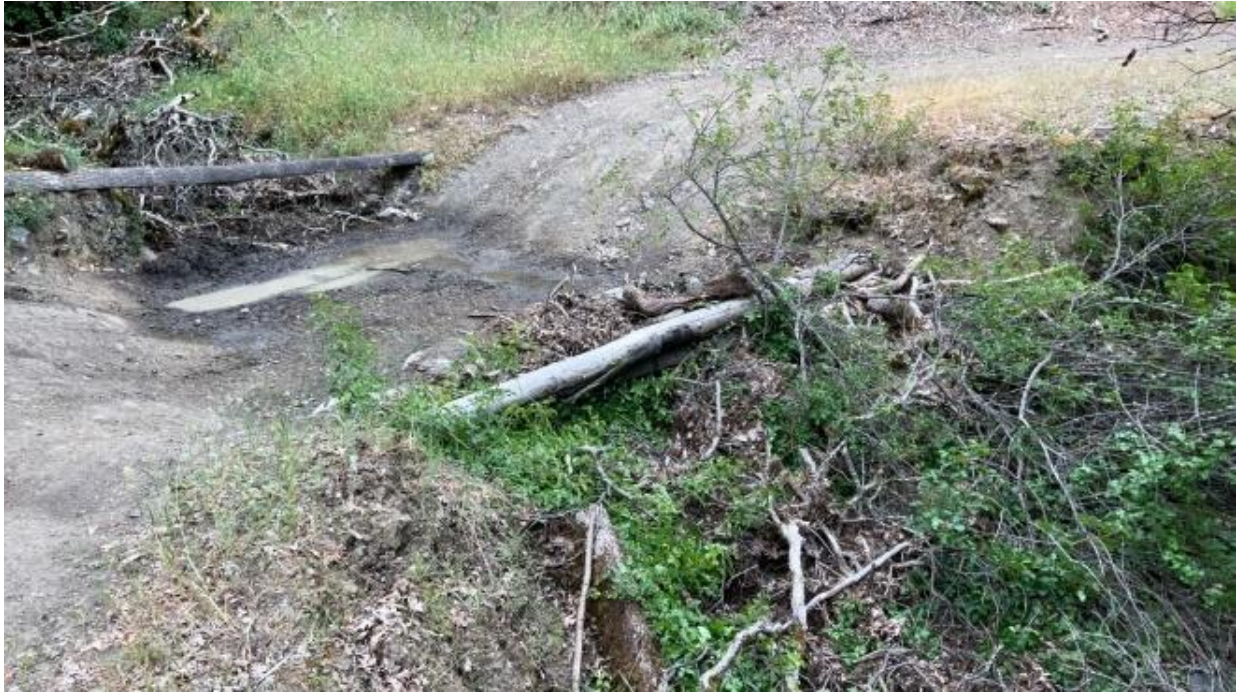
Figure 54. X7. Facing west, from right bank, downstream is to the right of photo.
