North Coast Regional Water Quality Control Board

INSPECTION MEMO

Eel River Scrap and Salvage
850 Riverwalk Dr.
Fortuna, Humboldt County

WDID #: 1 12I017276

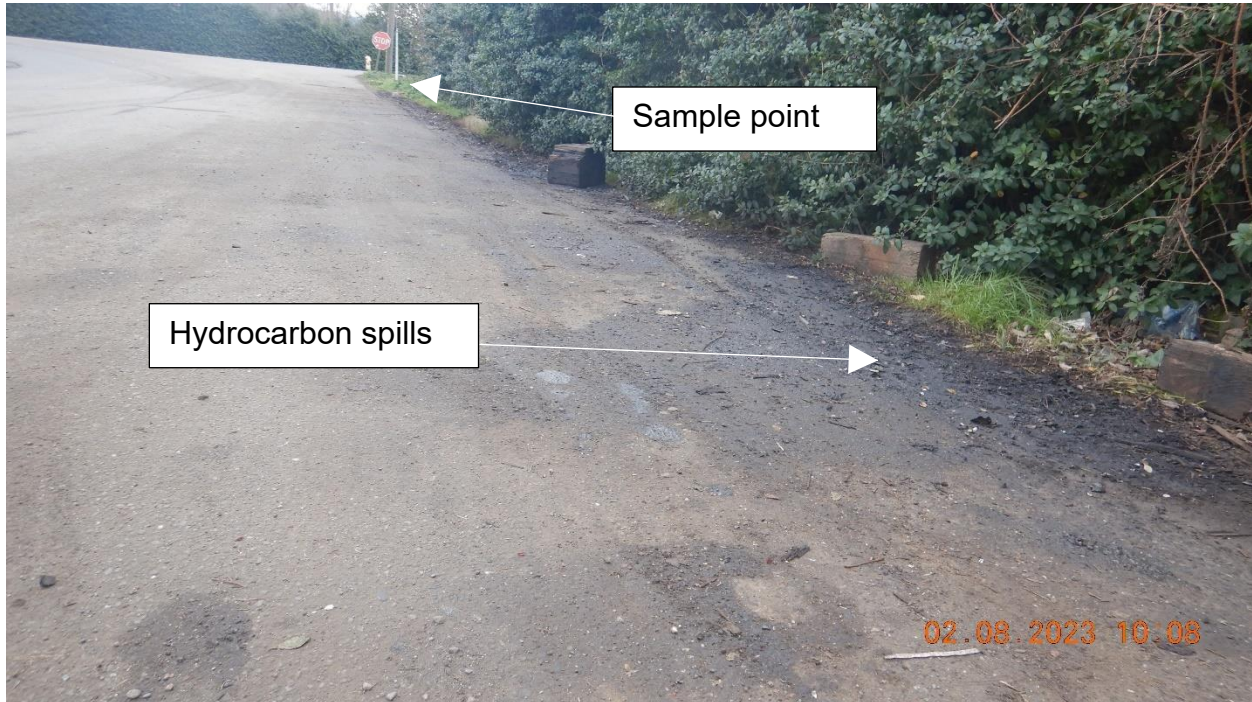
We walked through the Facility and inspected the eastern portion of the Facility where the samples are collected. Hydrocarbon spills were observed within this area (Picture 1). Also, hydrocarbon spills and oil sheens were observed on the ground at multiple locations including the fueling storage areas (Pictures 4a, 4b, 11, 17a, 17b). I reminded Mr. Weitz that the Facility is currently at level 1 status for Oil and Grease due to annual NAL exceedances during previous reporting years. I stated that it is critical to ensure that the spill prevention and response requirements are fully met at the Facility and Facility crew is properly trained.

Picture 1- View of the Hydrocarbon spills on the ground upstream of sampling point at the southeast corner of the Facility. Picture taken by Farzad Kasmaei.

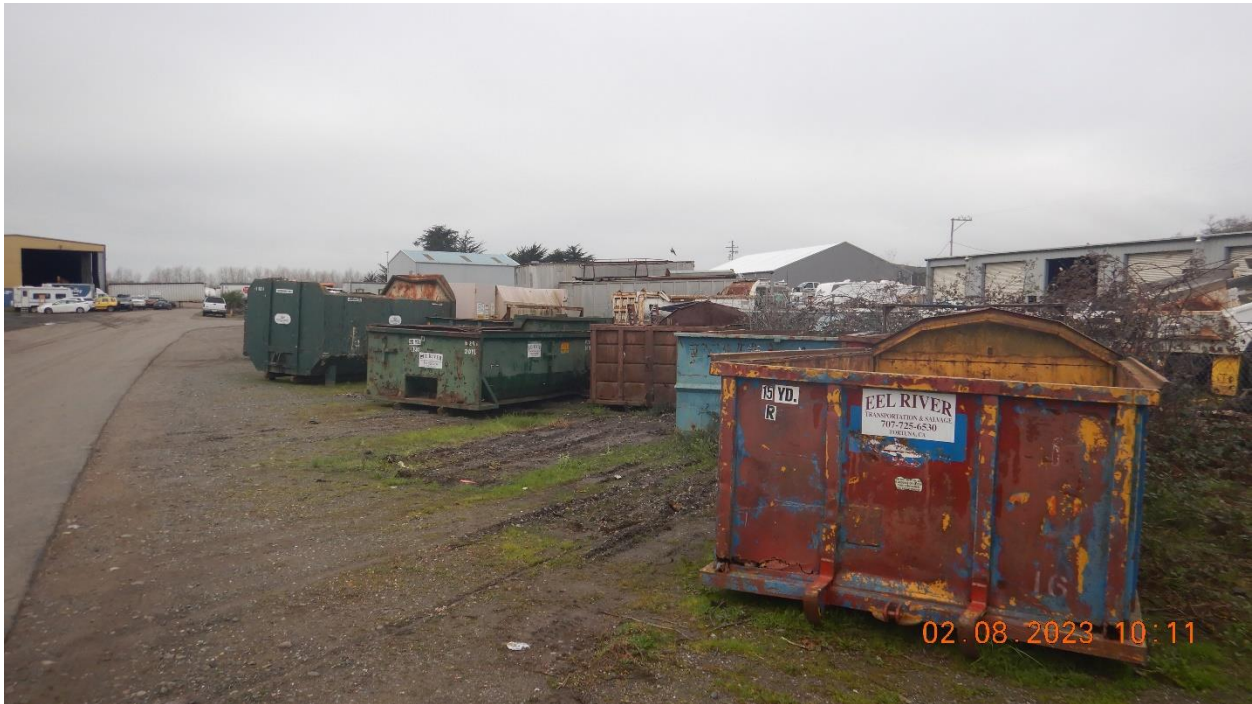
Most of the dumpsters, drums, and barrels that are used to store wastes and scrap metals are very old, rusty, and in poor condition. These containers are not sealed, and they are not equipped with appropriate lids to minimize the exposure of industrial materials to rain (Pictures 2, 8, 13 and 18). Using lidded and sealed dumpsters/containments was strongly suggested since these rusty containments can be considered as pollutant sources.

Picture 2- View of the old and rusty dumpsters on the east side of the Facility. Picture taken by Farzad Kasmaei.

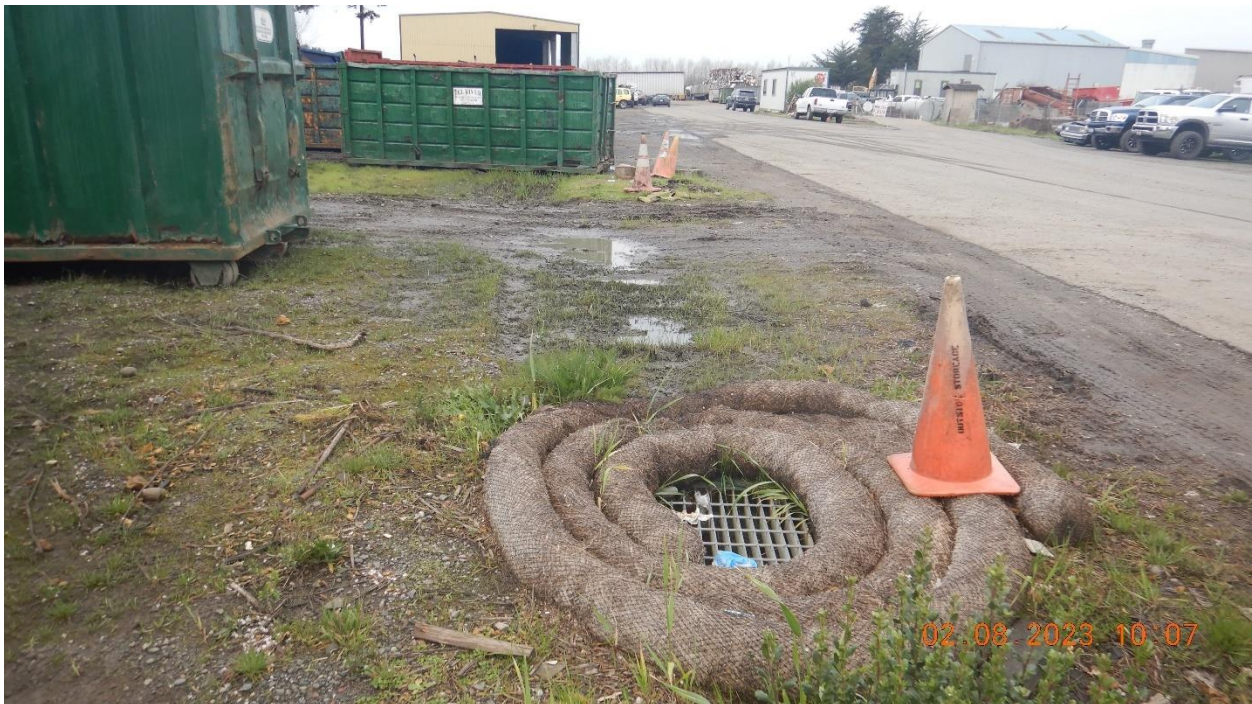
Picture 3- Looking west at the on-site storm drain inlet on the east side of the Facility. Picture taken by Farzad Kasmaei.

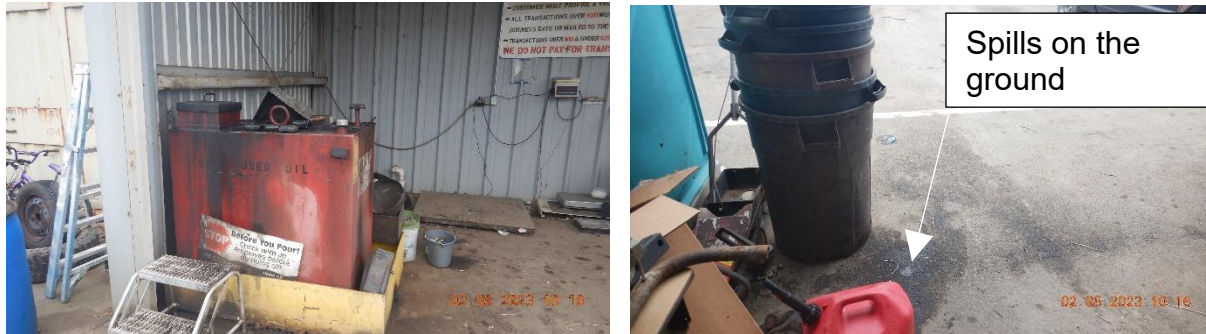
Pictures 4a, 4b - View of the fueling tank and secondary containment stored within a roofed area. Hydrocarbon spill was observed within this area. Picture taken by Farzad Kasmaei.

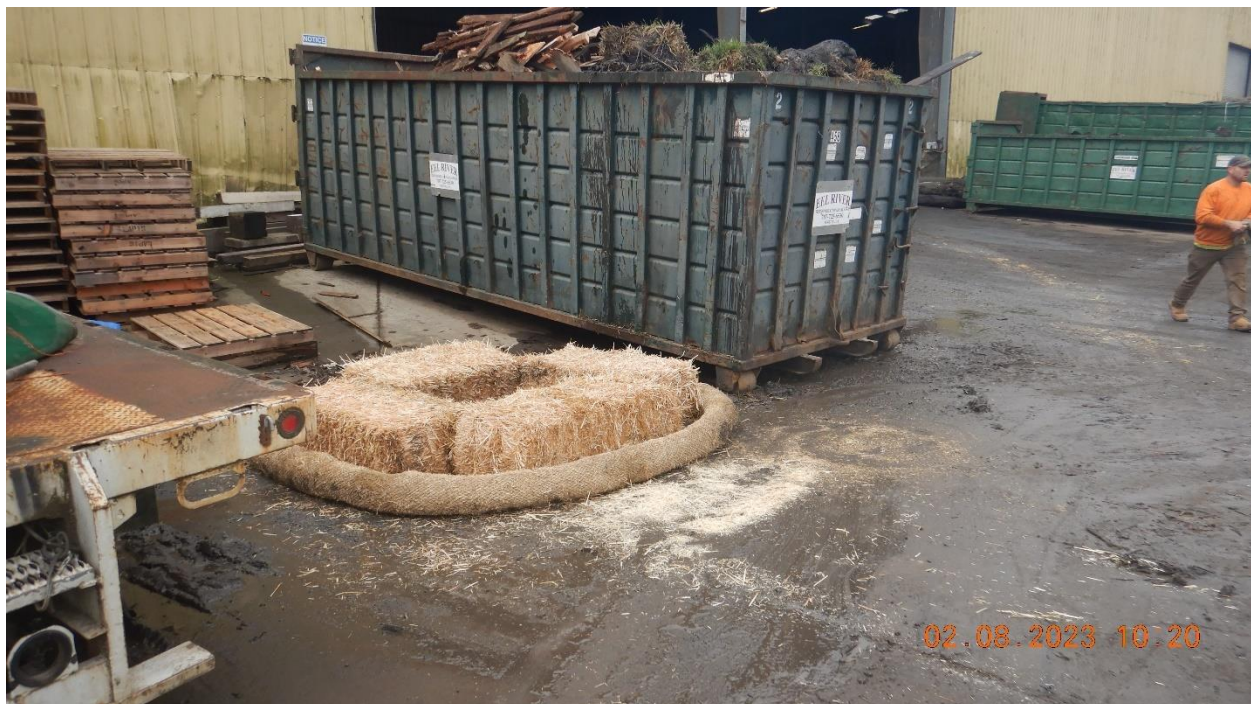
The inlet adjacent to the C&D building that is one of the Facility's sampling points was protected by haybales and fiber rolls (Pictures 5 and 6). An uncovered dumpsters full of scrap metals and wastes was stored adjacent to this inlet. Also, this inlet partially receives runoff from the areas where scrap metal stockpiles are stored. I reminded the Discharger that the Facility is currently at level 2 status for multiple metals due to several annual NAL exceedances that were occurred for those parameters during the past reporting years. Per the IGP, a site assessment must be conducted, and a technical report must be prepared by a QISP². I stated that adequate/effective BMPs

Picture 5- View of a storm drain inlet (sampling point) adjacent to an uncovered dumpster containing waste materials. Haybales and fiber rolls are used for inlet protection. Picture taken by Farzad Kasmaei.

must be implemented and installed in accordance with the ERA technical report. Also, the site map and SWPPP must be updated accordingly. These documents have not been submitted via SMARTs and are past due.

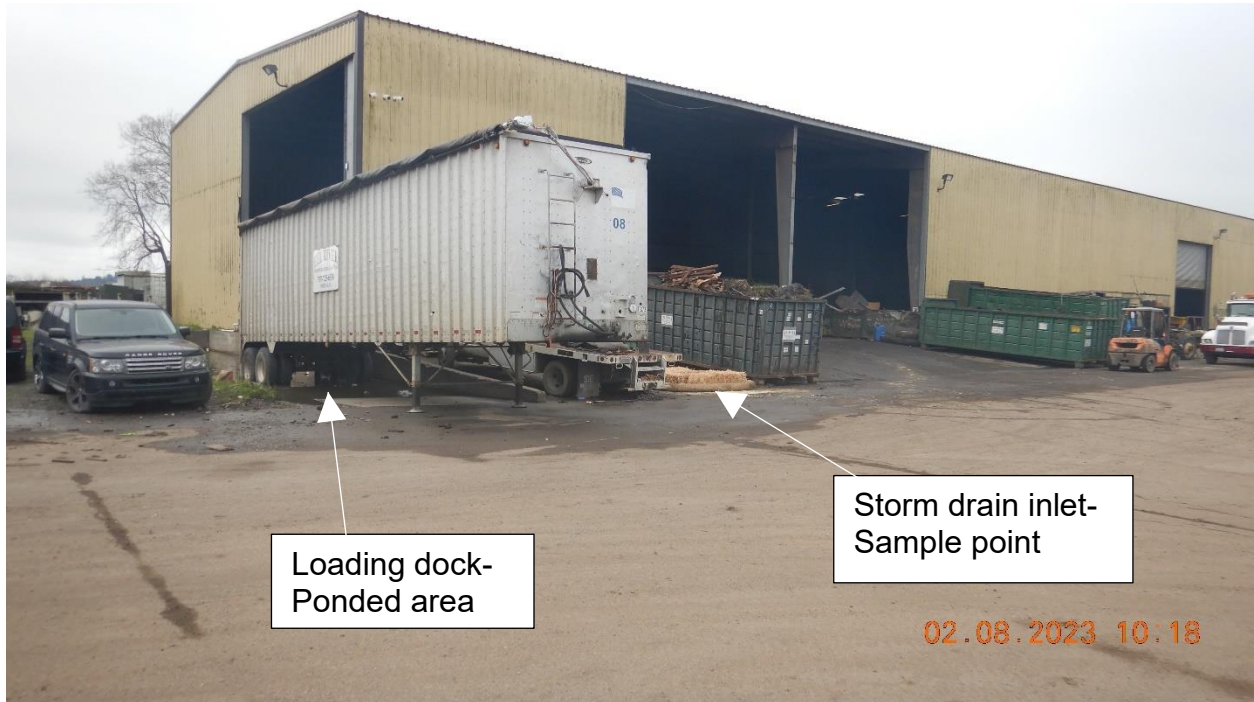
The warehouse where the Construction and Demolition Debris (C&D materials) are received and processed was inspected. Due to lack of maintenance, the storm drain inlet located at the low point of the loading dock adjacent to the warehouse was plugged. As a result, the loading dock was full of stormwater remaining from previous storm events (Picture 6). The Discharger was informed that all storm drainage systems including the stormwater drain inlets and drainage ditches must be maintained routinely, specifically prior to each Qualifying Storm Events (QSEs).

Picture 6- View of the existing warehouse where C&D materials are received and processed. Ponded area within the loading dock adjacent to the warehouse. Picture taken by Farzad Kasmaei.

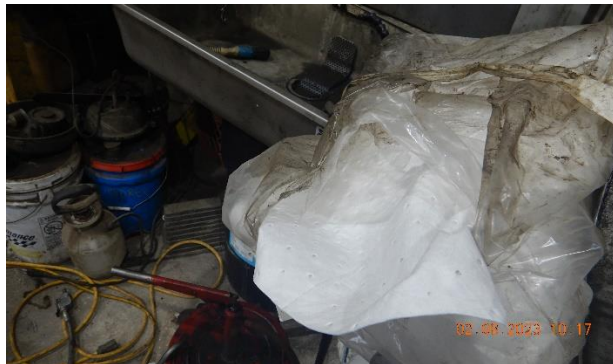
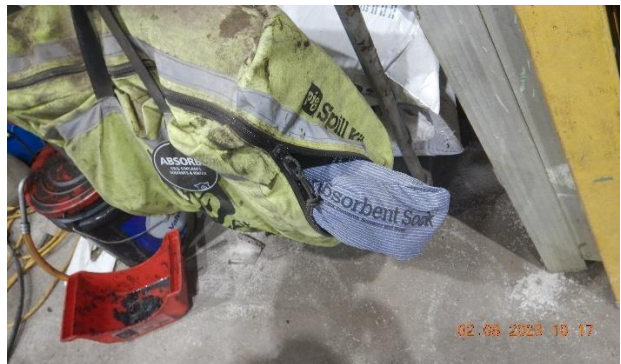
I also notified the Discharger that even if hydrocarbon spills originate from contractor's trucks not owned by the Discharger, it is LRP's responsibility to ensure that his contractor are using well-maintained vehicles and equipment and that spills are prevented and managed. The spill prevention kits were available on-site as required by IGP (Pictures 7a and 7b) but were not in use to address the observed spills.

Pictures 7a, 7b – Picture of spill prevention kit including absorbent pads and socks. Picture taken by Farzad Kasmaei.

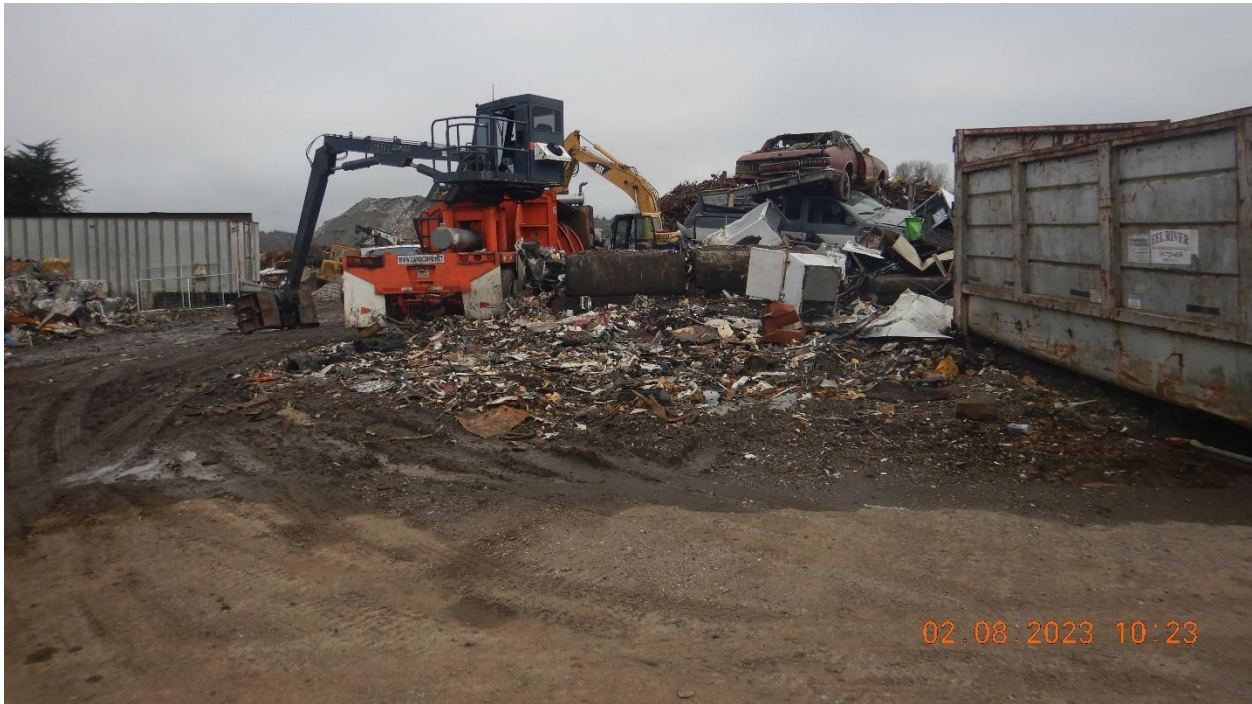
Significant amount of waste stockpiles including scrap metals and rusty auto parts were observed throughout the Facility with no adequate/effective BMPs (Pictures 8, 12, 14 and 15). Housekeeping and source control is not implemented at the Facility, which is a violation of the IGP requirements.

Picture 8- View of wastes on the ground with no BMPs in place. All dumpsters at the Facility are uncovered, in poor condition, and significantly rusty. Picture taken by Farzad Kasmaei.

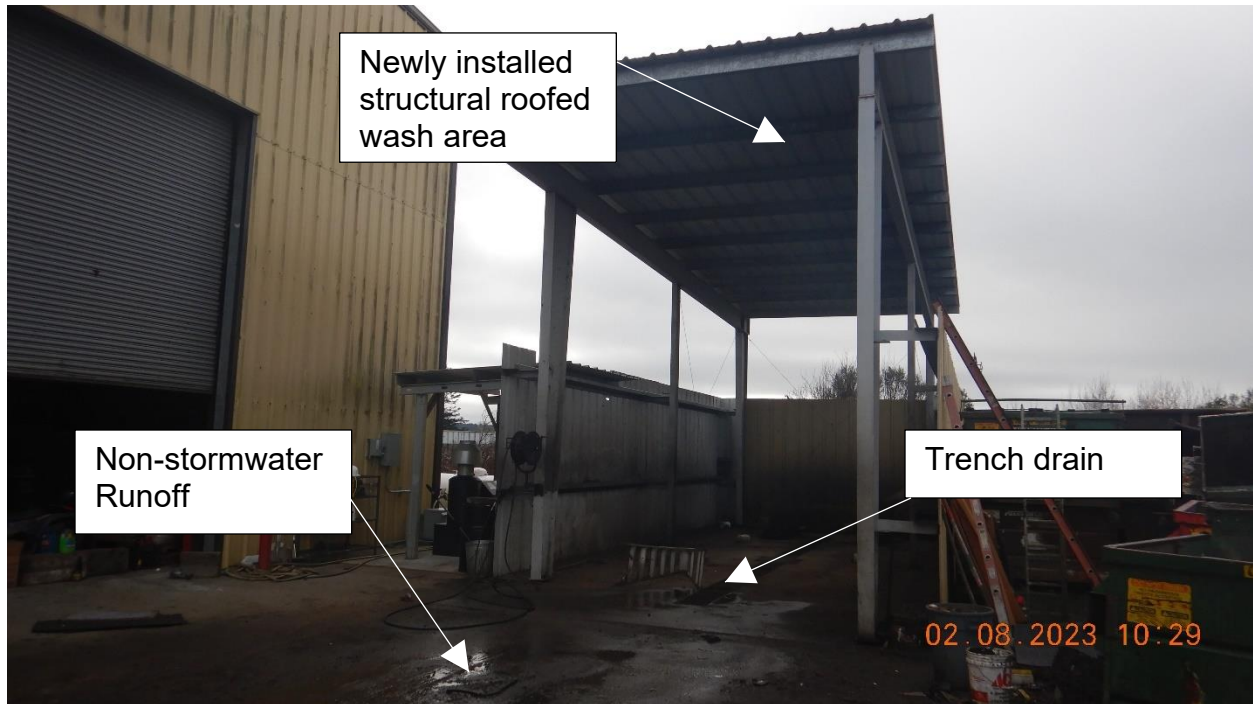
The newly installed structural cover within the truck washing area was then inspected. The existing trench drain under the roofed area is connected to an oil/water separator system; however, it does not fully capture the wash/rinse water and associated hydrocarbons. Non-stormwater runoff was observed on the ground flowing toward the storm drain inlet beyond the covered truck washing area (Pictures 9 and 10). Oil sheen was observed in this runoff. I notified the Discharger that they needed to proceed with the corrective actions in a manner to avoid any unauthorized non-stormwater discharges. The Discharger was reminded to meet the non-stormwater discharge requirements including sampling and reporting when such unauthorized discharges occur.

Picture 9- View of the newly installed structural covered area where the trucks are washed. Wash/rinse water (non-stormwater) is not fully captured within the existing trench drain that is connected to the oil/water separator. Picture taken by Farzad Kasmaei.

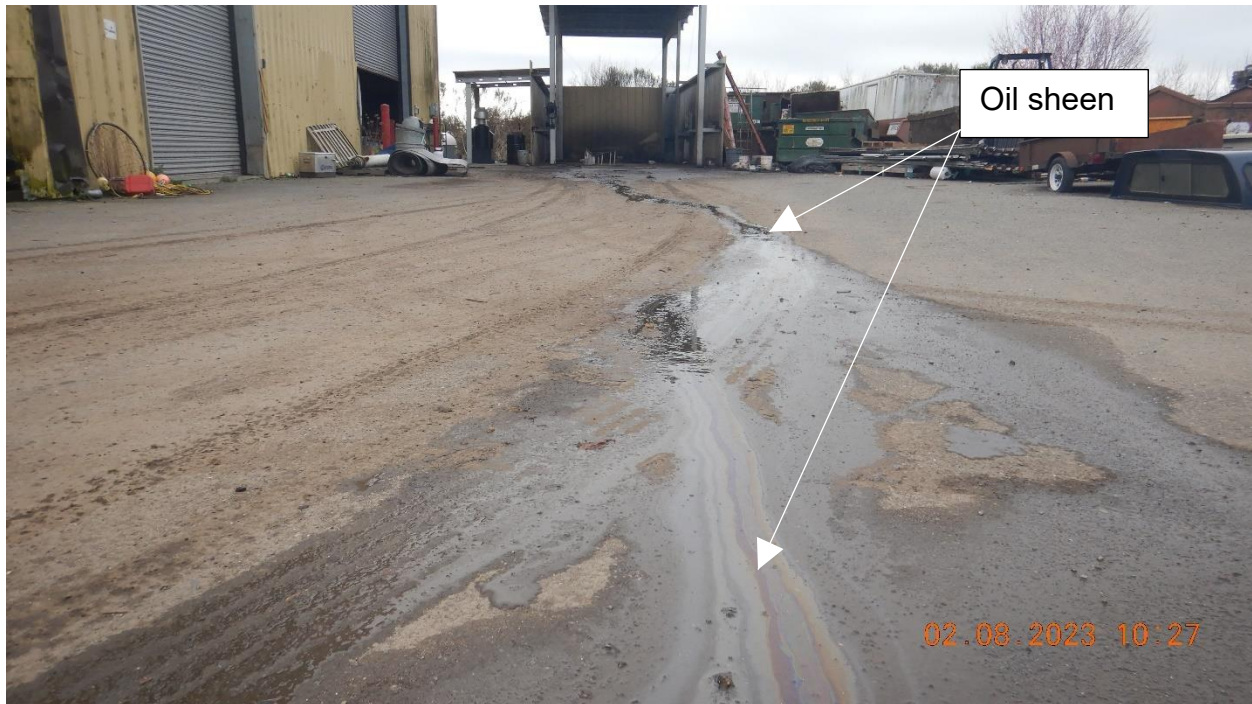
Picture 10 - View of non-stormwater runoff from truck washing area. Oil sheen was observed on the surface of runoff. Generated runoff within this paved area discharges to an onsite storm drain inlet. Picture taken by Farzad Kasmaei.
Pic

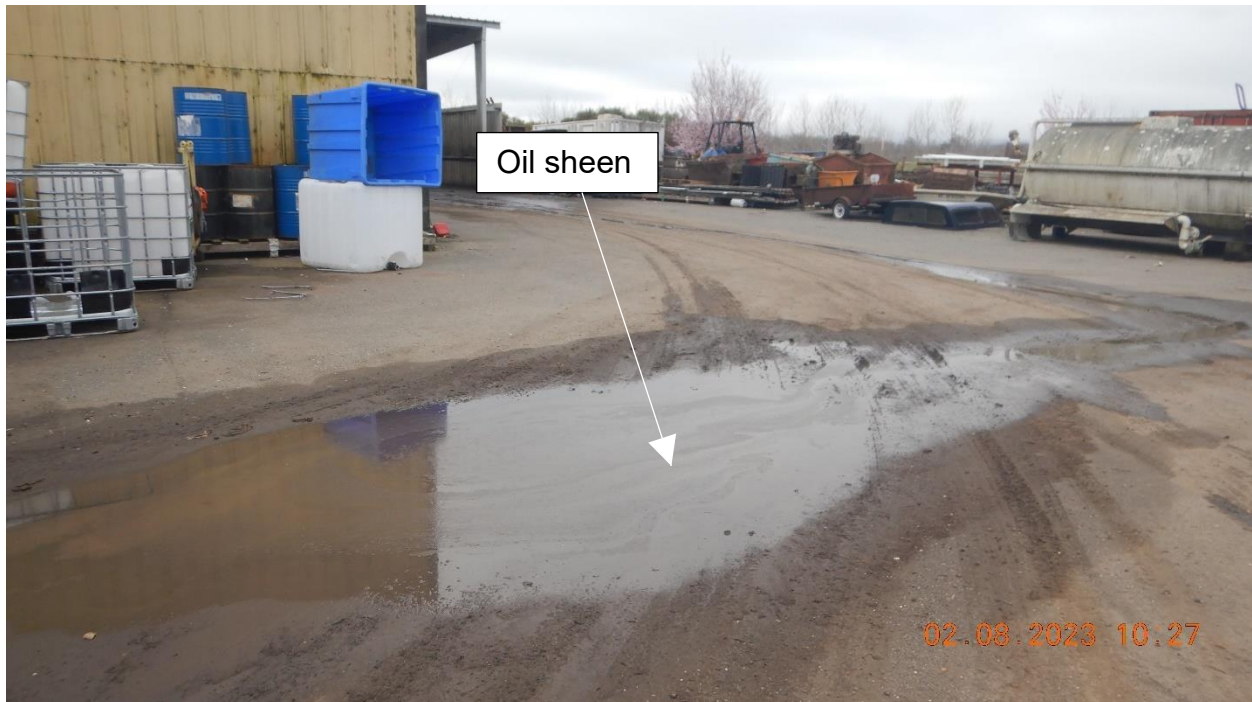
Picture 11 - View of oil sheen that was observed within a ponded area. Picture taken by Farzad Kasmaei.

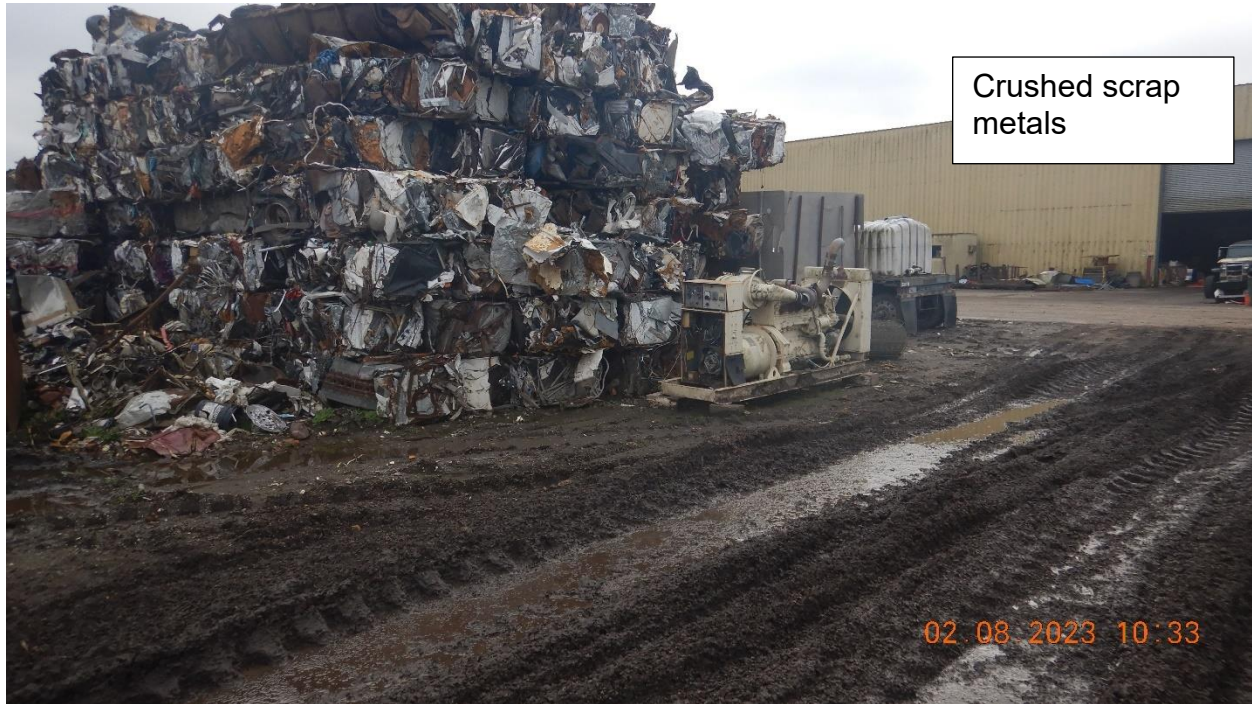
Picture 12 - View of the scrap metals that are baled/crushed and stored within the unpaved area. No BMPs observed to minimize the exposure of industrial materials (pollutant sources) to rain. Picture taken by Farzad Kasmaei.

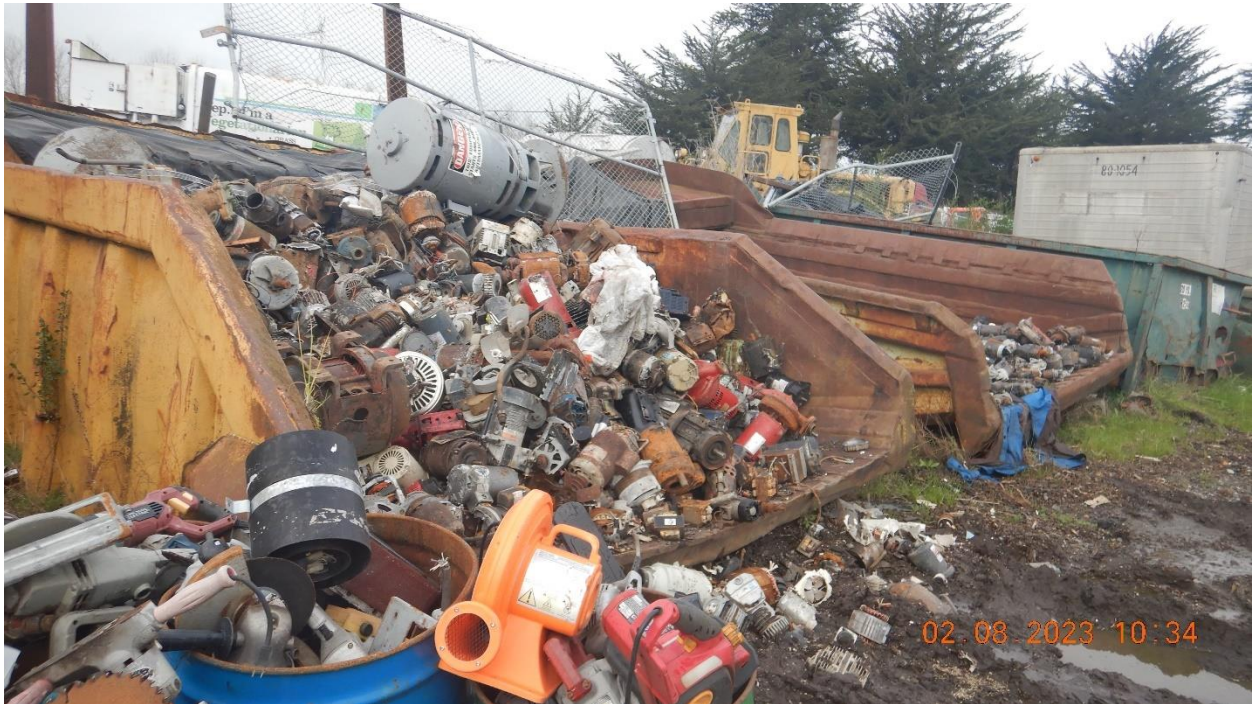
Picture 13 – View of the rusty auto parts and scrap metals that are stored in very old and rusty containments on the west side of the Facility. These storage bins are not sealed, and no lids or appropriate covers are provided. Picture taken by Farzad Kasmaei.

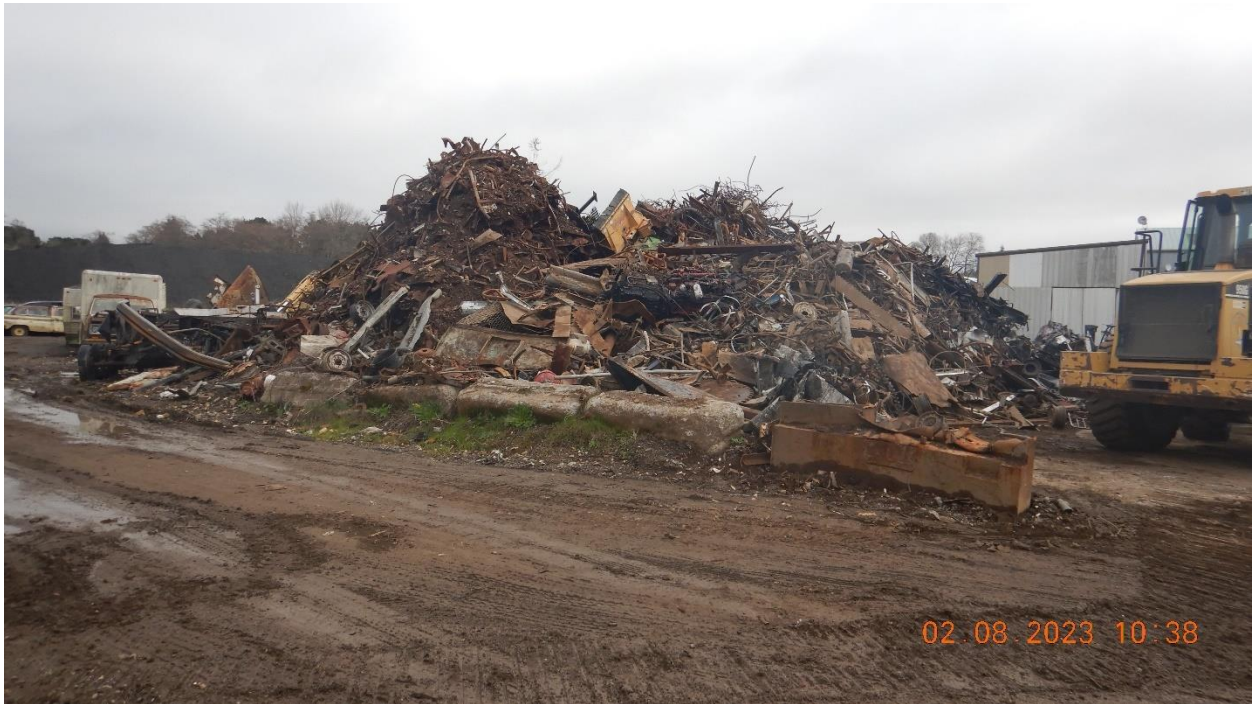
Picture 14 – View of scrap metals and wastes stockpile that are stored on the unpaved area. Source control is not implemented and no BMPs were observed to minimize the exposure to rain. The concrete blocks installed around the waste materials is not considered as a perimeter control BMPs and they are not effective. Picture taken by Farzad Kasmaei.

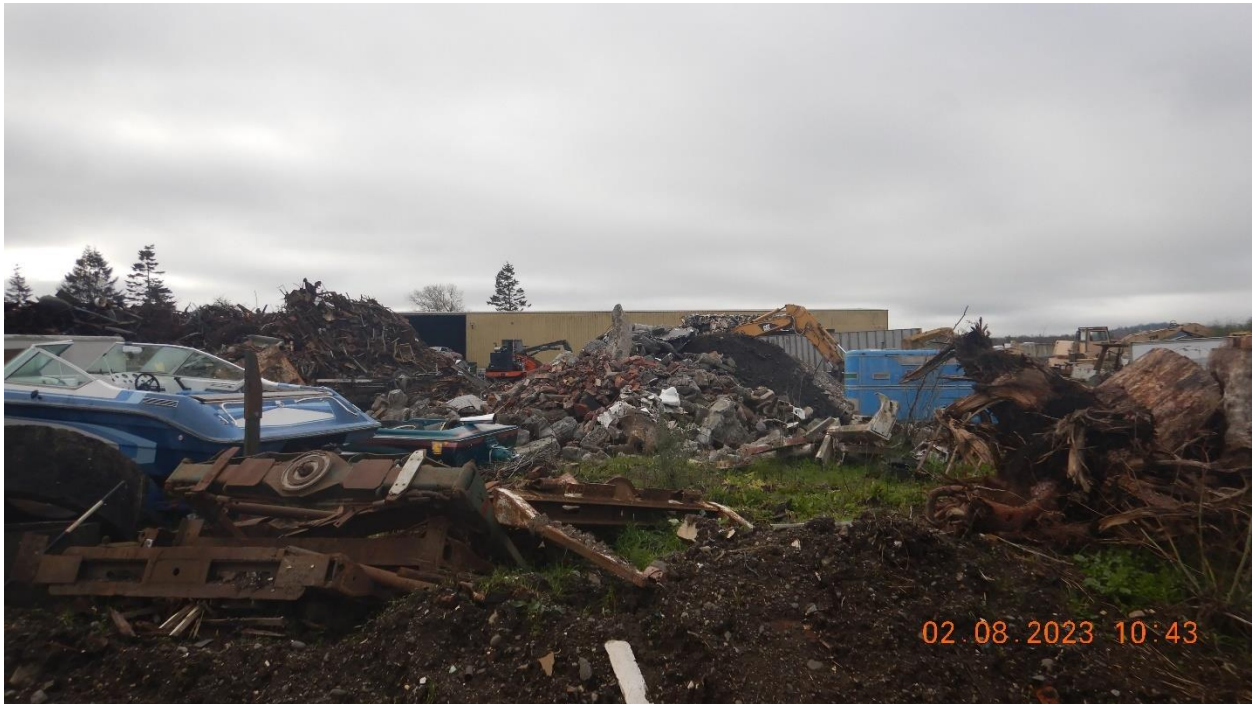
Picture 15 – View of the concrete and scrap metal stockpiles at the central portion of the Facility. Runoff from this area is discharged ton an on-site drainage ditch, that is in need of maintenance, before eventually discharging off the site to Strongs Creek. Picture taken by Farzad Kasmaei.

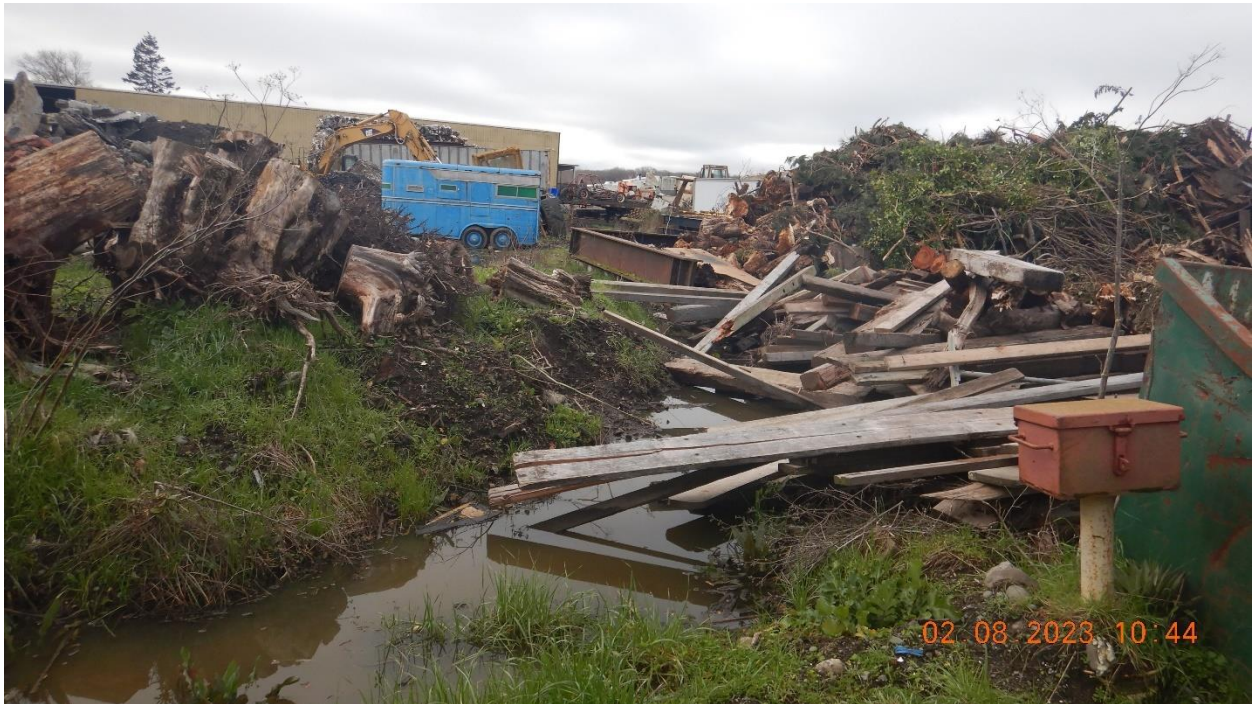
The stormwater drainage system including the existing drainage ditch is in a poor condition and in need of maintenance. Also, the existing site map indicates that check dams shall be installed at the ditch area. However, no check dams were observed during the inspection (Picture 16).

Pictures 16 – View of the existing drainage ditch. The ditch is buried under lumber and wastes and it is not maintained. No check dams were observed within the ditch as indicated on the site map. This drainage ditch eventually discharging off the site to Strongs Creek. Picture taken by Farzad Kasmaei.

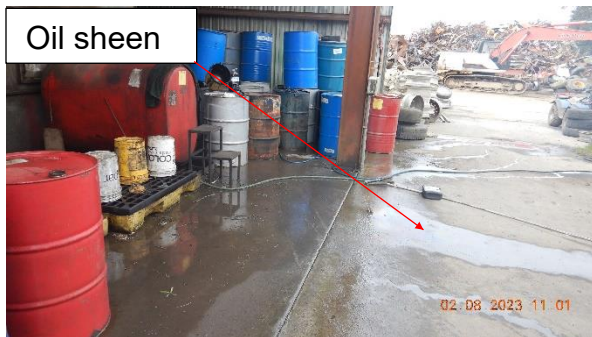
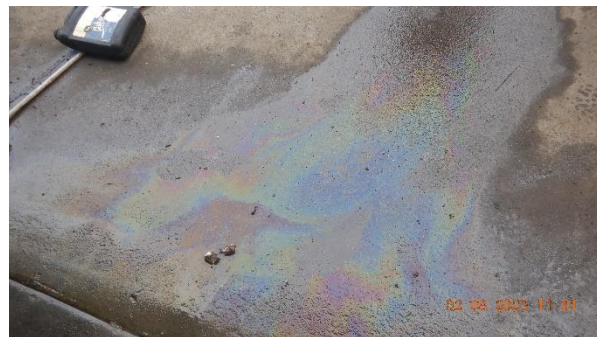
Pictures 17a, 17b – View of the fueling storage area. Oil sheen was observed within this area. No BMPs were present. Picture taken by Farzad Kasmaei.

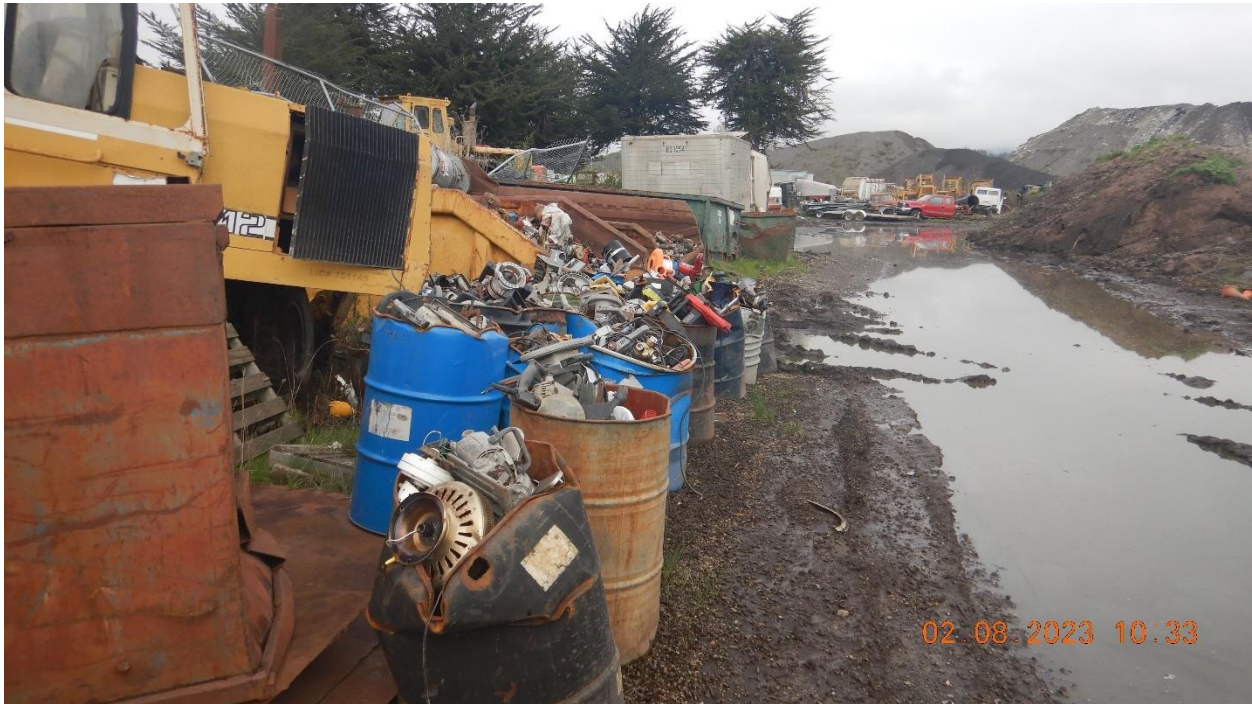
Picture 18 – Looking north at the ponded area within the west side of the Facility. The scrap metals are stored inappropriately in old/rusty barrels. These barrels are in poor conditions and not covered. Note- Background aggregate stockpiles are not associated with this Facility. Picture taken by Farzad Kasmaei.
