North Coast Regional Water Quality Control Board

Inspection Memo

Subject: March 6, 2023, Poppy Creek inspection at 2226 Oakview Court, Santa Rosa.

File: Felipe Olvera, 2226 Oakview Court, Santa Rosa, Sonoma County, APN 180-240-032
WDID No. 1B23027WNSO, ECM PIN: CW-887443,

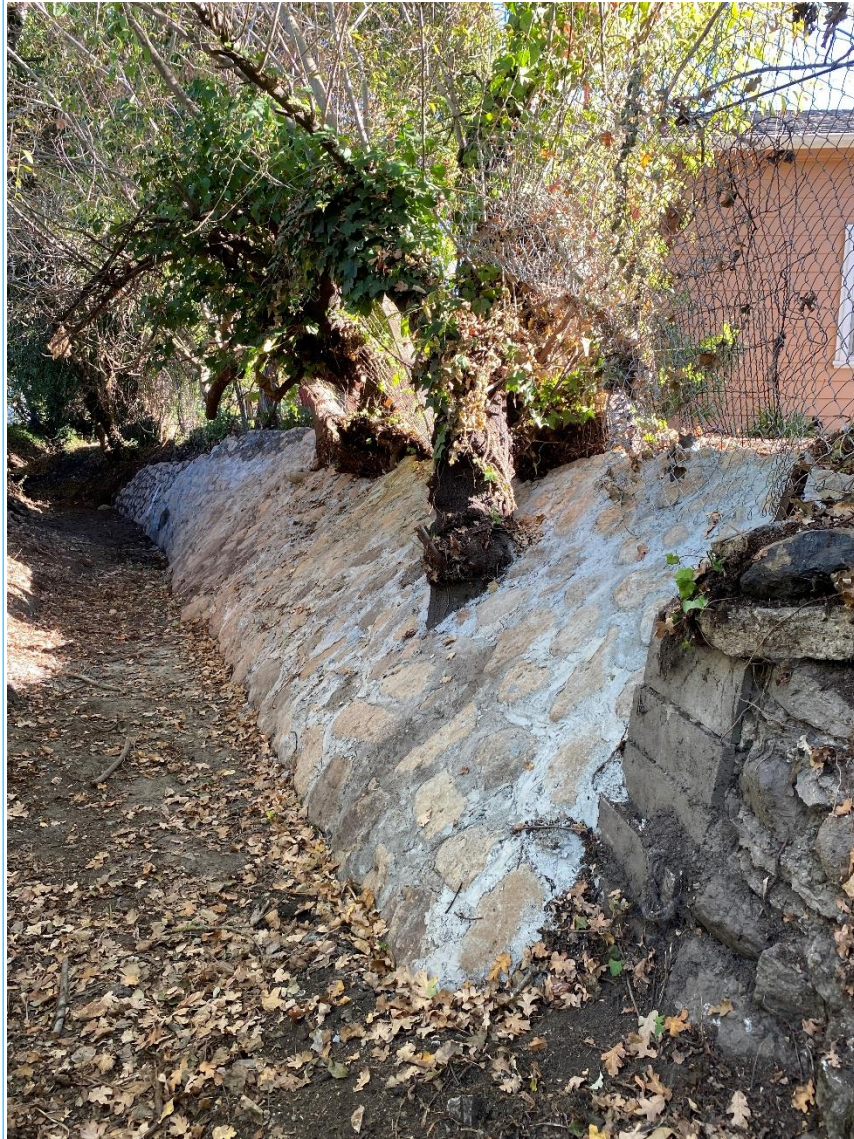
City of Santa Rosa Photograph: Photograph taken by City of Santa Rosa staff prior to October 2022, looking upstream Poppy Creek and showing grouted rock wall at the rear of 2226 Oakview Court, Santa Rosa.

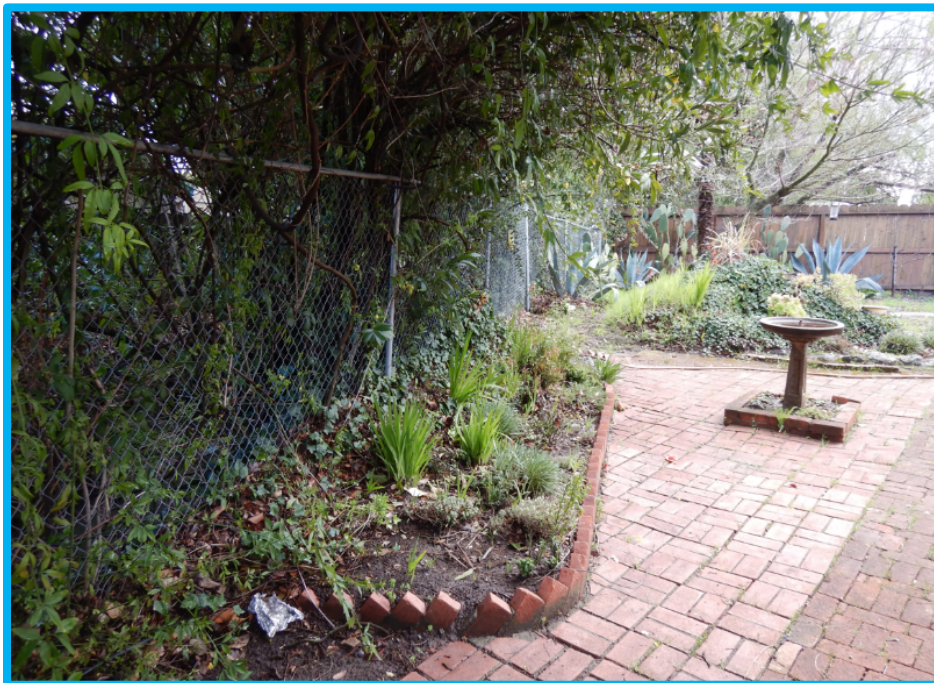
Mr. Stockman provided a brief history of the property. Mr. Olvera's home was built in 1950 as part of the North College Neighborhood. The house has an attached garage and has not been added onto. Mr. Olvera has owned the property since 2016 and has not enlarged his backyard into the streamway (Photograph 1), although the grouted natural rock wall is encroaching into the streamway (City of Santa Rosa Photograph). Poppy Creek channel was historically rerouted to follow property lines through the neighborhood and flows into Paulin Creek near the Sonoma County Administration Center.

Photograph 1: Mr. Olvera's backyard. Poppy creek top-of-bank closely follows the fence line.

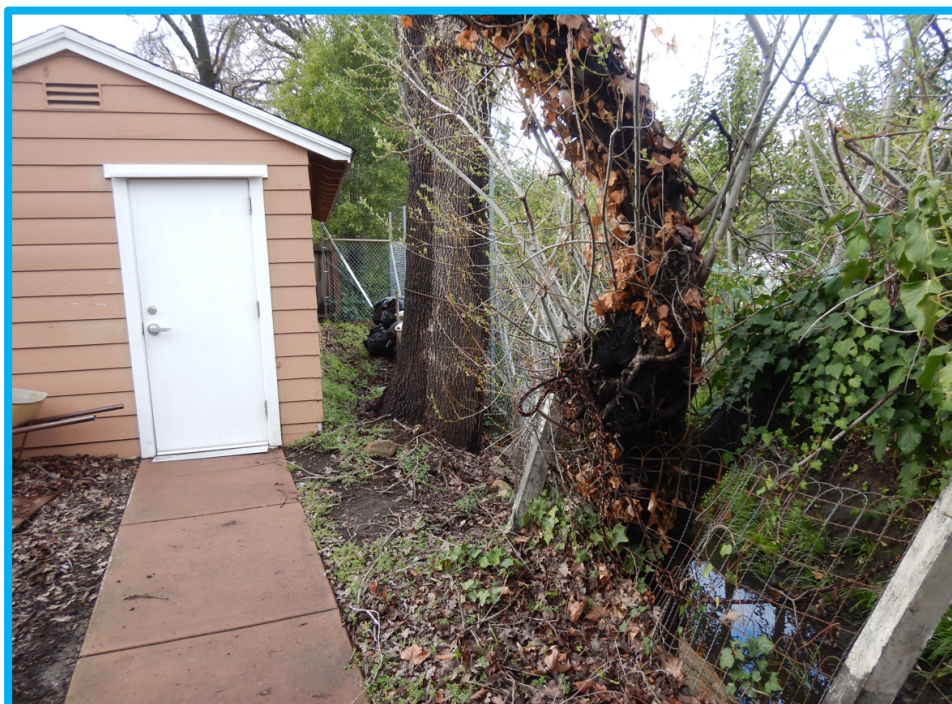
Mr. Olvera was concerned the banks of Poppy Creek were eroding and becoming unstable (Photograph 2). Mr. Olvera's family and friends installed the grouted natural rock wall along Mr. Olvera's streambank in August 2022 (City of Santa Rosa, Photograph 1). Work was stopped by City of Santa Rosa staff and Santa Rosa police. Ms. Olvera said their garage is located 5 feet from the top-of-bank and was concerned about Poppy Creek streambank failing and damaging their garage (Photographs 3 and 4). Ms. Olvera showed me a cell phone video of Poppy Creek taken this rainy season. Poppy Creek was a few inches below the top-of-bank and appeared to be entering a backyard on the opposite side of the creek. The high-water scour mark was clearly seen on the opposite bank (Photograph 5)

Photograph 2: Looking downstream, Mr. Olvera's fence falling over into Poppy Creek trees are leaning over.

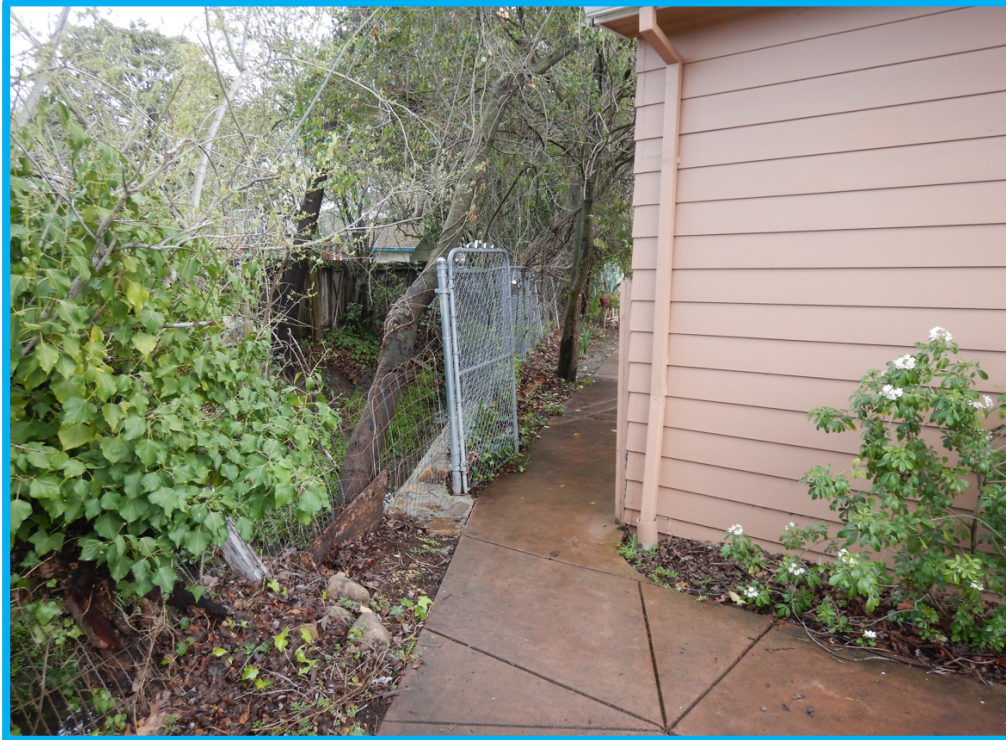
Photograph 3: Looking upstream, Mr. Olvera's garage is five feet from top-of-bank. White fence post is falling over into Poppy Creek.

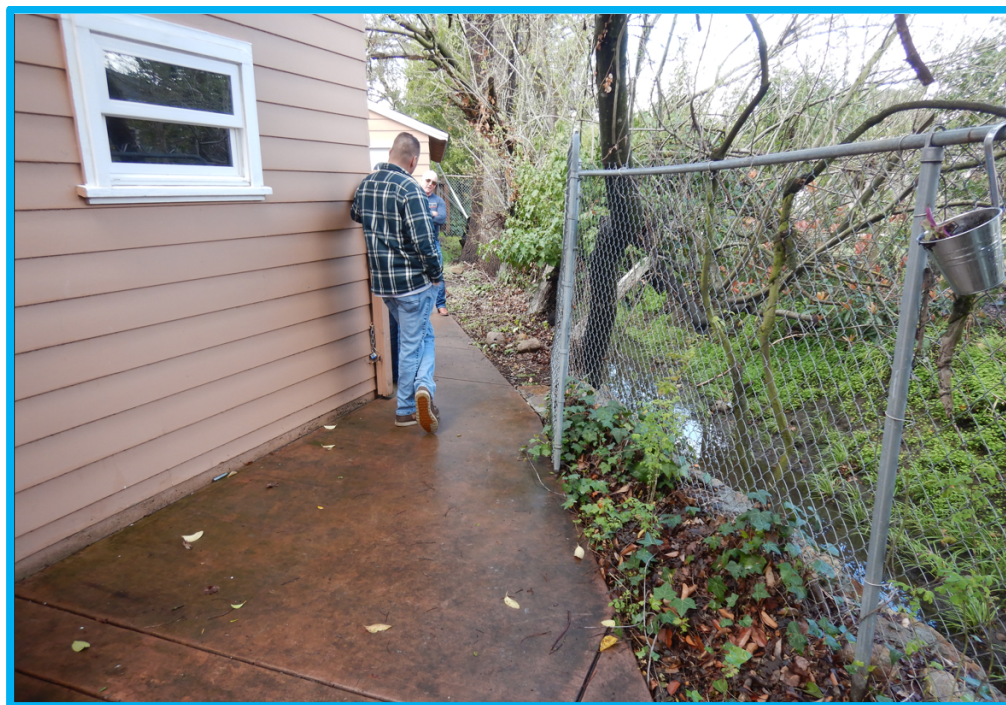
Photograph 4: Looking downstream, Mr. Olvera's garage is five feet from top-of-bank. White fence post is falling over into Poppy Creek.

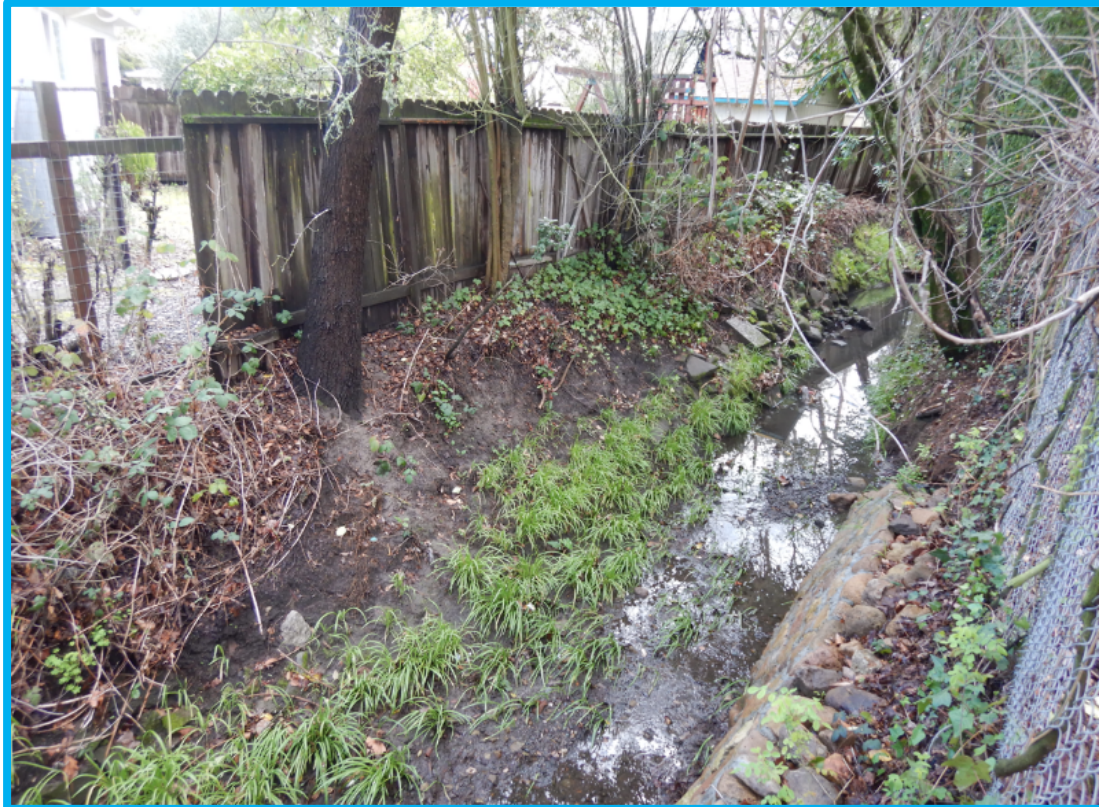
Poppy Creek in the Olvera neighborhood is a straightened earthen channel with pockets of disposed broken concrete debris on the right bank and channel (Photograph 6). The channel is trapezoidal in shape, an estimated 14 feet wide at top-of-bank, estimated 5-foot-wide streambed, and an estimated 6 feet deep (Photographs 5 and 6). Several large oak trees as well as other unidentified trees overhang and shade the channel. A dense grove of bamboo was observed on the downstream right bank (Photograph 7). The banks are vegetated with Himalayan blackberry, ivy, and landscaping plants. Sedges appeared to grow along the flowing channel and streambed appeared to be soil with gravel and scattered medium sized rocks.

Photograph 5: Looking upstream Poppy Creek. Poppy Creek is a trapezoidal channel. High-water scour mark at bottom of wooden fence.

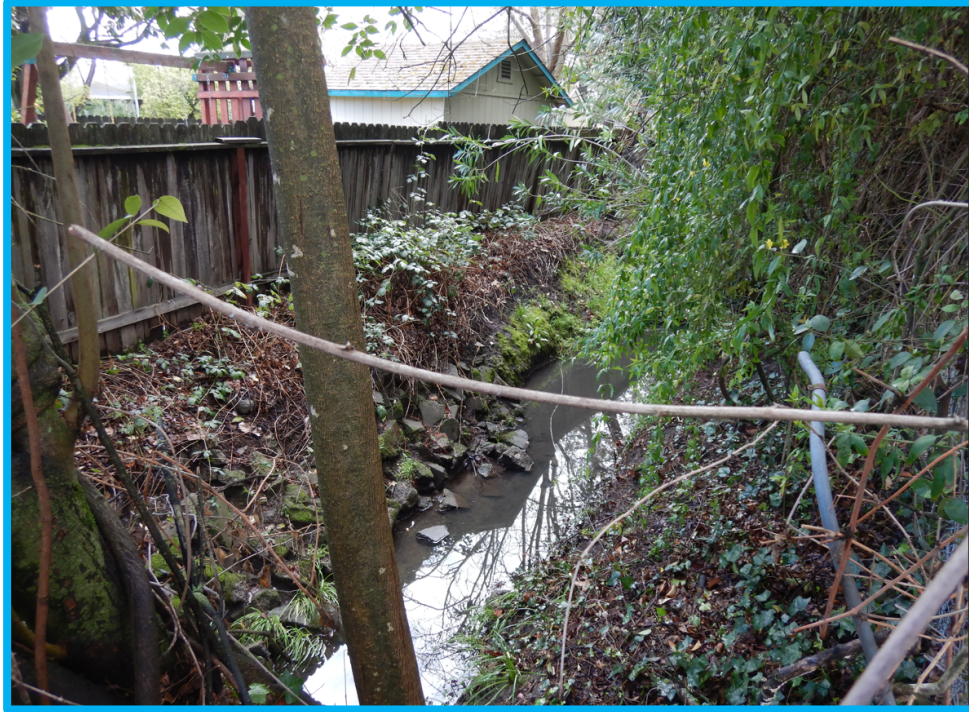
Photograph 6: looking upstream Poppy Creek of the grouted rock wall, broken concrete debris disposed on the right bank and in the active channel.

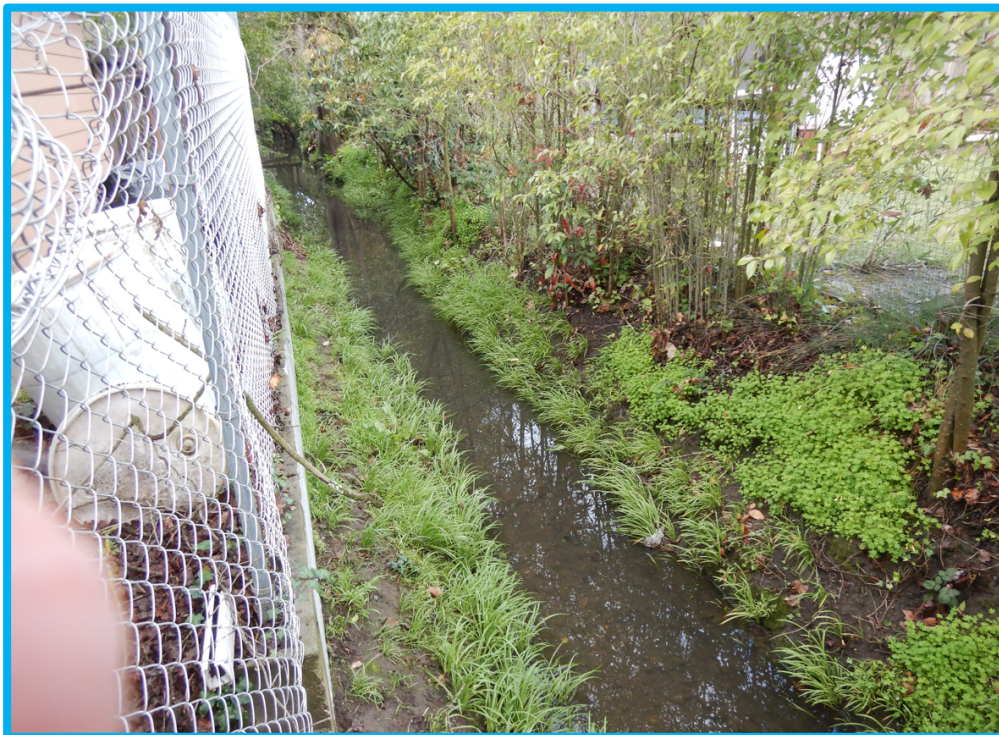
Photograph 7: Poppy Creek looking downstream showing vegetation and bamboo. Appeared high-water flooded the opposite bank backyard.

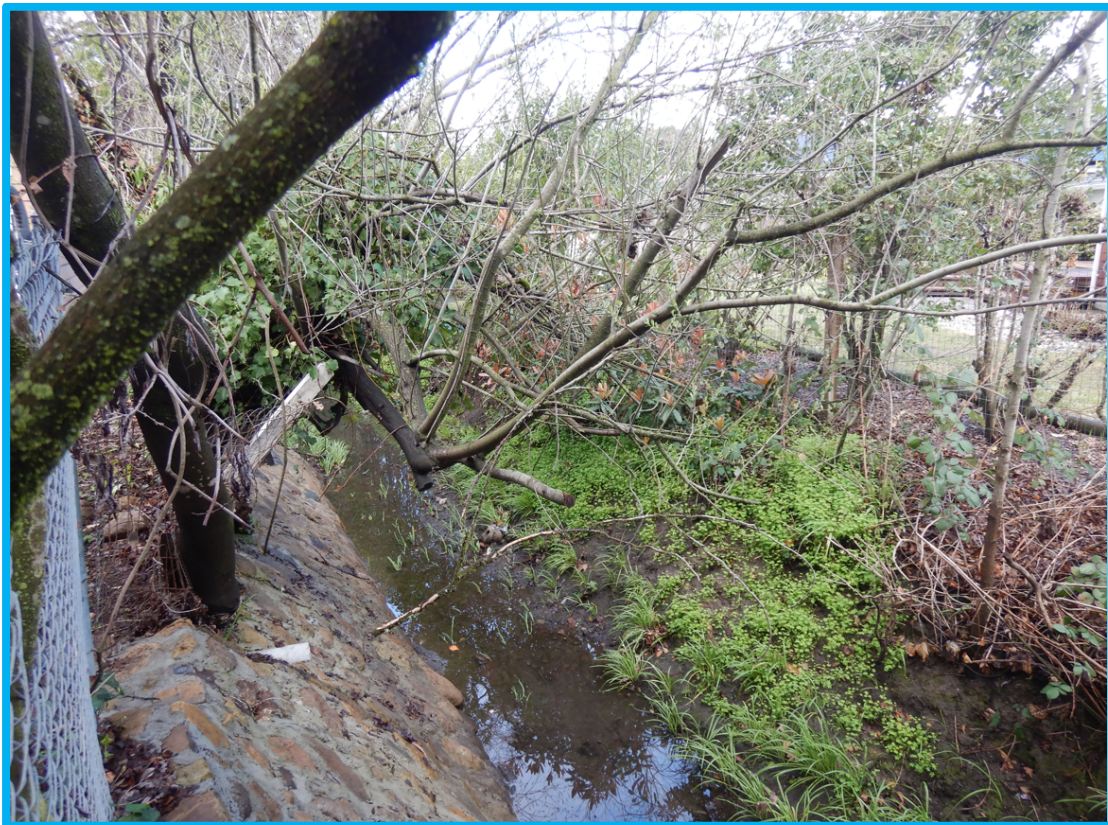
Mr. Stockham said the grouted natural rock wall was placed against an eroding and unstable earthen slope. The rock wall measured with a clinometer and averaged 65° angle and constricting an already narrow stream channel (Photograph 8). The finished wall was measured to be 35 feet long with an estimated 20 feet partially constructed. An additional estimated 60 feet of wall was proposed along the patio backyard

streambank. This type of work is not normally permitted by the RWB without mitigation either bioengineering or other. Typically, RWB staff engage early in the permit application process and ensuing discussions address avoidance and minimization methods for the entire project. These discussions would include ensuring the amount of rock used at the site is kept to a minimum and a bioengineered approach be considered. Because no permit was obtained from the RWB, these discussions never occurred. Obtaining a permit from the RWB ensures the project is the least environmentally damaging alternative.

Photograph 8: Grouted rock wall placed at an estimated 65° angle and constricting the Poppy Creek channel.

A licensed engineer, hydrologist or other qualified professional should be consulted to address the stability of the rock wall and earthen bank and address the hydraulic capacity of the channel with and without the rock wall as well as assessing the impacts to neighboring properties with regard to flood capacity future scour and armoring. Steep streambanks are commonly found along rerouted residential streams where backyard space is maximized at the expense of streambank stability, erosion concerns, and hydraulic capacity. In these scenarios, there is insufficient room for streambanks to slope gently from the backyard's edge down to the streambed.
