North Coast Regional Water Quality Control Board

INSPECTION MEMO

Scotia Sawmill and Cogeneration Plant, 125 Main Street, Scotia, Humboldt County

WDID #: 1 12I027974

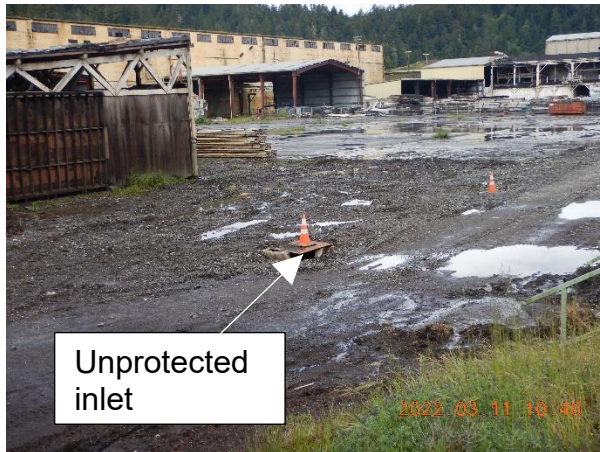
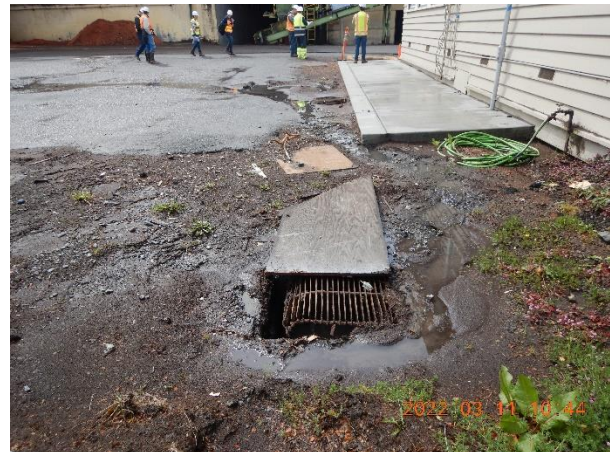
Pictures 1a, 1b: Storm drain inlets within drainage area 1 observed receiving very muddy discharge, many with observable oil sheen and had no inlet protection BMPs. Picture taken by Heaven Moore.

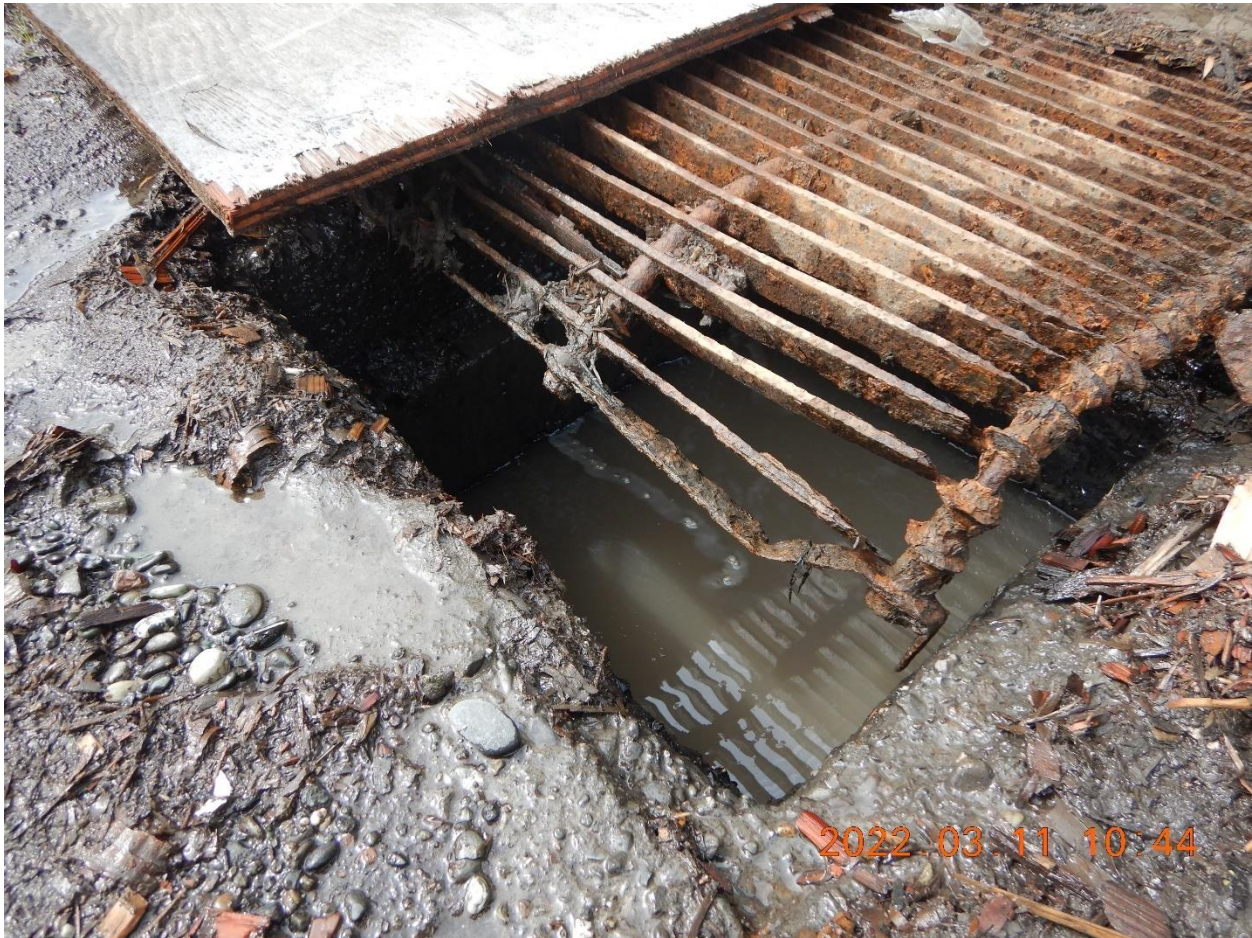
Picture 1c: Storm drain inlet within drainage area 1 observed receiving very muddy discharge, many with observable oil sheen and had no inlet protection BMPs. Picture taken by Heaven Moore.

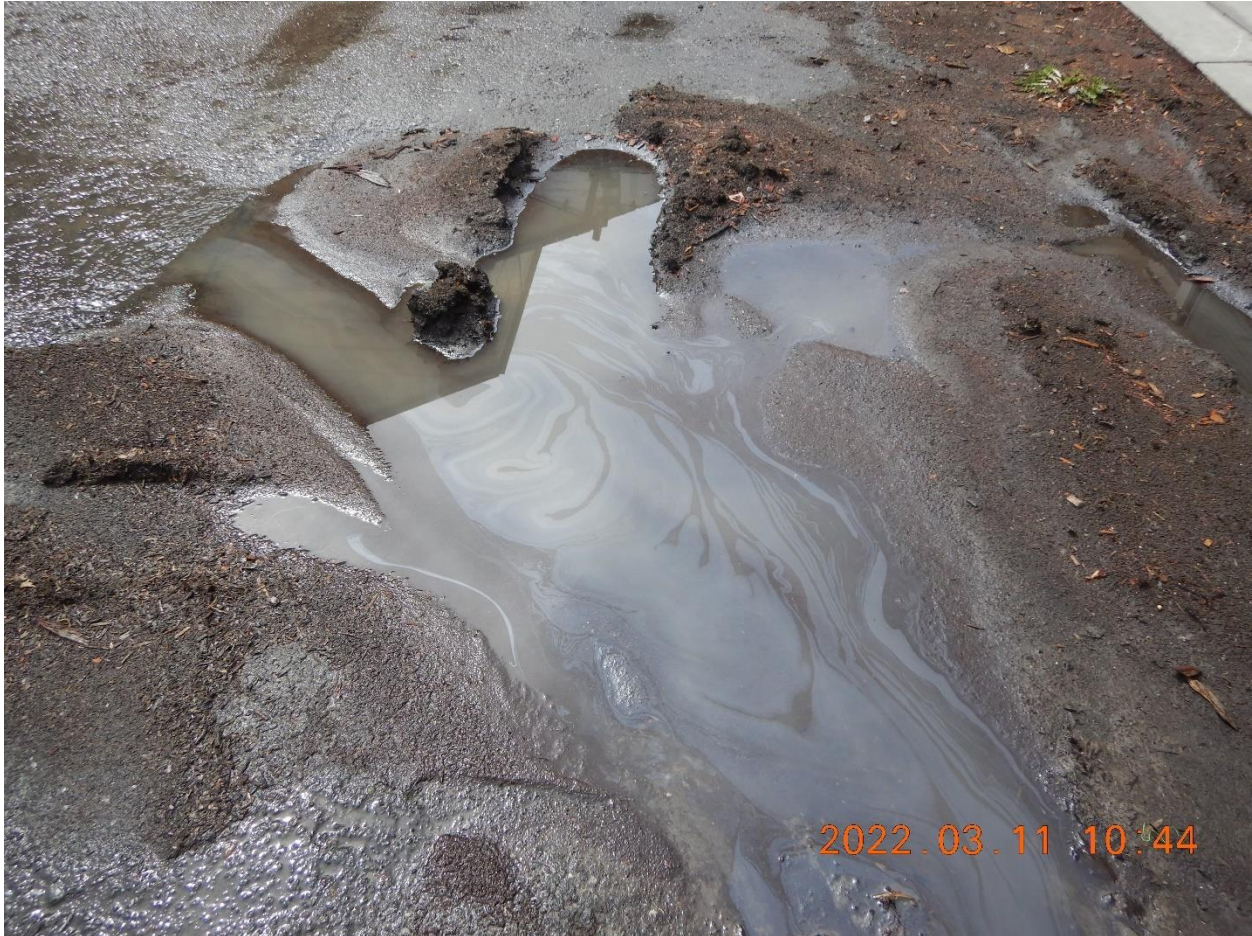
Picture 1d: Oil sheen upstream of storm drain inlet shown in Picture 1c above, which had no inlet protection BMPs. Picture taken by Heaven Moore.

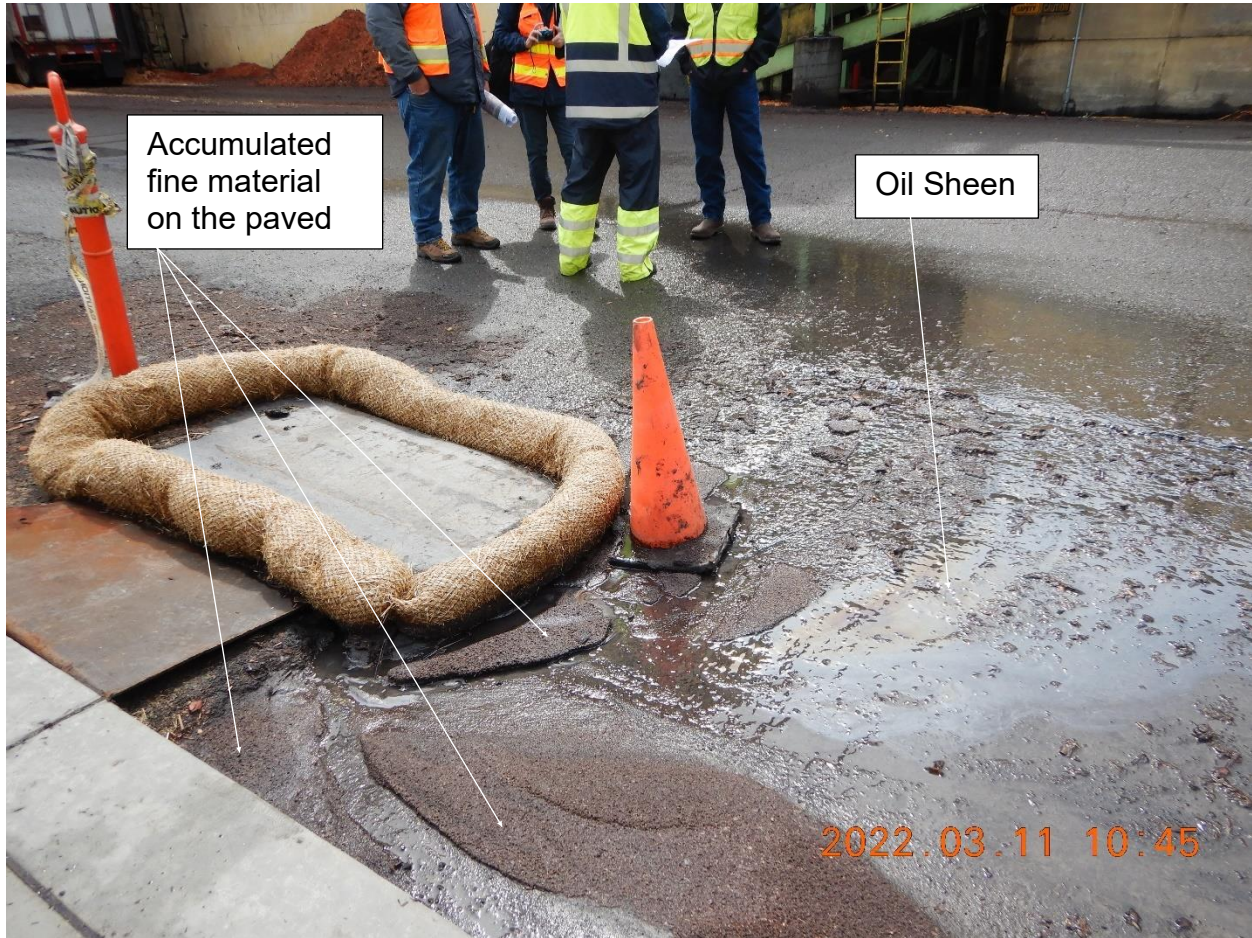
Picture 1e: Storm drain inlets within drainage area 1, with straw wattles incorrectly installed on pavement. Note the accumulated material on the paved surface that is so deep that erosion rills can be seen that demonstrated discharge is going under the straw wattle. Oil sheen be seen as well. Picture taken by Heaven Moore.

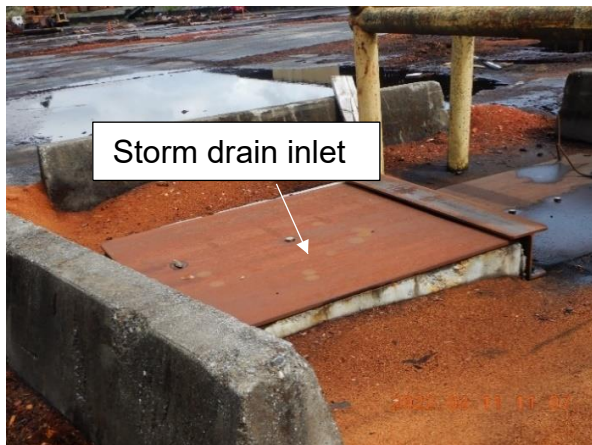
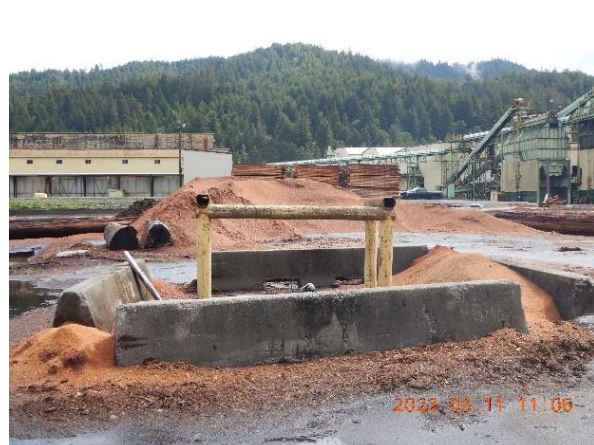
Pictures 1f and 1g: Storm drain inlets within drainage area 1 observed with no inlet protection BMPs and surrounded by wood waste material. Picture taken by Heaven Moore.

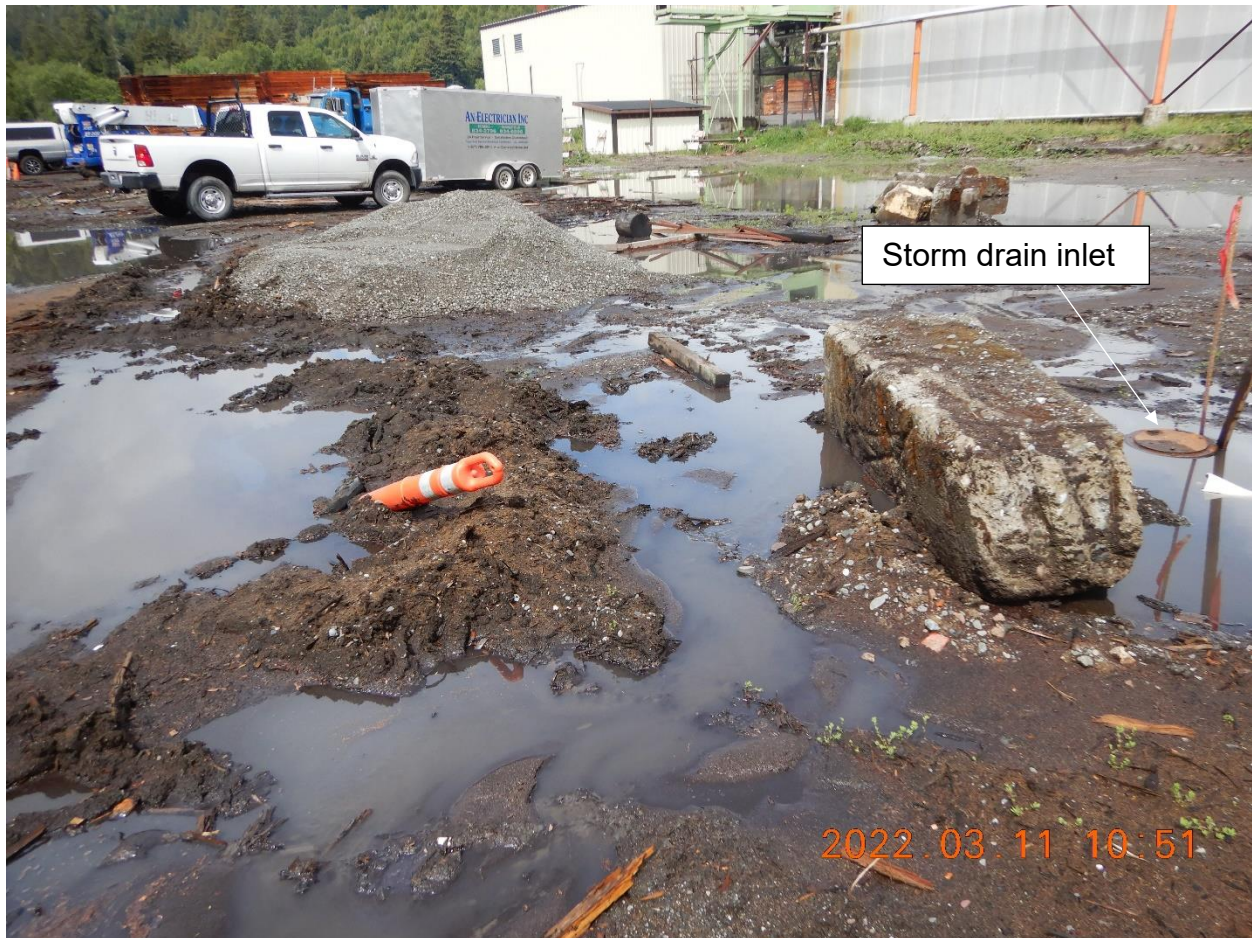
Picture 1h: A storm drain inlet is located within this area in drainage area 1. The storm drain inlet and the adjacent area is covered with many inches to feet of debris, mud, wood fiber, and unprotected stockpiled material. No housekeeping BMPs or inlet protection BMPs are present. Picture taken by Heaven Moore.

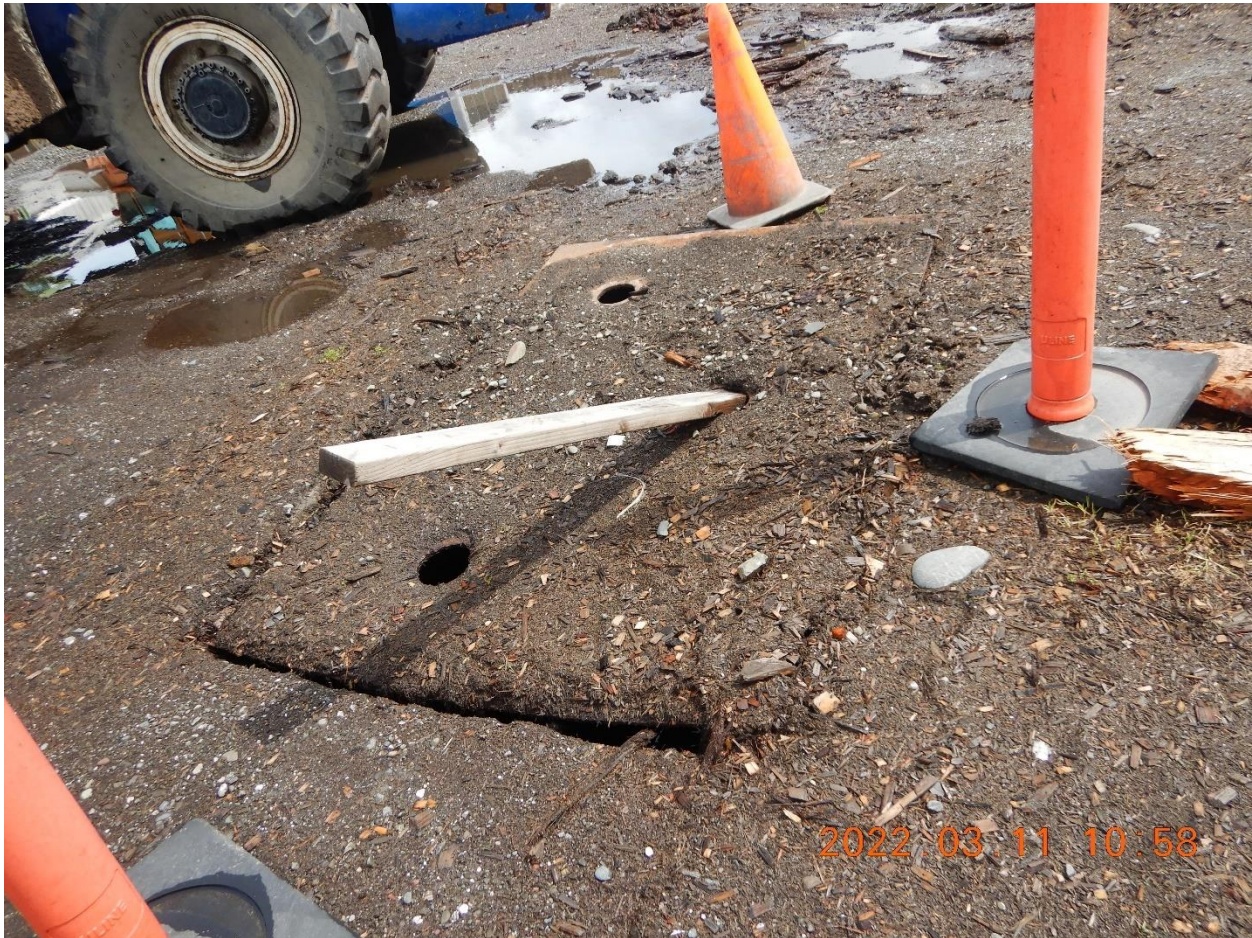
Picture 1i: Storm drain inlet within drainage area 1 observed with many inches of debris, mud, and wood fiber accumulated over the lid and adjacent to the inlet with no inlet protection BMPs. Note the piece of lumber inserted into the storm drain lid and that the lid is askew. Picture taken by Heaven Moore.

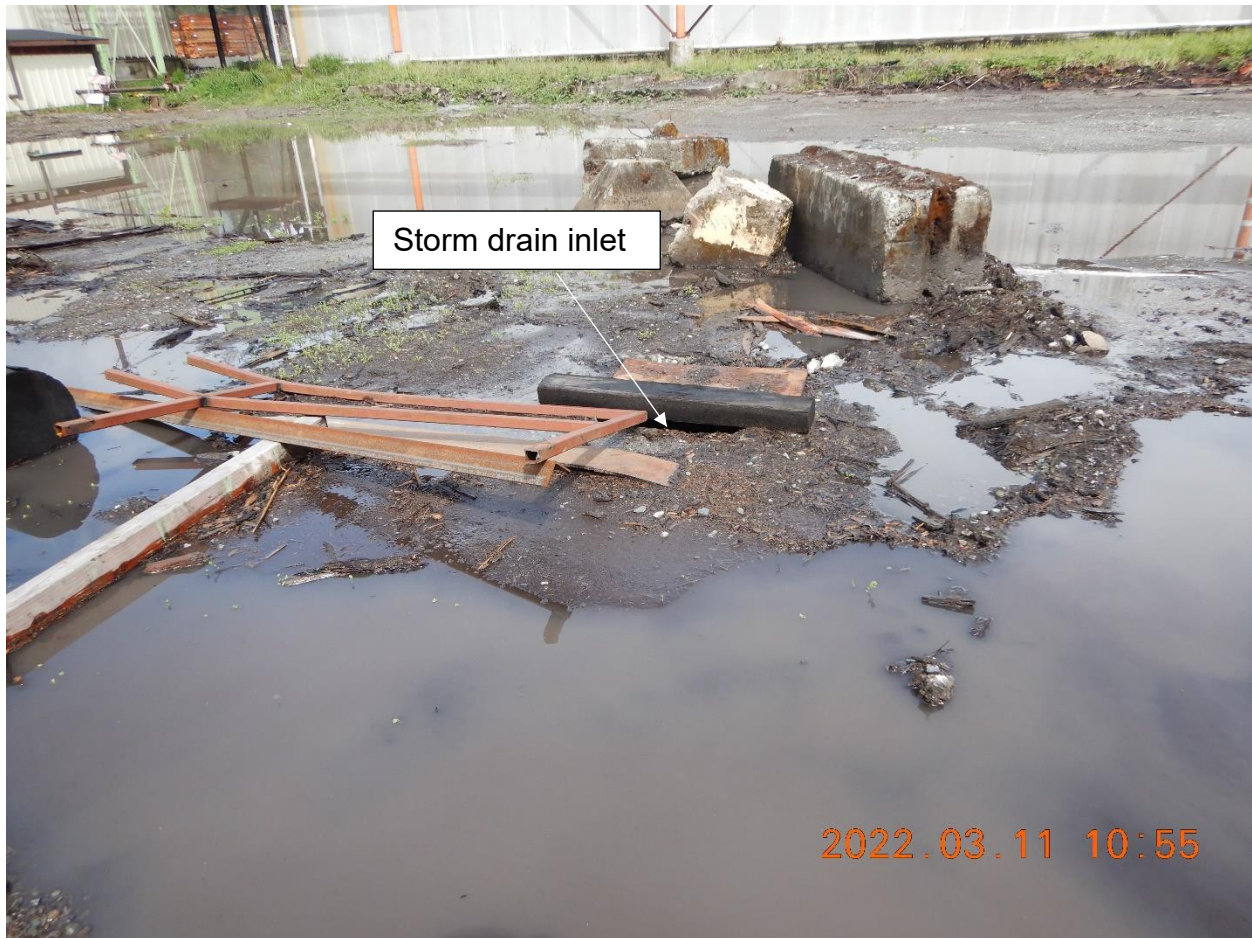
Picture 1j: A storm drain inlet is located within drainage area 1. The storm drain inlet and the adjacent area is covered with many inches to feet of debris, mud, wood fiber, and unprotected stockpiled material. No housekeeping BMPs or inlet protection BMPs are present. Picture taken by Heaven Moore.

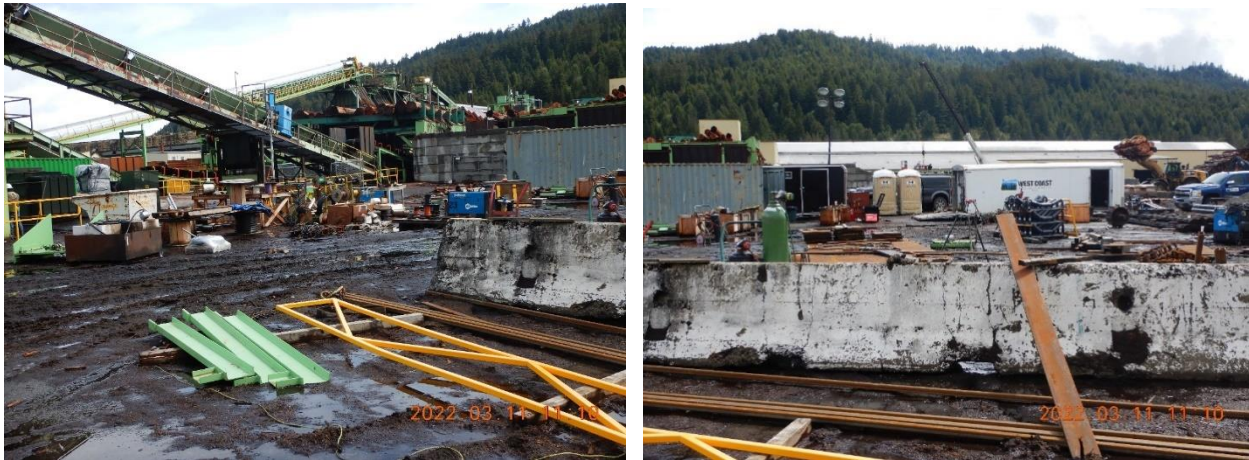
Pictures 2a and 2b: Industrial equipment, materials, and waste located within drainage area 1 exposed to rain. This paved area is covered with many inches debris, mud, wood fiber. No housekeeping BMPs or inlet protection BMPs are present. Picture taken by Heaven Moore.

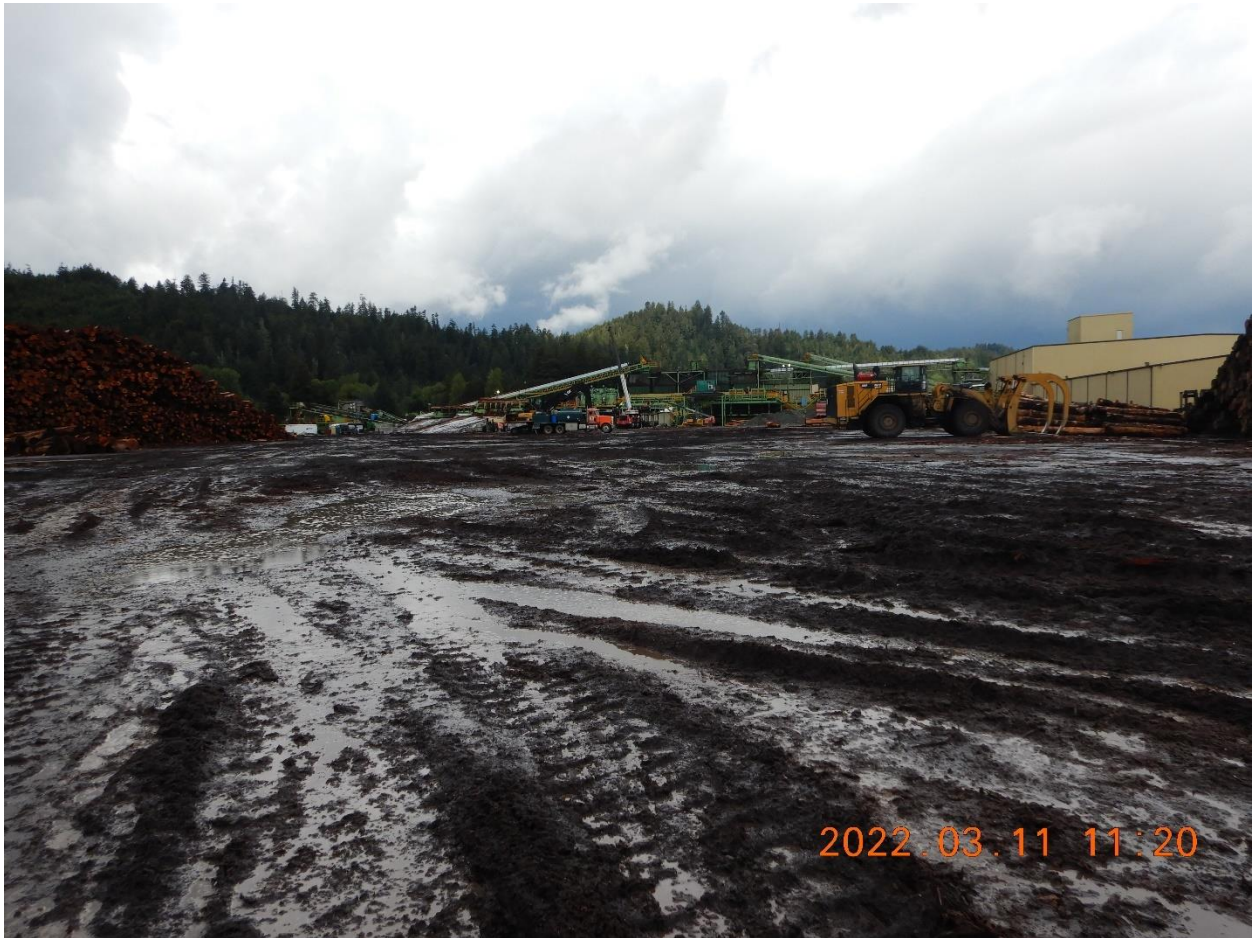
Picture 2c: Industrial equipment, materials, and waste located within the log deck area in drainage area 1 exposed to rain. This paved area is covered with many inches debris, mud, wood fiber. No housekeeping BMPs or inlet protection BMPs are present. Picture taken by Heaven Moore.

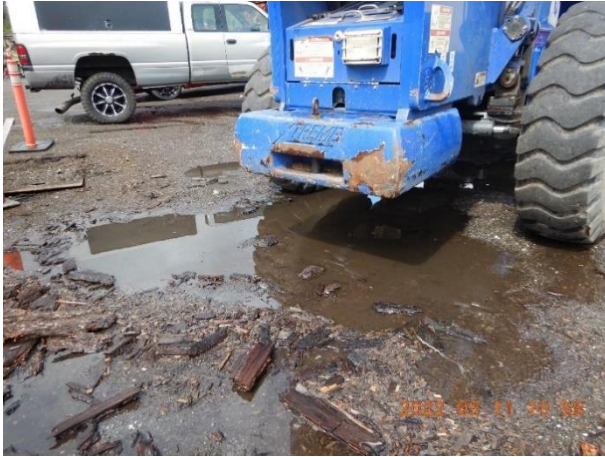
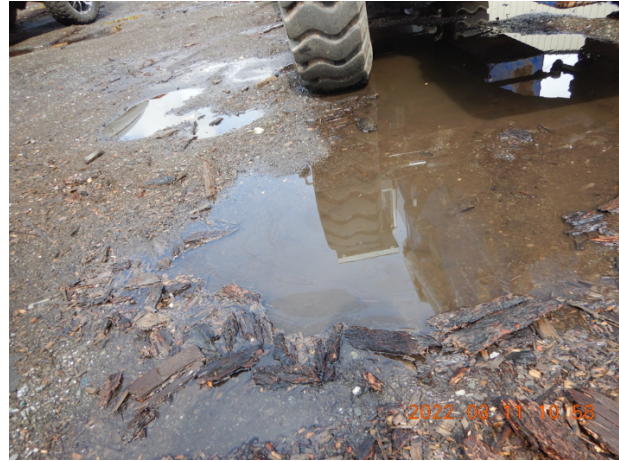
Pictures 2d and 2e: Industrial equipment and associated oil sheen in drainage area 1 exposed to rain. This area is covered with many inches debris, mud, wood fiber and directly adjacent to unprotected storm drain inlets. No housekeeping BMPs or inlet protection BMPs are present. Picture taken by Heaven Moore.

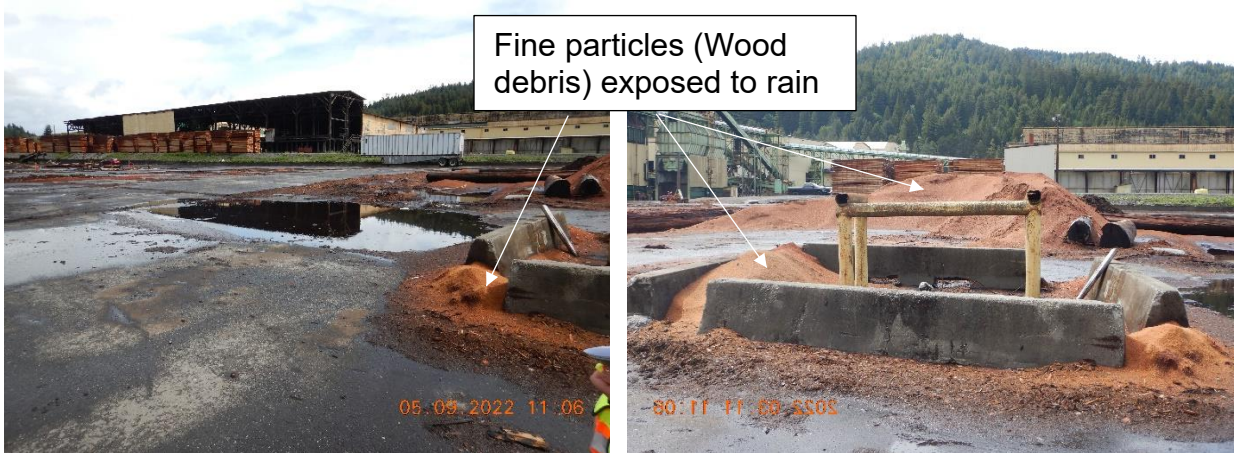
Pictures 2f and 2g: View of wood particles that are stored outside within log deck area and exposed to rain. Source control is not implemented. Picture taken by Heaven Moore.

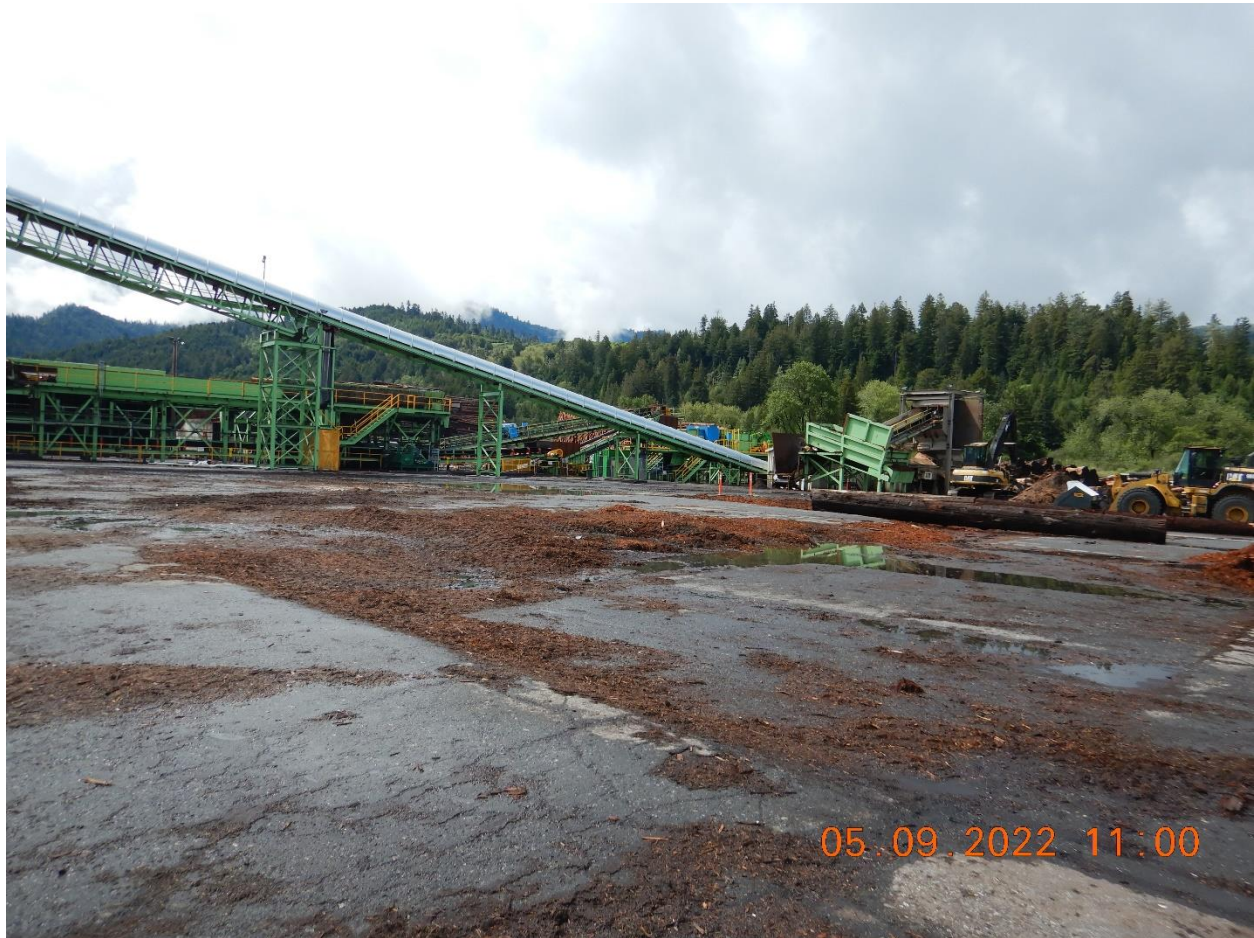
Picture 2j: Looking southwest at conveyer belts adjacent to the log deck area. Wood chips was observed on the ground throughout the paved area. Picture taken by Farzad Kasmaei.

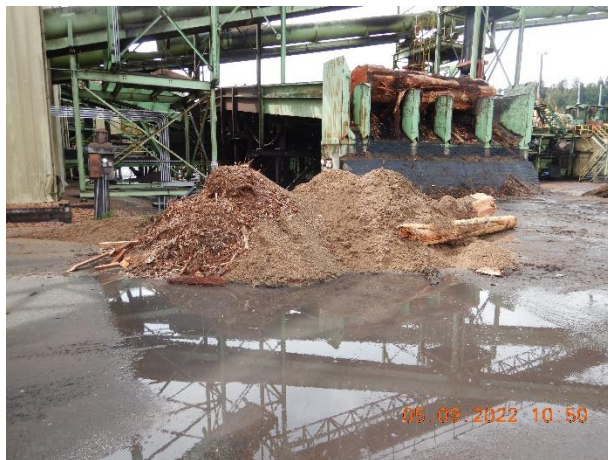
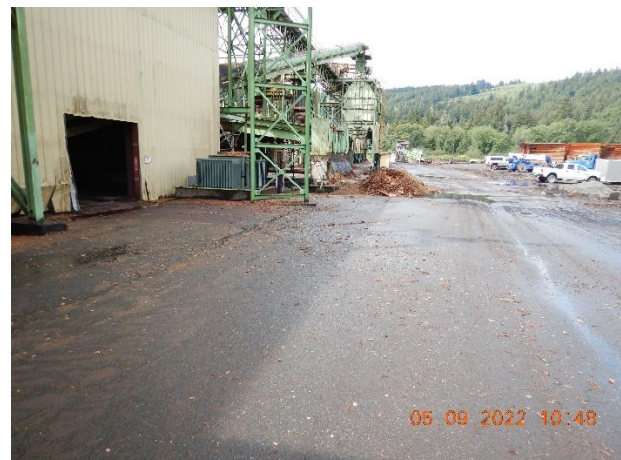
Pictures 3a and 3b: View of wood chips stockpiles stored outside by the sawmill building exposed to rain. Picture taken by Farzad Kasmaei.

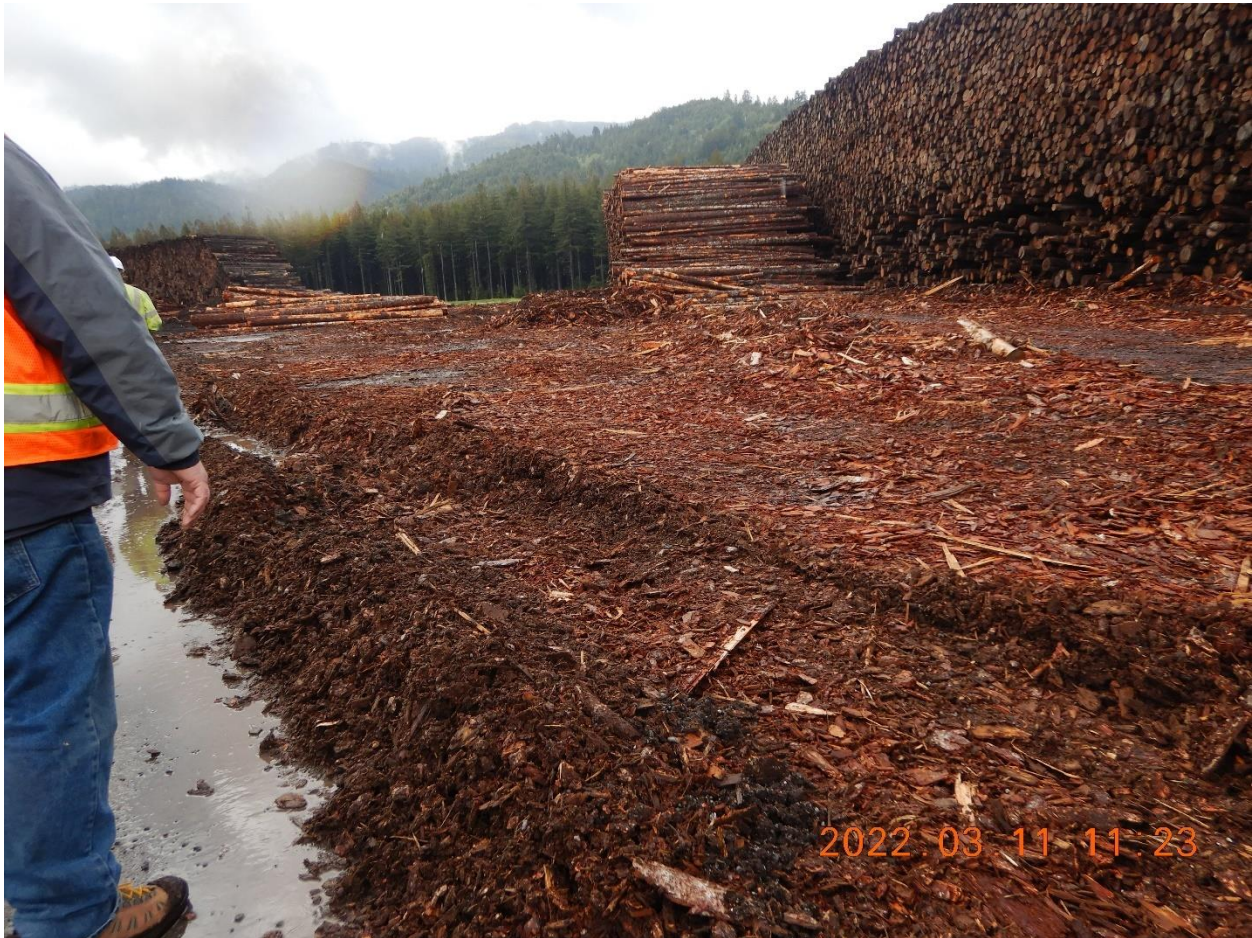
Picture 3e: Large material stockpiles located within the log deck area of drainage area 1 exposed to rain. This paved area is covered with many inches to feet of debris, mud, and wood fiber. No BMPs are present. Picture taken by Heaven Moore.

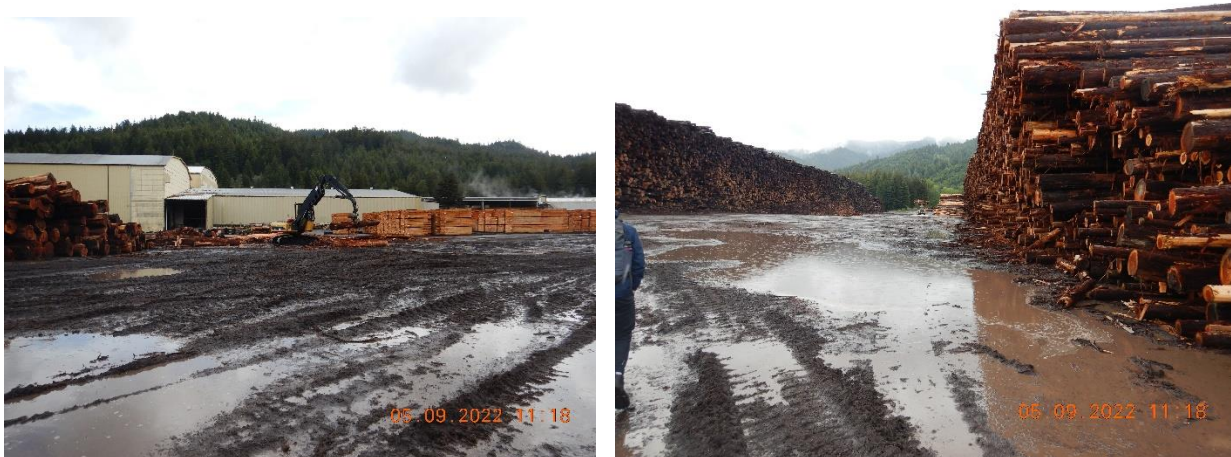
Photo 4a and 4b: View of highly turbid runoff and thick mud on the paved log deck. Picture taken by Farzad Kasmaei.

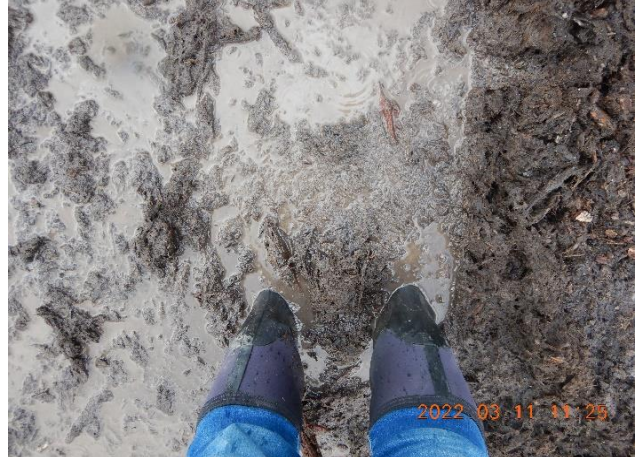
Pictures 4c and 4d: Closeup photos showing the depth of the mud, wood fiber, bark, and ponded stormwater on top of the paved log deck. The main retention pond receives runoff from this area. Picture taken by Heaven Moore.

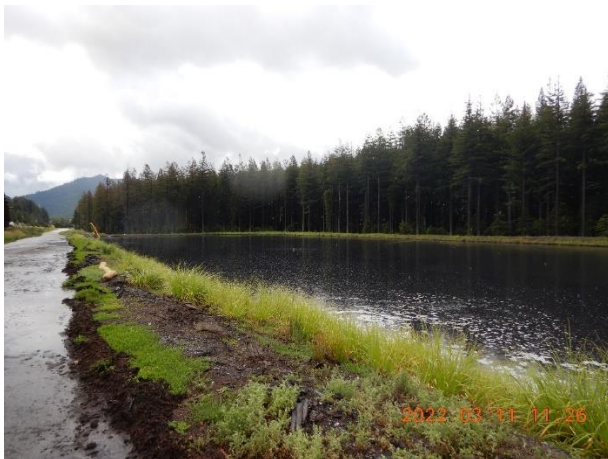
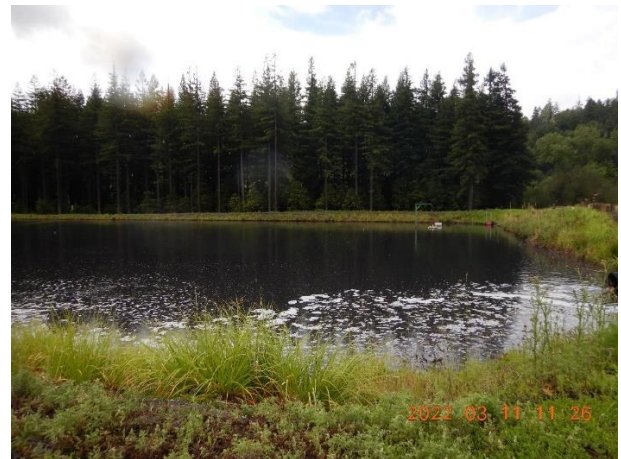
The Main Retention Pond receives the majority of the runoff from Drainage areas 1 and 7 as well as Drainage area 5 on the north side of highway 101 prior to discharging to the Eel River. The main outlet structure was open and discharging. The water in the pond and the discharge appeared to be highly turbid, dark, and had a gray hue, and foam was observed on the surface (Pictures 5a, 5b, 5c, 5d, 5e, 5f, 5g and 6a, 6b, 6c, 6d, 6e, 6f, 6g, 6h, 6i). When asked by Heaven Moore if the retention pond had been designed to a particular design storm standard and if the design plans and calculations could be provided, Facility staff, Dean Kerstetter, stated that it had not been designed but had rather been sized based on the space available.

Pictures 5a and 5b: Picture of the retention pond that receives the majority of the runoff from Drainage areas 1 and 7 as well as Drainage area 5 on the north side of highway 101 prior to discharge to the Eel River. Picture taken by Heaven Moore.

As a result, advanced BMP's including all ponds and the clarifier require sizing calculations and design as well as maintenance plans to ensure their proper operation. The observed comingling of industrial stormwater discharge with wastewater process water which is separately permitted is also of significant concern and unauthorized.

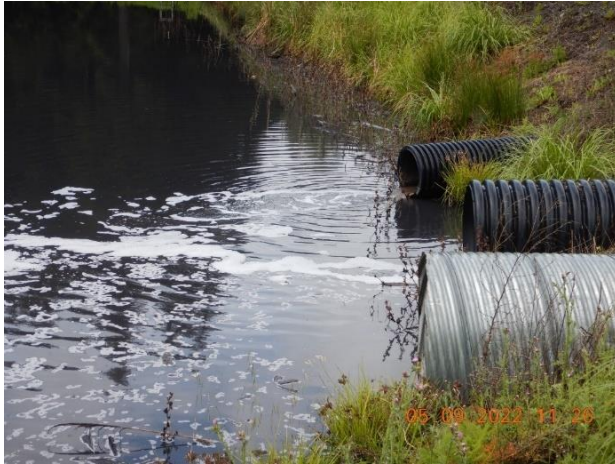
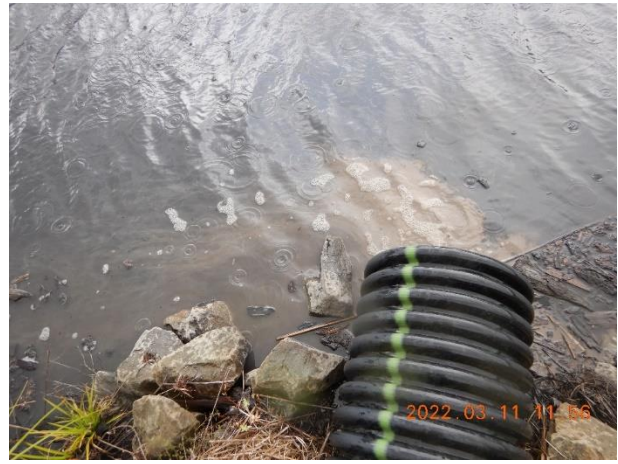
Pictures 5c and 5d: View of stormwater pipes discharging the runoff into the north corner of the main retention pond. These pipes mostly receive runoff from the diversion valve 001 and the DIs within drainage areas 1 and 7 as well as Drainage area 5 on the north side of highway 101. The water appeared to be highly turbid, dark, and had gray hue. Foam was observed on the surface. Picture 5c taken by Farzad Kasmaei. Picture 5d taken by Heaven Moore.

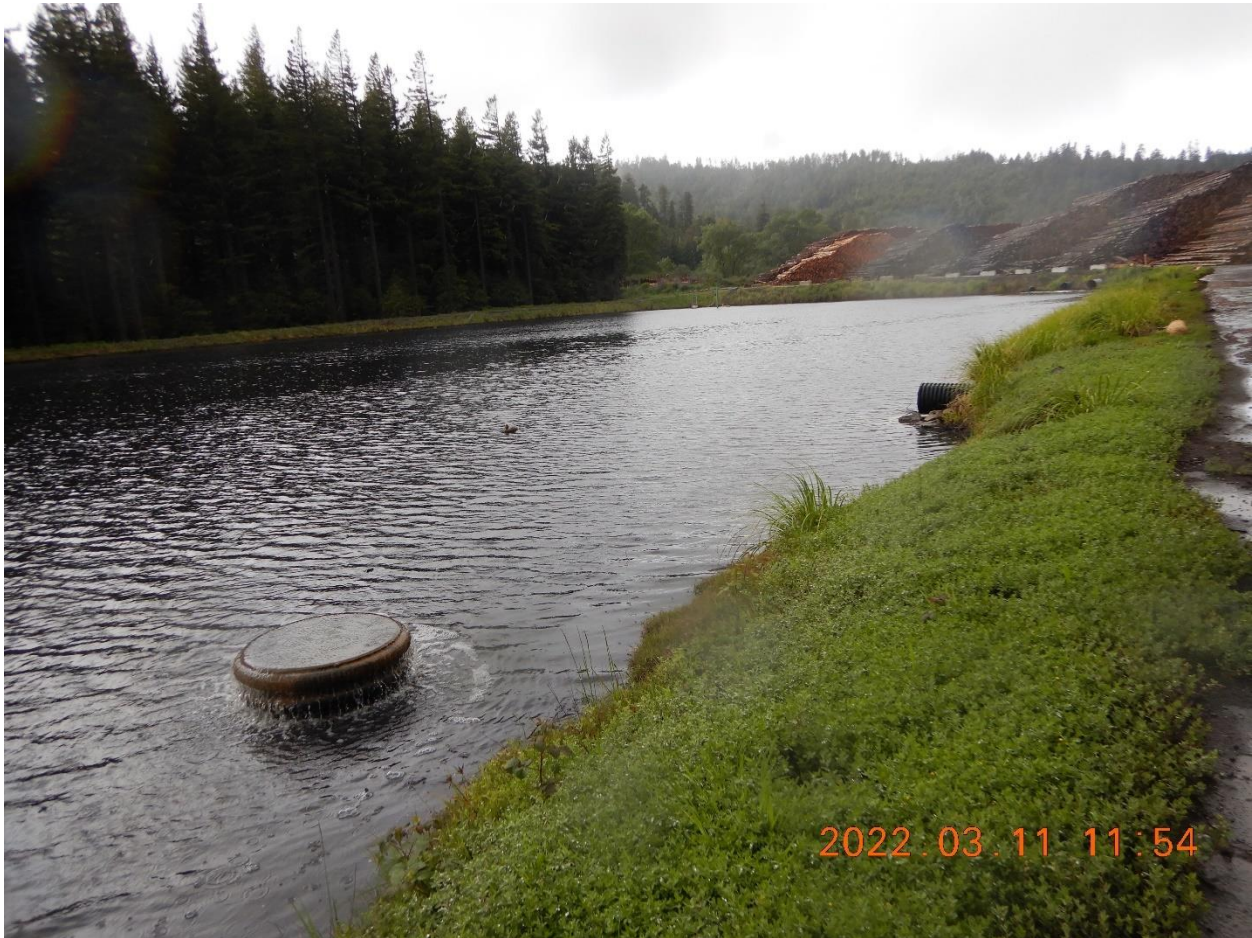
Picture : View of bubble-up stormwater pipe discharging runoff from Drainage area 5 on the north side of highway 101 into the retention pond. The water appeared to be highly turbid, dark, and had gray hue. Picture taken by Heaven Moore.

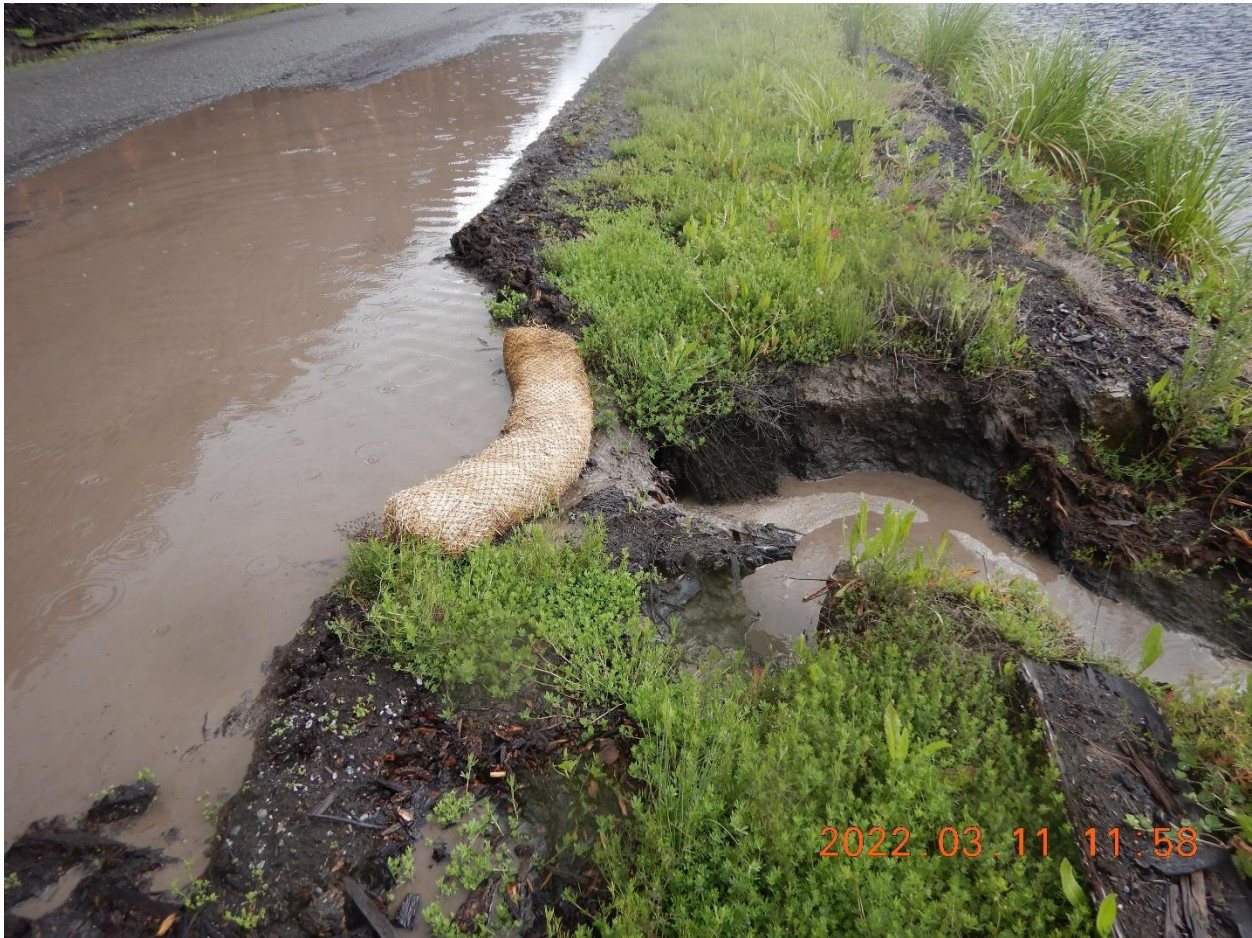
Picture 5f: View of runoff discharging into the retention pond from the access road along the north edge. The water appeared to be highly turbid, the bank was significantly incised, and the small piece of straw wattle appeared to be ineffective. Picture taken by Heaven Moore.

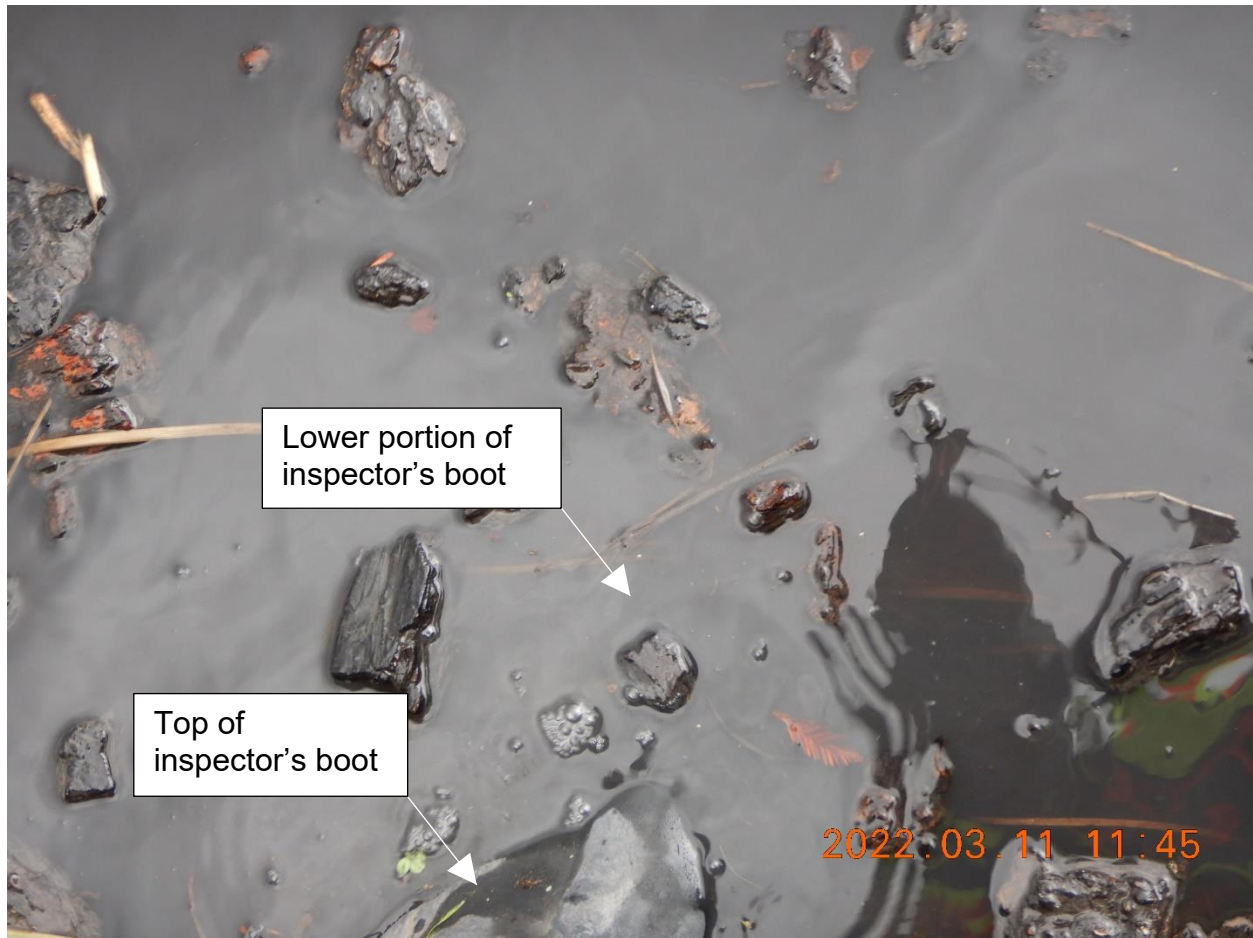
Picture 5g: Closeup of Heaven Moore's boot just under the water within the retention pond. The water appeared to be highly turbid, dark, and had gray hue. The water is so opaque that the lower portion of her boot is not visible just below the surface. Picture taken by Heaven Moore.

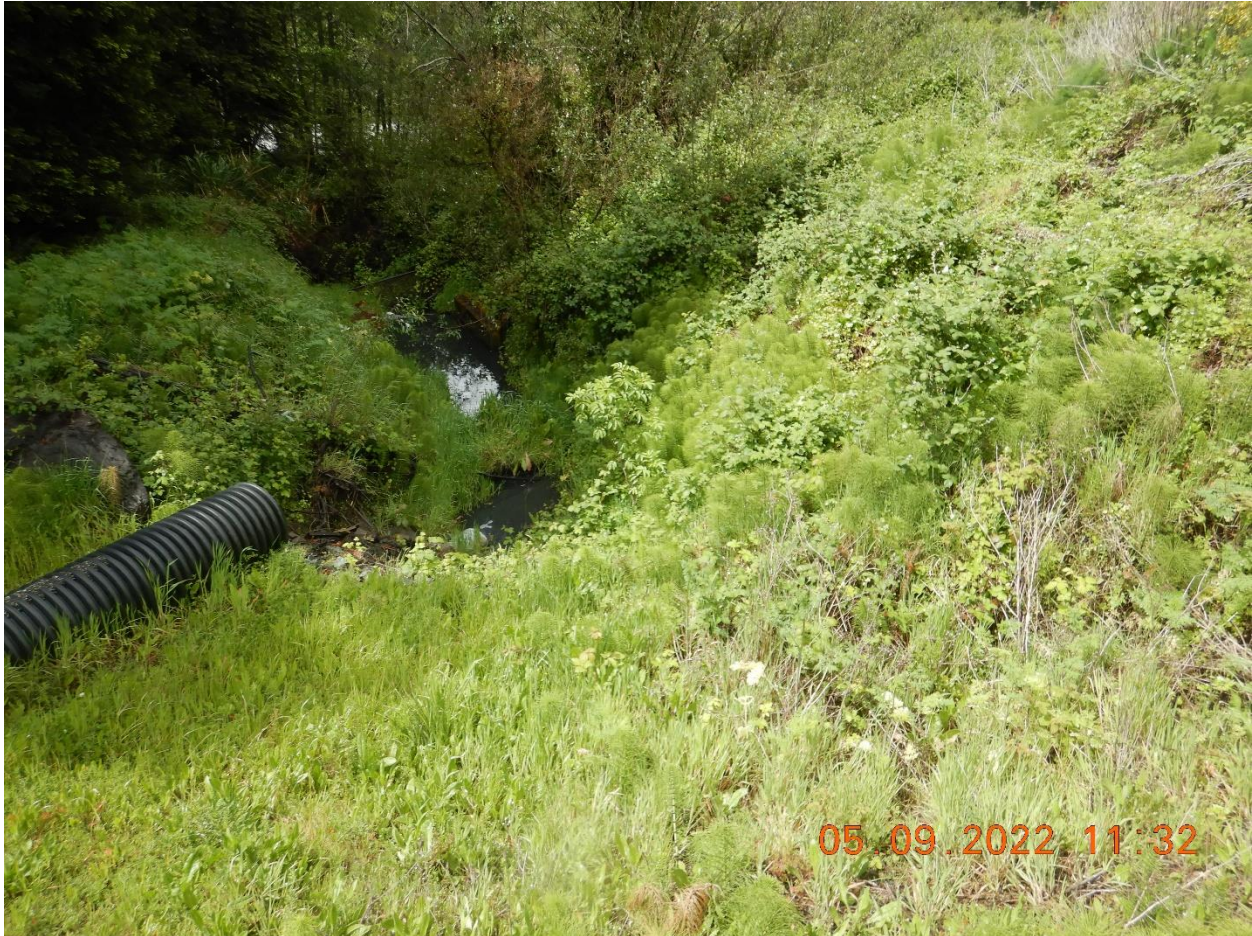
Picture 6c: Picture of the outlet pipes from the retention pond to the Eel River, which is visible in the background. The black corrugated plastic pipe is connected to the overflow with the red gate valve was closed at the time of inspection. The smaller corrugated metal pipe is connected to the outlet structure controlled by the pully suspended by the green cantilever structure and was open and discharging. Picture taken by Farzad Kasmaei.
