North Coast Regional Water Quality Control Board

INSPECTION MEMO

Scotia Sawmill and Cogeneration Plant, 125 Main Street, Scotia, Humboldt County

WDID #: 1 12I027974

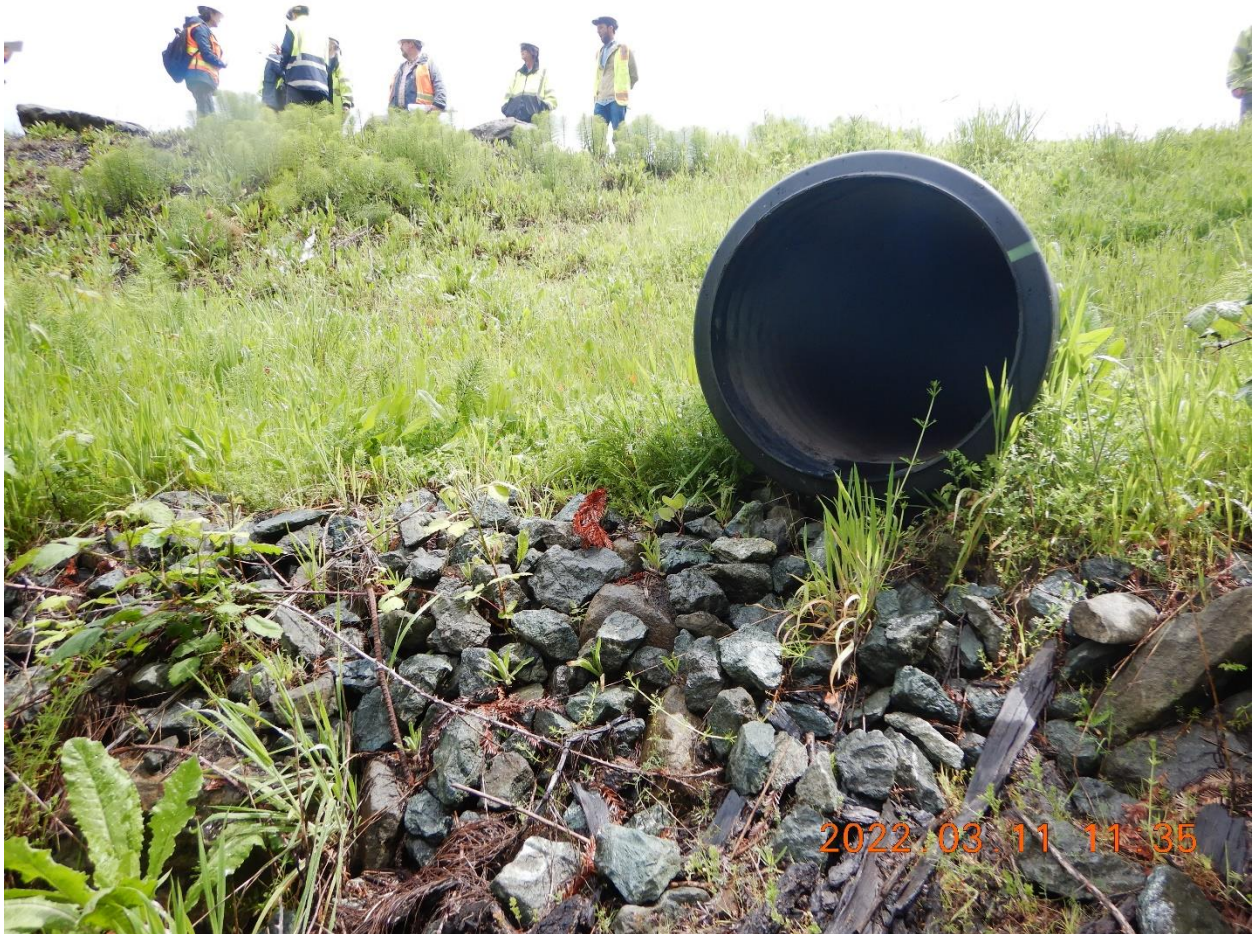
Picture 6d: Picture of the black corrugated plastic pipe that is connected to the overflow with the red gate valve was closed at the time of inspection. Picture taken by Heaven Moore.

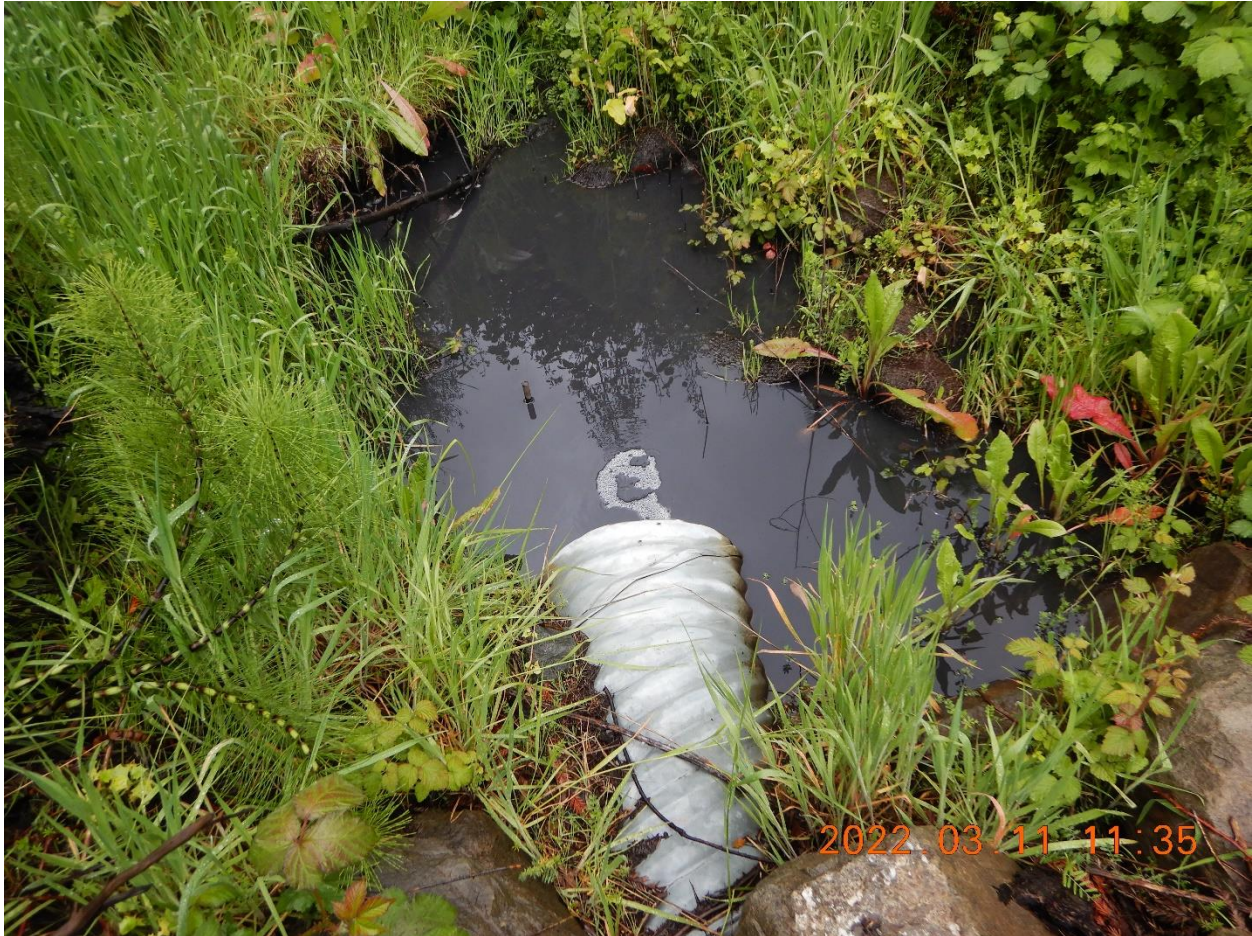
Picture 6e: Picture of the outlet pipe from the retention pond to the Eel River. The corrugated metal pipe is connected to the outlet structure controlled by the pulley suspended by the green cantilever structure and was open and discharging. The discharge appeared to be highly turbid, dark, and had gray hue. Foam was observed on the surface. Picture taken by Heaven Moore.

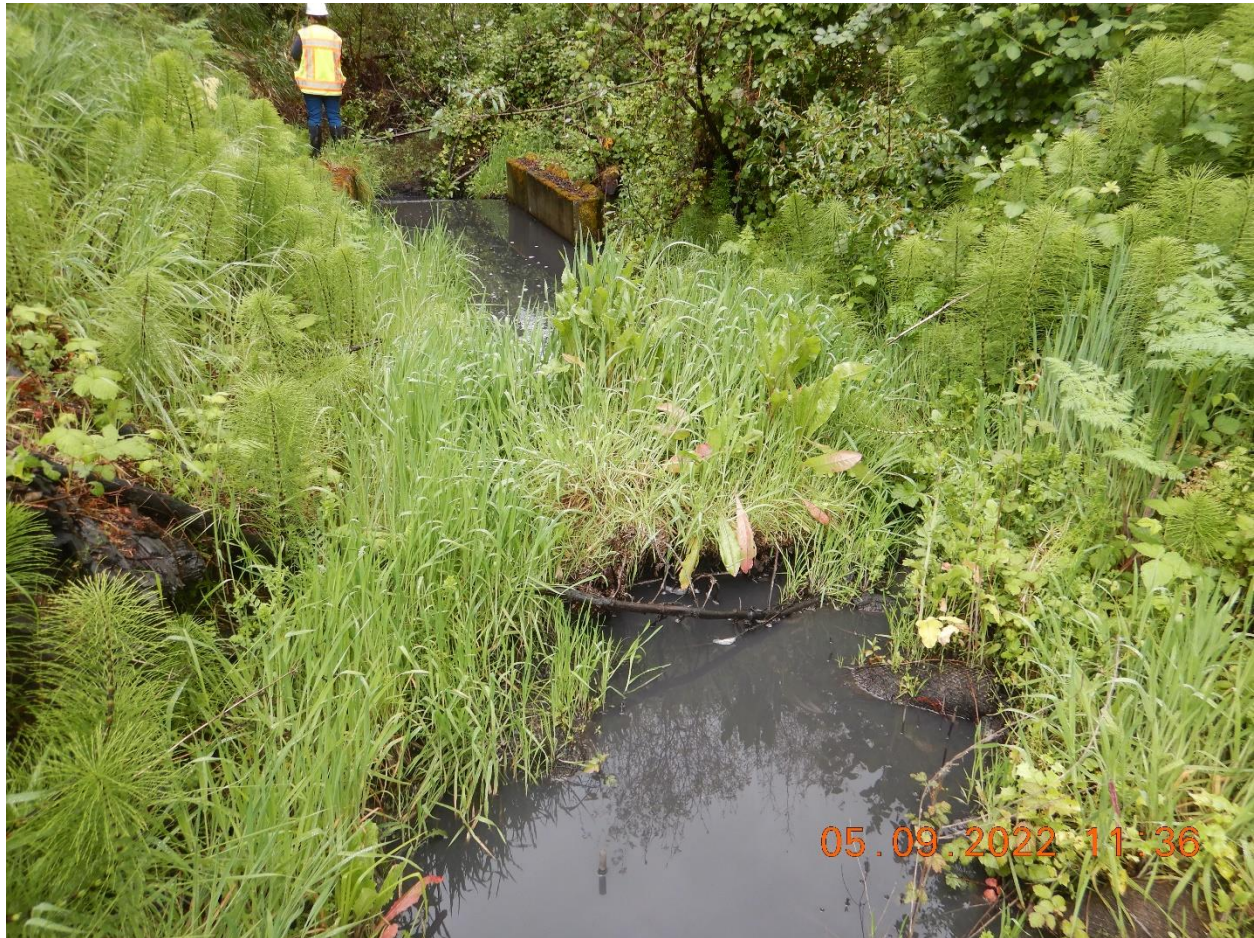
Picture 6f: Looking northwest at discharge point (outfall) from the main retention pond. The discharge water from the retention pond drains directly into Eel River which is just beyond the view of the picture. Picture taken by Farzad Kasmaei.

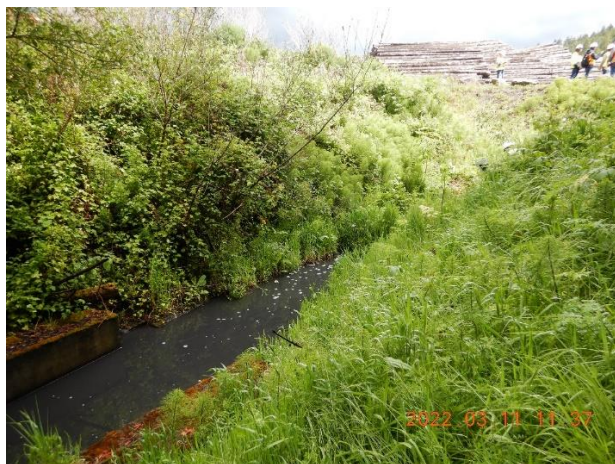
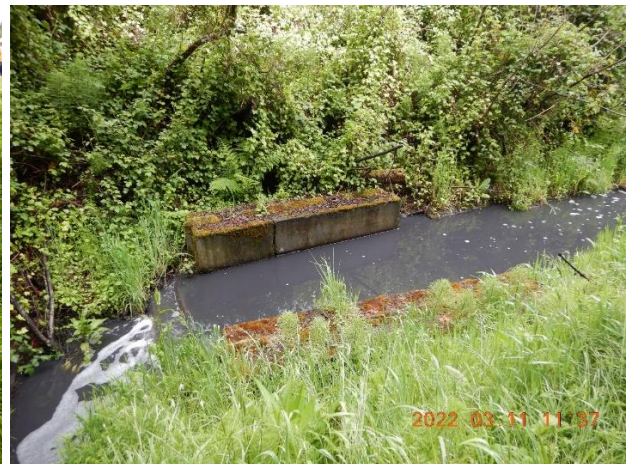
Pictures 6g and 6h: Picture discharge from the retention pond to the Eel River. The discharge appeared to be highly turbid, dark, and had a gray hue. Foam was observed on the surface. Pictures taken by Heaven Moore.

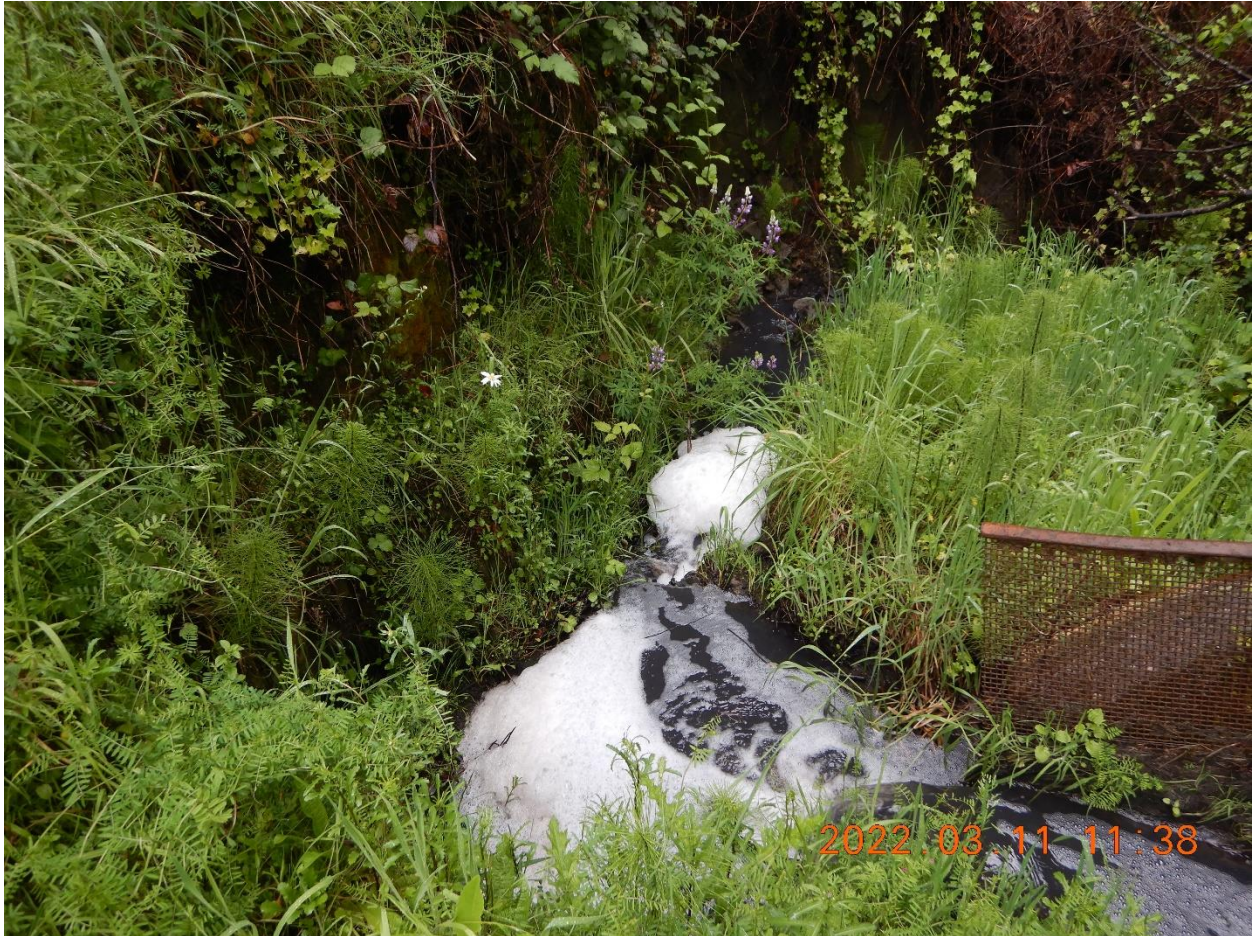
Picture 6i: Picture discharge from the retention pond into Eel River which is just beyond the view of the picture. The discharge appeared to be highly turbid, dark, and had a gray hue. Foam was observed on the surface. Picture taken by Heaven Moore.

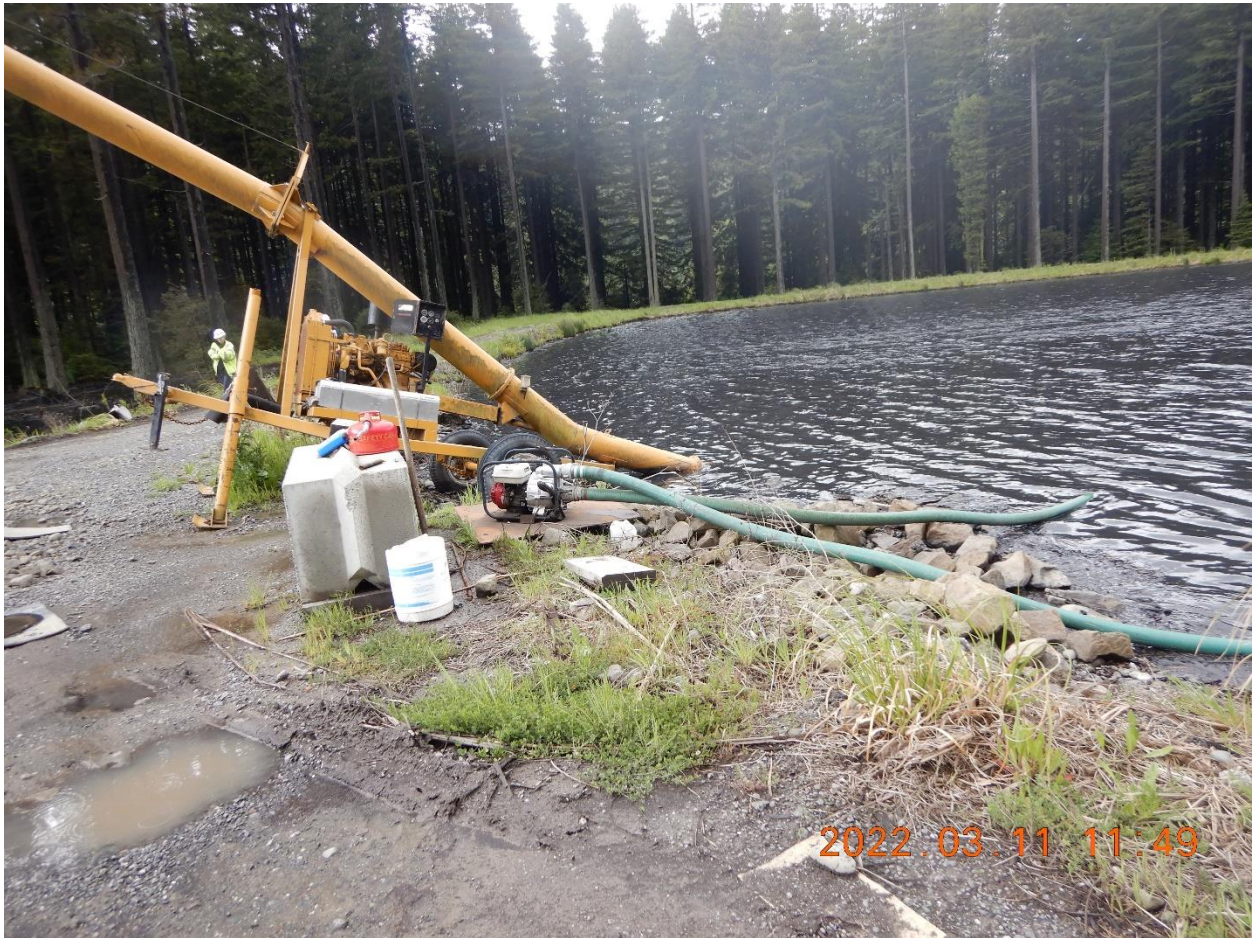
In addition to the outlets, water is also pumped out of the retention pond using a portable pump and discharged into the tree plantation area. This area is flooded to allow for infiltration and is bordered by a collection swale³ (Picture 7a, 7b, and 7c).

Picture 7a: Water being pumped from the retention pond with a portable pump and being discharged into the tree plantation area. Picture taken by Heaven Moore.

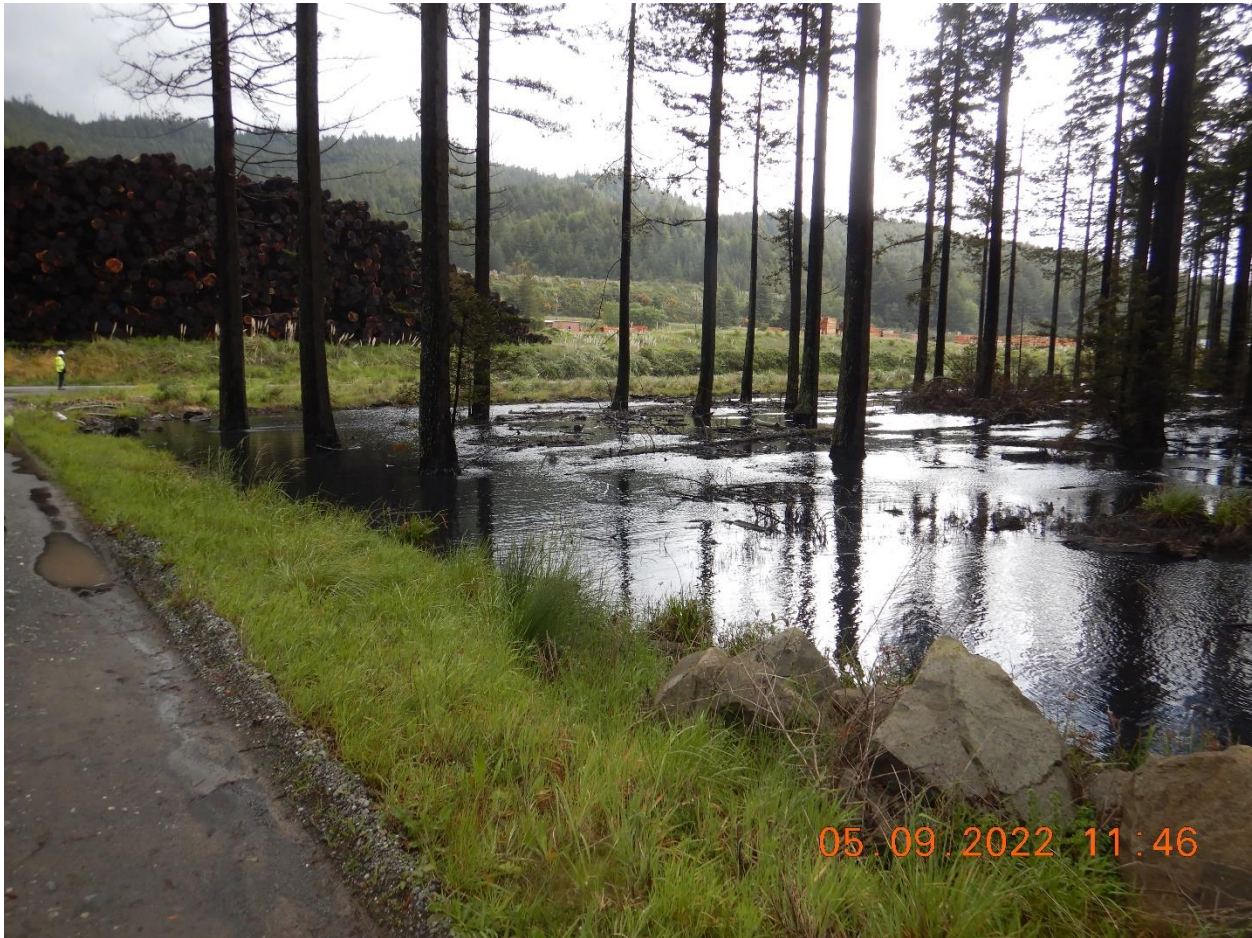
Picture 7b: Water that has been pumped from the retention pond with a portable pump and discharged into the tree plantation area. Picture taken by Farzad Kasmaei.

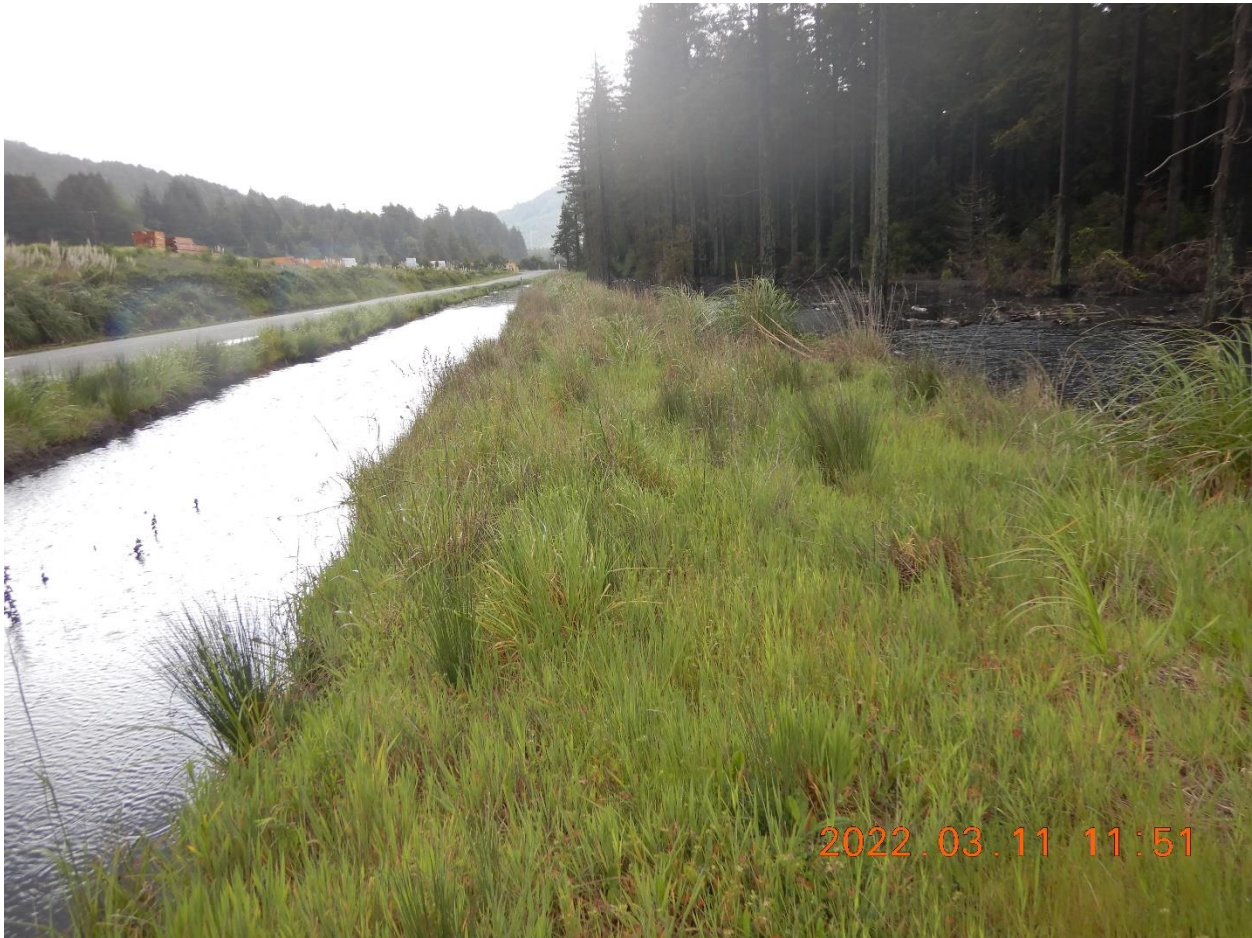
Picture 7c: Water that has been pumped from the retention pond with a portable pump and discharged into the tree plantation area, shown on the right of the picture, and the swale on the left of the picture. Picture taken by Heaven Moore.

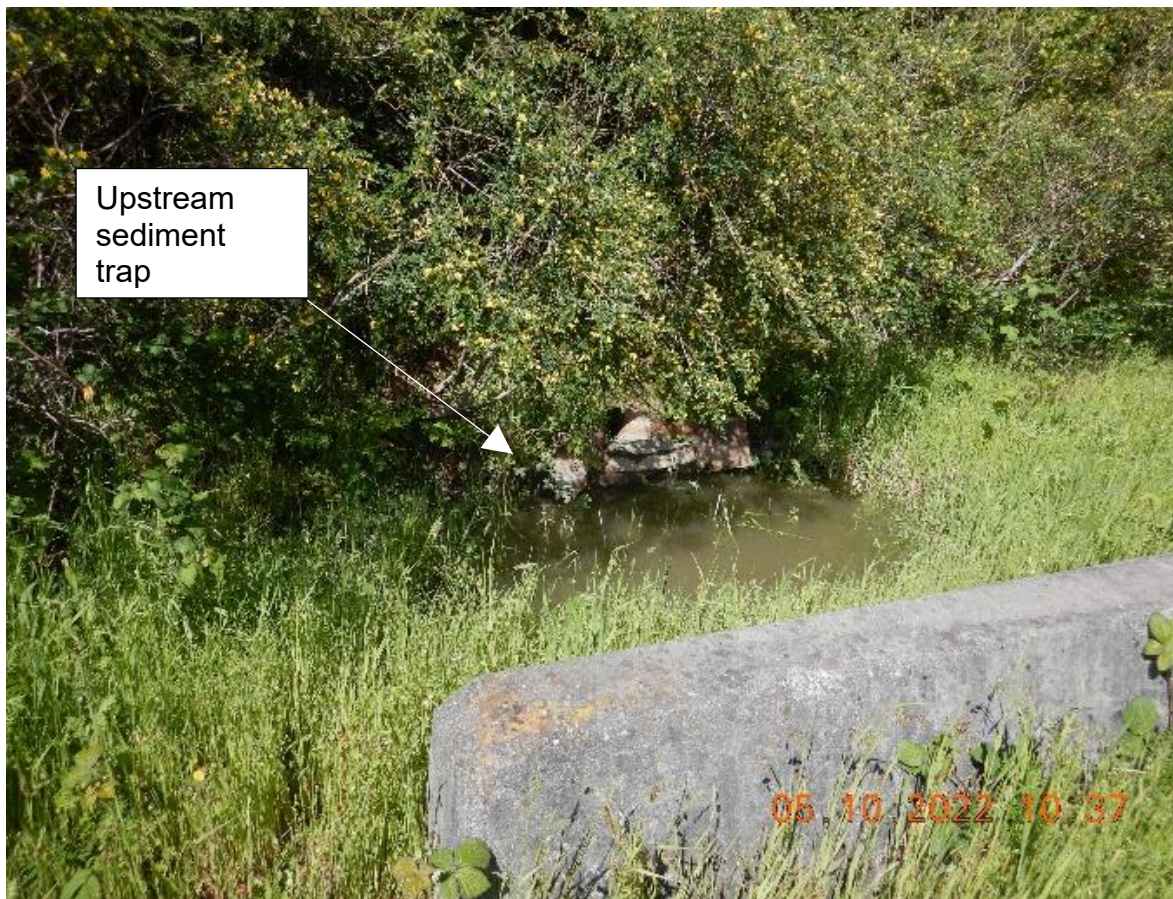
Picture 9a: Looking west at one of the sediment traps in air dry yard. Picture taken by Farzad Kasmaei.

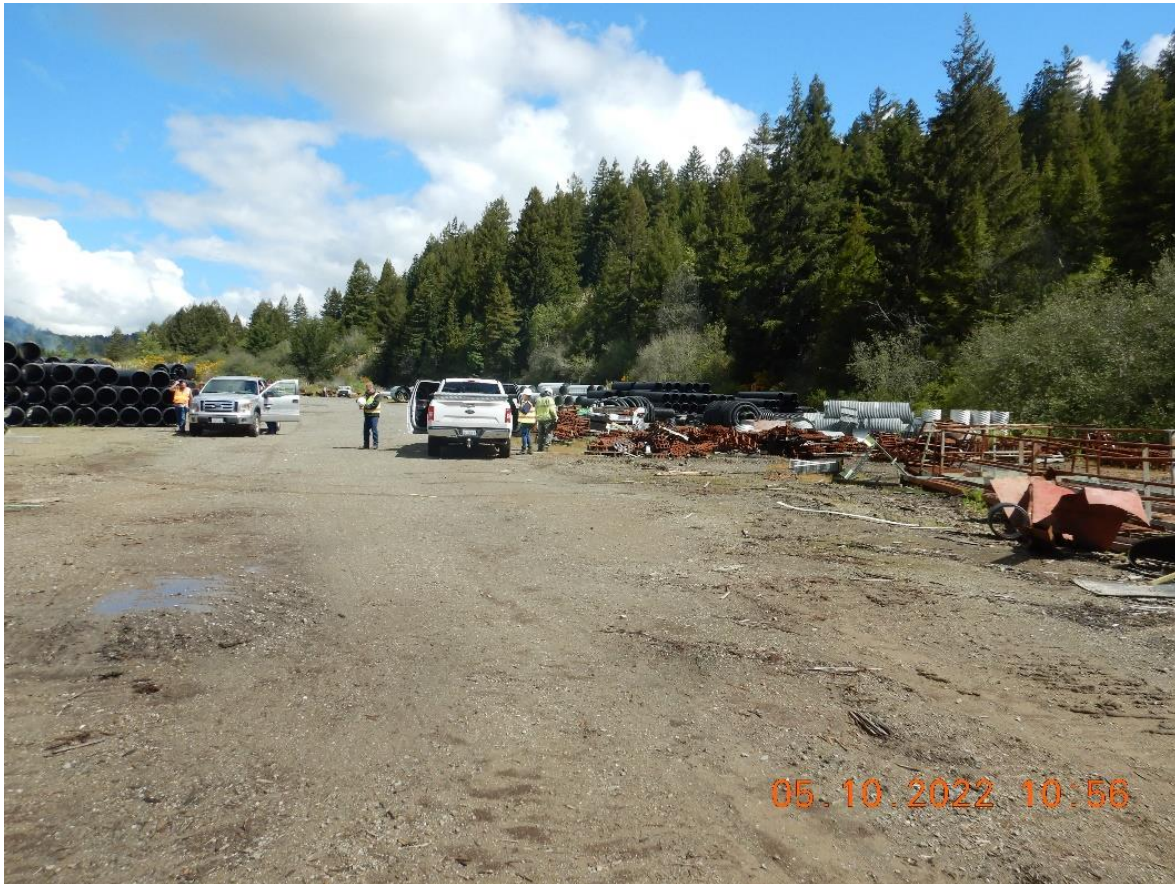
Picture 9b: Boneyard that discharges to small retention pond. Picture taken by Farzad Kasmaei.

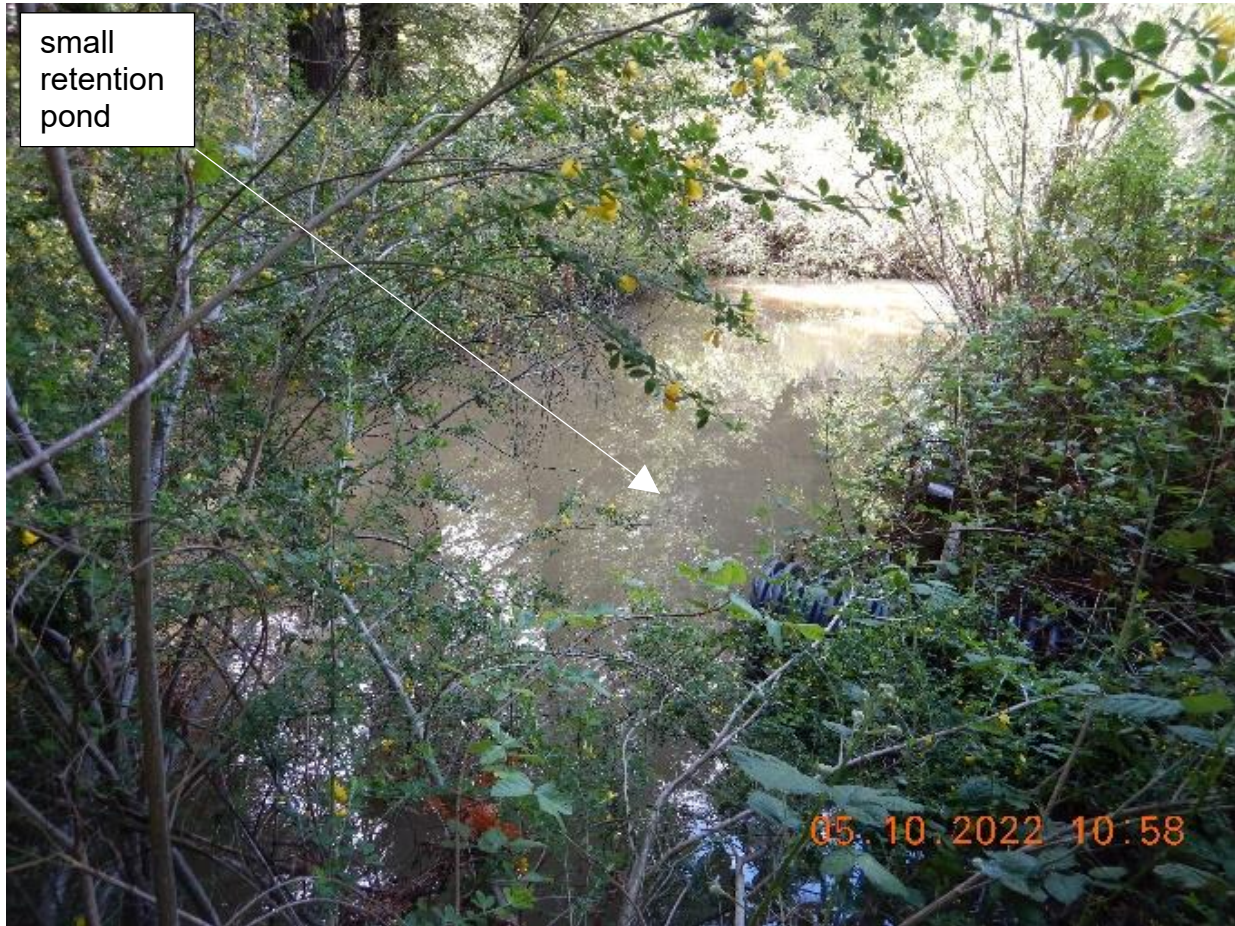
Picture 9c: Looking south at small retention pond in boneyard that receives runoff from upstream sediment traps via corrugated pipe shown on the photo. Picture taken by Farzad Kasmaei.

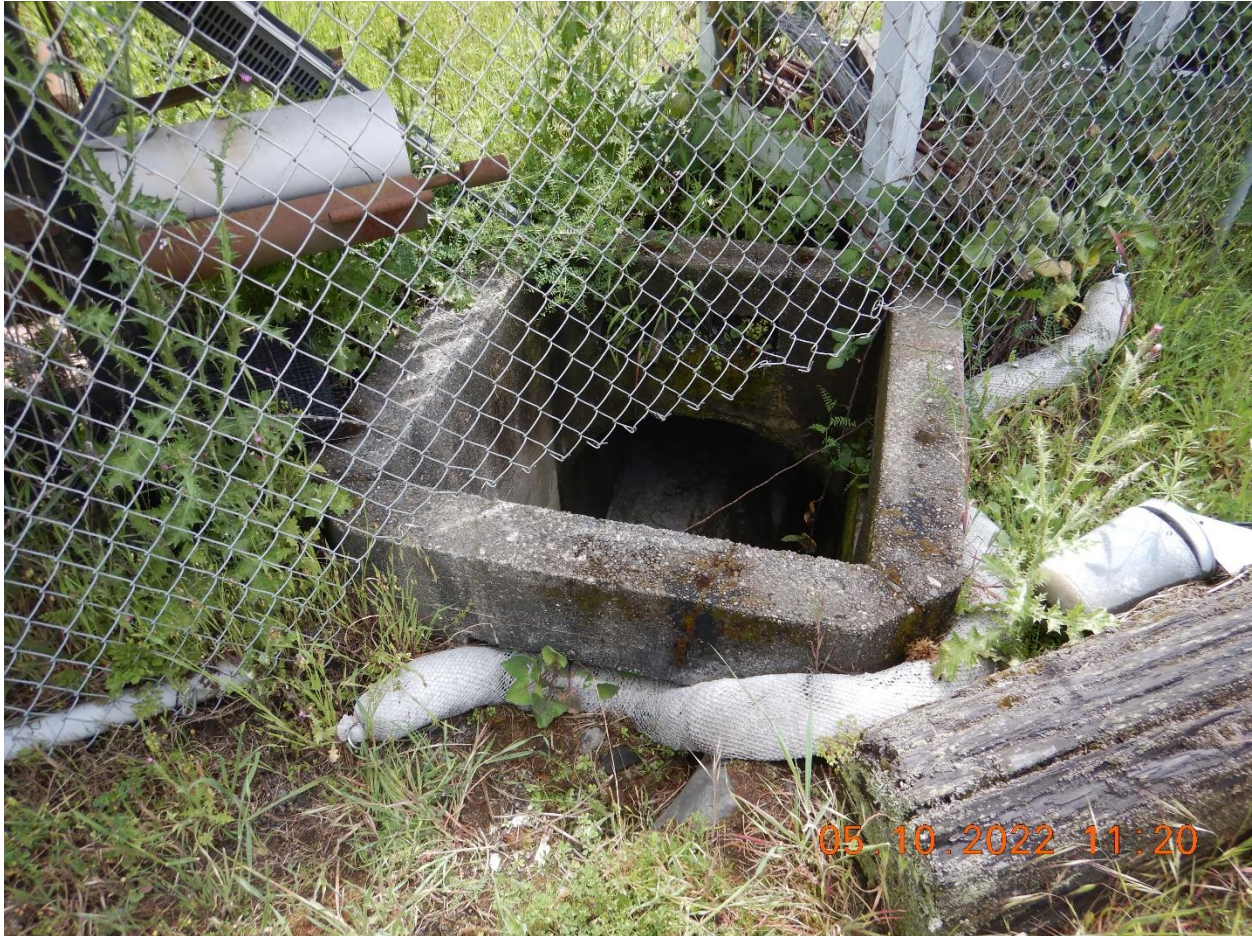
The Inspection Team also observed storm drain inlets, including the sampling point 003 (Picture 11) in the vicinity of the fueling station (Picture 12a, 12b). Facility staff stated that the storm drain inlet referred to as sampling point 003 receives run-on from the adjacent city streets and neighborhood and that it can be challenging to sample as a result.

Picture 11: Looking east at catch basin 003 where the samples are collected. This catch basin receives facility's runoff from northern areas of the facility as well as highway runoff. The catch basin open spaces have been covered with Filtrexx. Picture taken by Farzad Kasmaei.

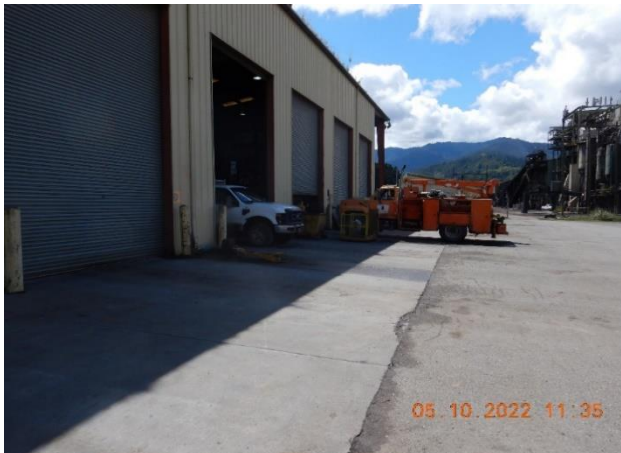
Pictures 13a and 13b: View of covered vehicle maintenance area. Picture taken by Farzad Kasmaei.

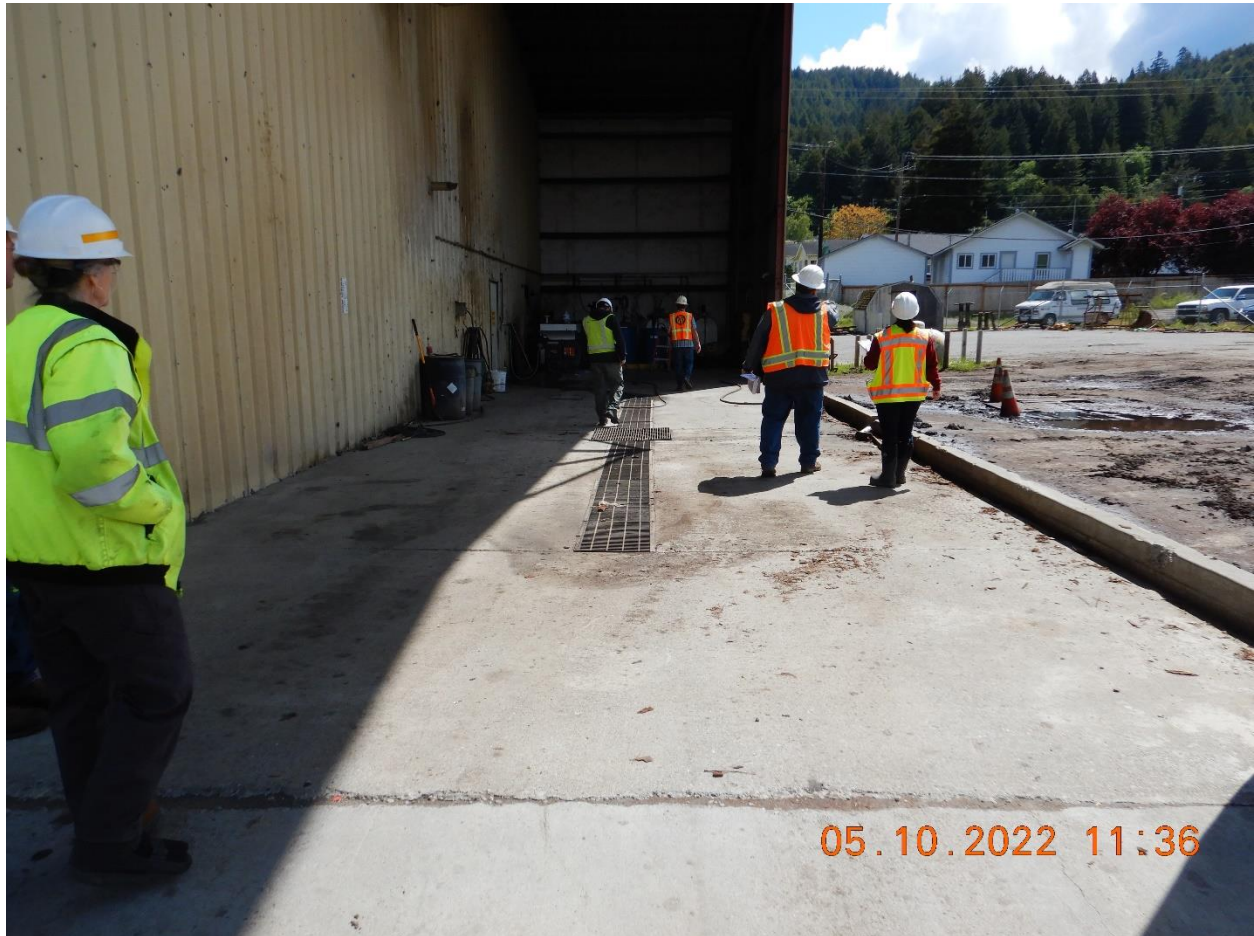
Picture 13c: View of covered vehicle wash area. Facility staff stated that drain within this area discharges to sewer. Picture taken by Farzad Kasmaei.

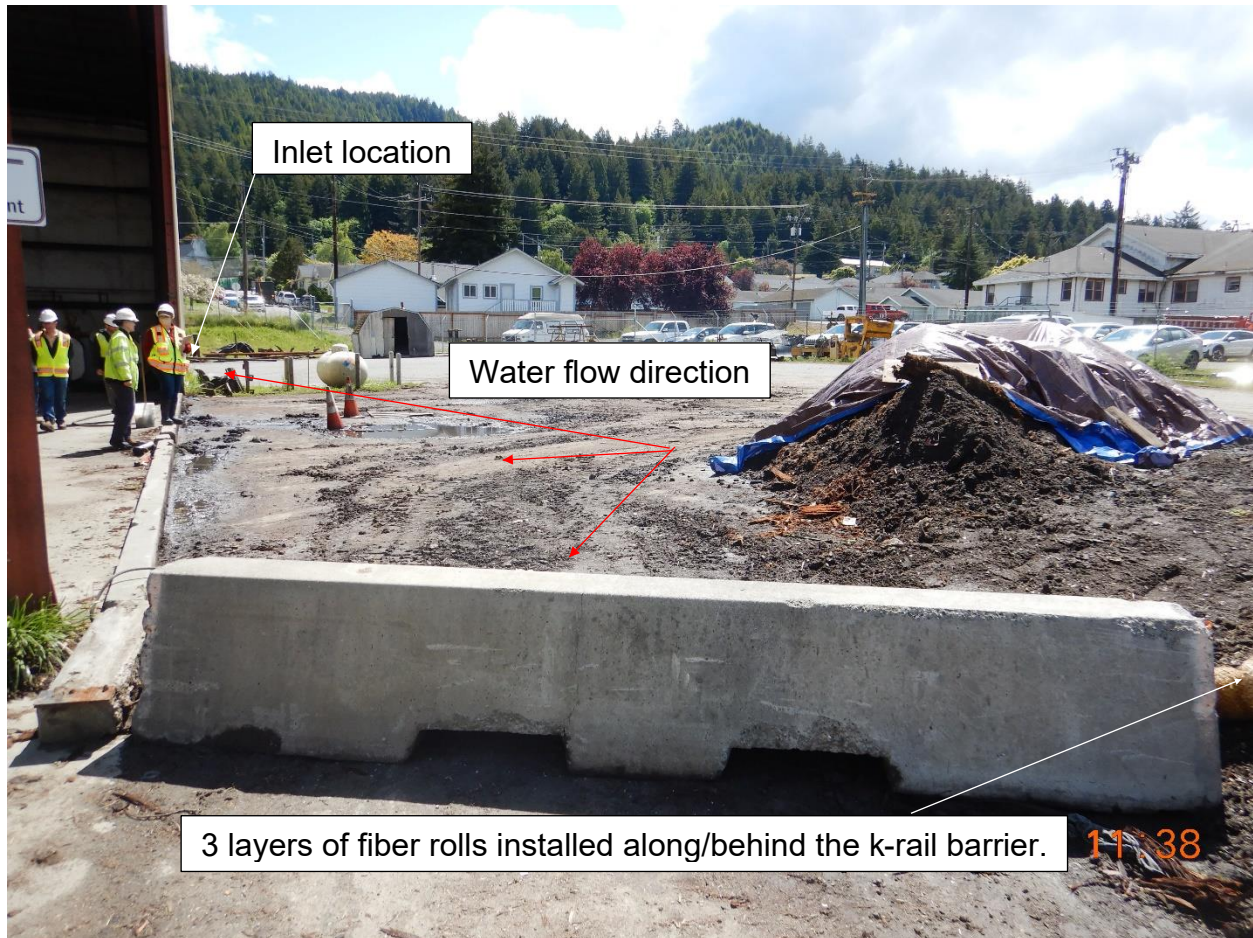
Picture 14a: View of area adjacent to vehicle wash bay area. Water flow directions are shown with red arrows on the photo. Note the storm drain inlet (Photo 15) behind the maintenance shed receives runoff from this area. Picture taken by Farzad Kasmaei.

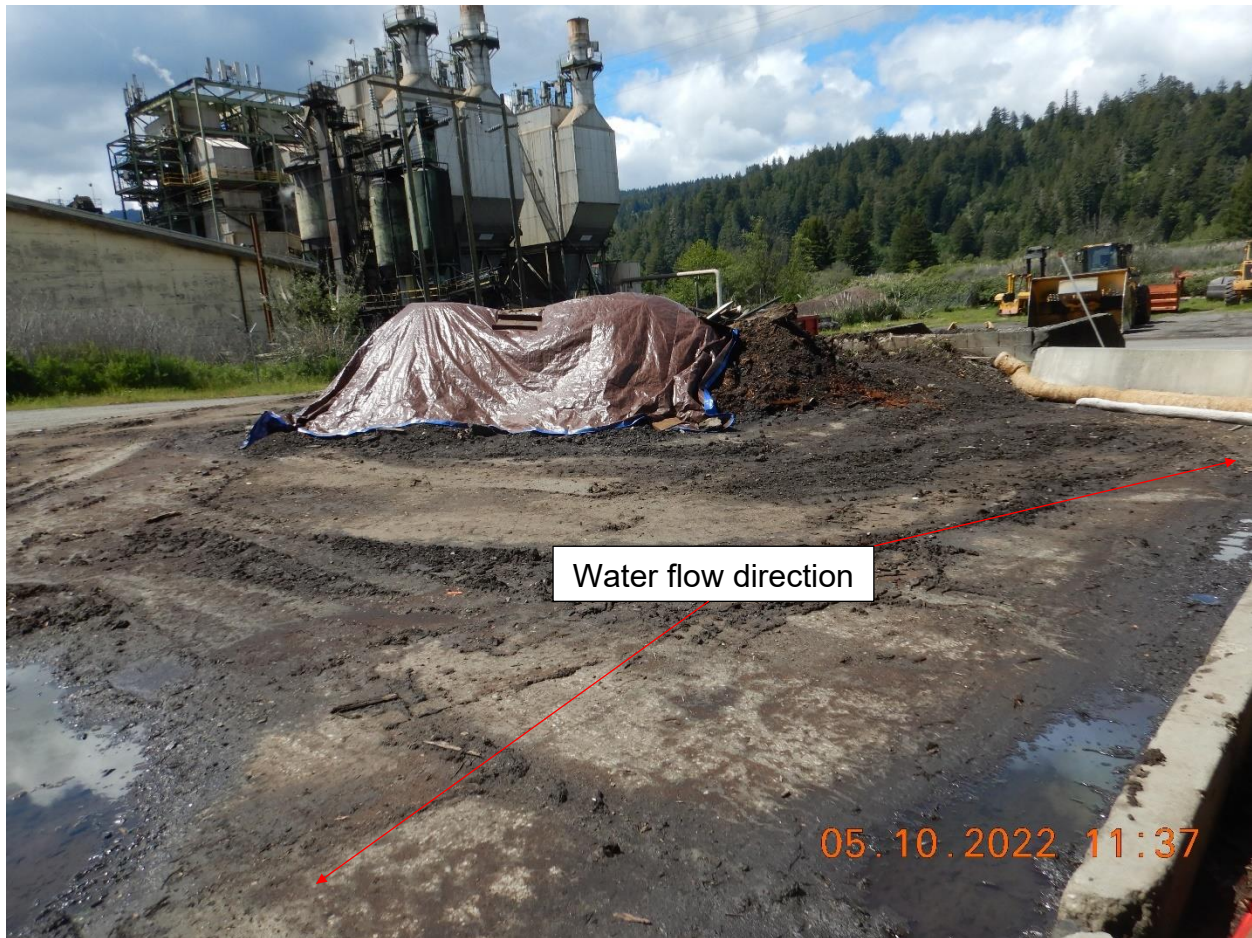
Picture 14b: Partially covered stockpile of the material that is washed from the equipment and vehicles is then stockpiled and removed as hazardous material every three to six months. Material is also present on the pavement. Water flow directions are shown with red arrows on the photo. Picture taken by Farzad Kasmaei.

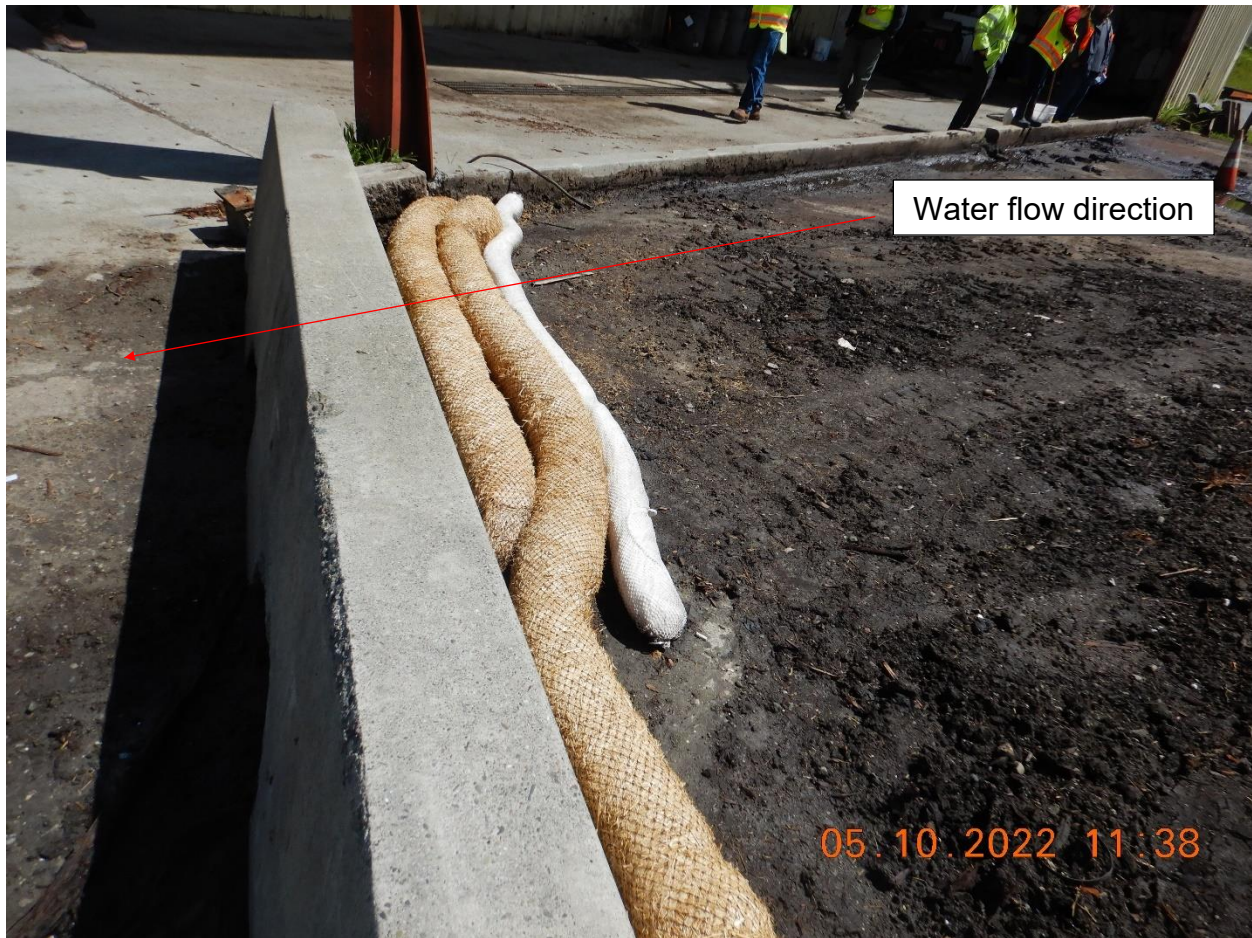
Picture 14c: Material that is washed from the equipment and vehicles on the pavement both within the designated area, as well as beyond the BMPs and concrete k-rail. Straw wattles and oil absorbing booms appear recently placed and are ineffective at containing the material. Water flow directions are shown with red arrows on the photo. Picture taken by Farzad Kasmaei.

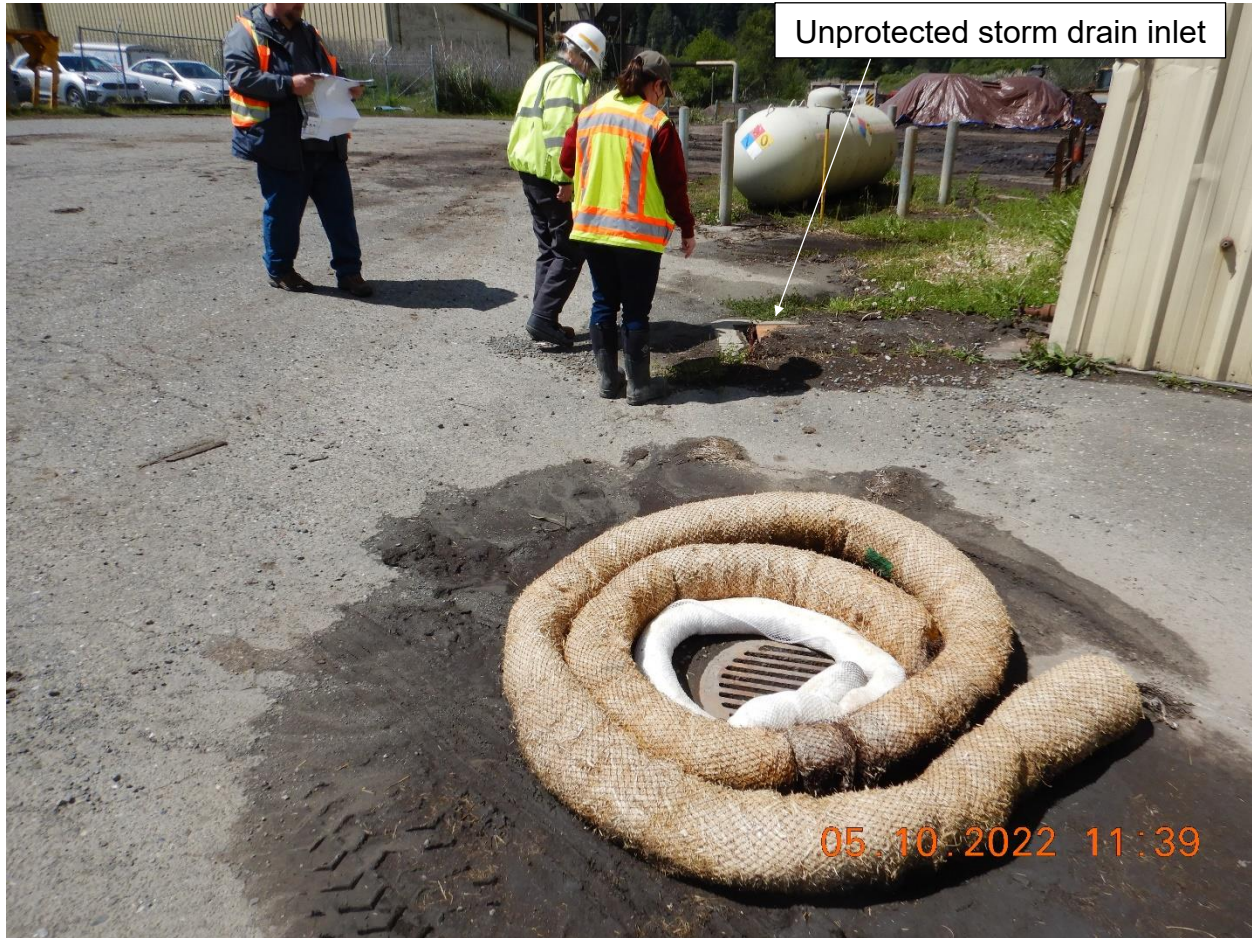
Picture 15: Storm drain inlets located behind the vehicle maintenance area, wash bay, and outdoor wash area. A fiber roll and Filtrex oil absorbing boom have been installed around the inlet in the foreground, but the inlet in the background is unprotected and propped open. Picture taken by Farzad Kasmaei.

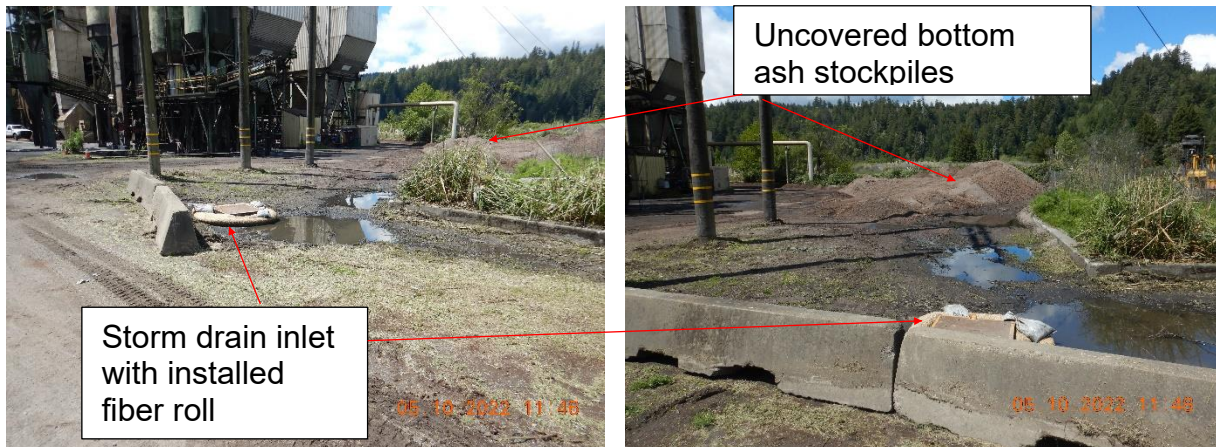
Pictures 16a, 16b: View of uncovered bottom ash stockpiles on the north side of the Cogen area and the storm drain inlet that receives runoff from this area. Picture taken by Farzad Kasmaei.

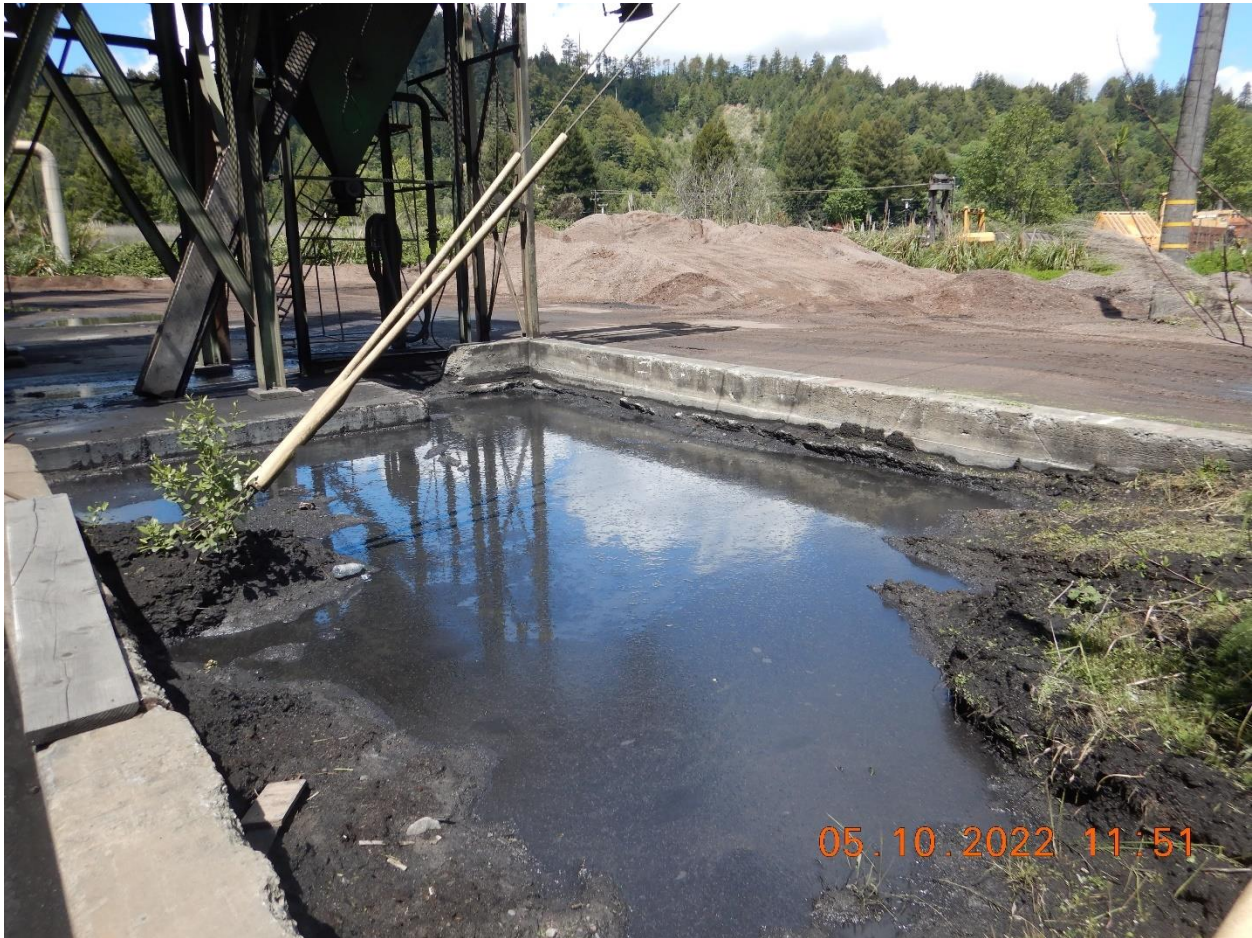
Ponded stormwater was present in the northeast side of the Cogeneration area. This ponded area receives stormwater runoff from Cogen area as well as from the outdoor vehicle wash area shown in photos 14a-c. Thick dark mud and oil sheen was visible and the water had a strong hydrocarbon smell (Picture 17a). Oil and hydrocarbon staining was on the ground around and on top of the unprotected storm drain inlets beneath cogeneration equipment (picture 17b, 17c). The area had a strong smell of hydrocarbons.

Picture 17a: Poned stormwater in the northeast side of the Cogeneration area. This area receives stormwater runoff from Cogen and outdoor vehicle wash areas shown in photos 14a-c. Thick dark mud and oil sheen was visible and the water had a strong hydrocarbon smell. This area discharges to downstream storm drain inlets and then into the Log Pond. The bottom ash stockpiles in the background are unprotected and would also discharge into the Log Pond. Picture taken by Farzad Kasmaei.
