North Coast Regional Water Quality Control Board

INSPECTION MEMO

Scotia Sawmill and Cogeneration Plant, 125 Main Street, Scotia, Humboldt County

WDID #: 1 12I027974

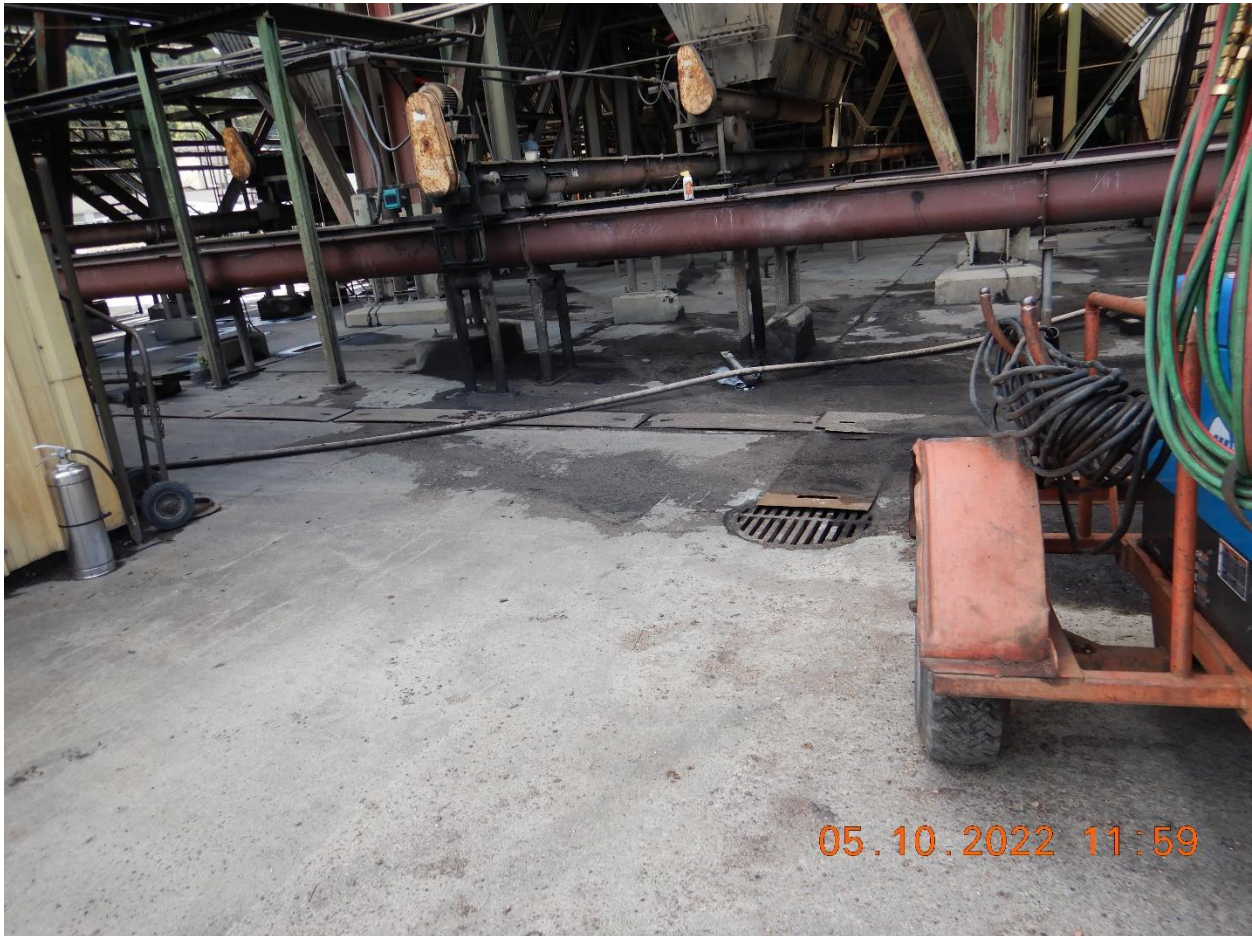
Picture 17b: View of the cogeneration operational area and a storm drain drop inlet within the paved area that drains to the Log Pond. Oil and hydrocarbons can be seen around and on top of the inlet. The area had a strong smell of hydrocarbons. This storm drain inlet discharges into the Log Pond. Picture taken by Farzad Kasmaei.

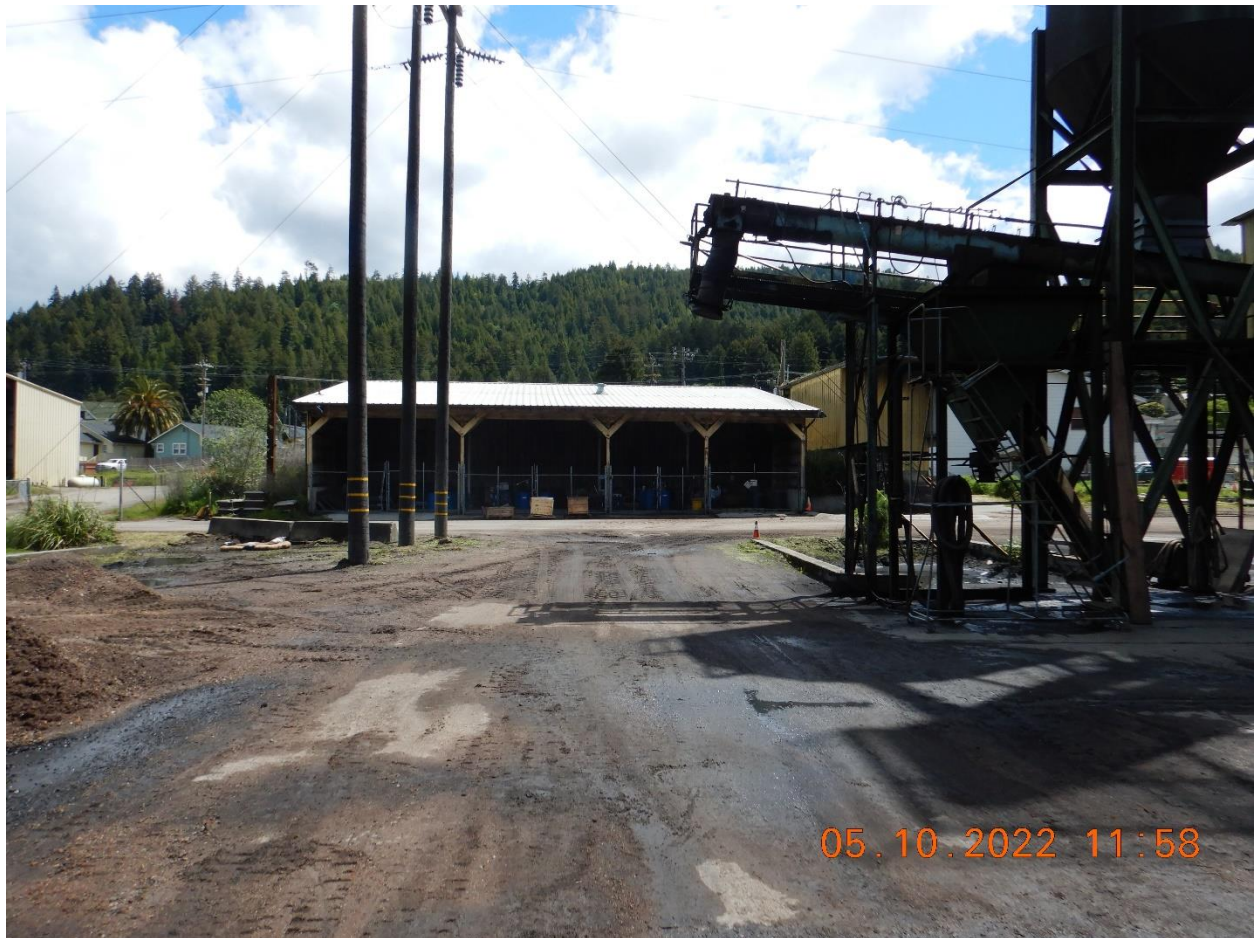
Picture 17c: Looking east at equipment shed within the paved cogeneration area. Observed sawdust and tracking on the ground, oil and hydrocarbon can be seen on the ground throughout this area and under the equipment. The area had a strong smell of hydrocarbons. The bottom ash stockpiles to the left of the image are unprotected and would also discharge into the Log Pond. The ponded stormwater from photo 17a can be seen behind the equipment on the right side of the picture and the storm drain inlet from photo 17b above is just beyond the date stamp to the right of this picture. Picture taken by Farzad Kasmaei

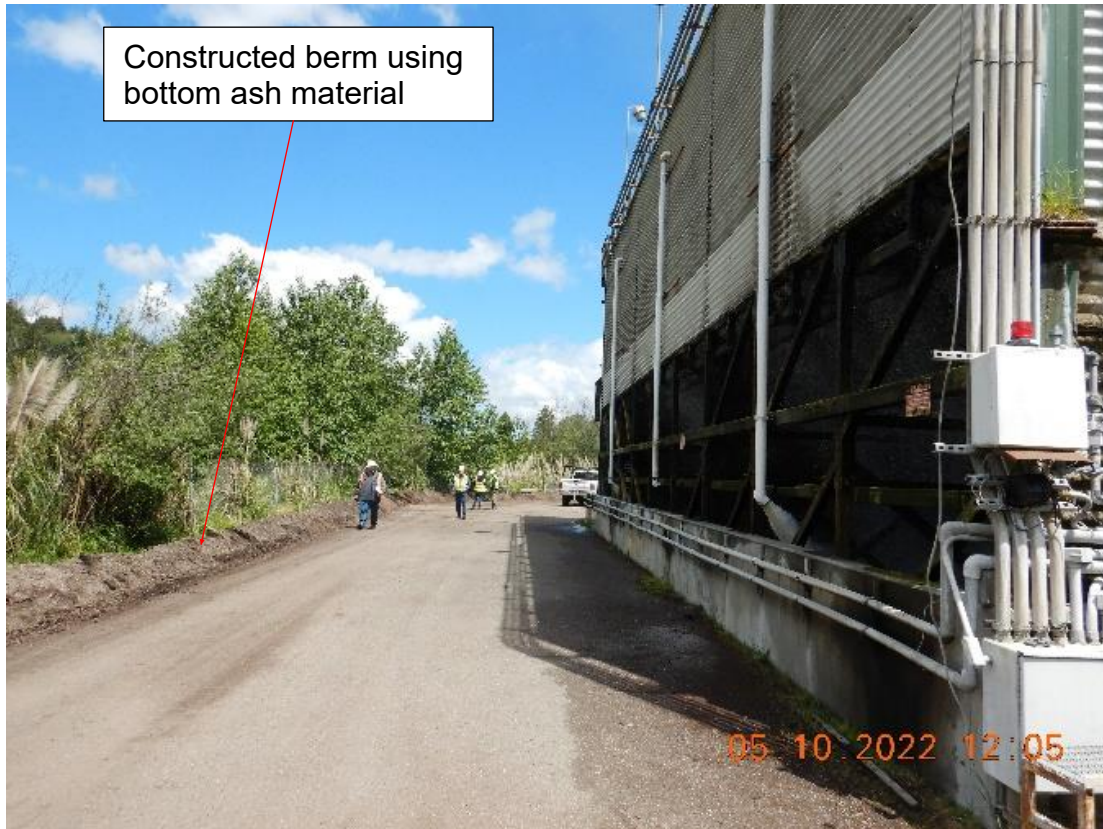
Picture 18a: Looking north at cooling tower and a constructed berm using the bottom ash materials along the west side of the Cogen along the edge of the Log Pond. Picture taken by Farzad Kasmaei.

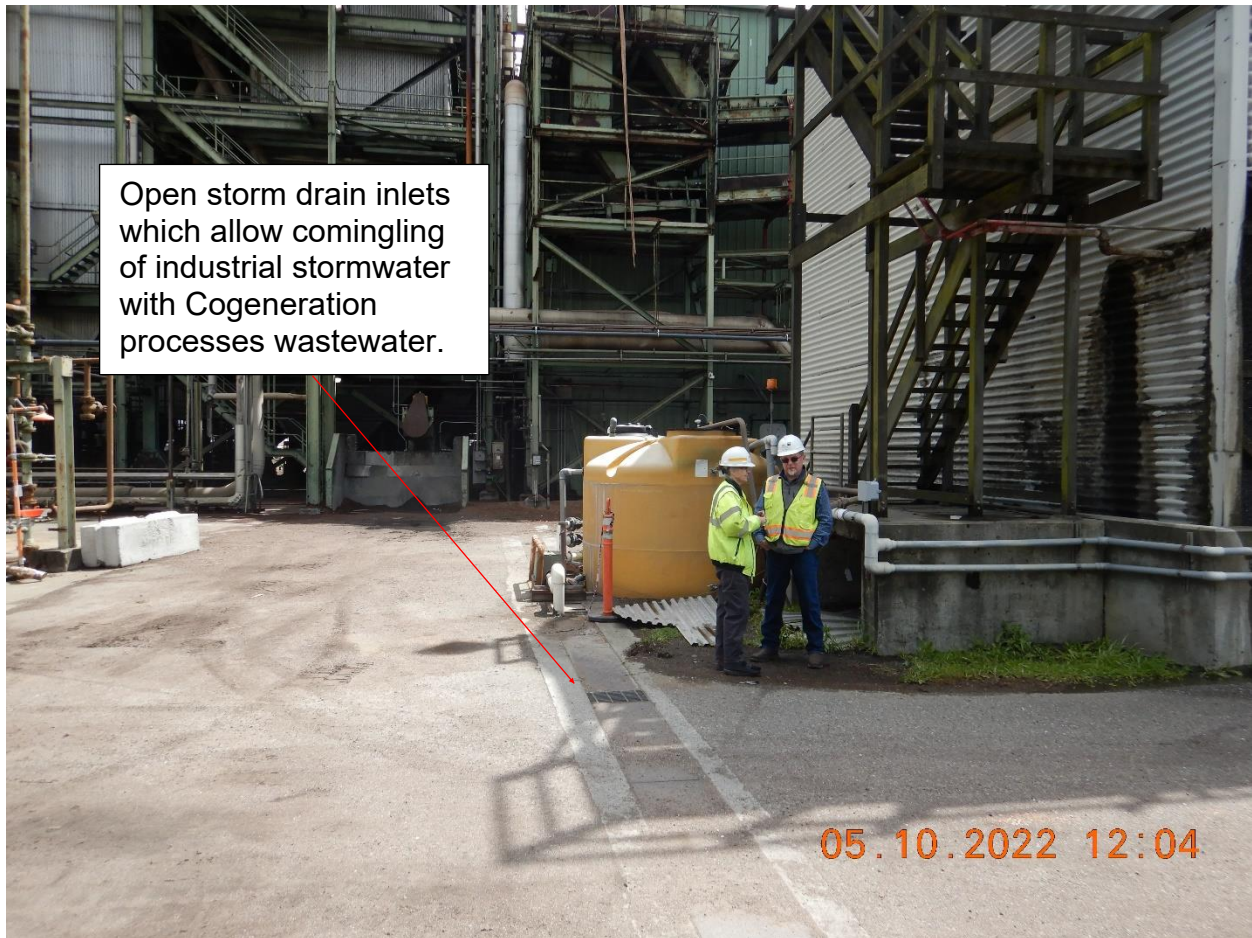
Picture 18b: Open storm drain inlets which allow comingling of industrial stormwater with Cogeneration processes wastewater. Picture taken by Farzad Kasmaei.

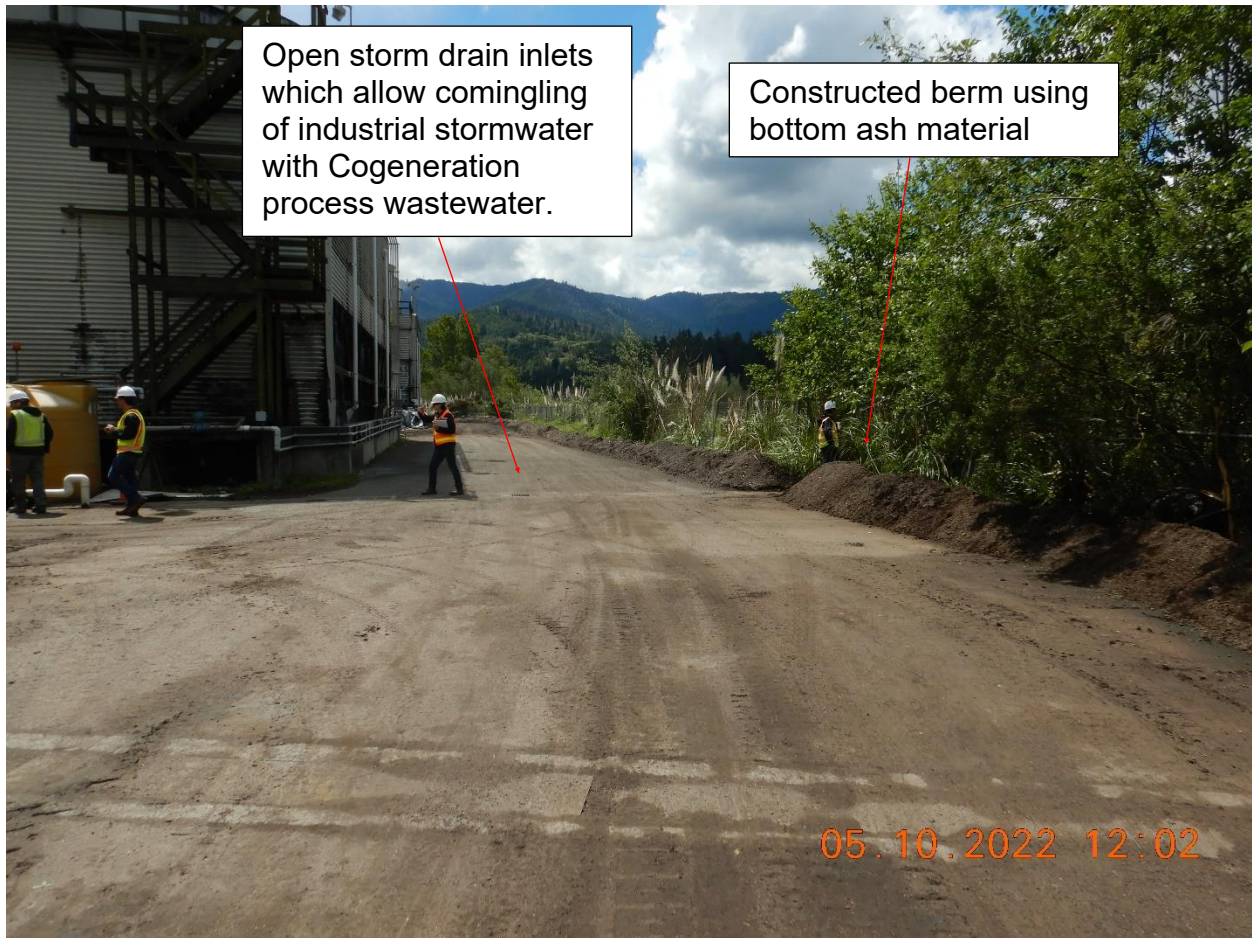
Picture 18c: Open storm drain inlets which allow comingling of industrial stormwater with Cogeneration processes wastewater. Berm constructed from bottom ash material the edge of the Log Pond. Picture taken by Farzad Kasmaei.

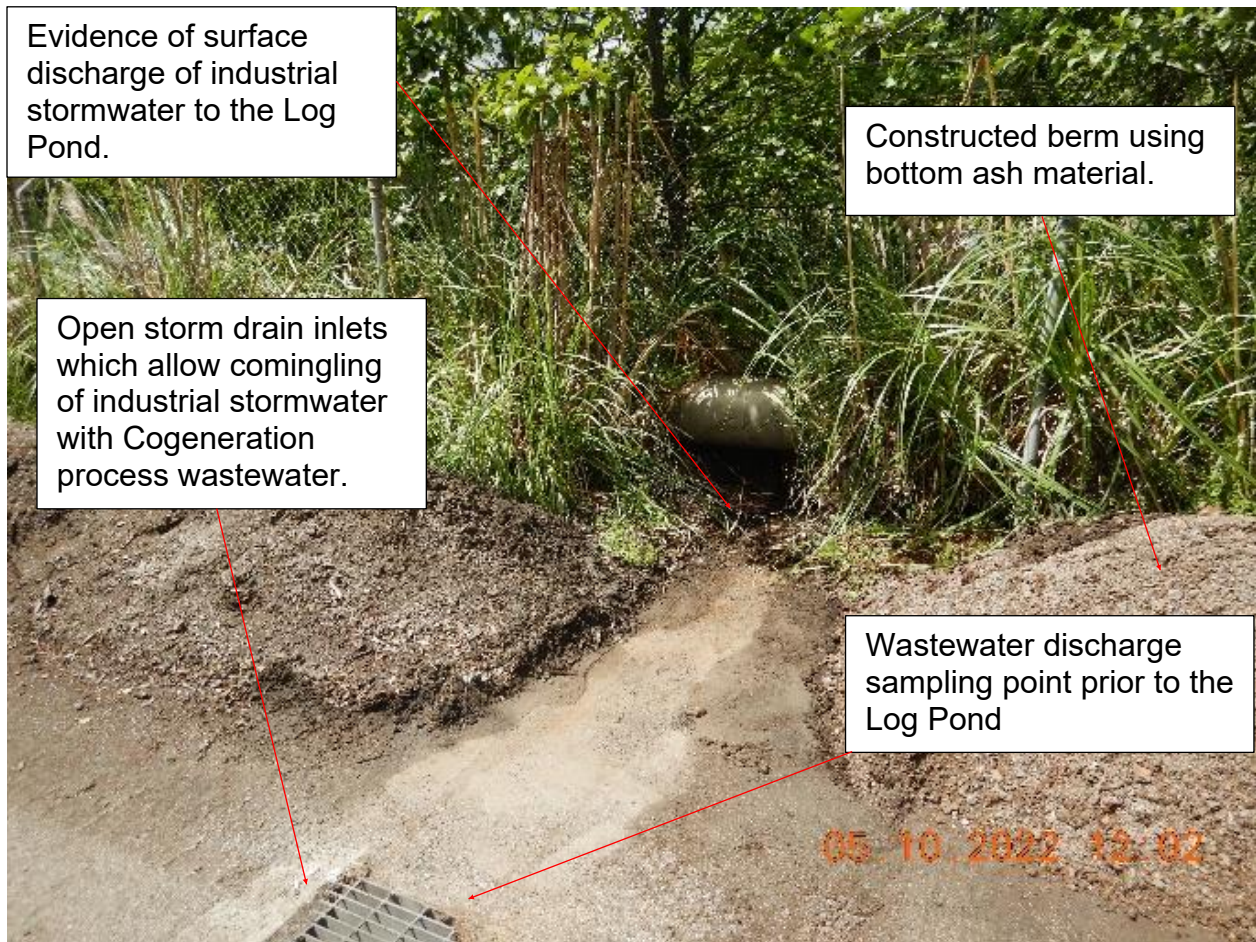
Picture 18d: Wastewater sample location and discharge point to the Log Pond with an open storm drain inlet which allow comingling of industrial stormwater with Cogeneration processes wastewater. Berm constructed from bottom ash material the edge of the Log Pond. Clear evidence of surface discharge of industrial stormwater to the Log Pond. Picture taken by Farzad Kasmaei.

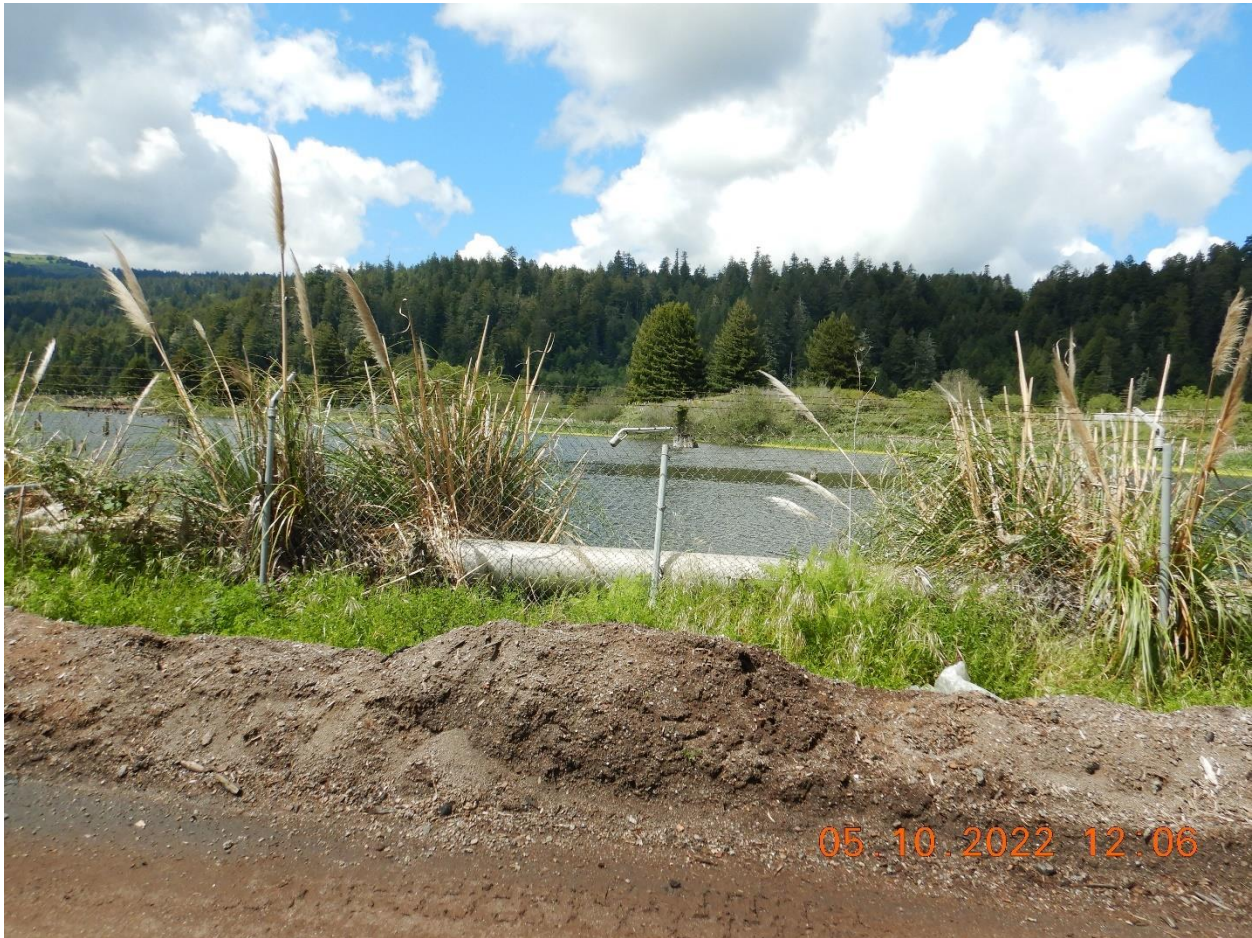
Picture 18e: Constructed berm made of bottom ash materials along the edge of the Log Pond. Picture taken by Farzad Kasmaei.

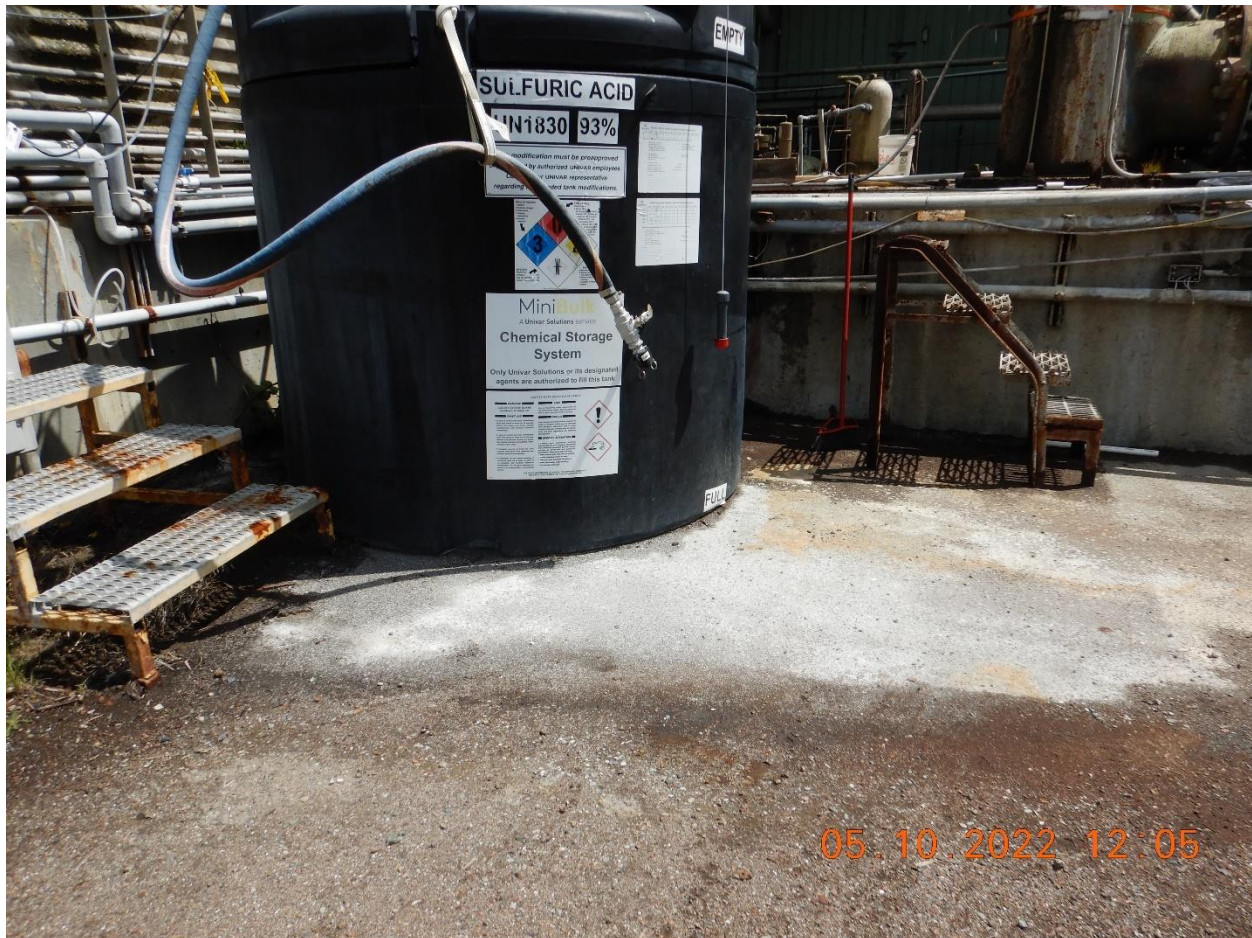
Picture 19a: Large sulfuric acid chemical storage tank without secondary containment or any other BMPs. Located in the Cogeneration area adjacent to the Log Pond. Picture taken by Farzad Kasmaei.

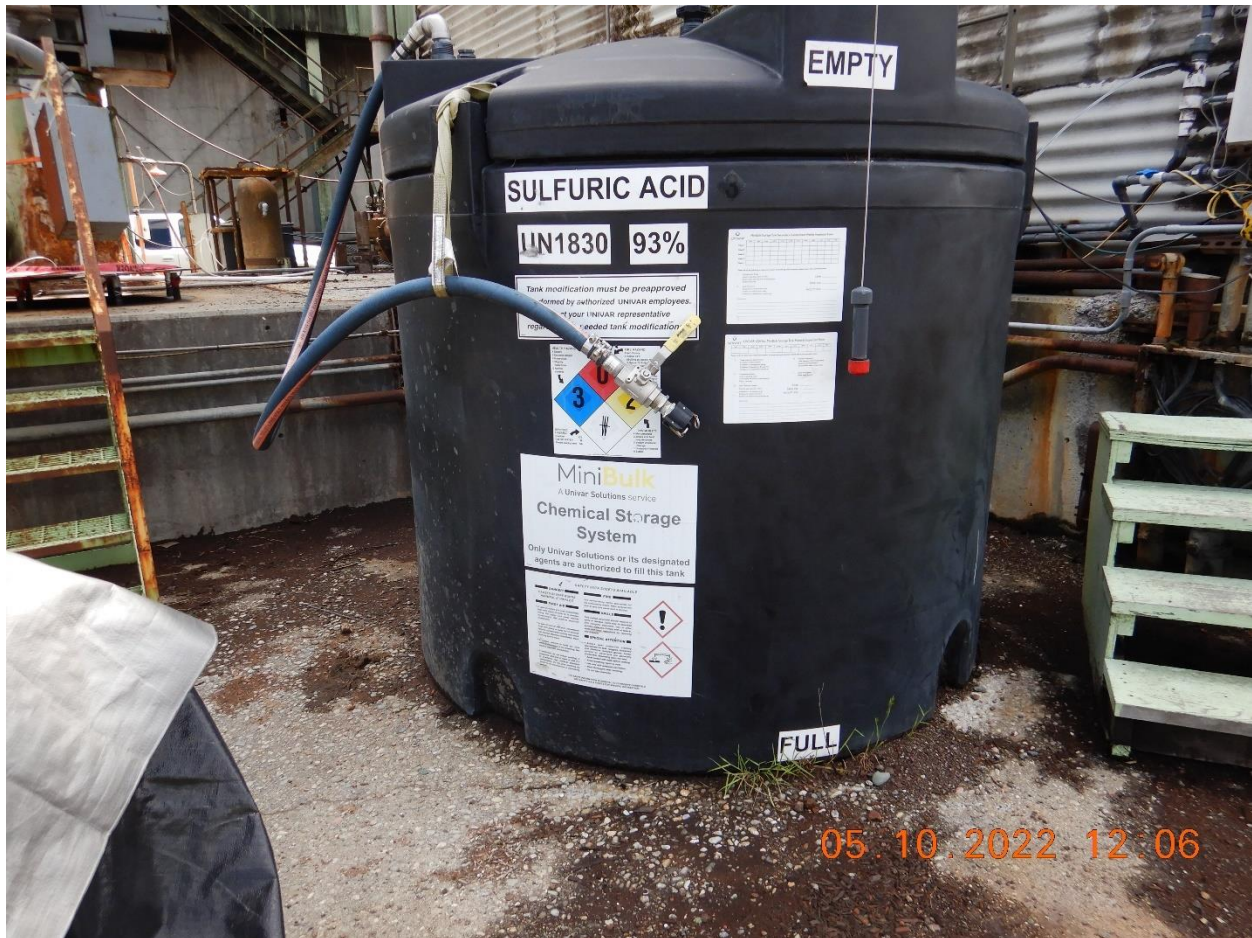
Picture 19b: Large sulfuric acid chemical storage tank without secondary containment or any other BMPs. Located in the Cogeneration area adjacent to the Log Pond. Picture taken by Farzad Kasmaei.

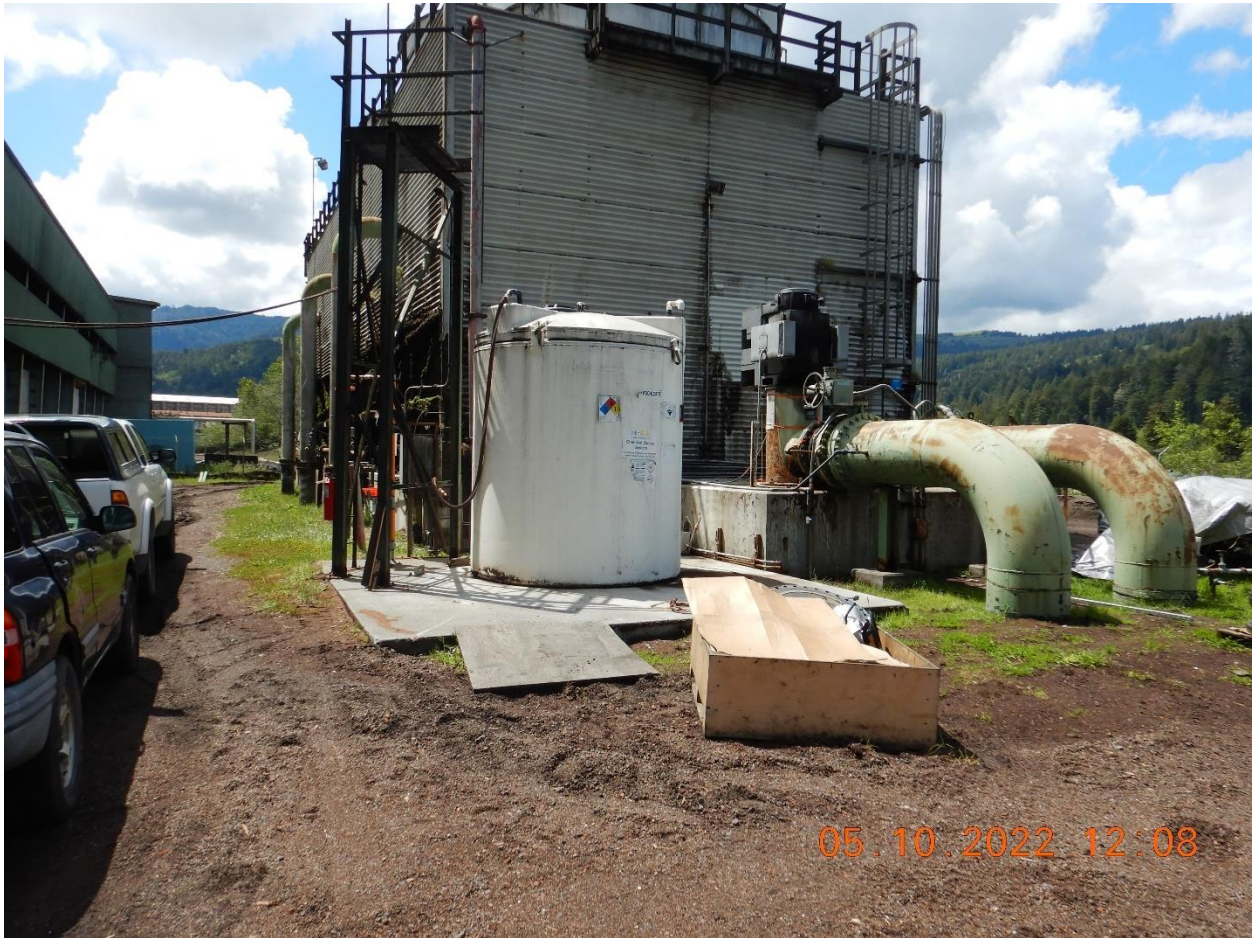
Picture 19c: Large hypochlorite chemical storage tank without secondary containment or any other BMPs. Located in the Cogeneration area adjacent to the Log Pond. Picture taken by Farzad Kasmaei.

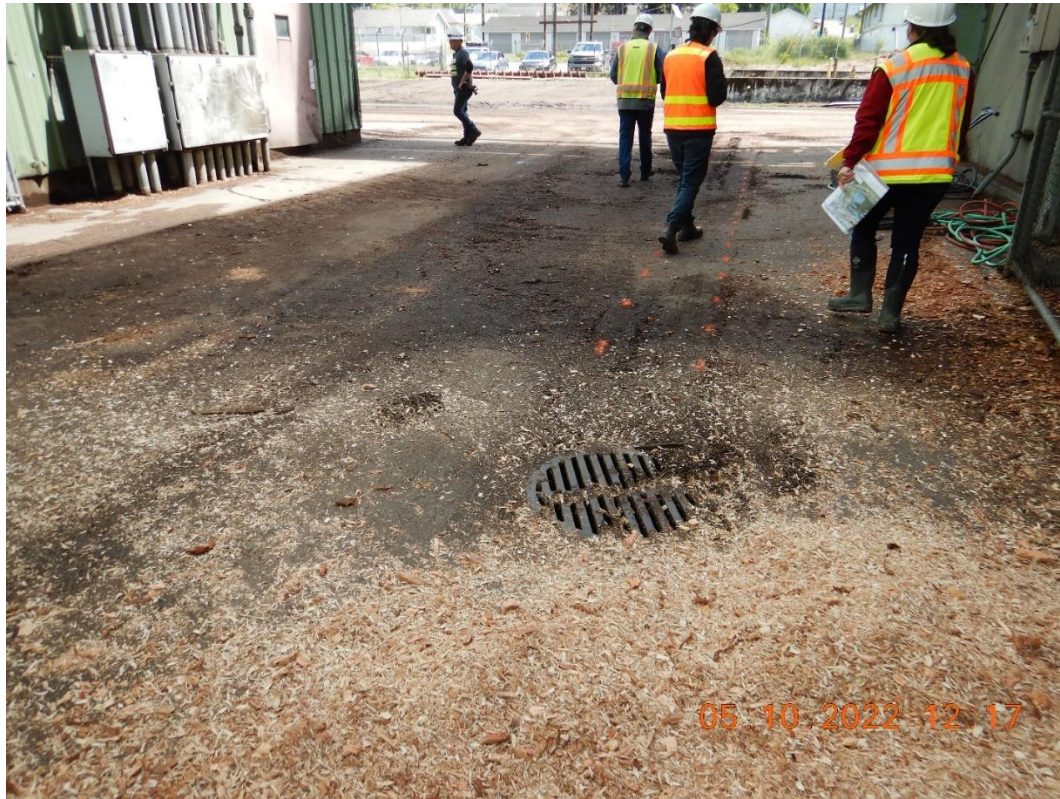
Picture 19d: View of unprotected storm drain inlet within Cogeneration area and significant amount of woodchips all around the inlet. Poor housekeeping is implemented within this area. Picture taken by Farzad Kasmaei.

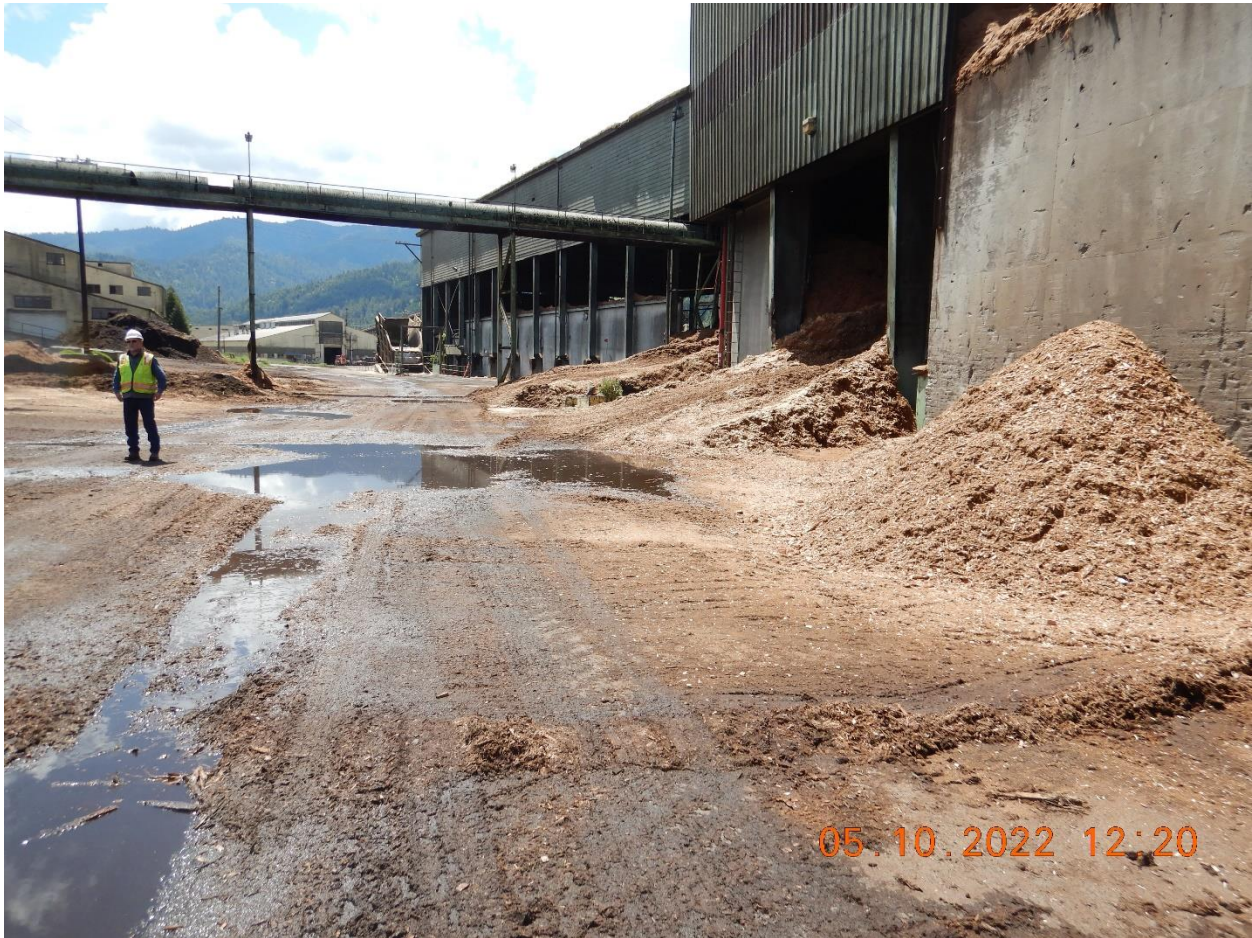
Picture 20a: Looking South at sawmill yard in Drainage Area 2. Wood chips and sawdust accumulations were observed outside throughout the yard as well as unprotected stockpiles. Picture taken by Farzad Kasmaei.

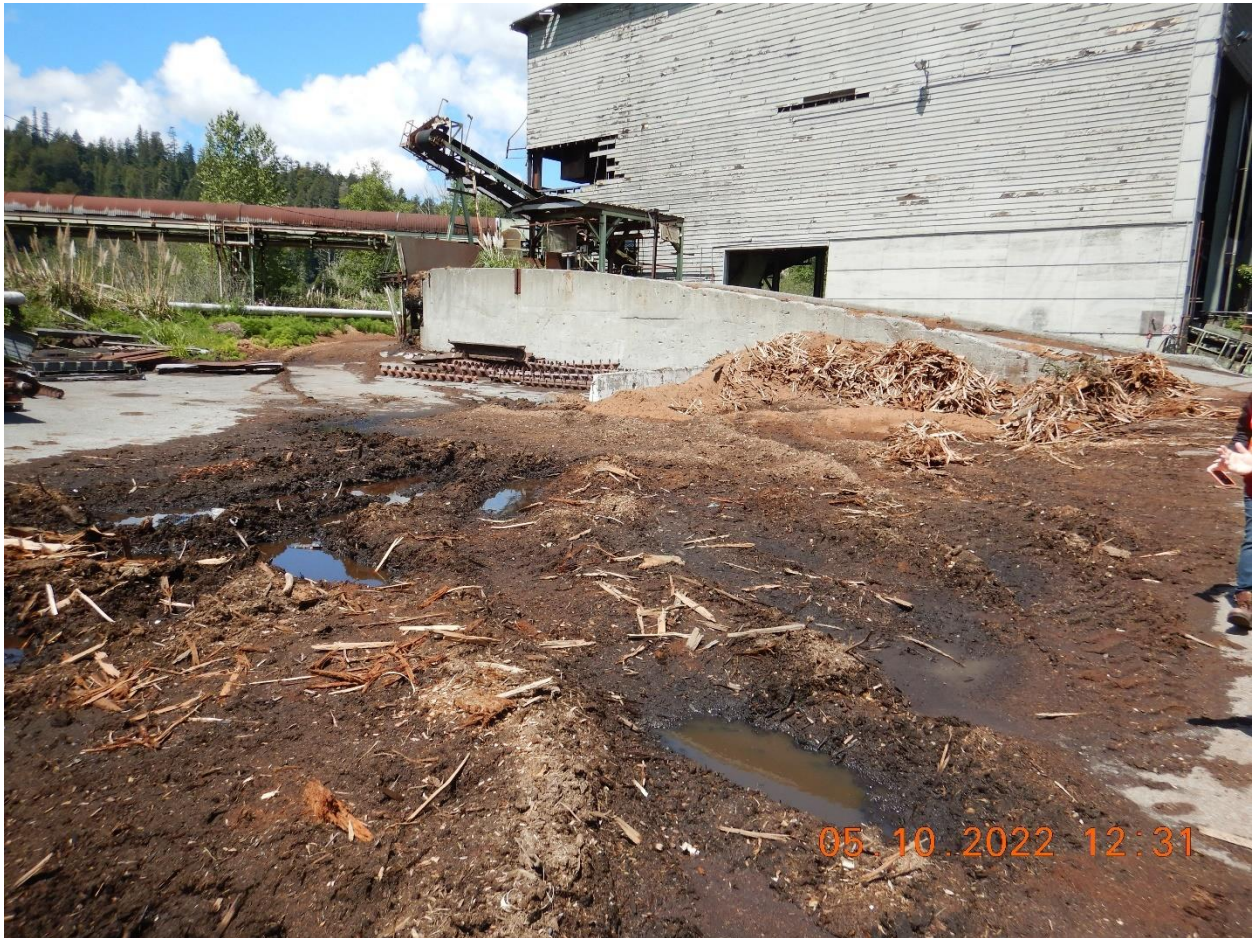
Picture 20b: Portion of Drainage Area 2. Wood chips and sawdust accumulations were observed outside throughout the yard as well as unprotected stockpiles. Picture taken by Farzad Kasmaei.

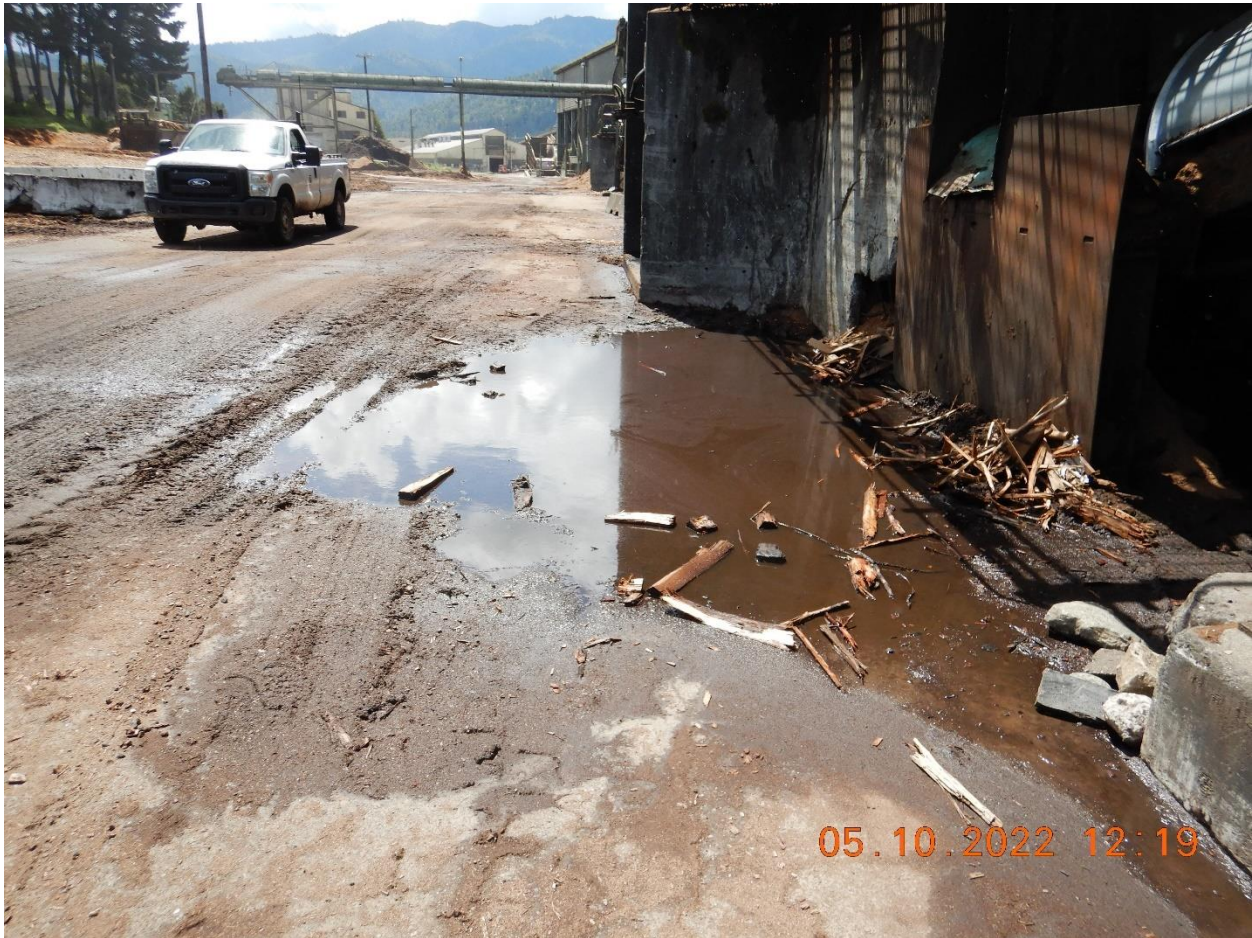
Picture 20c: Looking South at sawmill yard in Drainage Area 2. Standing stormwater in this area was dark brown and had a visible oil sheen. Picture taken by Farzad Kasmaei.

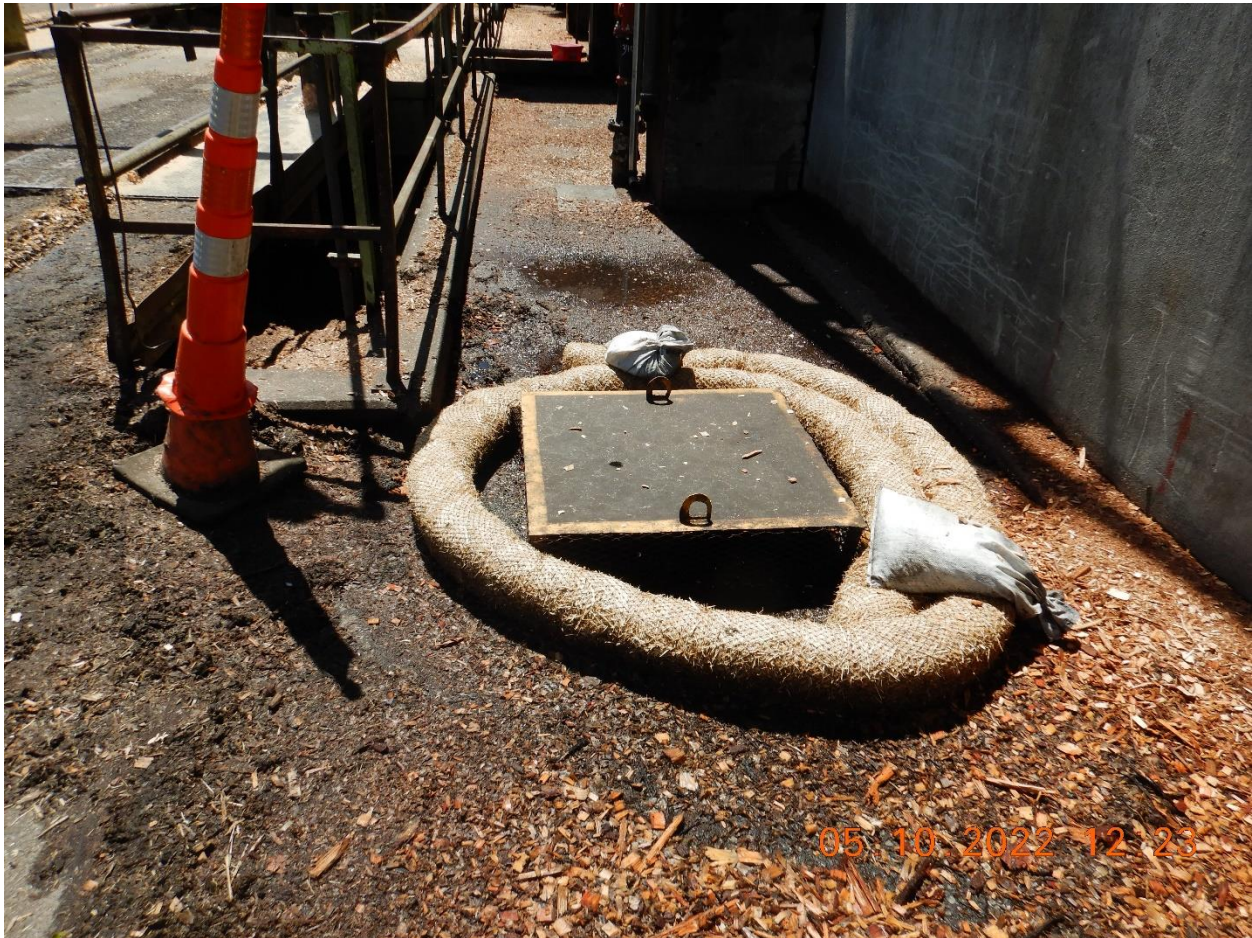
Picture 20d: Numerous storm drain inlets along the Planer Building that were not mapped on the site map. Picture taken by Farzad Kasmaei.

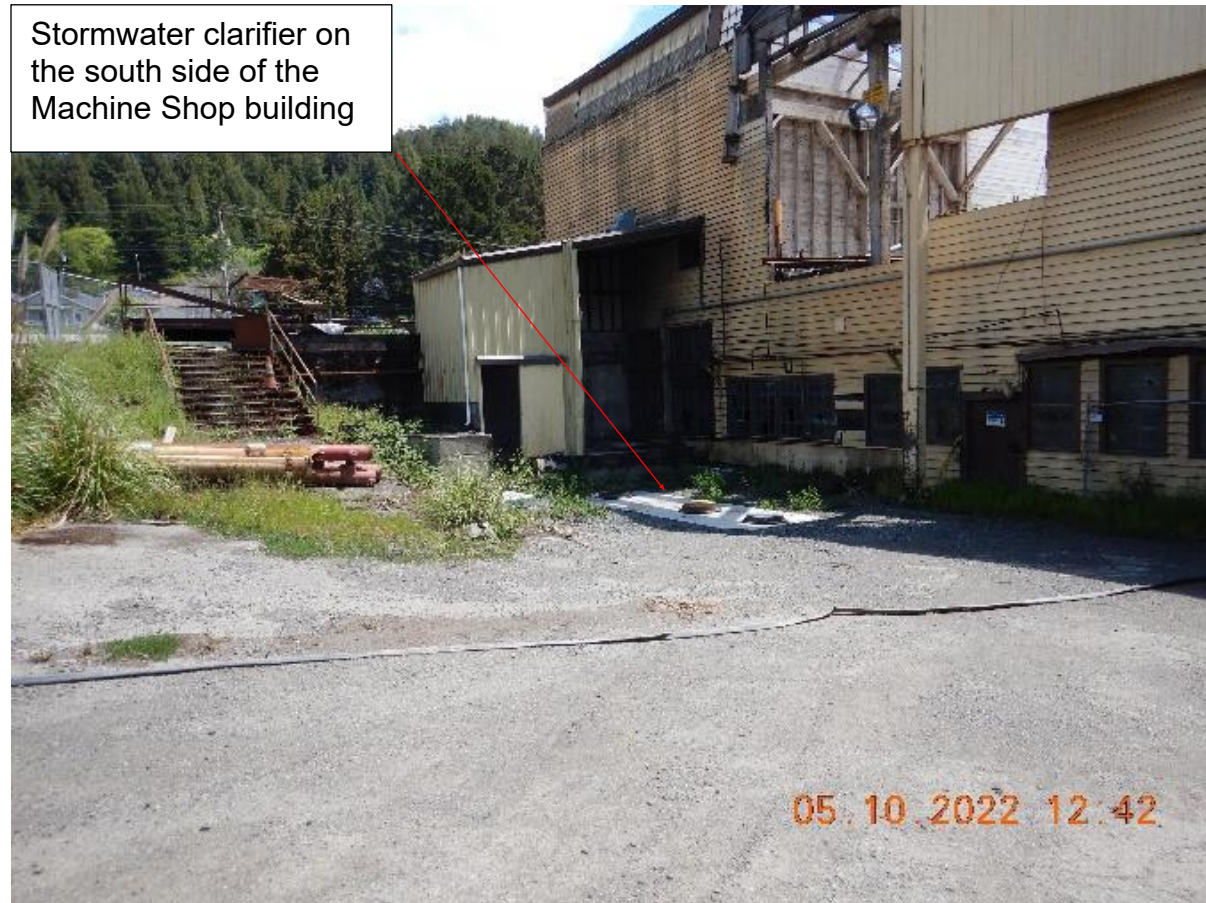
Picture 21a: Newly installed clarifier on the south side of the Machine Shop building where the samples are collected (SWDB 3B). Picture taken by Farzad Kasmaei.

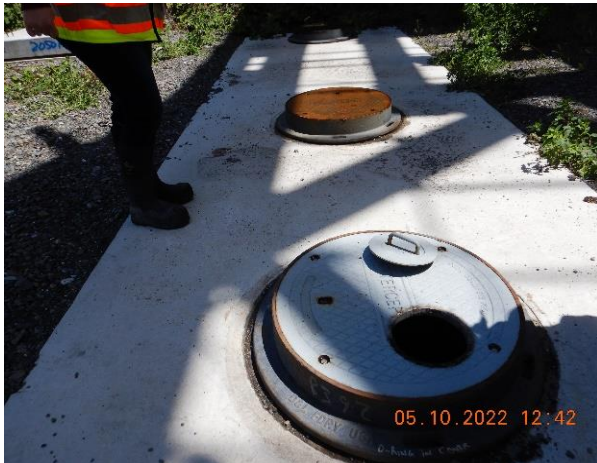
Pictures 21b, 21c: Newly installed clarifier on the south side of the Machine Shop building where the samples are collected (SWDB 3B). Picture taken by Farzad Kasmaei.

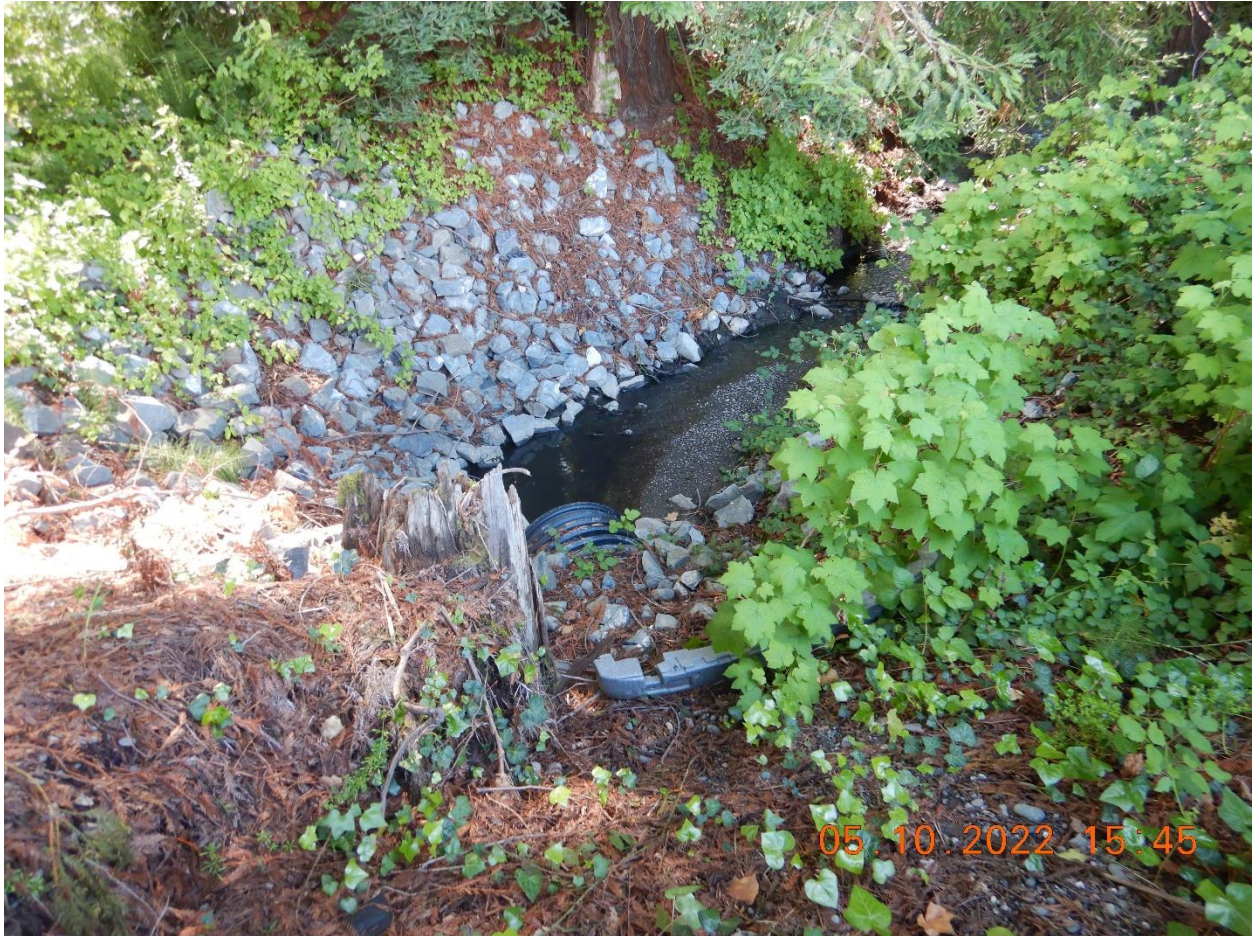
Picture 22. View of an off-site discharge point where the samples are collected (002). The facility's runoff that are captured by storm drain inlets within the Drainage Area 2 drains to Eel River via this outfall. Picture taken by Farzad Kasmaei.
