North Coast Regional Water Quality Control Board

Inspection Memo

Subject: July 13, 2023, inspection of Valley of the Moon Club flashboard dam maintenance project.

File: Valley of the Moon Club, 7025 Oakmont Drive, Santa Rosa, CA, Sonoma County, APN 016-150-014-000
ECM PIN: CW-889988, WDID No. 1B23134WNSO

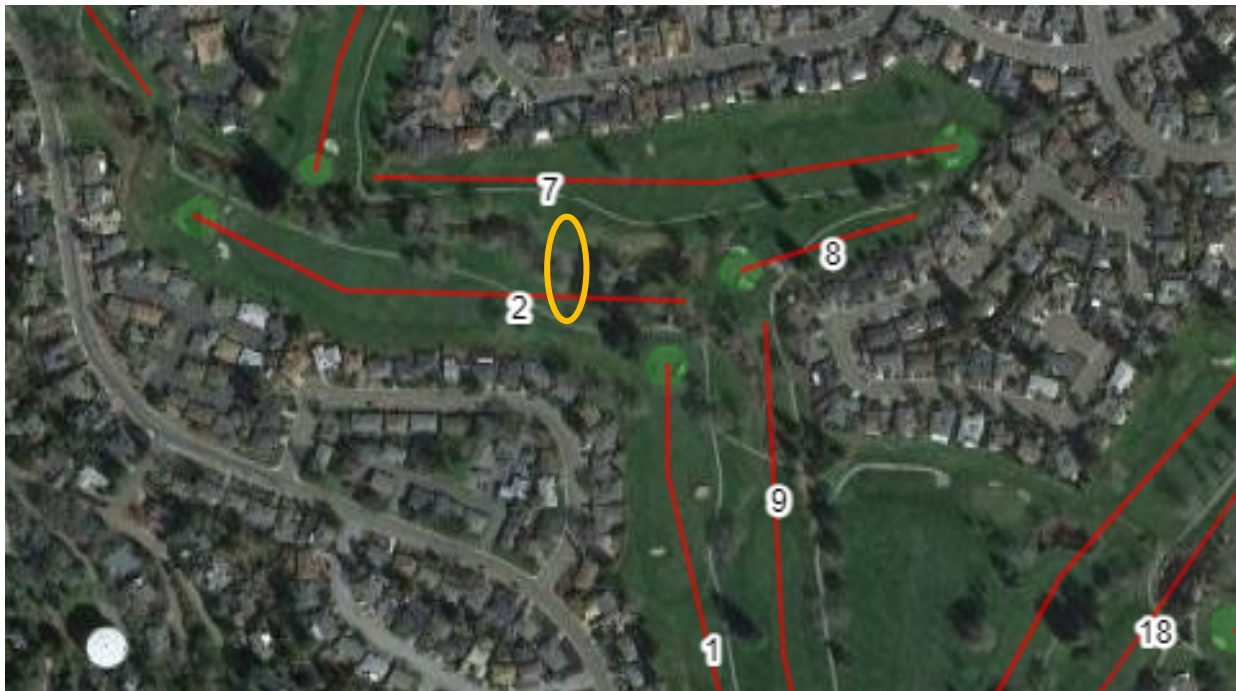
Image 1: Complaint site located in the orange oval showing a water hazard/irrigation dam between the second and seventh holes on the Valley of the Moon Club golf course.

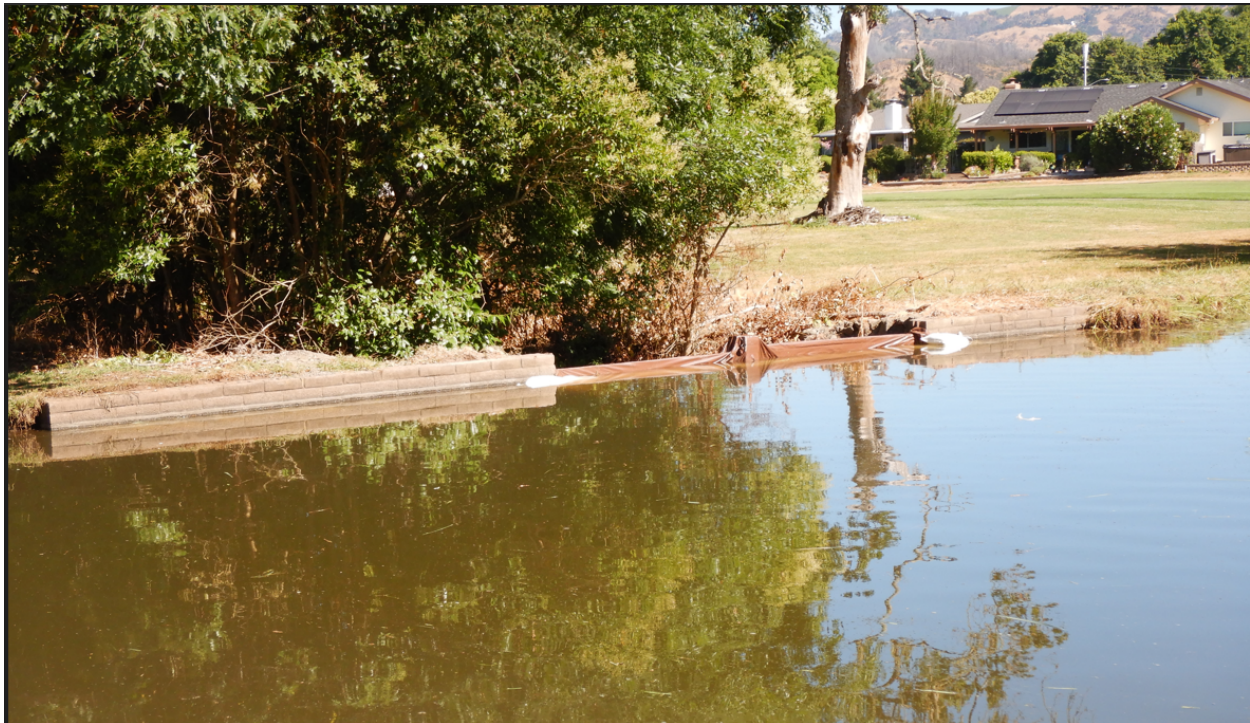
Photograph 1: Photographer is looking downstream at the flashboard dam. The photograph shows the irrigation pond, the two wing walls, and wooden flashboard dam. The flashboards have been recently covered with a brown tarp to help prevent water leakage.

Mr. Wayman alleged extremely high winter flows during the 2022 - 2023 winter damaged the dam causing the dam to leak 200,000+ gallons of water per day. Water was allegedly leaking between the 2 x 6-inch flashboards and under the dam foundation and concrete dam apron.

1. Issue a Notice of Violation (NOV) to Valley of the Moon Club.
2. Removal of the plastic sheeting and sandbags from the flashboard dam prior to the wet weather season.

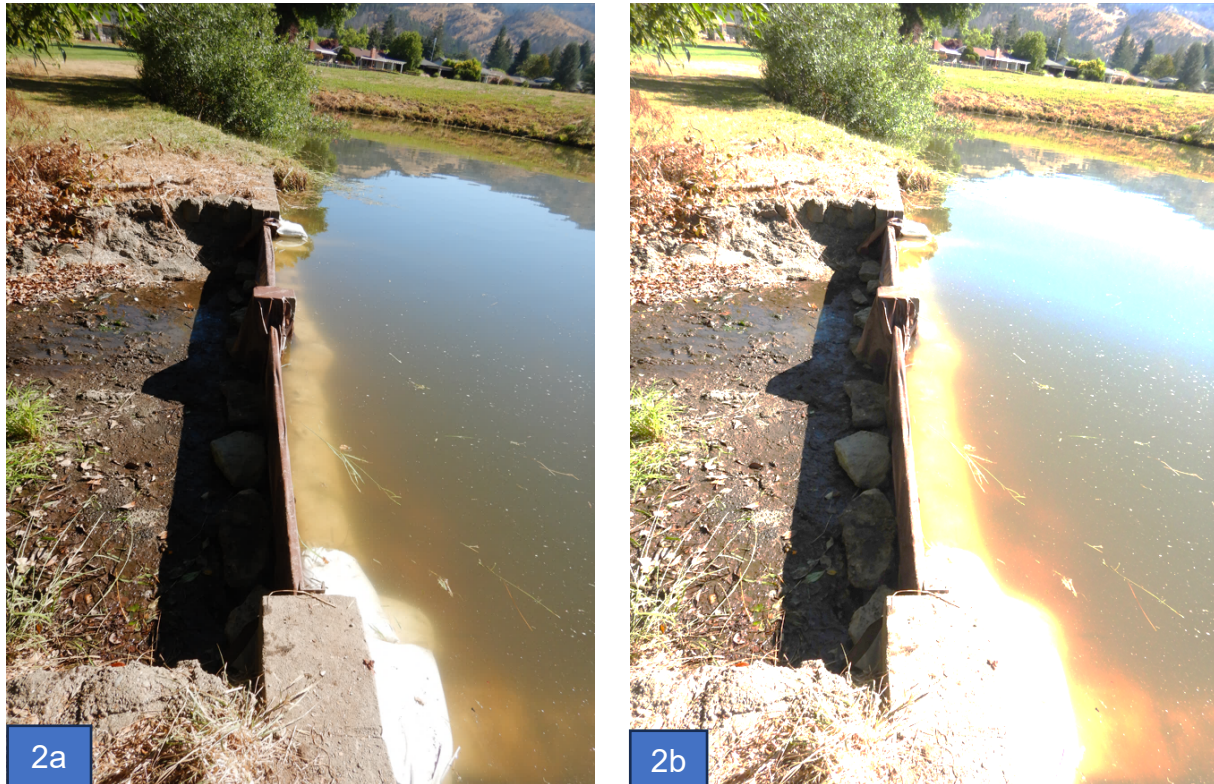
Mr. Wayman said maintenance work on the flashboard dam occurred on July 11, 2023. Prior to commencing the maintenance work, water elevation behind the dam was very low and had nearly stopped due to leakage from the dam. Plastic tarps were placed over the flashboard dam and foundation and weighed down using 60 sandbags along the interior and broken concrete along the exterior of the dam (Photographs 2a and 2b). Two holes in the dam apron were plugged using pre-mixed Sakrete concrete. Sandbags were placed over the curing concrete. Mr. Wayman began filling the dam after the concrete had cured the following day on July 12, 2023. I informed Mr. Wayman that concrete has a high pH and if curing concrete comes into contact with water, it can alter the pH of that water. Mr. Wayman said concrete mix was not used in the pond, only on the apron and absent flowing water during the curing process. I observed residual moisture on the apron and around the cured concrete (Photograph 3). The recently applied concrete did not appear to have been eroded by flowing water.

Photographs 2a and 2b: Brown plastic tarp is placed over the flashboard dam and concrete foundation and weighted down using 60 sandbags along the interior and broken concrete along the exterior of the dam. The photograph on the left (Photograph 2a) does not show the broken concrete because it is the dark shadow of the dam. The significantly lightened photograph on the right (Photograph 2b) shows the broken concrete along the dam's exterior and sandbags on the interior of the dam.

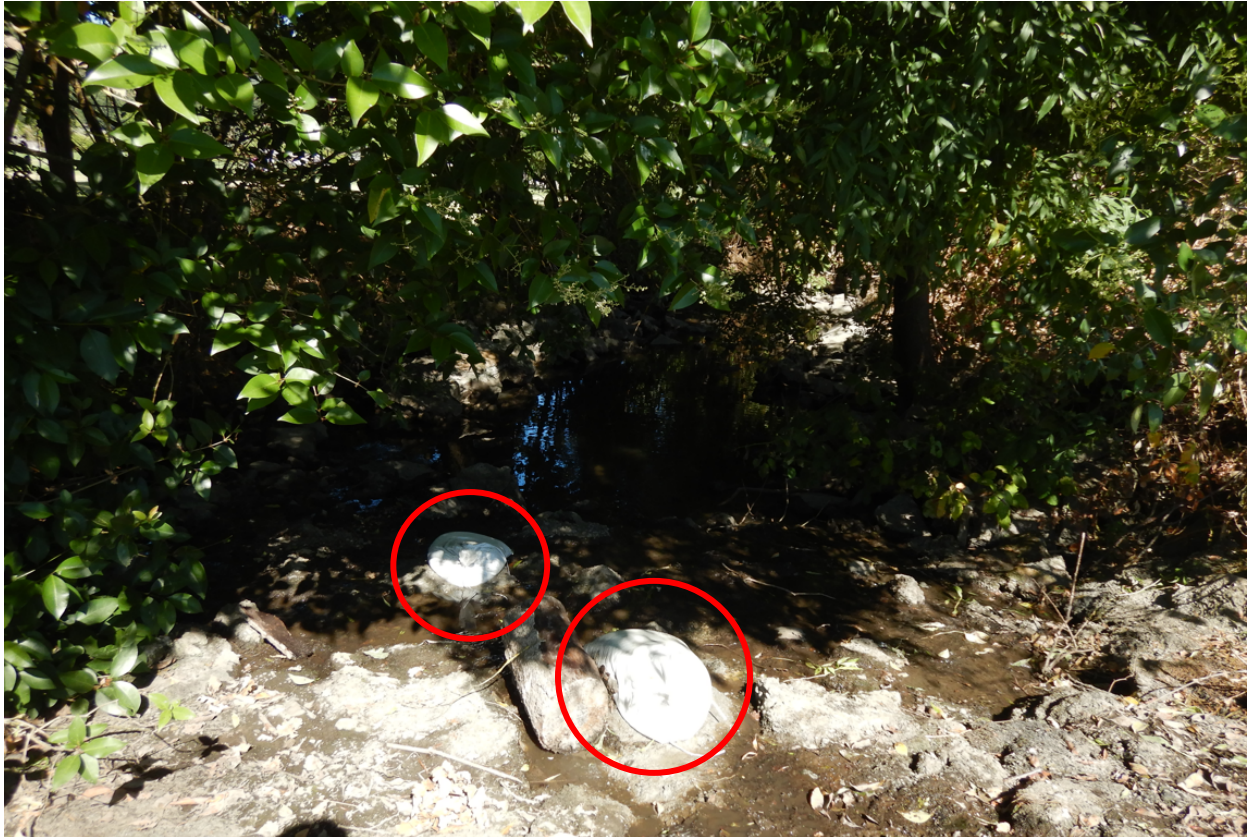
Photograph 3: Two holes in the dam apron that leaked a large quantity of water were plugged with pre-mix Sakrete concrete. White plastic sandbags were placed over the curing concrete (circled in red). Residual moisture is shown adjacent to the curing concrete.

Mr. Wayman alleged dam leakage had been significantly reduced from 200,000+ gallons to 15,000 to 20,000 gallons per day. Mr. Wayman said he estimated water volumes by comparing the amount of time the groundwater pump operated. Leakage appeared to be primarily under the concrete apron indicating leakage originating under the dam's concrete foundation.

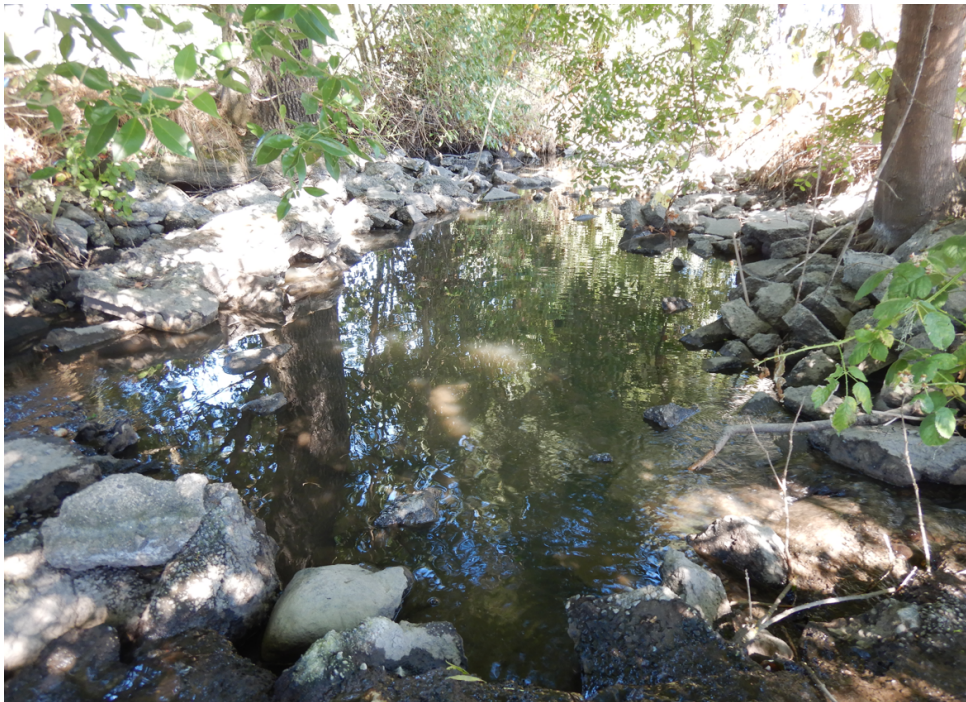
I told Mr. Wayman the 401 permit will also involve developing a mitigation plan for impacts to the stream during dam and cutoff wall replacement and he should consider potential mitigation projects involving habitat improvement. I told Mr. Wayman typically mitigation is located in the same watershed as the project, in this case Santa Rosa Creek. Downstream of the flashboard dam, the stream is heavily armored with broken concrete and could be considered for a potential habitat improvement project (Photographs 4 and 5).

Photograph 4: Photographer is standing on the concrete apron and looking downstream at Santa Rosa Creek channel hardened with broken concrete.

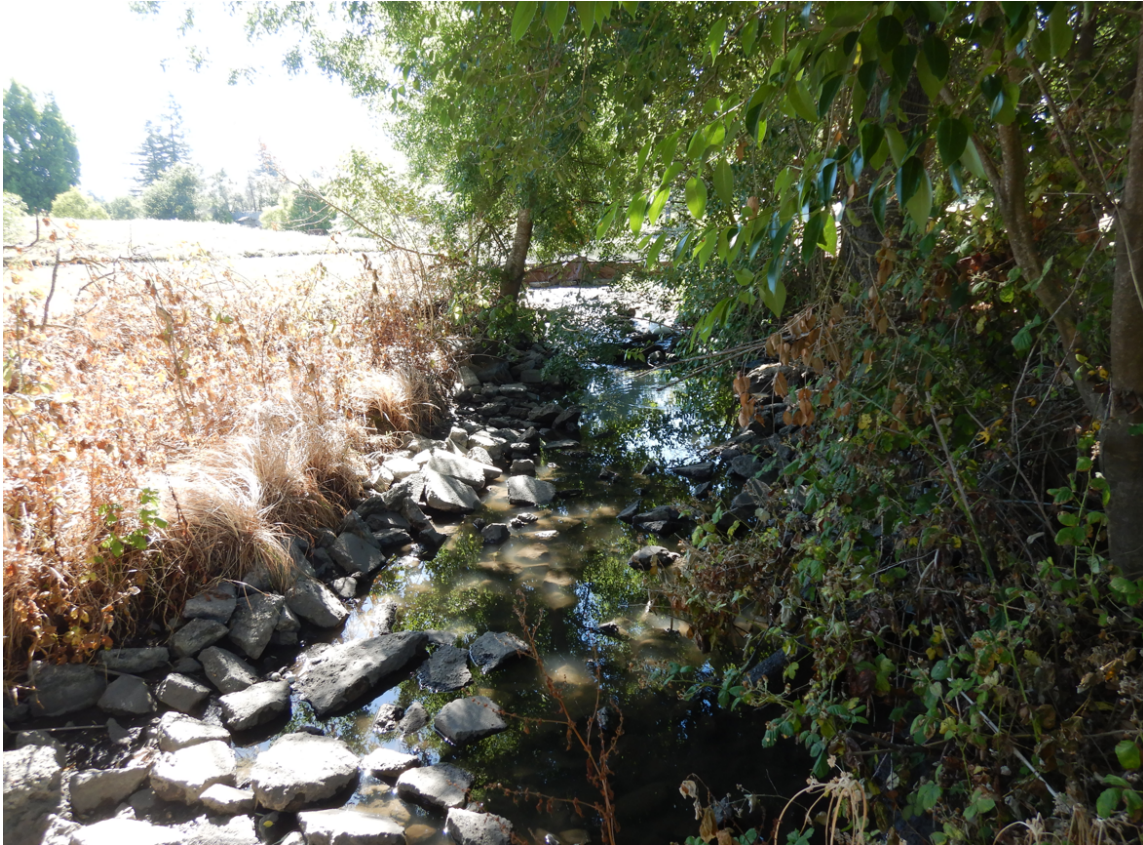
Photograph 5: Photographer is standing on the Santa Rosa Creek bank and looking upstream at Santa Rosa Creek channel hardened with broken concrete.
