North Coast Regional Water Quality Control Board

Og Kush Diet LLC, WDID 1_53CC411330

Inspection Date and Time			
Inspection Date	April 13, 2023		
Inspection Start Time:	10:30	Inspection End Time:	13:30
Site Location			
Address/Location	181 Oregon Mountain Road, Junction City CA 96048		
County	Trinity		
Assessor's Parcel Number (APN)	024-010-044-000		
Watershed	Lower Trinity River		
Property Owner and Cultivator Contact Information			
Property Owner's Legal Name and Company	Ivan Vlahov		
Mailing Address	181 Oregon Mountain Road, Junction City CA 96048		
Phone Number/E-mail Address	847-627-9909, ivlahov66@gmail.com		
Property Cultivator's Legal Name or Company	Og Kush Diet LLC, Ivan Vlahov		
Mailing Address	181 Oregon Mountain Road, Junction City CA 96048		
Phone Number/E-mail Address	847-627-9909, ivlahov66@gmail.com		
Consent to Inspect			
Full Name of Person Giving Consent	Ivan Vlahov		
Title of Person Giving Consent (e.g., owner, attorney)	Landowner		
Means of Giving Consent	Verbal

North Coast Regional Water Quality Control Board
 Cannabis Water Quality Inspection Report - Og Kush Diet LLC, WDID 1_53CC411330

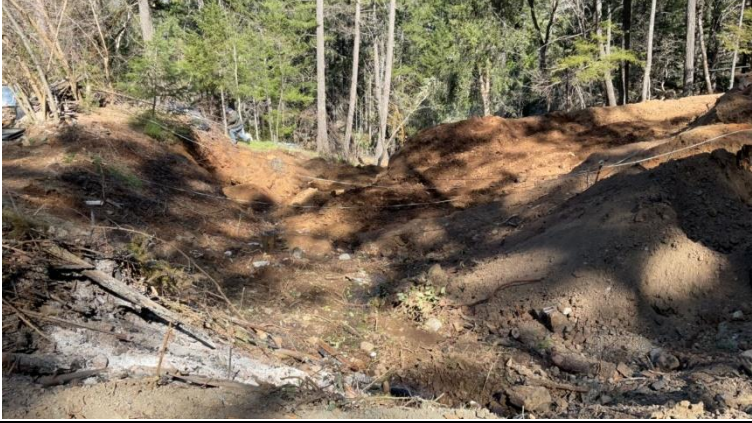
P1	
Category: Riparian Areas (RA)	Violation Present? Yes
Description: Extensive earthwork was done during the rainy season. I observed mounds of bare, unconsolidated soil encroaching on riparian areas. Ivan stated he owns an excavator and that a contractor had used it as recently as three days prior to develop a parking area, gather rocks, and move material from a mud slide.

Photo Number: 1
	Photo Description: Watercourse with downed trees on left bank. Loose earthen material is piled on the right bank and in the watercourse.
	Facing Southwest

P1 and P9: Store stockpile fill, grow bags, slash, trash, and any other materials at least 50 feet away from Class III watercourses, 100 feet away from Class II watercourses, and 150 feet away from Class I watercourses (riparian setbacks).

A1: Submit a proposal through the DASP to pull back loose fill from riparian areas, and stockpile in compliance with the riparian setbacks. Be careful not to drive machinery on the banks of, or into, any watercourses on the property. Install sediment and erosion controls with the aim of revegetating and stabilizing all disturbed areas.

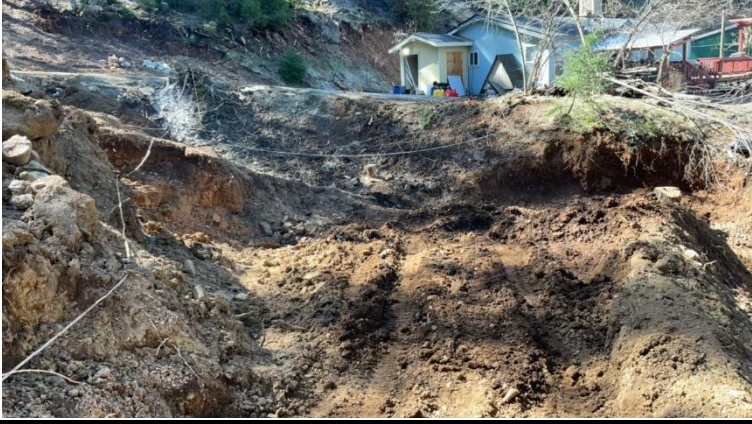
Photo Number: 2
	Photo Description: Excavator tracks on watercourse bank.
	Facing East
	Photo Number: 3
	Photo Description: Looking uphill at watercourse coming out of culvert stream crossing under access road. The channel was full of debris and lacked vegetation.

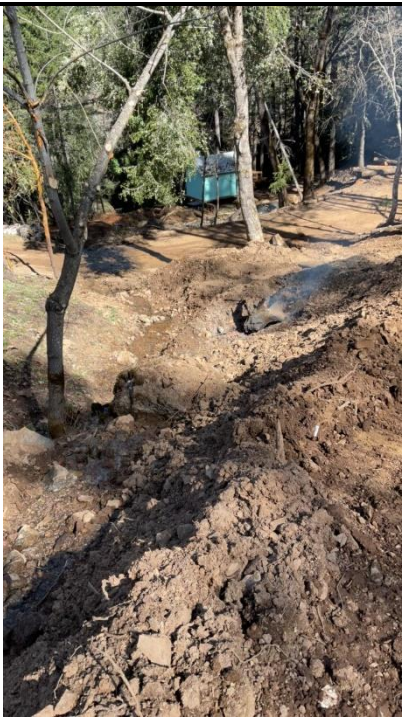
<p>Photo Number: 4</p> <p>Photo Description: Looking downhill at watercourse. Burning stump visible on right bank. Watercourse traversing road surface visible in back left of photo.</p> <p>Facing Northwest</p>
<p>P2</p>		
<p>Category: Watercourse Crossings (WC)</p>	<p>Violation Present? Yes</p>	
<p>Description: Dirt ford stream crossing.</p>

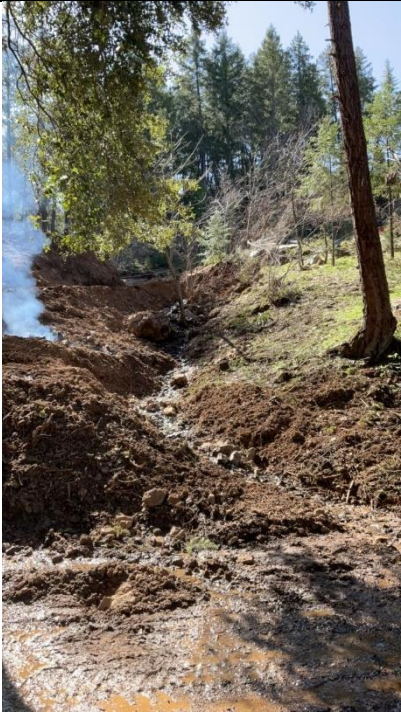
Photo Number: 1
	Photo Description: Looking uphill at watercourse from lower road.
	Facing Southeast

P2, P7, and P9: Apply for a 401 Water Quality Certification to install culvert stream crossings to replace dirt fords.

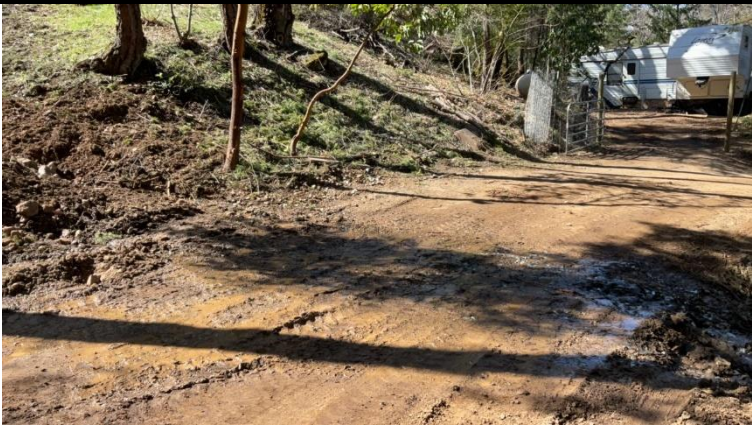
Photo Number: 2
	Photo Description: Watercourse traversing dirt road.
	Facing East

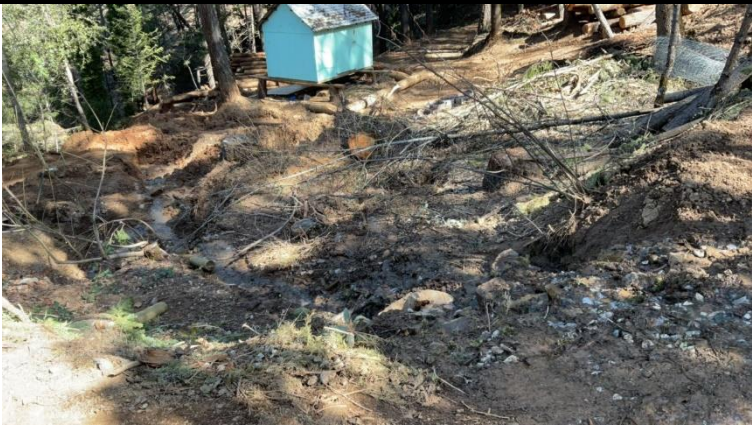
Photo Number: 3
	Photo Description: View of watercourse downstream of ford crossing.
	Facing West

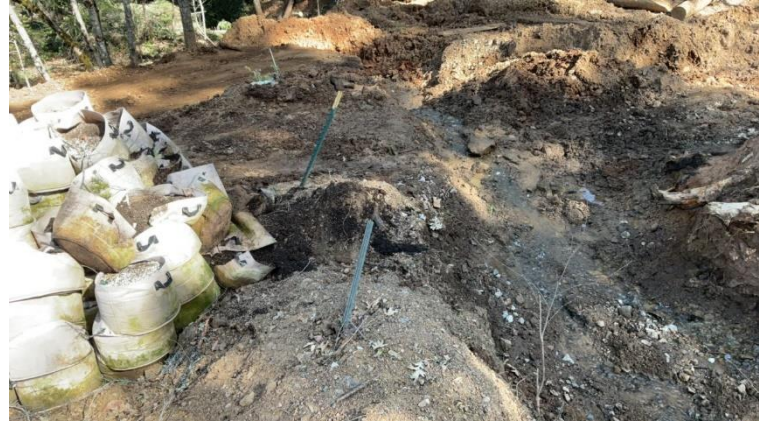
P3	
Category: Soil and Growing Medium (S)	Violation Present? Yes
Description: Approximately 300 grow bags with spent soil stockpiled on watercourse banks.

Photo Number: 1
	Photo Description: Potting soil discharging to watercourse.
	Facing West

P3: Relocate grow bags outside of riparian setbacks. Clean up spilled soil to prevent further discharge of sediment and nutrients/ chemicals to surface waters.

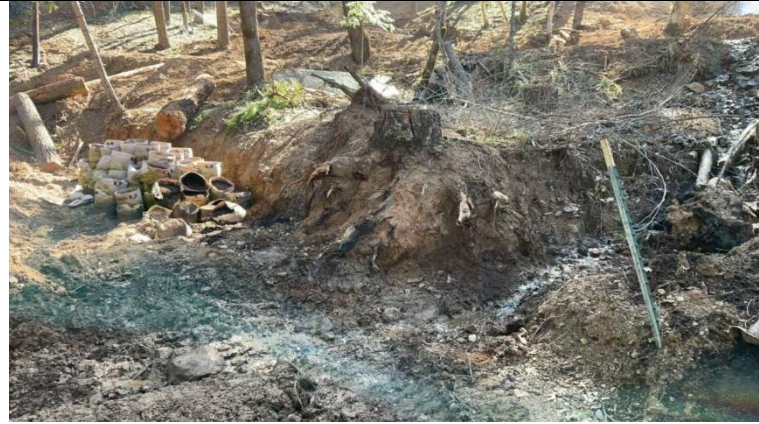
Photo Number: 2
	Photo Description: Excavator tracks through watercourse.
	Facing North

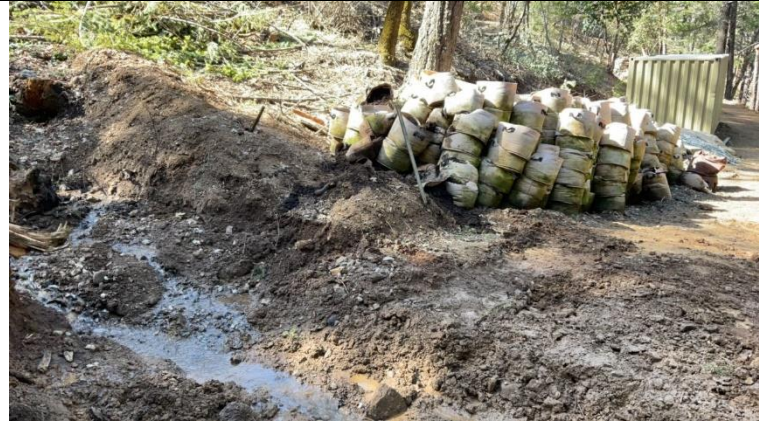
Photo Number: 3
	Photo Description: Bags stockpiled on watercourse bank.
	Facing Southeast
	Photo Number: 4
	Photo Description: View of bags on both sides of watercourse.

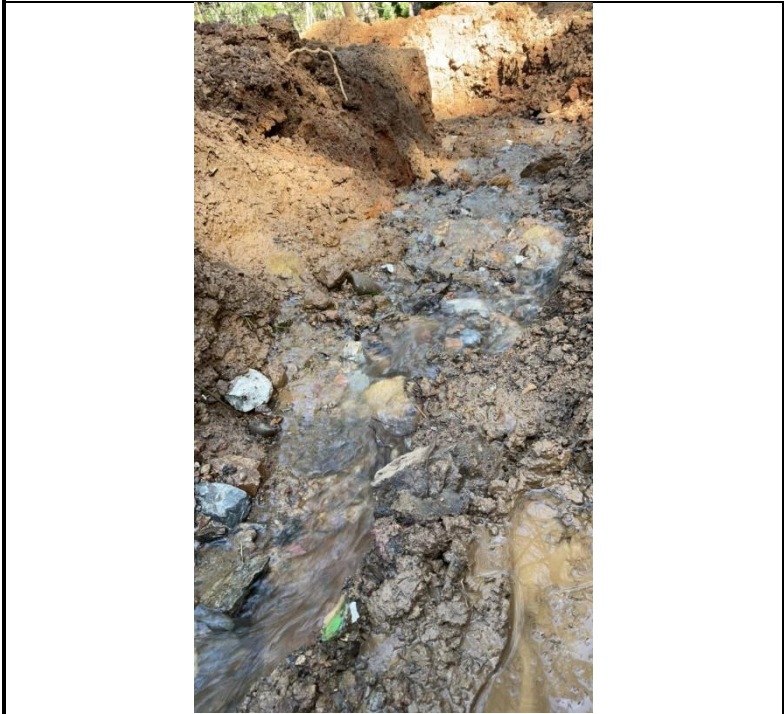
Description: Domestic waste in watercourse.

Photo Description: Trash in watercourse.

P4 and P11: Remove trash from watercourse. Contain and regularly dispose of trash outside of riparian setbacks in a permitted transfer station or landfill.

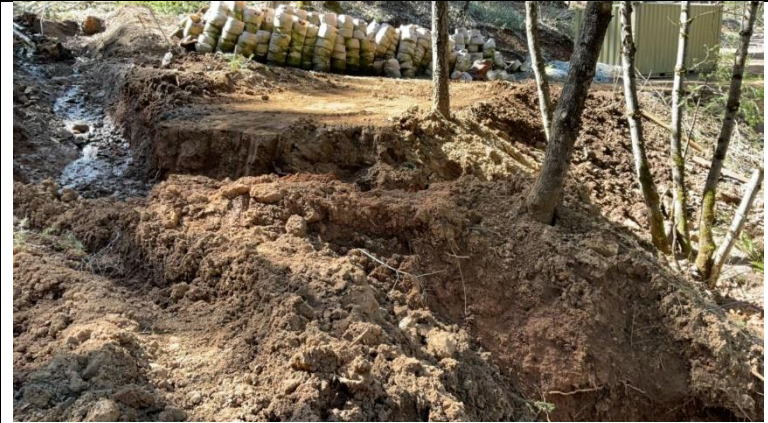
Description: Fill placed in 3- to 4-foot-high piles. Watercourse diverted from channel by fill.

<p>Photo Description: Mound of fill with excavator tracks blocking watercourse channel.</p>
	<p>Facing East</p>

P5: Submit a proposal through a 401 Water Quality Certification application to remove the stockpiled fill from the watercourse, to realign the watercourse with its channel, and to revegetate the banks with native riparian plants.

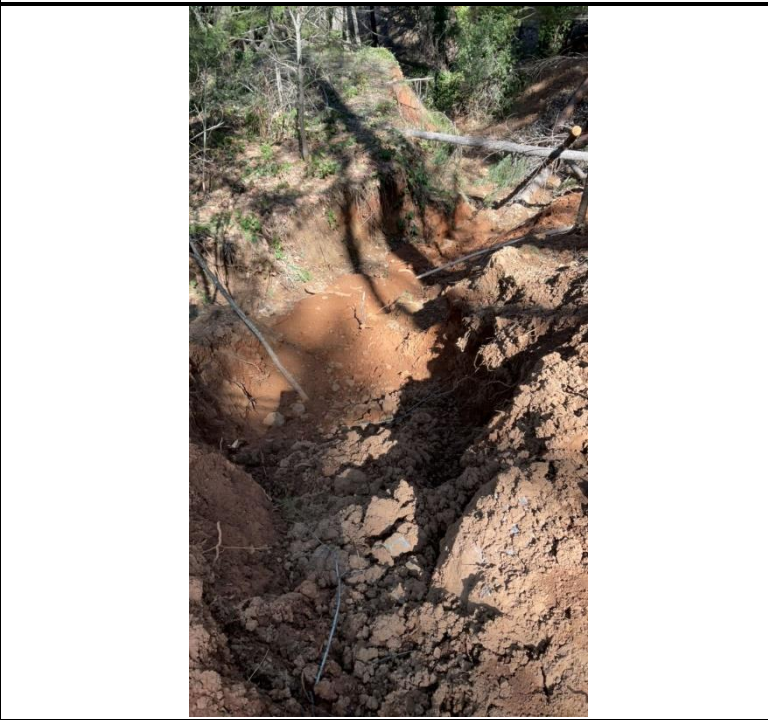
<p>Photo Number: 2</p>
	<p>Photo Description: Dry, blocked watercourse channel full of fill.</p>
	<p>Facing Northwest</p>

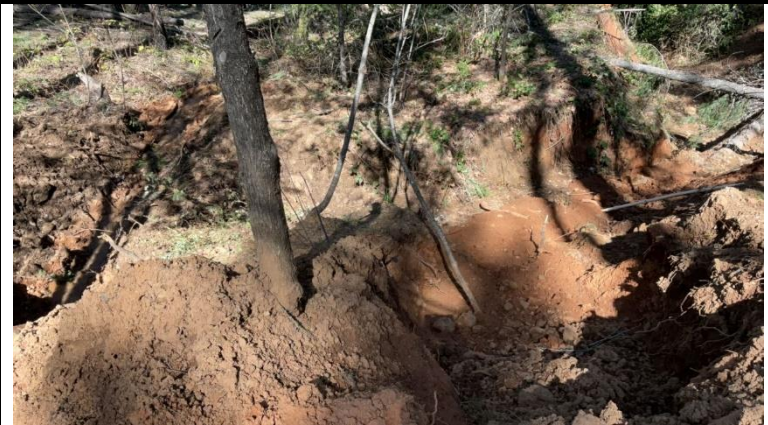
<p>Photo Number: 3</p>
	<p>Photo Description: Watercourse channel on right side. Fill piled around tree.</p>
	<p>Facing South</p>

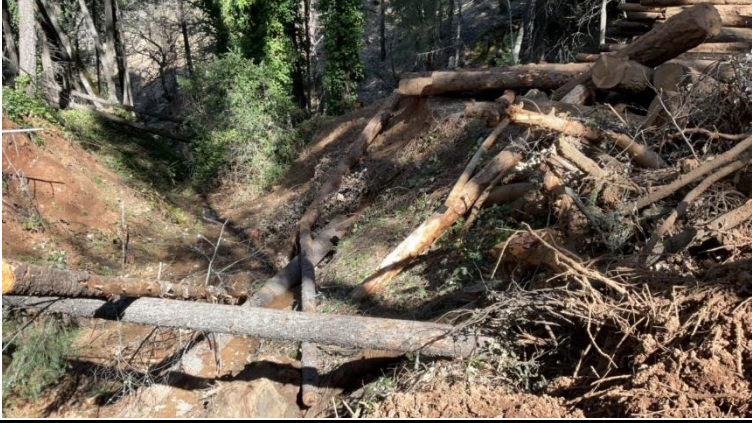
Photo Number: 4
	Photo Description: Slash in watercourse channel.
	Facing Southwest

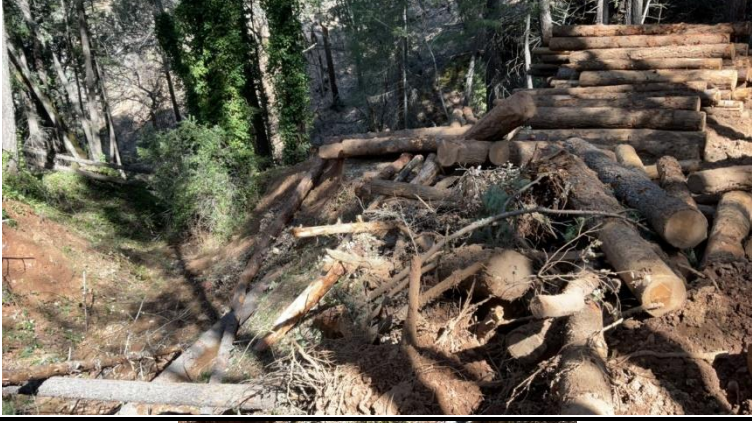
Photo Number: 5
	Photo Description: Slash stockpile on bank of watercourse channel.
	Facing Southwest

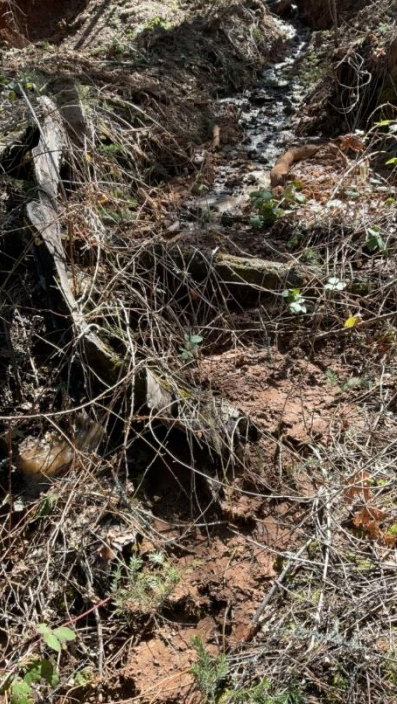
Photo Number: 6
	Photo Description: Water finding new route through fill.
	Facing East

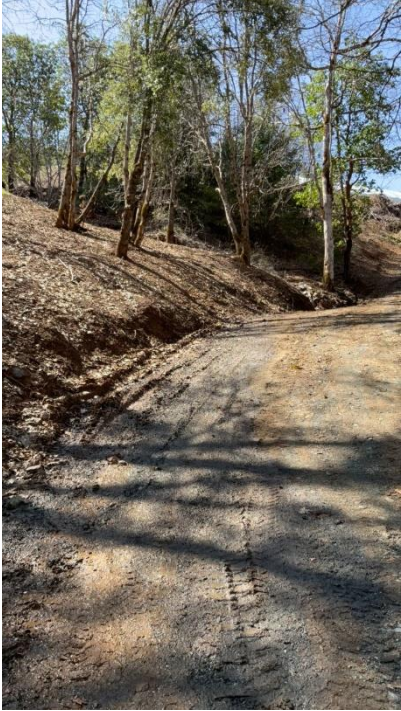
Photo Number: 1
	Photo Description: Excavator on site.
	Facing South
P7	
Category: Watercourse Crossings (WC)	Violation Present? Yes
Description: Two dirt fords. Stream diverted down road.	
	Photo Number: 1
	Photo Description: First dirt ford crossing.

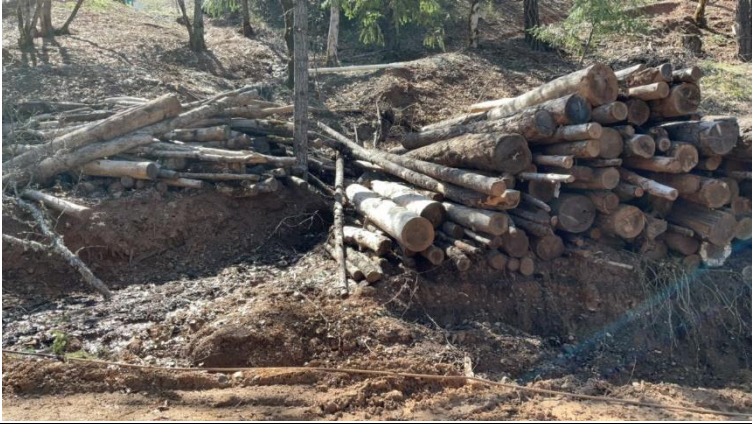
<p>Photo Number: 2 Photo Description: Second dirt ford crossing. Logs stockpiled on watercourse. Facing East</p>

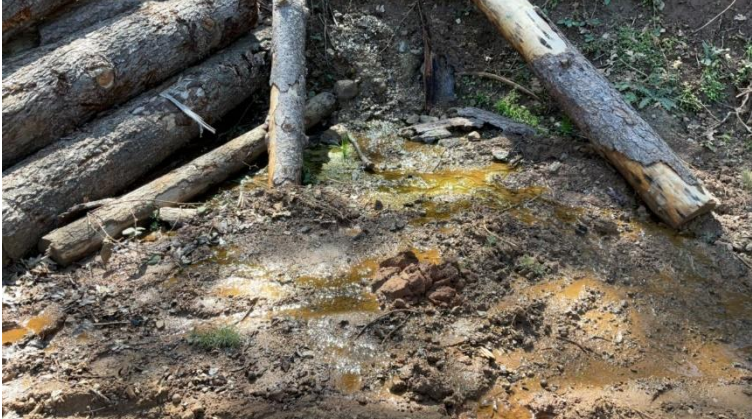
<p>Photo Number: 3 Photo Description: Algae growth under log stockpile where watercourse is diverting across road. Facing Northeast</p>

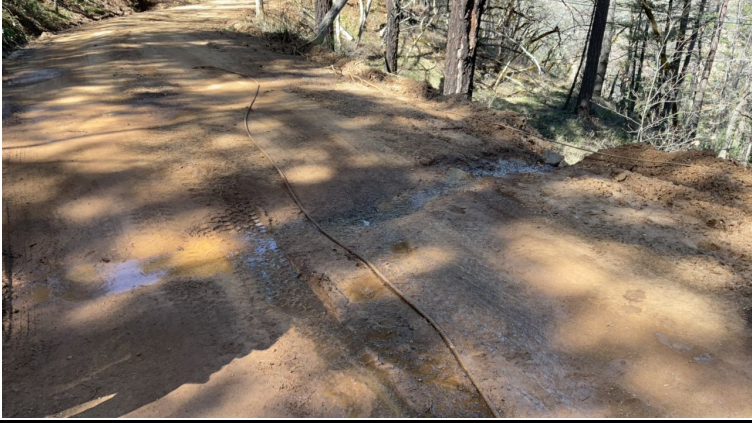
Photo Number: 4
	Photo Description: Ford crossing eroding dirt road.
	Facing South
P8	
Category: Watercourse Crossings (WC)	Violation Present? Yes
Description: Culvert stream crossing with perched outlet.

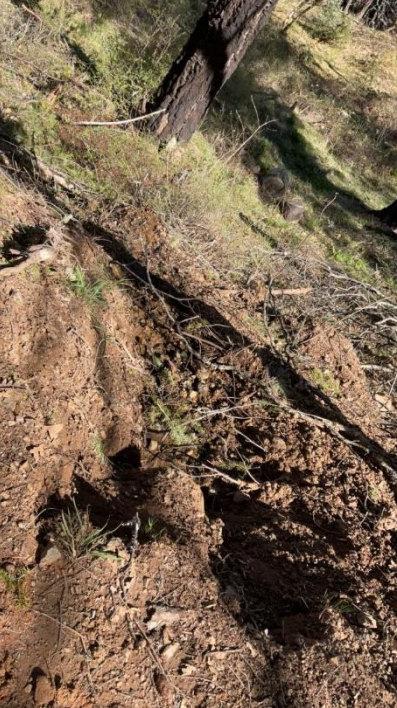
Photo Number: 1
	Photo Description: Perched culvert outlet.
	Facing Northwest
	Photo Number: 2
	Photo Description: Looking uphill at stream diverted into ditch. Culvert inlet on right side.

P8 and P11: Apply for a 401 Water Quality Certification to replace the misaligned and undersized culvert stream crossings.

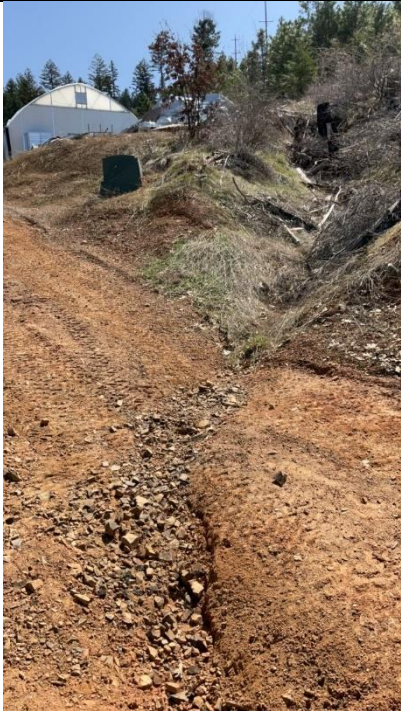
Facing East
P9		
Category: Watercourse Crossings (WC)		Violation Present? Yes
Description: Dirt ford stream crossing.

Photo Number: 1 Photo Description: Evidence of watercourse crossing road. Facing East

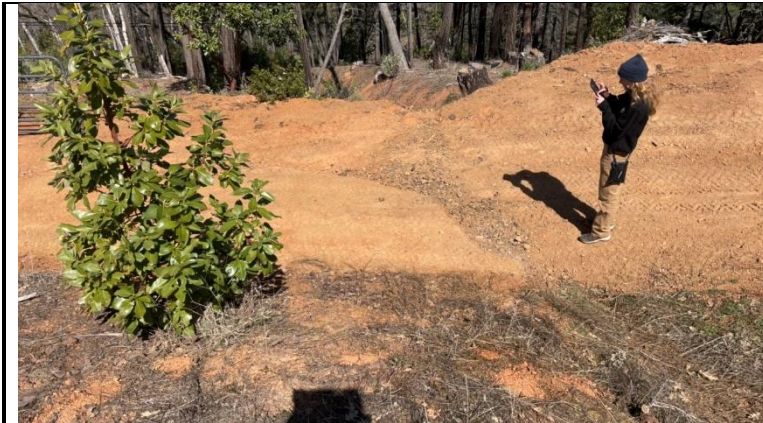
Photo Number: 2
Photo Description: Evidence of watercourse diverting down road to left.
Facing Southwest

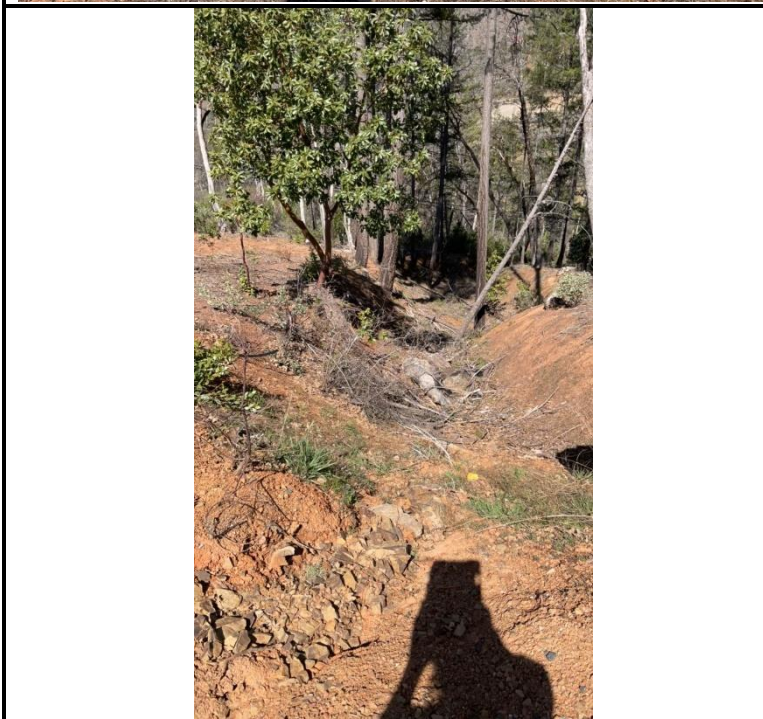
Photo Number: 3
Photo Description: Downstream view of watercourse channel.
Facing Northwest

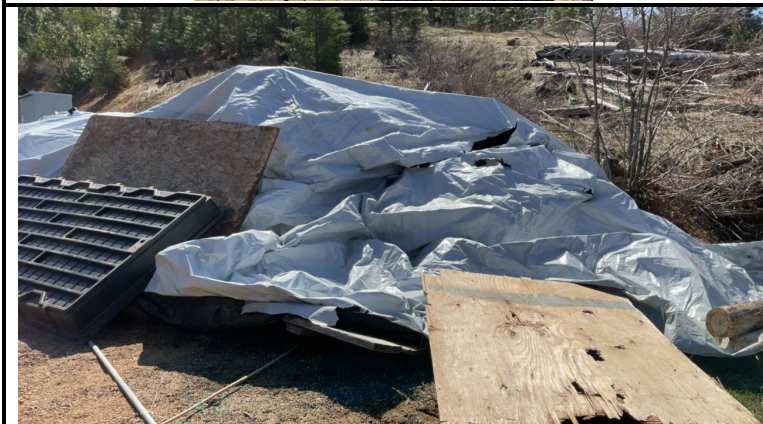
Photo Number: 4
Photo Description: Cultivation related material stockpiled near watercourse.
Facing Northeast

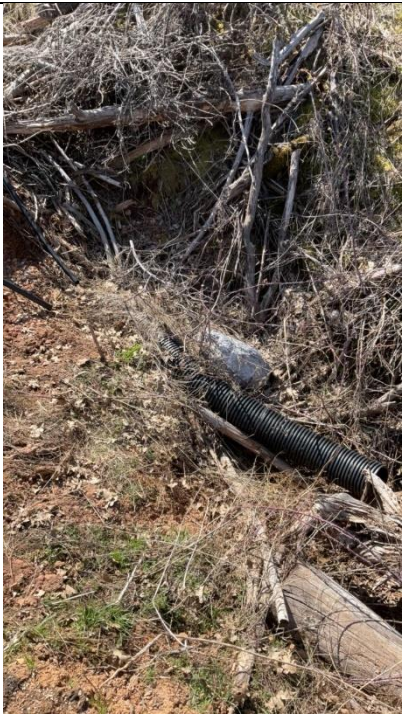
Photo Number: 5
		Photo Description: Trash in watercourse.	
		Facing South

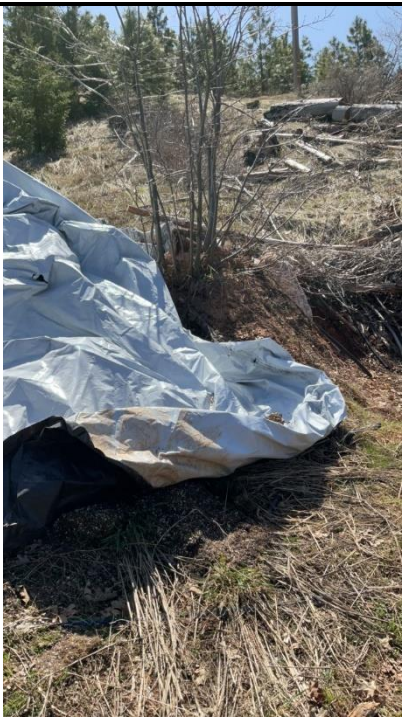
Photo Number: 6
		Photo Description: Soil stockpile under tarp 5 feet from watercourse.	
		Facing Southeast	
P10			
Category: Miscellaneous or Other (M)		Violation Present? No

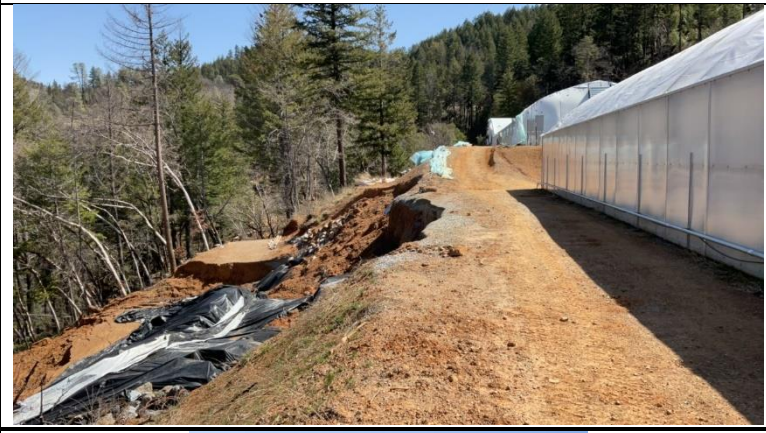
Description: Rock was installed on top of hillside. Area collapsed following significant rainfall. Trees bowing below and above.

Photo Number: 1
 Photo Description: Greenhouse on eroding flat. Trees bowing on hillside.
 Facing Northwest

P10: Retain a licensed geologist or engineer to assess the stability of the greenhouse flat.

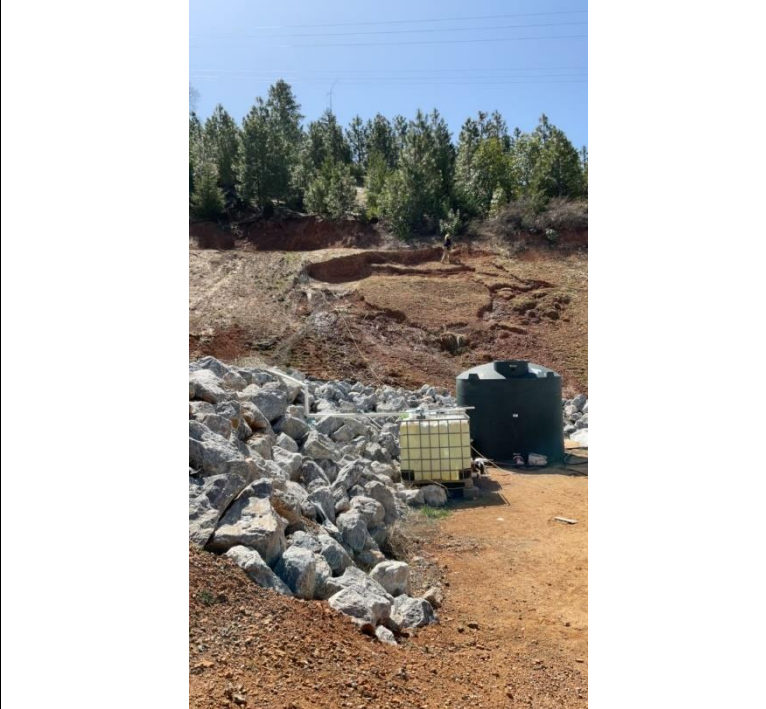
Photo Number: 2
 Photo Description: View uphill of greenhouse.
 Facing South

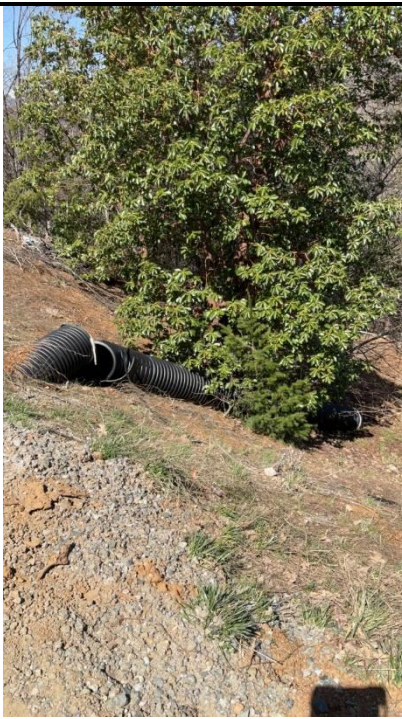
Description: Culvert stream crossing. Tire marks 5 feet from stream. Stream diverts down road.

Photo Number: 2 Photo Description: Culvert outlet and downspout. Facing Northwest
		Photo Number: 3

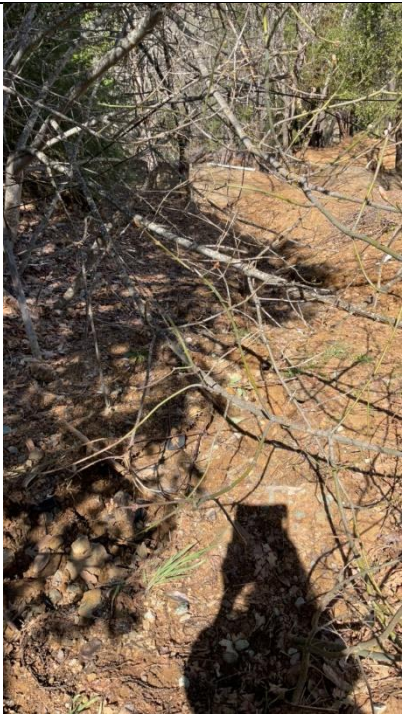
<p>Photo Description: Downstream of culvert. Plastic pots, metal cans, and other waste in watercourse.</p> <hr/> <p>Facing Northwest</p>

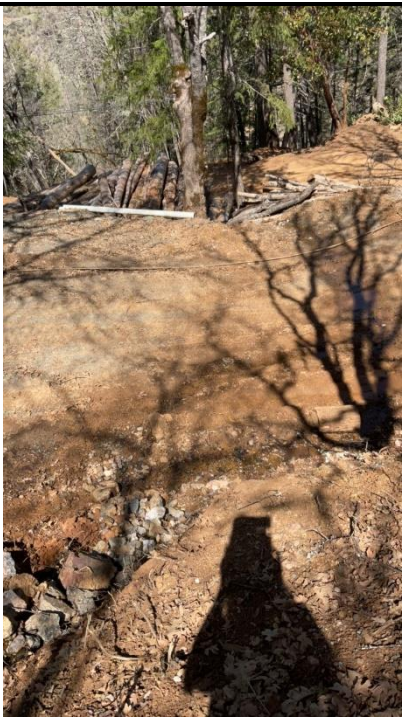
<p>Photo Number: 4</p> <hr/> <p>Photo Description: Downstream side. Watercourse diverts down road to right and across road to log pile.</p> <hr/> <p>Facing Northwest</p>
		<p>Photo Number: 5</p> <hr/> <p>Photo Description: Stream diverts to right into trash pile.</p>

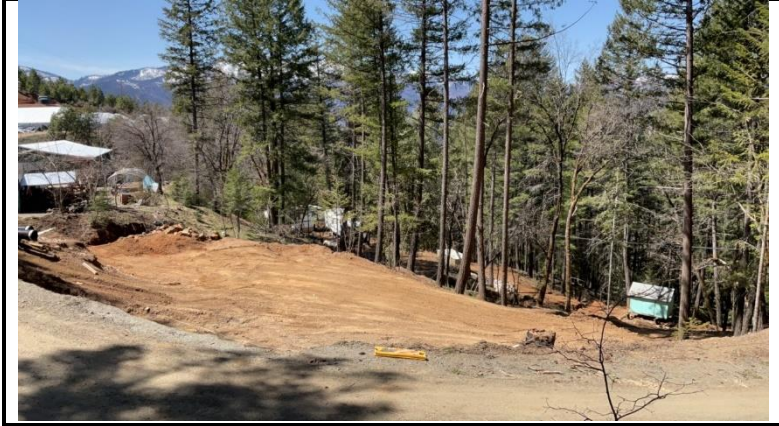
A1	
Category: Erosion and Sediment Control (ES)	Violation Present? Yes
Description: Large recently graded area with no erosion or sediment controls.

Photo Number: 1 Photo Description: Graded area. Facing South
	Photo Number: 2 Photo Description: Graded area.
