North Coast Regional Water Quality Control Board

Subject: **Notice of Violation** of State Water Resources Control Board Order No. 2014-0057 DWQ General Permit for Storm Water Discharges Associated with Industrial Activities (Industrial General Permit/IGP) for the West Coast Metals

File: West Coast Metals, 470 Caletti Avenue, Windsor, Sonoma County, WDID No. 1 49I018939

Attachment B: November 1, 2022, Facility Stormwater Inspection Report

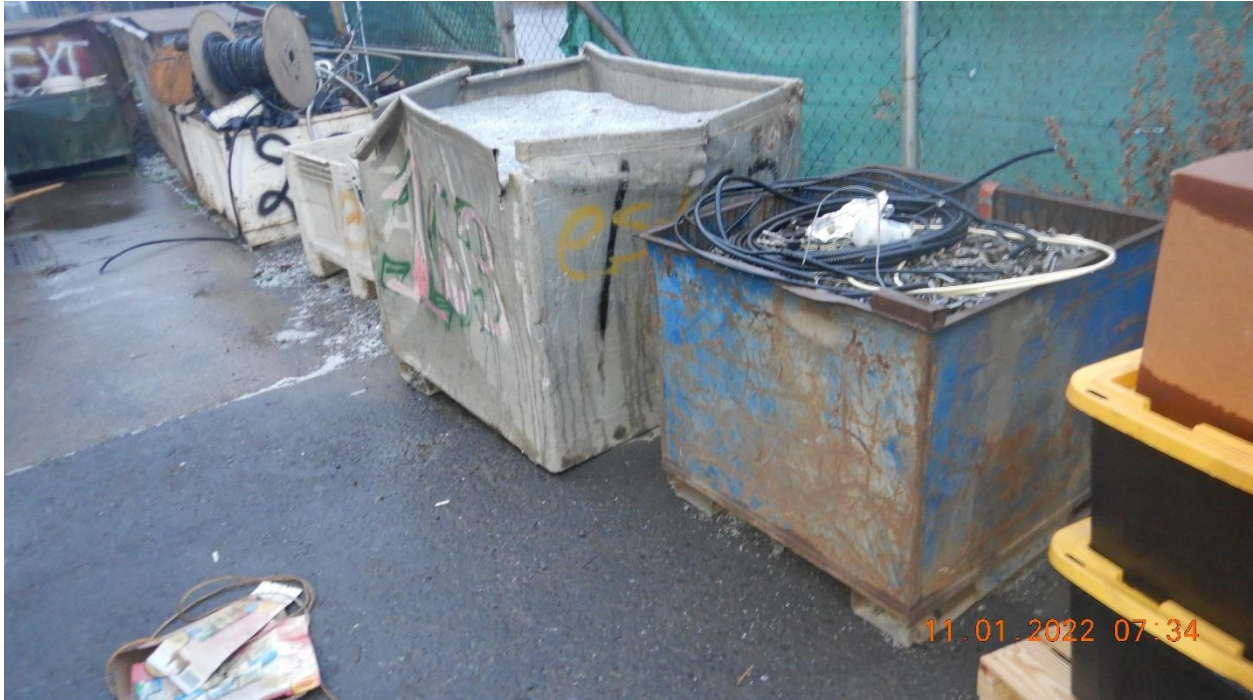
Picture 1- Broken and rusty metal storages/bins stored outside exposed to rain. Picture taken by Farzad Kasmaei.

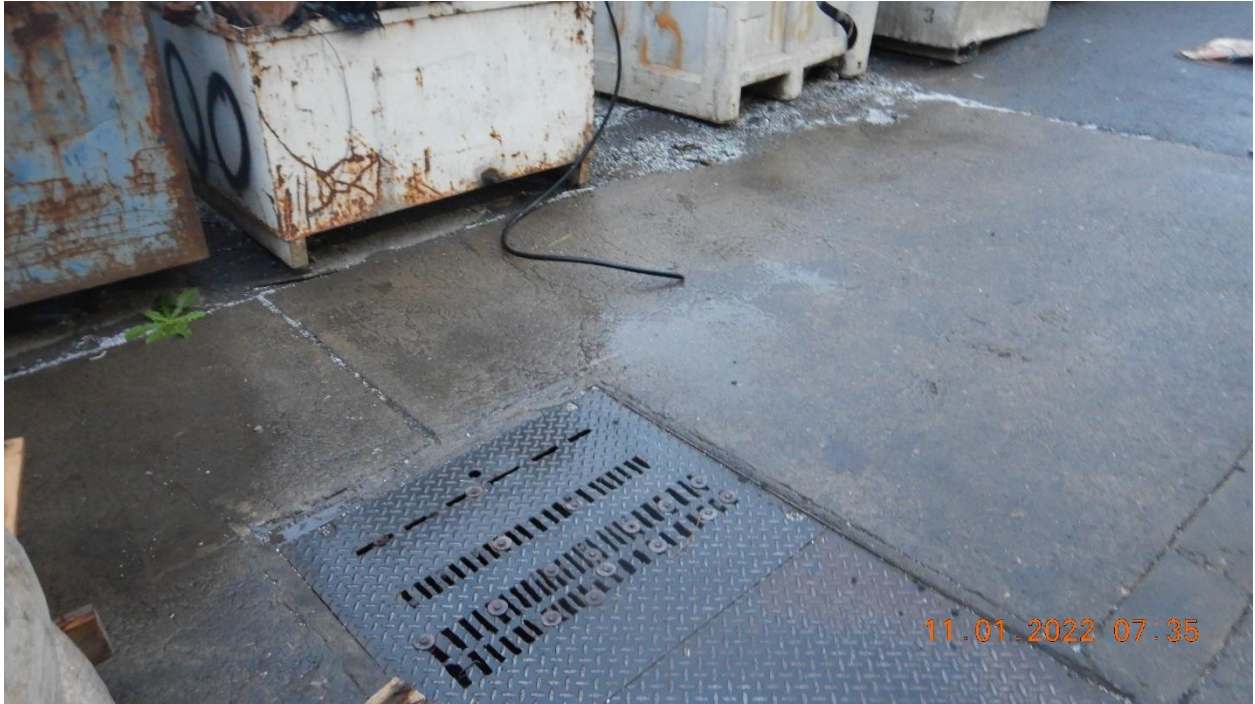
Picture 2 – View of white aluminum chips on the ground adjacent to metal bins. Picture taken by Farzad Kasmaei.

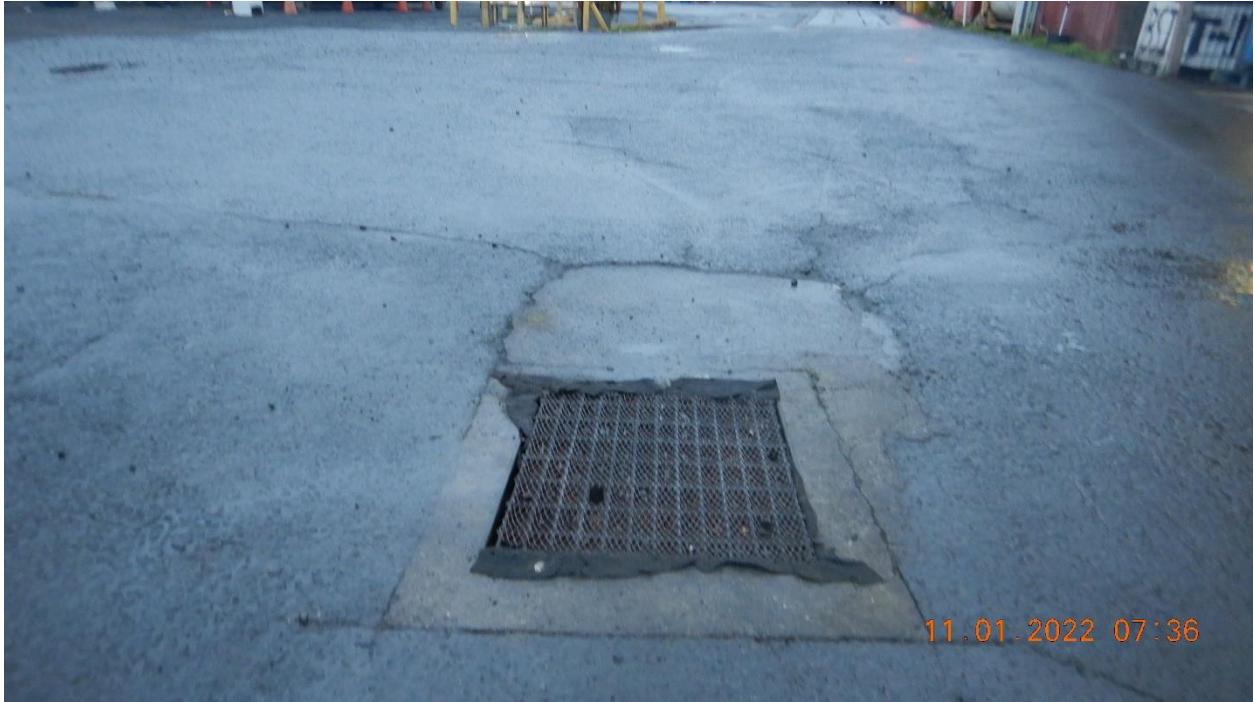
Picture 3 – View of Drop inlet that receives runoff from the metal bin storage areas shown on the previous pictures. Picture taken by Farzad Kasmaei.

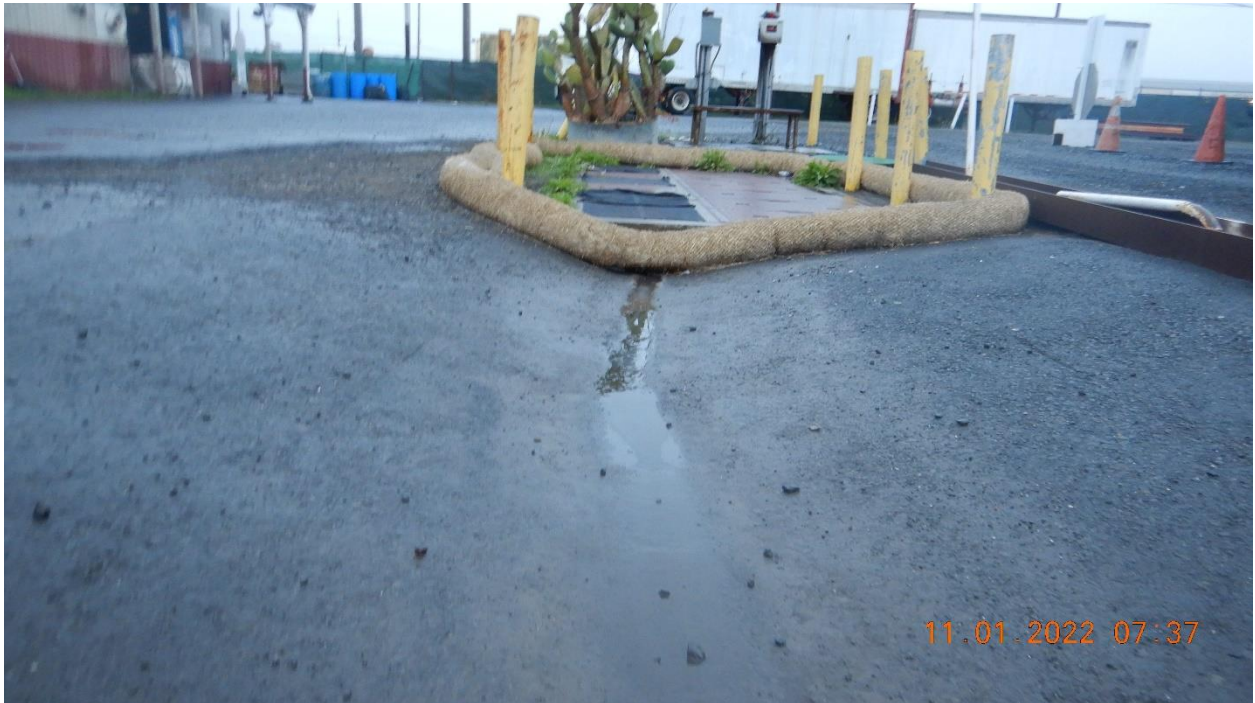
Picture 4 – View of the vditch that drains the facility runoff from the processing area into the filtration system. Picture taken by Farzad Kasmaei.

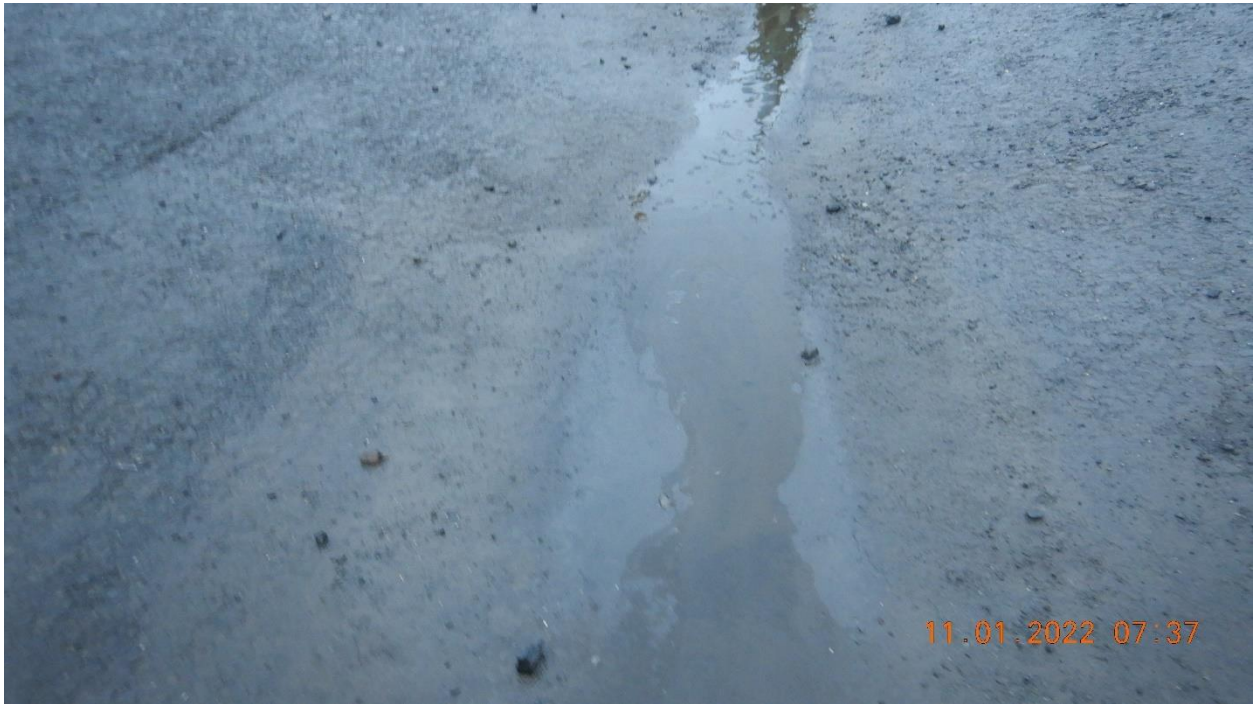
Significant amount of rusty scrap metal and metal chips were observed on the ground during the storm event. Also, I observed oil sheen in facility's runoff. The Discharger has failed to identify and cleanup debris, waste, spills, or leaked materials as required by IGP.

Picture 5 – View of sheen on the surface. Picture taken by Farzad Kasmaei.

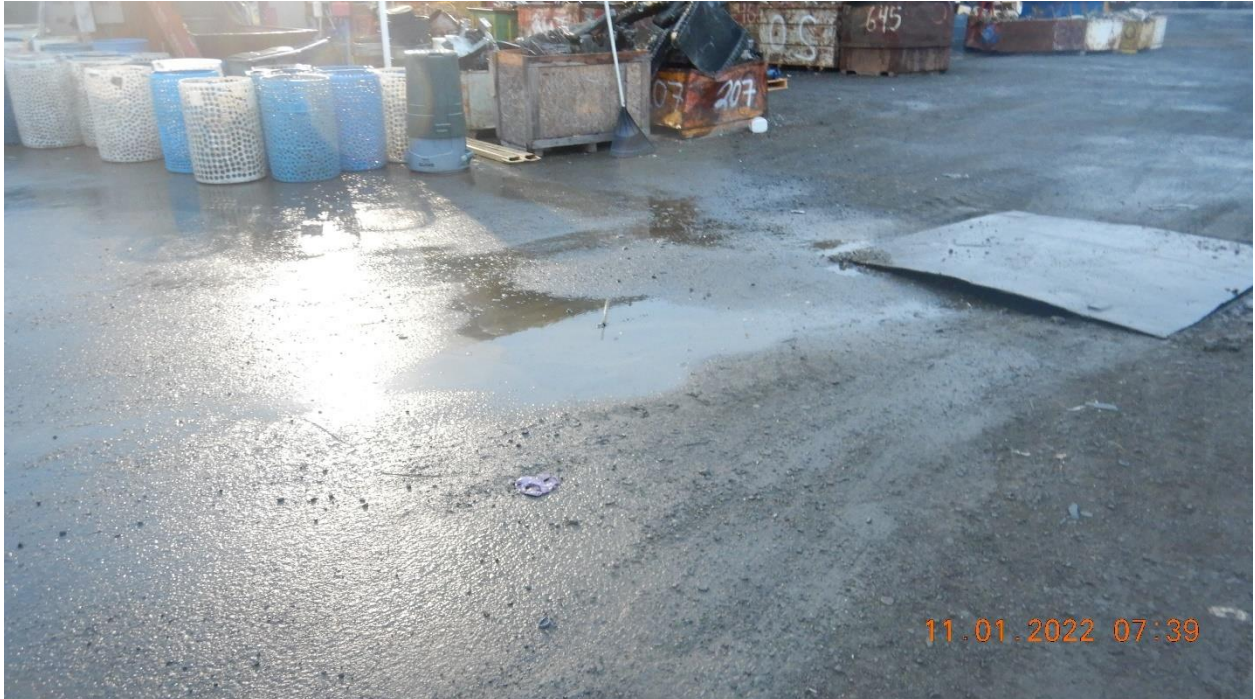
Picture 6 – View of sorted metals inside of the very old and rusty bins exposed to rain. The inlet under the steel plate receives the runoff and then it drains to filtration system. Picture taken by Farzad Kasmaei.

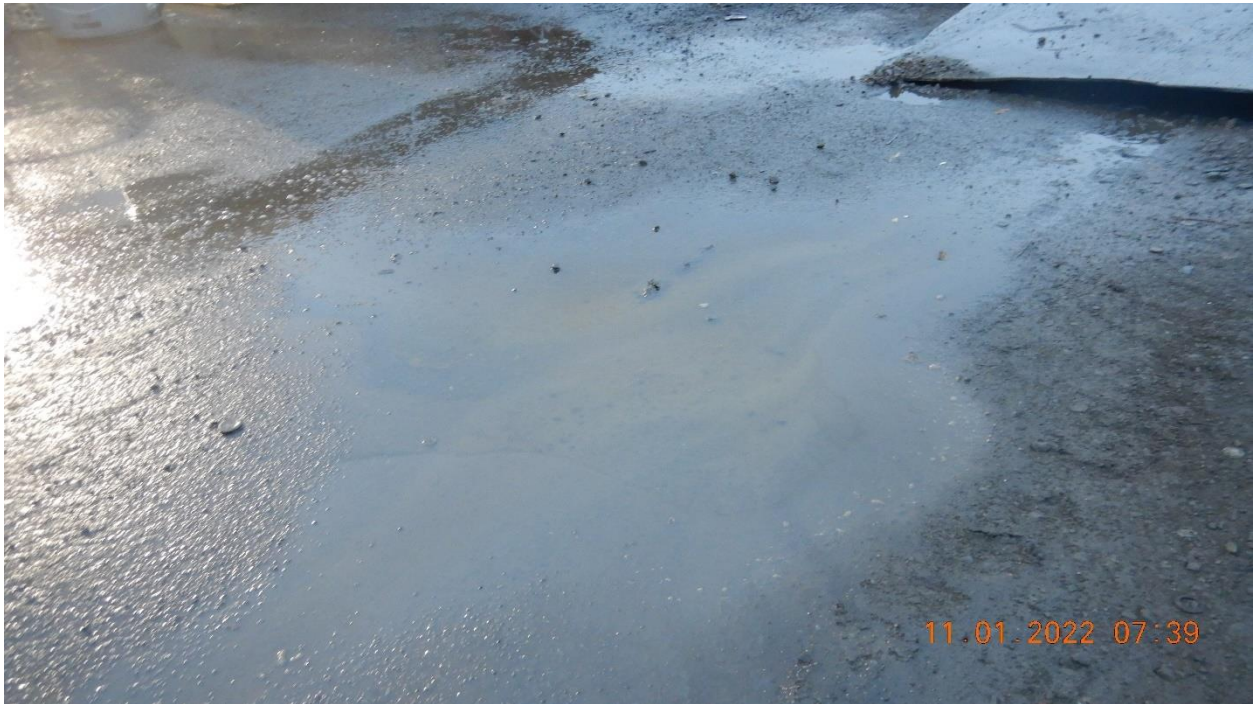
Picture 7 – View of sheen in facility's runoff prior to discharging into a DI. Picture taken by Farzad Kasmaei.

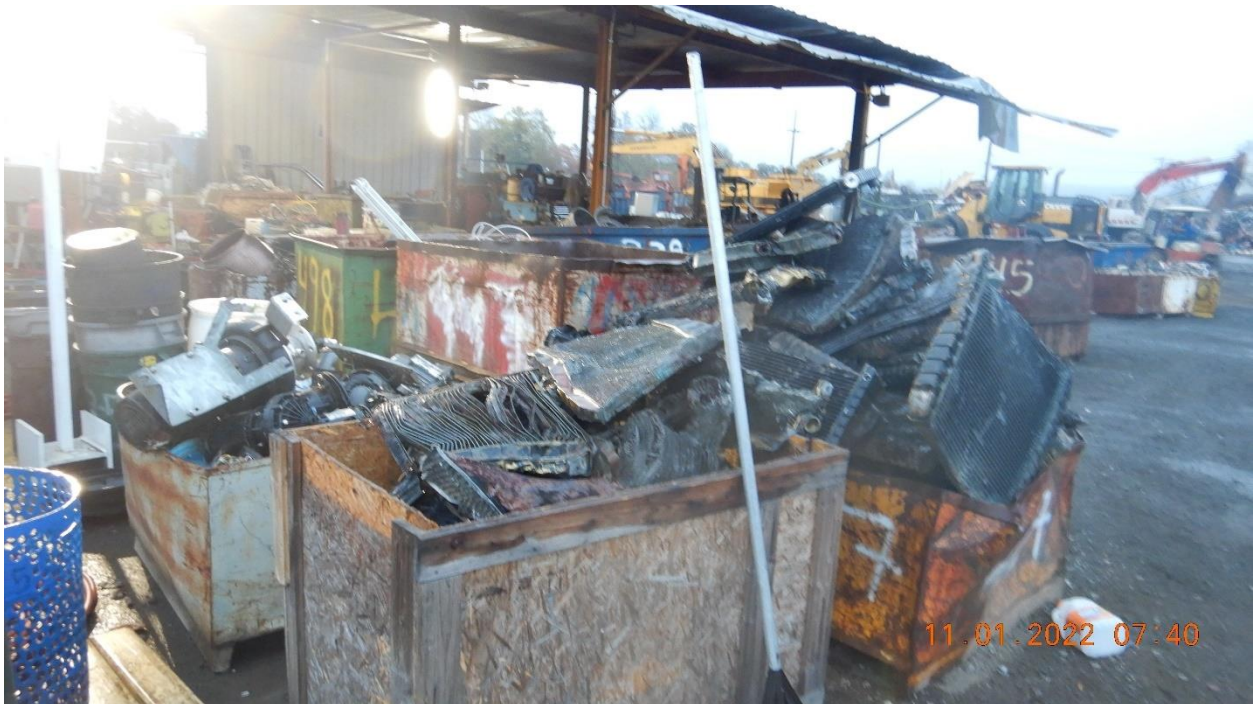
Picture 8 – View of radiators and other scrap metals all stored inappropriately in the non-sealed and rusty bins exposed to rain. Picture taken by Farzad Kasmaei.

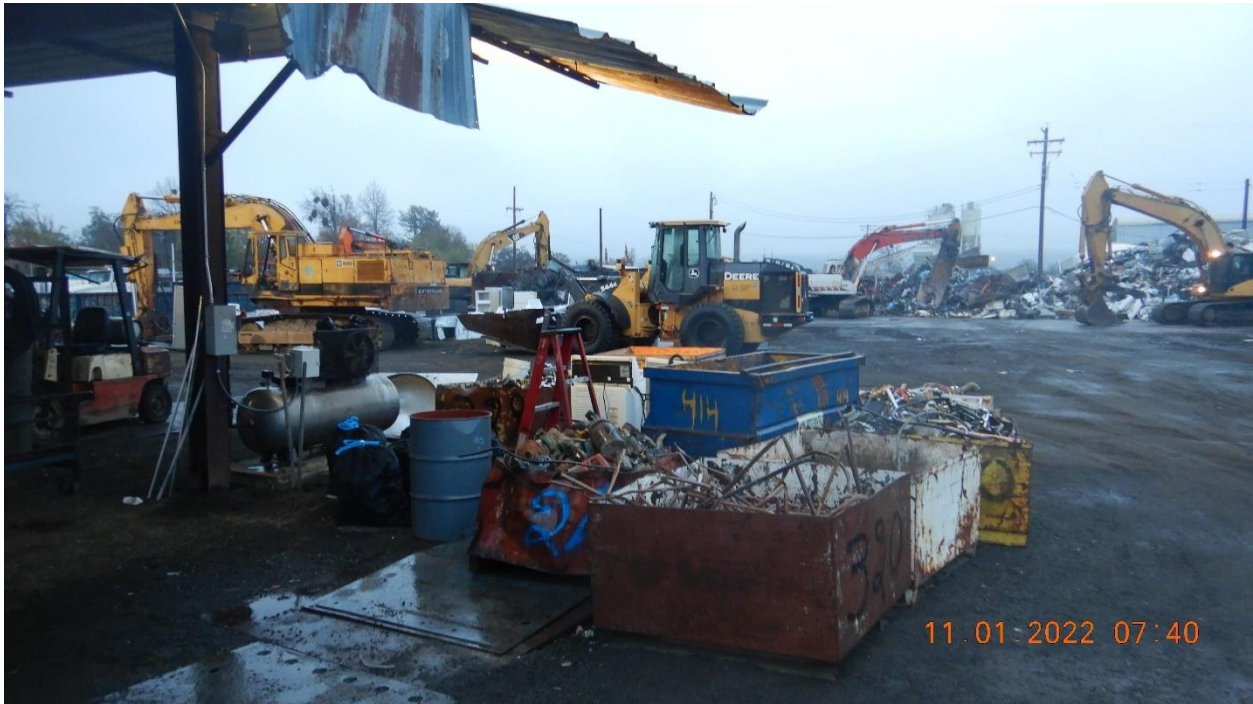
Picture 9 – View of sorted scrap metals stored in broken and rusty bins next to the inlet. Picture taken by Farzad Kasmaei.

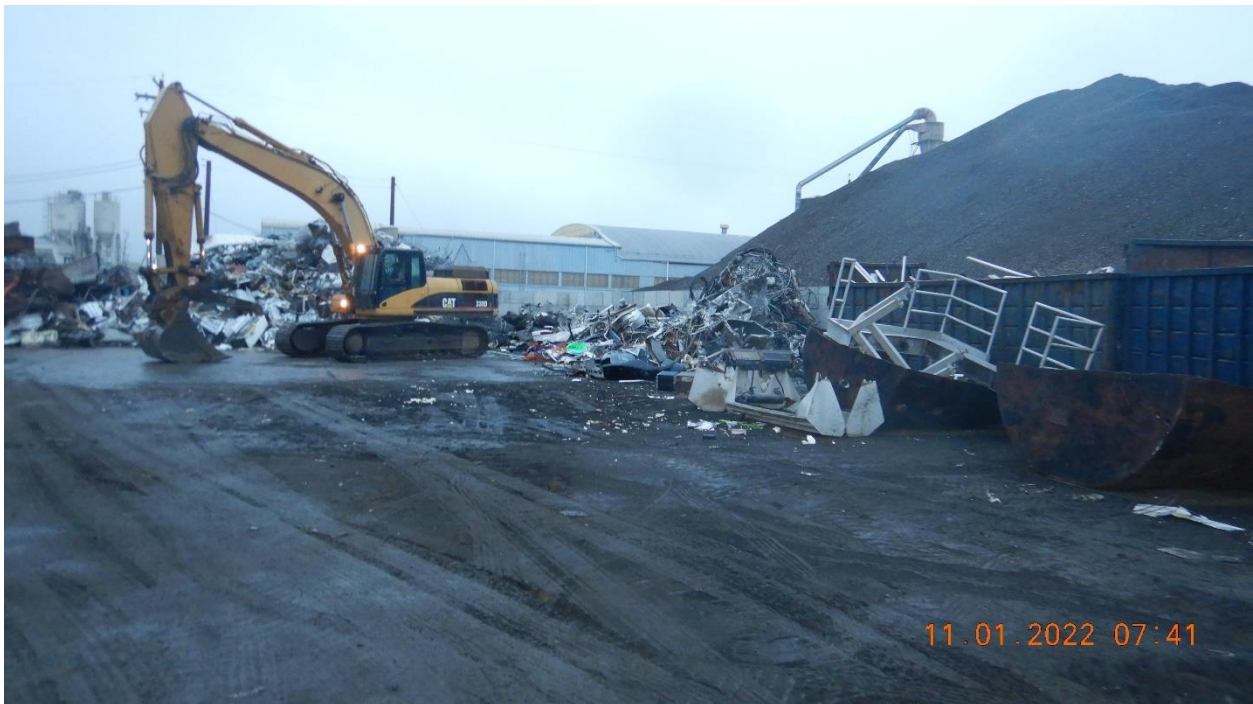
Picture 10 – View of scrap metal stockpiles within the eastern portion of the facility's yard. The aggregate stockpile on the background belongs to adjacent facility that is operated by BoDean Company. Picture taken by Farzad Kasmaei.

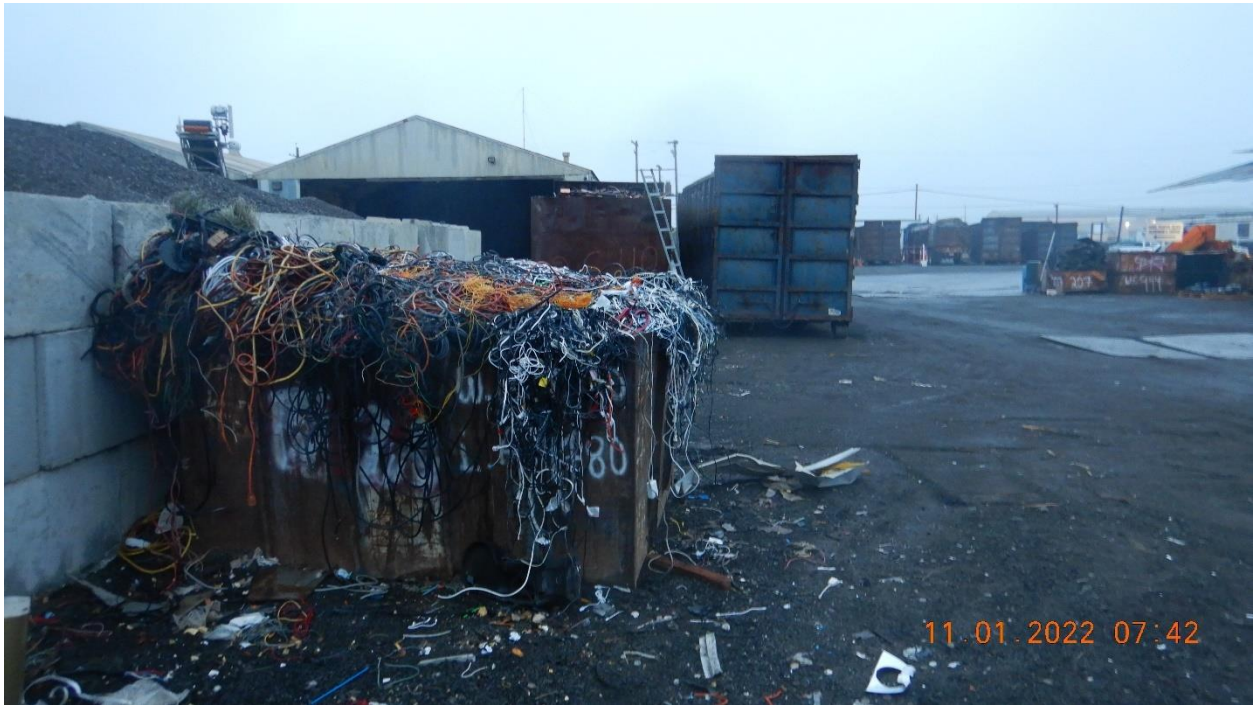
Picture 11 – View of a rusty bin full of wires. Debris and wastes are on the ground around the bin. Picture taken by Farzad Kasmaei.

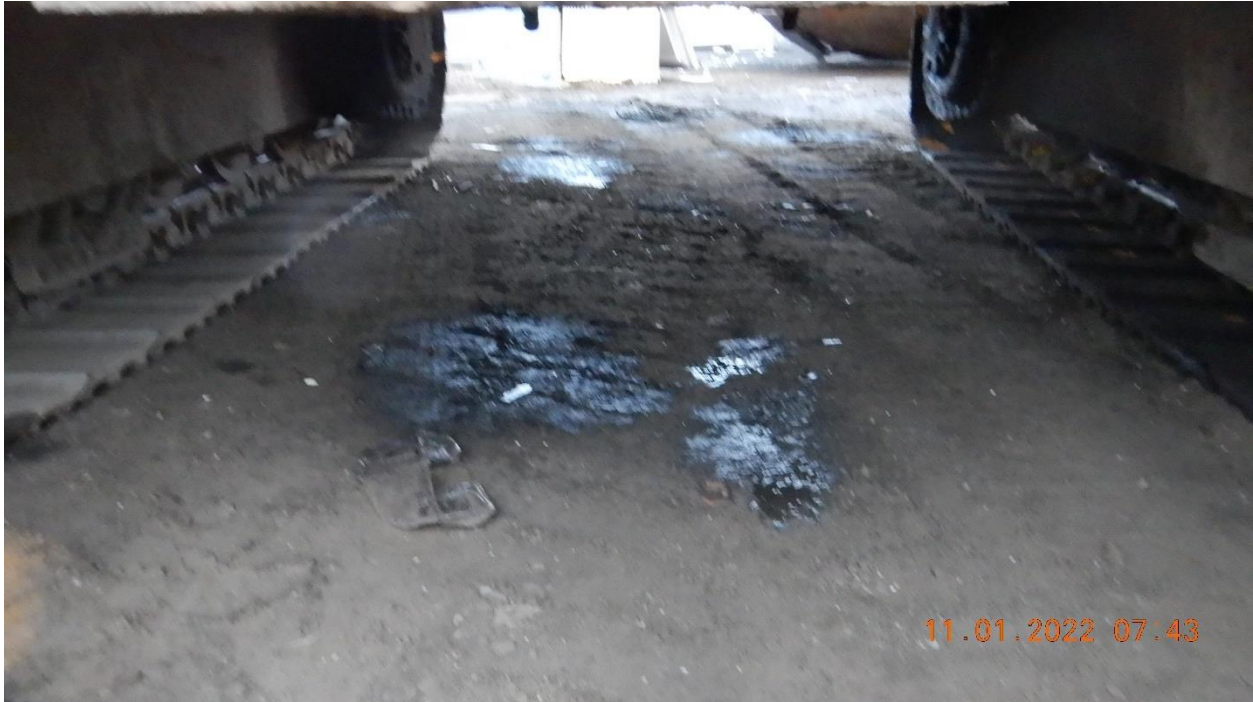
In addition to the oil sheen observed in facility's runoff, I observed hydrocarbon spills on the ground from the dozers and other equipment on the site. Preventative maintenance as well as spill prevention and response are not properly implemented to prevent these types of discharges.

Picture 12 – View of hydrocarbon leaks from a dozer that was parked within the facility's yard. Drip pans are not used to capture any potential spills. Picture taken by Farzad Kasmaei.

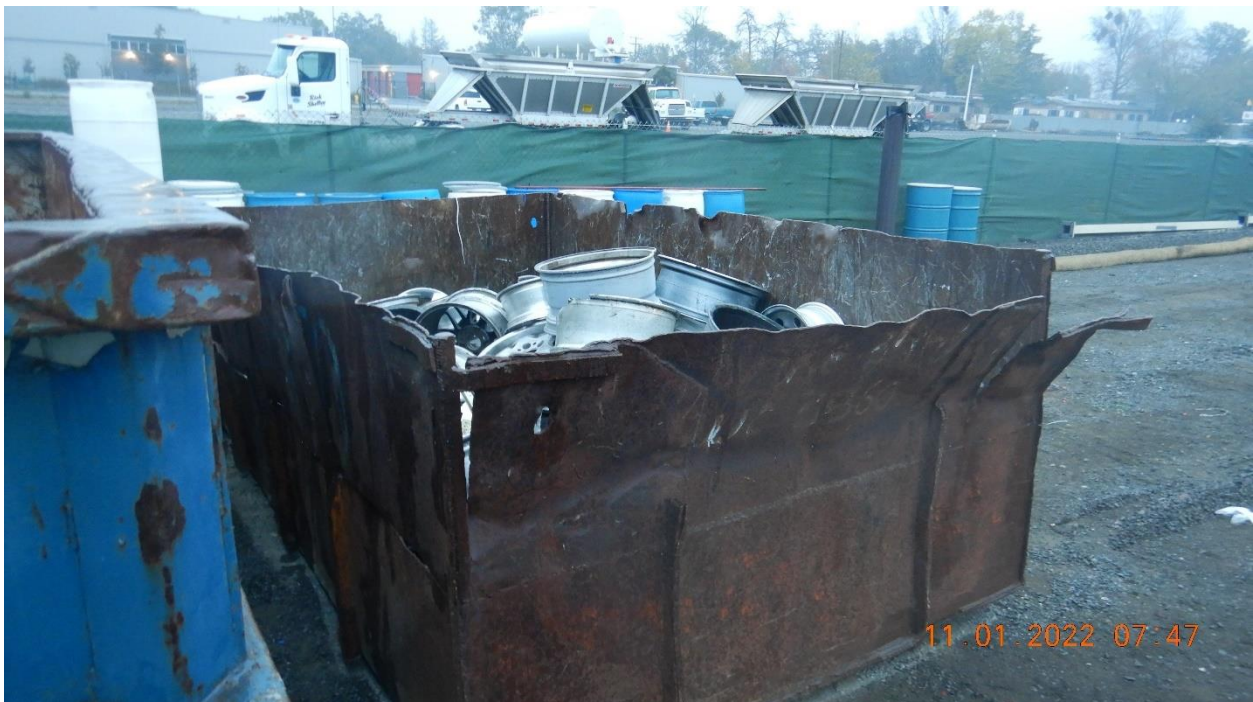
Picture 13 – View of sorted auto metal parts stored in a very old and rusty bin. Picture taken by Farzad Kasmaei.

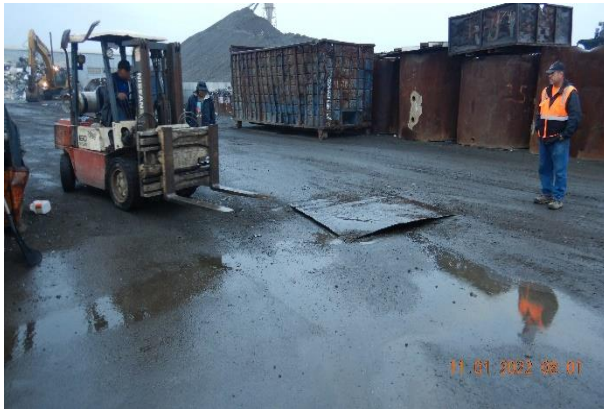
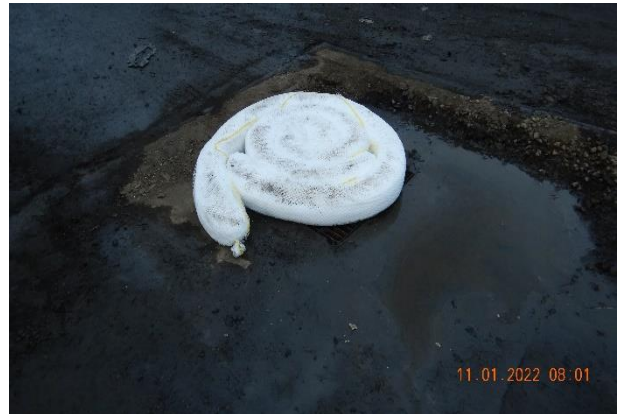
Picture 14a and 14b – View of the absorbent socks placed on top of a DI beneath the steel plate in the central portion of the facility. Picture taken by Farzad Kasmaei.

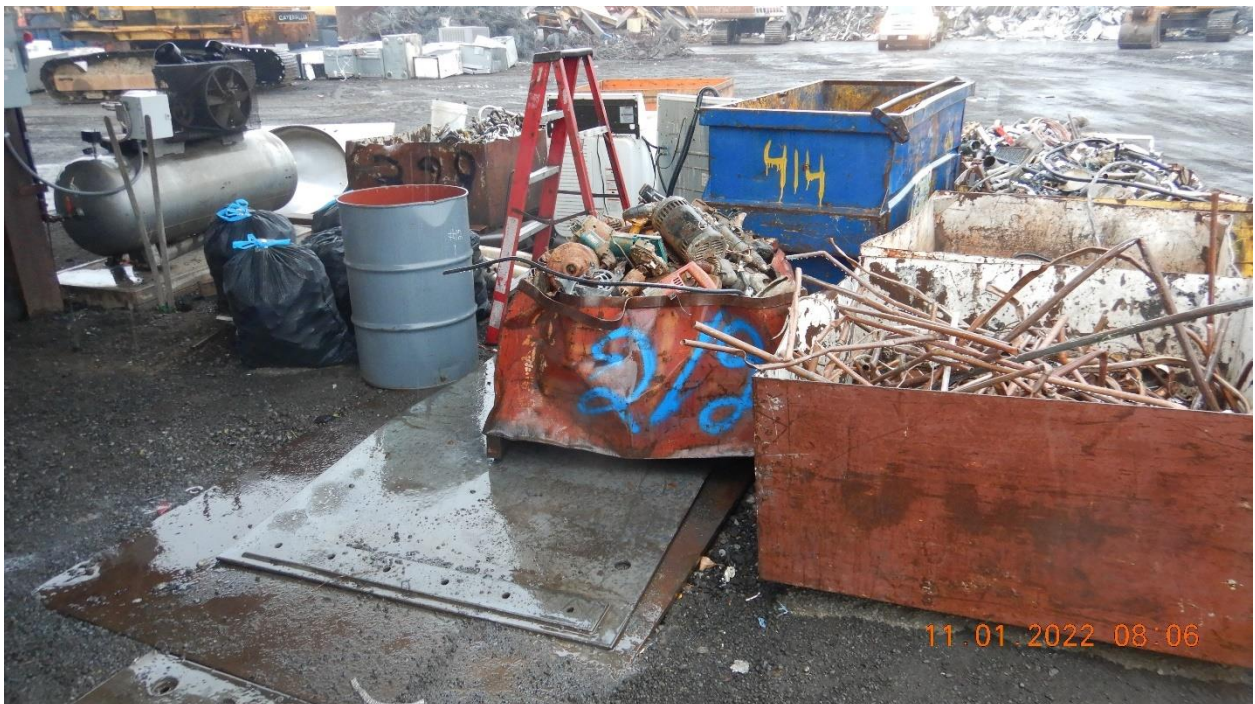
Picture 15 – View of sorted metals stored in rusty bins adjacent to a DI. Picture taken by Farzad Kasmaei.

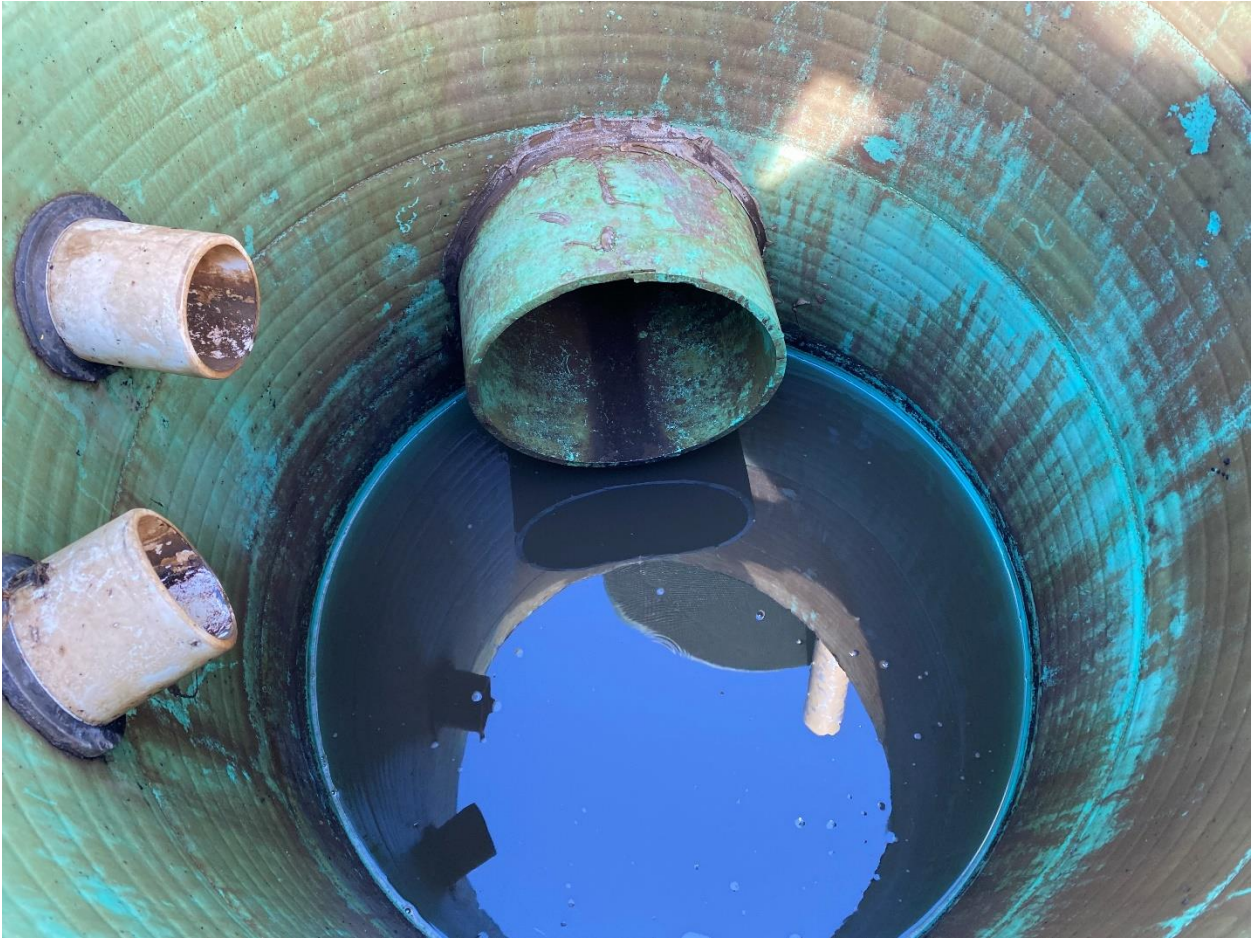
After my inspection, Mr. Puccioni, Facility consultant, emailed me a couple of photos from the outlet pipe under the green poly manhole cover that I could not get into during my inspection (Picture 16). Per his explanation, two small pipes shown on the photos are where the auto-pumped water from the storage vault enters the outlet area. And the large pipe is the gravity fed outlet pipe that ties into the downstream stormwater conveyance system that serves the Facility as well as neighboring parcels before heading to Pruitt Creek. He stated that the outlet bottom is sealed so water level can only drop below the bottom of the outlet pipe by evaporation. So, with the water level in the area clearly below the outlet pipe, it shows there was no recent discharge from the site during the rain event. However, the Discharger notified me that the runoff was manually pumped out from filtration system and samples were collected on the same day after I left the site.

Picture 16: The two small pipes are where the auto-pumped water from the storage vault enters the outlet area. Post inspection picture taken by Facility's consultant (Greg Puccioni)

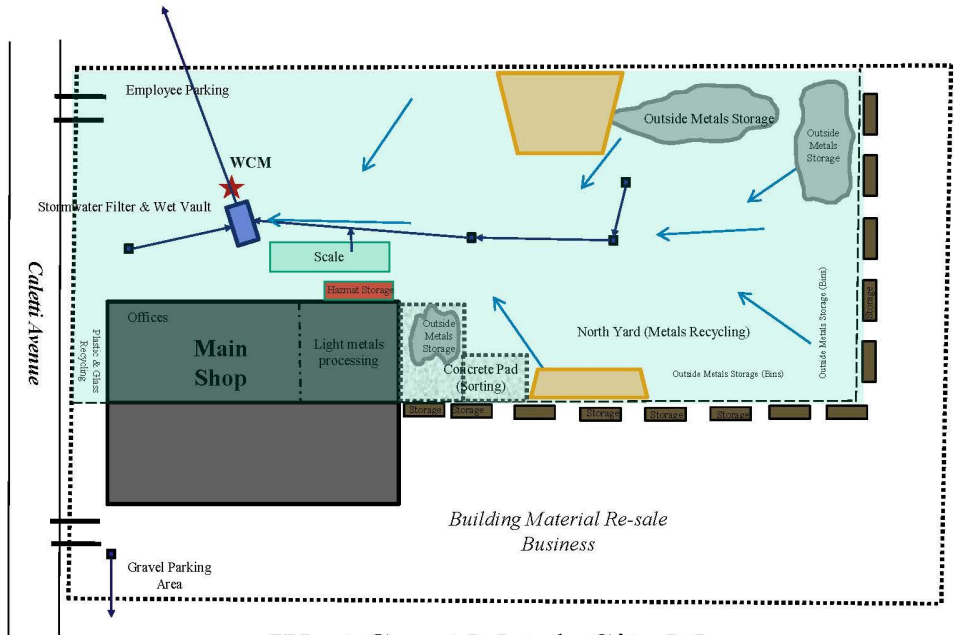
West Coast Metals Site Map

I noticed that there are several issues with the current site map. A portion of the Facility which is shown on the current site map is actually no longer in use by West Coast Metal and per Brian, it is operated by BoDean Company. Also, the storm drain drop inlets located on the west side of the Facility's main shop are not shown on the existing site map. Furthermore, the location of the roofed metal storage area onsite is in a different location that shown on the current site map. The site map and Storm Water Pollution Prevention Plan (SWPPP) must be updated to reflect the current condition of the Facility.

Site Map: The old Site map has been prepared by the Discharger's consultant that indicates the water flow directions and the storm drain inlets. However, the site map must be revised to include the drop inlets that are not shown and make corrections on the roofed metal storage locations.
