Inspection Memorandum

To: File: Fox Meadows, Notice of Emergency 1-20EM-00125-SON

Subject: 1052.1 (a)(2) Dead, Dying (Fire, etc.) Emergency Notice Inspection Report and Recommendations, 1-20EM-00125-SON

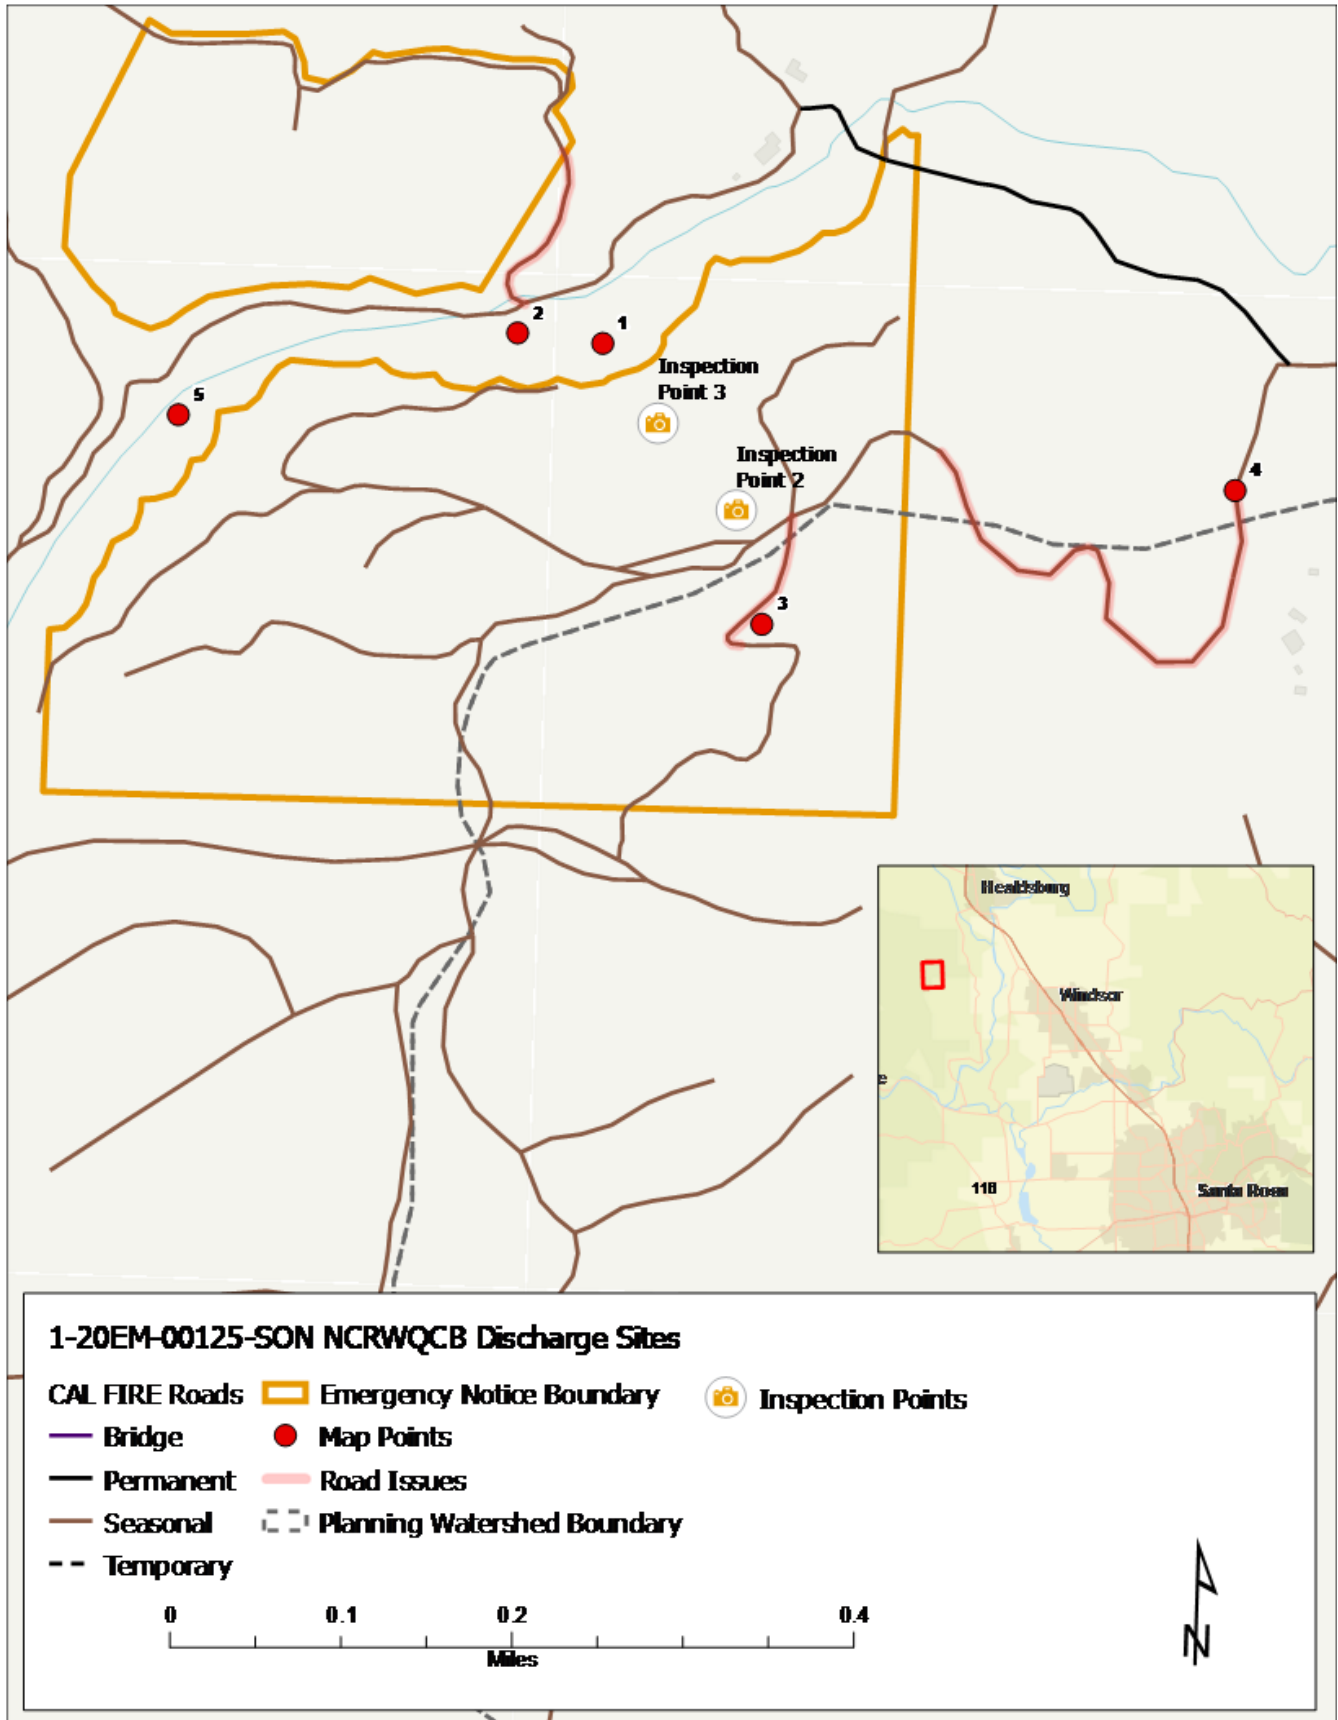
Map Point 2: Loose soil must be removed from the outlets of several waterbars on the seasonal haul road leading to the north bank of Felta Creek in order for them to function as intended and erosion control (straw bales) where the road meets the river terrace should be enhanced. That work has been completed.

Inspection Point 2: A skid trail on a steep slope (approximately 50%) leading directly to a Class III watercourse less than 50 feet below terminates in a perched mass of soil and organic material. The downslope face of this mass is approximately 6 feet high and nearly vertical. There is high potential for this material to lose internal strength and fail when saturated, with a high likelihood of discharge to the watercourse below. Regional Water Board staff advised you that this perched material should be pulled back and stabilized. This was not done and the potential for sediment discharge remains high at this location.

Inspection Point 3: A swale below the landing at Map Point 3 that was highly disturbed from skidding logs and operating heavy equipment. Soil berms remains in the swale that will likely be eroded and sediment transported further down, potentially into the drainage network below. On October 29, 2022, CAL FIRE issued a Notice of Violation of Forest Practice Rules for equipment operations in an Equipment Limitation Zone (ELZ) Bare soil in the swale had previously been covered with slash for erosion control but had been removed. While it would potentially result in more disturbance to bring heavy equipment back into the swale to remove the berms, Regional Water Board staff advise you at a minimum to replace the slash on bare soil in contact with the ground to the extent feasible to try to prevent sediment movement. That was not done and the potential for sediment discharge remains at this location. It

Map Point 3: This is a complex area with several issues that had required addressing. The final item that required addressing were to remove slash and other organic debris from the Class III watercourse channel and construct additional waterbars as needed along the edge of the landing and skid trails to prevent concentration of runoff and resulting sediment discharge. The remaining work has been completed.
