## Inspection Memorandum

**Subject:** 1052.1 (a)(2) Dead, Dying (Fire, etc.) Emergency Notice Inspection Report and Recommendations, 1-20EM-00125-SON

**Fire Name**  
Walbridge Fire (2020)

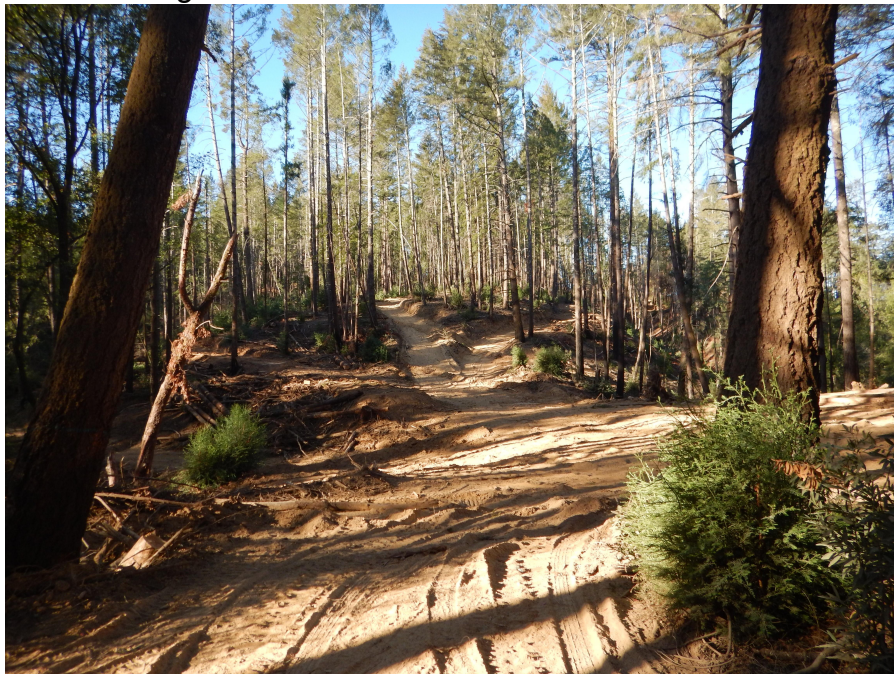
The waterbars on the landing were installed such that surface runoff from the landing would be directed down a hillslope to a swale connected to a Class III watercourse, where there had previously been sediment discharge. Additionally, any runoff would flow over bare mineral soil due to operation of heavy equipment, exacerbating the threat of discharge. In the watercourse itself, there was evidence of disturbance of the channel bed with heavy equipment, most likely an excavator bucket. Woody debris had been removed from the channel at the site of the disturbance, but there was still debris further down and upstream.

Photo Point 1.1 - Landing site.

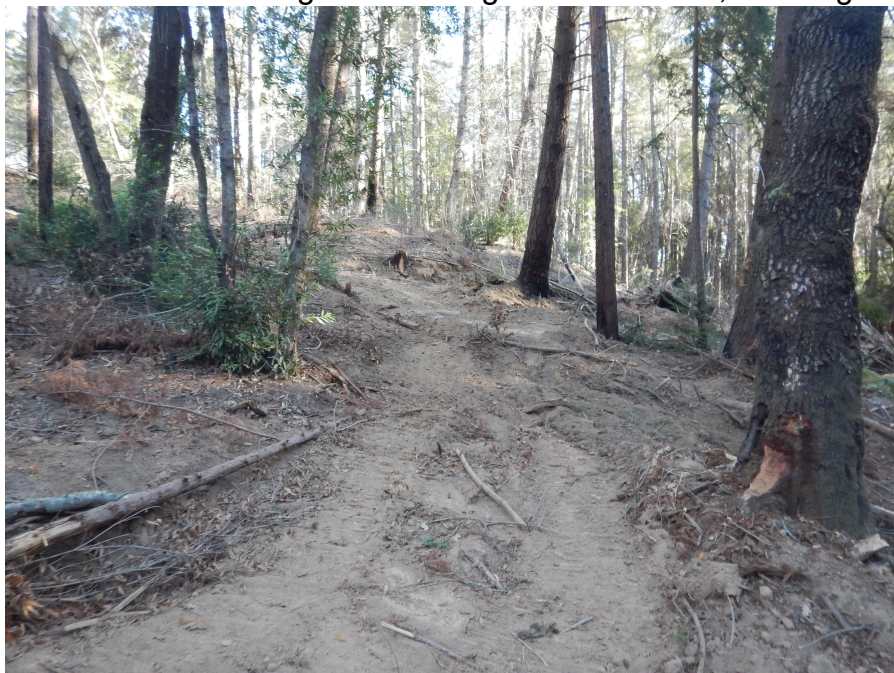
Photo Point 1.2 - Skid trail leading from landing to watercourse, showing bare mineral soil

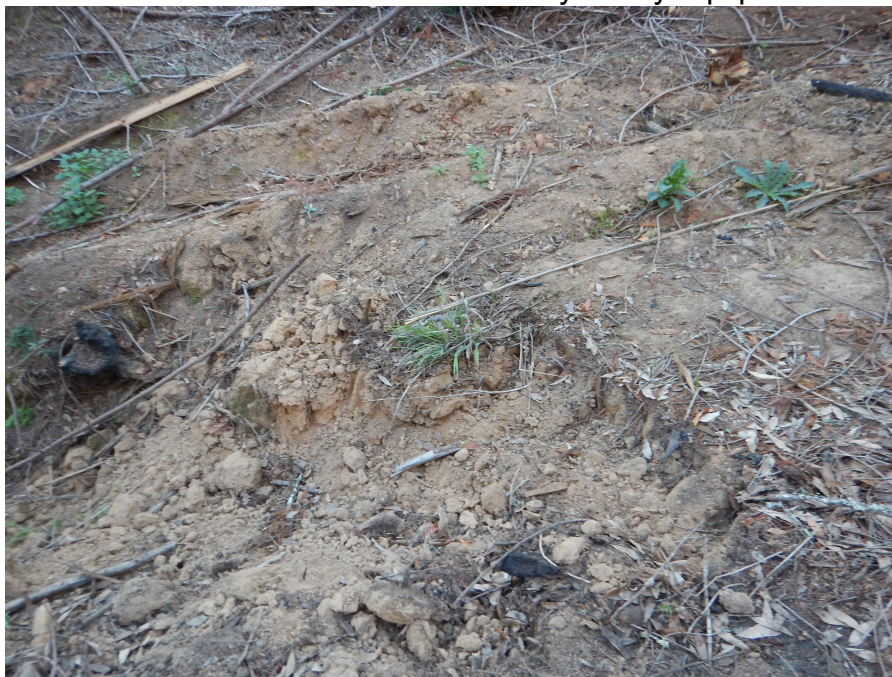
Photo Point 1.3 - Disturbance of Class III channel by heavy equipment.

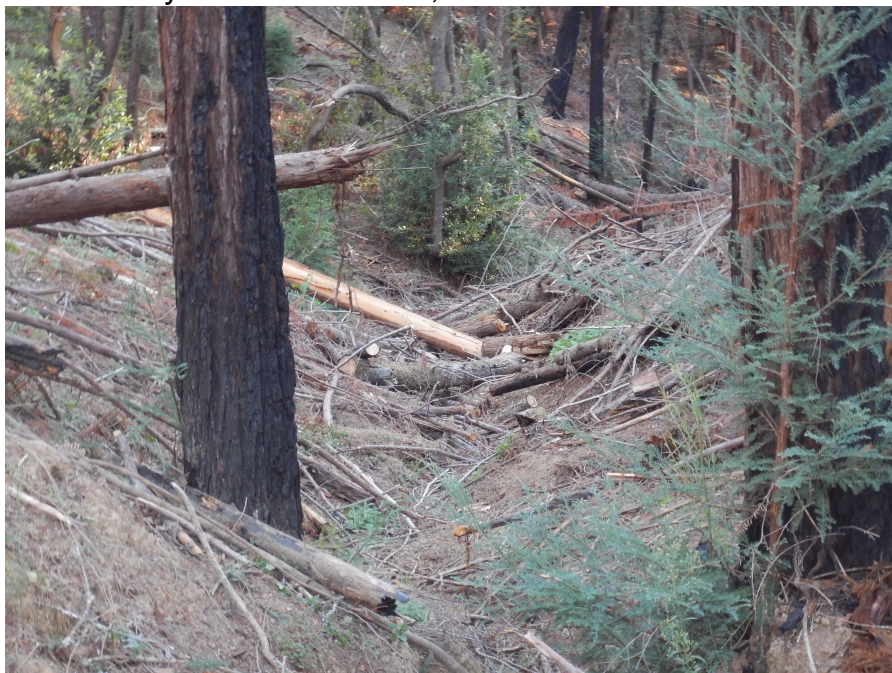
Photo Point 1.4 - Woody debris in channel, downstream of channel disturbance.

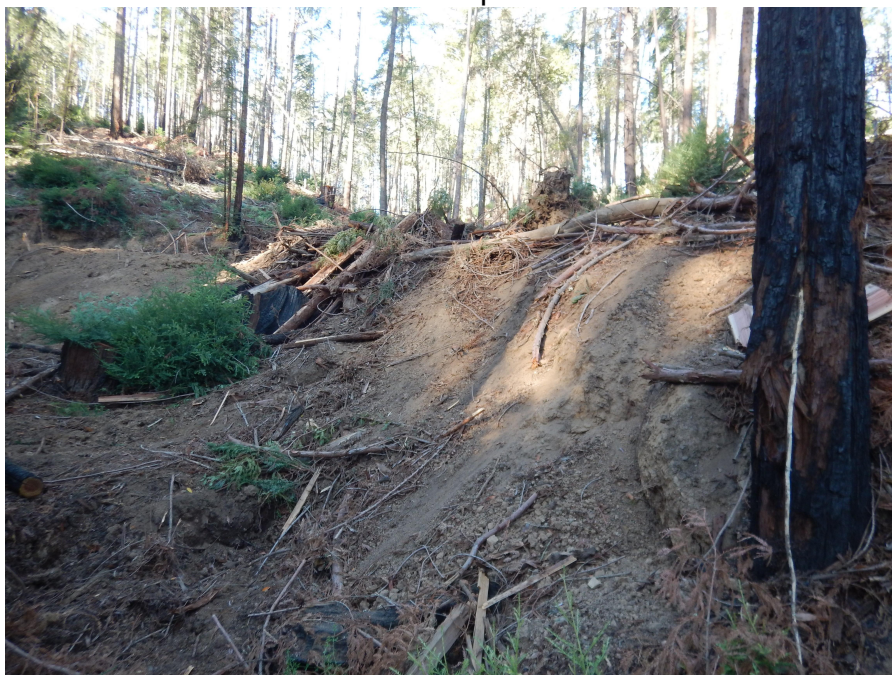
Along the road segment, there was still sidecast material perched above the watercourse.

Photo Point 1.5 - Sidecast material from road perched above channel.

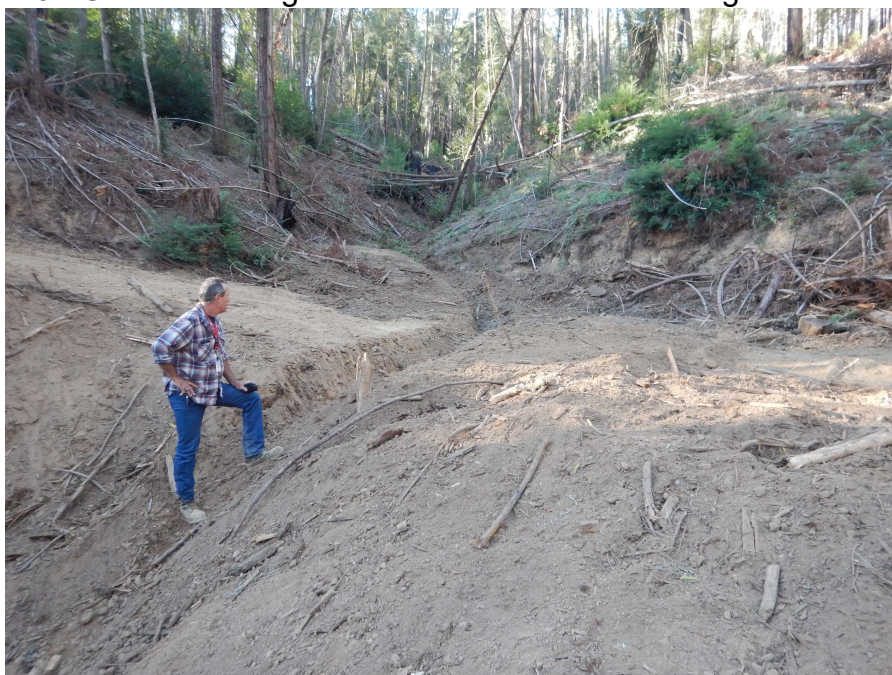
At the watercourse crossings, two channels had been excavated to convey flow across the road. These channels were not at the original stream grade and will likely experience erosion until the site stabilizes naturally.

Photo Point 1.6 - Channel through road surface. Not to natural grade.

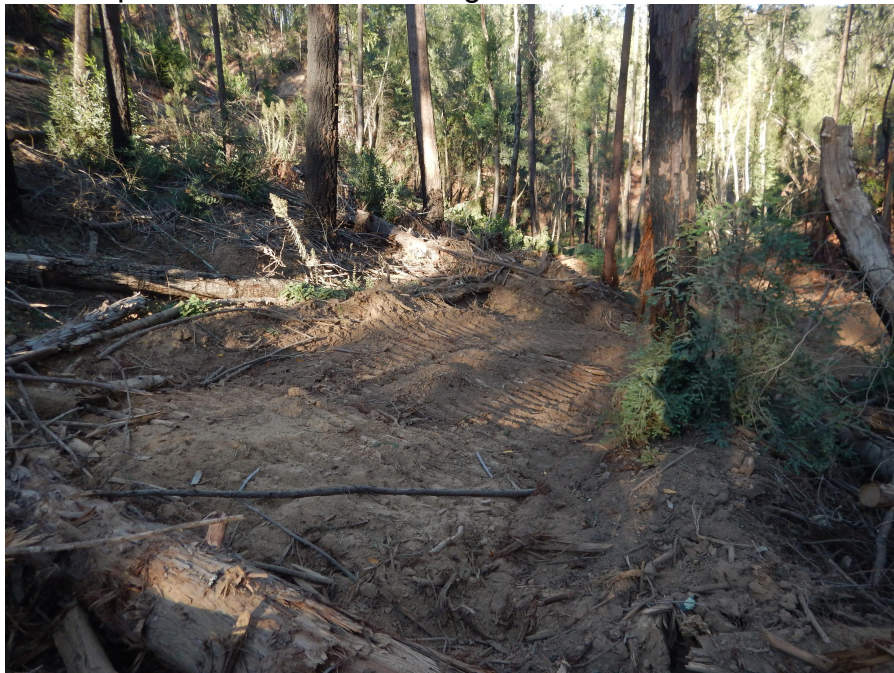
Steep skid trail leading from a landing down a natural swale. Skid trail ends roughly 25 feet from a Class III watercourse. Skid trail had previously been partially slash packed, but slash pack had been removed since previous inspection. Several waterbars had been installed, but given the site in in a swale, there is no place to direct the water and these will be ineffective. In addition, there are several large piles of soil with potential to mobilize into the Class III watercourse below.

Photo Point 2.1 - Top of skid trail from landing.

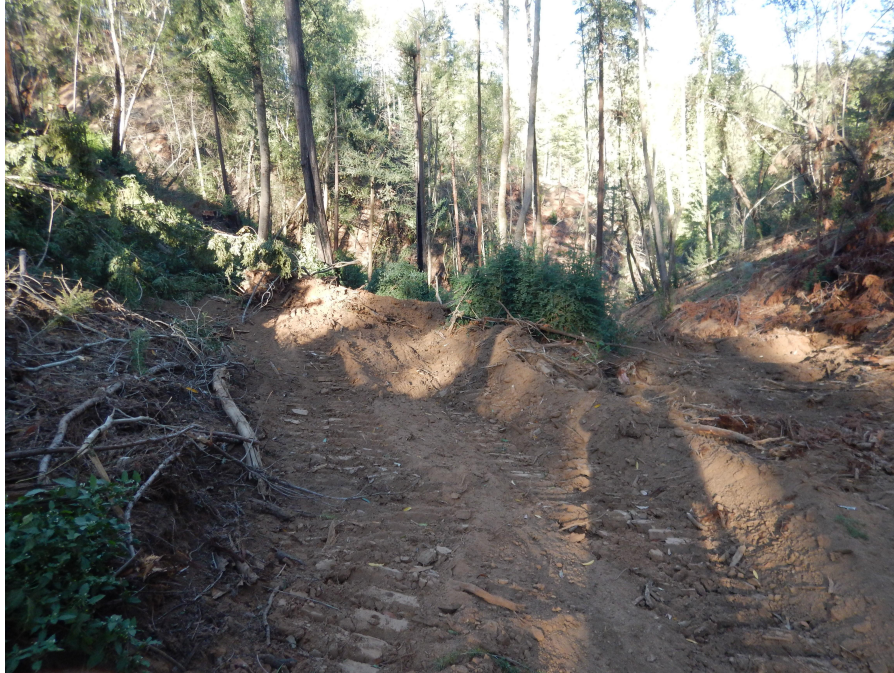
Photo Point 2.2 - Midway down skid trail, showing ineffective water bar.

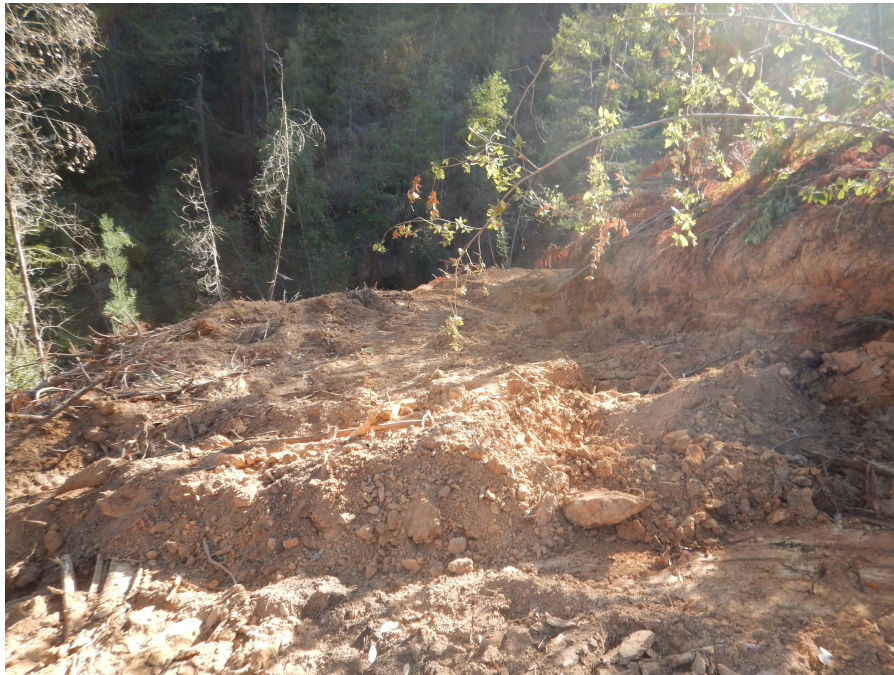
A skid trail ends here with a large pile of mineral soil mixed with organic debris perched on very steep slopes (over 65% but the perched material is essentially vertical on the downslope face) above a Class III watercourse. Several waterbars had been installed on this segment of skid trail, but the pile of spoils and the end has the potential to mobilize when it becomes saturated or the organic matter decomposes and the mass loses strength.

Photo Point 3.1 - Pile of material at the end of the skid trail. Looking downhill towards the Class III watercourse.

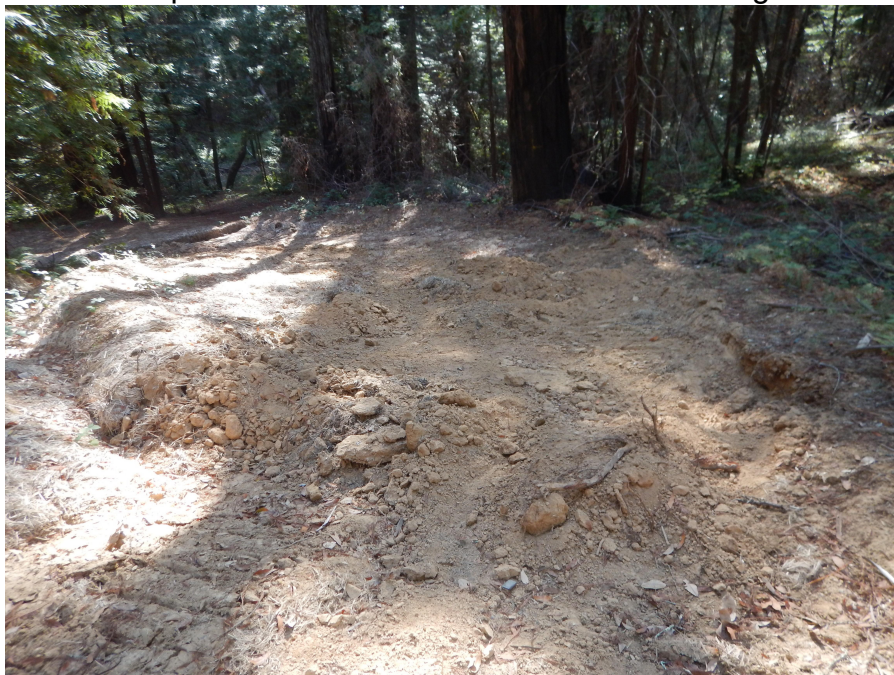
This is Map Point 2 from previous RWB inspections. During the RWB inspection of September 20, 2022, it was noted the the erosion control measures that had previously been installed at the site had been removed. Waterbars have been constructed along this segment of road leading down to Felta Creek. However, these newly installed waterbars were inadequate to prevent the delivery of sediment; they were too low in places which would allow water to divert down the road before being diverted to a vegetated hillslope, or the outlets of the skid trails were blocked by mineral soil, leading to the same result. Additionally, there should be an additional waterbar or other erosion control measure at the bottom of the road, where there had previously been a line of straw bales.

Photo Point 4.1 - Inadequate waterbar towards bottom of road segment.

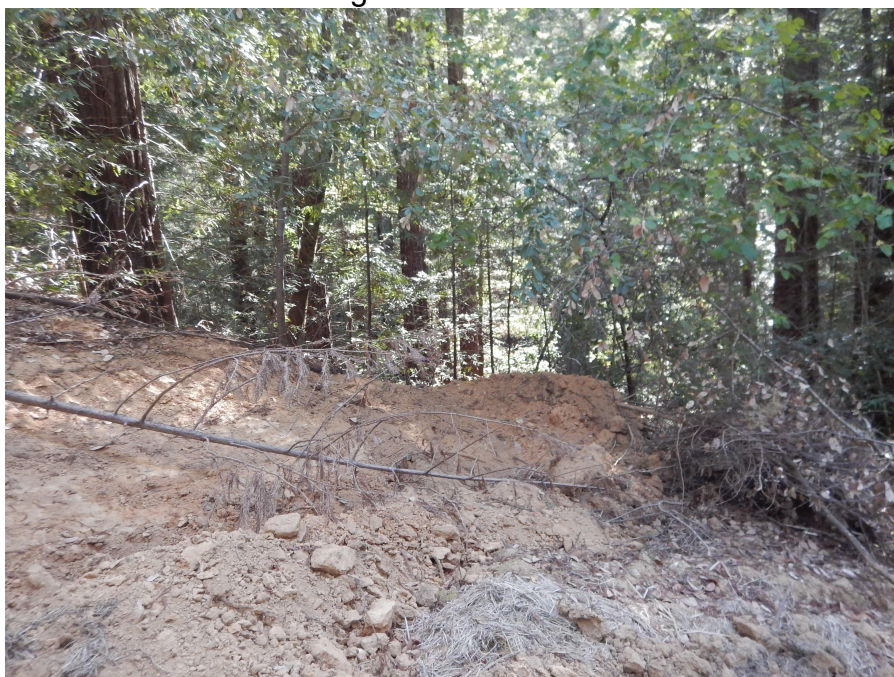
Photo Point 4.2 - Mineral soil blocking outlet of waterbar.

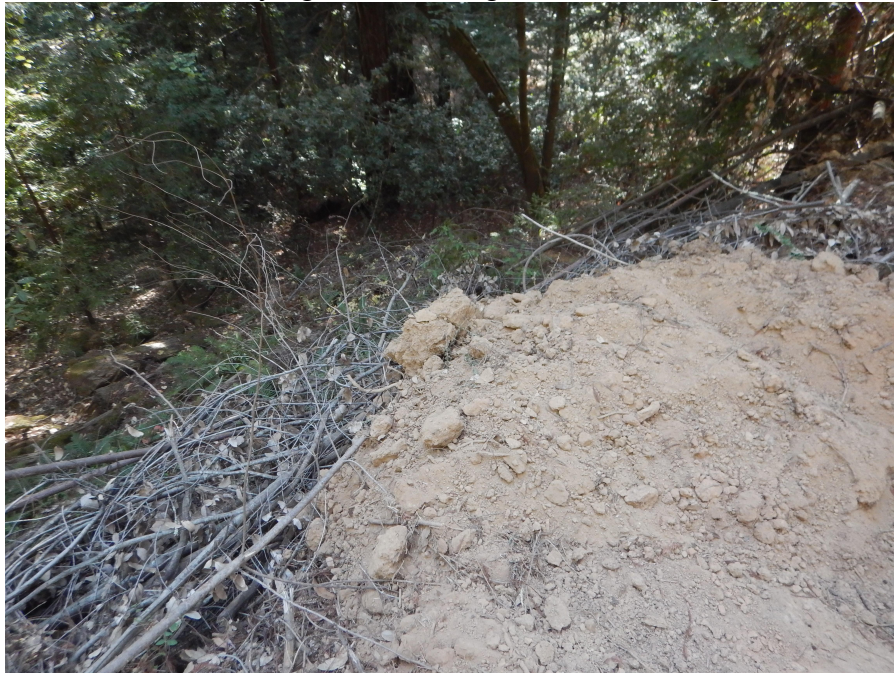
Photo Point 4.3 - Mineral soil lying on dead vegetation blocking outlet of waterbar.
