**CALIFORNIA REGIONAL WATER QUALITY CONTROL BOARD
NORTH COAST REGION**

Order No. R1-2023-0042

Amending Cleanup and Abatement and 13267 Order No. R1-2021-0056

**Justin Baldwin and Mia Baldwin as Trustees of the Baldwin J and M Trust,
Humboldt Spirit Inc. and Sprowl Creek LLC**

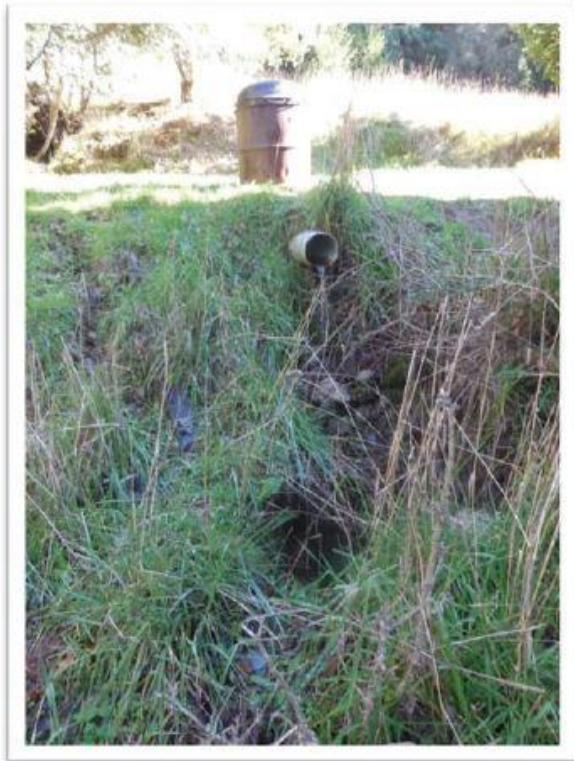
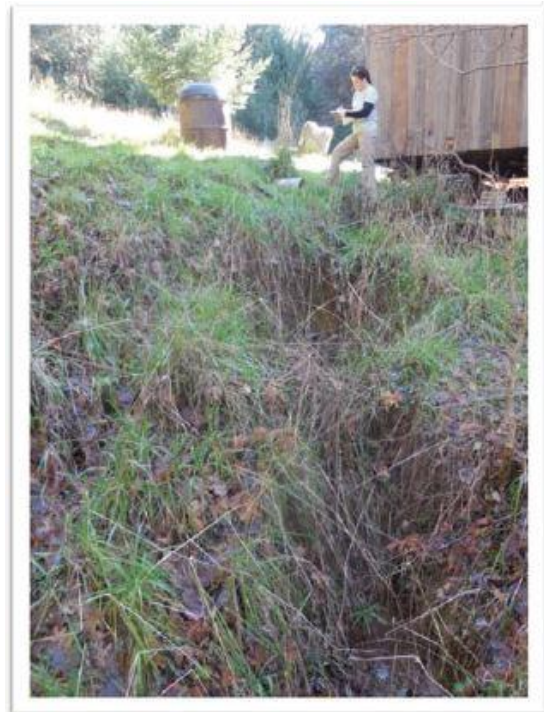
- Residence D: Access roads from the north and west show signs of erosion and inadequate drainage. The culvert just to the north of the residence (C1) is shotgunned, with erosion at the inlet and outlet, and downstream of the outlet. These features generally drain downslope toward the road and watercourse to the southwest.

Culvert C1 – outlet and eroding channel below

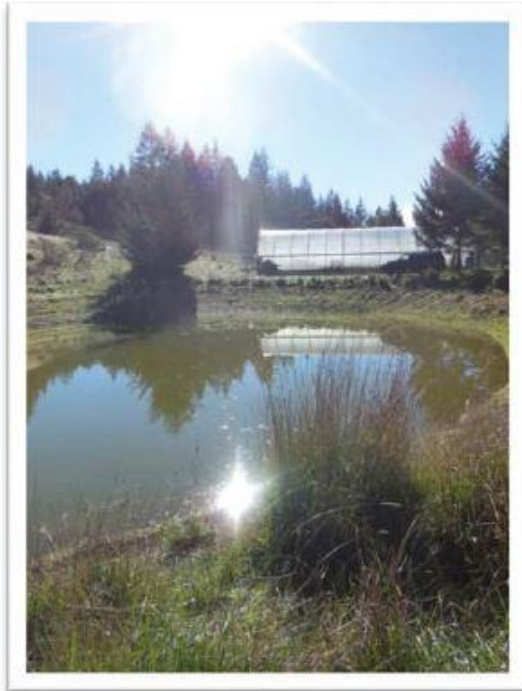
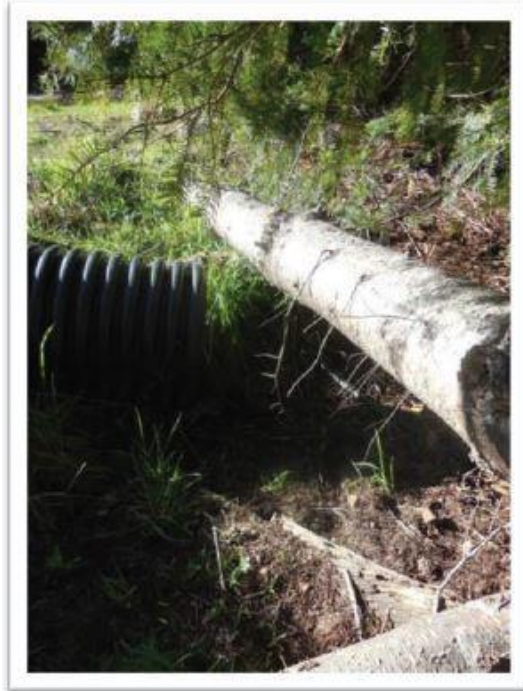
- Reservoir R1: This pond captures flow from one or more springs. There is a stream channel located downslope of the pond outlet culvert, beyond the fence to the west of Area I. Intervening terrain appeared flat and did not show signs of recent erosion. There are pole/tarped structures and various random materials, equipment, and supplies, stored to the west of the pond, and brush piled near the outlet of the pond culvert. We observed some vermiculite on the ground in the storage area.

Reservoir R1 and overflow culvert outlet in brush/slash pile

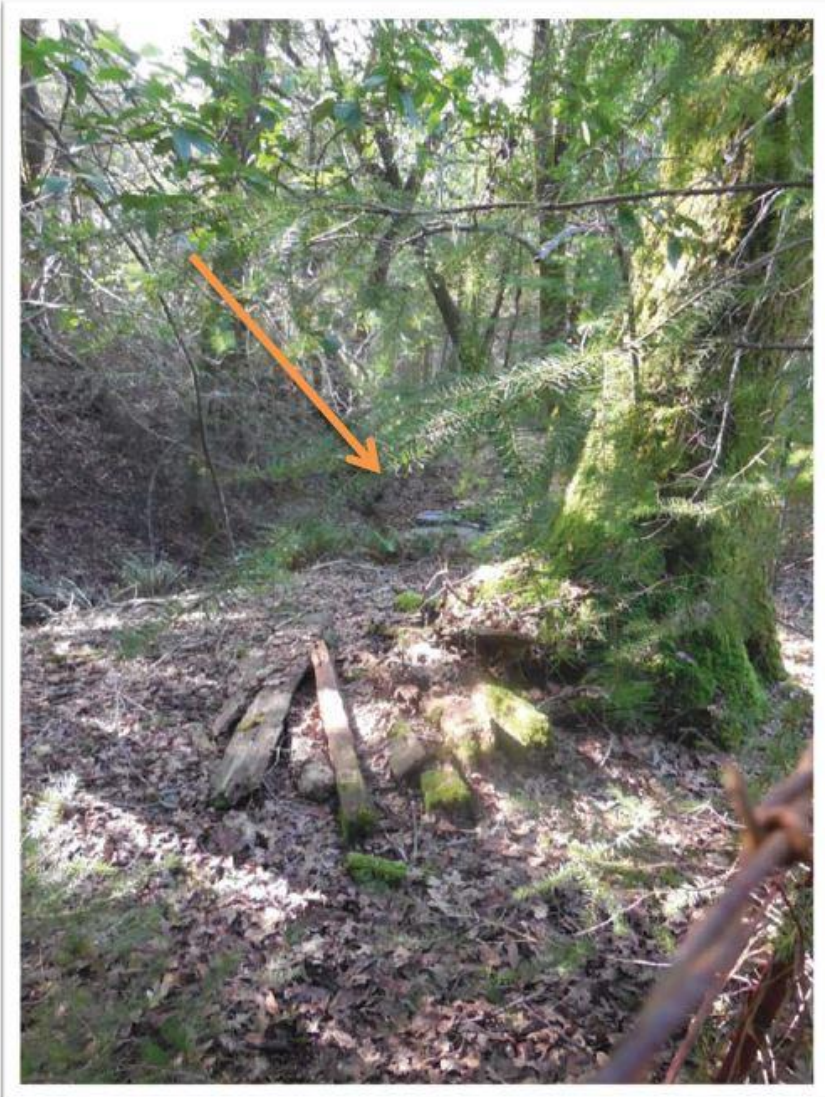
We observed water tanks in this stream channel, and conditions in the channel appeared poor, and susceptible to eroding and delivering sediment. We observed erosion and deposited sediment in the channel upstream of the road. The stream crossing culvert at this location (Crossing C2) appeared to be undersized, and we observed erosion along the road and around the culvert outlet.

Looking towards the west over fence along access road; the orange arrow points to the tanks in the stream channel.

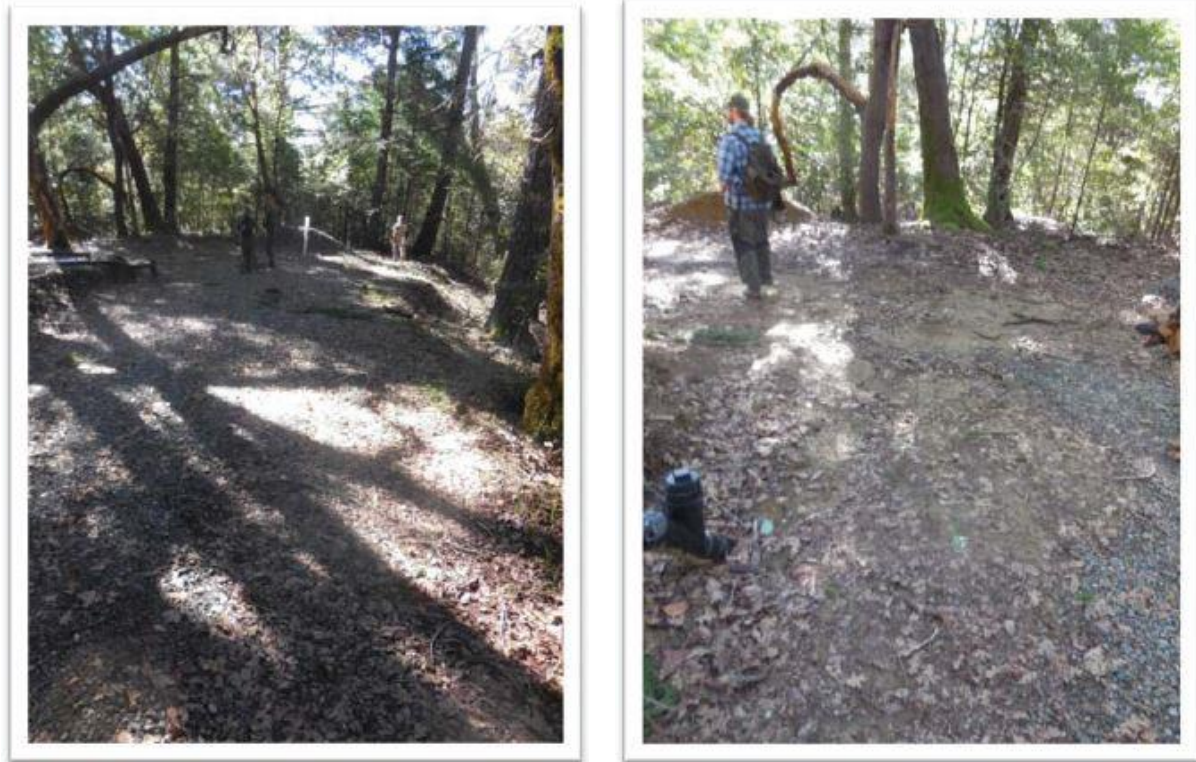
The feature identified as ST3 is a travel trailer located on an access road/driveway that widens out around the trailer and continues south to the outdoor grow area shown as Map Point OG3. Terrain slopes roughly north to south in this area, and we saw evidence of sediment movement, rilling, and gullying as we travelled from feature ST3 to feature OG3 and on downslope toward the property line.

Signs of erosion on the driveway between features ST3 and OG3

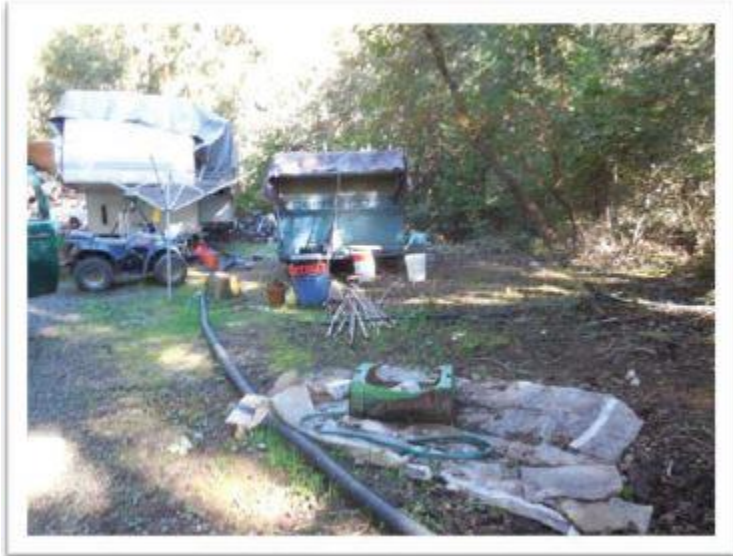
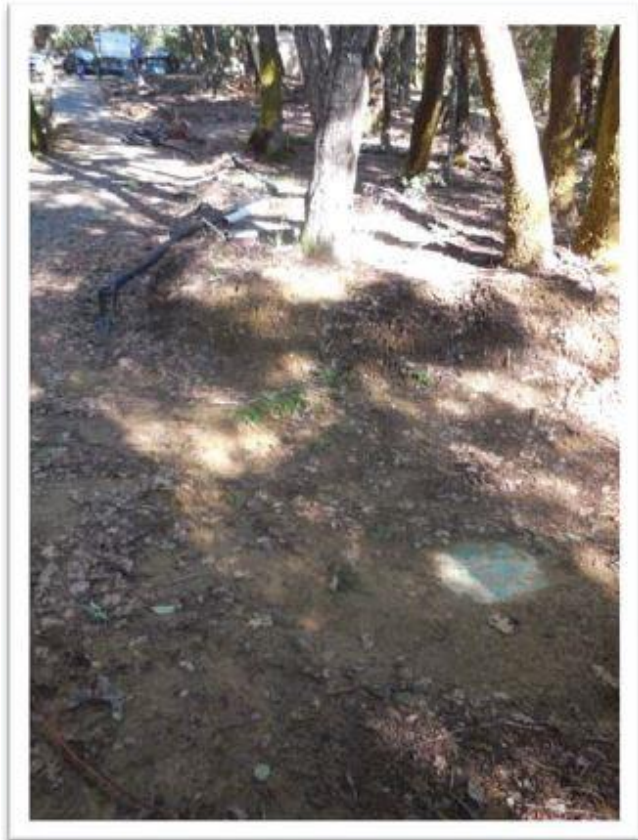
At map point ST3, we observed a travel trailer that appears to be inhabited, another trailer, an ATV, and miscellaneous items including buckets, propane tanks, pipes, materials and equipment, toys, fuel containers, refuse, etc. The team observed a ~4-inch plastic corrugated hose running from the trailer downhill toward feature OG3, connecting to black plastic sewer pipe with a cleanout stub, and just downslope of this, we observed what appears to be the lid of a buried holding tank. This domestic wastewater disposal system may not meet County standards.

Hose leading from the trailer southward to the buried container; lower picture shows the round green container lid.

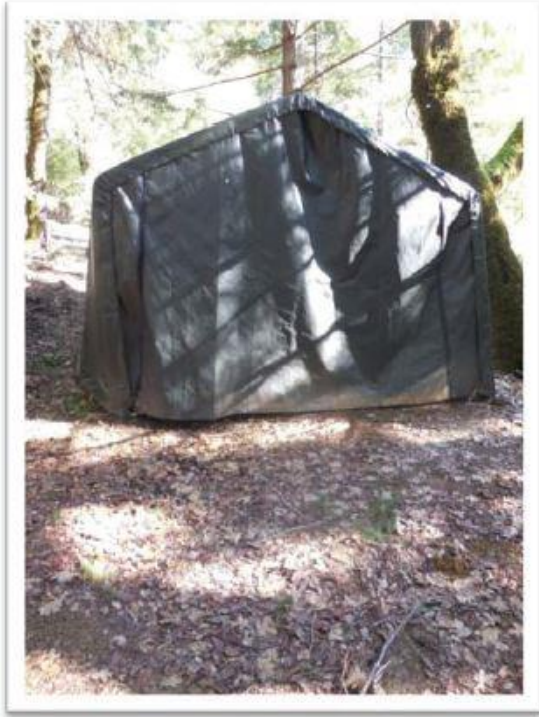
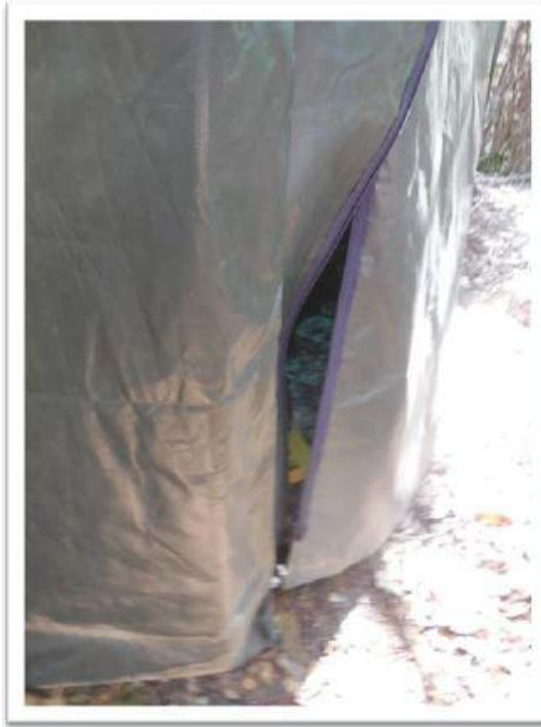
Near feature OG3 we observed a tarp and pole structure, with a zipping flap zipped mostly closed. Through the opening in the flap, we observed that the structure is sited on bare ground, and we observed white particles or pellets on the ground just inside the flap. It appears possible that runoff passing through or originating in this area could pick up and transport sediment and uncontained chemicals from the floor of the structure.

Tarped structure, white chunks/particles visible inside the flap

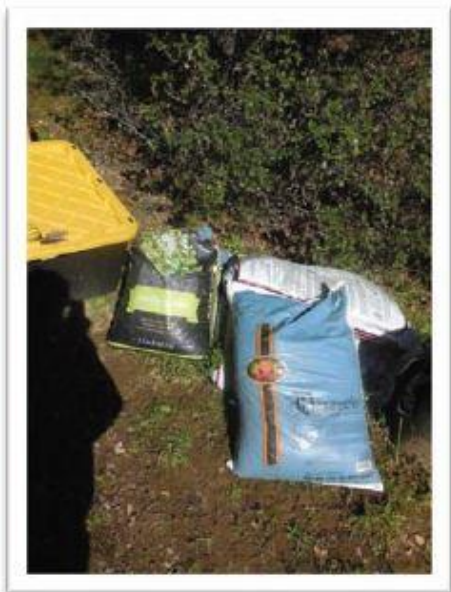
We did not observe apparent threats to water quality at the fenced outdoor growing area, OG3, but we observed some bags and containers of soil amendment/ growing products nearby; housekeeping practices could be improved in and around this area.

Bagged cultivation products near OG3

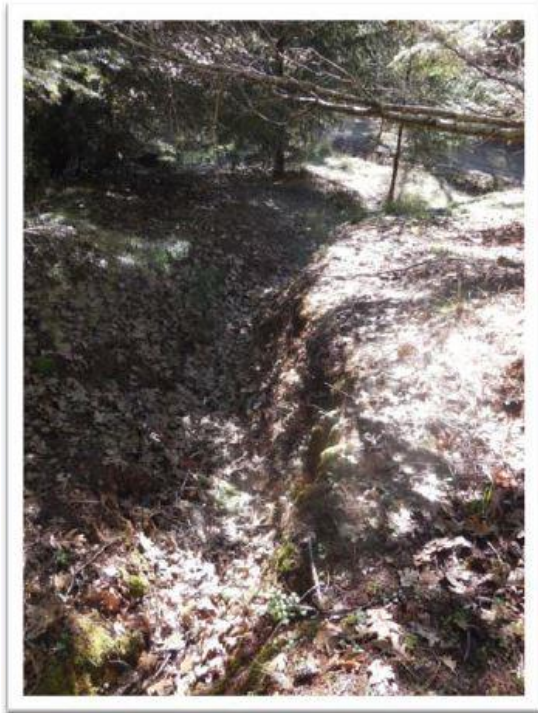
We also observed an erosion gully to the east of OG3 that we followed down to the property line and roadway.

Gully, looking south

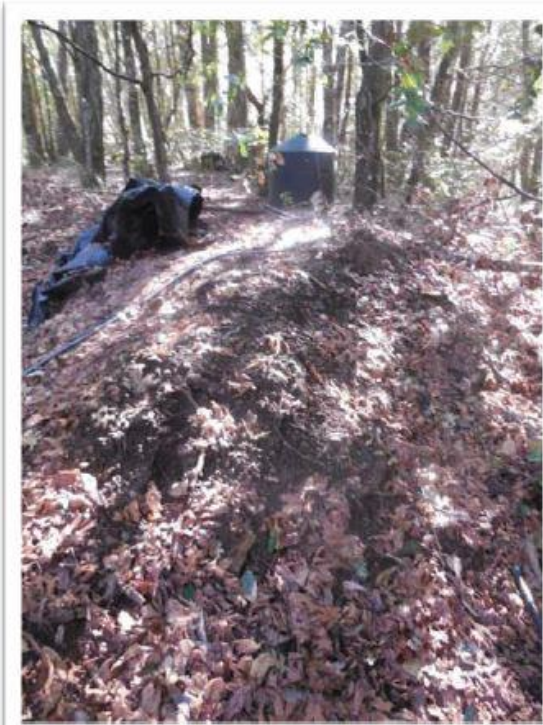
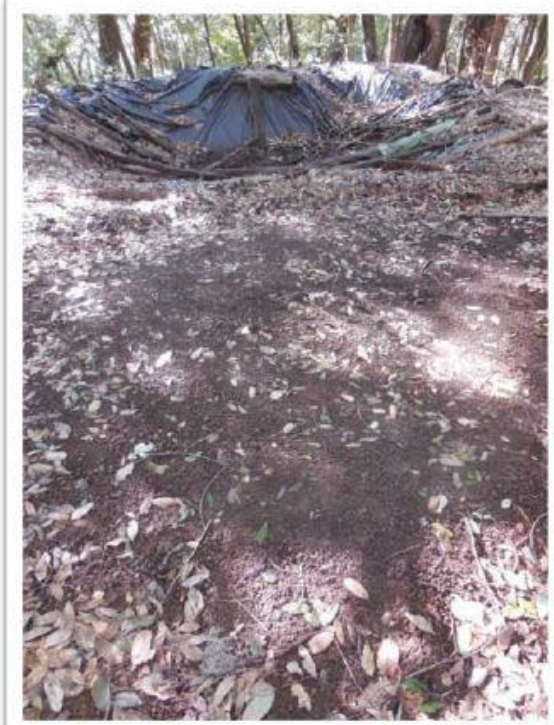
The remaining features on the parcel are located along either side of Sproul Creek. We observed tanks, water bladders, and what appeared intended to be a small lined impoundment, all in the vicinity of ST2, a tarped/poled structure.

Tank and plastic liner near ST2

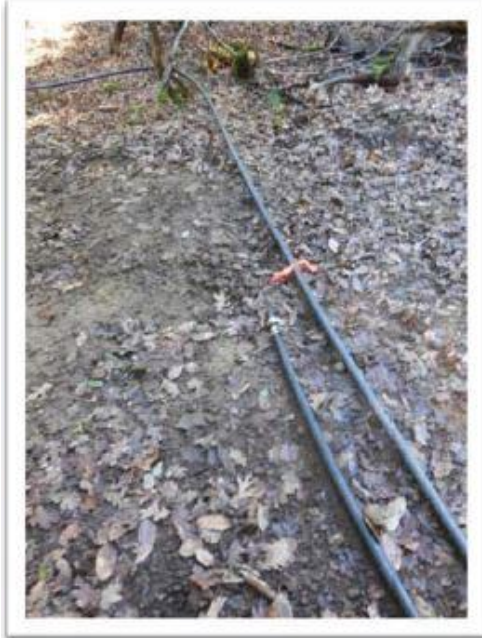
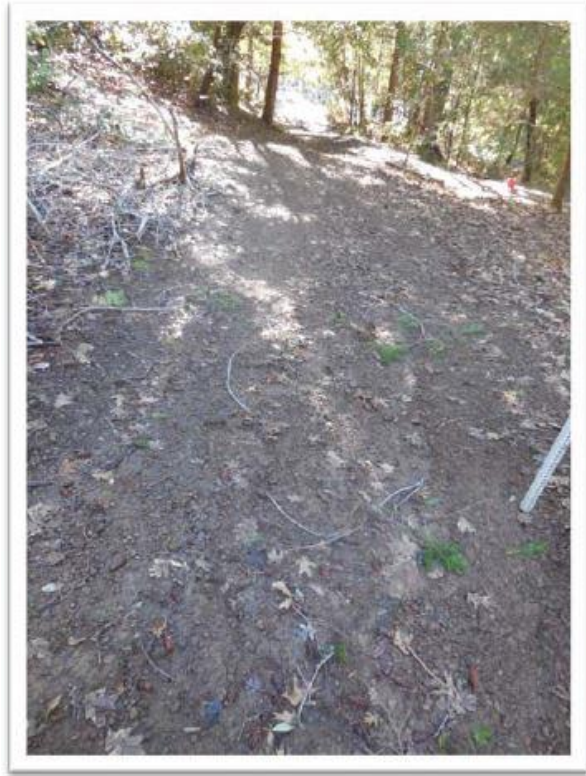
Following waterlines down the access road to the feature at Map Point G1, we observed signs of road surface erosion, rilling, gullying, and sediment transport.

On the roadway between ST2 and G1

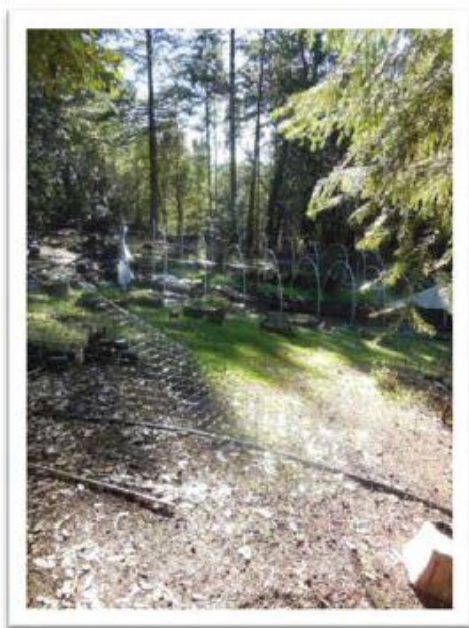
At Map Point G1, we observed a large fenced area with greenhouse hoops, piled brush, plant containers, potting soil, etc.

Greenhouse area G1

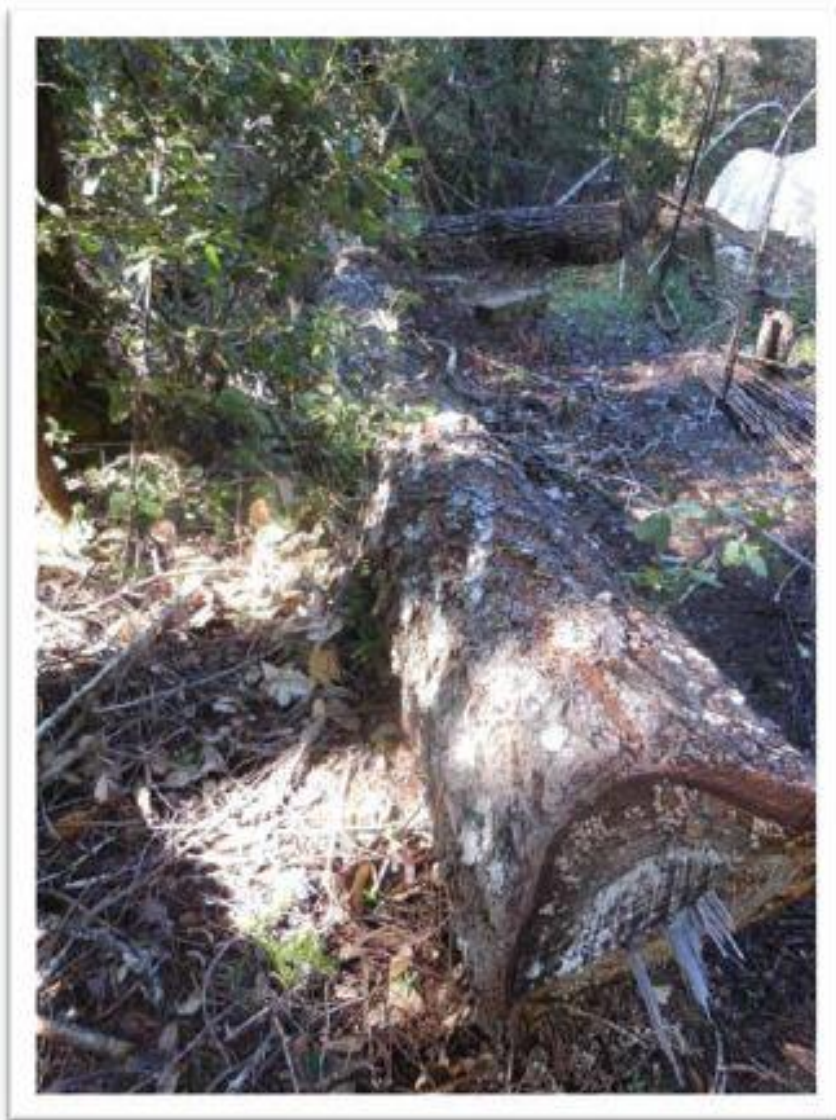
A short distance to the south and east of this feature, we found additional small outdoor growing areas and piles of empty plant containers, and miscellaneous waste materials associated with plant cultivation. Ground cover and vegetation was in fairly good condition in this area, so the potential for sediment delivery to receiving waters from the cultivation areas appears fairly low at this time, although piled vegetation, trees, and soil adjacent to the large grow area at G1 suggests that development of this feature involved a significant amount of vegetation removal and soil disturbance.

Piled soil and slash along the edge of the G1 clearing

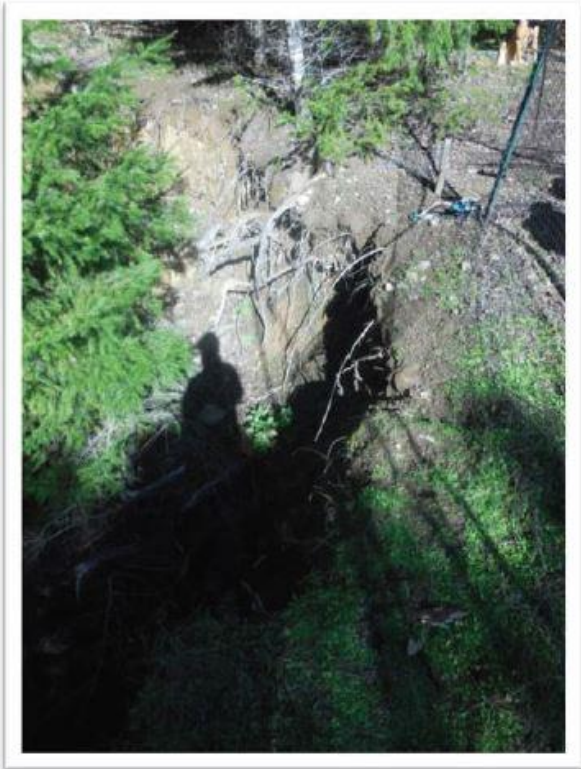
Feature OG1, a small, fenced outdoor growing area, is located immediately to the west and adjacent to a watercourse (apparently Sproul Creek), and the edge closest to the creek is failing, with a steep dropoff down to the channel, perhaps 8-10 feet. (note the map incorrectly shows the watercourse passing to the east of OG1.

Fence along the edge of OG1 is in the upper right-hand corner of this photo, and steep failing streambank is located just to the left, adjacent to the fence.

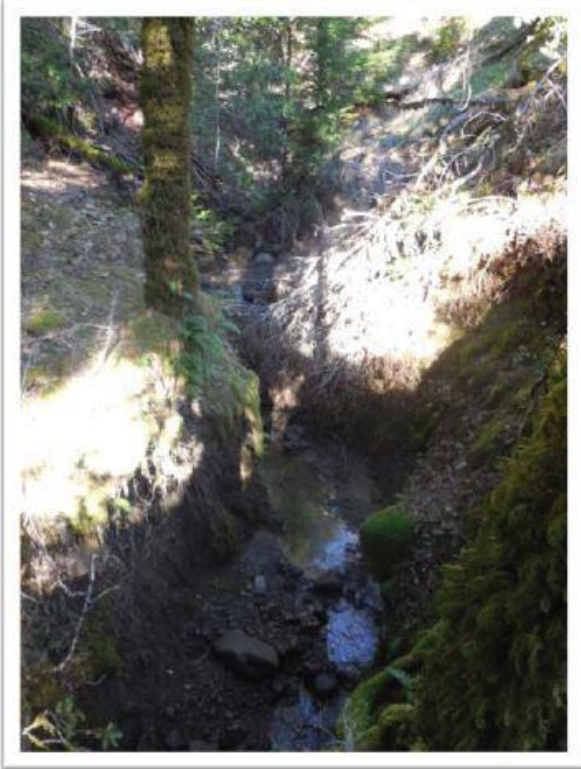
Stream channel alongside OG1

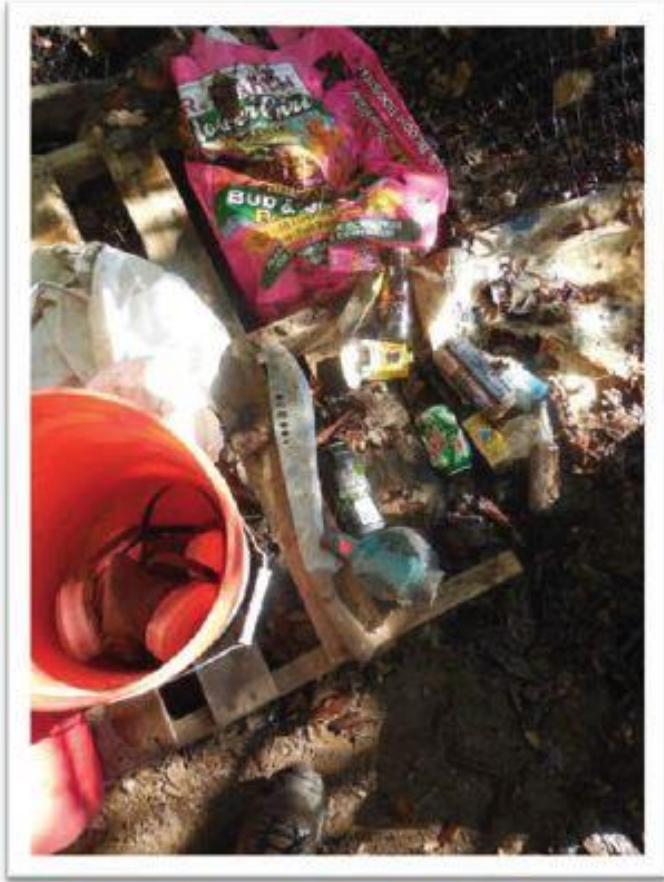
Just to the north of this area, we observed a pallet with containers and bags of various chemicals, and fuel containers, as well as some equipment/supplies and garbage.

Pallet with miscellaneous cultivation chemicals, tools, and supplies

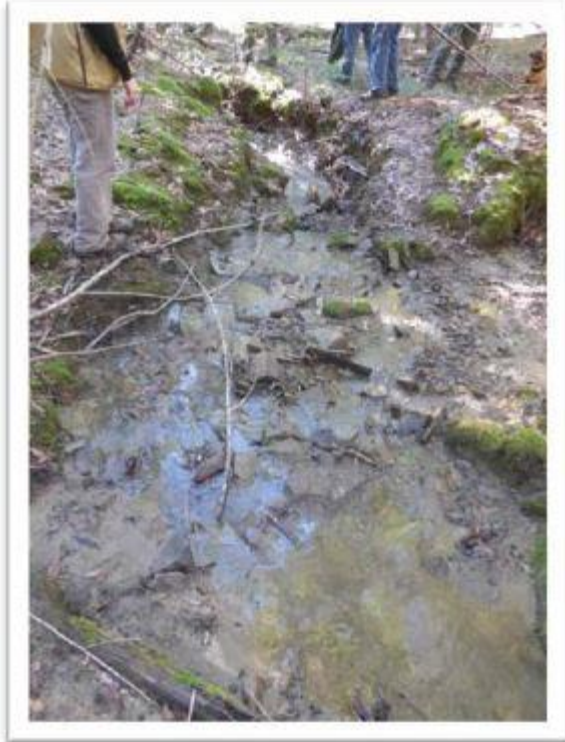
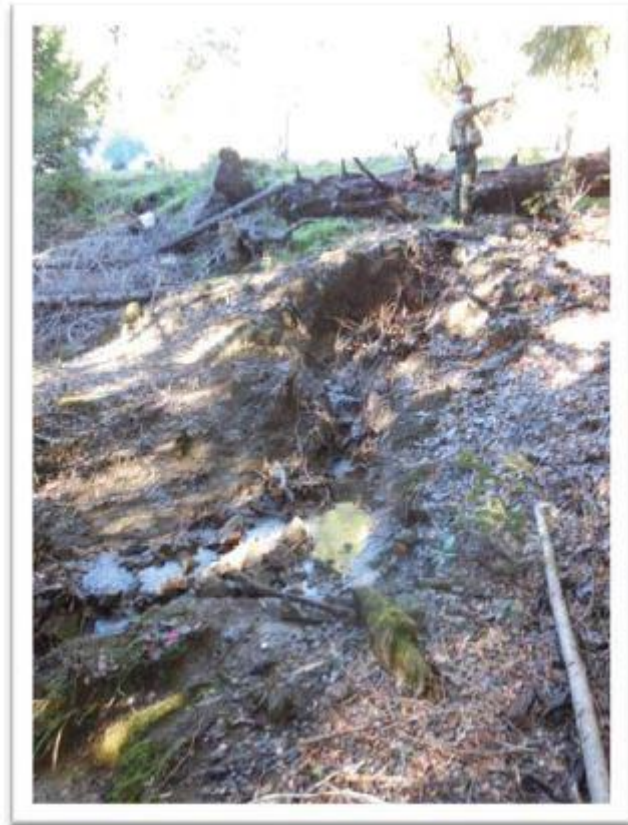
Walking north from Feature OG1 to Feature G5, we observed that the instream channel conditions were extremely poor, with extensive erosion and sediment deposition. [At this point, part of the inspection team split off to inspect the remaining features towards the south edge of the property line (Features identified as I and K, and Ponds 2 and 3 on Figure 2), while the remainder of the team, including Water Quality staff, continued to investigate instream conditions and to head toward Feature G5.]

It appears the stream channel may have been moved or may have diverted in the vicinity of development at and around Feature G5.

Stream channel just south of G5

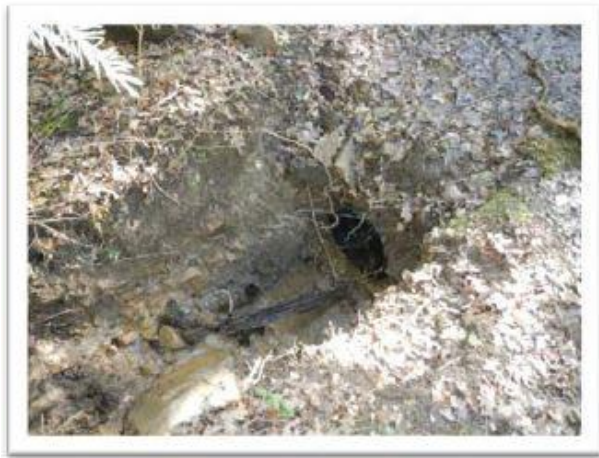
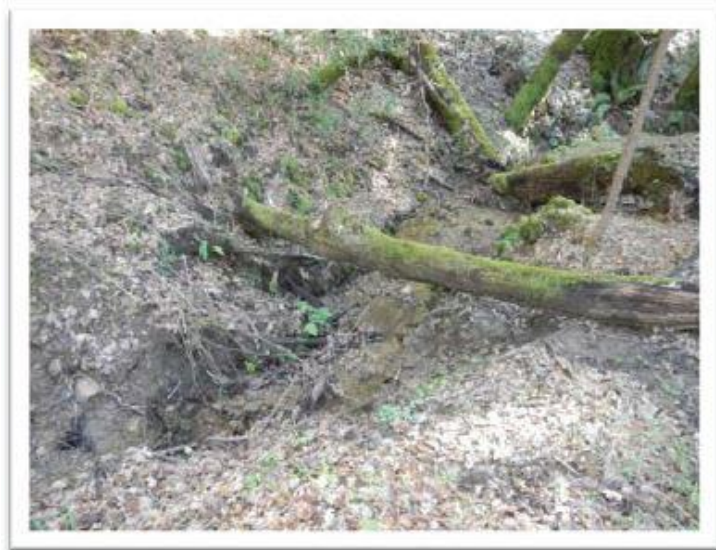
movement, deposition, and discharge into the watercourse. A culvert crossing in this area (C4) also appears to be undersized and silting-in, and shows signs of erosion around the outlet.

Culvert C4 inlet and channel below outlet (photos taken by DFW)

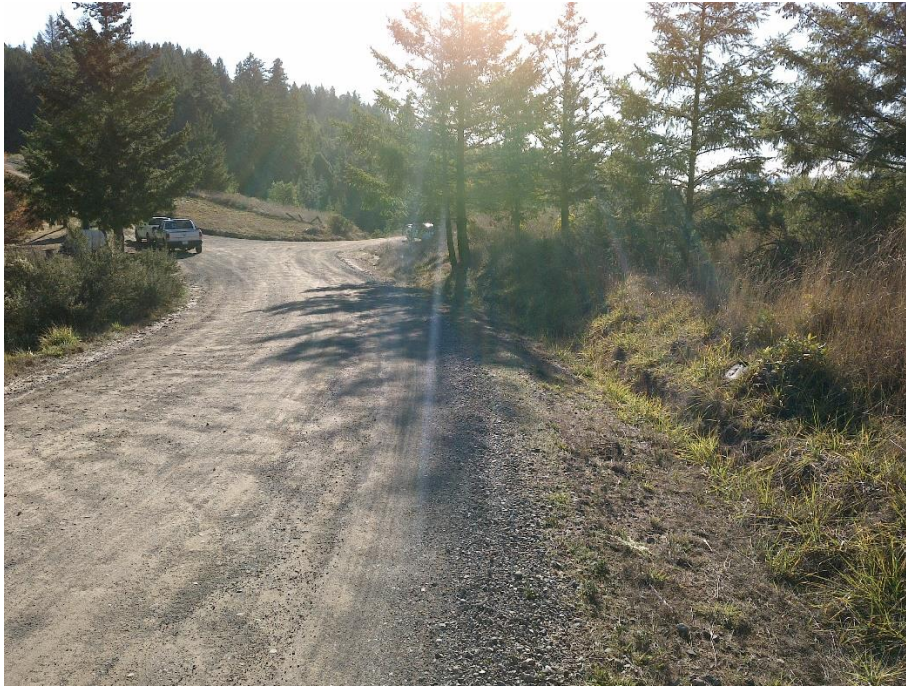
Photo 1—Looking south from WQ 1 toward WQ 2. Road collects stormwater and discharges to inboard ditch, shown in the right of the image before discharging into incising channel at WQ 2 pictured in the below photo.

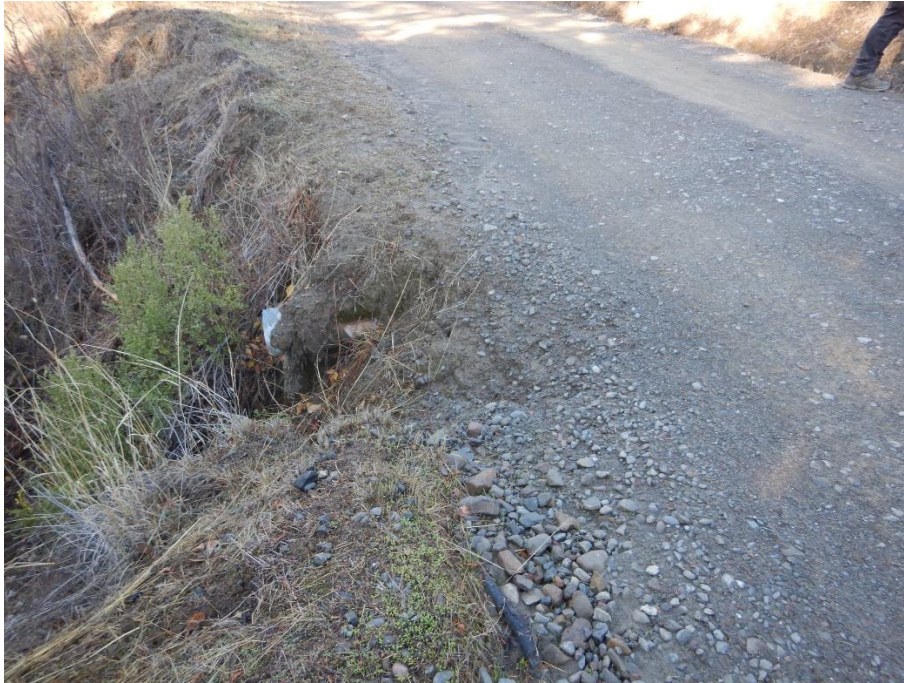
Photo 3—Looking west at culvert outlet located at WQ 3. The culvert is perched, and the channel has incised below the outlet.

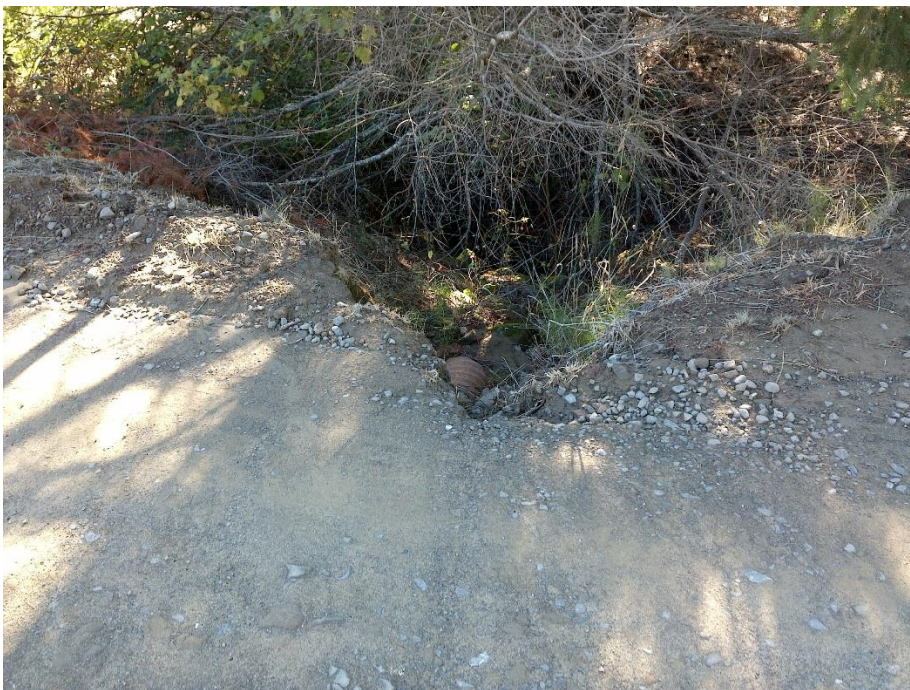
Photo 10—Looking south at culvert outlet at WQ 8. The road prism has failed above the culvert outlet.

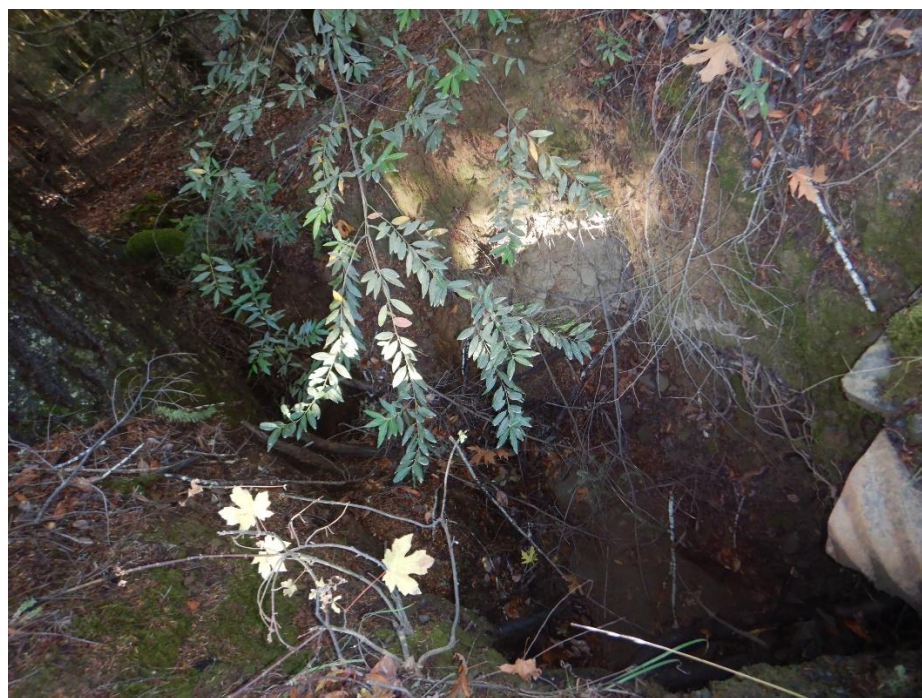
Photo 14—A 12inch diameter culvert perched above a scoured watercourse at WQ10.

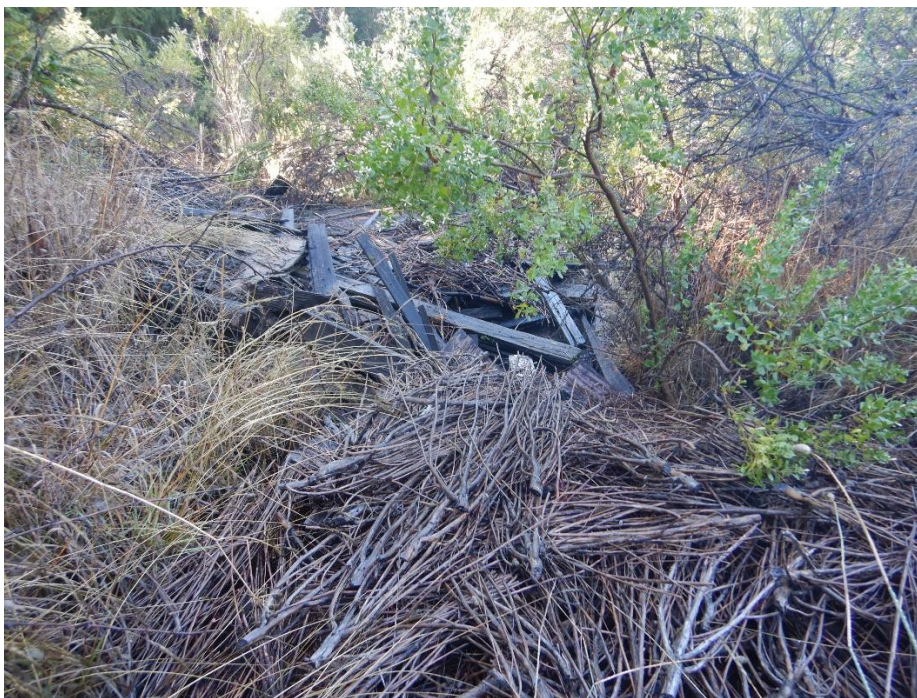
Photo 20—Waste lumber and plant stalks in a watercourse at WQ 13.

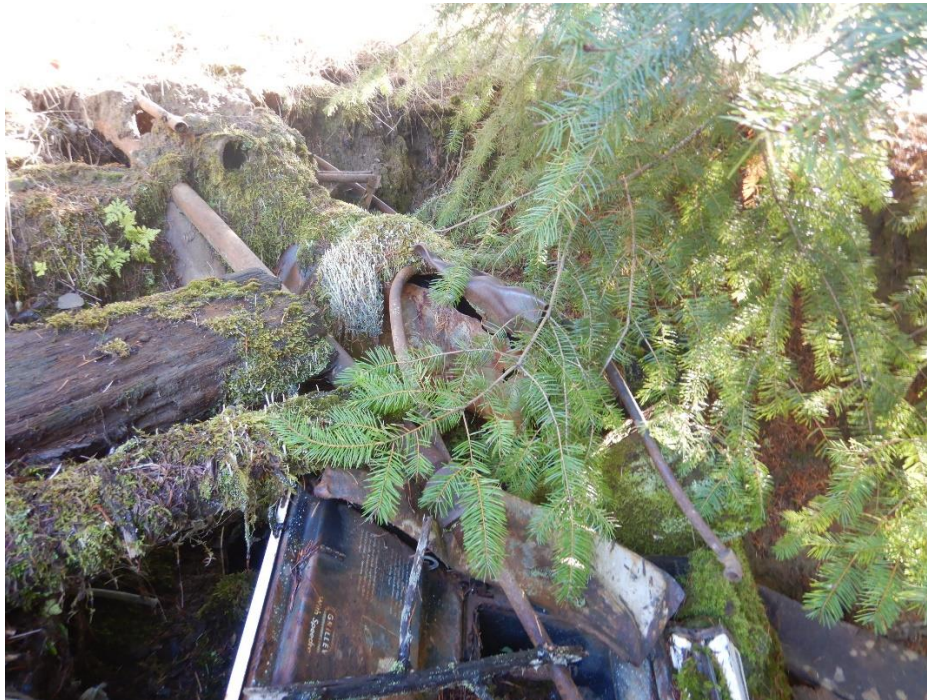
Photo 22— Scrap metal in a watercourse at WQ 14.

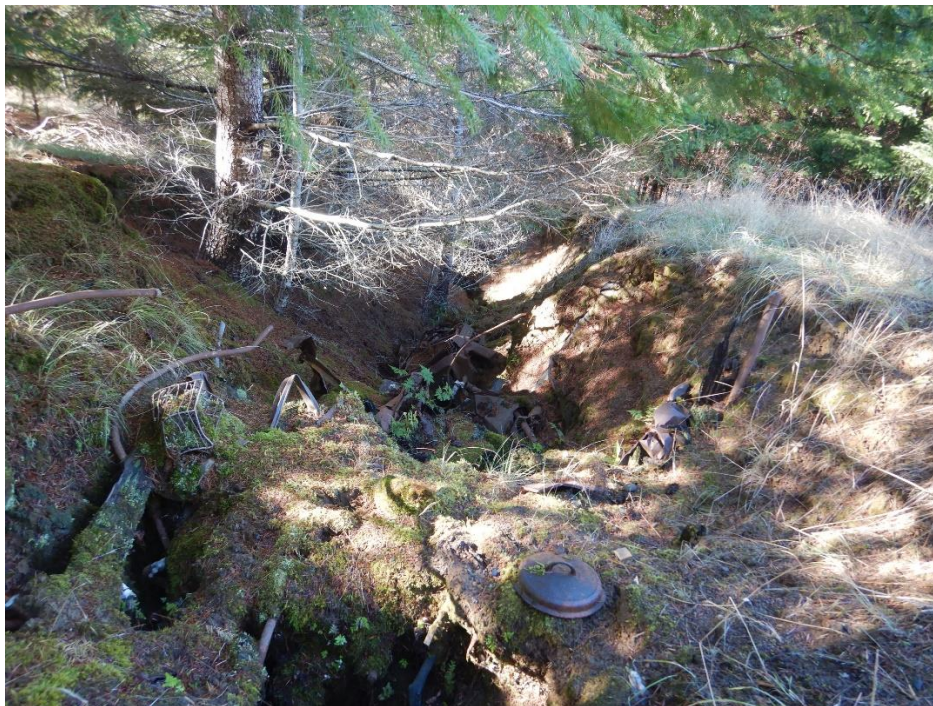
Photo 23— Looking west and downstream at scrap metal in a watercourse at WQ 14.

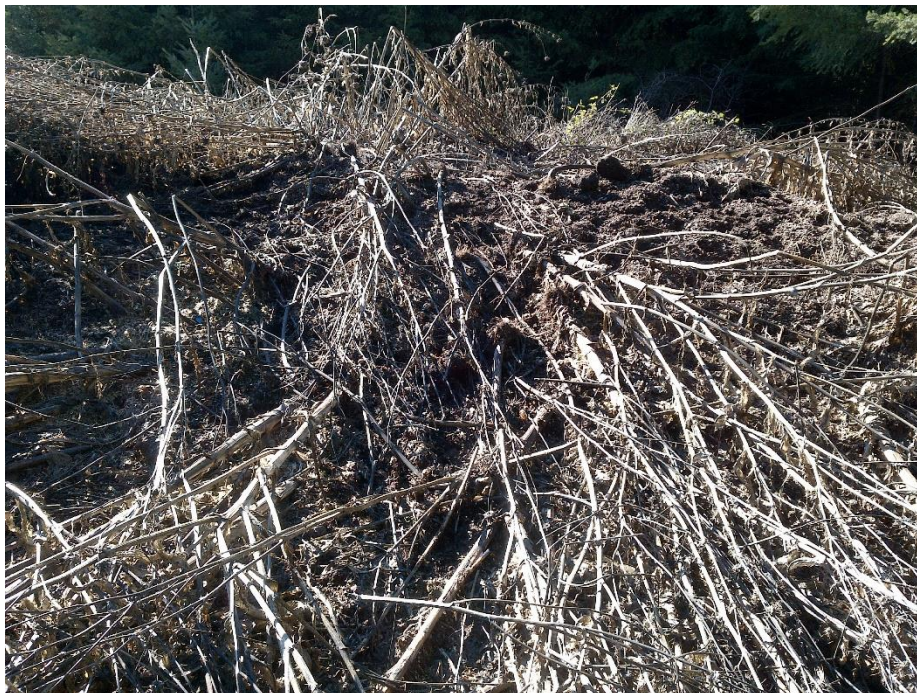
Photo 25—Uncontained potting soils southwest of greenhouse located at WQ 15.

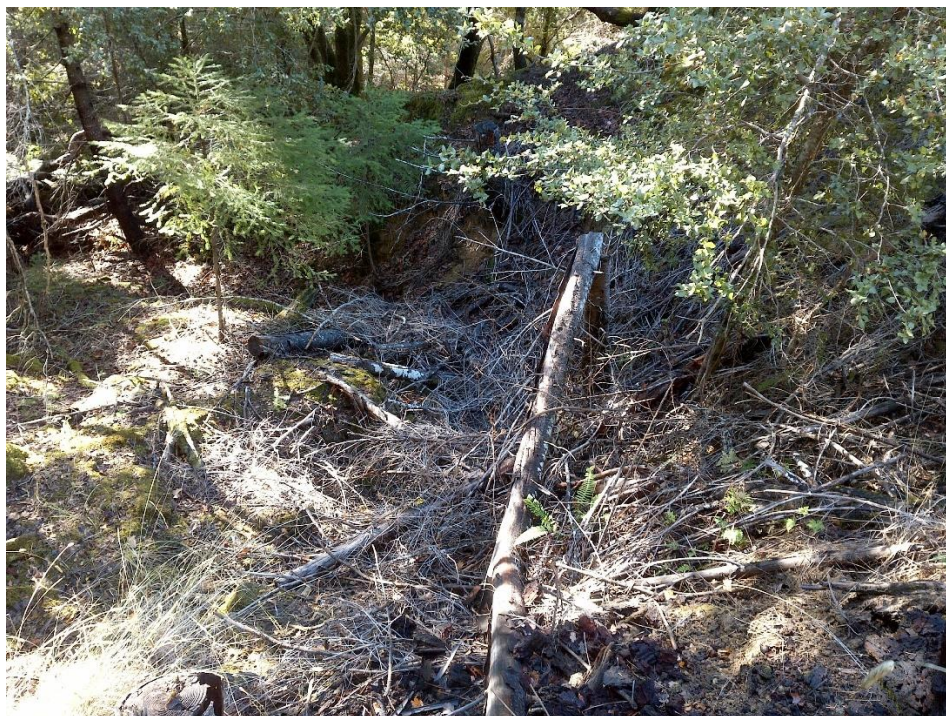
Photo 36—Looking at incised watercourse west of receiving drainage of watercourse that has been redirected by road in the vicinity of WQ 22.
