North Coast Regional Water Quality Control Board

INSPECTION MEMO

Eagle Rock, Inc. - La Grange Pit
40029 La Grange Road
Junction City, Trinity County

WDID #: 1 53I000476

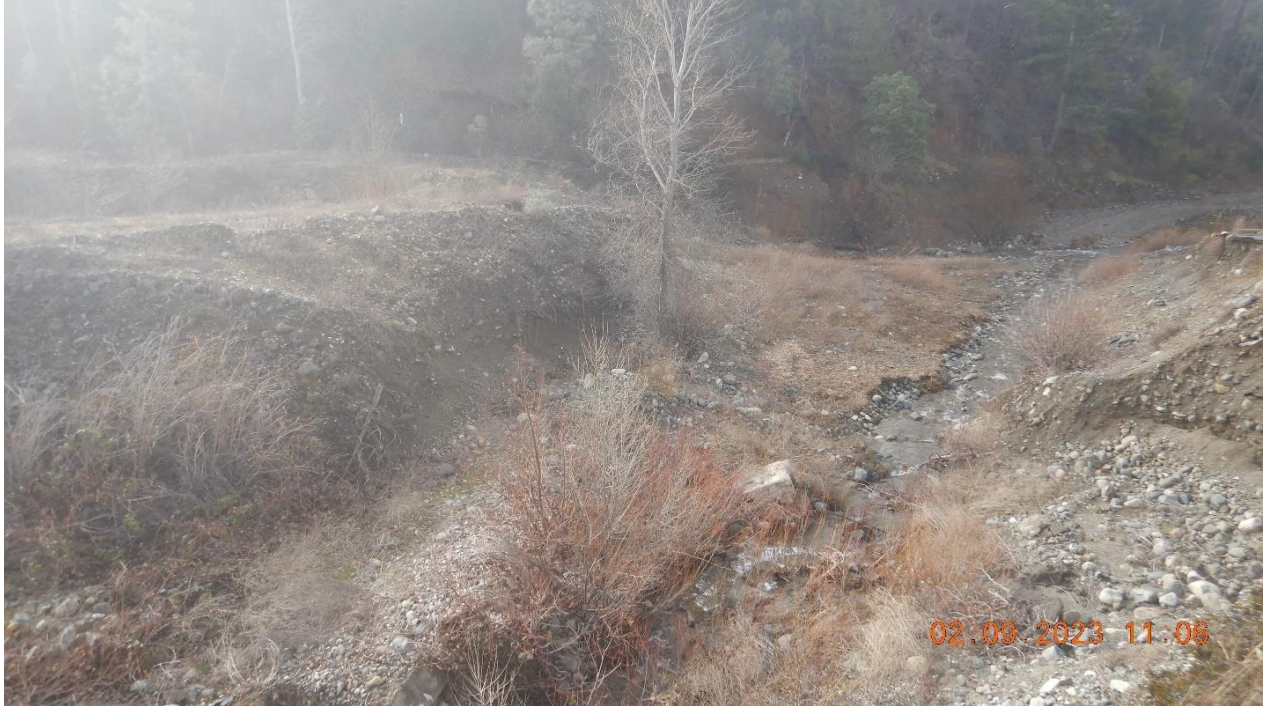
The inspection group inspected two discharge points, DP-3 and DP-4, located at the southwest corner of the facility where the facility's runoff discharge to Oregon Gulch (Pictures 1 and 2). Per the sampling reports that were recently reported via Stormwater Multiple Application and Tracking System (SMARTS), high concentration of TSS and Iron were detected in Facility's runoff. Also, Mr. Tillinghast confirmed that the highly turbid runoff was observed at these Discharge points during the previous sampling events. As a result, the Discharger is required to install additional effective BMPs to avoid further exceedances in future. The large berms in Oregon Gulch were inspected and the inspection group discussed the property line in that area (Picture 3). Large

Picture 1- View of discharge point (DP-3) located at southwest corner of the facility. Existing settling pond is shown on the top left corner of the picture adjacent to DP-3. Picture taken by Farzad Kasmaei.

The Discharger is currently utilizing unlined ponds to infiltrate the concrete wastewater. Per the sampling reports submitted via SMARTS, high concentration of TSS and Iron have been detected in facility's runoff at discharge points (DP-3 and DP-4). The Discharger must reevaluate the facility to ensure adequate/effective BMPs including sediment and erosion control BMPs are in place to avoid further exceedances in future. Per Mr. Tillinghast, the site map will be updated to include the drainage areas.

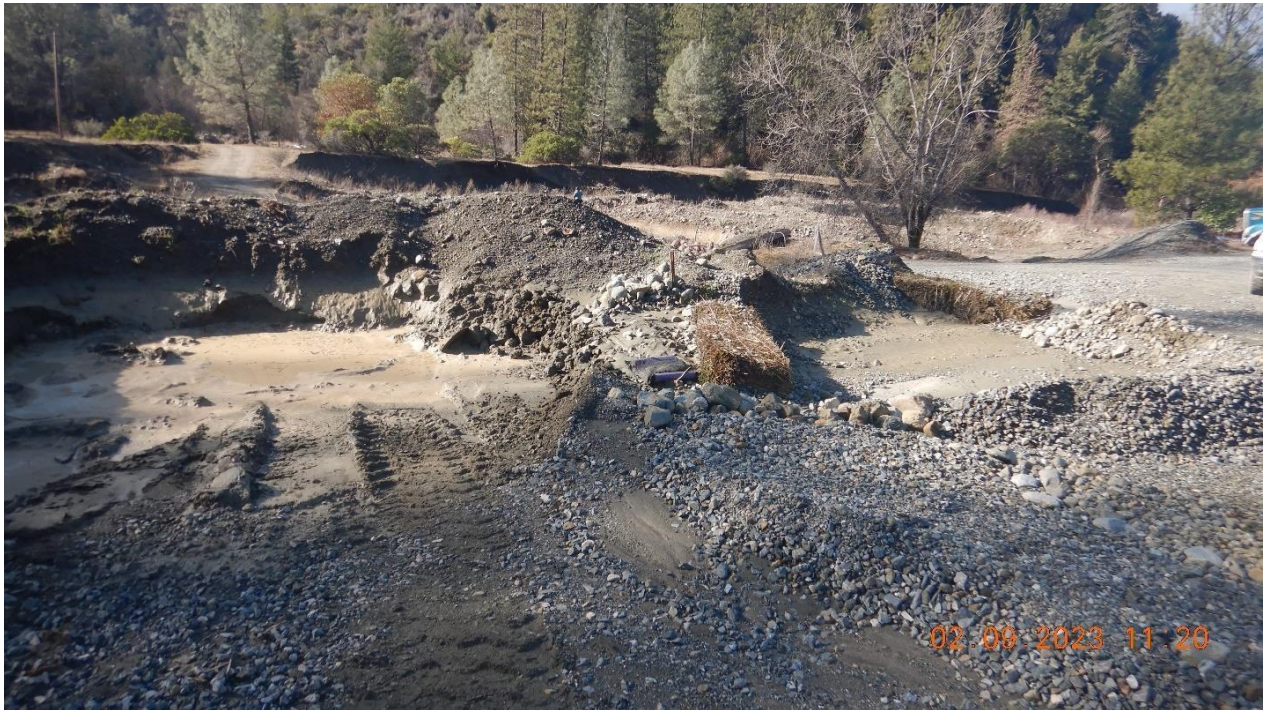
Picture 2- View of sediment traps in vicinity of the discharge point (DP-4) located at southeast corner of the existing concrete ready mix. Picture taken by Farzad Kasmaei.

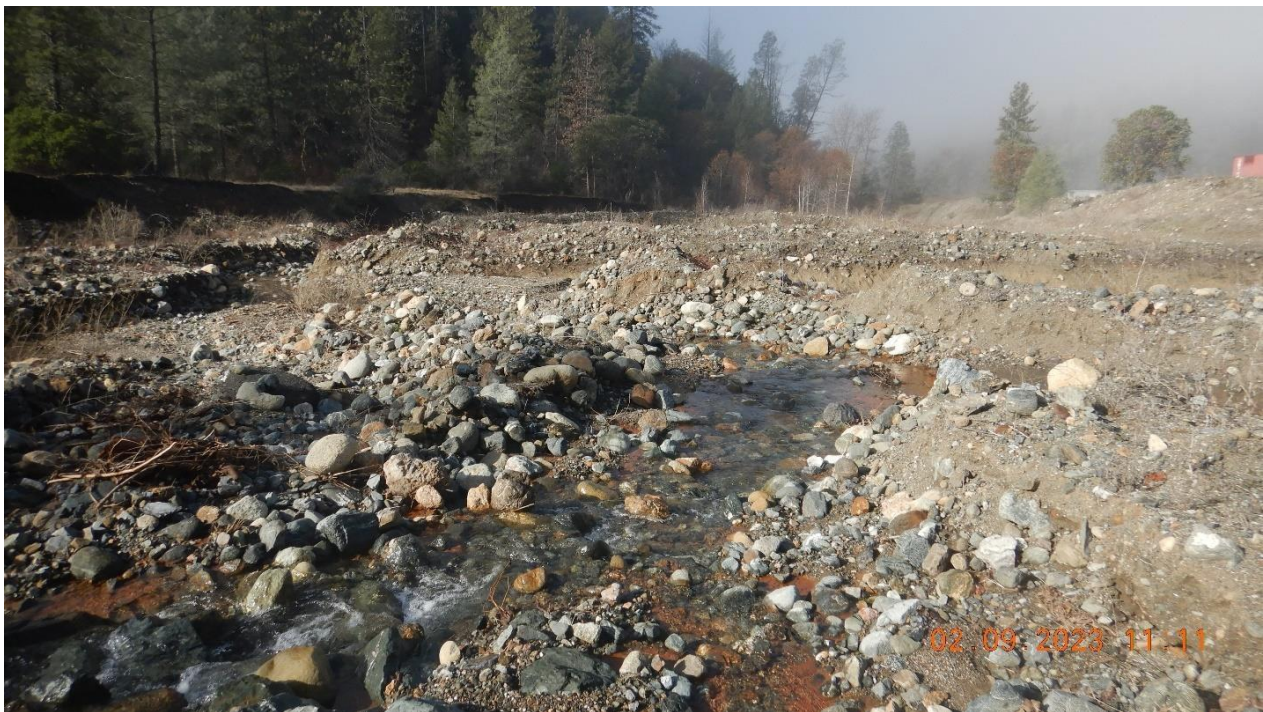
berms have been installed years ago by Facility staff without obtaining any applicable permits from 401 unit, CDFW or USACE.

Picture 3- View of large berms that were installed by Facility staff in Oregon Gulch on the south side of the facility. Picture taken by Farzad Kasmaei.

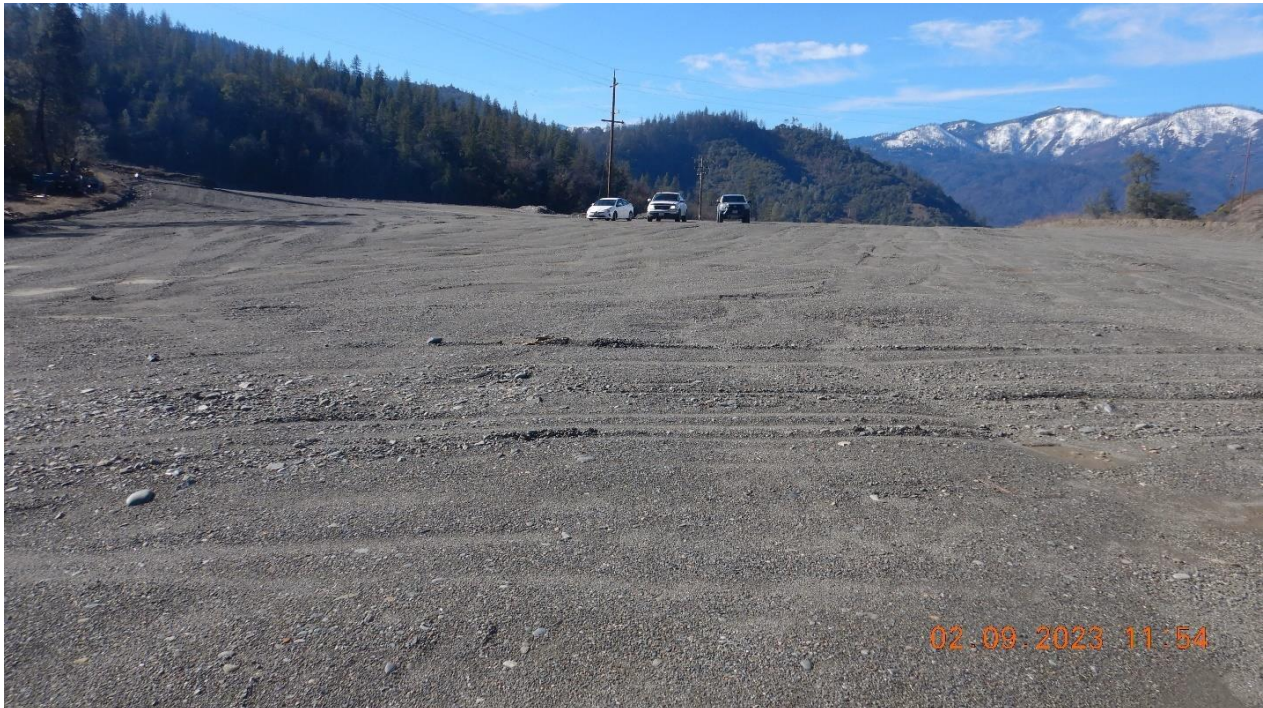
The inspection group inspected the fill area adjacent to Poison Gulch. Per Mr. Tillinghast explanation, no industrial activities are performed and no industrial materials/equipment will be stored within this area. Therefore, this area is considered as a non-industrial area (Picture 4).

Picture 4- Looking southwest at fill area located on the north side of the facility in vicinity of Poison Gulch. Picture taken by Farzad Kasmaei.

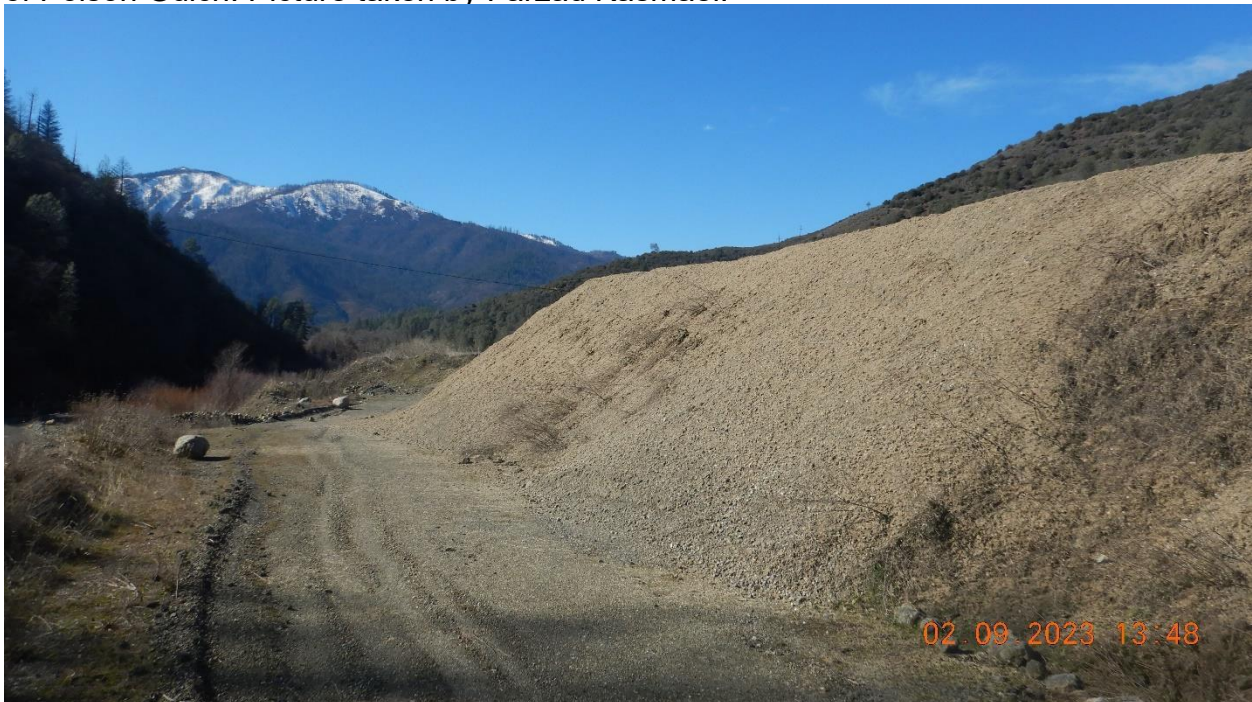
Picture 5 - Looking west at the office area berm that has been stabilized temporarily with BFM materials in accordance with the CAO requirements. Picture taken by Farzad Kasmaei.

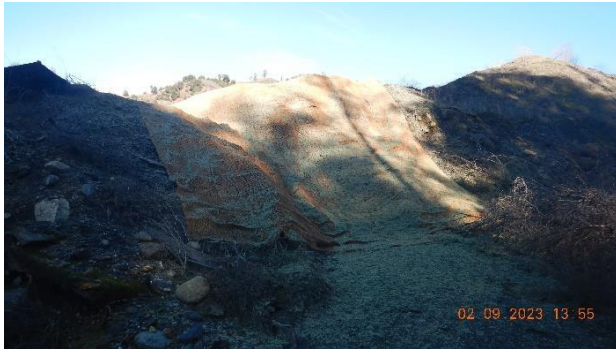
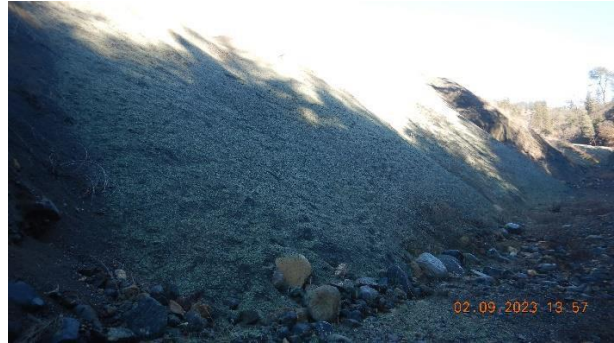
Pictures 6a, 6b – View of the erodible creek slope stabilized with BFM and netting in accordance with the CAO requirements. Picture taken by Farzad Kasmaei.

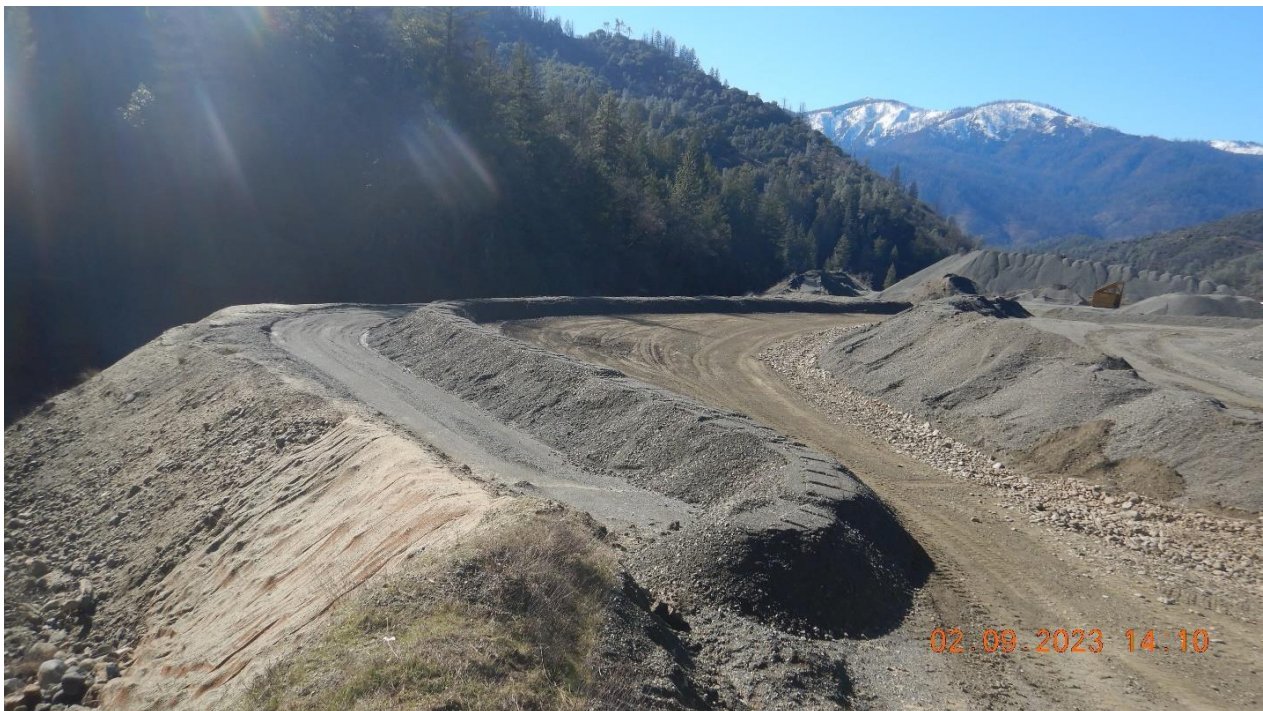
Picture 7 – Looking west at stabilized area adjacent to Oregon Gulch. This area has been recently improved in accordance with emergency CAO. The newly constructed access road, installed berm and netting are shown on the picture. Picture taken by Farzad Kasmaei.

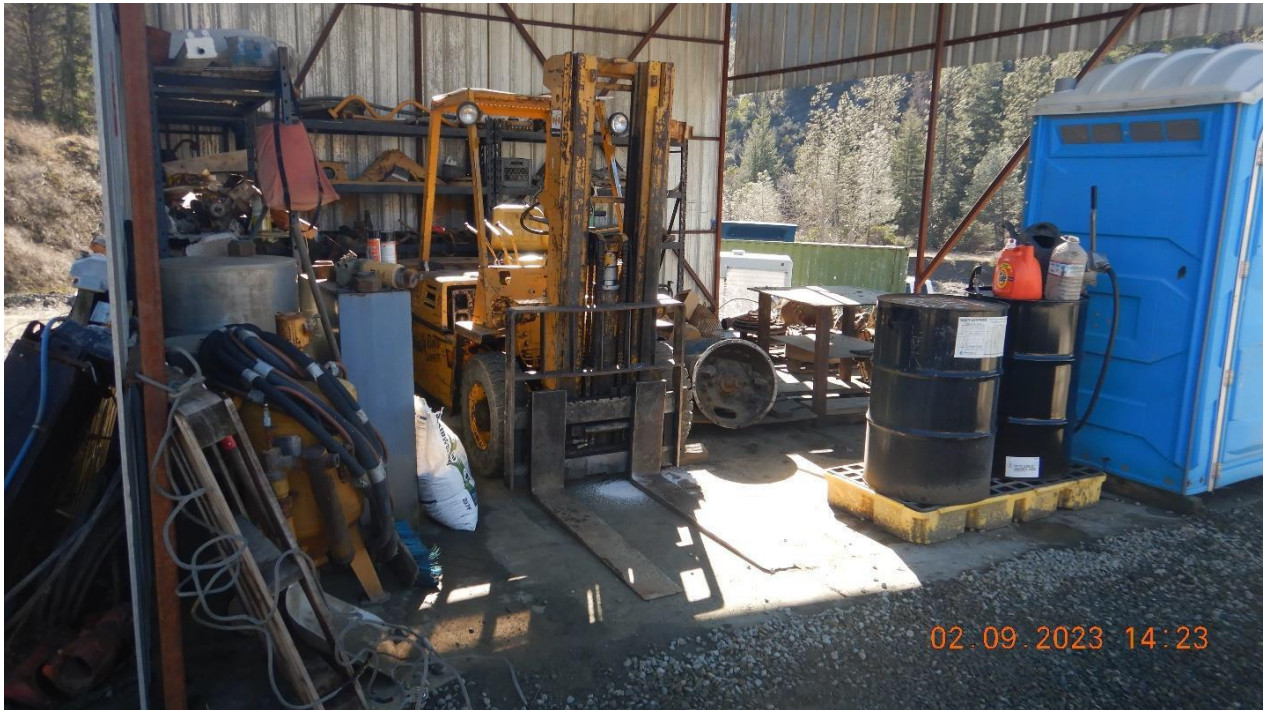
The roofed fueling storage area/repair shop was inspected. Significant spills were observed during the last inspection. However, this area has been maintained by Discharger's contractor. No spill was observed on the ground (Picture 8).

Picture 8 - View of the fueling storage area that was maintained. Significant improvements made to this area since last inspection and no spills were observed on the ground. Picture taken by Farzad Kasmaei.

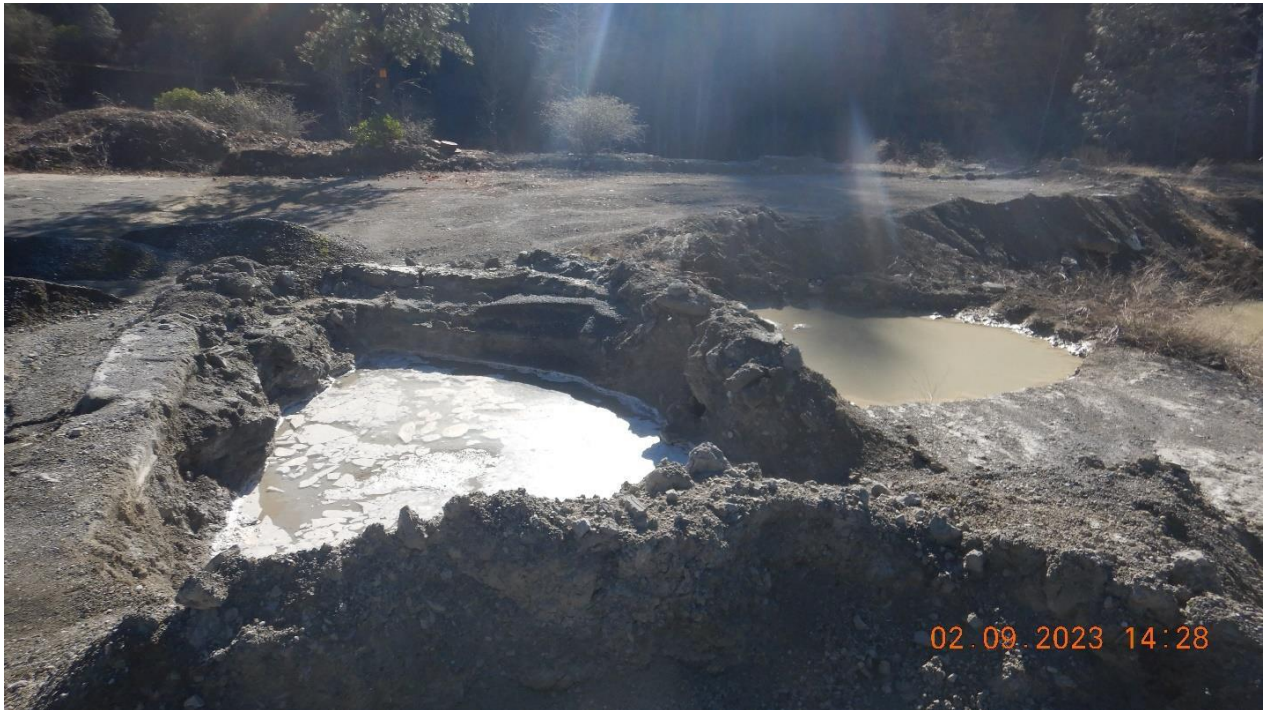
Lastly, both concrete wastewater ponds were inspected (Picture 9). The Discharger is still utilizing these unlined ponds to infiltrate the concrete wastewater. The Regional Water Board has previously informed the Discharger that such infiltration BMPs/ponds can be used to infiltrate stormwater runoff only. Infiltrating the wastewater can pose a threat to groundwater quality. No groundwater monitoring and sampling have been previously conducted by Discharger.

Picture 9- Looking east at couple of unlined concrete wastewater ponds on the west side of the facility. Picture taken by Farzad Kasmaei.
