North Coast Regional Water Quality Control Board

INSPECTION MEMO

Eagle Rock, Inc. - La Grange Pit
40029 La Grange Road
Junction City, Trinity County

August 25, 2022

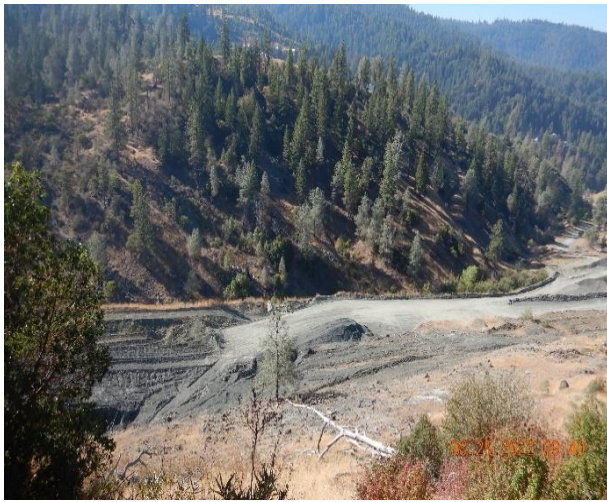
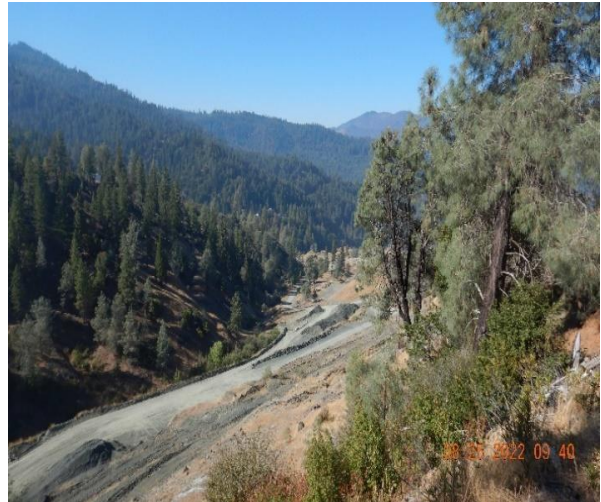
The inspection group then drove along Highway 299 to view the easternmost portion of the Facility where materials are stored, and mining operation is performed. This portion of the Facility was viewed from a distance. Photos 1a and 1b show that the Facility is located downslope of Highway 299 and the property slopes downhill overall from east to west. Due to an existing large pit in the easternmost portion, no significant runoff anticipated to be generated within this area.

Photos 1a, 1b: Looking south at the easternmost portion of the facility where materials are stored, and mining operation occurs. Picture taken by Farzad Kasmaei.

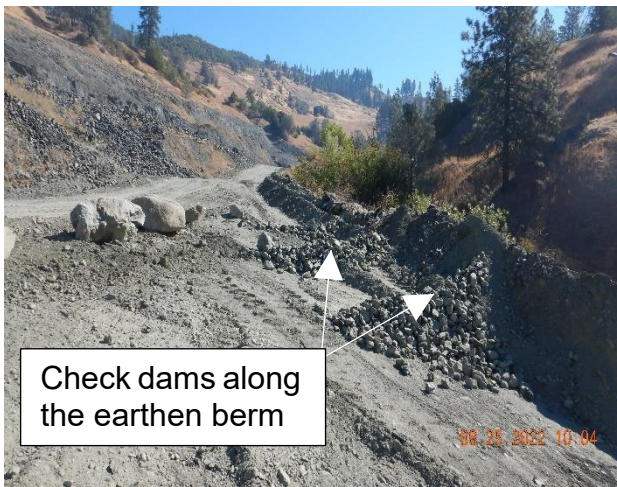
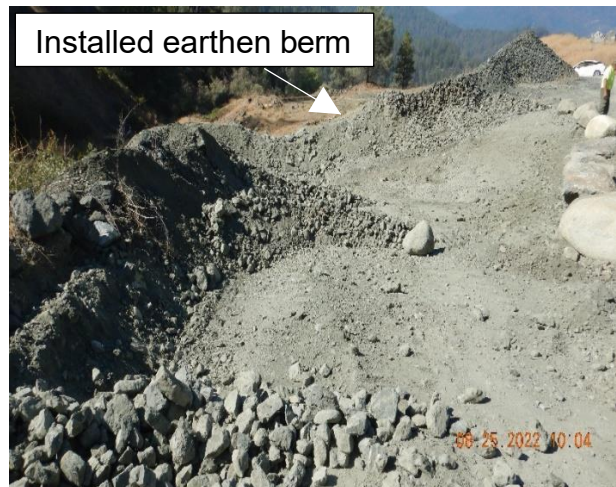
The inspection group then drove down to inspect the eastern portion of the Facility where a few check dams were installed along the earthen berm. The discharge point (DP-6) is located at the low point of this area before the runoff drains to Oregon Gulch (See photos 2a, 2b).

Photo 2a, 2b: Looking northeast at the check dams installed along the earthen berm where the stormwater samples are collected (DP-6) prior to discharging into Oregon Gulch. Picture taken by Farzad Kasmaei.

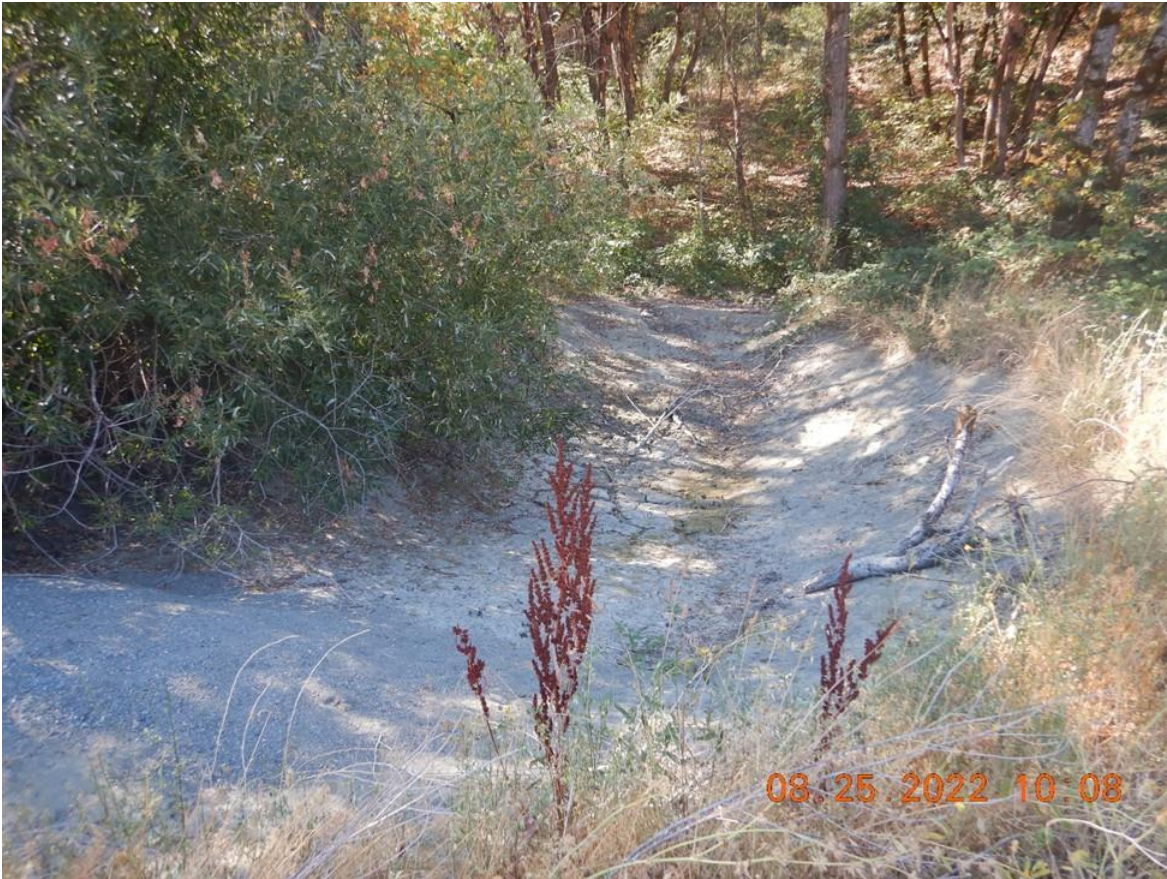
We observed a sediment detention basin constructed adjacent to and within the channel of Oregon Gulch, near DP-6, at upstream (eastern) end of property. Facility staff stated the basin was initially constructed for sediment but is no longer actively managed. The sediment basin appeared approximately 15 by 20 feet (see photo 2c).

Photo 2c: Sediment basin on Oregon Gulch near access road on eastern portion of parcel. Picture taken by Amanda Piscitelli.

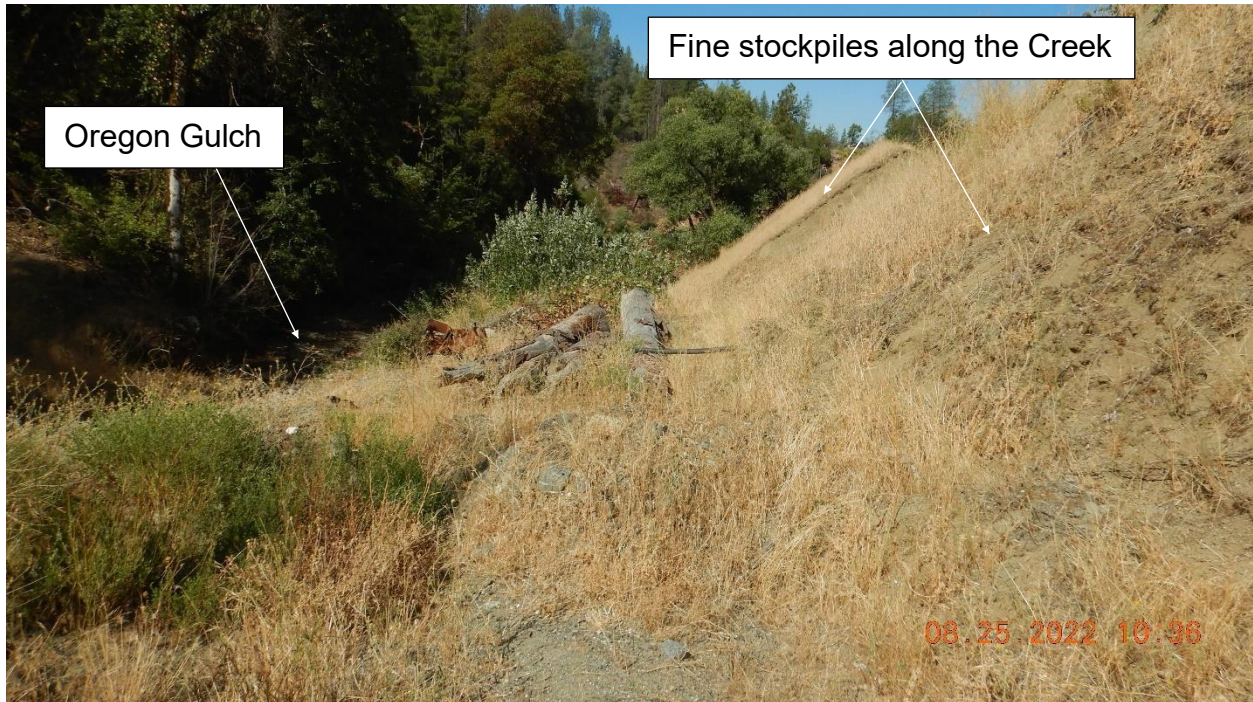
The inspection group then drove toward the central portion of the facility where large stockpiles of fine sediment were stored (see photos 3, 4a and 4b). Regional Water Board staff identified a couple of potential discharge points in this area adjacent to Oregon Gulch behind the stockpiles of fine material (see attached site map 1). Farzad Kasmaei directed Dustin Tillinghast (Facility staff) and Kristine Cloward (Facility consultant) to monitor these areas and collect samples when runoff occurs during Qualifying Storm Events (QSEs). The site map must be updated accordingly to include drainage areas and all potential sampling/discharge points for the entire Facility. Also, the Discharger was notified to avoid storing any industrial materials that can be readily mobilized by contact with stormwater in and adjacent to the watercourses (creeks).

Photo 3: Looking southwest at naturally vegetated fine materials stored adjacent to Oregon Gulch. Potential discharge point. Picture taken by Farzad Kasmaei.

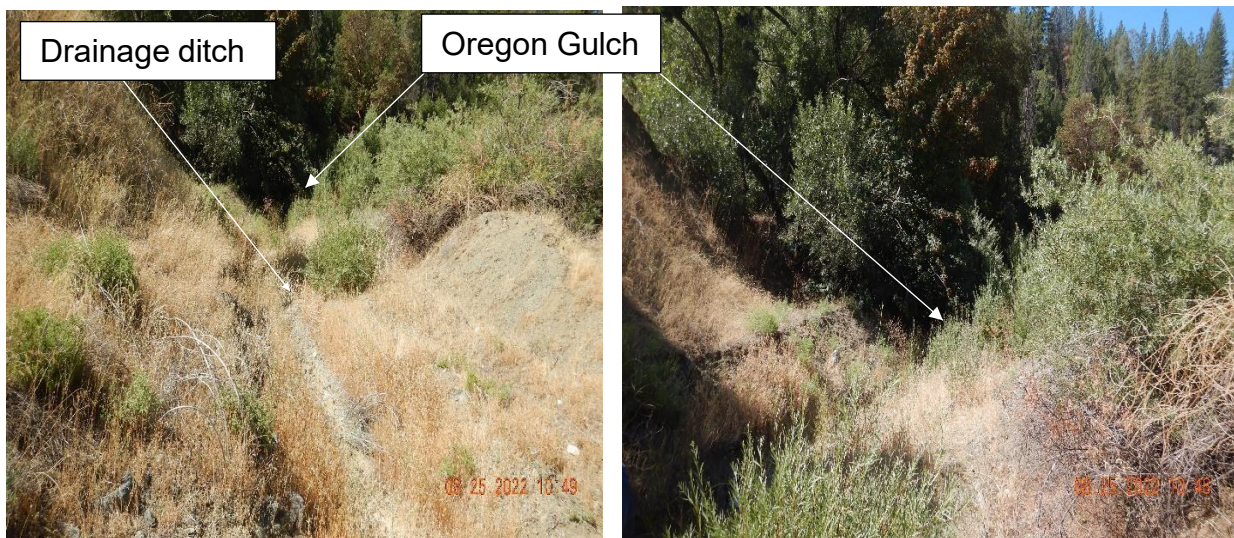
Photo 4a, 4b: Looking southwest at a shallow drainage ditch that drains into Oregon Gulch. Potential discharge point. Picture taken by Farzad Kasmaei.

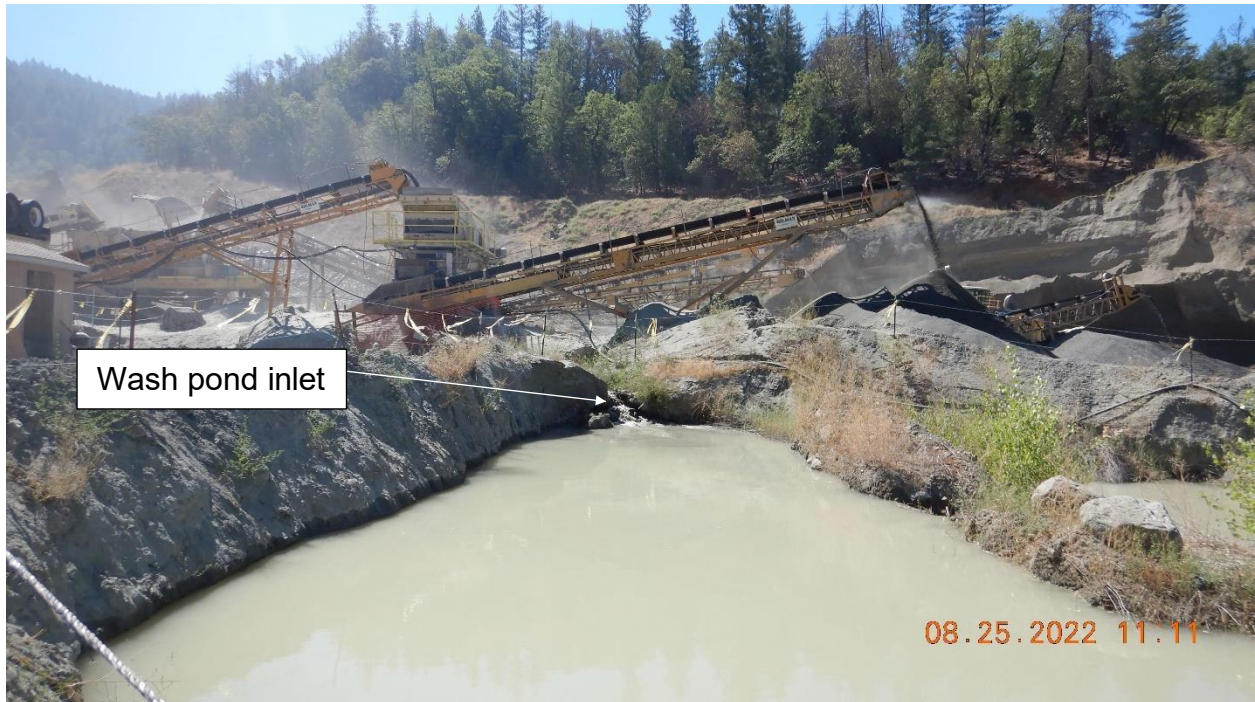
Also, the processing area where screening and crushing operations take place was inspected. Farzad Kasmaei observed an existing wash pond that receives wash water via a pond inlet and it appeared to be turbid (see photo 5). However, the pond is not shown on the site map. Per the Discharger, this pond is connected to an adjacent settling pond (photo 6) via a subsurface perforated pipe for further treatment. The Discharger was directed to include these stormwater features that are missing on the site map (see attached site map 1).

Photo 5: Looking south at the processing area where screening and crushing operations take place. The wash pond receives a highly turbid wash water from this area, and then it drains to a settling pond via a subsurface perforated pipe for further treatment. Picture taken by Farzad Kasmaei.

Site map must be revised to reflect the current condition of the site. All discrepancies must be addressed. The drainage areas, potential monitoring/sampling points and any stormwater features such as missing wash pond must be included on the site map. The SWPPP may need to be revised accordingly.

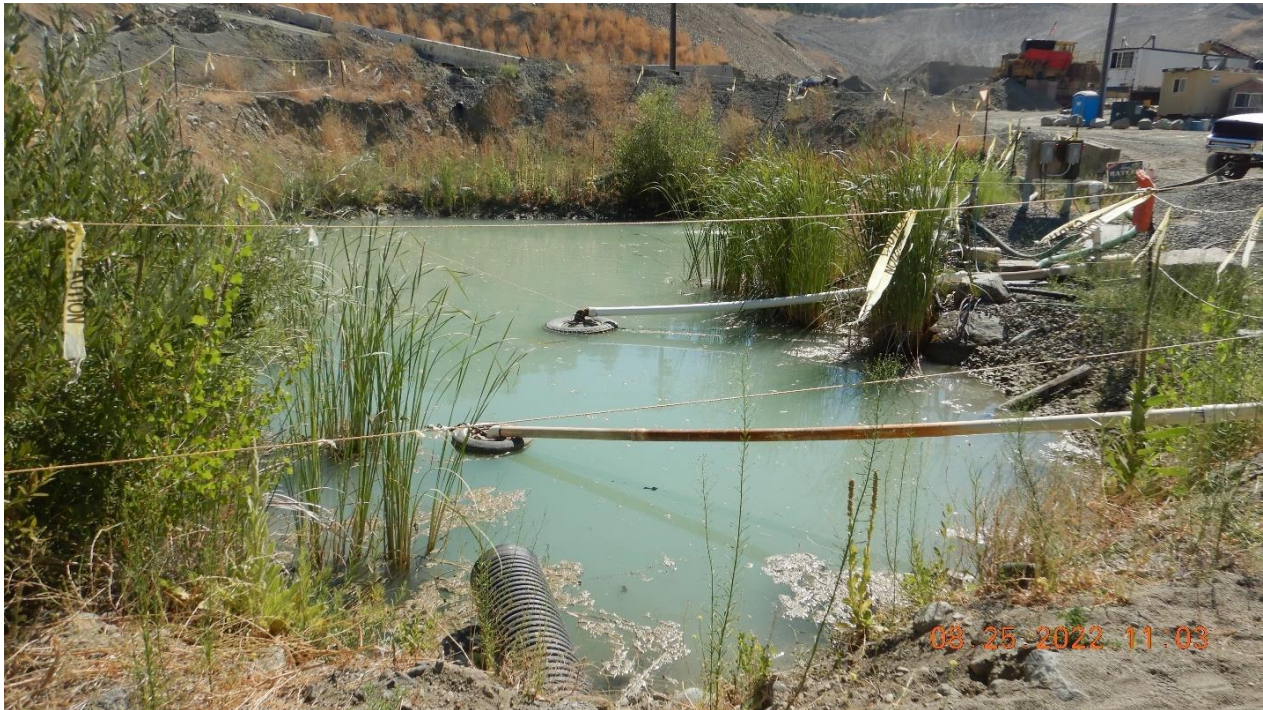
Per the Discharger the water stored in this pond is mostly reused and recirculated. However, excessive water from the pond drains to a large settling pond downstream via a trench. Per the Discharger, the large pond is maintained approximately every six years.

Photo 6: View of settling pond that receives wash water from the wash water pond via a perforated pipe. The water is mostly recirculated/reused. Picture taken by Farzad Kasmaei.

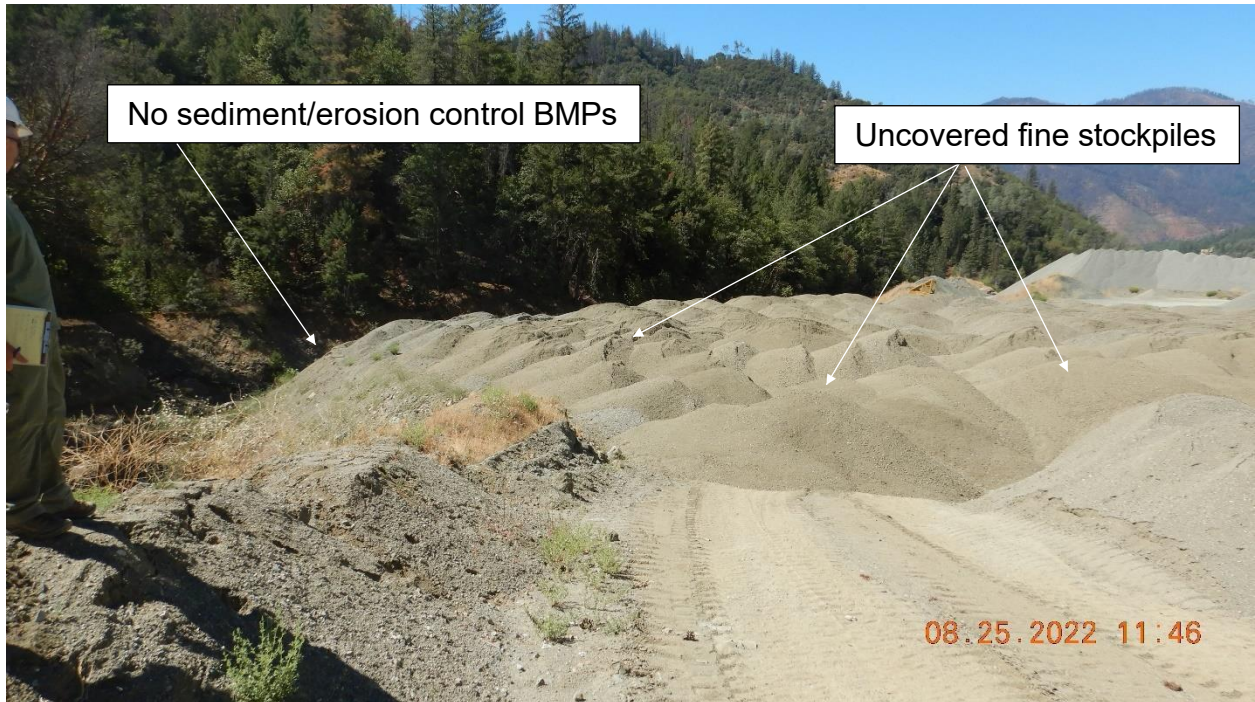
Staff observed a significant number of uncovered large stockpiles of fine material on the west side of the boneyard and adjacent to Oregon Gulch. These stockpiles were placed adjacent to Oregon Gulch with no sediment or erosion control BMPs installed to prevent erosion and sediment delivery into the receiving water which cause an imminent threat to receiving water (see photo 7 and site map 3). Per the SWPPP map provided, an

earthen berm was installed as a perimeter control at the time of SWPPP preparation. During the inspection the earthen berm was indiscernible from the stockpiles. Stockpiles appear to have been placed on top of the berm rendering it wholly ineffective. These fine materials can be readily mobilized by contact with stormwater which would result in a direct discharge to Oregon Gulch, which is a tributary to the Trinity River which is impaired for sediment/siltation.

Uncovered fine materials are currently stored adjacent to Oregon Gulch without implementing applicable minimum BMPs such as housekeeping and sediment/erosion control BMPs. These fine materials can be readily mobilized during the next rainfall event.

Photo 7: View of significant number of uncovered fine stockpiles stored adjacent to Oregon Gulch. No sediment/erosion control BMPs were observed to protect the Creek. Picture taken by Farzad Kasmaei.

The Regional Water Board staff instructed Kristine Cloward and Dustin Tillinghast to move the stockpiles away from the creek before the rainy season starts. Also, Regional Water Board staff stated that erodible material should not be stored adjacent to receiving waters. Additionally, earthen berms used as a BMP throughout the facility can be a pollutant source when they are constructed from fine erodible material.

The Regional Board staff identified additional potential discharge/sampling points. Also, no erosion control berms were observed along with the fine stockpiles as it is shown on the site map. The Discharger was notified to avoid storing fine materials adjacent to the Creeks to the extent feasible and install an effective sediment/perimeter control BMPs for receiving water protections.

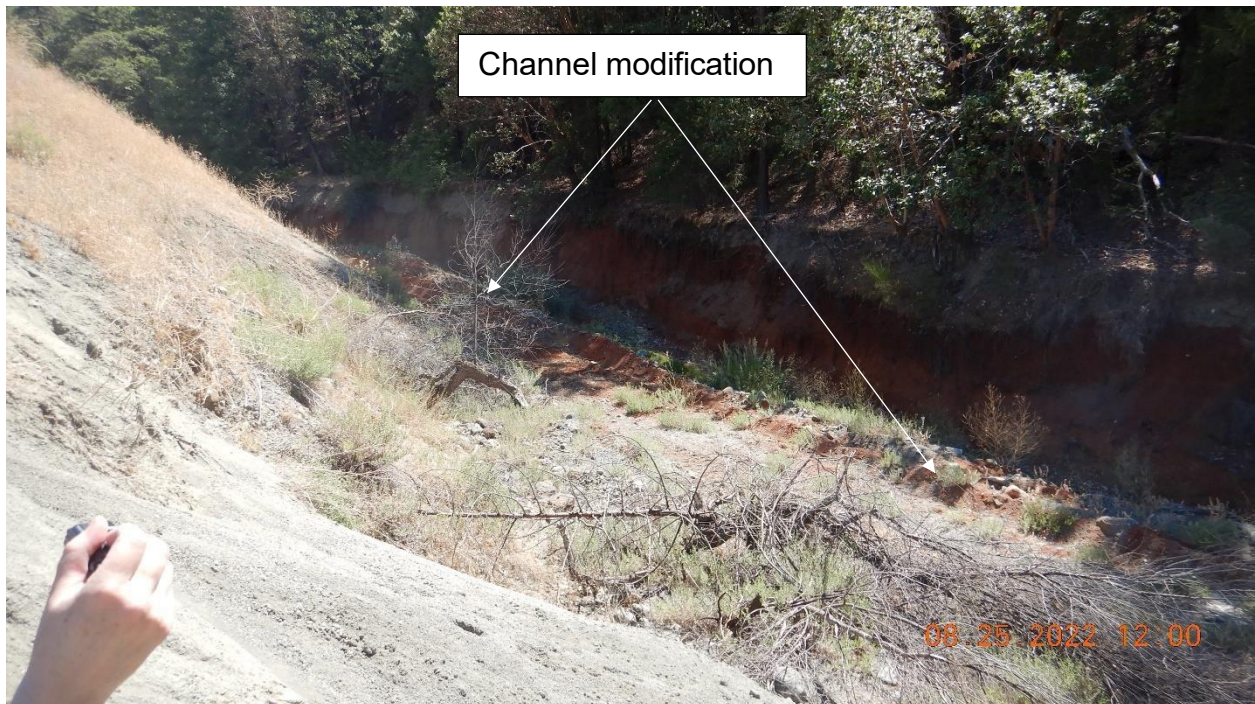
While inspecting the area on the southern side of the yard near the wash ponds, Regional Board staff observed substrate disturbance in Oregon Gulch. It appeared that equipment had operated in and manipulated the channel. A pile of earthen material was observed along the channel for approximately 100 linear feet. It is unclear where material originated (see photo 8).

There are additional imminent threats to water quality at the Property. Channel bed modifications and in-stream crossings (fords) in Oregon Gulch have destabilized the channel substrate. During rainfall events, fine sediment generated from these activities will be deposited downstream. Fine sediment is deleterious to aquatic resources, especially salmonids. Several earthen berms (check dams) have been constructed in Oregon Gulch. This un-permitted placement of fill within the channel diverts flow and disrupts natural flow regimes. Storms with significant rainfall have the potential to destabilize the berms and deposit earthen material, including fine sediment, downstream.

Photo 8: View of channel modification in Oregon Gulch. Picture taken by Farzad Kasmaei.

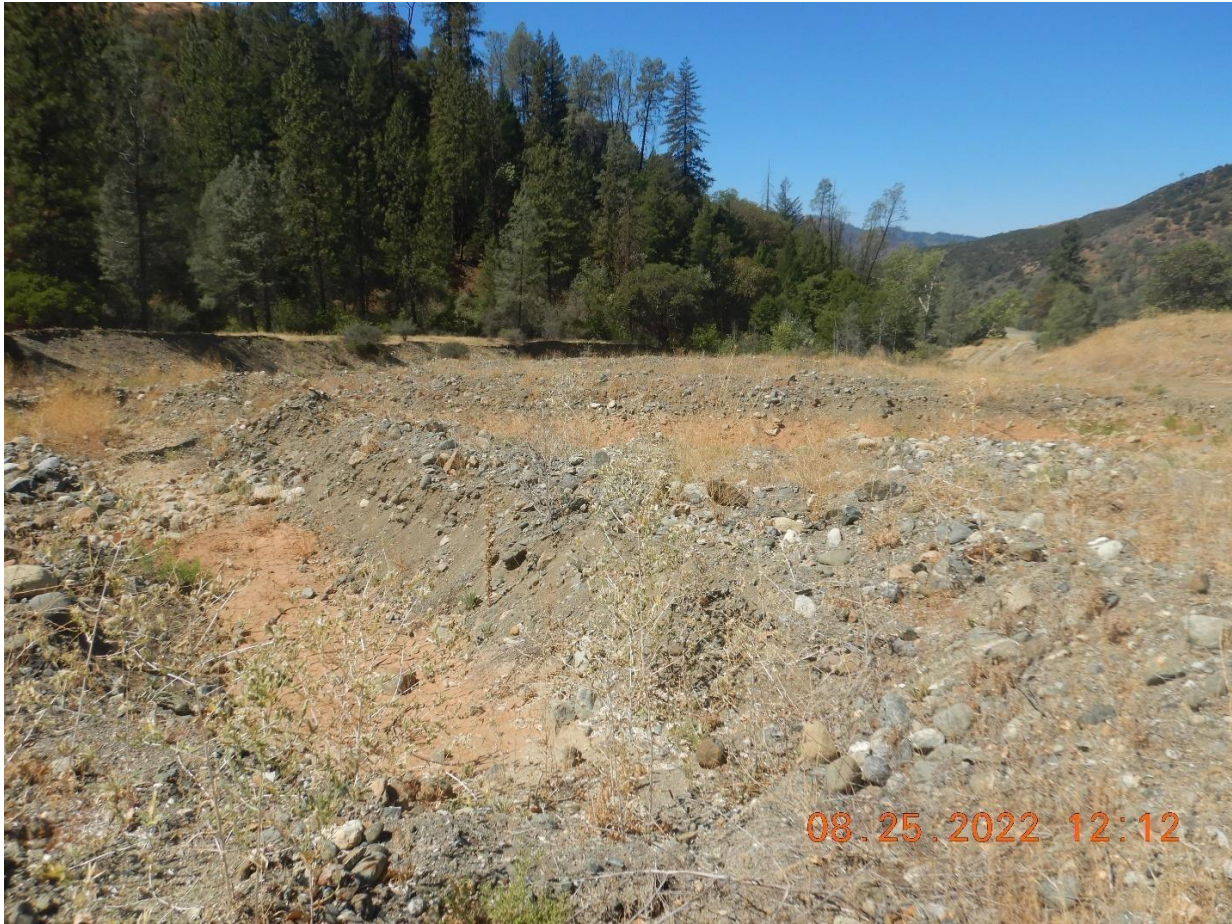
Several large check dam berms were installed in the Oregon Gulch channel below a road crossing, the check dams cover approximately 0.4 acres and 350 linear feet along Oregon Gulch. Discharger stated that these check dams were installed at the request of a neighboring parcel owner and are located on the adjacent BLM parcel (see photo 9). The Regional Water Board has no record of any active or past permits for culvert installation or other crossing construction on this parcel. Amanda Piscitelli stated that permits are needed for channel maintenance or other activities in waters of the State. In the course of walking through the Facility, the inspection group observed evidence of hydrocarbon material spills on the ground from the construction dozers as well as spills from a forklift within the oil shed area (see photos 10, 11a and 11b). The Discharger has stored the spill prevention kits in the truck maintenance building. However, Farzad Kasmaei reminded Dustin Tillinghast to ensure that the trucks and industrial equipment are well maintained, the facility's crew are trained, and to ensure that spills are responded to immediately in accordance with preventative maintenance and spill prevention and response sections of the IGP.

Photo 9: View of the installed wide berms in Oregon Gulch. Picture taken by Amanda Piscitelli.

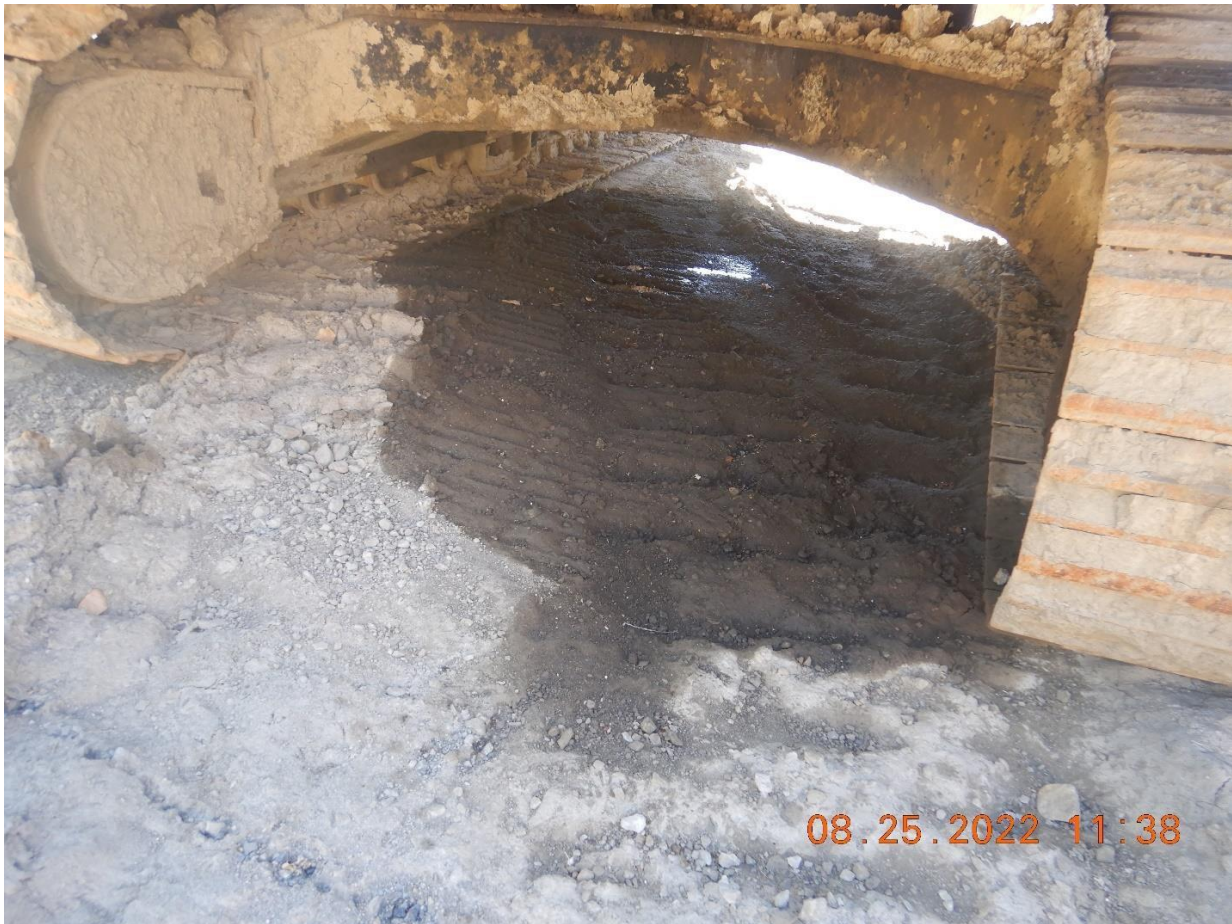
Evidence of hydrocarbon material spills were observed on the ground. The truck and industrial equipment must be well maintained, and the facility's crew must be well

Photo 10: Evidence of hydrocarbon spills on the ground from a dozer near Poison Gulch. Picture taken by Amanda Piscitelli.

trained to respond to any leakage immediately in accordance with spill prevention and response section of the IGP.

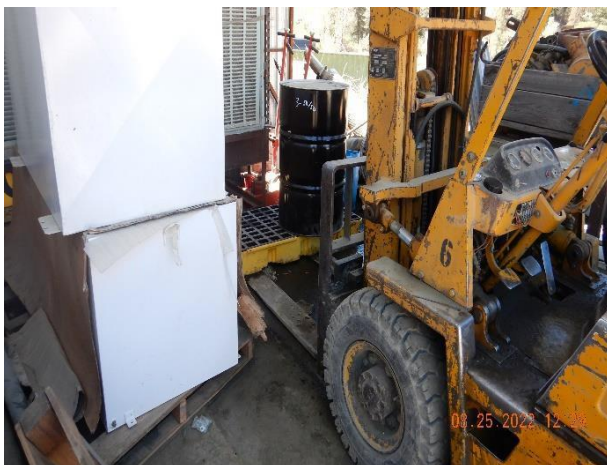
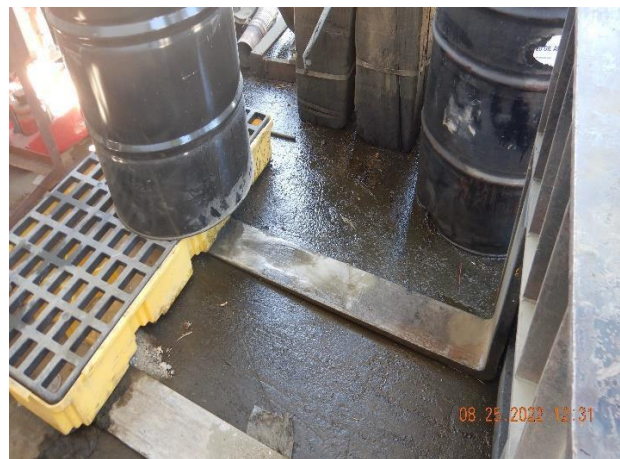
Photo 11a, 11b: Evidence of hydrocarbon spills within the roofed oil shed area. Picture taken by Farzad Kasmaei.

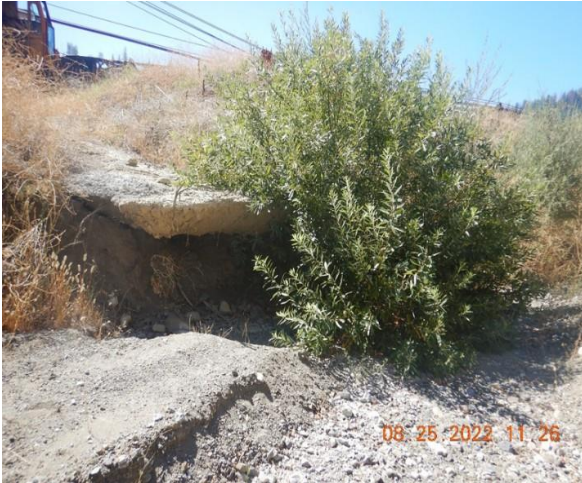
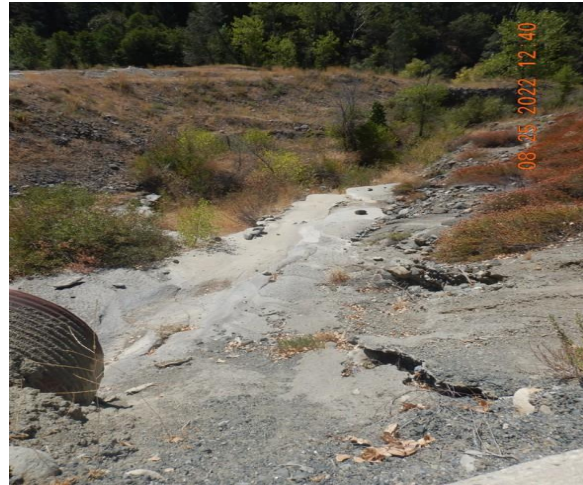
Concrete bank armoring was observed on the left bank of Poison Gulch, upstream of the culvert crossing near DP-5. Additional concrete armoring was observed along the bank of Poison Gulch downstream of the crossing near the office (see photos 12a and 12b). Culverts in Poison Gulch, as shown on SWPPP site map, appear to have been installed or replaced without water quality certification. The Regional Water Board has no record of any active or past permits for culvert installation or other crossing construction.

Poison Gulch has also been modified and impacted by unauthorized activities. Several culverted watercourse crossings were observed, and it is unclear if they were sized to accommodate 100-year flood flow with debris and sediment loads. Some culverts appeared improperly installed. Crossings with undersized and incorrectly installed culverts are at risk of plugging, overtopping, and failure. Failed crossings deliver earthen fill material, including fine sediment, downstream. Concrete armor observed on the bank and near a culverted watercourse crossing appear to be for bank stabilization. Concrete is non-native fill, vulnerable to deterioration, and not typically authorized for bank stabilization projects. It is unknown if other portions of Poison Gulch have been modified, filled, crossed, or stabilized. Further review, delineation, and assessment of all Waters of the State on the Eagle Rock, Inc. parcels is needed.

Photos 12a, 12b: Photo 12a concrete armor on left bank of Poison Gulch. Photo 12b concrete armor on right bank of Poison Gulch downstream of road crossing near office.

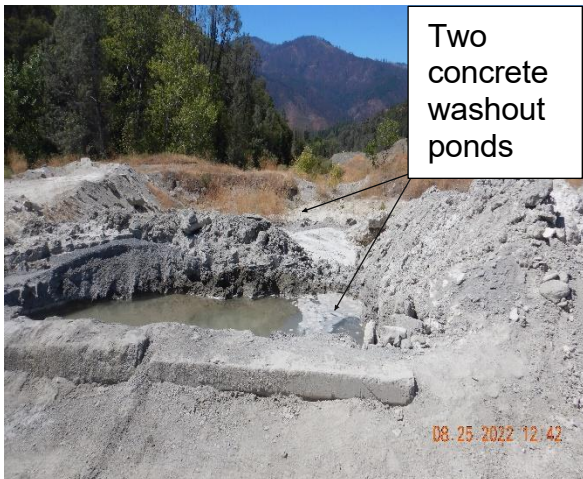
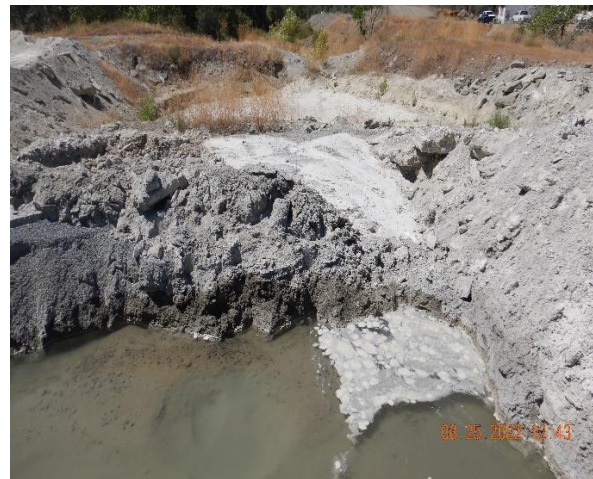
The inspection group then walked down to the western portion on the facility where concrete operations take place. There are a couple of existing concrete washout ponds that are not lined (see photos 13a and 13b). These washout ponds are filled with concrete washout water from the concrete plant. Concrete wash water is an industrial process waste and is typically very high in pH. Per Dustin Tillinghast, these ponds are not lined and allow untreated concrete washout materials to be infiltrated into the soil upgradient of Oregon Gulch. Kristine was not able to confirm that the Discharger had conducted any investigation or groundwater monitoring to ensure that there is no threat to groundwater quality. While the IGP allows for and encourages the Discharger to reuse and infiltrate the Facility's stormwater runoff, this does not apply to hazardous materials, process wastes, or pollutants such as contaminated wastewater with a high pH.

Photos 13a, 13b: looking east at existing concrete washout ponds that are not lined. Picture taken by Farzad Kasmaei.

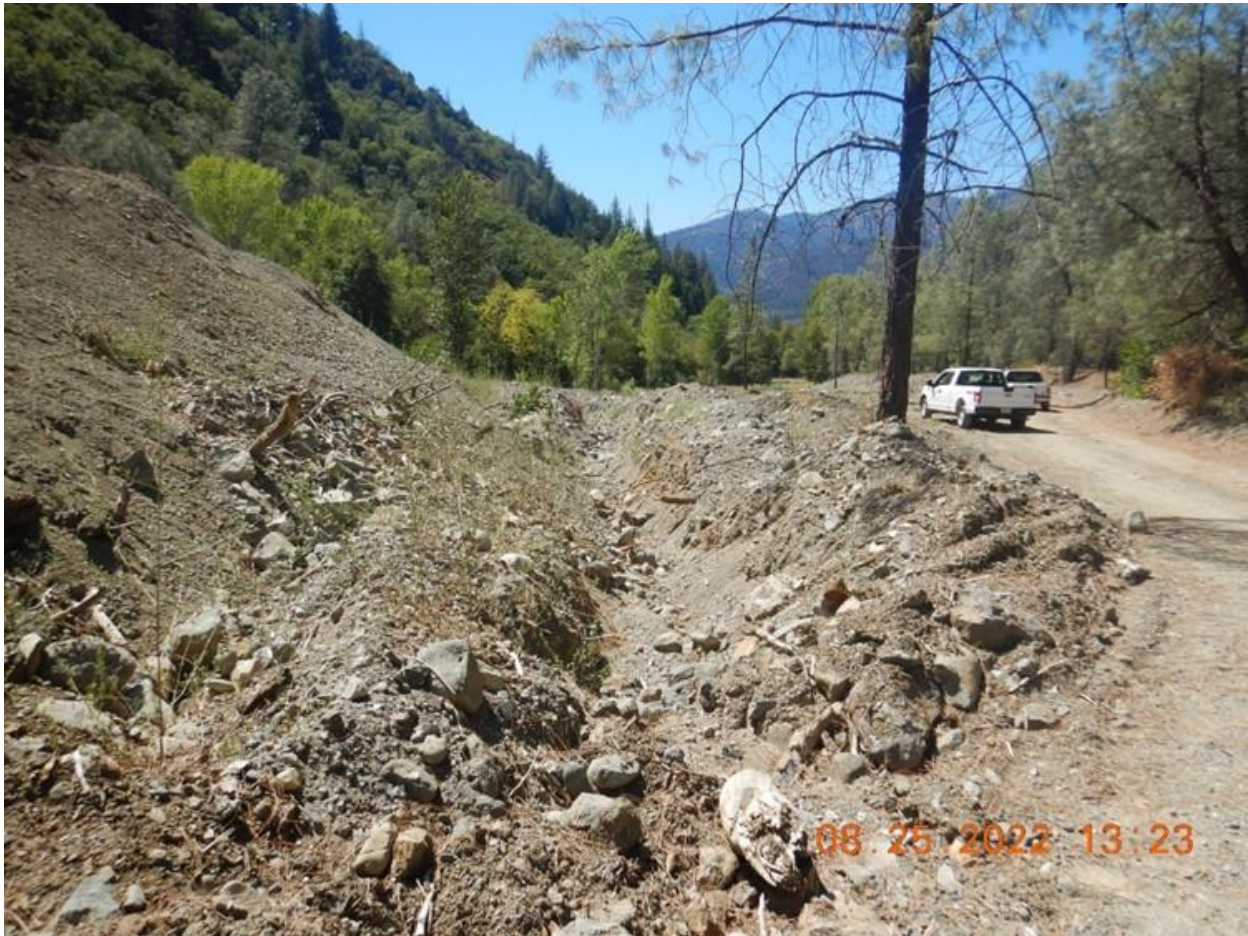
Amanda Piscitelli accompanied Dustin Tillinghast to the adjacent parcel (APN 024-010-046-000) owned and managed by Eagle Rock Inc., but that is not currently enrolled under the IGP as no regulated industrial activities are occurring. Regional Water Board staff observed that an access road was installed with several watercourse crossings lacking any culverts (see photos 14a, 14b). An access road appears to have been installed through several ephemeral drainages flowing southerly toward Oregon Gulch, with graded material present in drainages. The Regional Water Board has no record of any active or past permits for road installation or other crossing construction on this parcel.

On the adjacent Eagle Rock Inc. parcel (024-010-046-000) the access road has several unpermitted watercourse crossings. None of the observed crossings contained culverts suggesting that vehicles and equipment are driving through the watercourses at any time of the year. Access road approaches are currently hydrologically connected to the watercourses. Crossings should be assessed by a qualified professional to determine appropriate crossing design. The constructed off-channel pond installed is filled with water piped subsurface from Oregon Gulch. Division of Water Rights should be contacted to review potential water rights that may be needed. Observed channel modification in Oregon Gulch should be assessed and remediated. Dredge and fill activities within waters of the United States require prior authorization from the U.S. Army Corps of Engineers under section 404 of the Clean Water Act and issuance of a state water quality certification by the Regional Water Board under section 401 of the Clean Water Act. Permits will need to be obtained to address the crossings and channel modification.

Photo 14a: Access road drainage crossing, facing downstream.

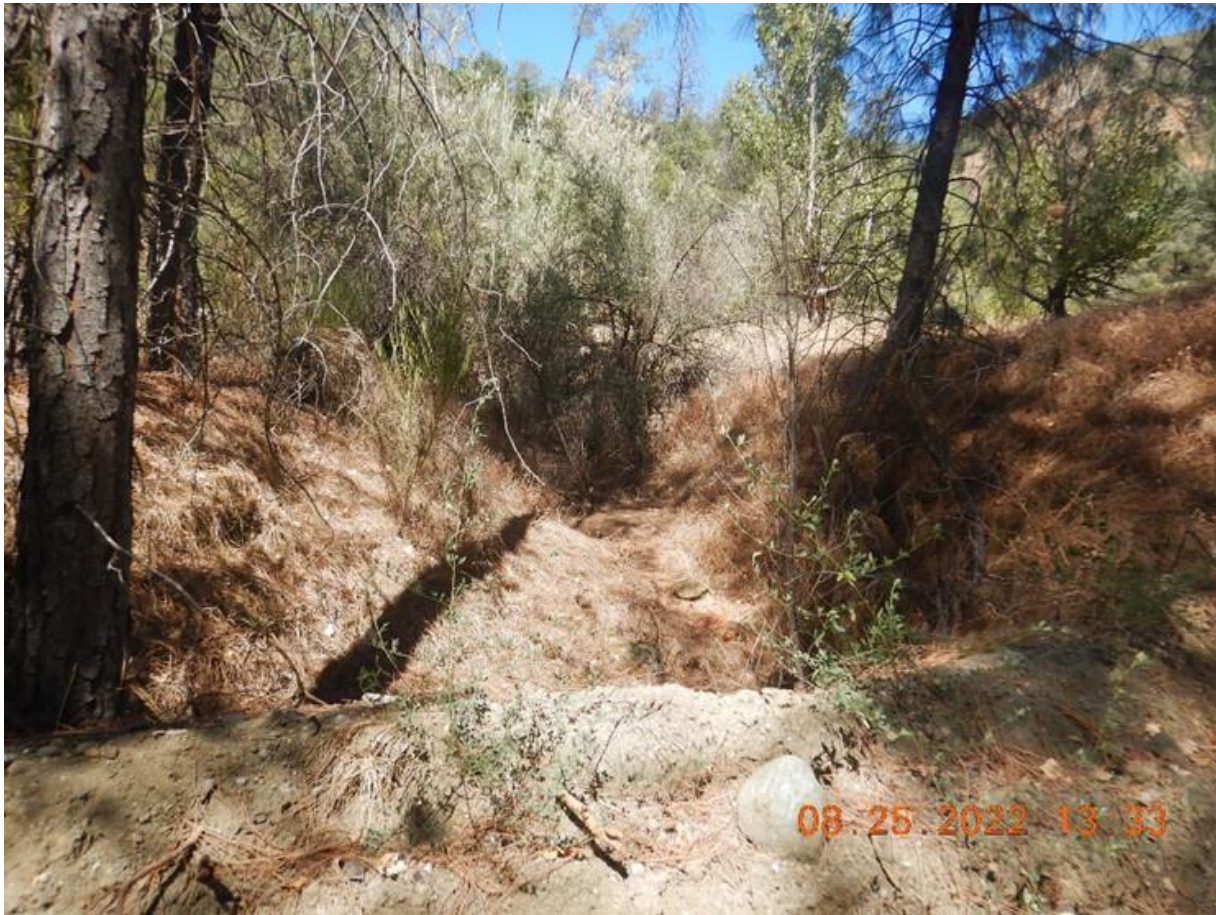
Photo 14b: Drainage swale with road crossing material in foreground.

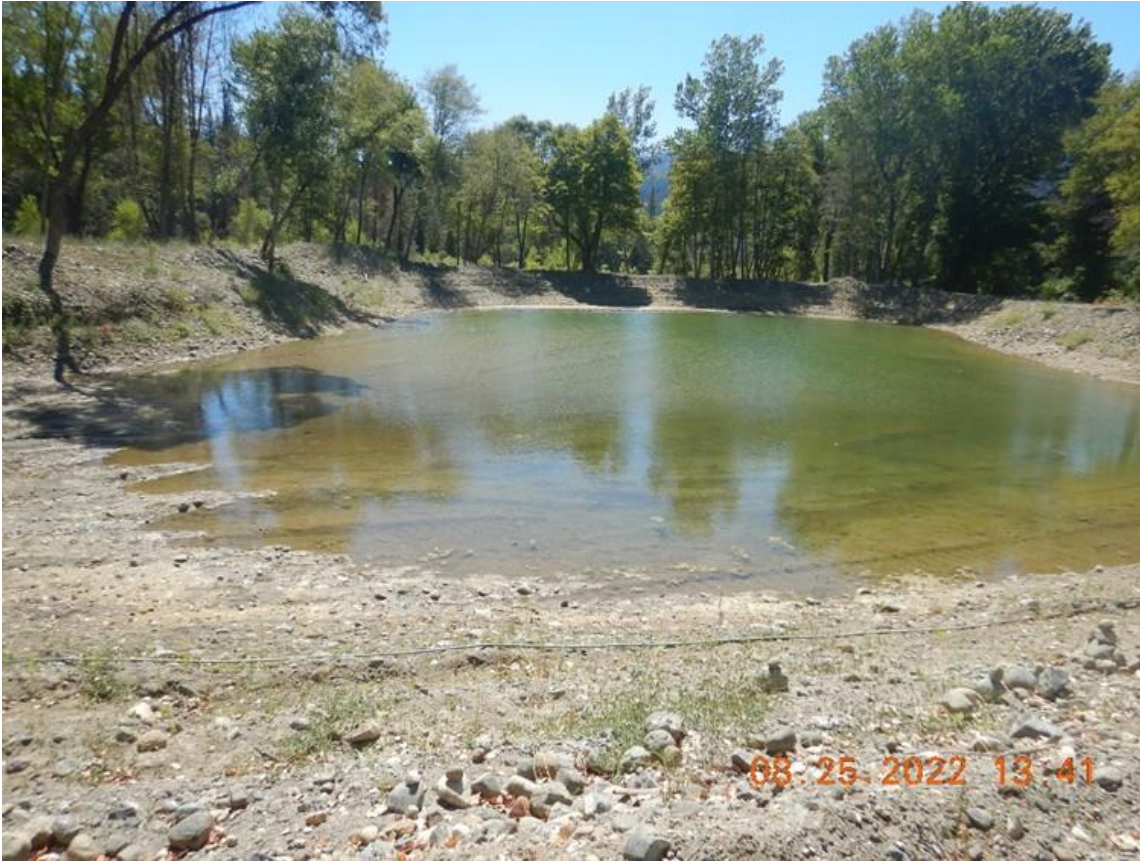
Staff also observed a constructed off-channel pond with a graded berm. The pond area with berm is approximately one acre (see photo 15a). The pond appeared to have been recently installed and the Discharger stated it is filled with water piped subsurface from Oregon Gulch. Additionally, bark was spread throughout the parcel, as well as around the pond and near access road crossings (see photos 15b). Staff observed channel modification in Oregon Gulch with surface water flow that appeared to go subsurface downstream. The Discharger stated that channel had been modified to access water (see photos 16a and 16b).

Photo 15a: Pond installed off channel, filled with water piped from Oregon Gulch.

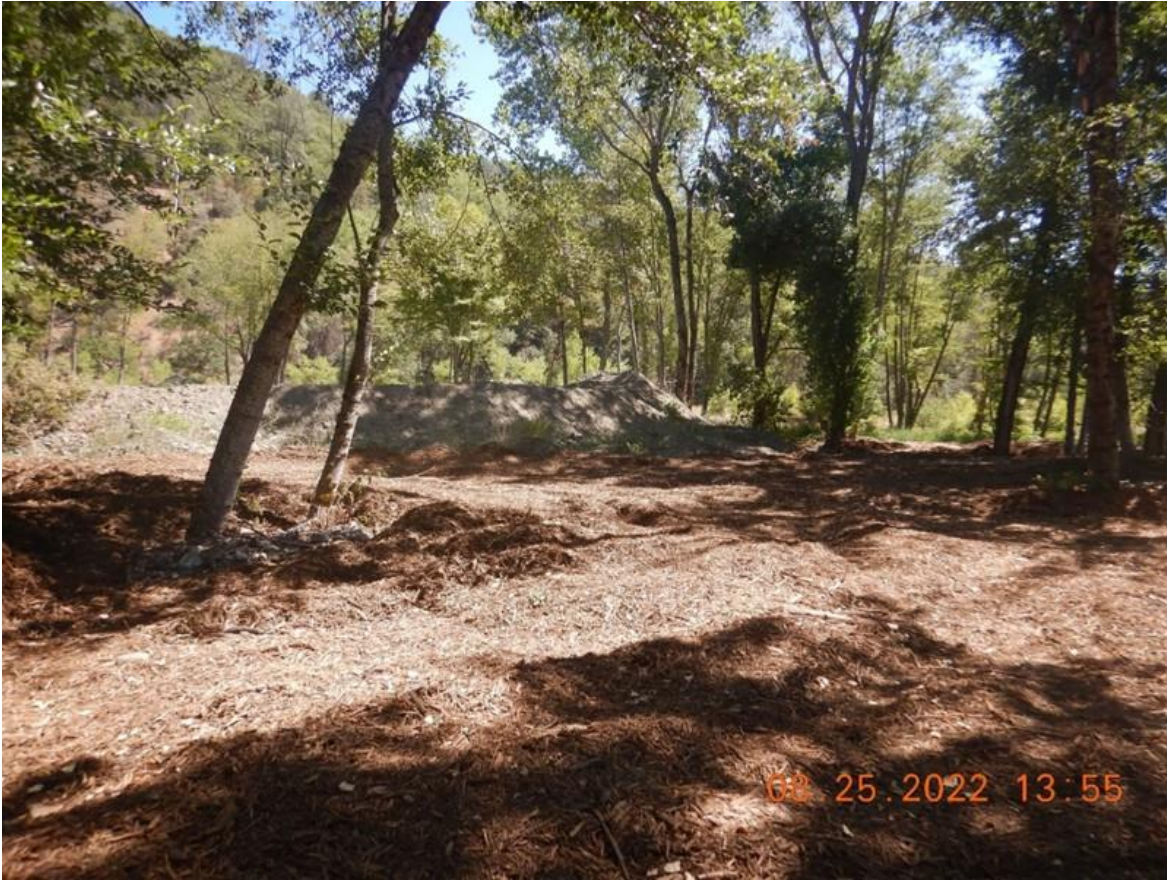
Photo 15b: Back of pond with bark spread on ground around pond.

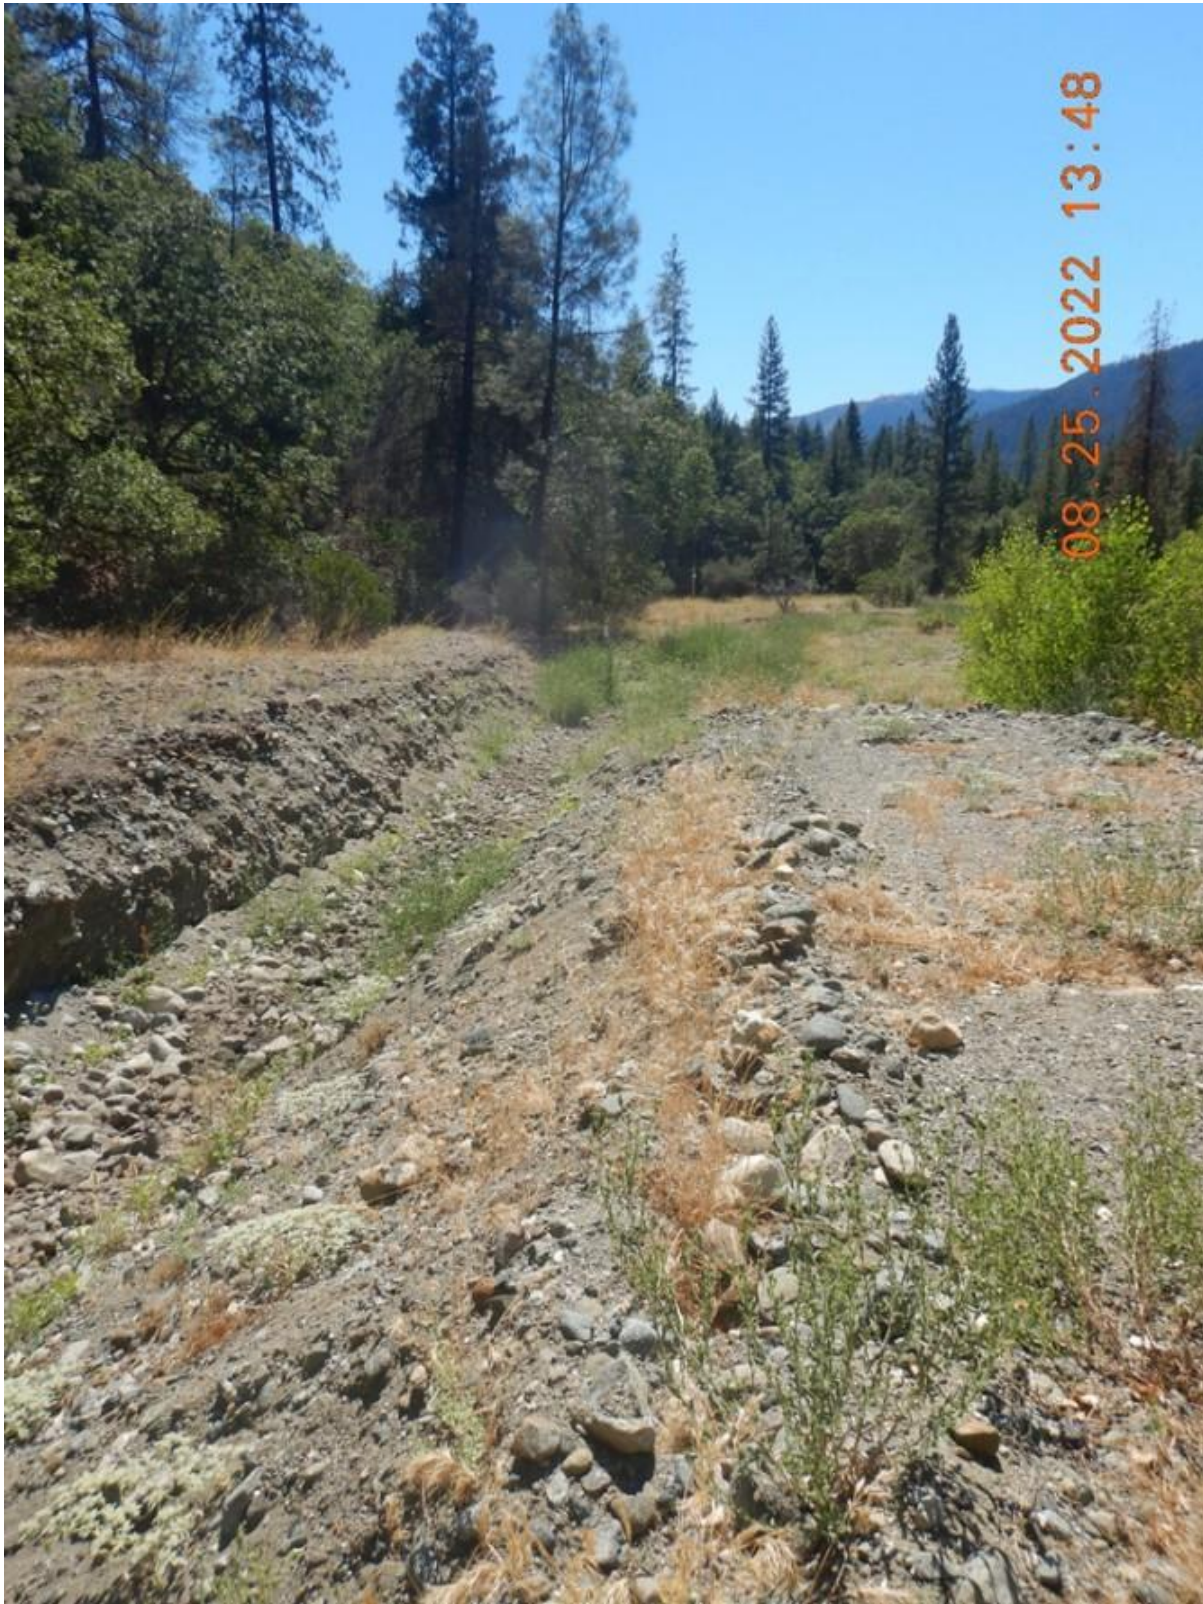
Photo 16a: channel modification in Oregon Gulch, facing downstream.
