North Coast Regional Water Quality Control Board

INSPECTION MEMO

Eagle Rock, Inc. - La Grange Pit
40029 La Grange Road
Junction City, Trinity County

August 25, 2022

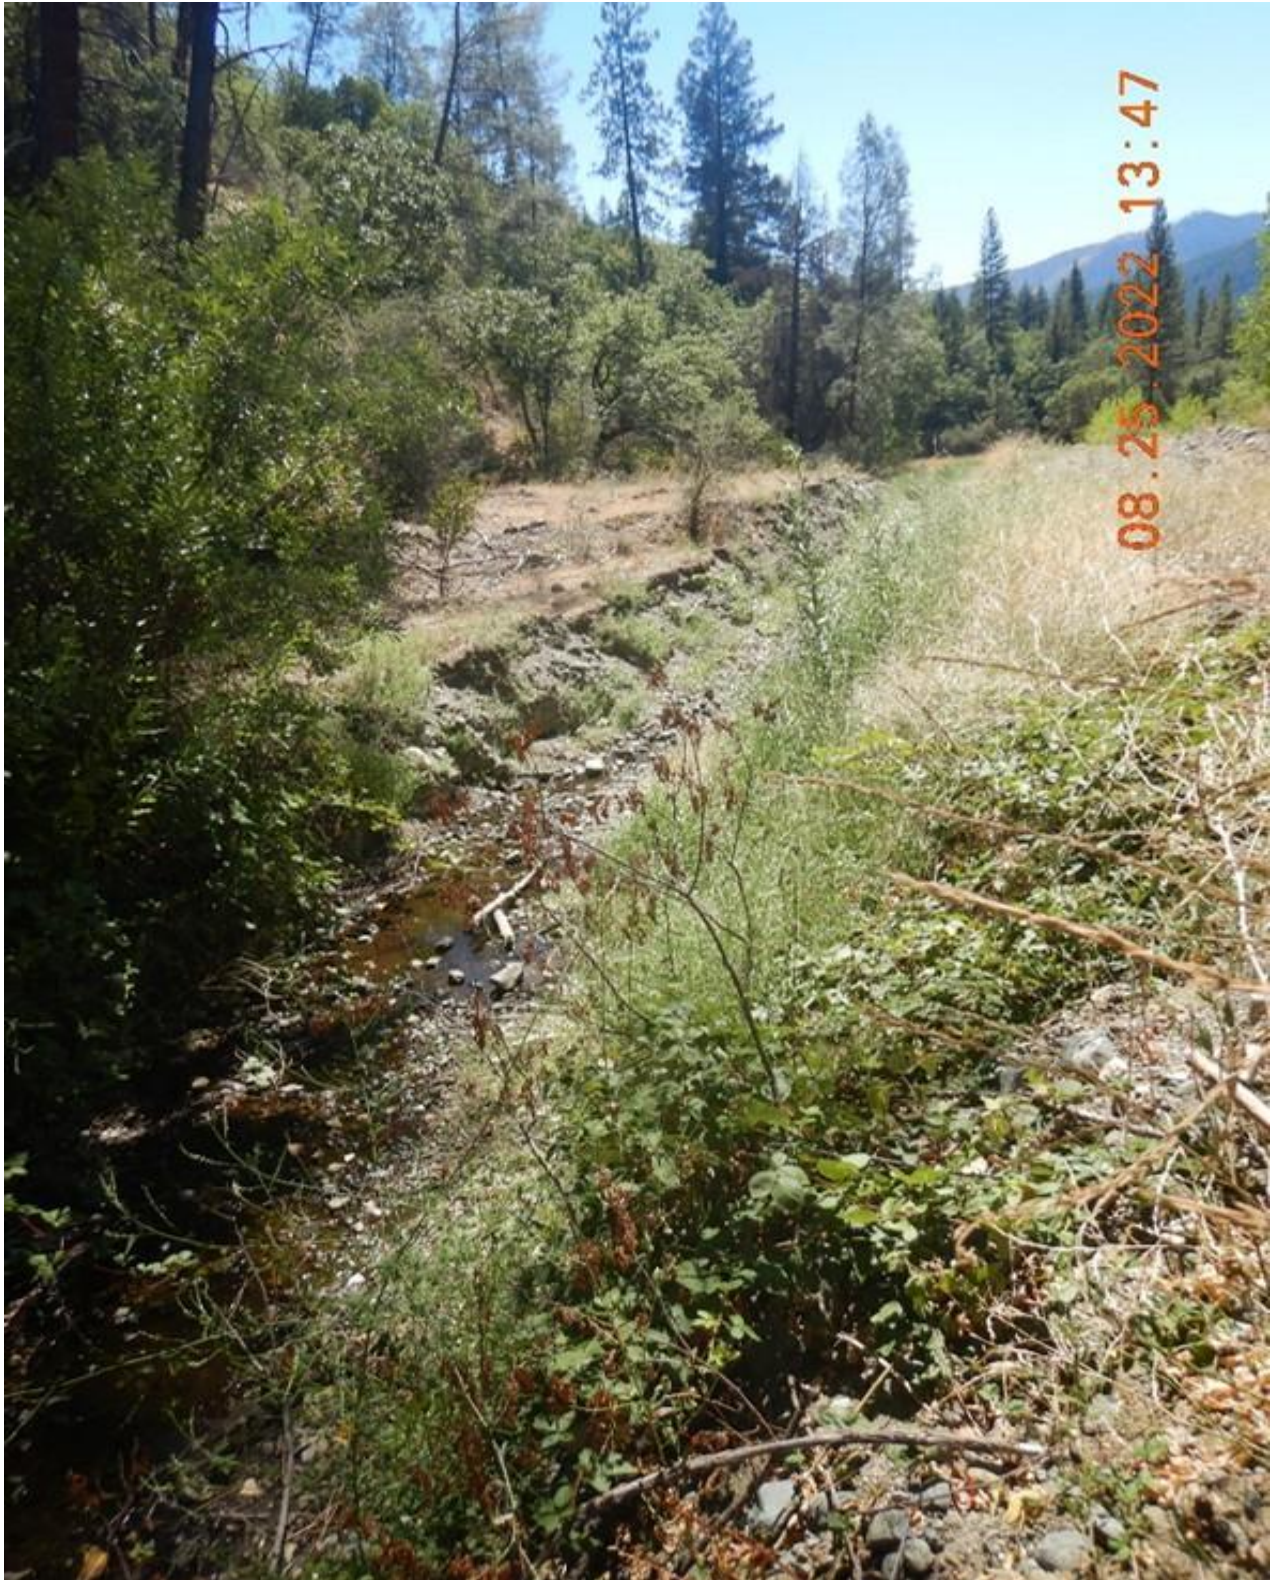
Staff also observed a constructed off-channel pond with a graded berm. The pond area with berm is approximately one acre (see photo 15a). The pond appeared to have been recently installed and the Discharger stated it is filled with water piped subsurface from Oregon Gulch. Additionally, bark was spread throughout the parcel, as well as around the pond and near access road crossings (see photos 15b). Staff observed channel modification in Oregon Gulch with surface water flow that appeared to go subsurface downstream. The Discharger stated that channel had been modified to access water (see photos 16a and 16b).

Photo 16b: Surface water in Oregon Gulch, goes subsurface at downstream end.

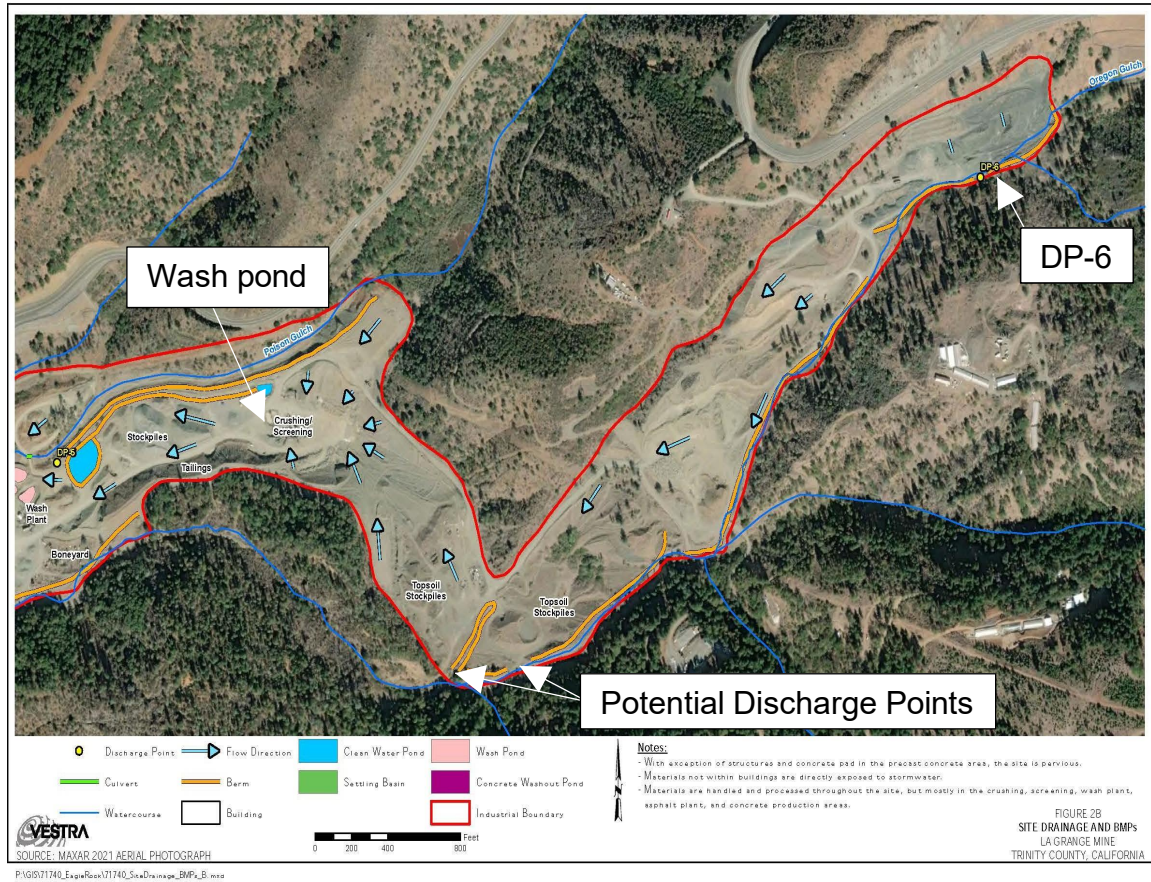
Also, the processing area where screening and crushing operations take place was inspected. Farzad Kasmaei observed an existing wash pond that receives wash water via a pond inlet and it appeared to be turbid (see photo 5). However, the pond is not shown on the site map. Per the Discharger, this pond is connected to an adjacent settling pond (photo 6) via a subsurface perforated pipe for further treatment. The Discharger was directed to include these stormwater features that are missing on the site map (see attached site map 1).

Site map 1: The site map has been prepared by Discharger’s consultant, indicating the central and eastern portions of the Facility. Stormwater flow directions, sampling locations, clean water pond locations and the location of the earthen berms are shown on the site map.

Site map must be revised to reflect the current condition of the site. All discrepancies must be addressed. The drainage areas, potential monitoring/sampling points and any stormwater features such as missing wash pond must be included on the site map. The SWPPP may need to be revised accordingly.

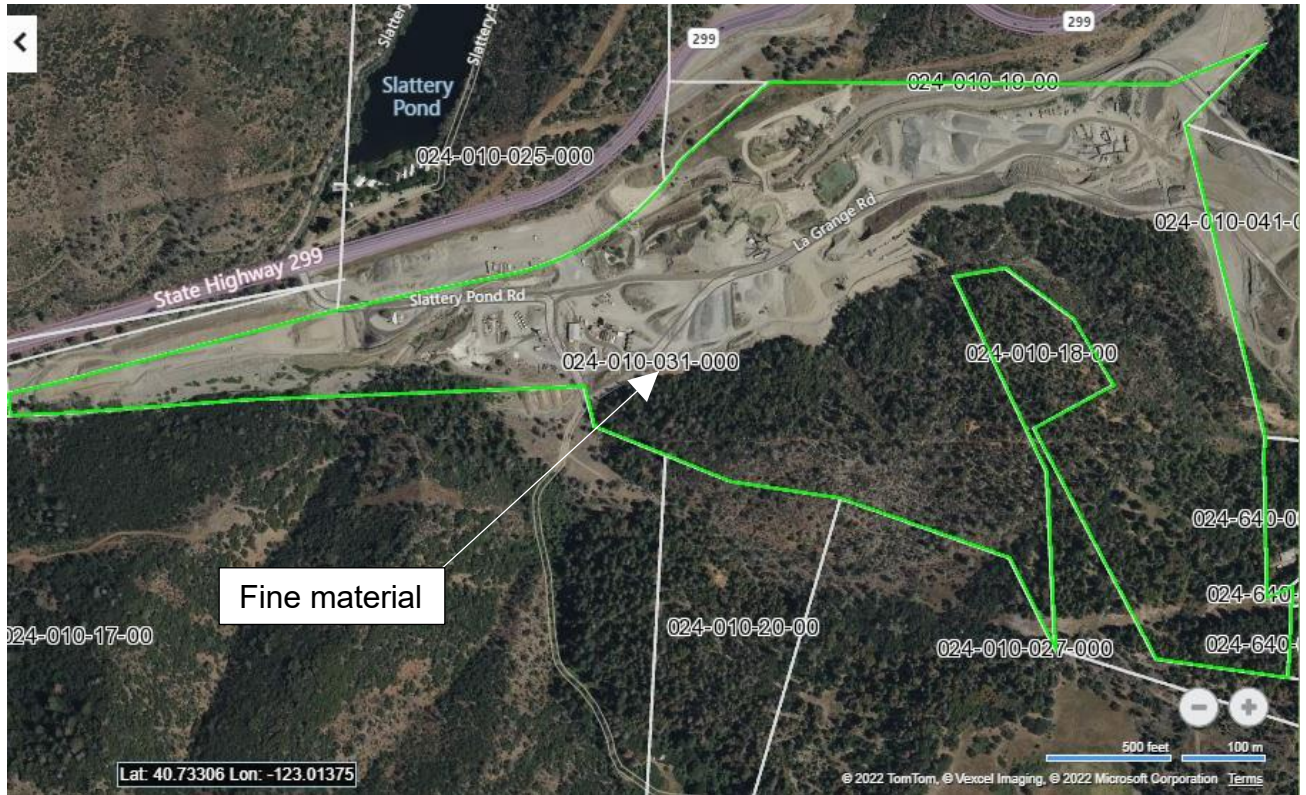
Staff observed a significant number of uncovered large stockpiles of fine material on the west side of the boneyard and adjacent to Oregon Gulch. These stockpiles were placed adjacent to Oregon Gulch with no sediment or erosion control BMPs installed to prevent erosion and sediment delivery into the receiving water which cause an imminent threat to receiving water (see photo 7 and site map 3). Per the SWPPP map provided, an

Site map 3: Aerial view of parcel (APN 024-010-031-000) outlined in green where large fine materials are stored adjacent to Oregon Gulch. Per LandVision this parcel is owned by ERI.
