CALIFORNIA GEOLOGICAL SURVEY

Memorandum

Subject: Preliminary Engineering Geologic Assessment of Water Storage Bladder Failure and Erosion, Portion of Section 34, T18N, R11W, MD BL&M; Potter Valley Area, CA.

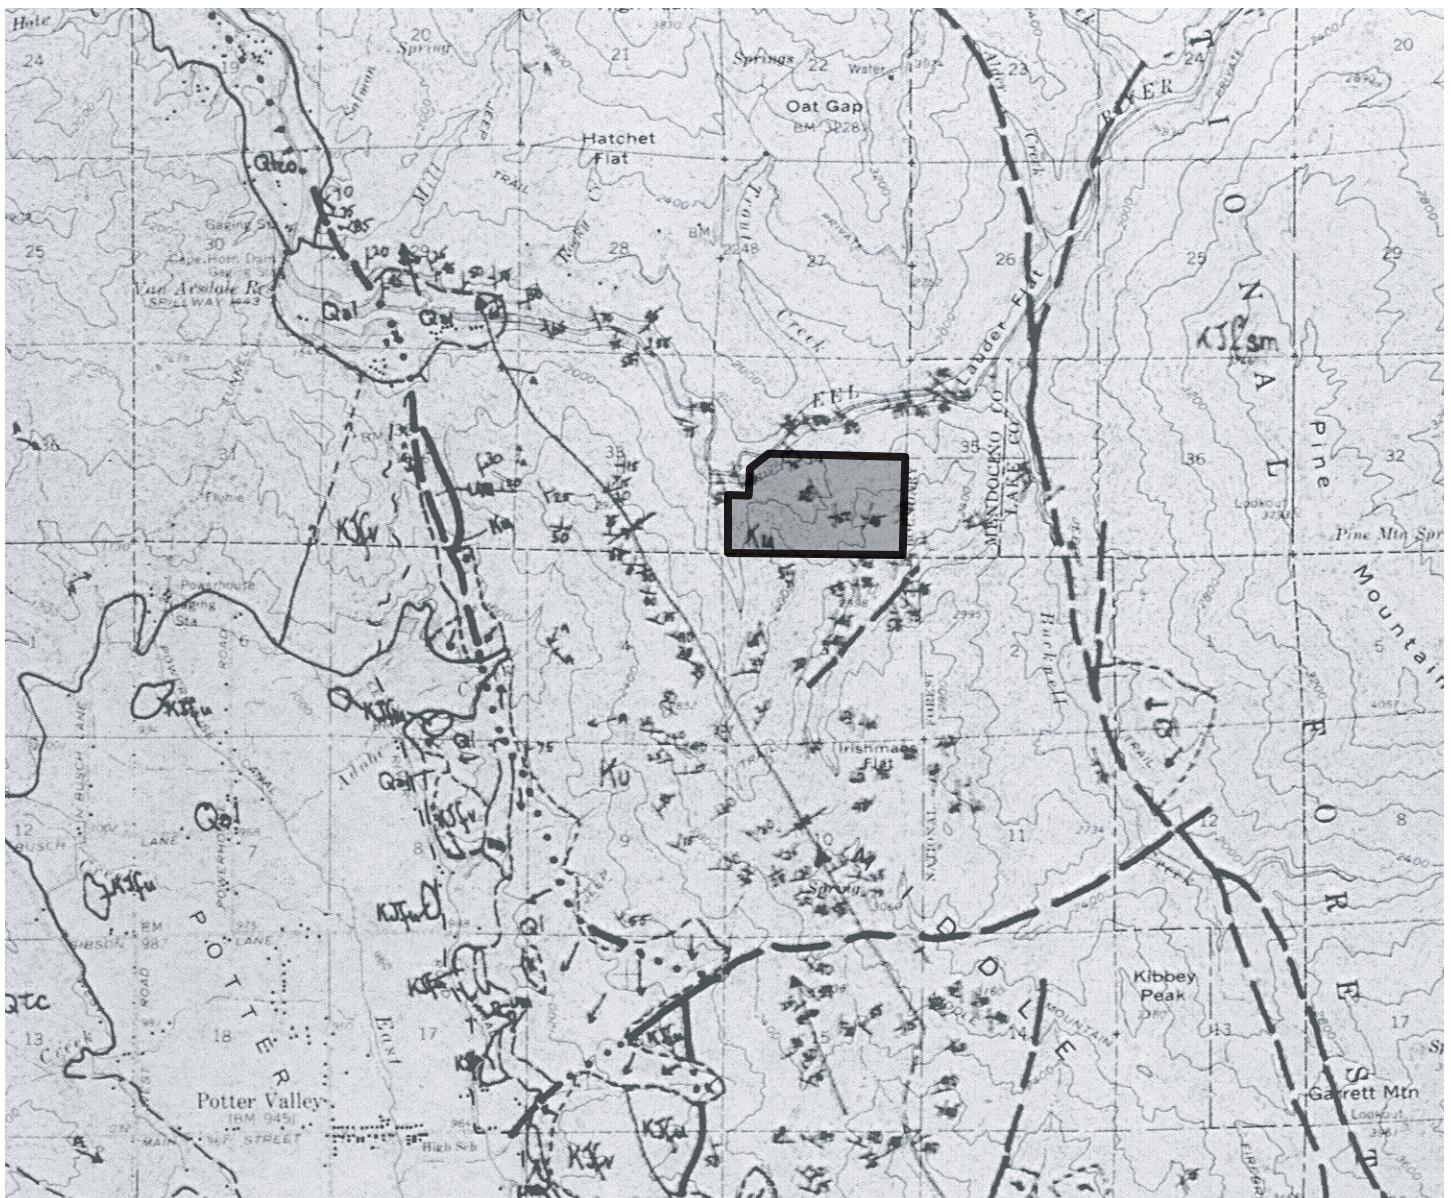
Figure:
1

The site area is located approximately 4 miles northeast of Potter Valley, Mendocino County, California. The slopes are underlain by Cretaceous age sedimentary bedrock of the Upper Great Valley Sequence (Durham, 1979, Figure 1) described as interbedded sandstone, siltstone and mudstone. CGS (1994, Figure 2) performed a pre-harvest inspection of THP 1-94-375 MEN describing site rocks as highly sheared and deeply weathered sandstone and gray mudstone. Site observations during this inspection concur with the bedrock descriptions.

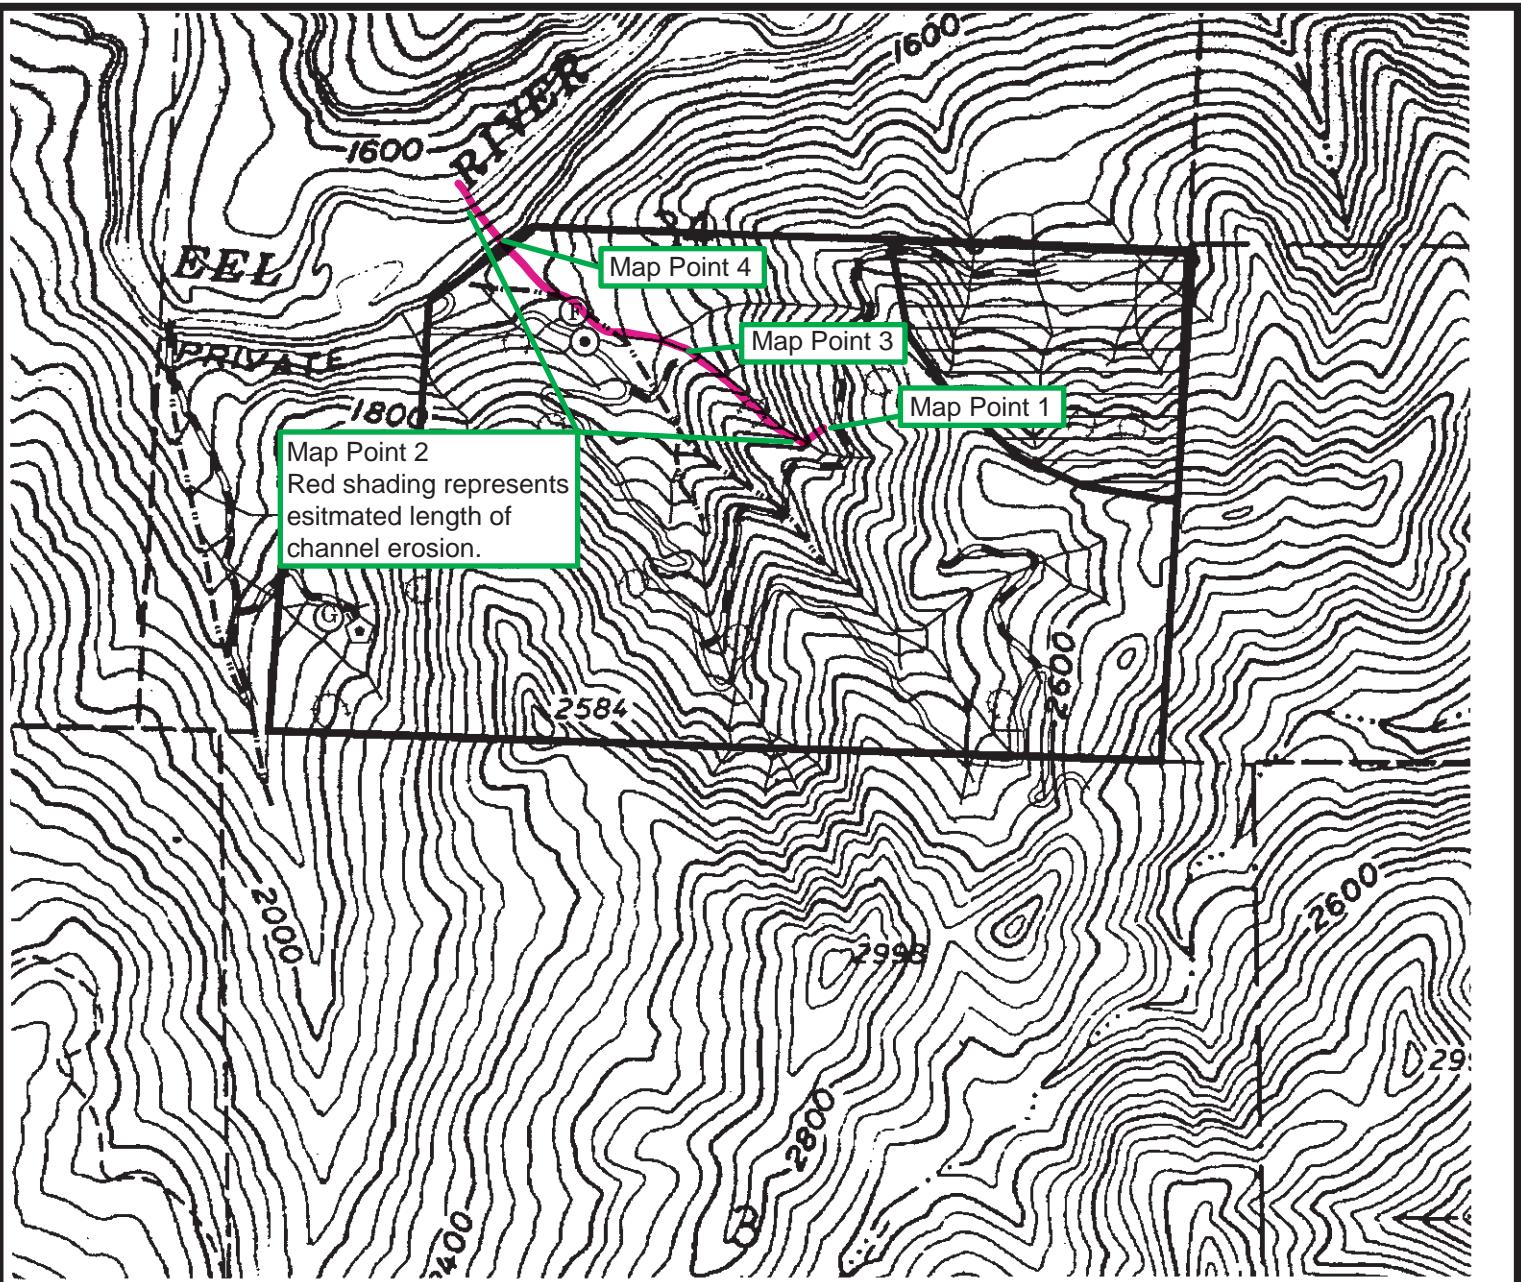
Figure: 3

Observations: (keyed to Figure 3)

Map Point 1 - Water Bladder Failure. Reportedly a 50,000 gallon water bladder (measured to be 70 feet long and 25 feet wide) used for irrigation purposes catastrophically failed during the night of April 24/25, 2013 and released water into a Class II tributary of the Eel River. The bladder was placed on a graded pad located just above the watercourse. According to the landowner the gravity fed water supply to the bladder was left open during a storm event filling the bladder to beyond its capacity and to a point where it burst along a seam. Apparently all the water from the bladder was released and concentrated into the Class II watercourse at one time. CDFW (2013) estimates that approximately 80,000 gallons of water was released. Although little erosion of the pad area that contained the bladder was observed it was noted that fill materials appeared to be perched immediately above the watercourse.

Map Point 2 - Channel Bank Erosion and Scour. Based on observations during our site visit it appears that approximately 2000 feet of a Class II watercourse channel was eroded and scoured as a result of the water release. The eroded watercourse consists of a "V" shaped watercourse on 50 to 80 percent slopes. It appears that the concentrated release of water eroded and scoured the watercourse channel bottom and transported material down slope to the Eel River. The volume of eroded material may have increased (bulked) as it flowed downslope, ultimately forming a small debris flow. Scour of channel banks was observed to range from 2 to 5 feet in depth and 2 to 6 feet in width. Boulders on the order of 2 to 4 feet in diameter appeared to be involved in the debris flow. Very little sediment was observed deposited on the banks of the Eel River. It appears that most of the sediment generated during the water release and subsequent debris flow were delivered to the Eel River. Using an average V shaped scour channel of 3.5 feet of depth and 4 feet of width it is estimated that on the order of 500 cubic yards of sediment and debris was delivered to the Eel River as a result of the water bladder failure.

Map Point 3 – Logging Road Watercourse Crossing. The outside edge of a logging road located approximately 700 feet downstream of the failed water bladder was eroded by material that overtopped the road. A gully on the order of 12 feet wide, 15 feet long and 2 to 5 feet deep was observed in the outside edge of the road. An 8 inch diameter metal culvert was observed to be washed about 10 feet downstream of the watercourse crossing and wrapped around a tree. Because additional fill material was observed to remain in the crossing it appears that additional erosion and sediment delivery can occur at this location.

Map Point 4 - M8 Road Watercourse Crossing. A publically used road known as the M8 Road is located near the base of the slopes where the watercourse drains into the Eel River. What appears to be a 24 inch diameter metal culvert used as a watercourse crossing was buried by sediment at the inlet. While much of the debris had been removed prior to our site visit it appears that debris was deposited on the roadway by an apparent debris flow. The outside fill face appeared eroded with rills and gullies on the order of 1 to 2 feet deep. Because the culvert inlet is plugged it appears likely that seasonal flow within the watercourse will be diverted down the M8 road increasing the potential for future sediment delivery.

1). Erosion Control Plan. An erosion control plan should be developed by California licensed Professional Geologist or California licensed Civil Engineer for the site area. Among other things the plan should include evaluation and mitigation of:

- Map Point 1. Perched fills in the pad area where the water bladder is located.
- Map Point 3. The watercourse crossing on the logging road located approximately 700 feet downstream of the water bladder.
- Map Point 4. The watercourse crossing on the M8 Road.
- The erosion control plan should evaluate the existing road system and infrastructure with regard to the potential for sediment delivery. The erosion control plan should include mitigations developed to minimize the potential for road generated erosion and sediment delivery.
