May 30, 2013

FROM : Rick Macedo, CDFW

SUBJECT : Incident Involving Failure of a Water Storage Bladder Affecting an Unnamed Class II Stream and the Eel River Below Lake Pillsbury on the Franklin Property

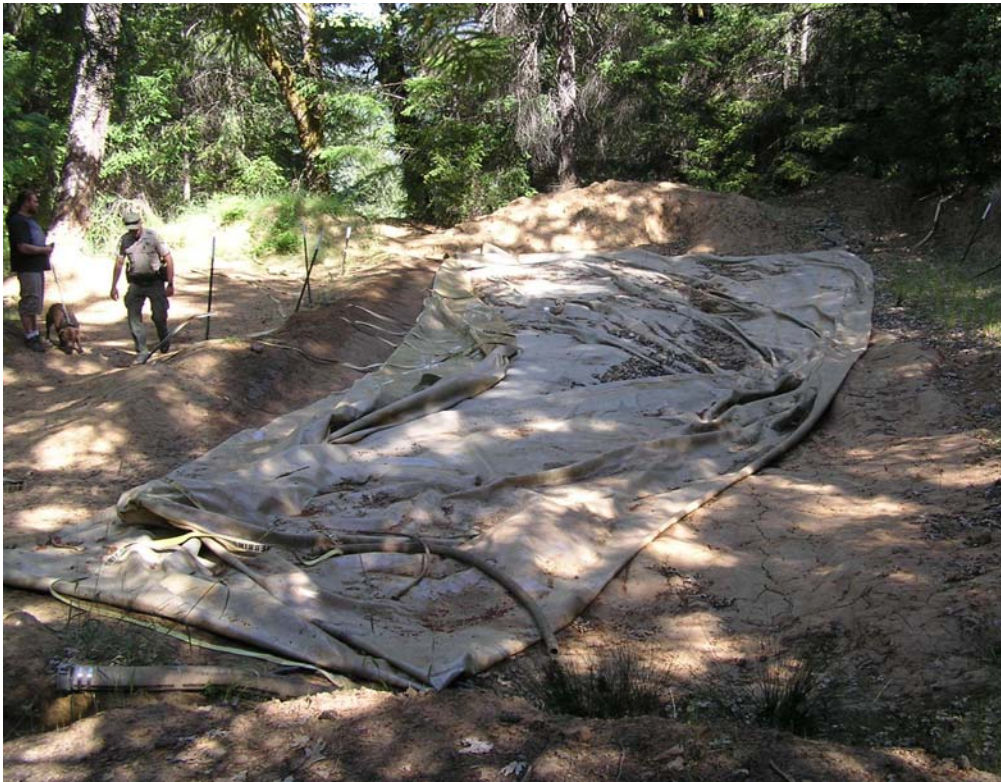
Mr. Franklin reported being absent with the bladder failed. Based on reports from various sources including a phone call I received from Phillip Harrison who was working on a neighboring property, the incident occurred between 1700 hours on April 24 and 0630 hours on April 25. This incident was caused by an over-filled water storage bladder located adjacent to a non-fish bearing stream (aka Class II) that discharges directly into the main-stem Eel River. The 25X65 foot bladder is reported designed to hold up to 50K gallons of water. Operator error resulted in a partially open valve filling the bladder to an estimated 80K gallons of water before it burst along a seam and instantaneously emptied its entire contents into the adjacent Class II stream. Water and sediment were subsequently transported downstream, flowing over the M8 Road (aka "Logging Road") and discharging into the Eel River near a location known as "Hippie Rock".

Figure 2. Collapsed water bladder.

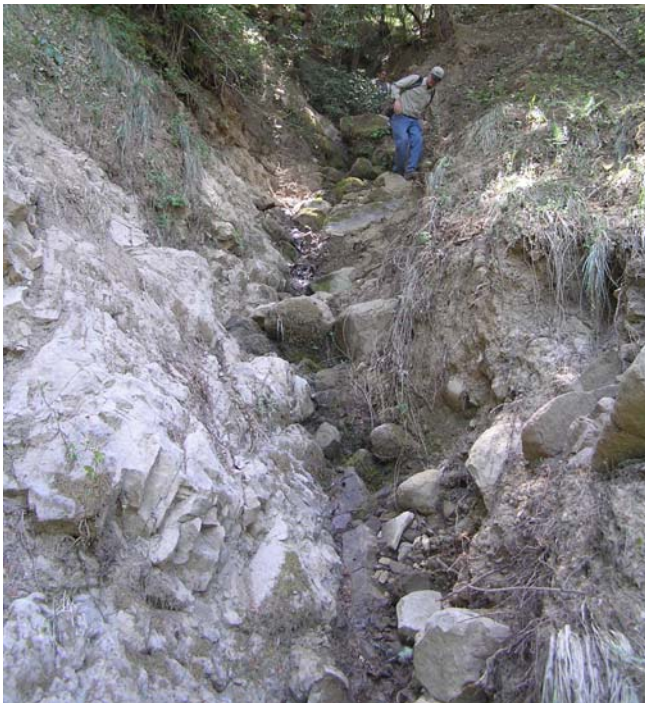
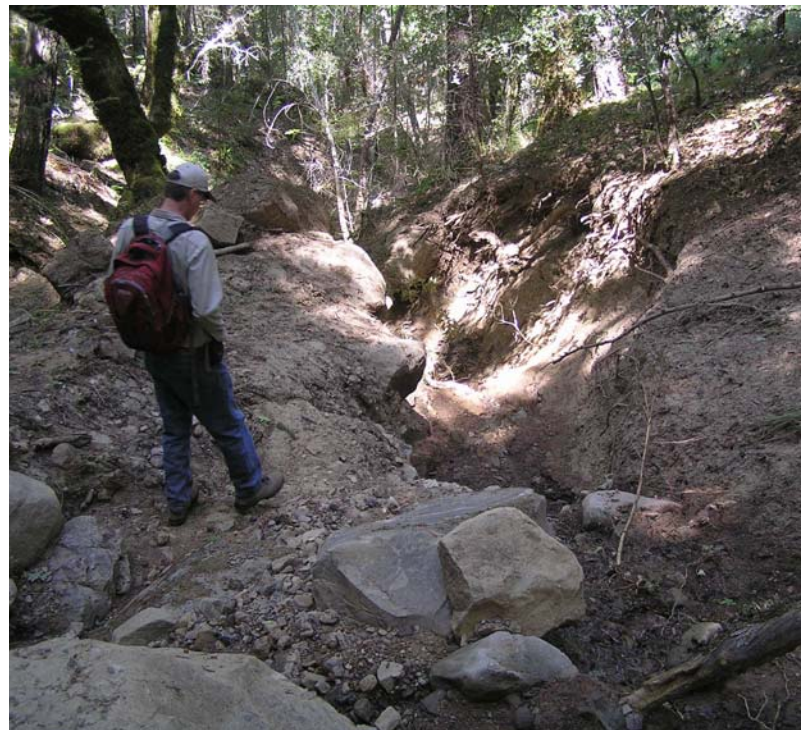
The Class II stream affected by the failed bladder has a steep gradient and a well-confined channel over most of its reach. The near-immediate release of an estimated 80K of water resulted in the following observed and/or reported events: a) complete scour down to bedrock or pseudo-bedrock of virtually the entire stream from the point of entry to the M8 road, b) near complete removal of vegetation along the bed and bank, c) complete removal of aquatic invertebrates/vertebrates (insects, amphibians and reptiles), d) damage to an existing culvert-type road crossing on the Franklin property between the entry point and the M8 Road, e) damage to the culvert crossing on the M8 Road, f) discharge of sediment directly into the Eel River and g) increased turbidity for an unknown distance in the Eel River downstream of the entry point (note, CDFW staff working approximately three miles downstream at the Van Arsdale Fisheries Station reported significant turbidity at the facility following this incident).

Figure 3. Impacted channel.

With the exception of road crossing work at the M8 Road and the damaged private road crossing upslope of the M8 Road on the Franklin property, I did not observe areas within the affected stream channel that would notably benefit from habitat restoration work. However, I did observe numerous erosion sources along the access road on the Franklin property. To mitigate for impacts caused by the subject incident, I recommend that the landowner be required to complete the following:

- 1) Obtain a LSAA from CDFW prior to diverting water from streams or other conducting other activities that may substantially alter the bed, bank or channel of any stream.
- 2) Retain a licensed engineer or other appropriate licensed professional to develop a comprehensive erosion control plan for the property. This plan will focus on various erosion and sediment delivery issues caused by roads, trails, modified stream channels and other observable features.
- 3) In consultation with CDFW and other interested agencies, implement projects that were developed by the comprehensive erosion control plan.

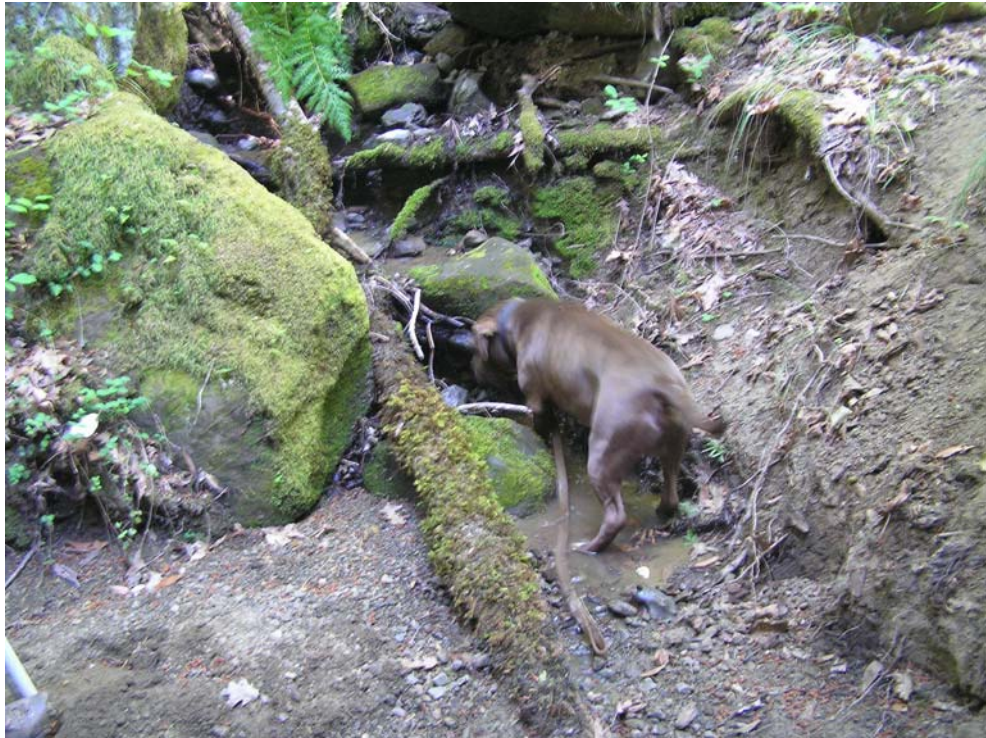
The subject water bladder was used for irrigation and fire protection. The bladder is emptied during the winter period and filled beginning in the late winter/early spring. Two reported water sources are used to fill the bladder. Point of Diversion (POD) #1 is upslope of the bladder site and on the next drainage that lies immediately West of the damaged stream. Water is gravity fed from POD #1 to a 2.5K gallon rigid plastic water tank then to the bladder. POD #1 is used until it dries.

Figure 4. Near point of diversion (POD) #1.

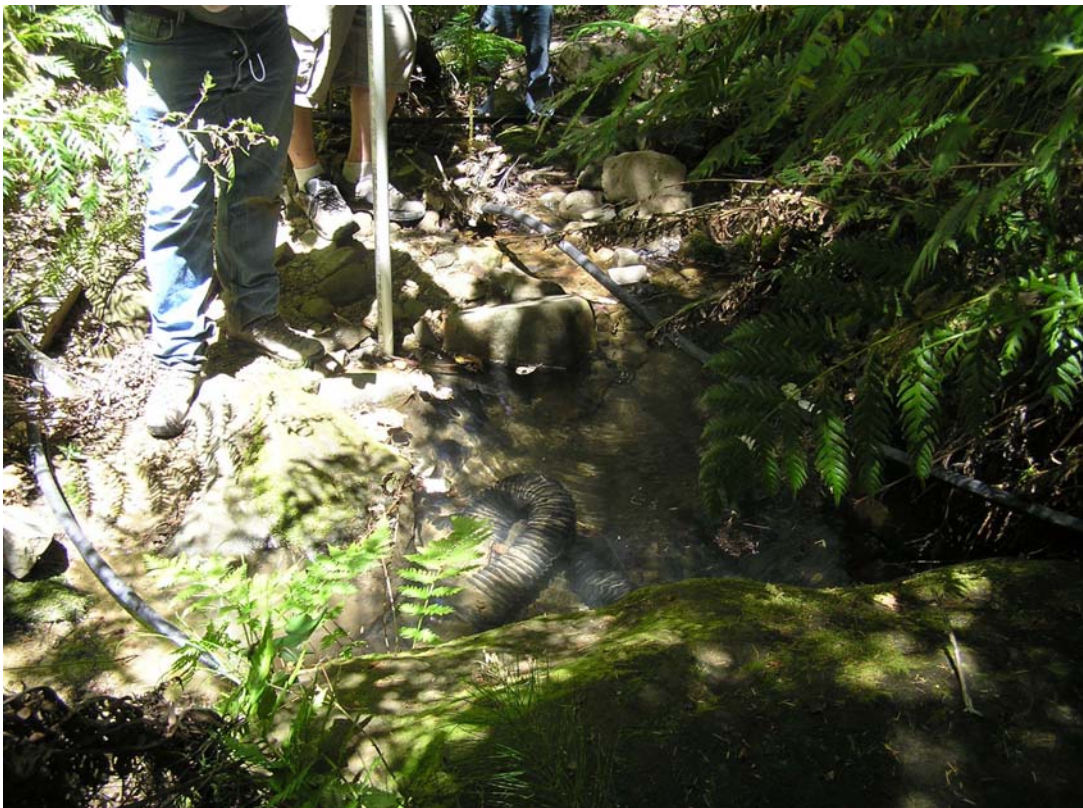
POD #2 is down slope of the water bladder and on a small tributary to the stream that is the source for POD #1. Water from POD #2 is gravity fed to a 1K plastic tank, then

pumped upslope and eventually enters the water bladder after going through the same 2.5K gallon rigid plastic tank that's used for POD #1. While the source for POD #1 goes dry, the source for POD #2 maintains perennial flow and is reportedly used throughout the summer.

Figure 5. Near point of diversion (POD) #2.

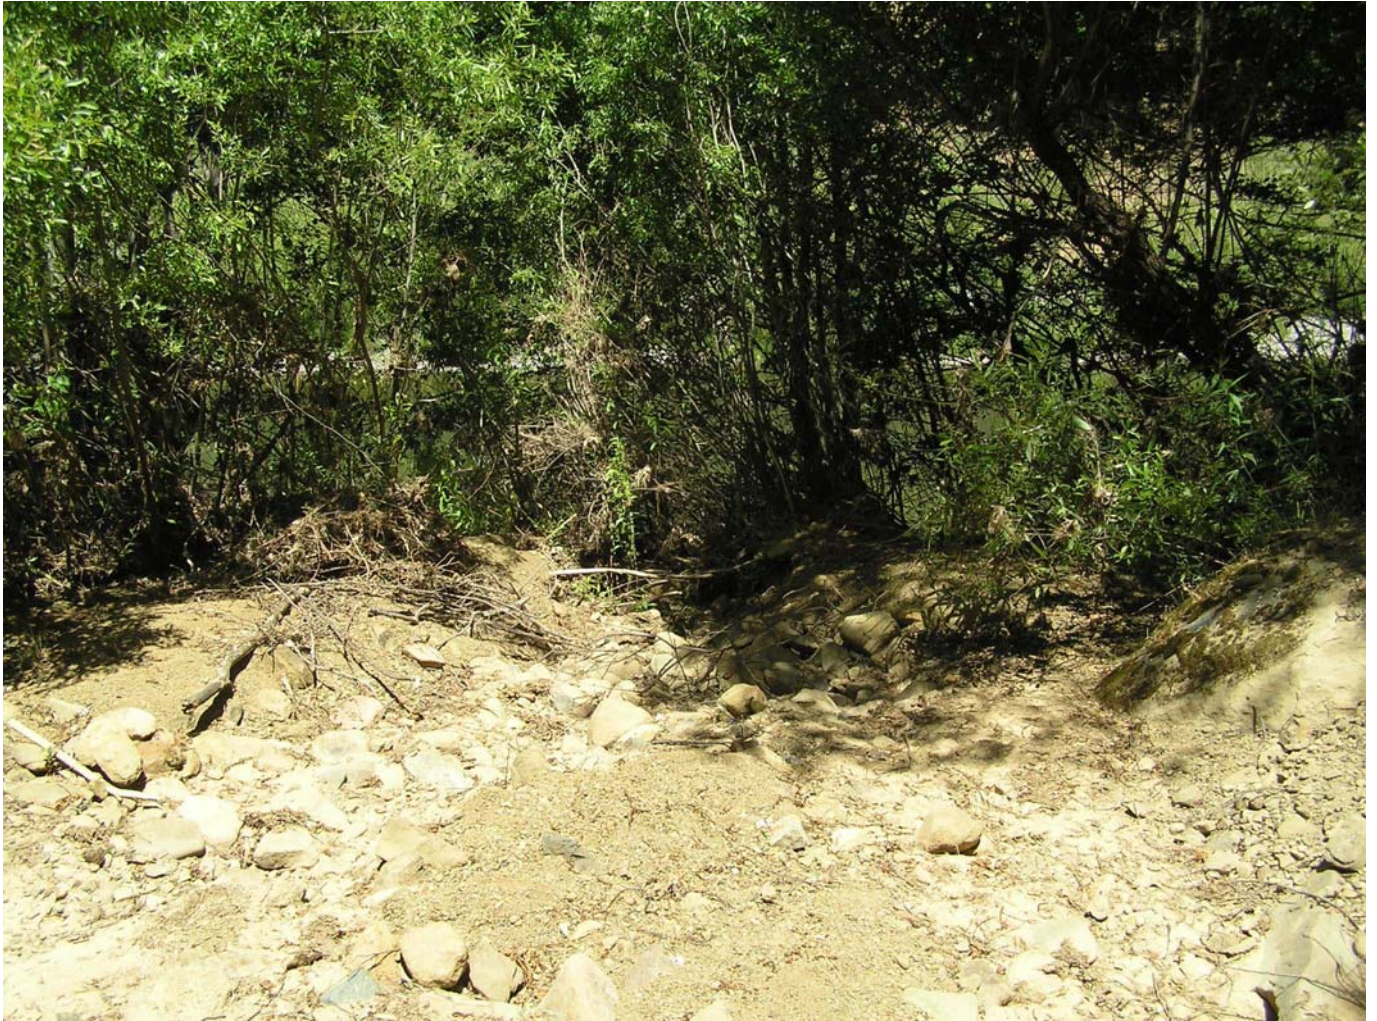
section 5650 of the Fish and Game Code. Sediment, when released during this period and in the quantity released into the Eel River, was likely “deleterious to fish” [5650(a) (6)]. Issuance of an LSAA allows CDFW the opportunity to review projects and propose conditions that serve protect important plant, fish and wildlife resources.

Figure 6. Area where the impacted stream discharged water/sediment into the Eel River.
