Re: Restoration Work at 17777 Eel River Road, Potter Valley, Mendocino County, California.

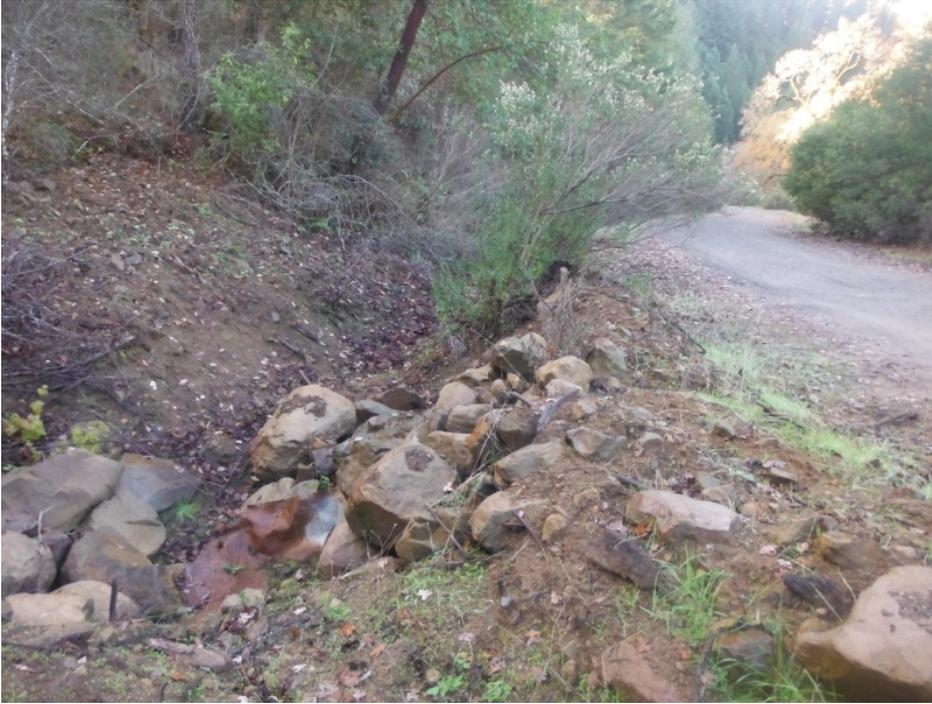
Soil berm above the culvert inlet and fill on the bank west of channel.

- East of the culvert inlet, fill shall be sloped back and excavated as needed (approximately 10 cubic yards of fill).
- West of the culvert inlet, fill shall be excavated down to the original hill slope (approximately 5 cubic yards).
- Above the culvert inlet, the berm shall be removed (approximately 3 cubic yards).

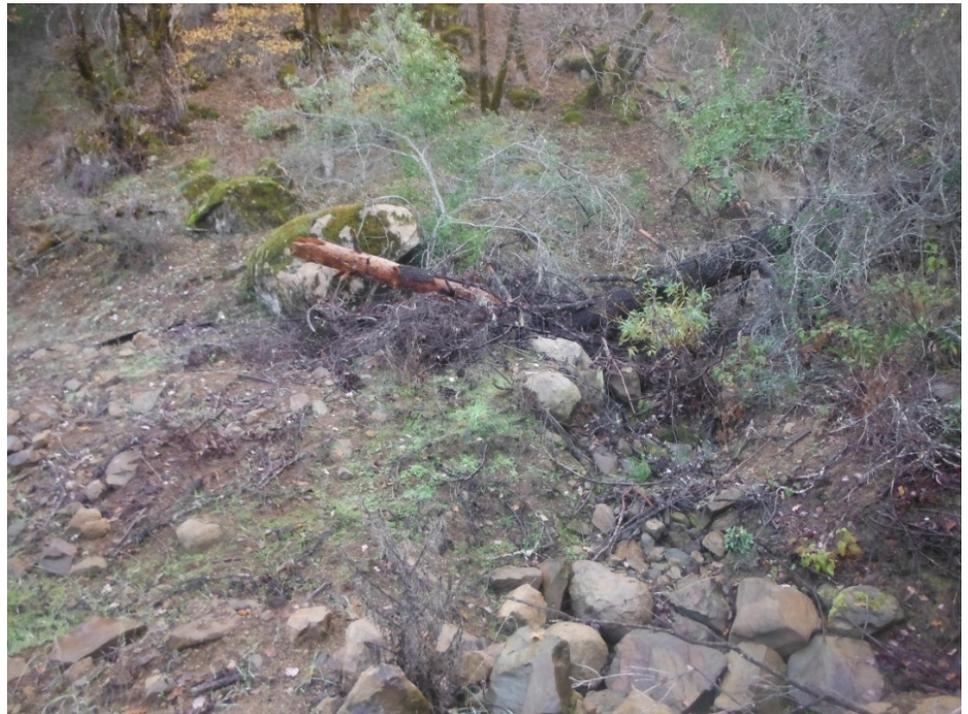
Fill located east of the culvert inlet.

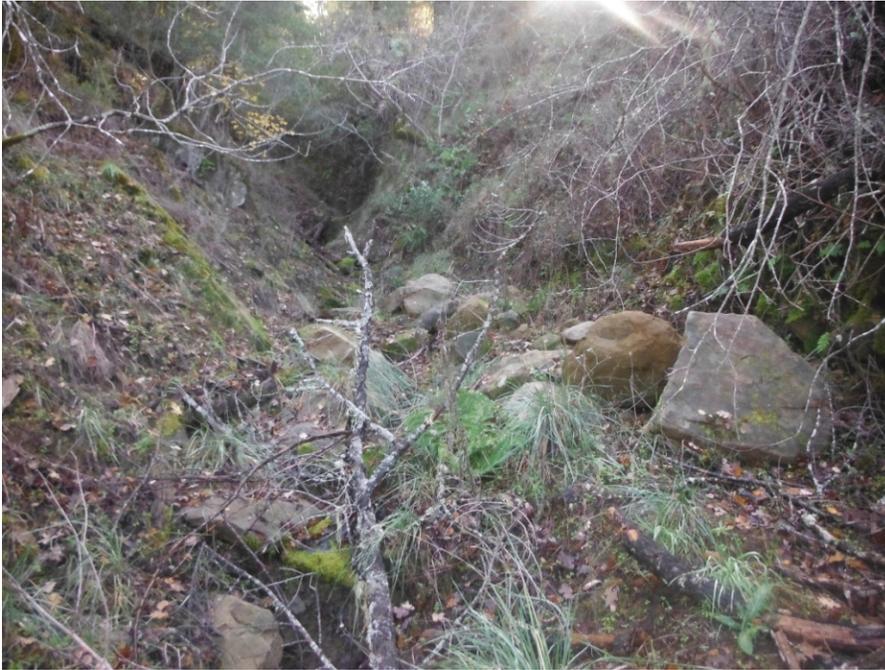
Stream channel above the culvert where re-vegetation has occurred.

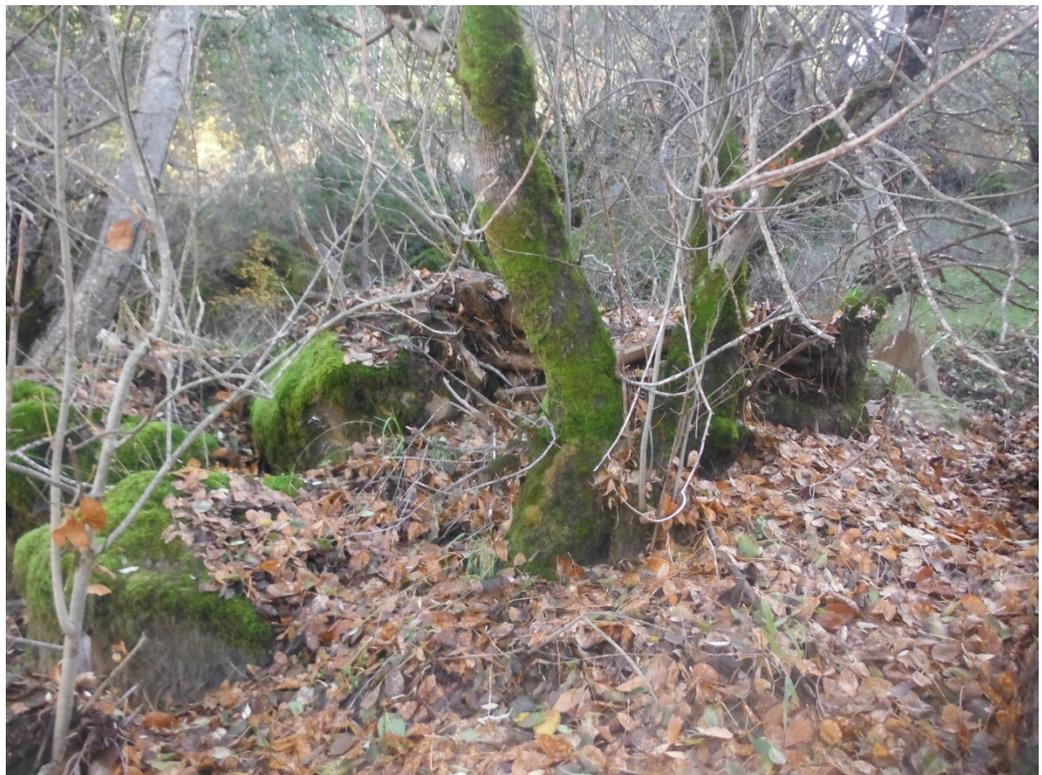
Small sediment plug, located above the Eel River
