## **REBUTTAL**

In the Matter of Olive Franklin Trustee of the  
Charles A. Franklin & Julia F. Franklin Trust and  
Daniel Franklin  
Sediment Discharges Upper Main- Eel River  
ACLC No. R 1-2016-0033

## Case Rebuttal ACLC R12016-0033

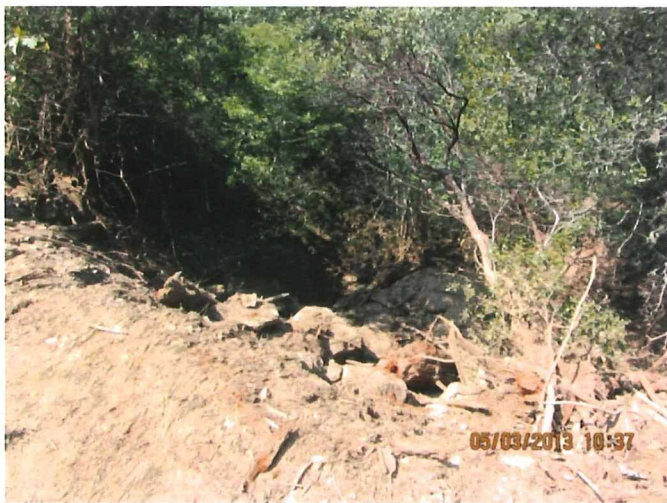
The Photo (below left) is of the culvert blocked by sediment at the M-8 Road. (Image 4255 of the Inspection Team's photos taken May 23<sup>rd</sup> 2013. See Water Board's Case in Chief DVD, Exhibit 8). The photo, below right, shows the same culvert repaired and, after 3 years, still perfectly serviceable.

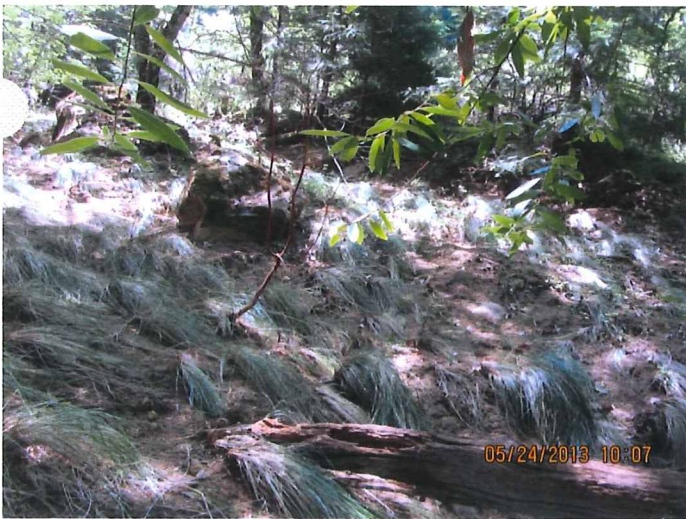
3. The force of the flow over the length of the escape, and therefore the amount of sediment calculated to have been removed from the Affected Stream were greatly overestimated and not relevant in this situation because the sediment was not contained in the water which escaped the tank. It was not "sediment laden discharge", but, instead, as you can see from these photos, pure water which flattened these grasses. It picked up sediment after discharge.

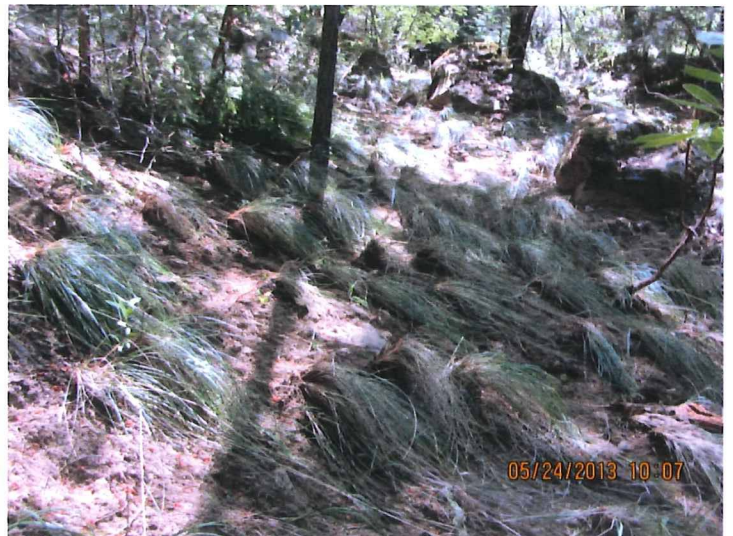
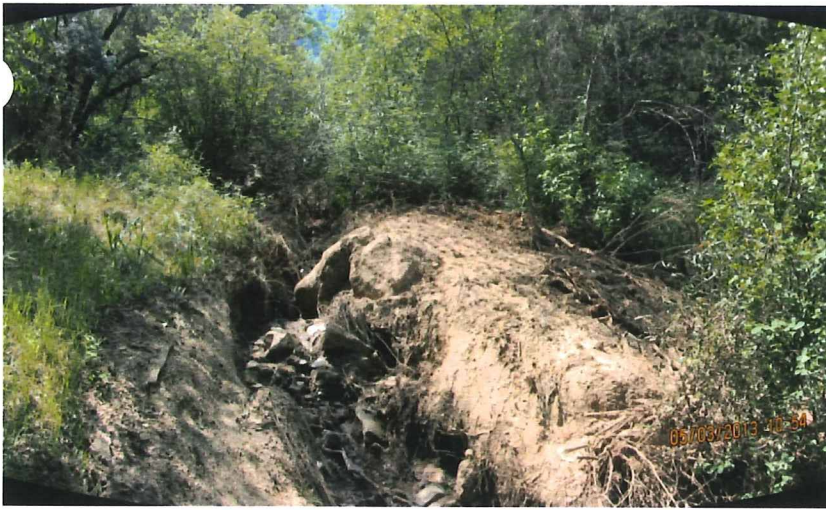
Compare these images with the photo (below) in which flattened grasses are heavily weighted down with sediment – collected as what had begun as pure water raced down the stream channel.

In this photo, image 5, of the Complaint Inspection Report, taken on May 3, 2013, the grasses on right of the Affected Stream are weighted down with sediment picked up as the escaped water flowed down channel from its source at the torn tank.

NB: The good news is that the vegetation quickly recovered. It was flattened, not uprooted, and was soon indistinguishable from that on the Left Bank.

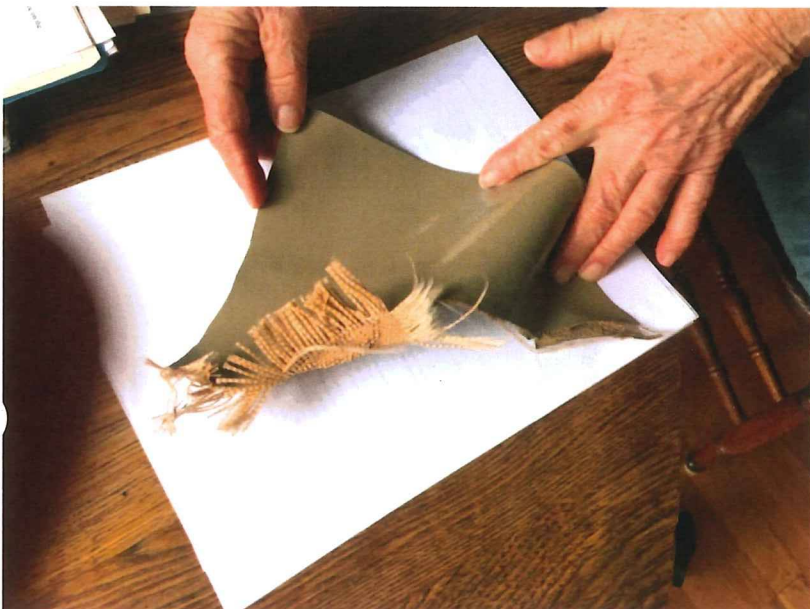
This photo of a sample of the fabric cut from the water bladder on November 17<sup>th</sup>, 2016 shows the fabric to be flexible and with no sign of deterioration. (N.B. one edge of that tank sample is badly frayed: this happened when the bladder burst and tore.)

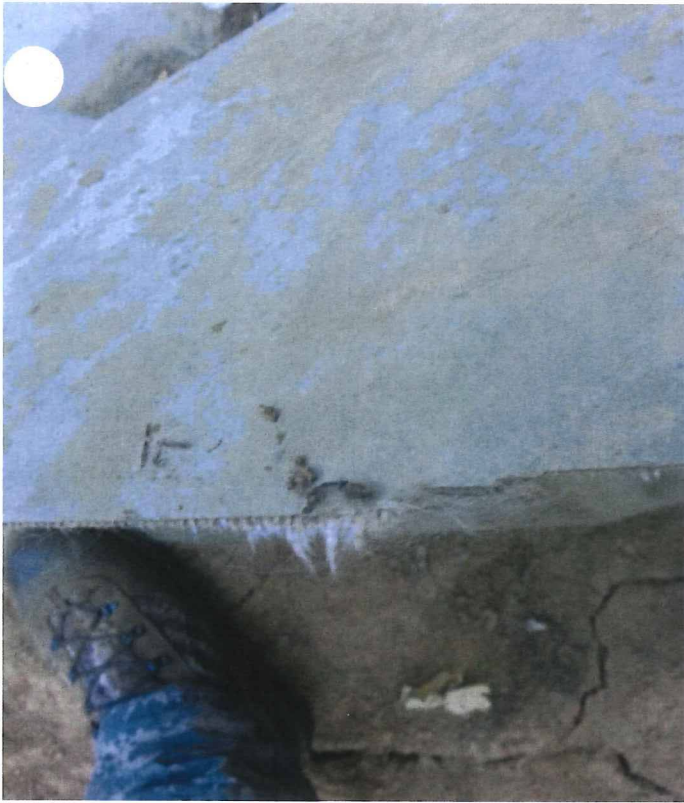
The following photo was taken Nov 17<sup>th</sup>, 2016, and focuses on the tear in the tank, and a possible site of the puncture

This photo was taken on-site. Note the fraying, the ragged edge, the damage at the edge, and the black marks which will not come off. This is likely to be the location of the original puncture.

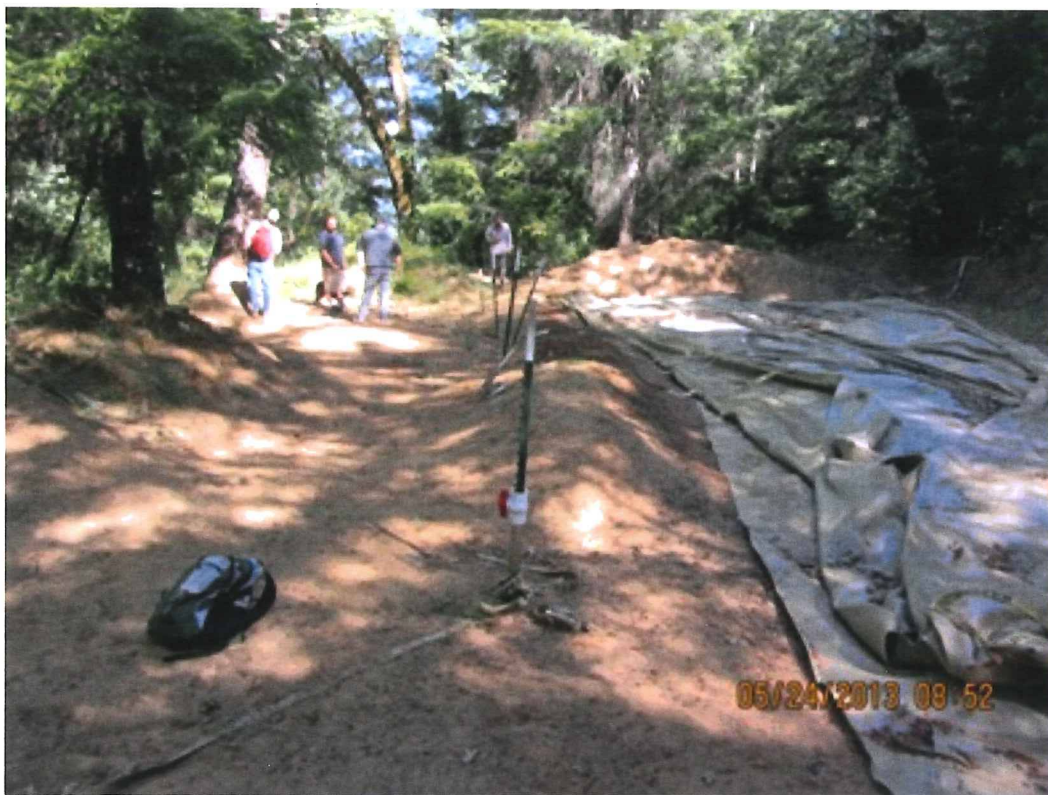
The "fill perched immediately above the watercourse" was, in fact, a berm on the logging deck, created and compacted in preparation for installation of the water bladder several years before, as a containment area – a prudent precaution against the possibility of a leak. A photo of the berm is included in the Complaint Inspection Report; the even height and smooth contours at the end which did not suffer from the initial pulse of water, show the care with which it was constructed in 2010.

As to its "perch immediately above the watercourse the presence of the inspection team in the photo provides scale, clearly showing that there is quite some distance between the berm and the trees, beyond which the land slopes down, over grassy vegetation (see Images 4515 & 4516 , p. into the streambed below. At that point the wide streambed begins. Image 4439 of the Water Boards Inspection photos. (See Water Board's Exhibit 9 DVD)

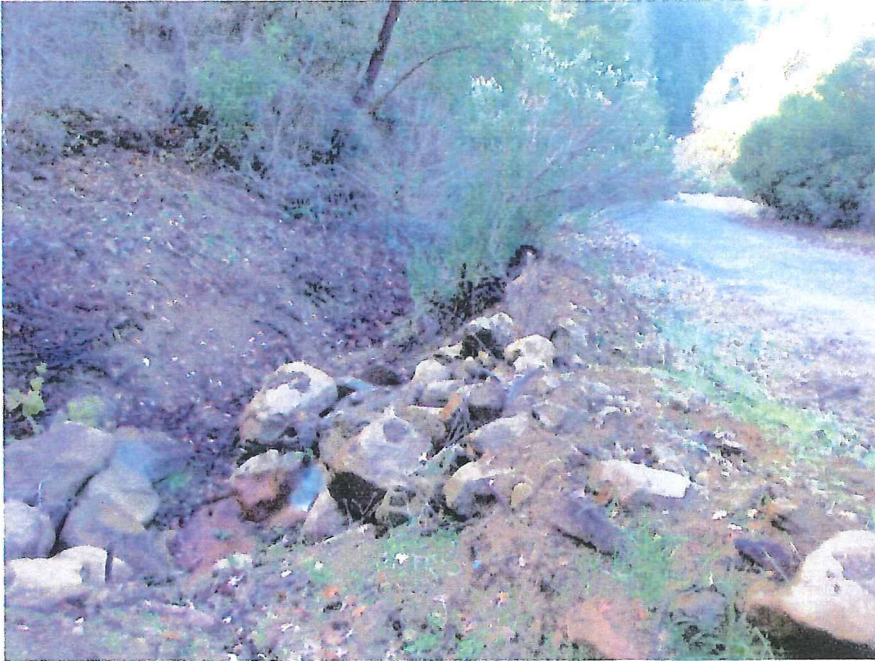
Soil berm above the culvert inlet and fill on the bank west of channel.

Fill located east of the culvert inlet.

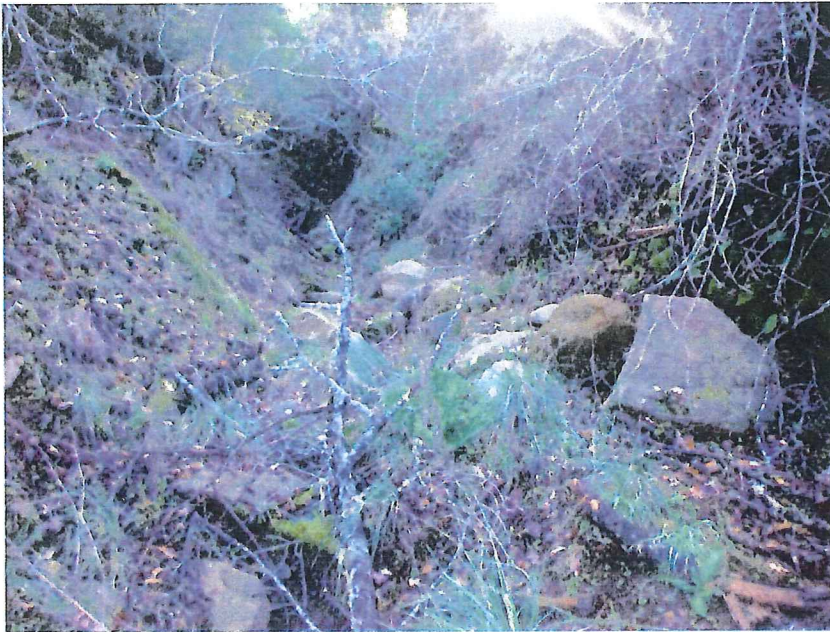
Stream channel above the culvert where re-vegetation has occurred.

Small sediment plug, located above the Eel River

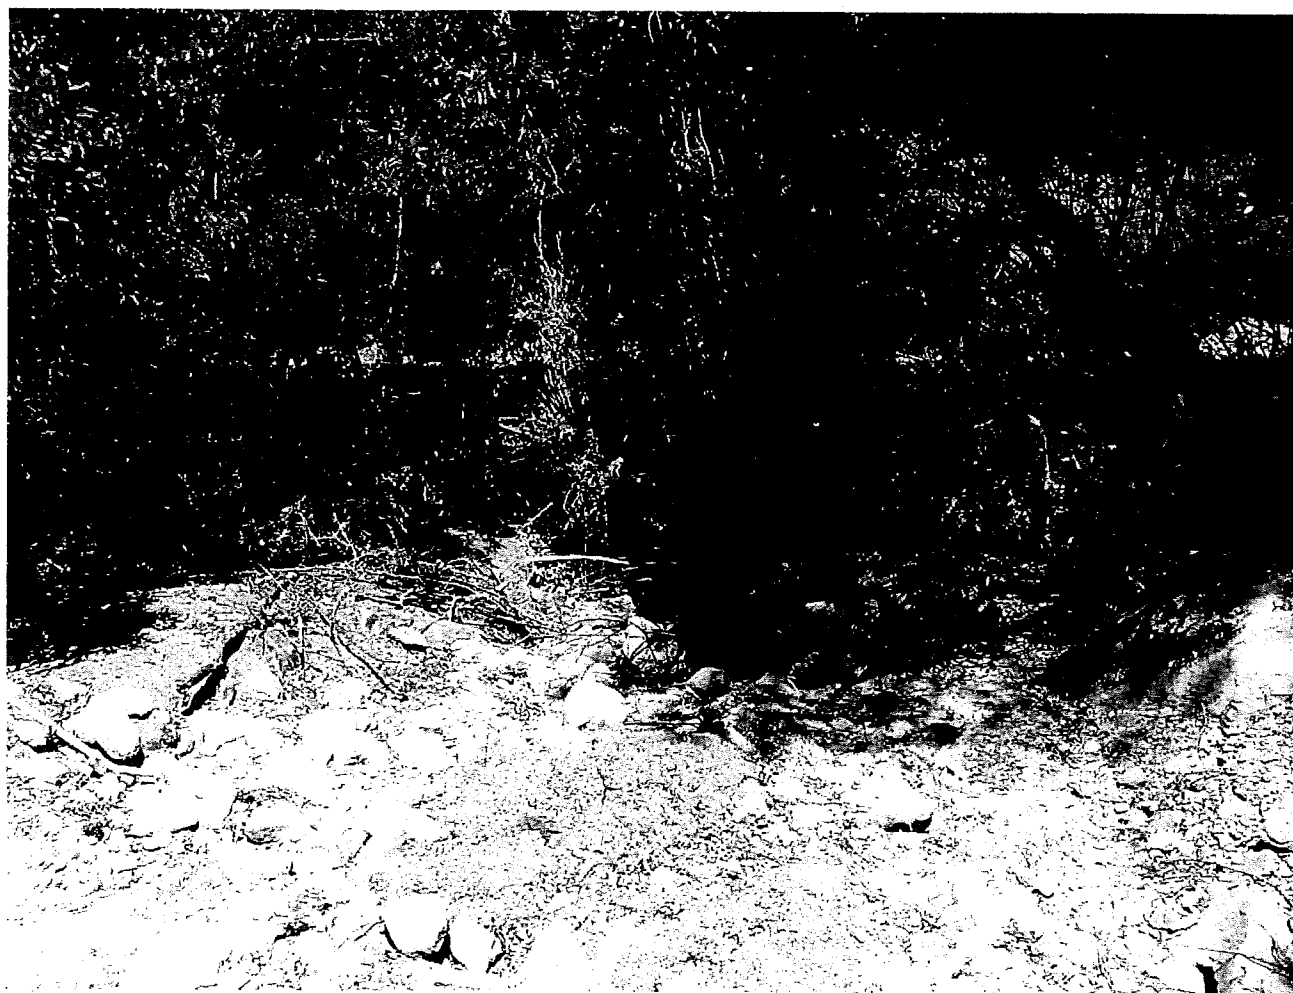
Figure 6. Area where the impacted stream discharged water/sediment into the Eel River.

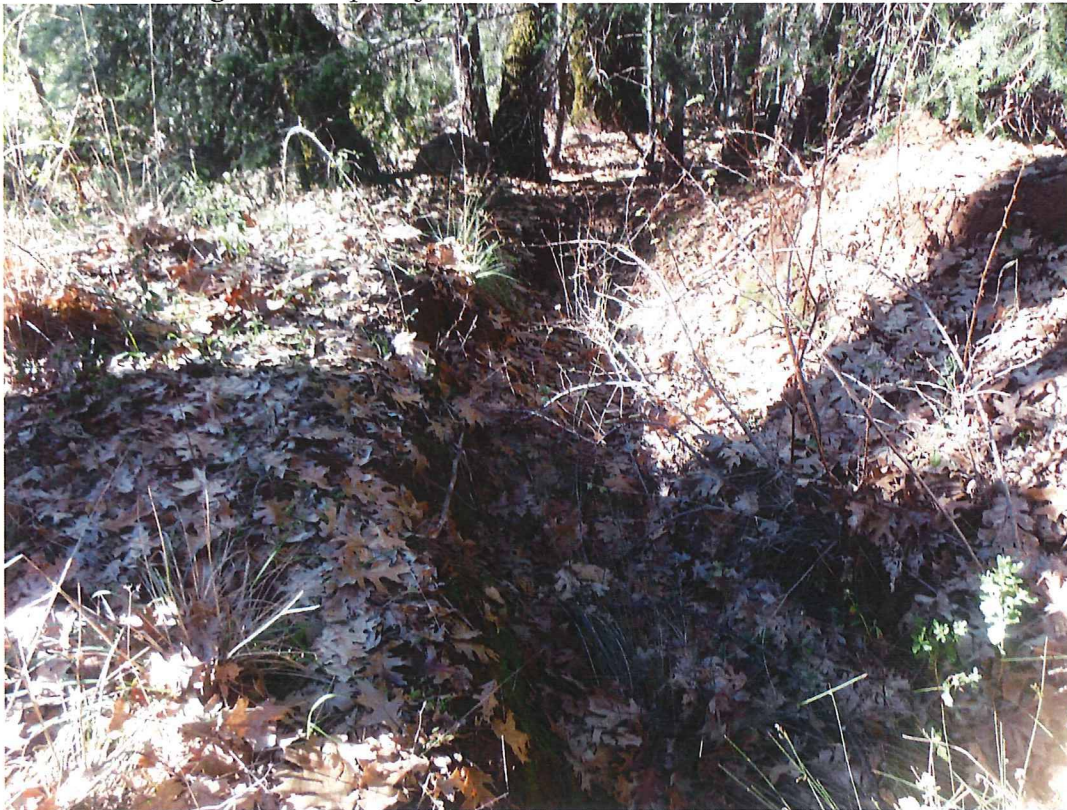
Photo 1: Looking down slope adjacent to bladder site.

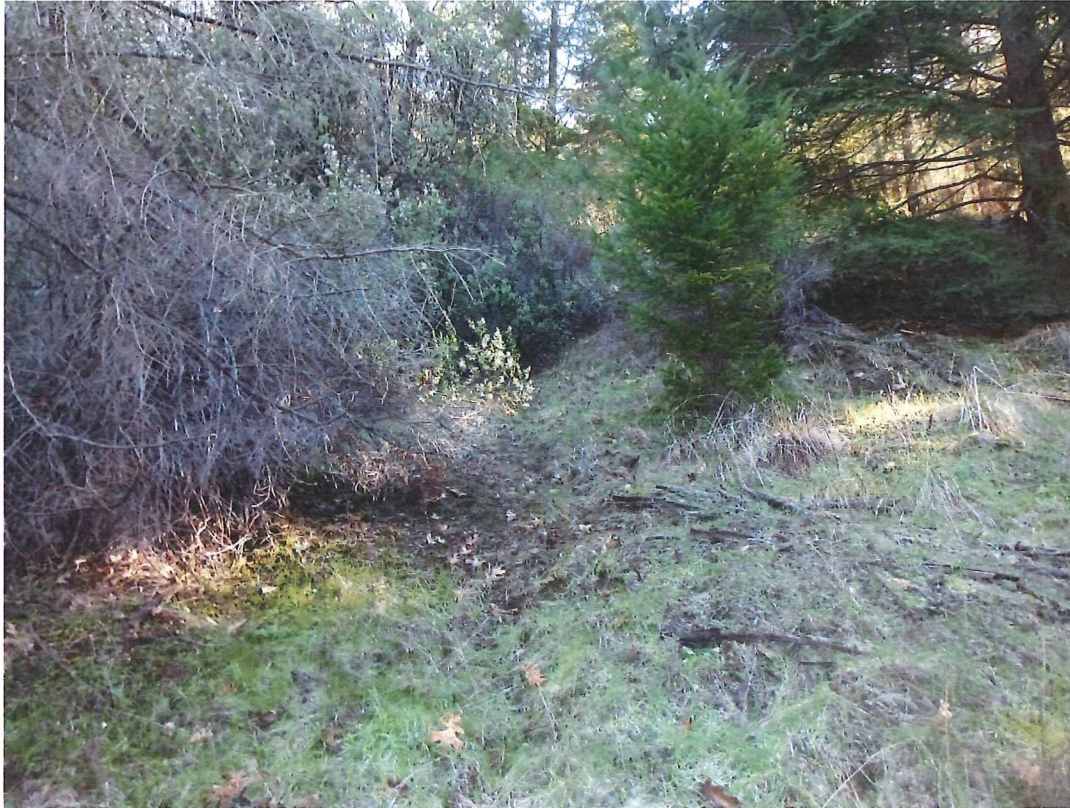
Photo 2: Above the stream channel, looking upslope towards bladder site.

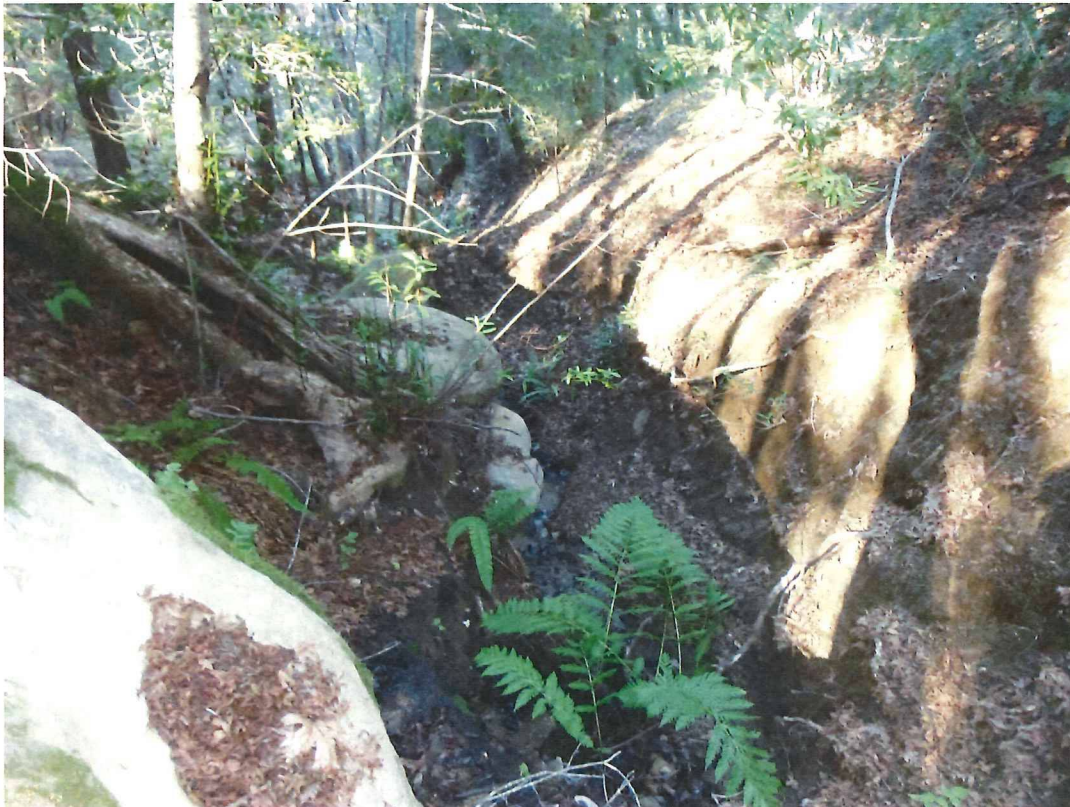
Photo 3: Looking downslope at stream, below bladder site.

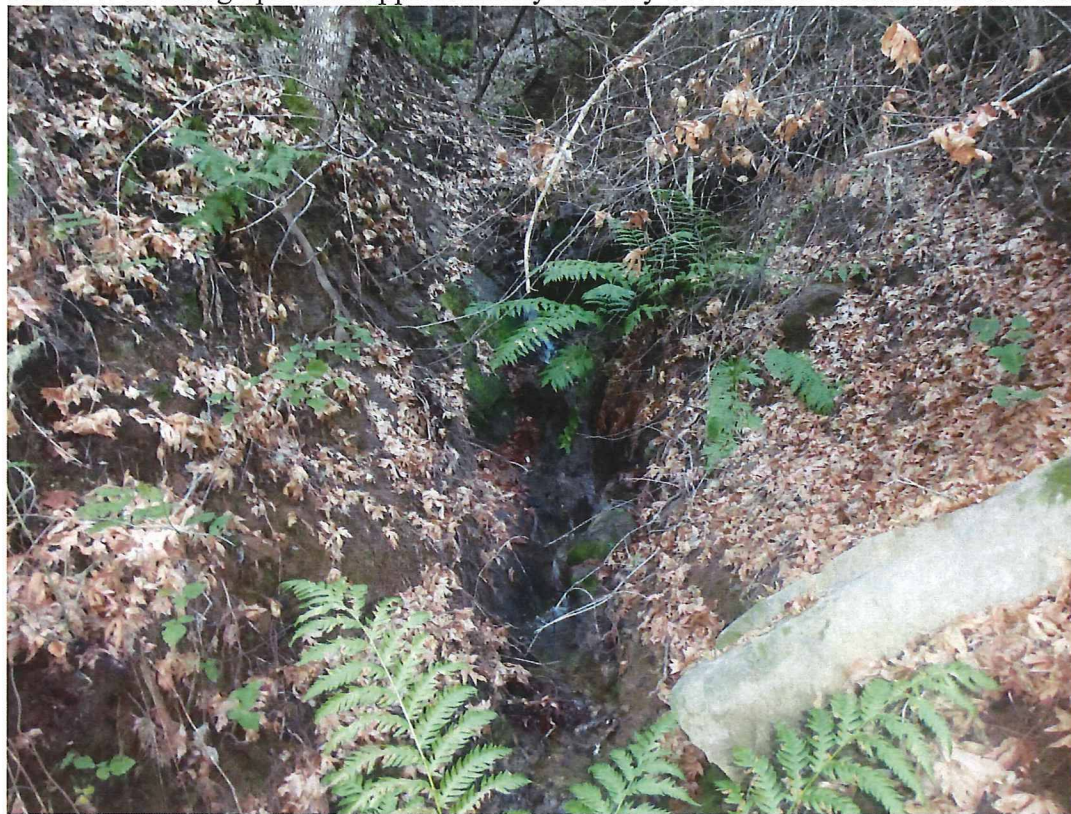
Photo 4: Looking upstream approximately halfway between the bladder site and the Eel River

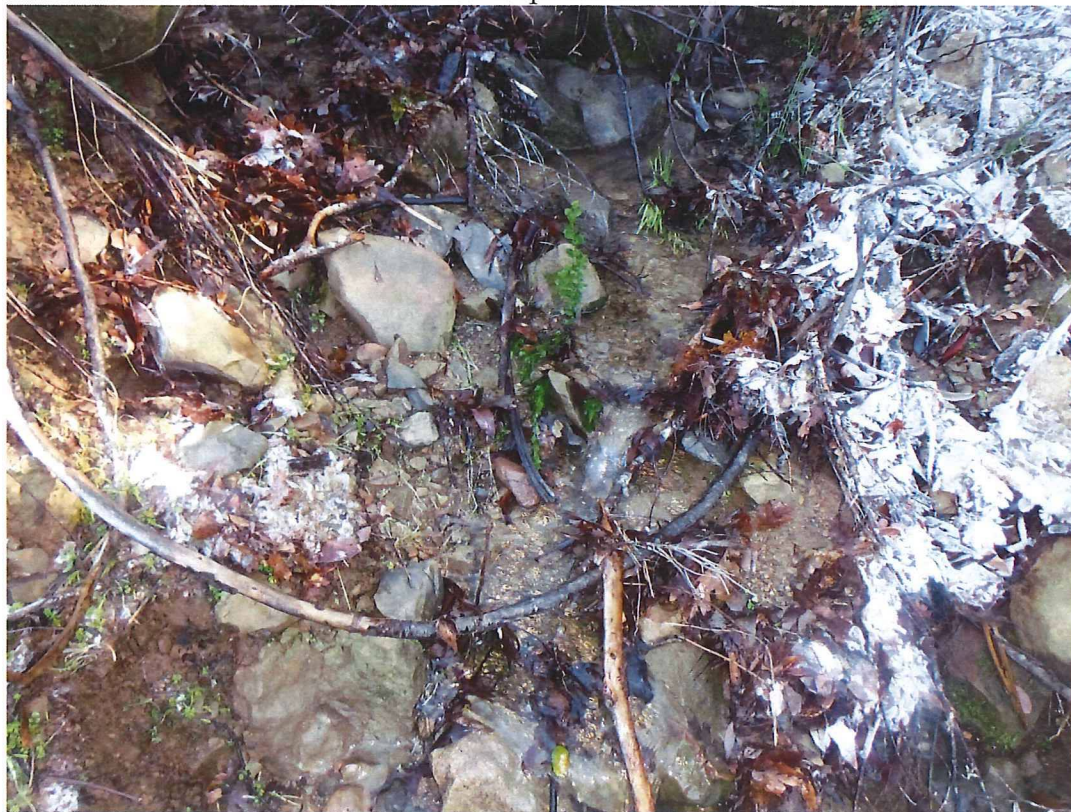
Photo 5: View of the substrate at mid-slope location

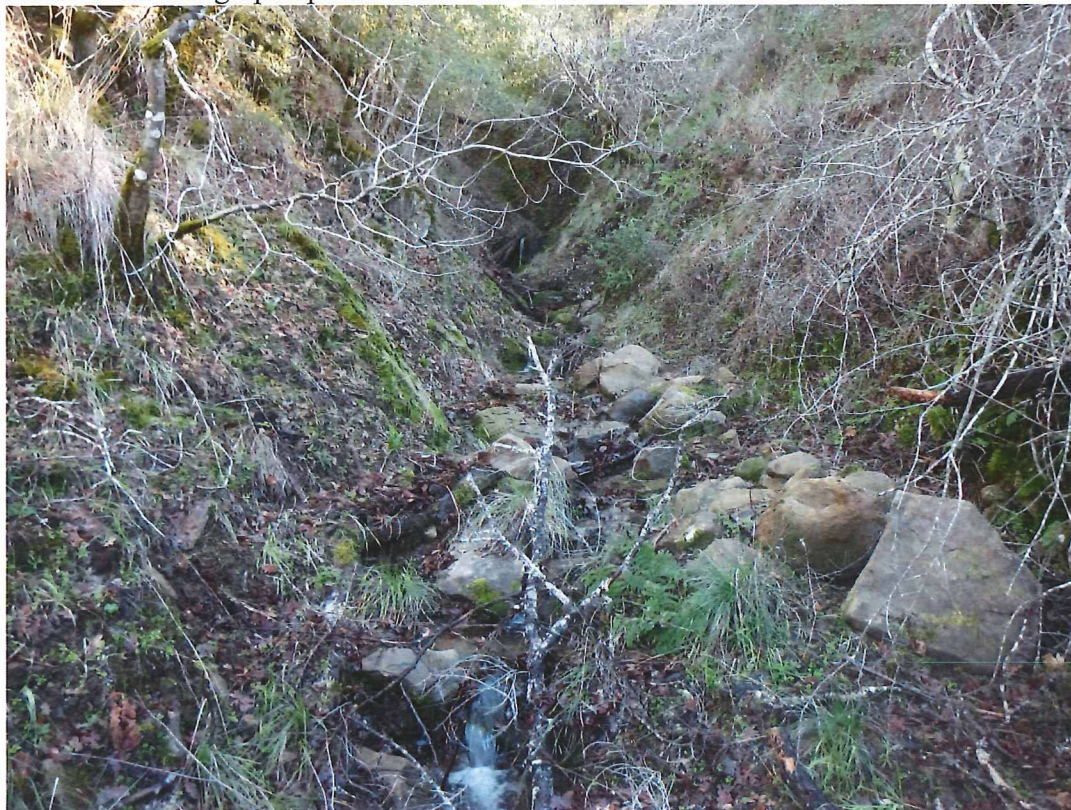
Photo 6: Looking upslope from above the Forest Service M8 Road

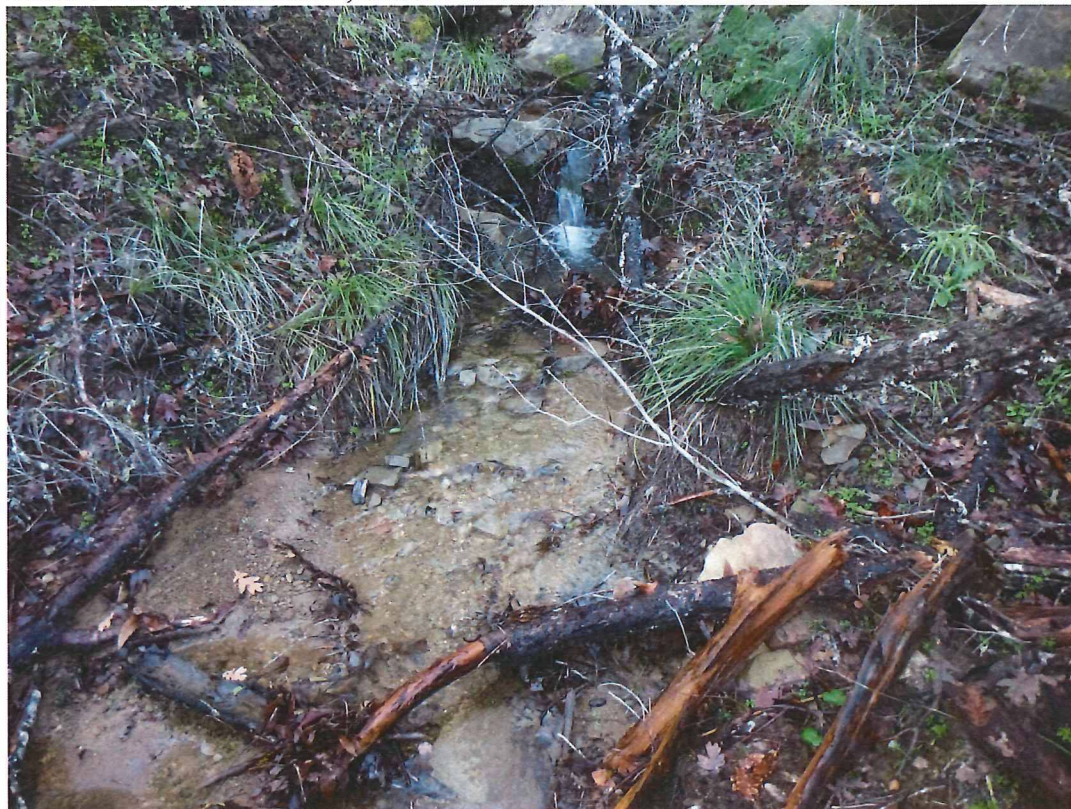
Photo 7: View of substrate, above M8 Road.

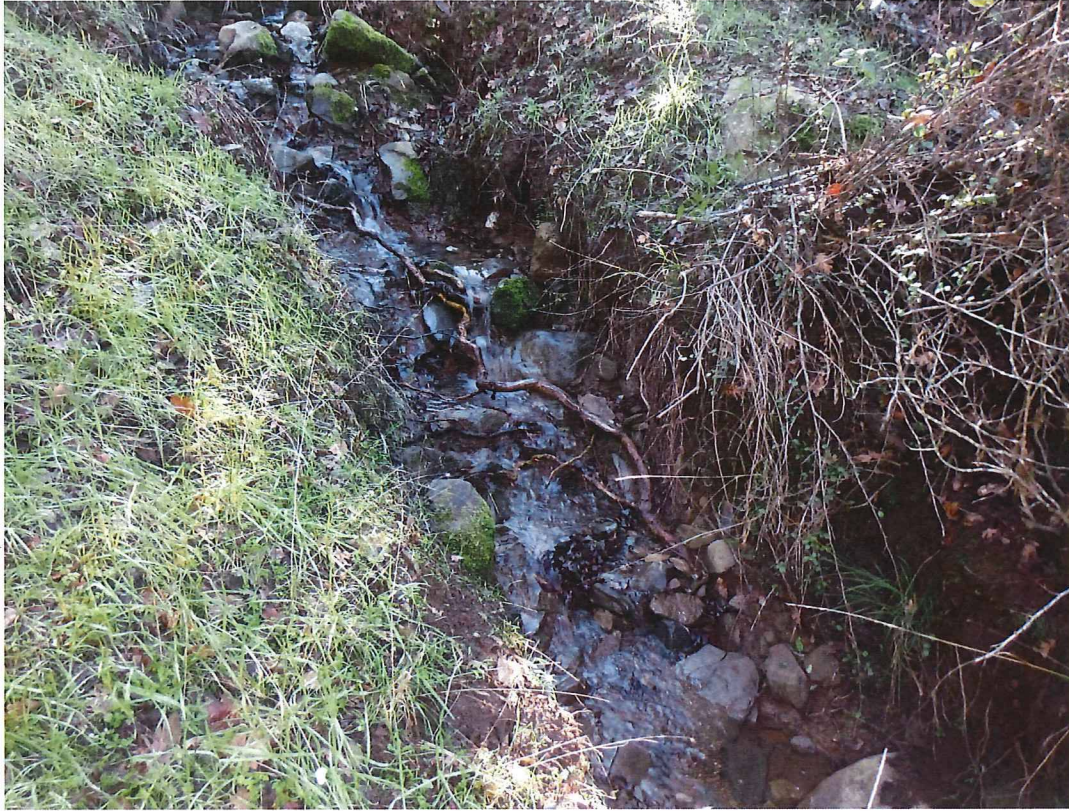
Photo 8: Looking upstream above the Eel River confluence

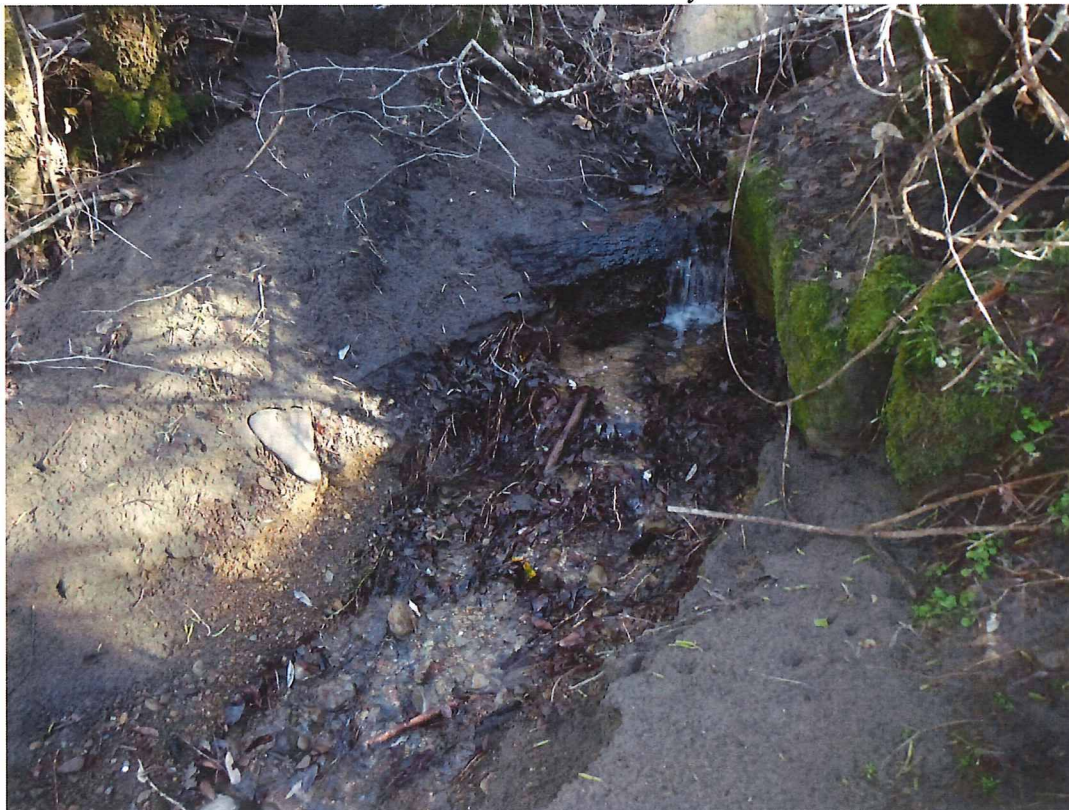
Photo 9: The stream's outlet into the Eel River's sandy bank.

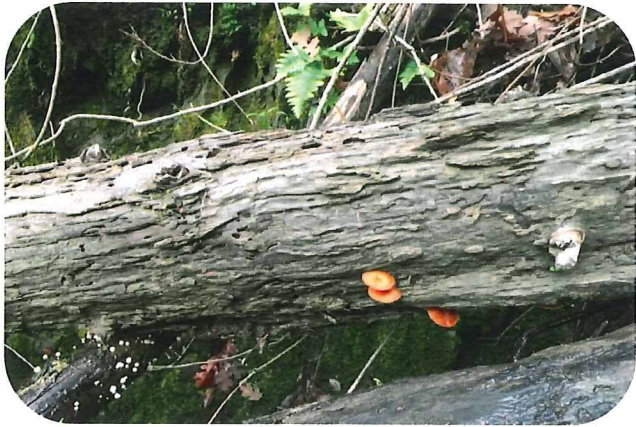
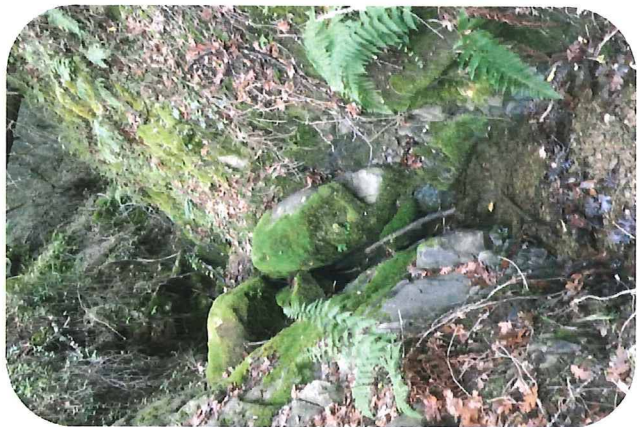
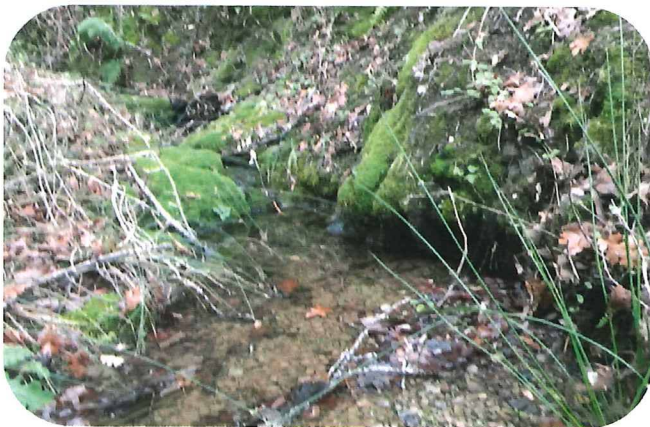
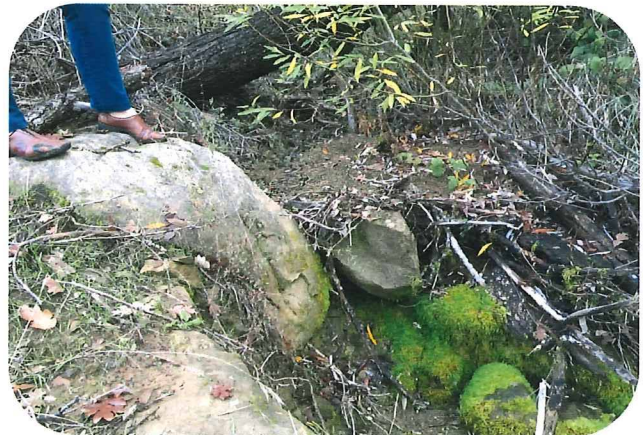
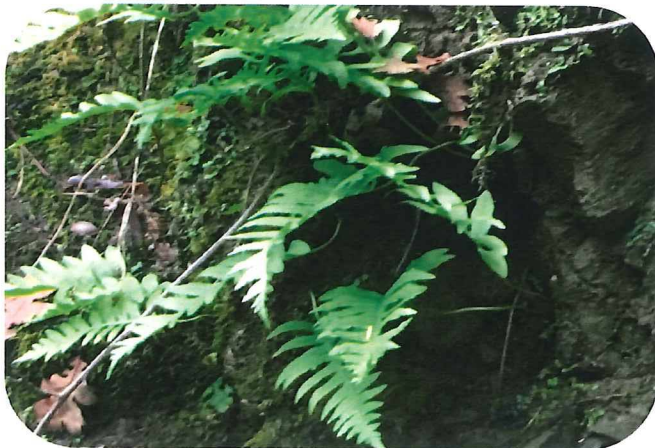
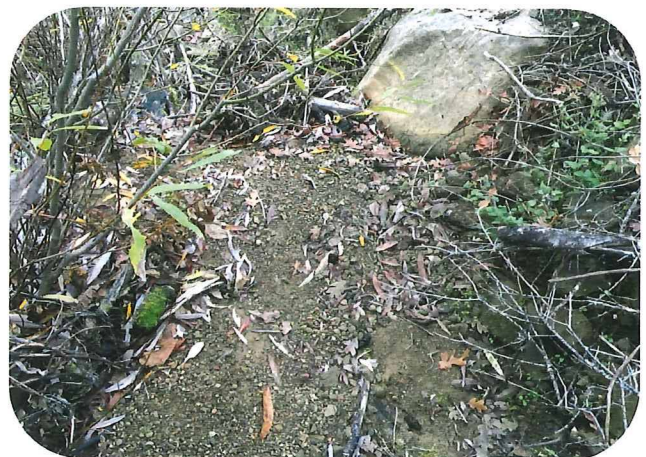
Images of Affected Stream near the M-8, November 17, 2016  
Note the recovery of the streambed and the streambank vegetation.
