C3. Sample Inspection Report and Erosion Control Plan

Date: January 20, 2012

From: Colin Hughes, PG #8549
Pacific Watershed Associates Inc.
PO Box 4433
Arcata CA, 95518
colinh@pacificwatershed.com / 707-839-5130

Subject: Inspection report and erosion control plan for APN 123-456-789, Brown Cow, Valley County, California.

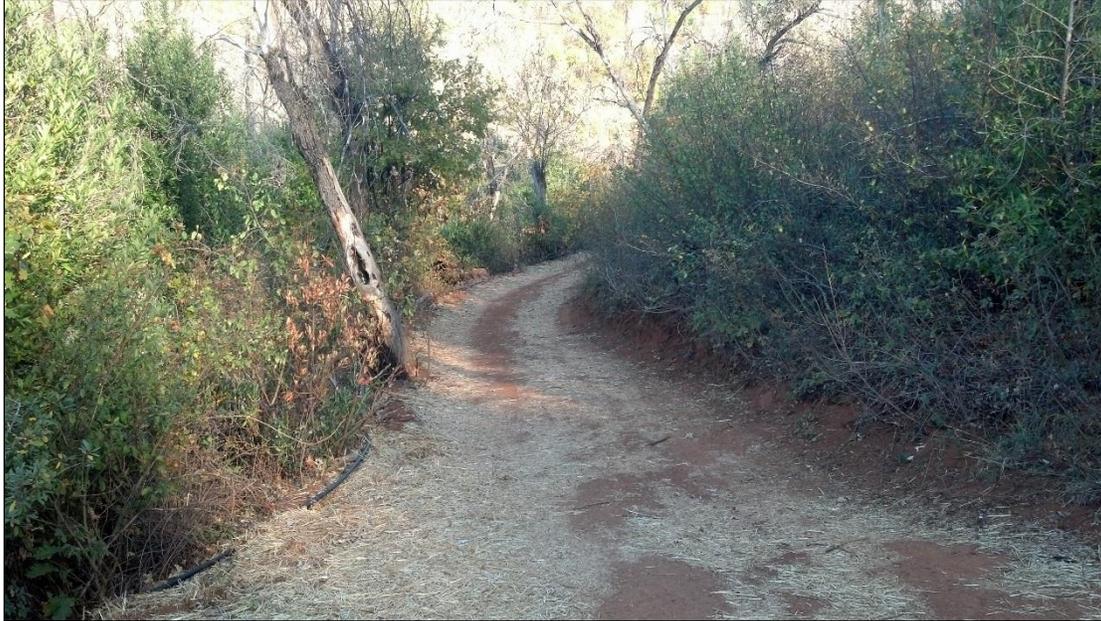
Photo 1. View of the Main Access Road through the XYZ Ranch with low cutbanks and small berm visible at the outboard edge of the road (Map 1).

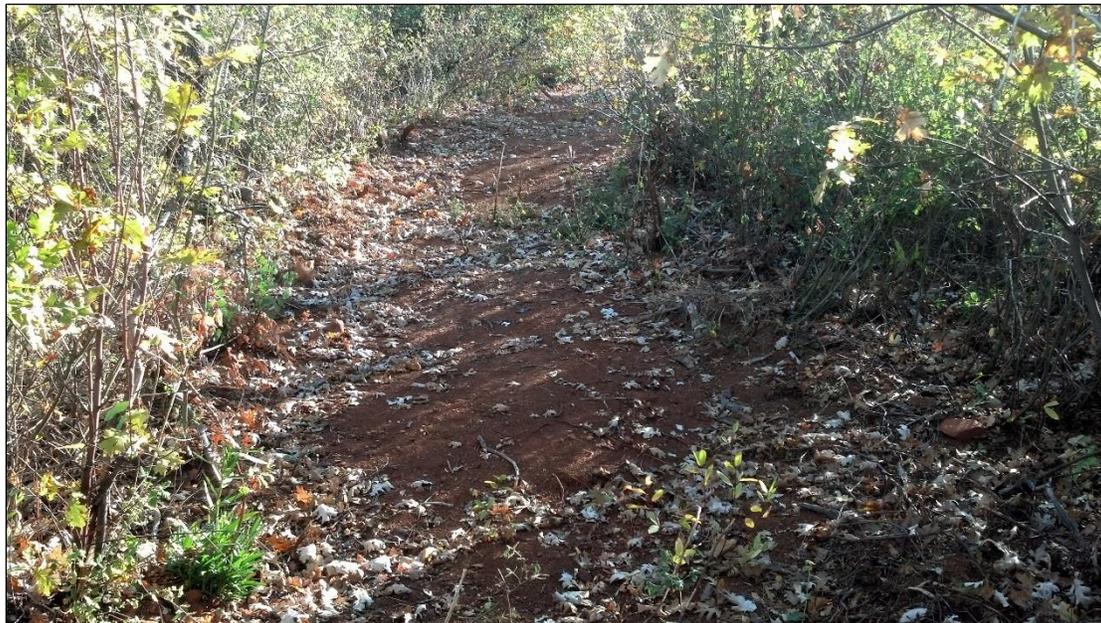
Photo 2. View looking west, of the Main Access Road along the sharp ridgeline in the center of the parcel (Map 1).

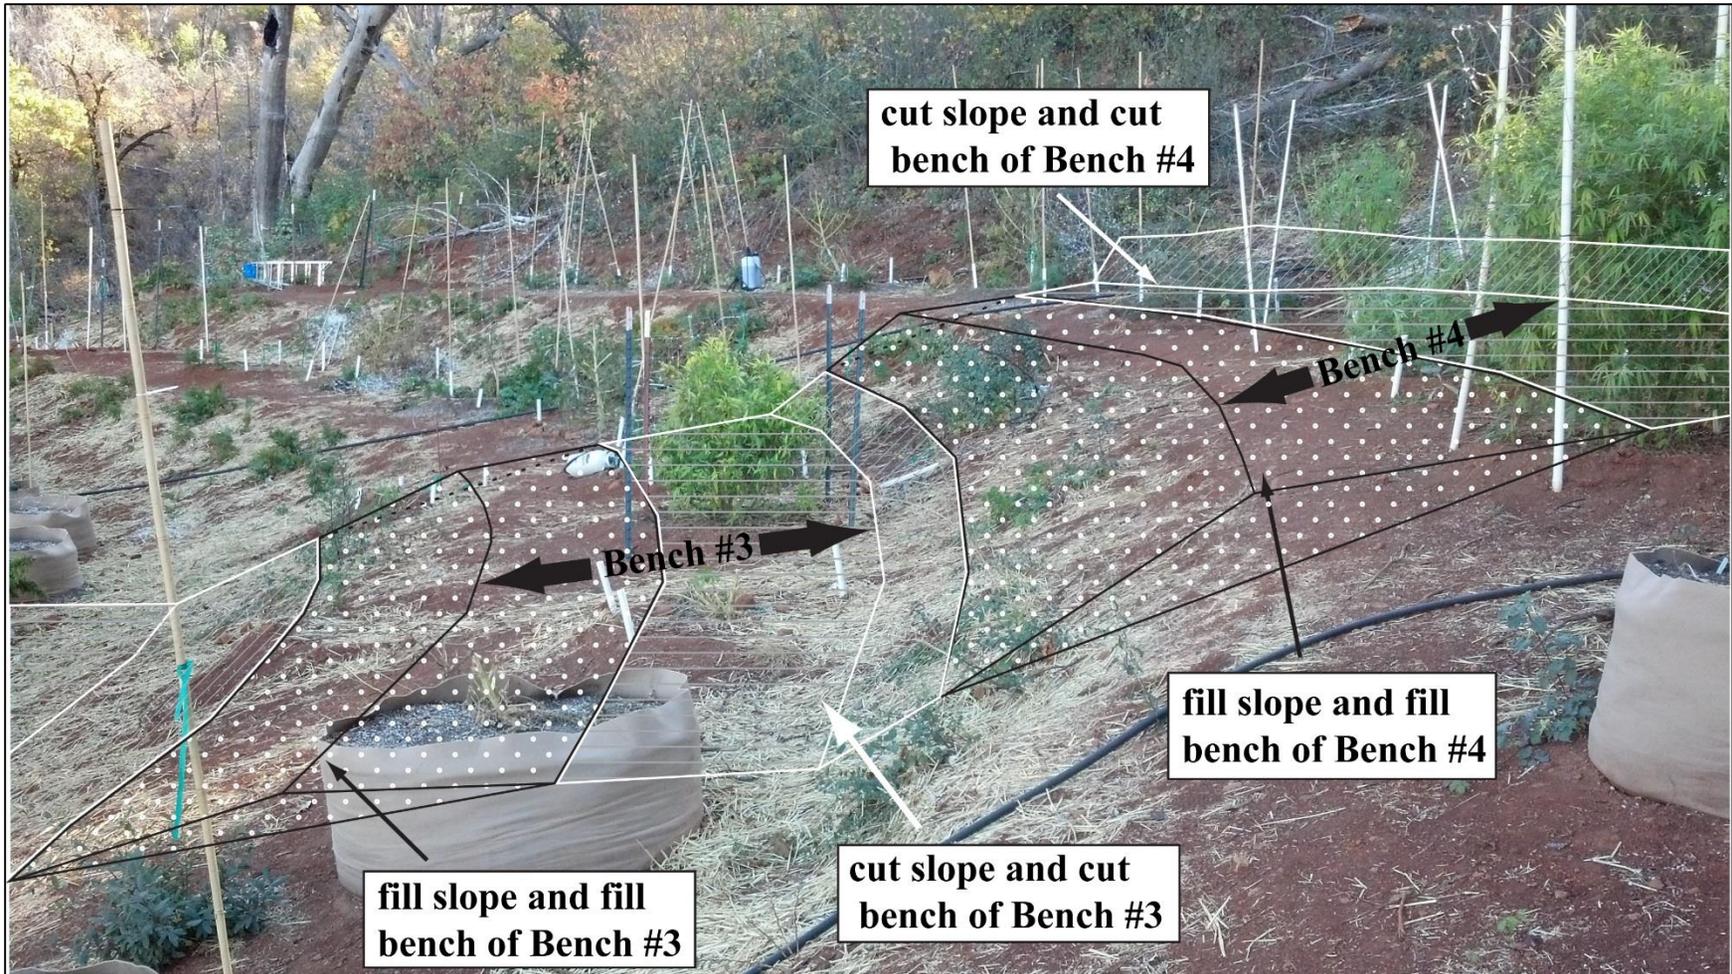
- 1) Projection of the 42% gradient native hillslope from the cutbank above Bench #4 would intersect the middle of terrace surface of Bench #4, suggesting that material excavated from the cutbank was emplaced on the preexisting surface downslope of the excavated bench to form a 7 to 10 foot wide bench surface of both cut and fill sections (Map 2, Photos 3 and 4).
- 2) Preexisting vegetation not entirely removed during pre-construction clearing and grubbing protrudes (i.e. is sprouting), in most areas, from the boundary between cut and fill slopes. The broken and stripped stems of the protruding shrub remains is consistent with the inferred means of pad clearing and terrace construction (bulldozer blade). Vegetative regrowth of the shrubs is only possible due to the root structures remaining intact and in place. The orientation of the broken shrub stems (lying down and

Photo 3. View looking east across Pad #1. Cut and fill areas of Benches #3 and 4 are graphically illustrated in cross section to display the cut and fill bench areas and thicknesses. Approximate fill areas are bounded by black lines with white stippling patterns, and cut areas are bounded by white lines with white lined patterns.

- 3) Fill depths are observable as being equal to or less than approximately 2 feet at the outboard edges of each bench and no large stockpiles of excess graded earthen material are built up on the pad. Cross section #5, at station 1+25 ft has no cut area identified and only fill volume surveyed, suggesting a predominant bulldozer push direction of west to east (Appendix B).

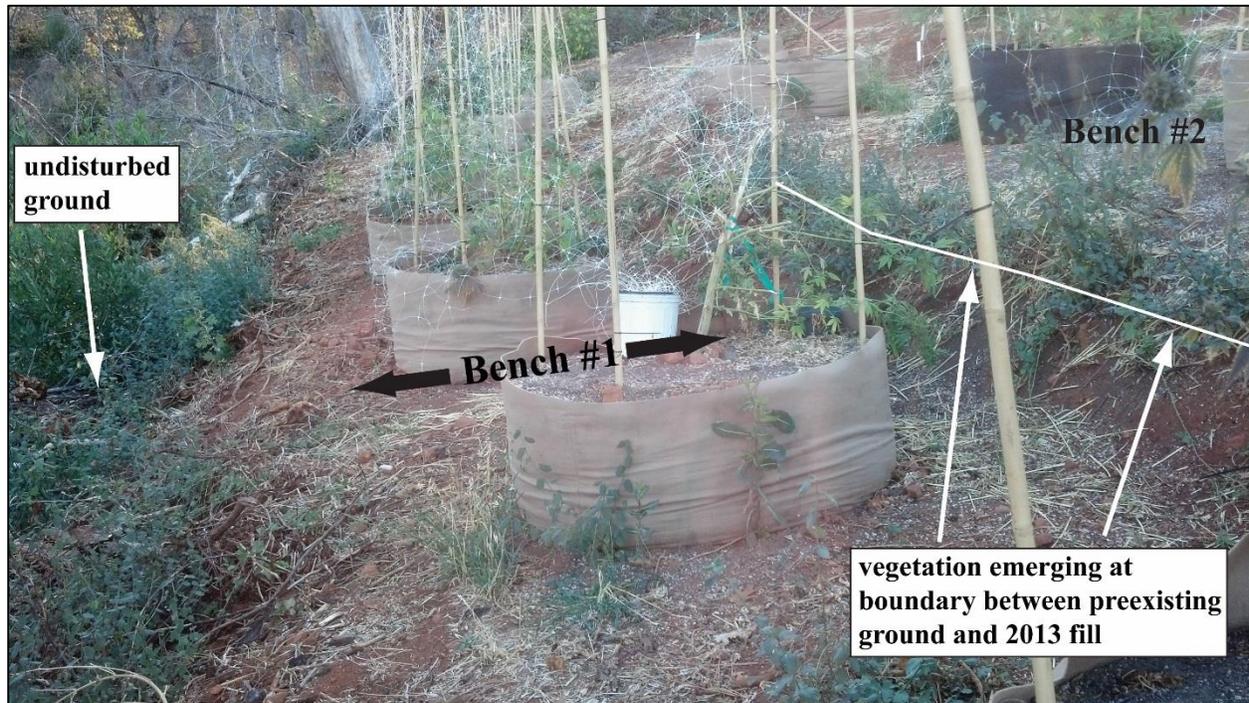
Photo 4. View of the outboard portion of Pad #1, looking southeast at Bench #1. Note the stripped stems and regrowth of vegetation from in place root structures midway up the cutslope of Bench #1.

Analysis of the tape and clinometer survey of Pad #1 estimates that a maximum of 60 - 65 yd³ of earthen material was cut from the preexisting landing to construct the 3 new terraces and modify the large Bench #2 through grading performed in 2013.

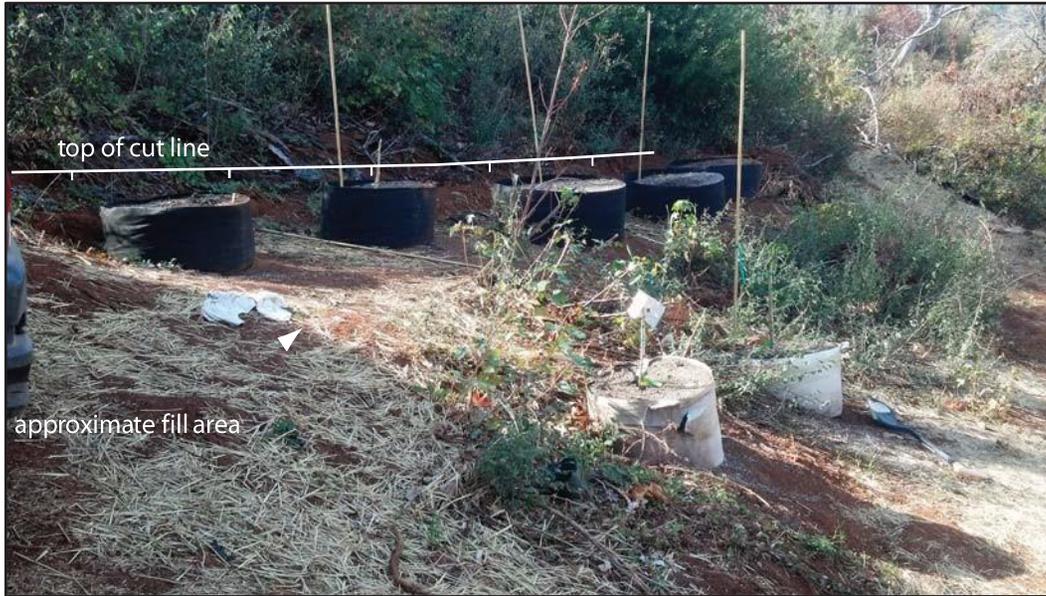
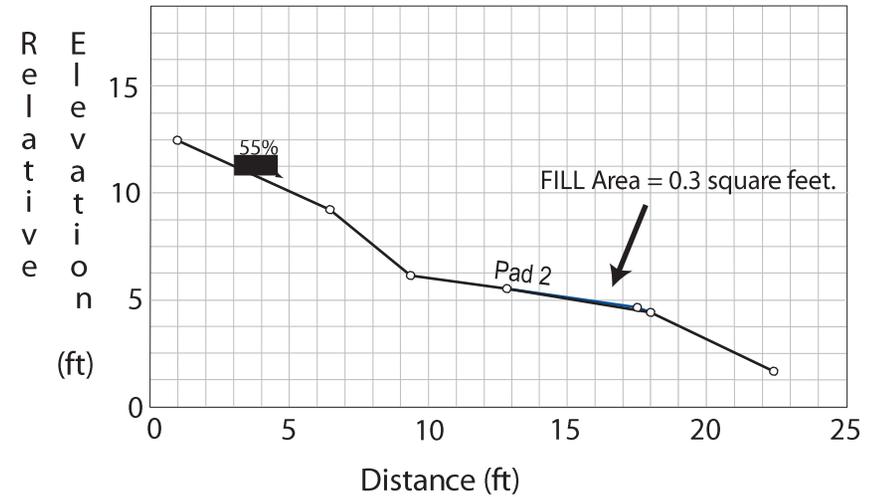
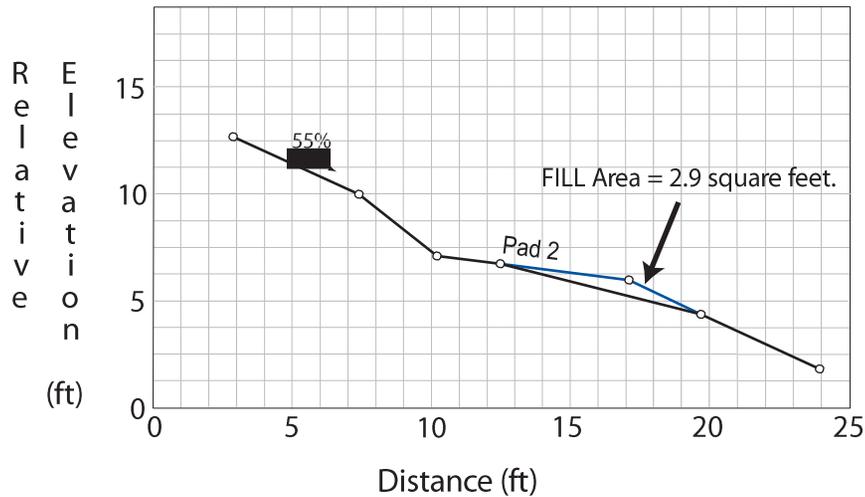
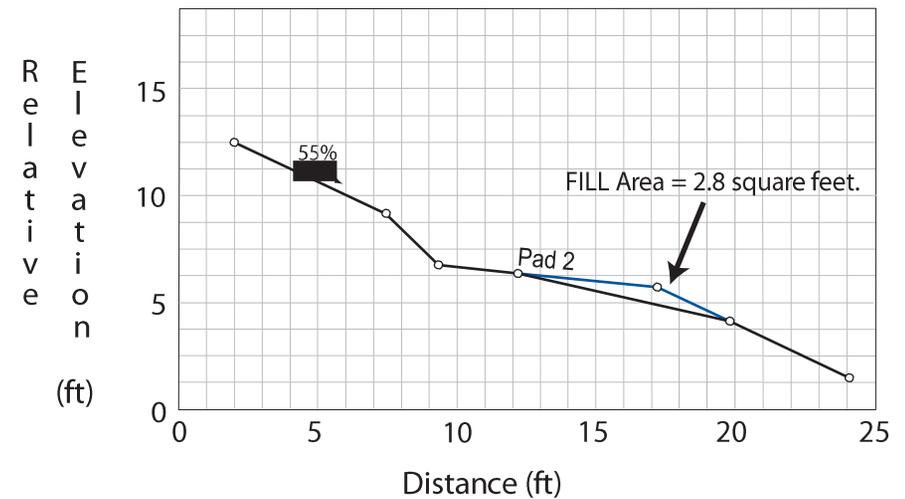
Pad #2, illustrated photograph and cross sections 1 - 3 (estimated fill volume = 3 cu yd)

mulch was observed to have been placed on the Pad #2 bench and fillslope surfaces for the purpose of erosion prevention, achieving approximately 10% coverage of exposed mineral soil.

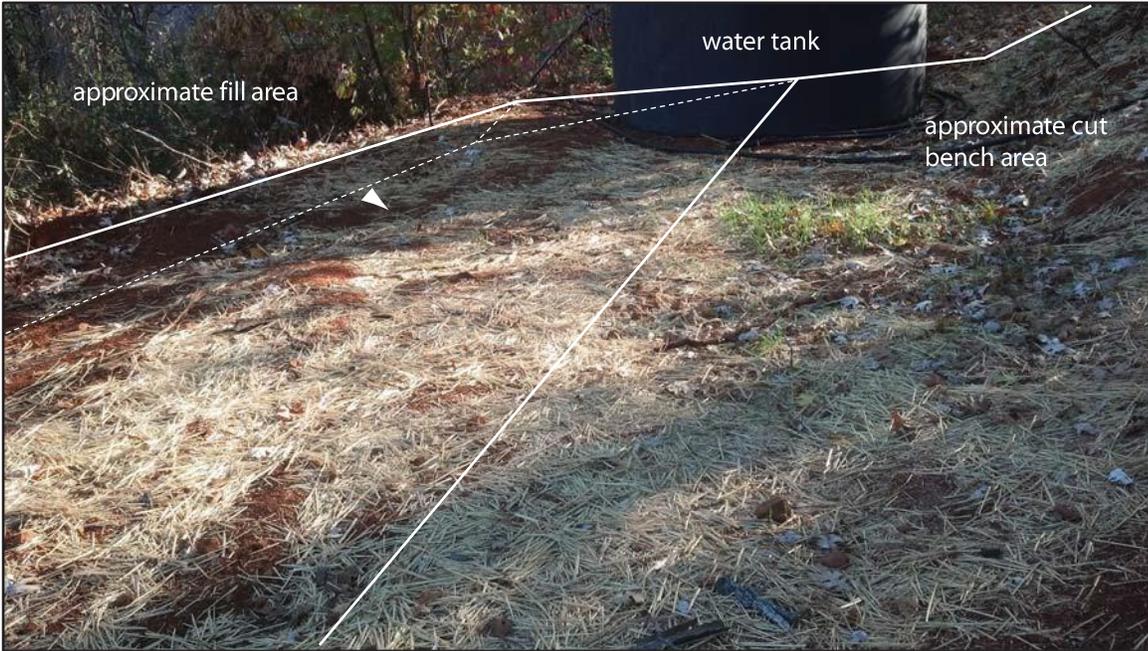
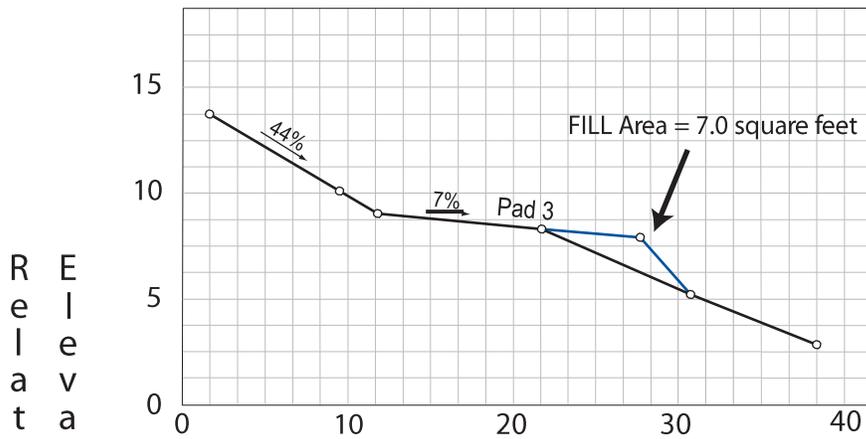
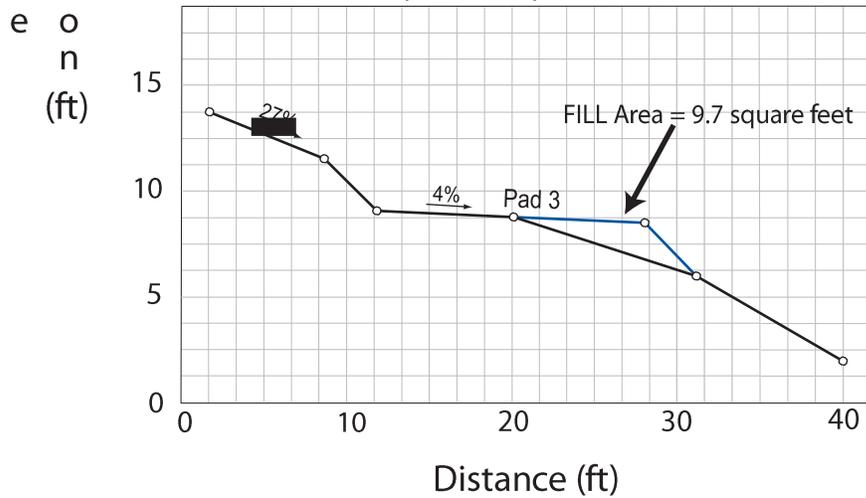
**Pad #3, illustrated photograph and cross sections 1 and 2
(estimated fill volume = 8 cu yd)**

A large bench skid road was observed to intersect with Pad #3 and continue both downslope towards Pad #1 and contour upslope to the northwest. It is highly likely that Pad #3 has been constructed on a preexisting small tractor cut connecting the Main Access Road alignment with the large skid road to the east.

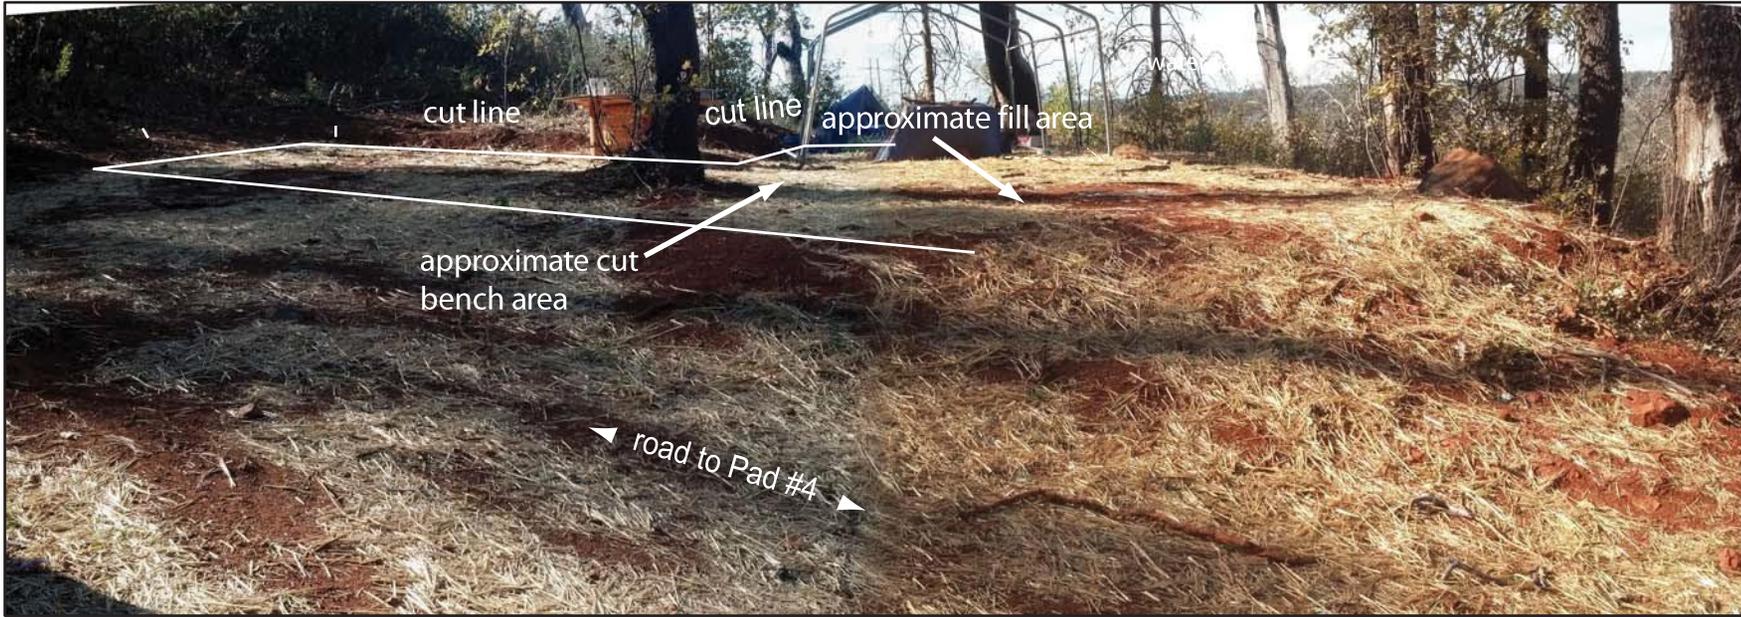
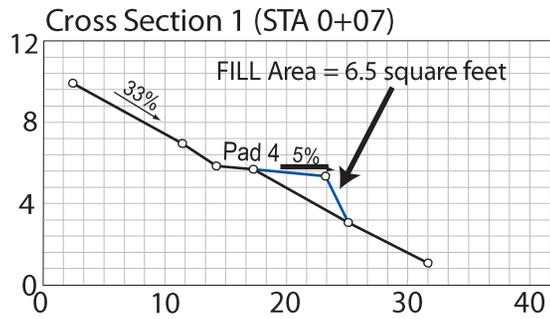
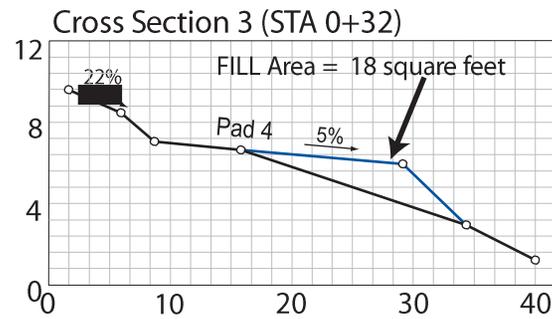
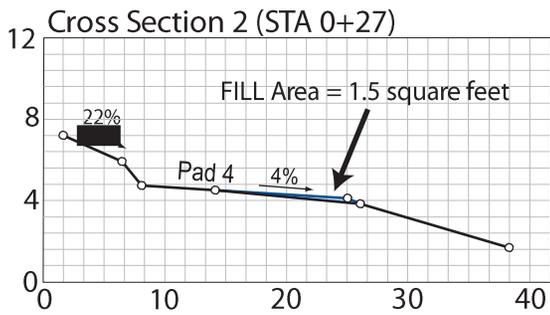
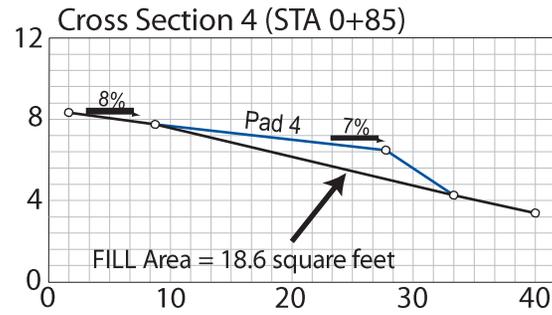
Pad #4, illustrated photograph and cross sections 1 - 4, (estimated fill volume = 41cu yd)

An area approximately 6,450 ft² in size located directly downslope (northeast) of Pad #4 and a smaller, 675 ft² area, immediately south of Pad #4 were observed to have been cleared of vegetation during 2010 grading activities on the property (Maps 1 and 2). No evidence of substantial grading was observed within these areas (e.g. cuts, fills, overturned soils with root material). Stripped stems of in place vegetation were observed protruding from in place soil. Activities conducted in these areas in 2010 are inferred to have been brush removal with a bulldozer or Bobcat blade.

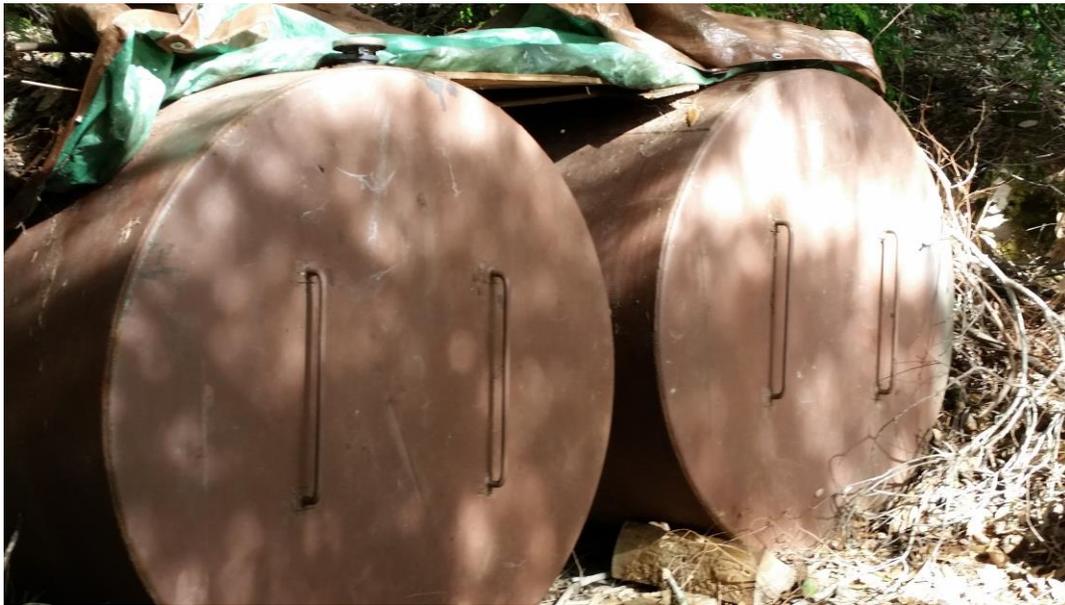
Photo 1. Two 1000-gallon AST. Tanks are located on wooden pallets. There is no visible or olfactory indications of a hazardous material spill or soil contamination.

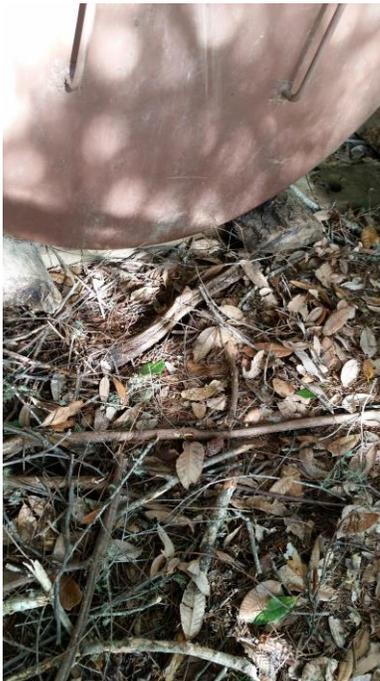
Photo 2. Base of one of the 1000-gallon AST. No soil contamination observed.

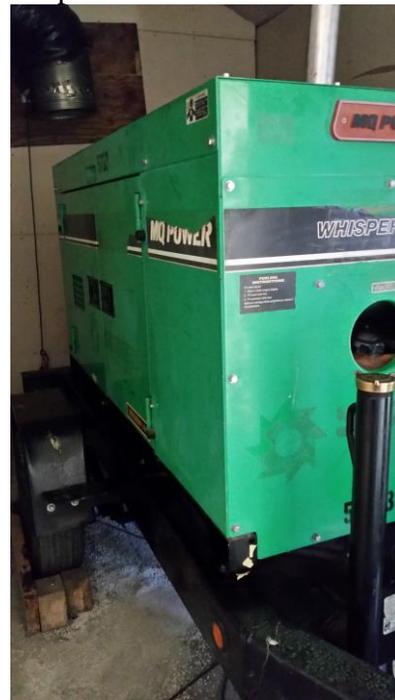
Photo 3. 25 KW Generator. Note that generator is on a concrete floor and there are absorbent chips beneath the generator to clean up small drips.

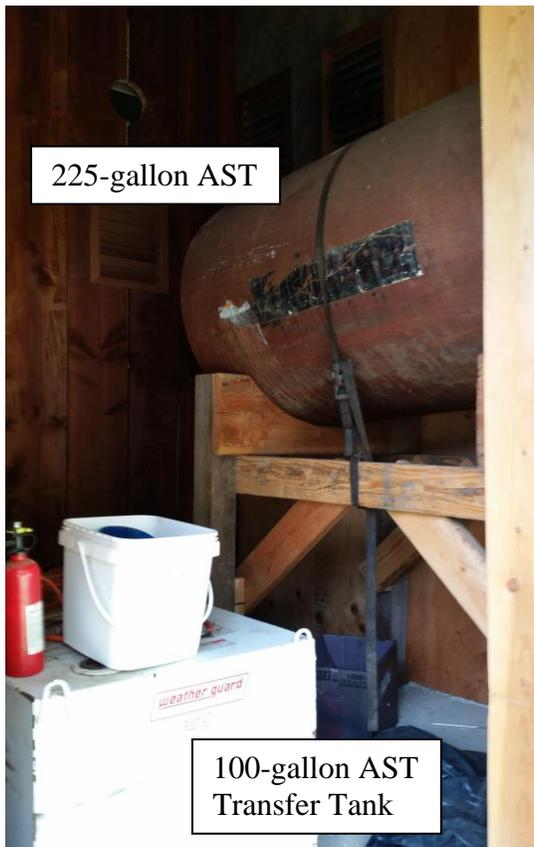
Photo 4. 225-gallon AST and a 100-gallon transfer tank. Also note empty 3-gallon bucket and fire extinguisher.

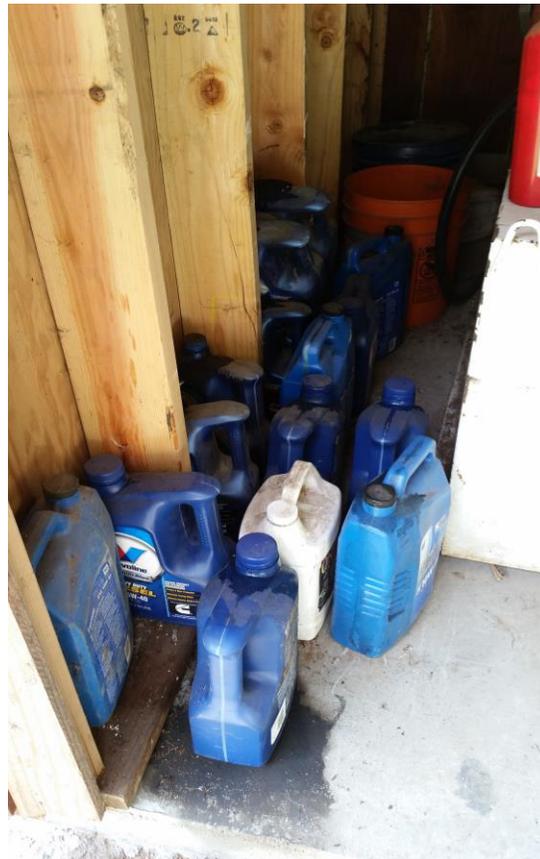
Photo 5. Twelve 5-quart plastic containers containing used motor oil totaling 15-galons.

3. Characterize and dispose of all hazardous waste (used motor oil, used oily rags, etc.) and contaminated soil using a licensed hazardous waste hauler and a licensed hazardous waste disposal facility. Provide copies of manifests to DEH verifying legal disposal.

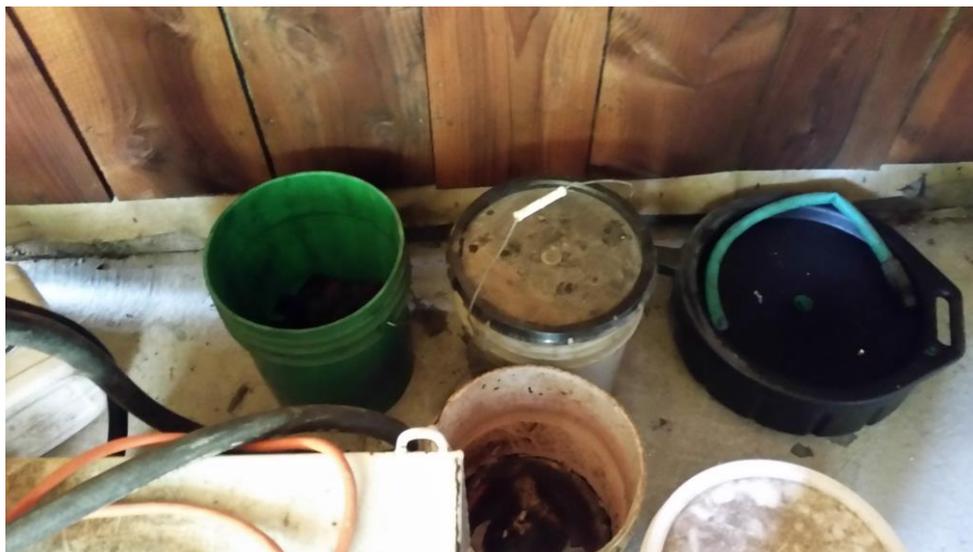
Photo 6. Two 5-gallon buckets containing approximately 4-gallons of red dyed diesel fuel, two empty 5-gallon buckets, and an empty oil changing pan with fuel transfer hose.

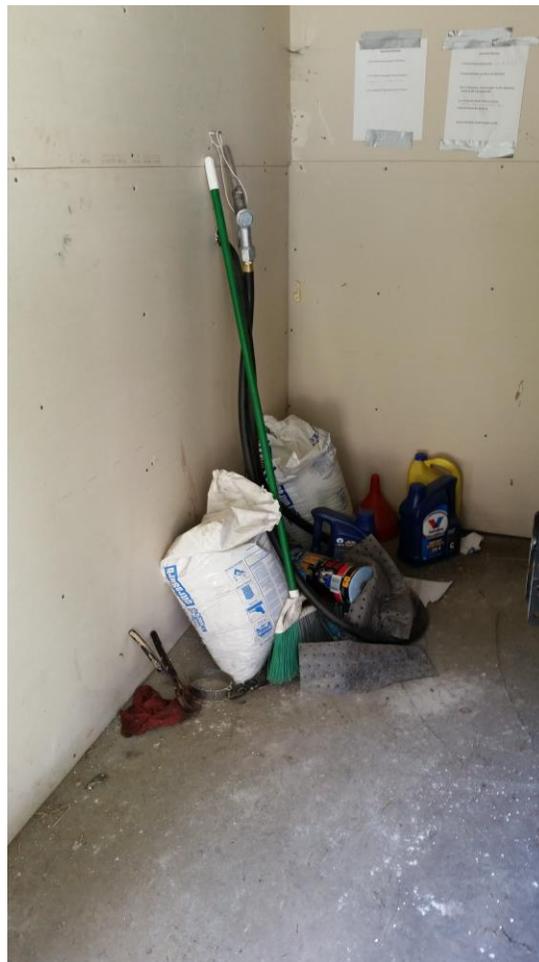
Photo 7. Fuel hose from 225-gallon AST used to transfer fuel to the generator. Also shown are two bags of absorbent chips and some absorbent towels. All unused chips and absorbent towels will be retained by the property owner for personal use. Any used items will be cleaned up and disposed of at the Humboldt Household Hazardous Waste facility

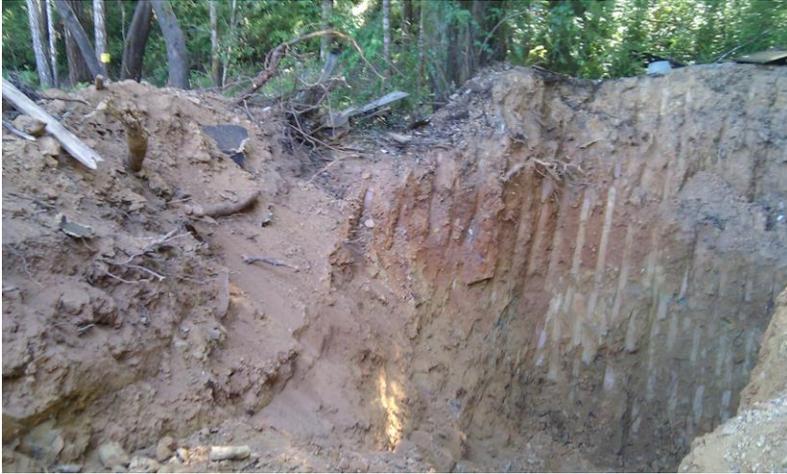
Photo 1. South and East Wall

The bulk of contaminated soil has been removed and disposal of at an appropriate facility. Any remaining soil that may still have some level of hydrocarbon contamination on this site is within water quality standards (<100 mg/kg). The excavation pit has been backfilled with clean soils and the slope re-contoured so as to not create a hazardous environment.

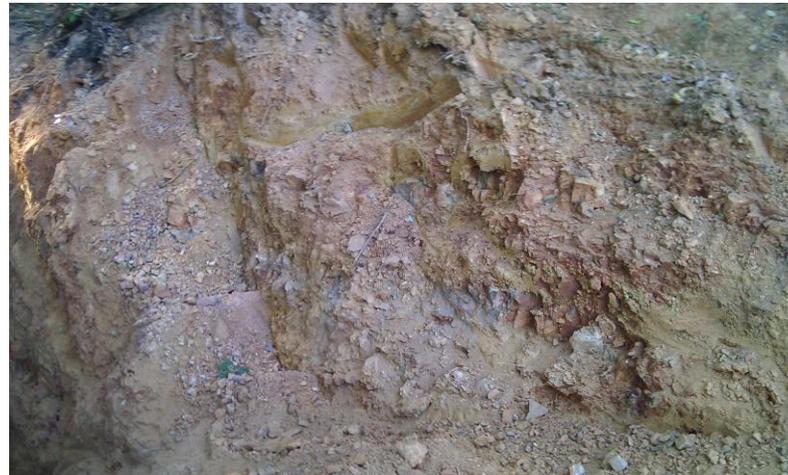
Photo 3. This photo illustrates the rocky nature of soils.
