Humboldt Redwood
COMPANY, LLC

Subject: Enrollment of THP 1-11-008 HUM in the Elk River WWDR, "Tier I and II"

project: **Iron Gate THP**

Figure 2a: Regional Geomorphic Map
 Iron Gate THP

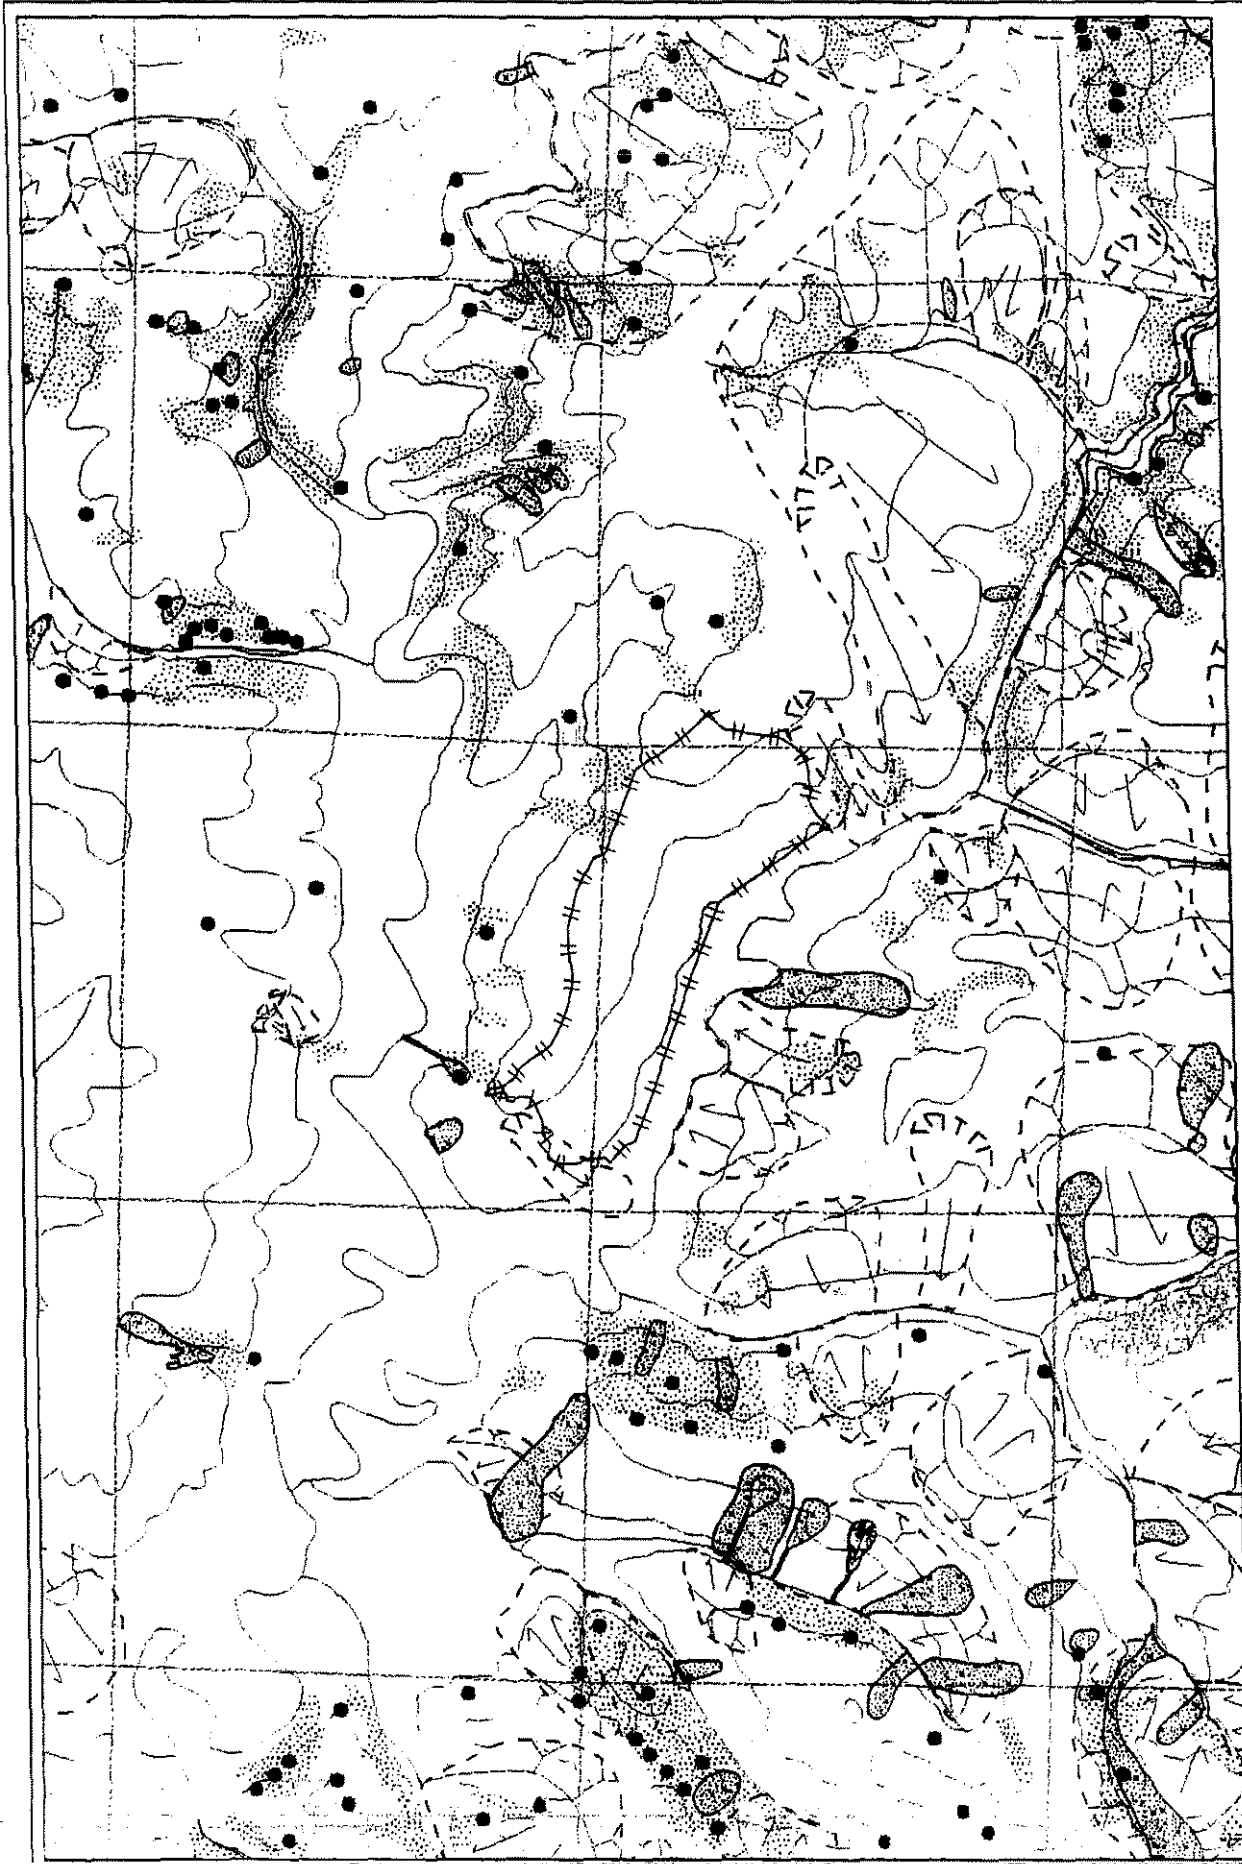
CGS (1999b) mapped the plan as underlain by the Quaternary- to Tertiary-aged undifferentiated Wildcat Group and the eastern portion of the plan area as underlain by the Quaternary Hookton Formation (Figure 2a). Ogle (1953) describes the Hookton Formation as Quaternary aged, predominantly non-marine, poorly consolidated, gravel, sand, and clay. Exposures of the Hookton Formation are described as loose brown sand, brownish gray clay, and silt (Ogle, 1953). The undifferentiated Wildcat Group is described as Quaternary to Tertiary aged, marine siltstone and sandstone regionally cropping out predominantly north of the Yager and Little Salmon faults. The Hookton Formation is exposed in the eastern portion of the plan area along the ridgetop that separates the South and North Forks of the Elk River. This mapping is taken from Ogle (1953) who initially mapped the plan area. The undifferentiated Wildcat Group is described as light brown to gray mudstone and sandstone (Ogle, 1953). Light brown to gray, massive, weakly consolidated, fine sandy siltstone and silty fine sandstone was observed exposed in natural exposures and road cuts throughout the plan area, consistent with descriptions of the Undifferentiated Wildcat Group (Ogle, 1953).

A review of published geomorphic mapping shows shallow landslide hazards as potentially present and mapped debris slide amphitheater slopes in the lower slope portions of the proposed harvest unit (CGS; 1999b)(Figure 2a) and more recent mapping shows a relatively large earthflow just outside of the western harvest boundary (CGS, 2005). Recent mapping does not show debris slide amphitheater slopes. Mapping by CGS (1999b and 2005) is somewhat consistent with mapping from this investigation and is modified in the project site maps introduced and described below.

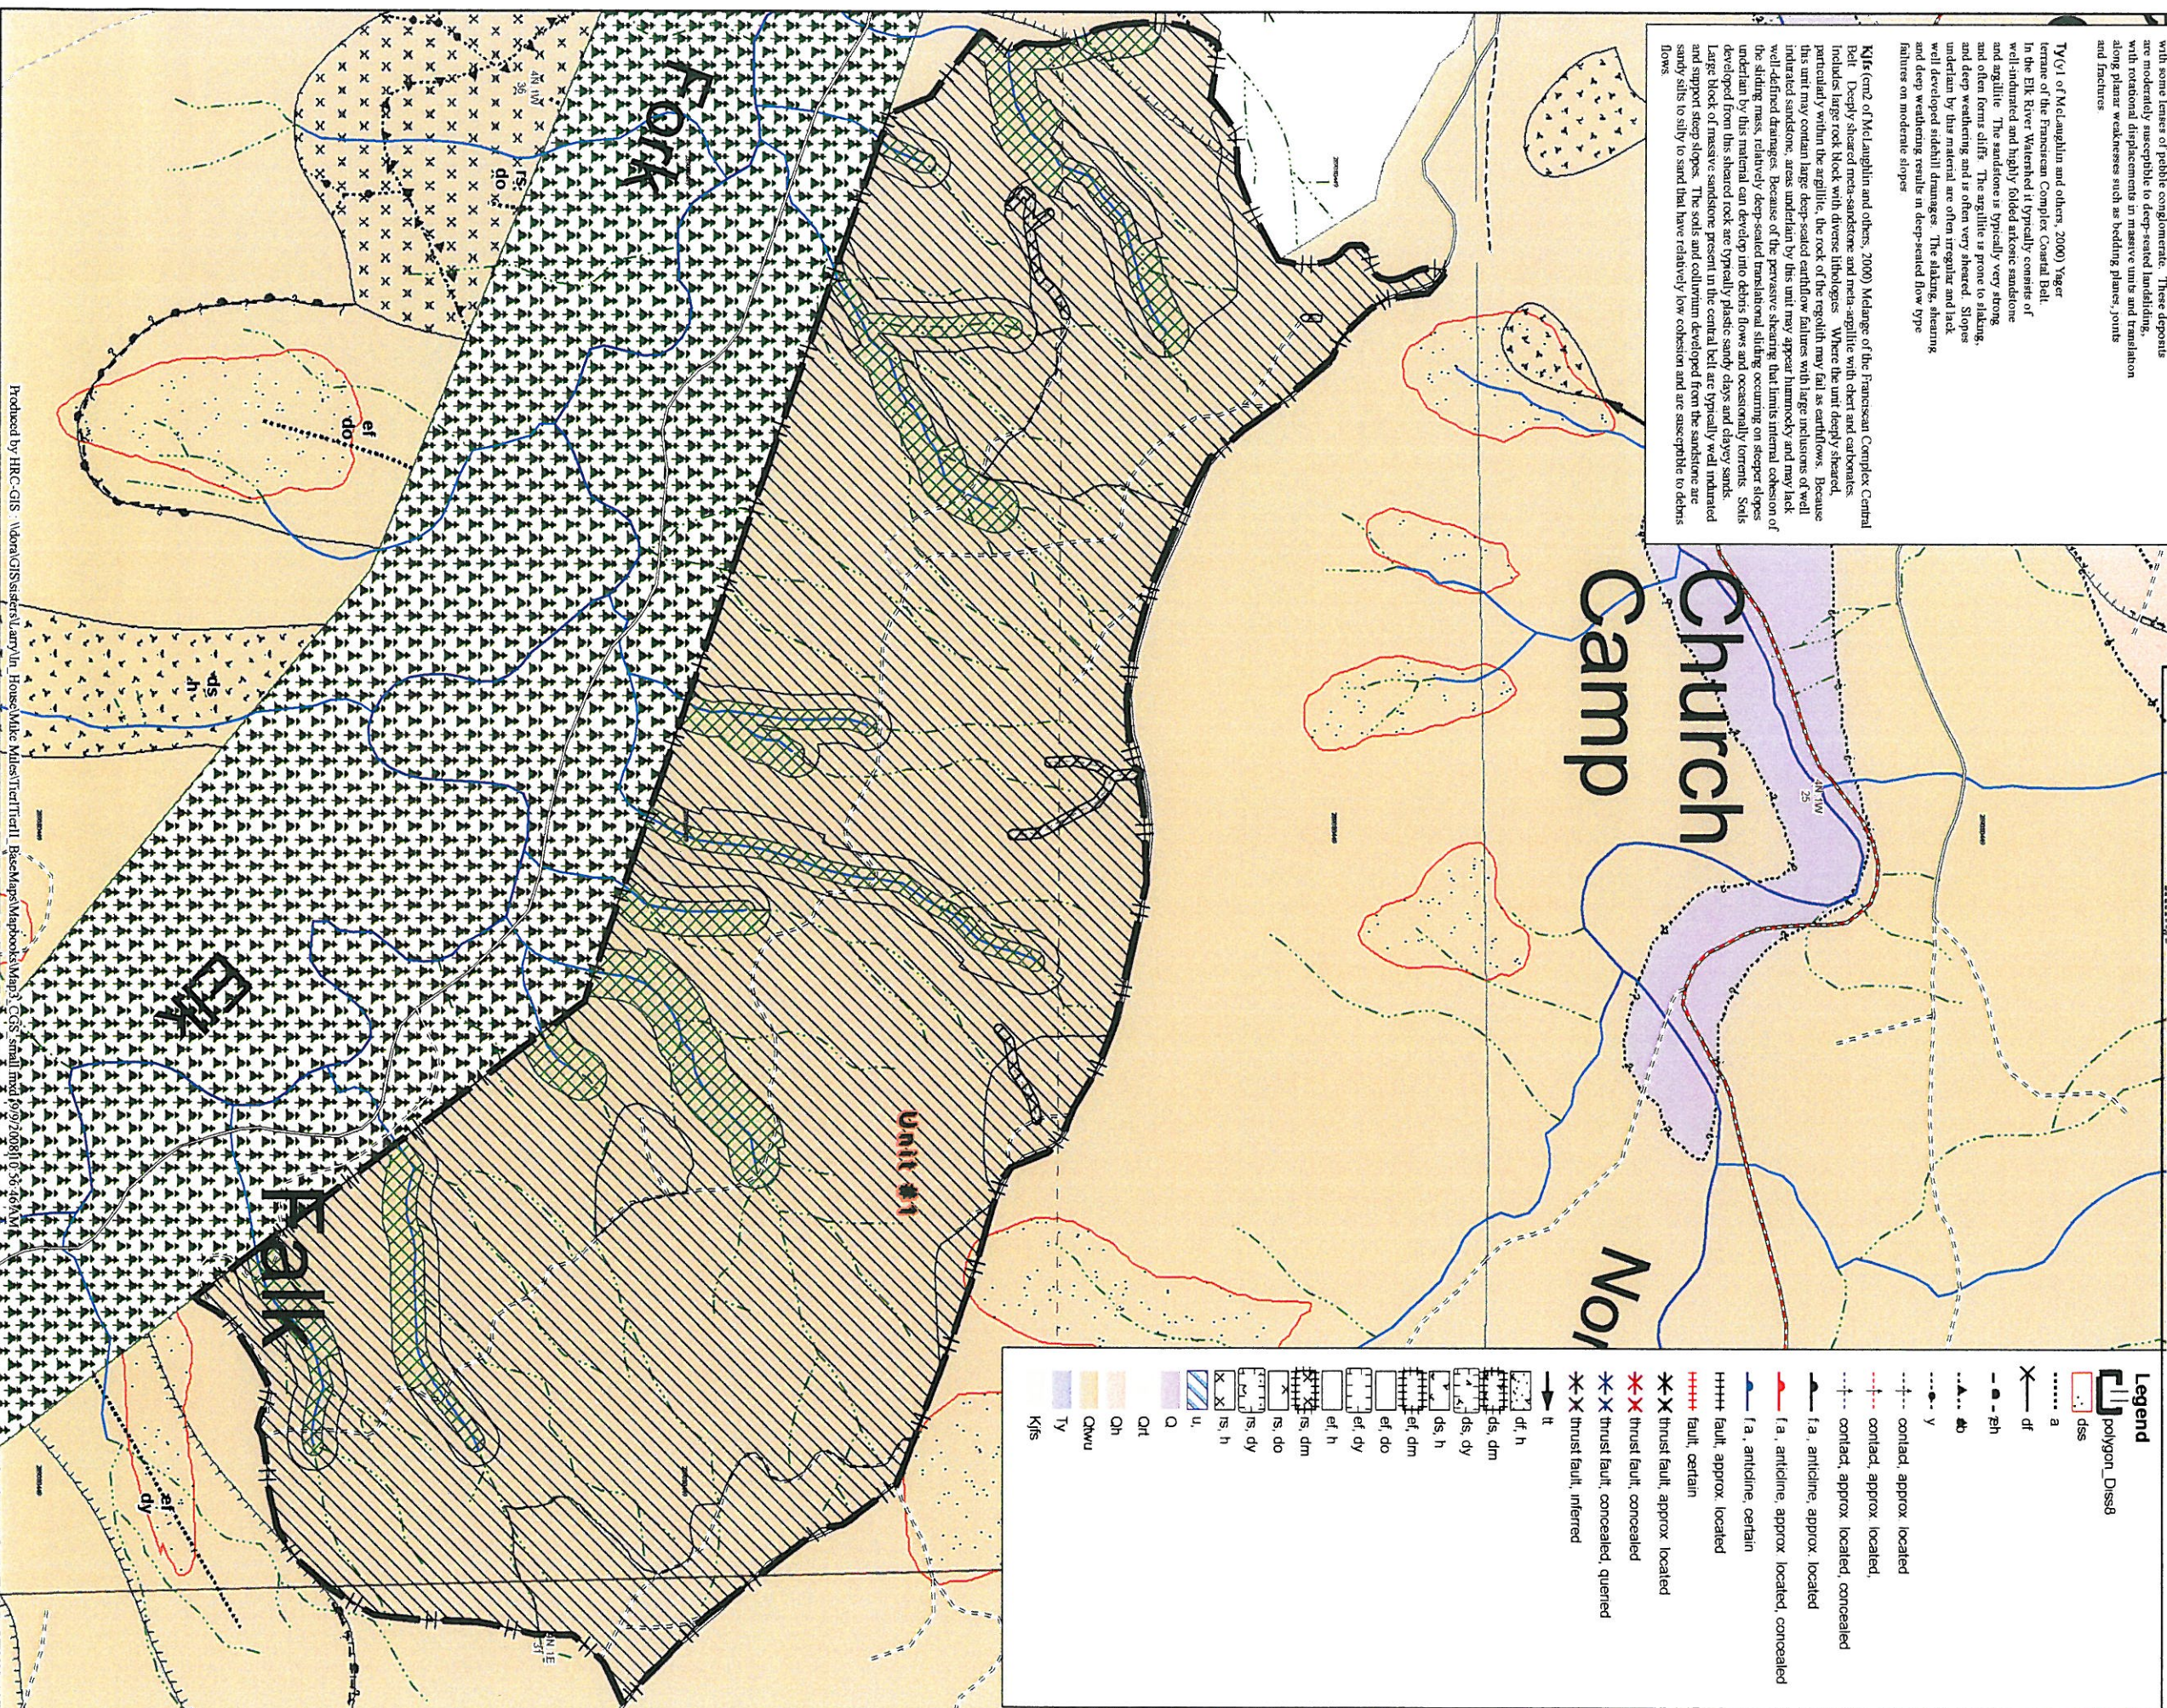
Figure 4
Iron Gate
THP # 1-1-009
Mass Wasting Potential
 1 inch = 375 feet

Figure 6 shows 2 areas of deep-seated mass wasting that extend into the proposed Tier II acres. These areas correspond with low to moderate Mass Wasting Potential shown on Figure 4. No evidence of deep-seated mass wasting was observed in these areas during field review.
