Subject: Enrollment of THP 1-05-123 HUM (Unit 1) in the Freshwater Creek WWDR, "Tier II"

**THP: Mid Incline      THP 05-123      Unit # 1      3-9-09**

## **Erosion Control Plan (ECP) for the “Mid Incline” THP 1-05-123HUM**

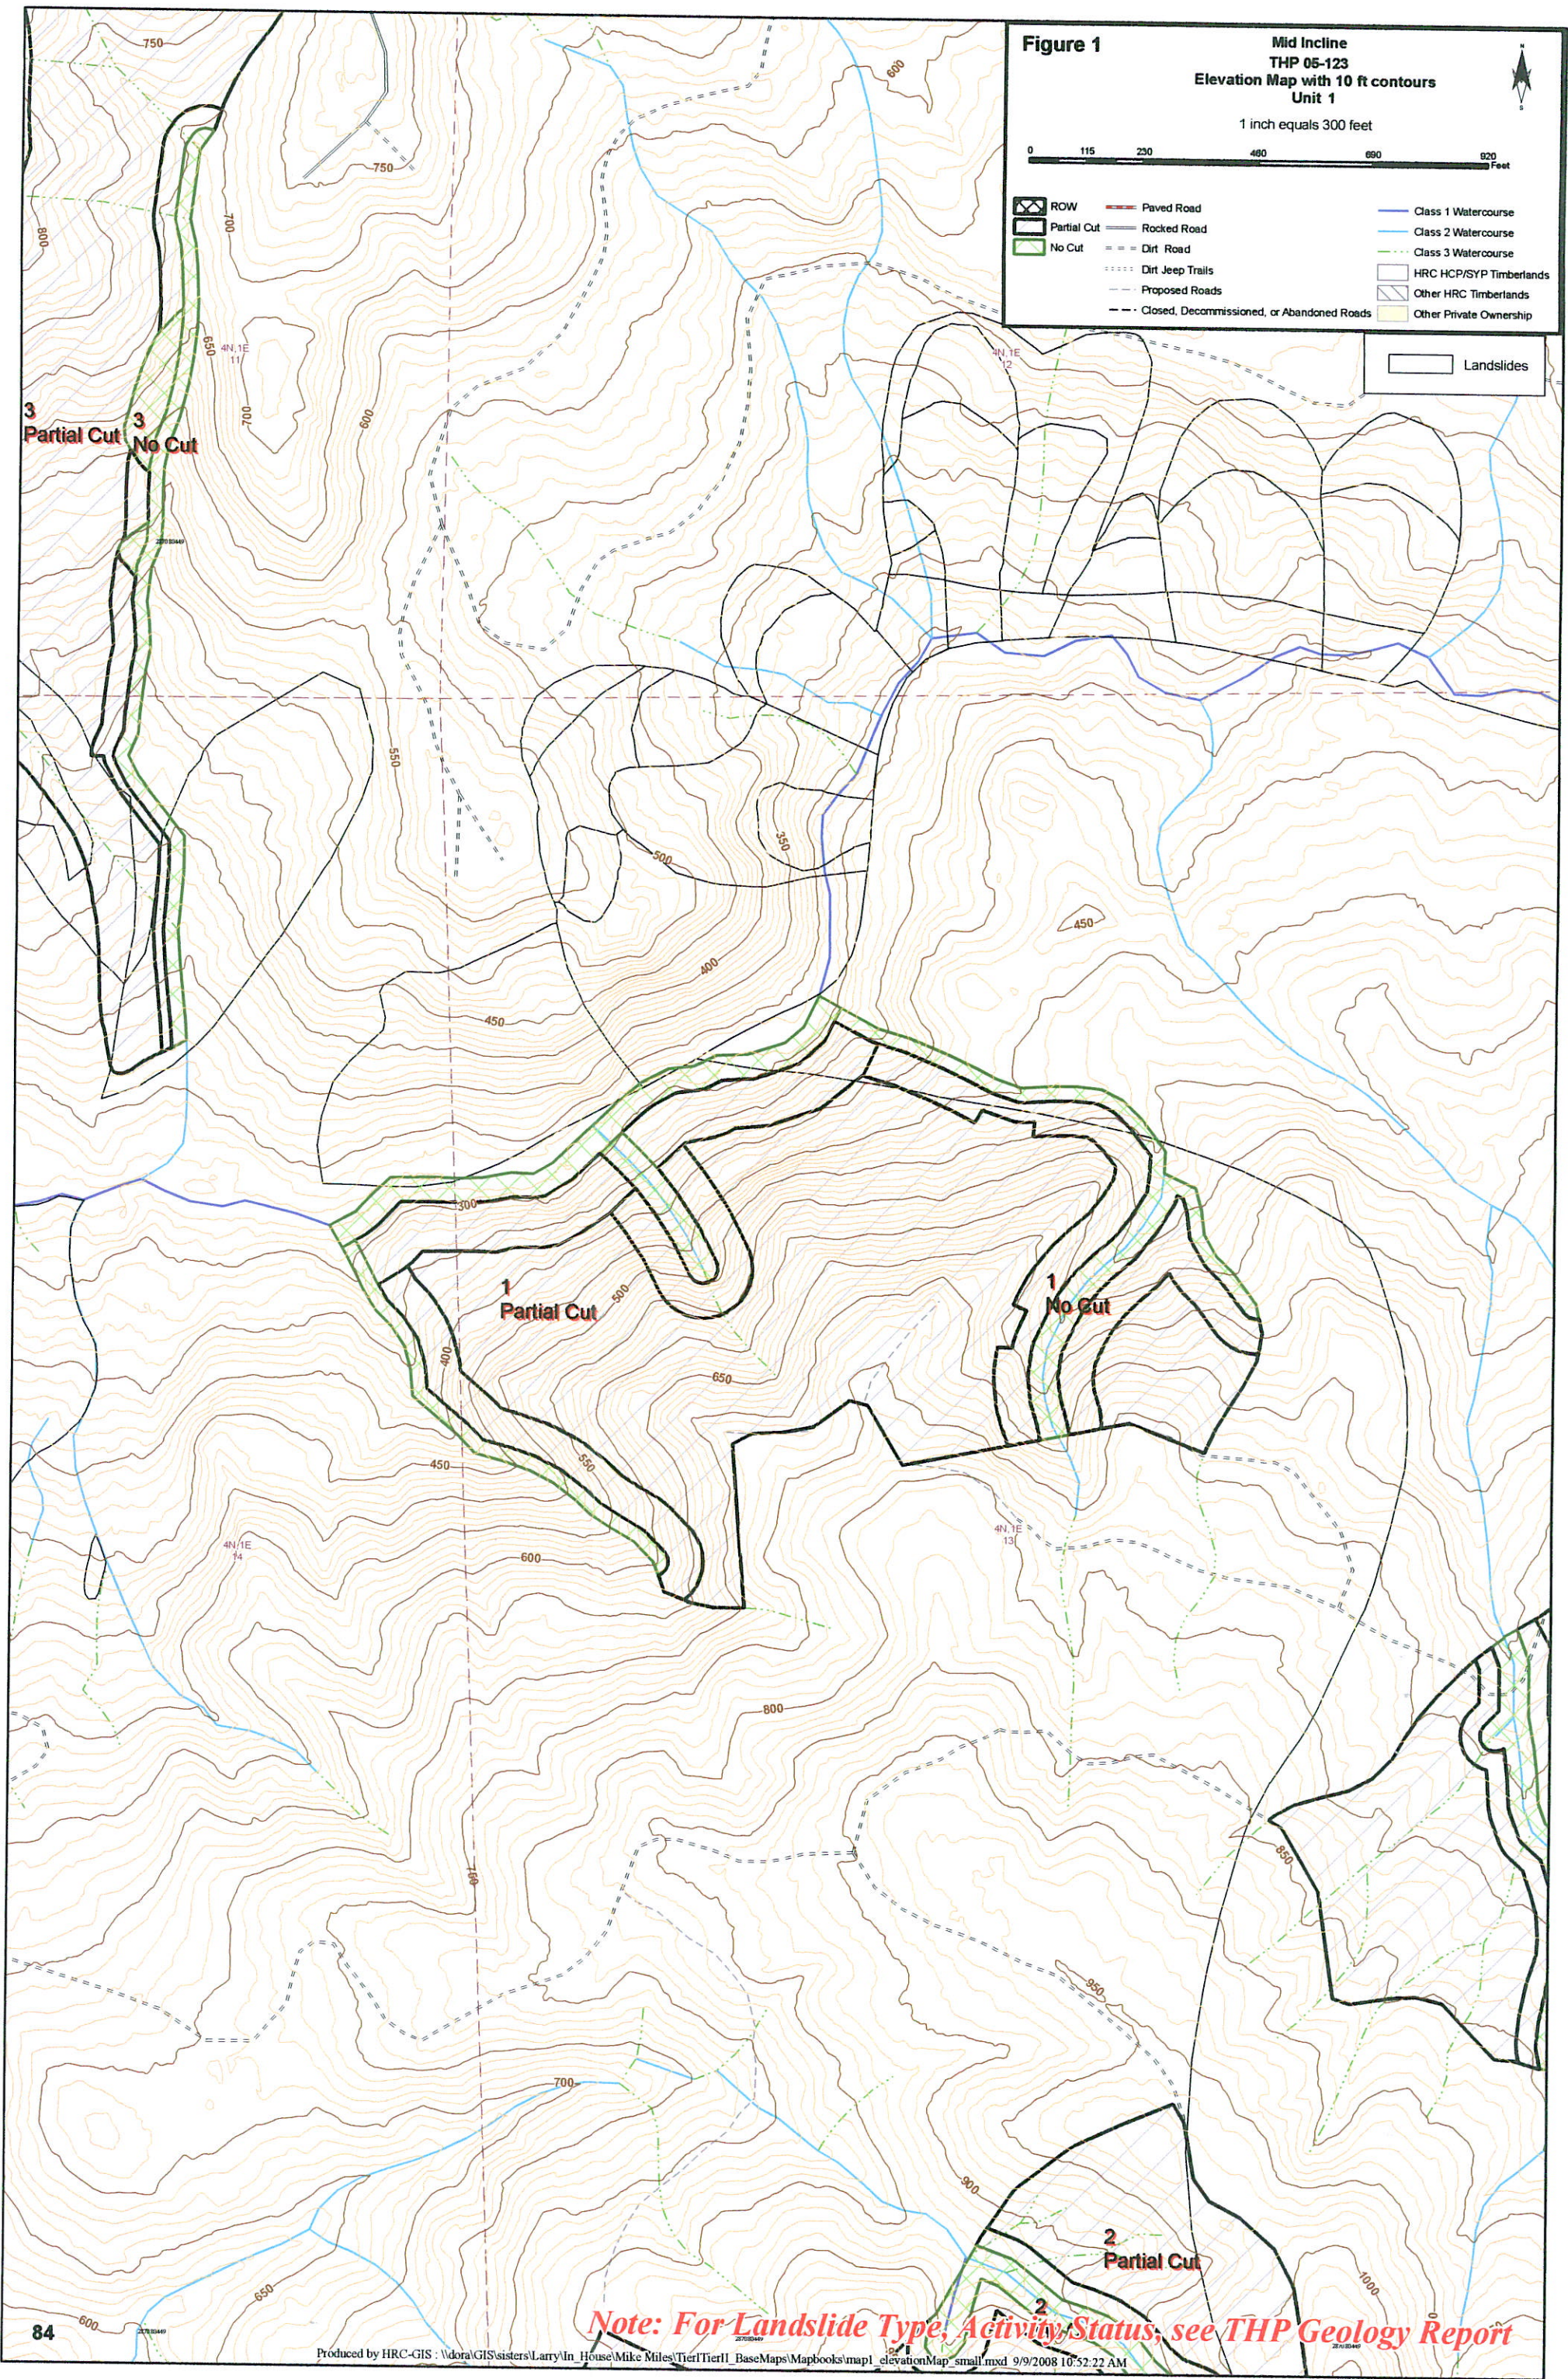
Figure 2

Hillslope Shade Relief review (figure 2) shows high gradient, surprisingly uniform slope inclination, along with planar to broadly convergent topography underlying the unit. This morphology is generally not consistent with Wildcat Group sediments and/or regional dormant mass wasting. We interpret the fault to be located either to the extreme west and outside of the unit or along the eastern margin of the unit due to the general uniform slope morphology within the unit. Faulting should have resulted in a regional hummocky nature to the slopes. In addition, the margins of the mapped earthflows (Figures 3 and 6) are not obvious and may have been interpreted due to the general and regional irregular surface morphology common to the mélange. The prominent watercourses appear moderate to well entrenched and without significant alteration to the channels from any recent earthflow deformation. A train grade is also observable across the toe of the unit.

SHALSTAB modeling indicates elevated (value 2) hazard within and adjacent segments of the watercourse (figure 2). Five pixels of elevated SHALSTAB (value 1) have been modeled within the operational portion of the unit. Two of those pixels are located within the Class III and will be mitigated with the Class III RMZ. One of the pixels is located within the outerband of the Class I watercourse. The remaining two pixels of value 1 SHALSTAB are located away from watercourses.

The elevated landslide hazard modeled by SHALSTAB is indicative of the high gradient topography but discounts the underlying geology.

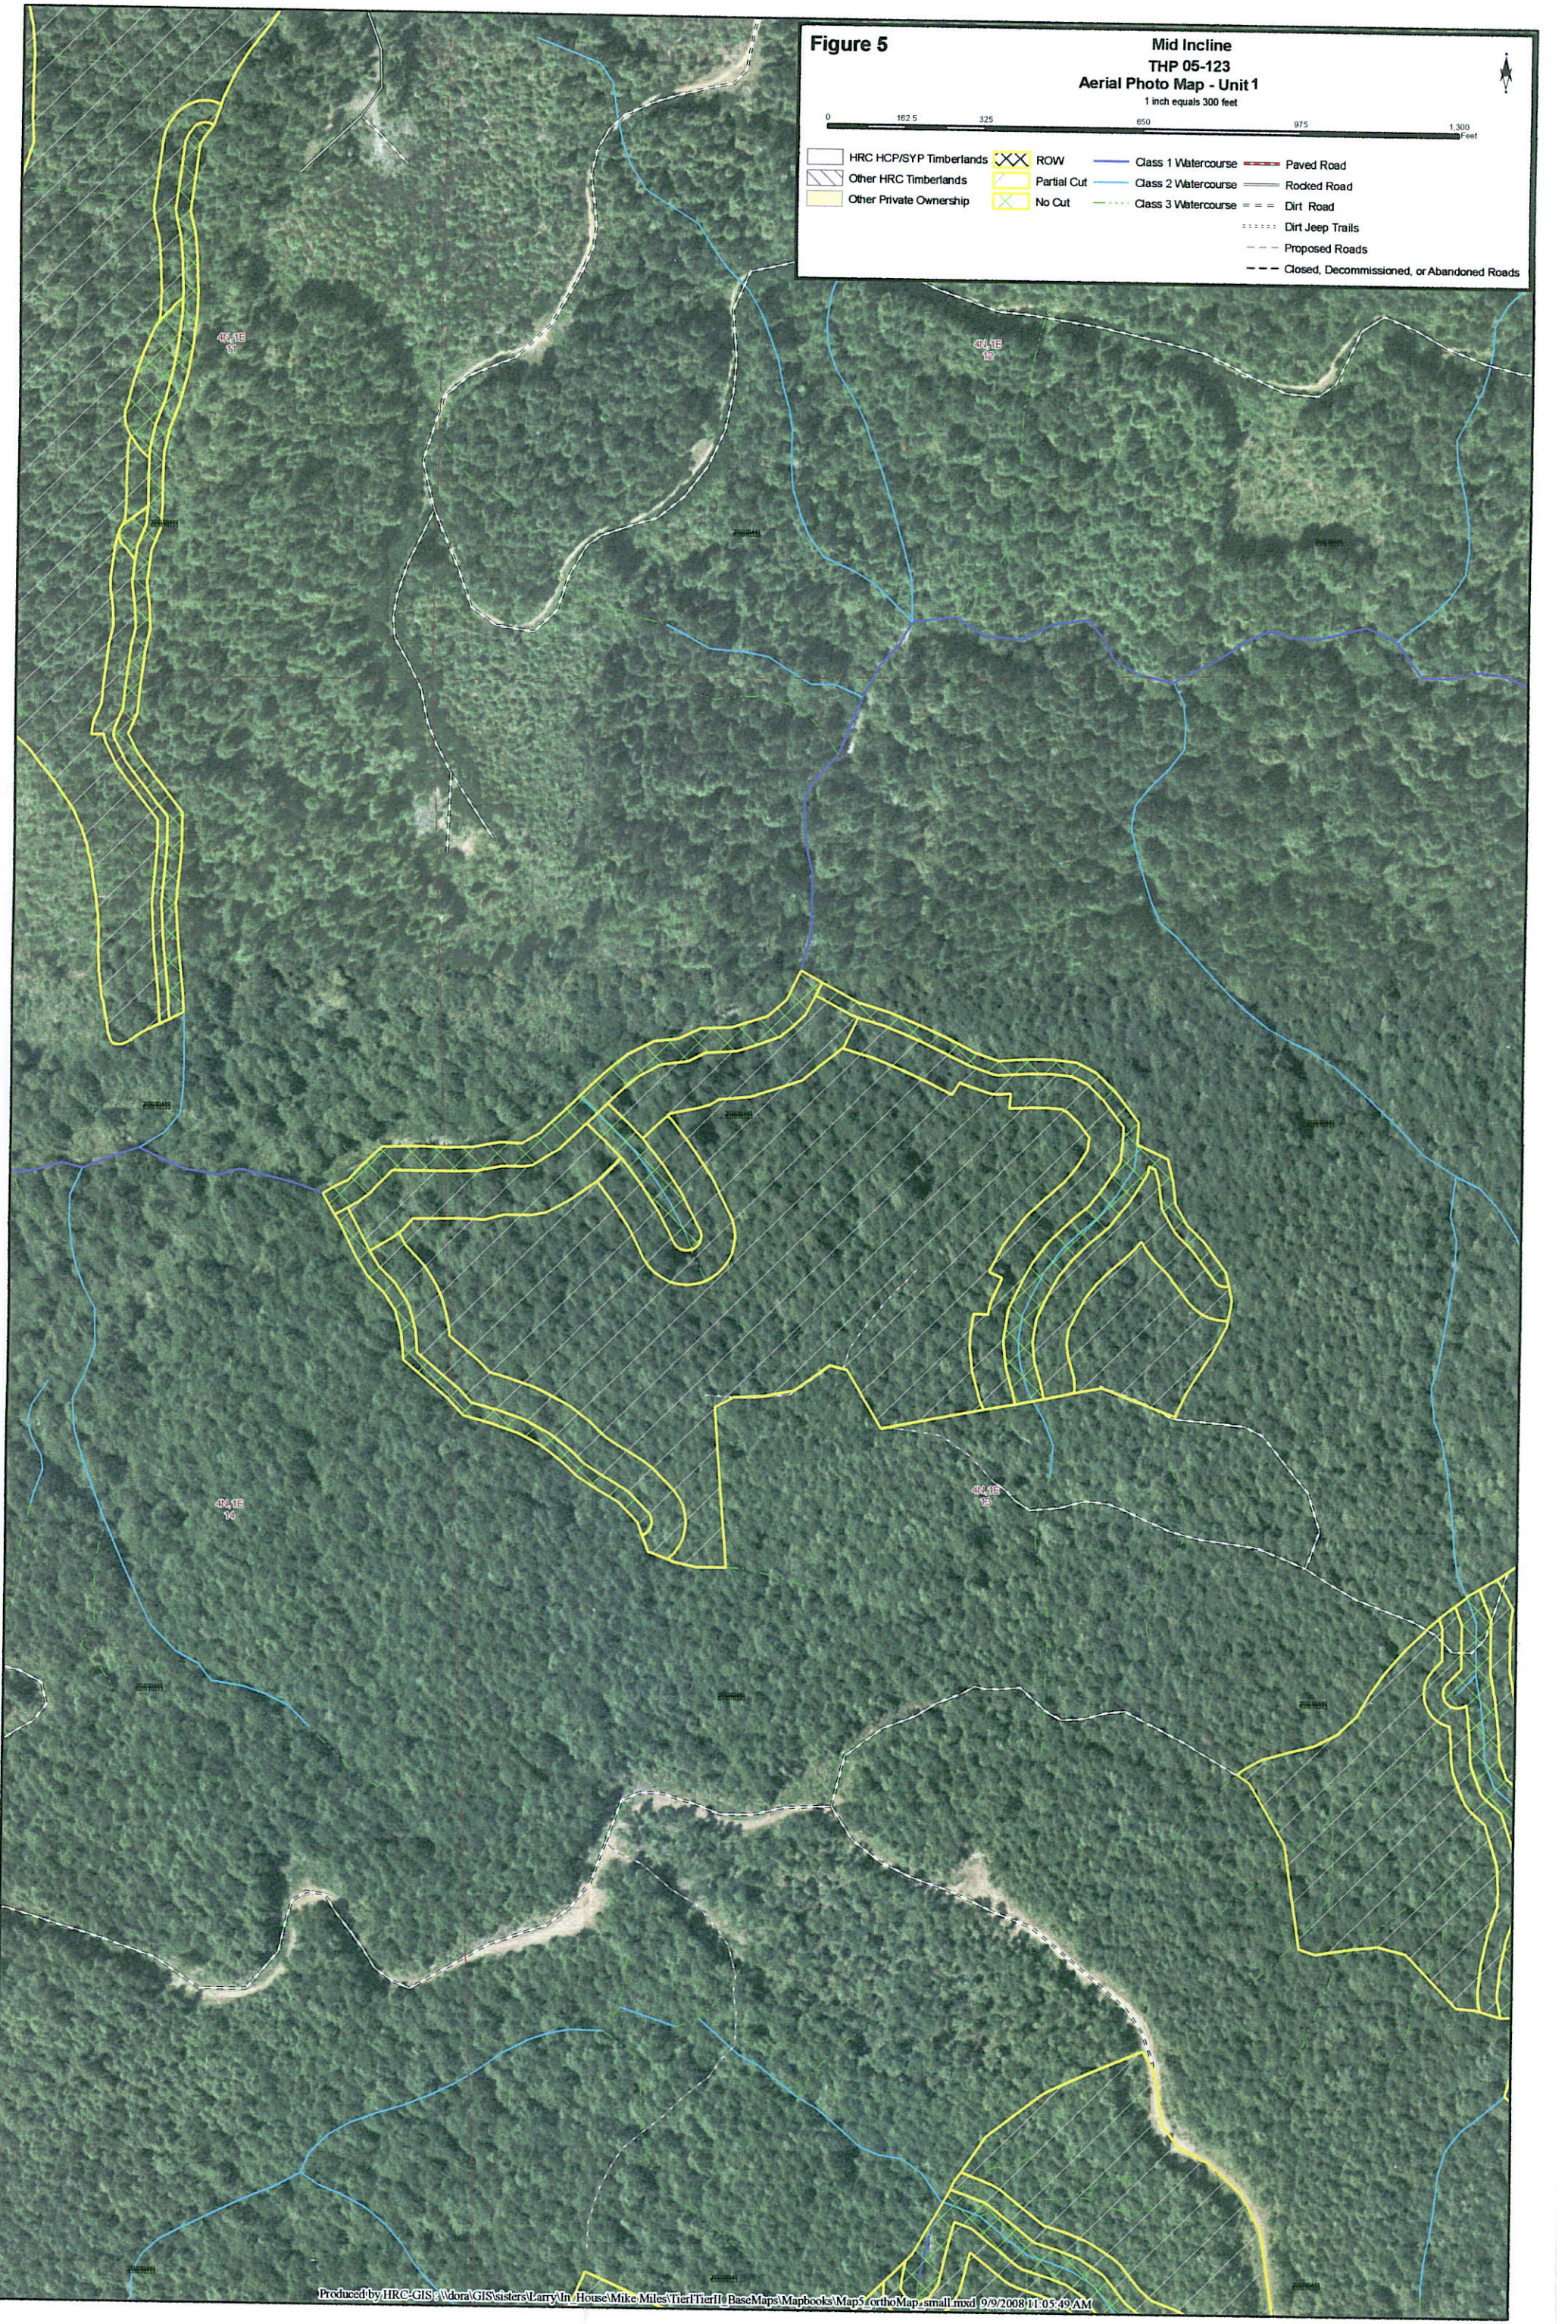
Figure 6 (Watershed Analysis mapping) concurs with the CGS (1999) dormant translational landslide however place more the feature within the unit. The landslide was mapped as having low to moderate potential for re-activation.
