Humboldt Redwood
COMPANY, LLC

Subject: Enrollment of THP 1-05-123 HUM (Unit 2) in the Freshwater Creek WWDR, "Tier II"

THP: Mid Incline THP 05-123 Unit # 2 3-10-09

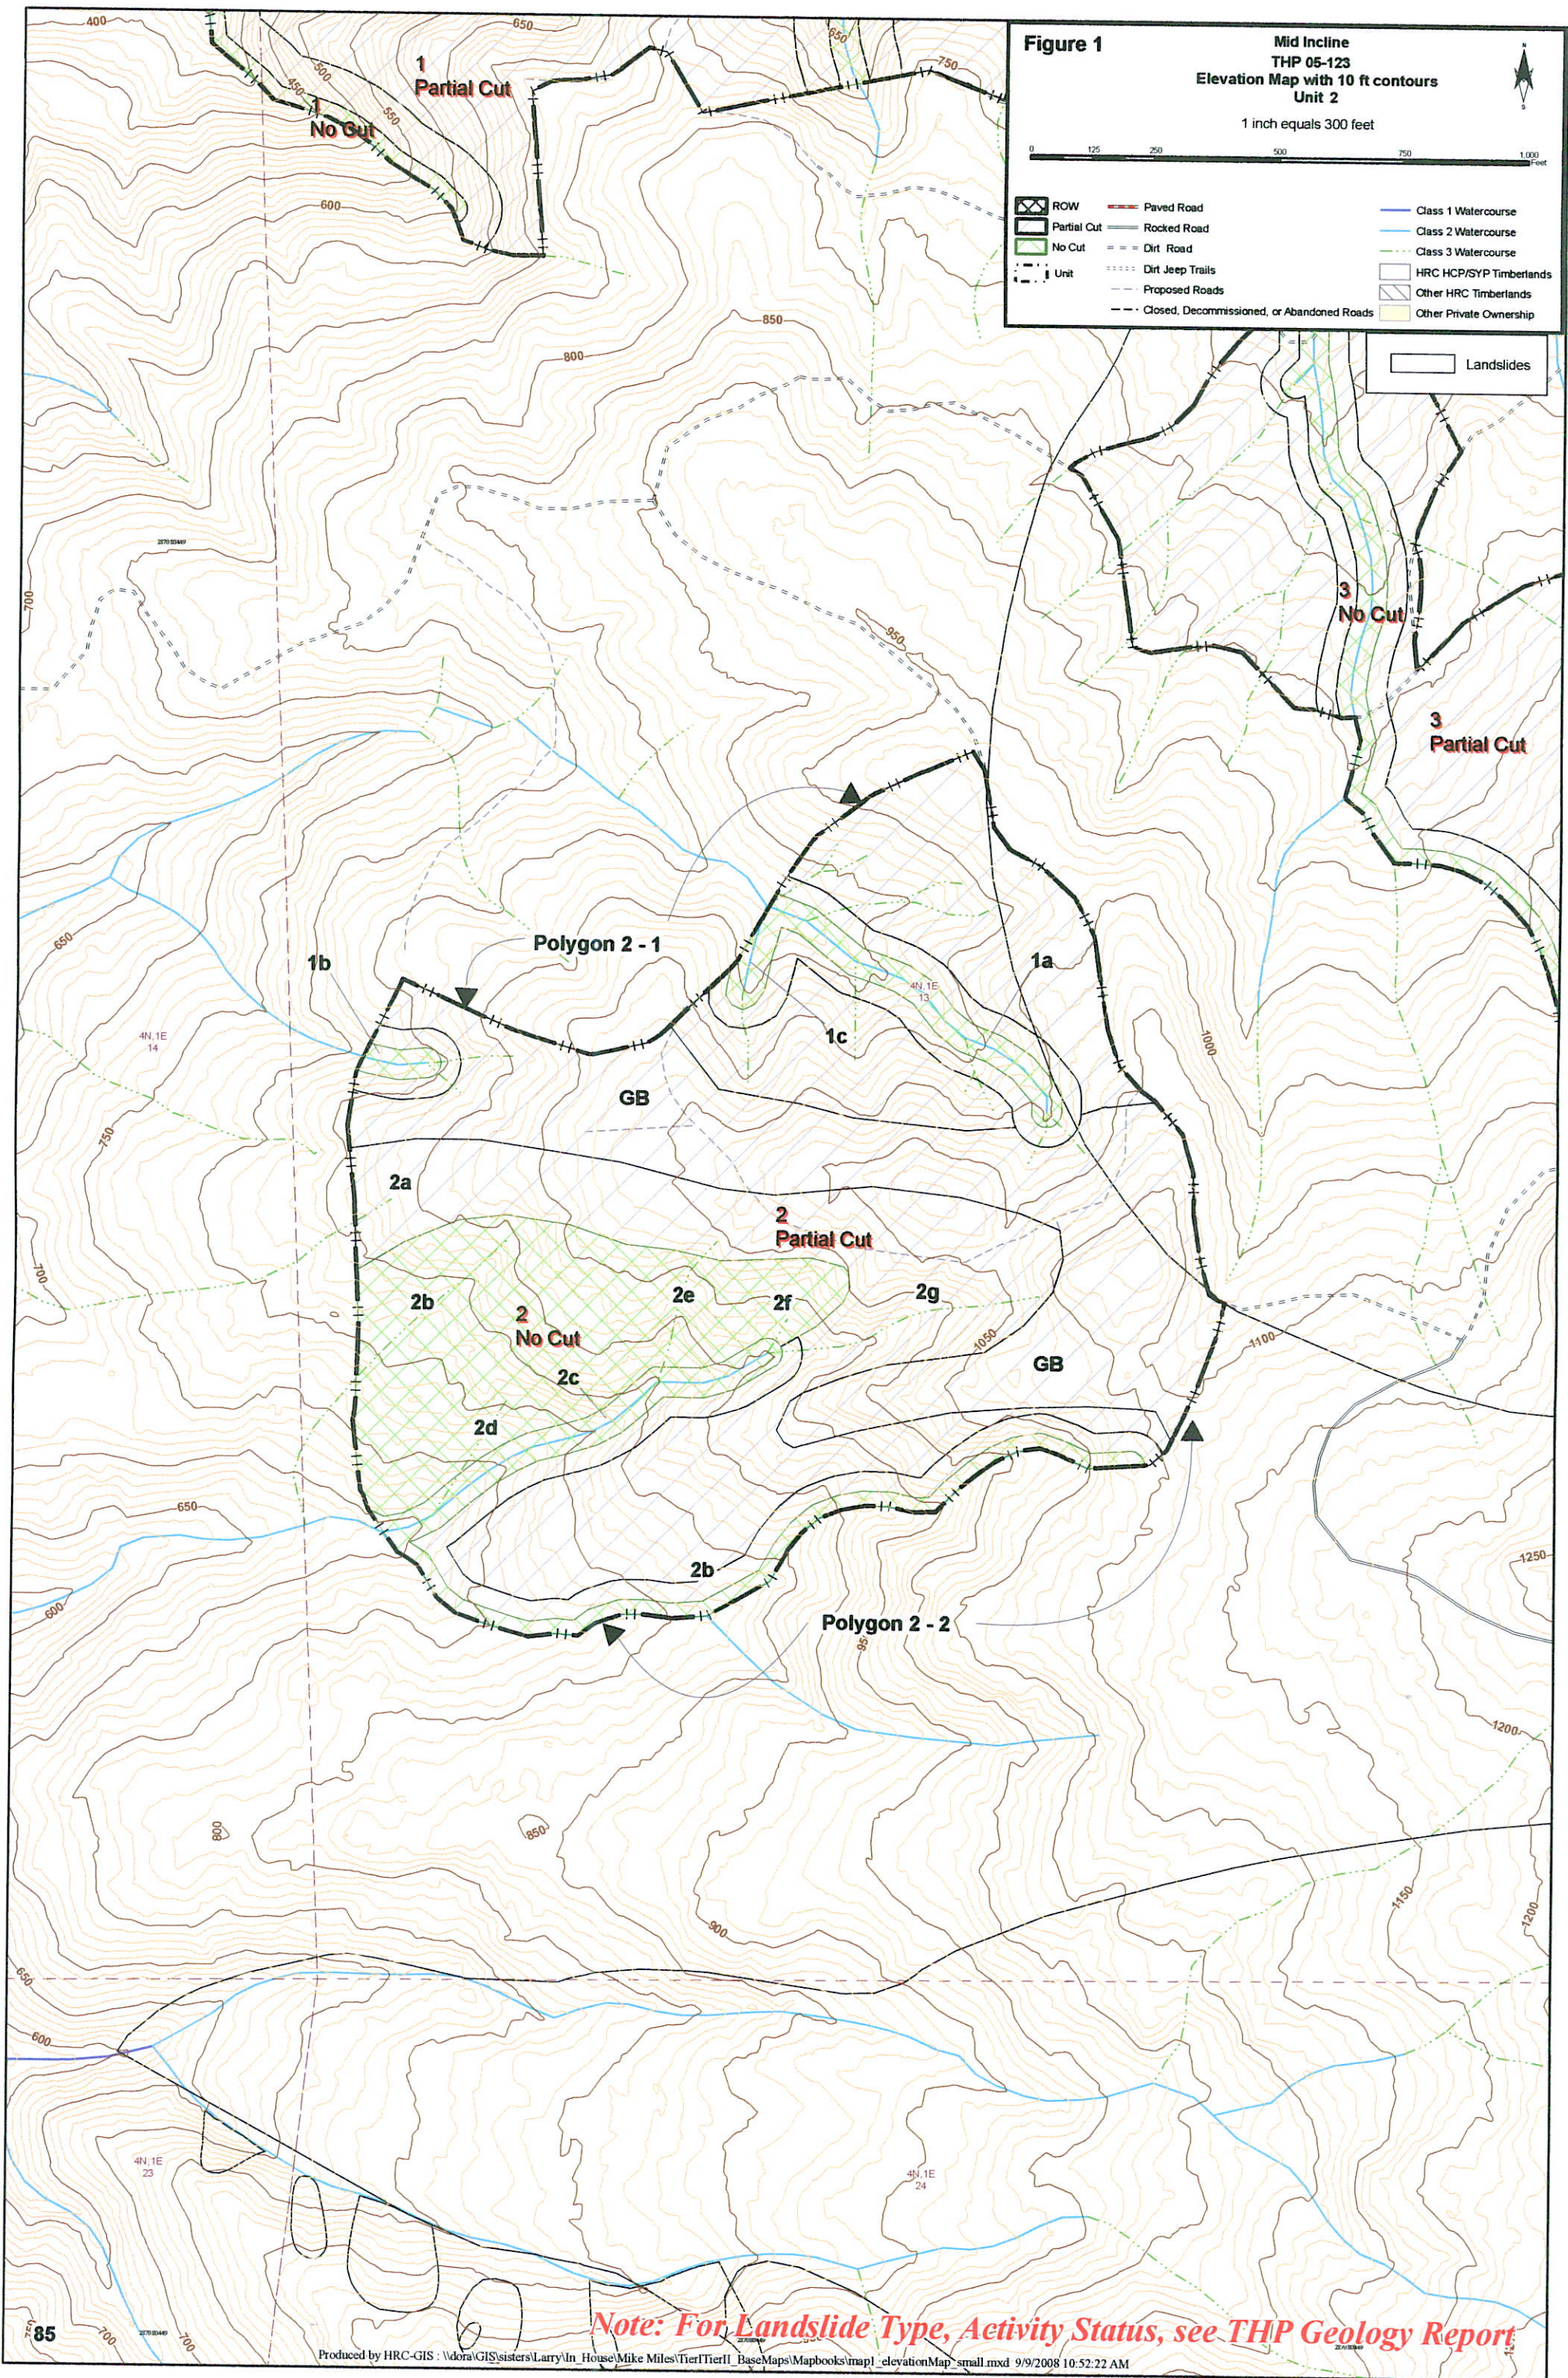
Review of Figure 2 (Hillslope Shade) shows a texture correlation consistent with the mapped geologies. The Lower Unit of the Wildcat Group appears as smooth rounded slopes with apparent uniform weathering. The areas mapped as mélange appear smooth but include an irregular surface exposing the many erratics common to mélange. The prominent watercourses appear well entrenched and include long flanking slopes. The watershed analysis mapped low to moderate deep-seated landslide is marginally observable.

Debris slide slopes are mapped (Figure 3) along the northern boundary as encompassing the south forking Class II watercourse (1c). Review of the slope map (Figure 2) shows the area to be inclined between 40 and 60%. No unstable areas including any evidence of previous landslide activity was observed in this area during THP development or the subsequent Tier 2 field investigation. Of note, a significant portion of this area is within the Class II watercourse RMZ.

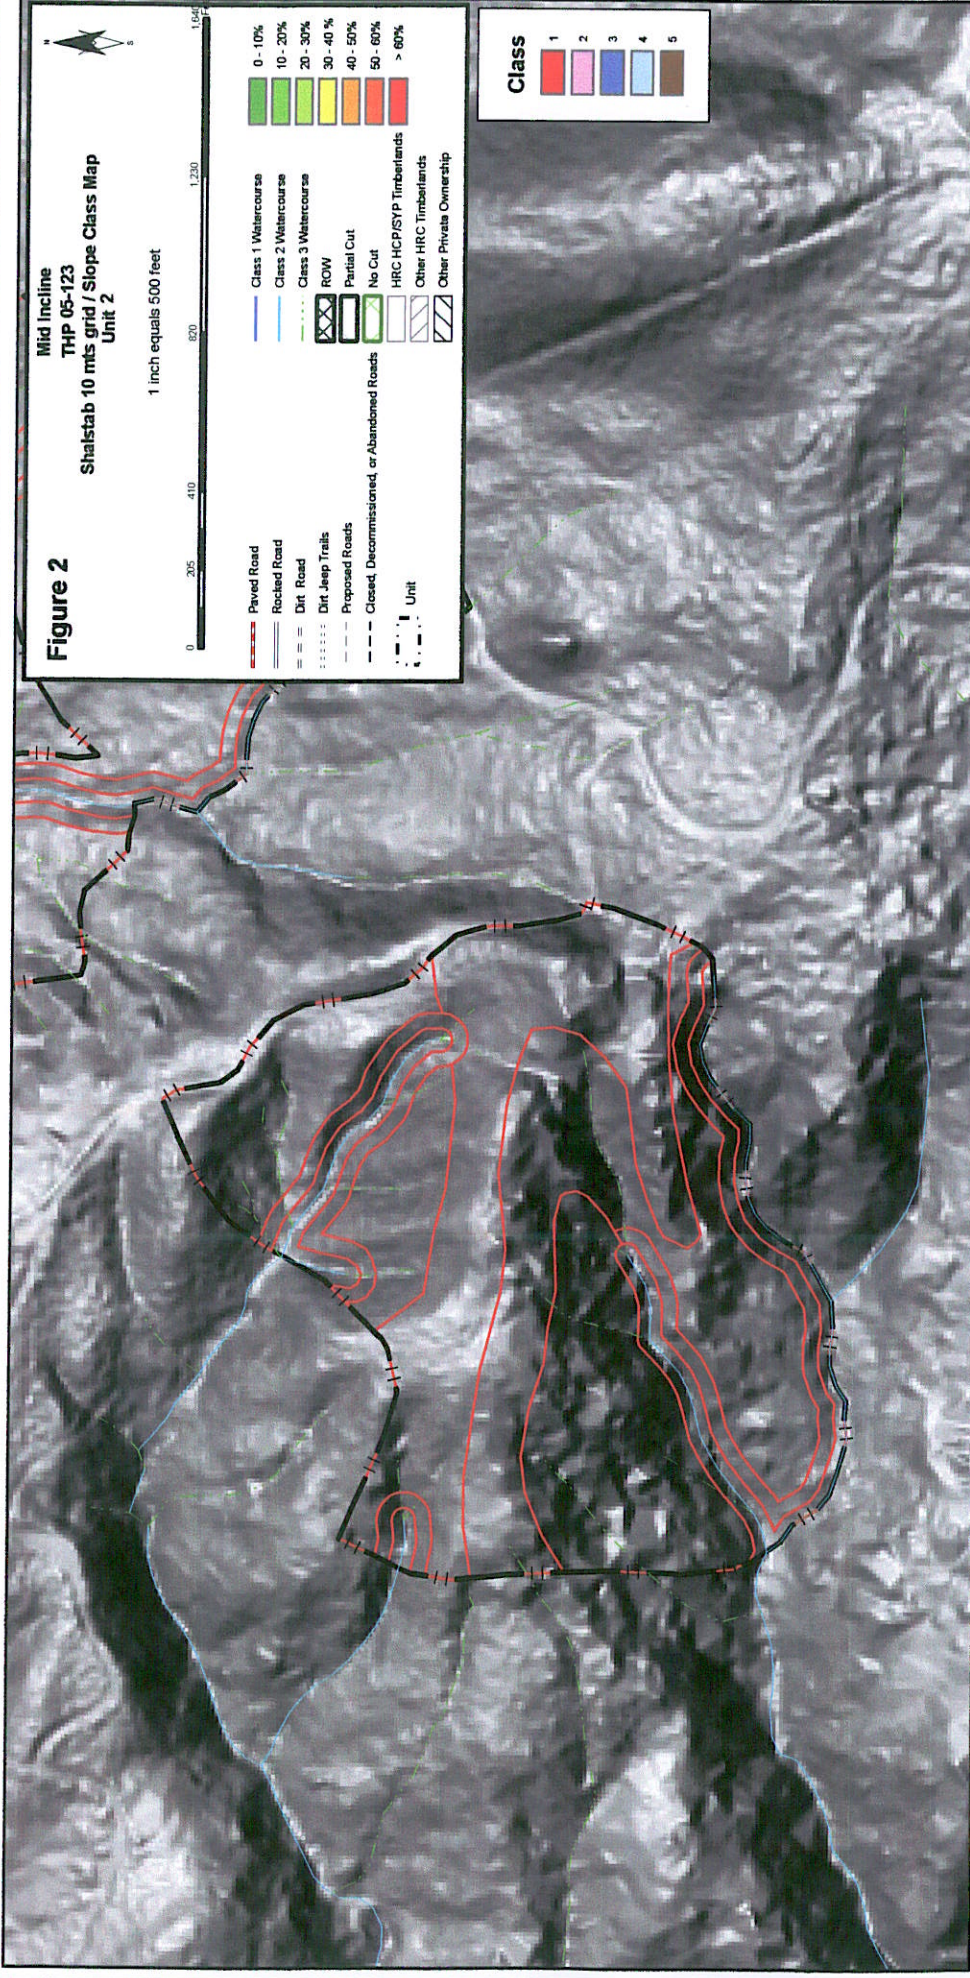
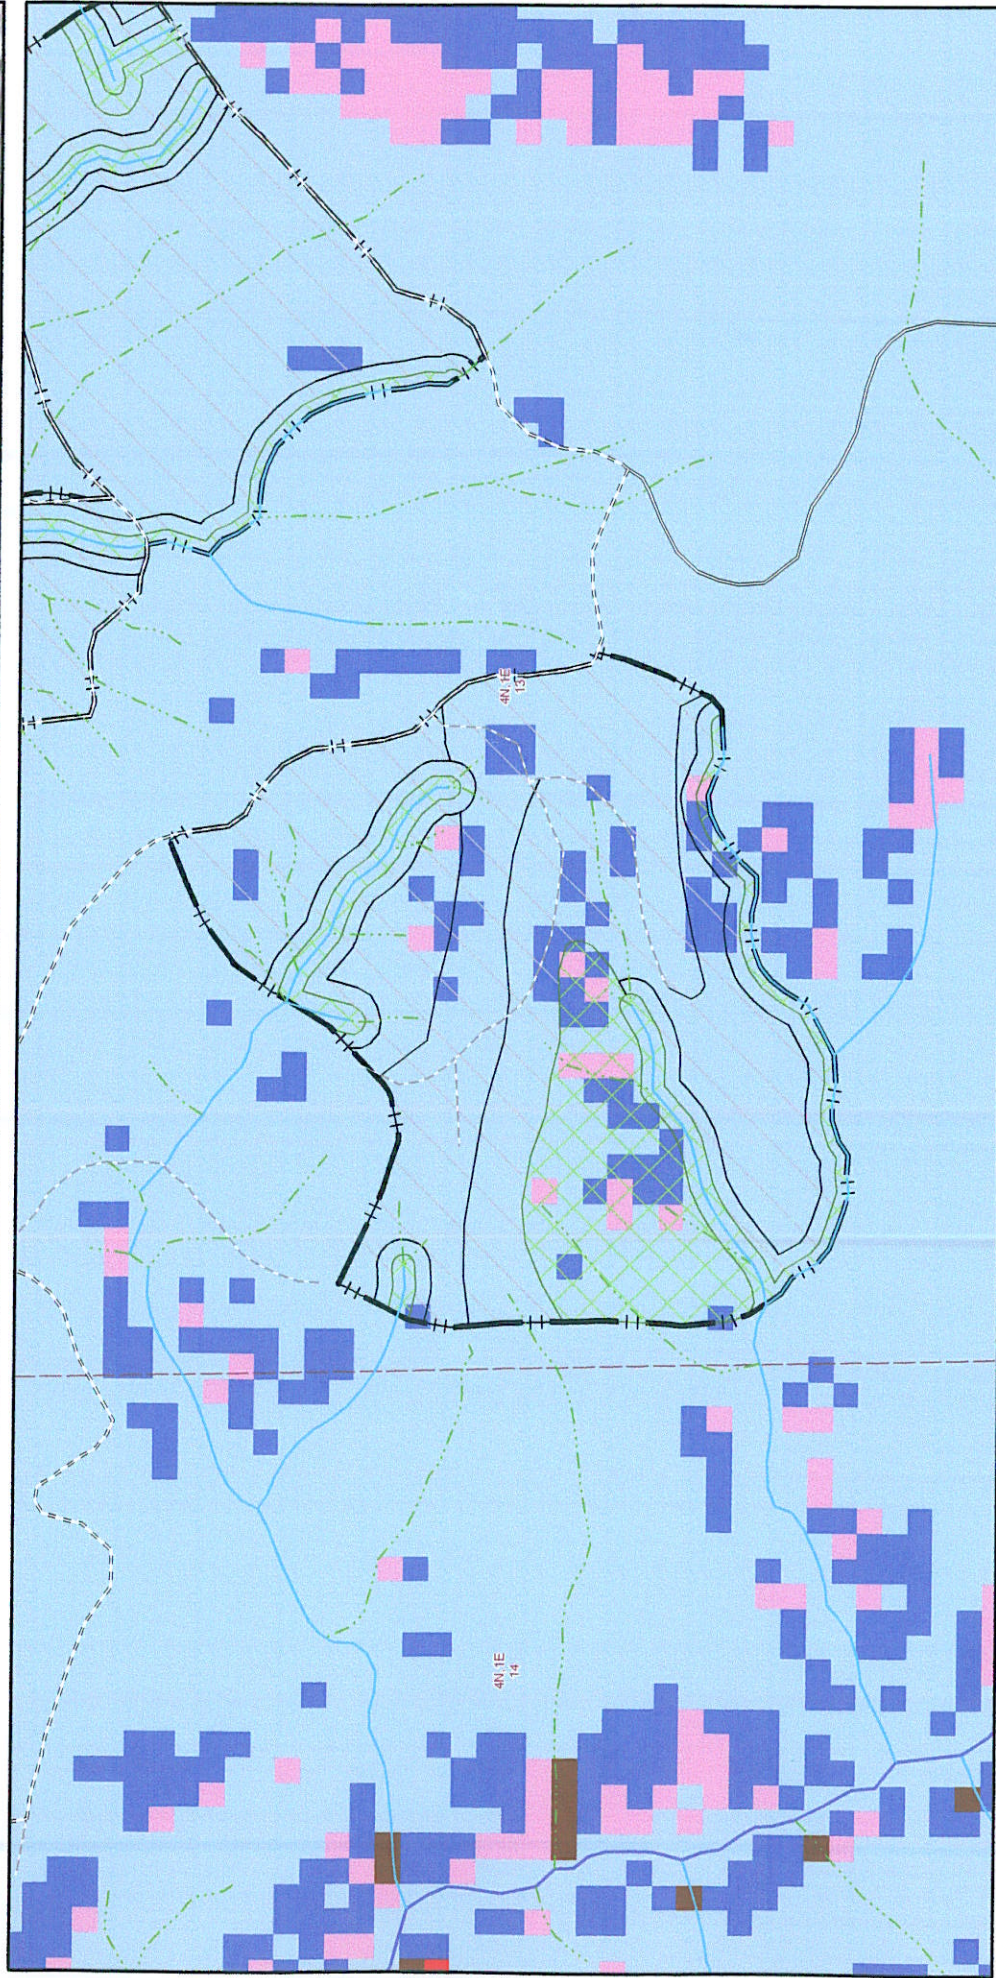
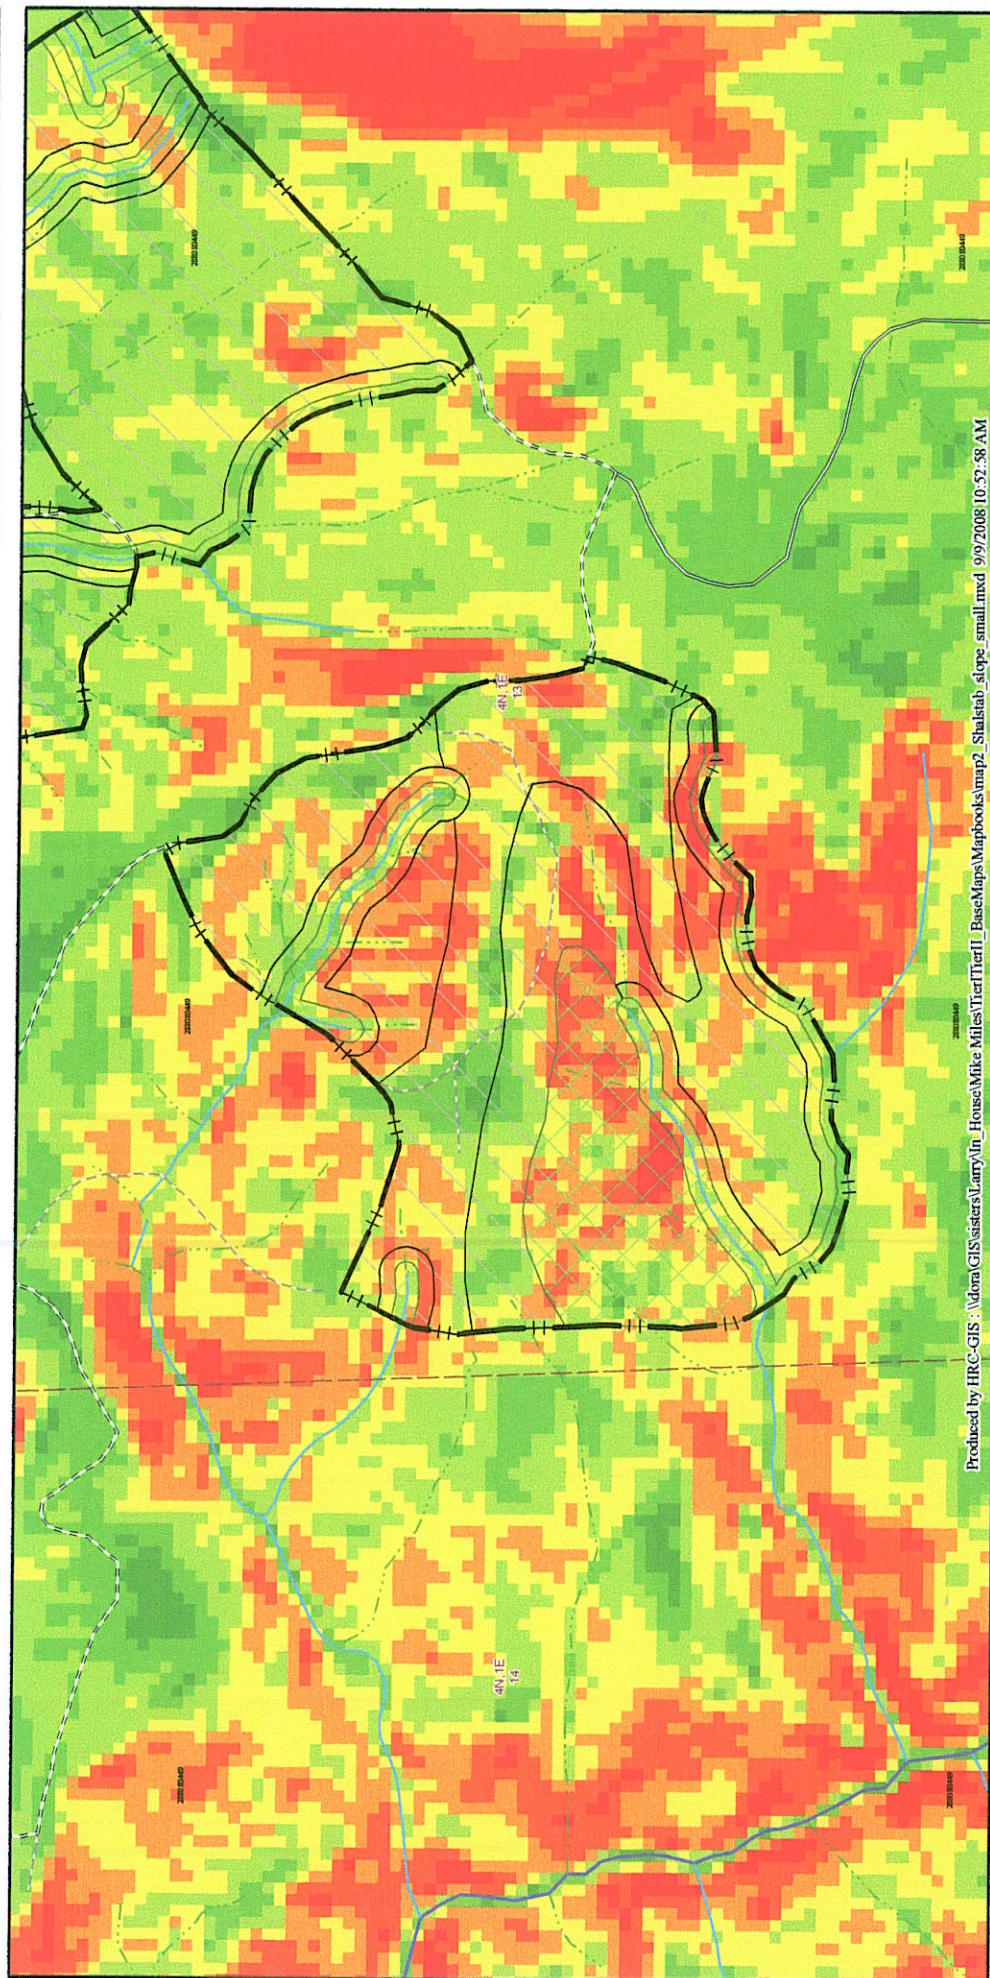
Figure 3

The harvest unit occupies a west-facing ridge that is predominantly underlain by the lower unit of the Wildcat Group. A small portion of the unit in the east may be underlain by Mélange of the Central Belt within the Franciscan Complex. The contact is mapped as a fault (figure 3). Debris slide slopes are mapped within the unit (figure 3).

Debris slide slopes are also mapped along the right flanking slopes of the western Class II watercourse (1b). These slopes are inclined 20 to 60%.

No evidence of past instability was observed in the CGS mapped debris slide slopes. Typically, we find that their designation suggests potential source areas as opposed to actual slopes that are debris sliding.
