**Final Report:
2004 - 2005 South Humboldt Bay Coastal Resources Protection
Project, Salmon Creek and South Fork Elk River Watersheds,
Humboldt County, CA**

**California State Water Resources Control Board
Agreement #03-211-551**

**Pacific Watershed Associates
Arcata, California
(707) 839-5130
December 2005**

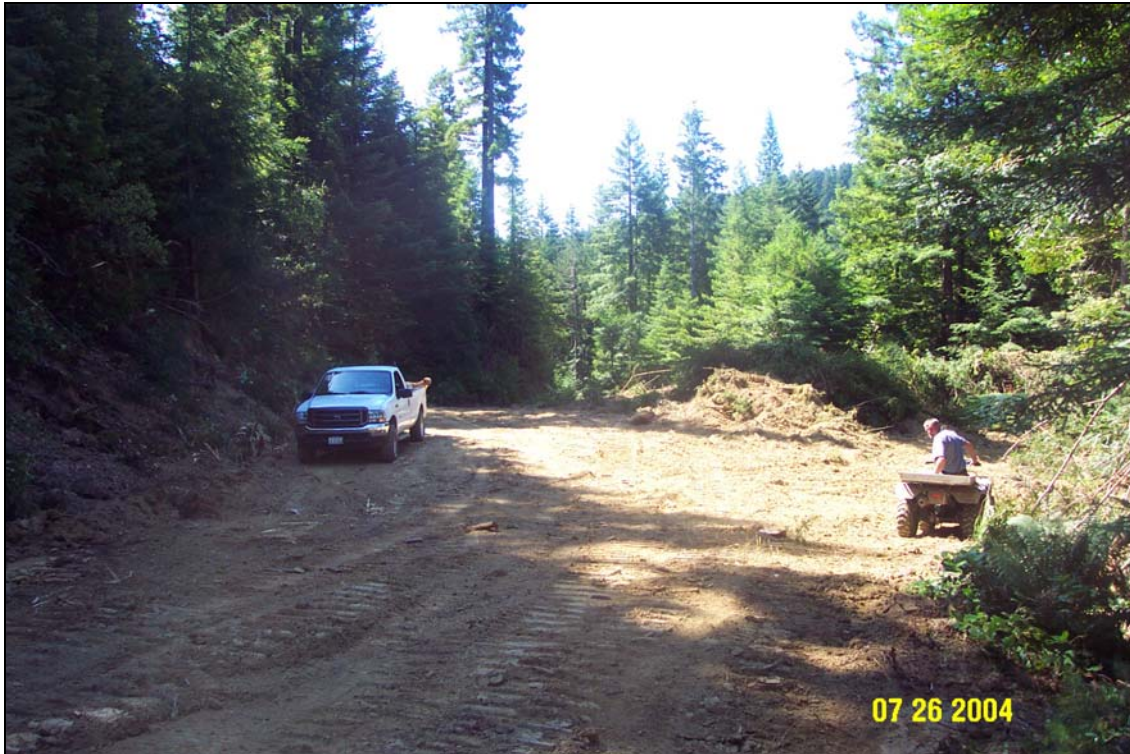
Photo #1. Site #1, U06.6966 Road, pre-treatment. Landing buried stream valley which had actively enlarging sinkholes. Site #2, another stream crossing, is located on the far side of the landing near the center of the photo.

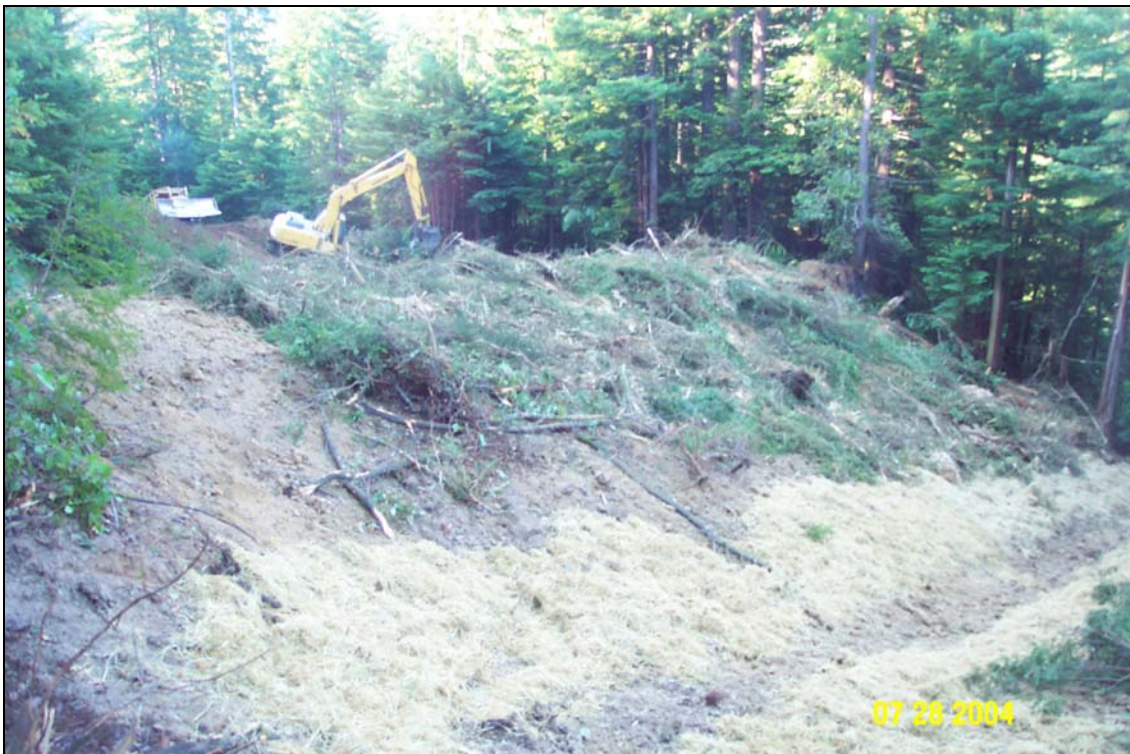
Photo #2. Site #1, U06.6966 Road, post-treatment. Spoils were stockpiled on the left side of the crossing and covered with slash to protect the surface from rain-splash. Straw mulch was placed along the sides of the excavated channel to help catch fines generated from the fresh surface. The excavator and dozer are working on site #2, in the upper left of the photo.

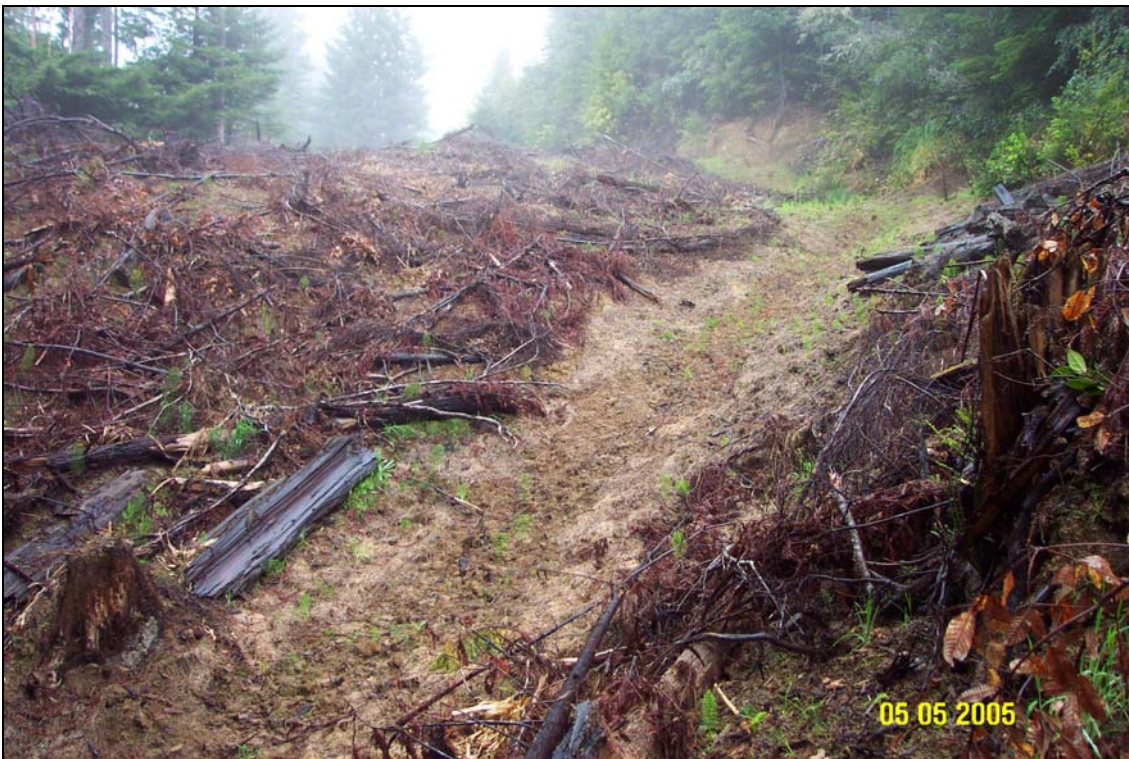
Photo #4. The same stream crossing as it looked after going through one winter. The view is from the lower end of the excavation looking upstream to the top.

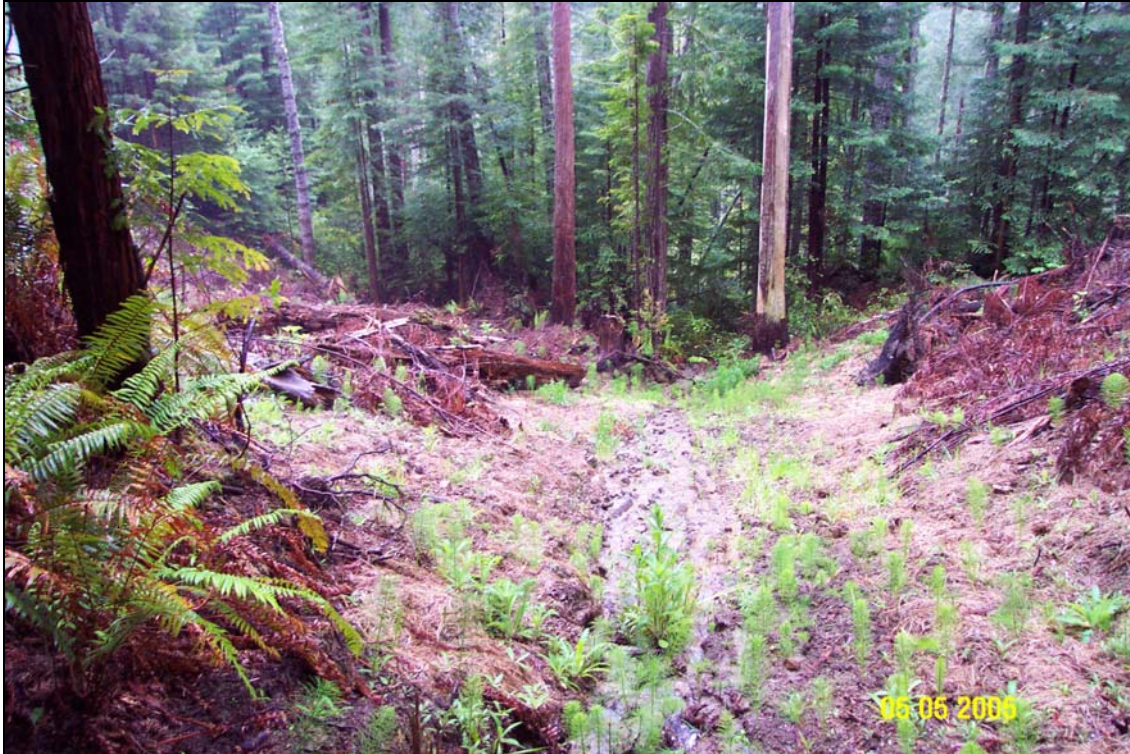
Photo #6. Site #3, U06.6966 Road, post-treatment. View is from the top of the excavation looking down to the bot. This picture was taken in May, 2005 after the site had gone through it's first winter, post treatment. The channel is showing almost no signs of adjustments.

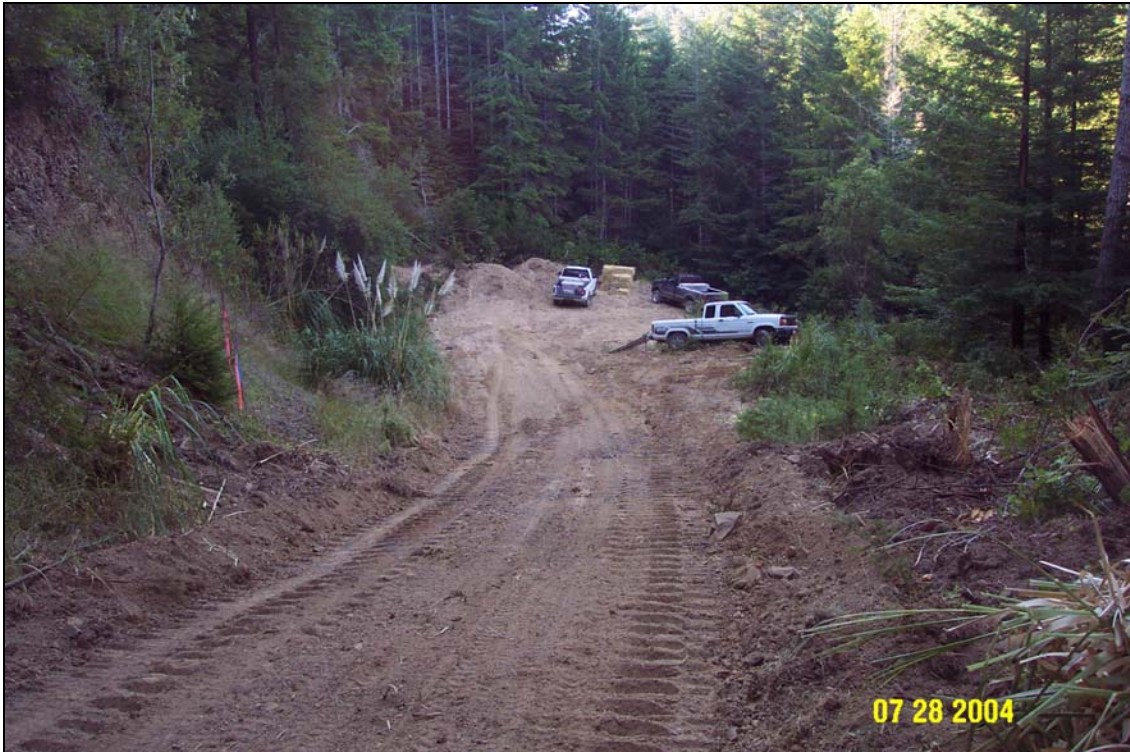
Photo #7. Site #4, another near origin stream crossing, pre-treatment. The view is from the right road approach looking across the crossing toward the upper portion of site #5, a stream crossing located within the landing and switchback where the distant truck is parked in the photo.

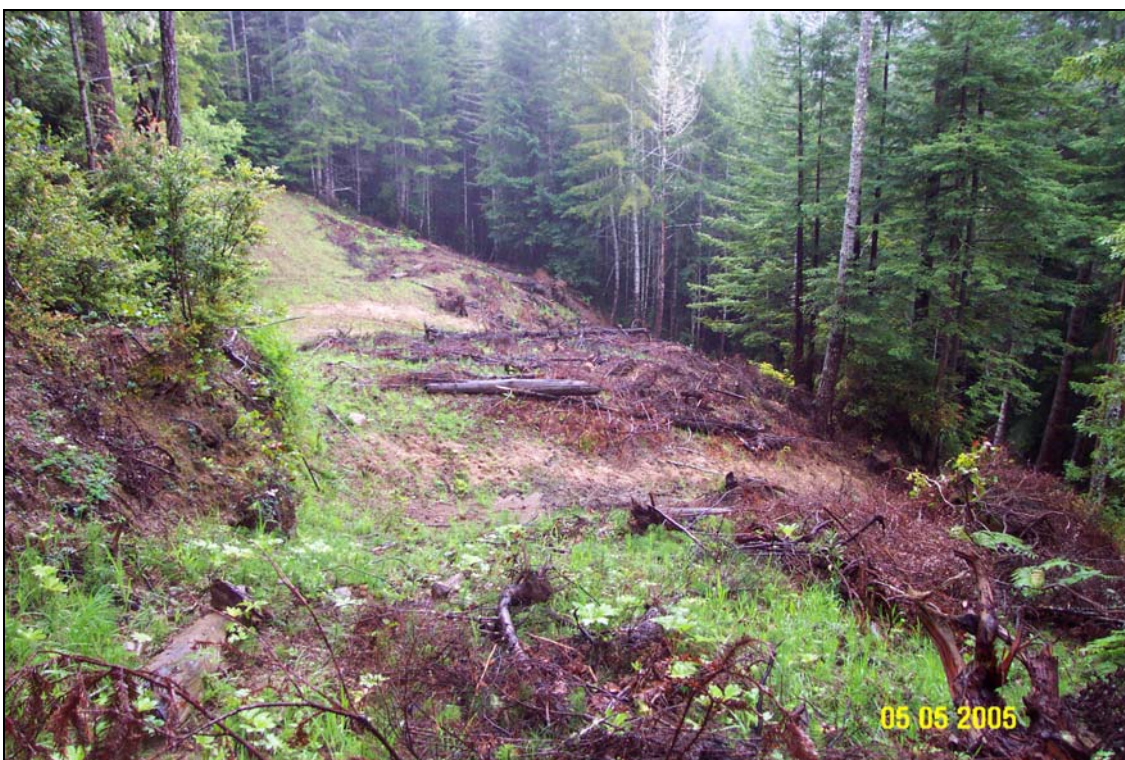
Photo #9. Stream crossing #4 located in the lower half of the photo, and the upper portion of site #5 in the upper center of the photo, both after going through their first winter post-treatment. Compare this photo with Photo #7, pre-treatment with a similar view.

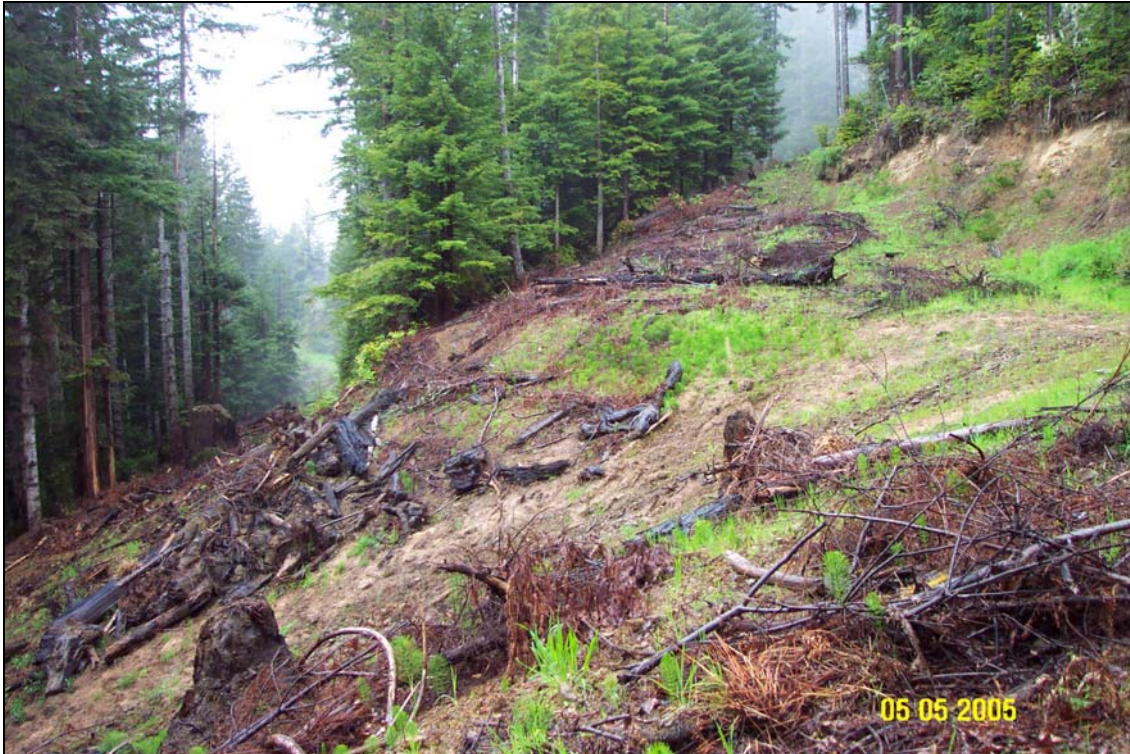
Photo #11. The upper portion of site #5, almost one year after treatment. The view is similar to the previous photo.

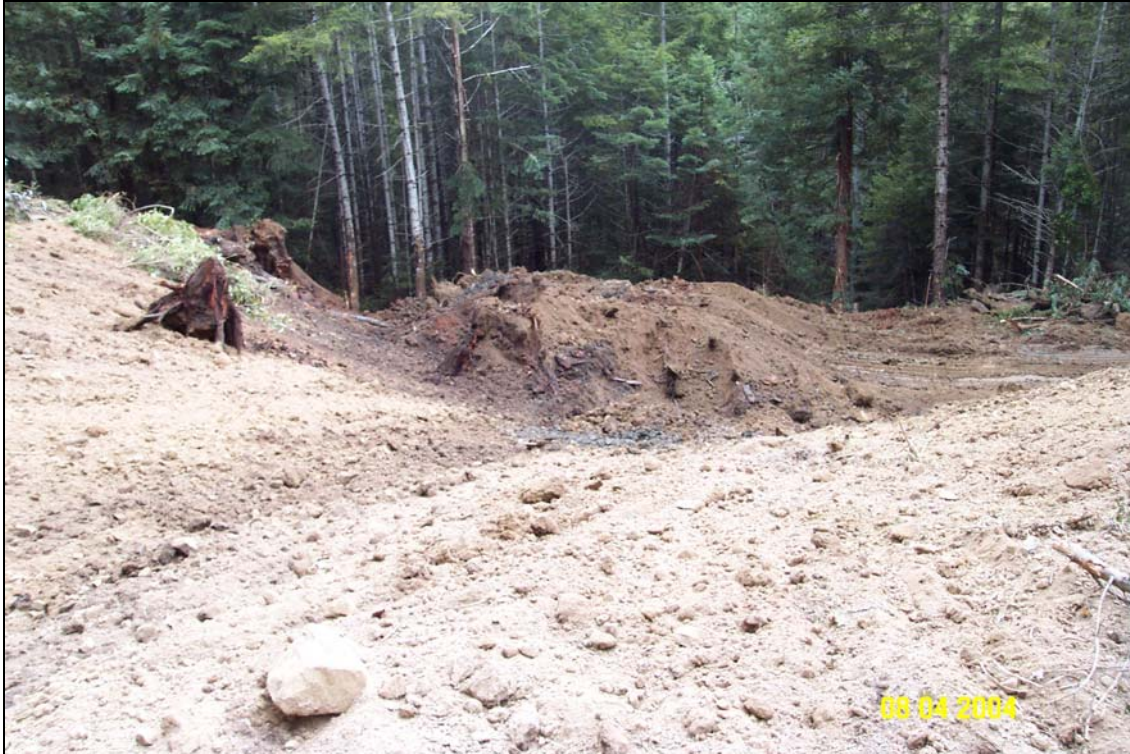
Photo #12. The lower portion of stream crossing #5, U06.6966 Road, in progress. The view is from the upper segment of the old switchback looking downslope toward the bot (hidden from view by the pile of material in the center of the photo). The lower road approach meets the site in the right-center of the photo.

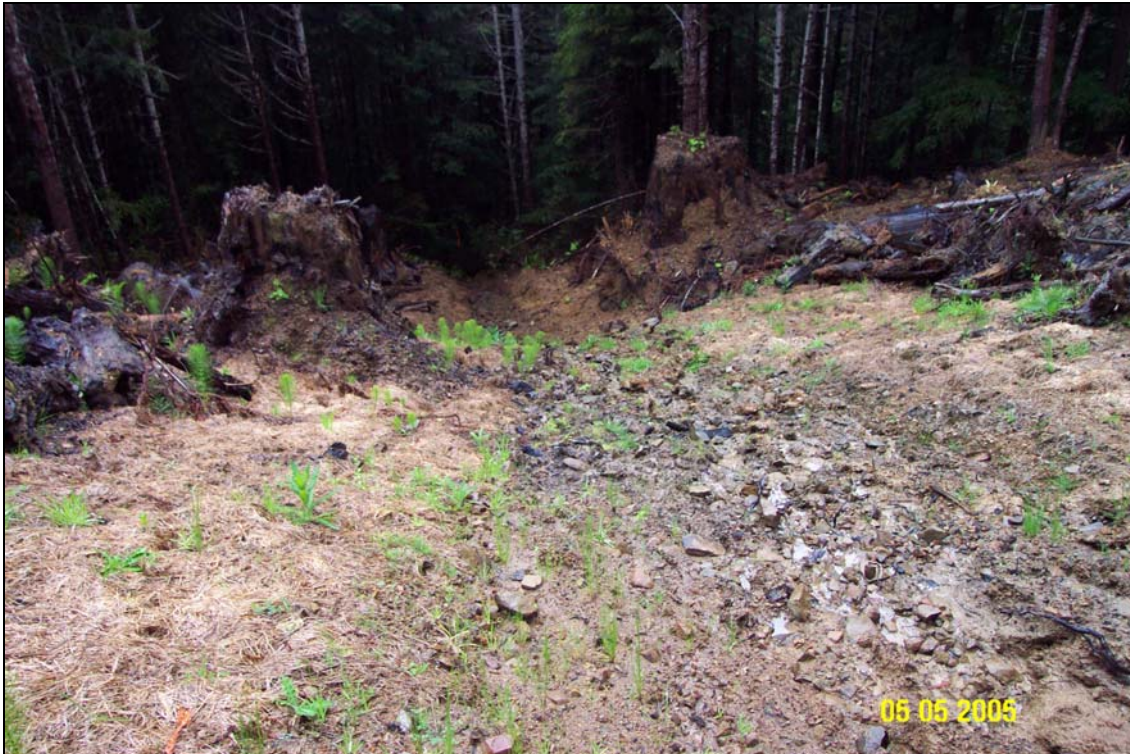
Photo #13. The lower portion of Site #5, after the first winter, post-treatment. The view is similar to the previous photo, only from the left side of the excavated swale-still looking downstream to the bot. The stump in the left side of the photo was unearthed from the pile of fill shown in the photo above.

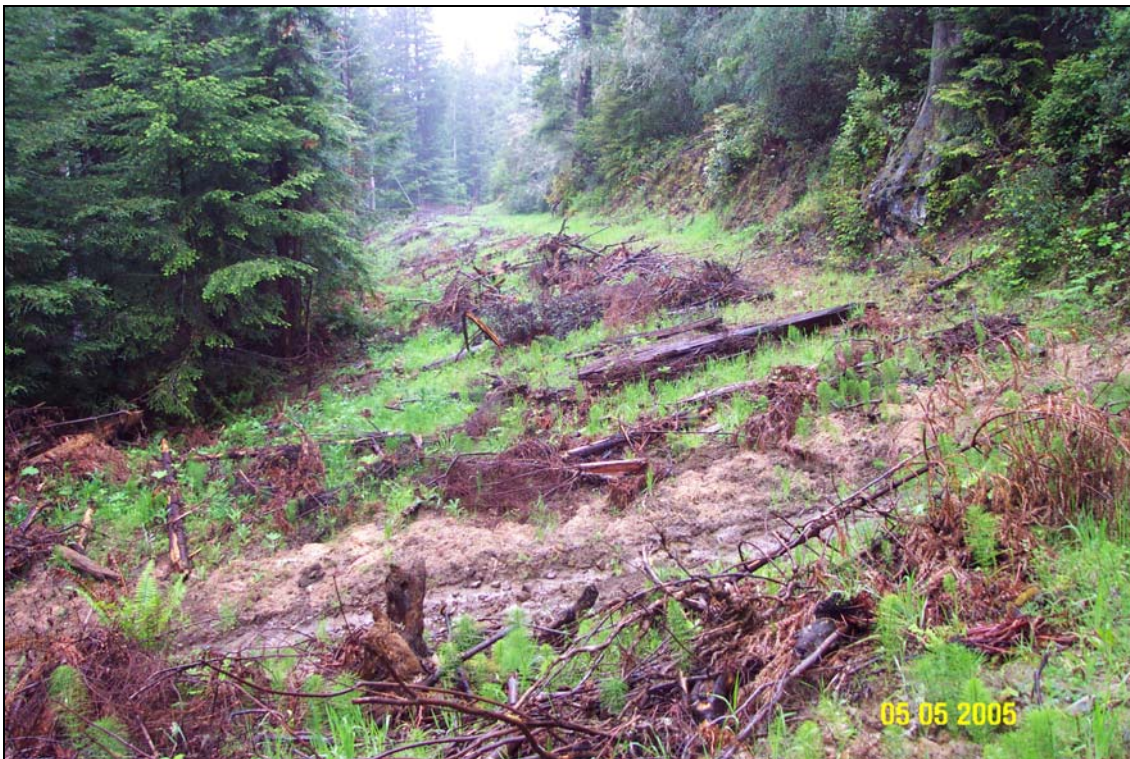
Photo #15. Site #6, post treatment, almost one year later. The view is similar to that in the photo above, only closer to the crossing. Note stump in the upper right of the photo.

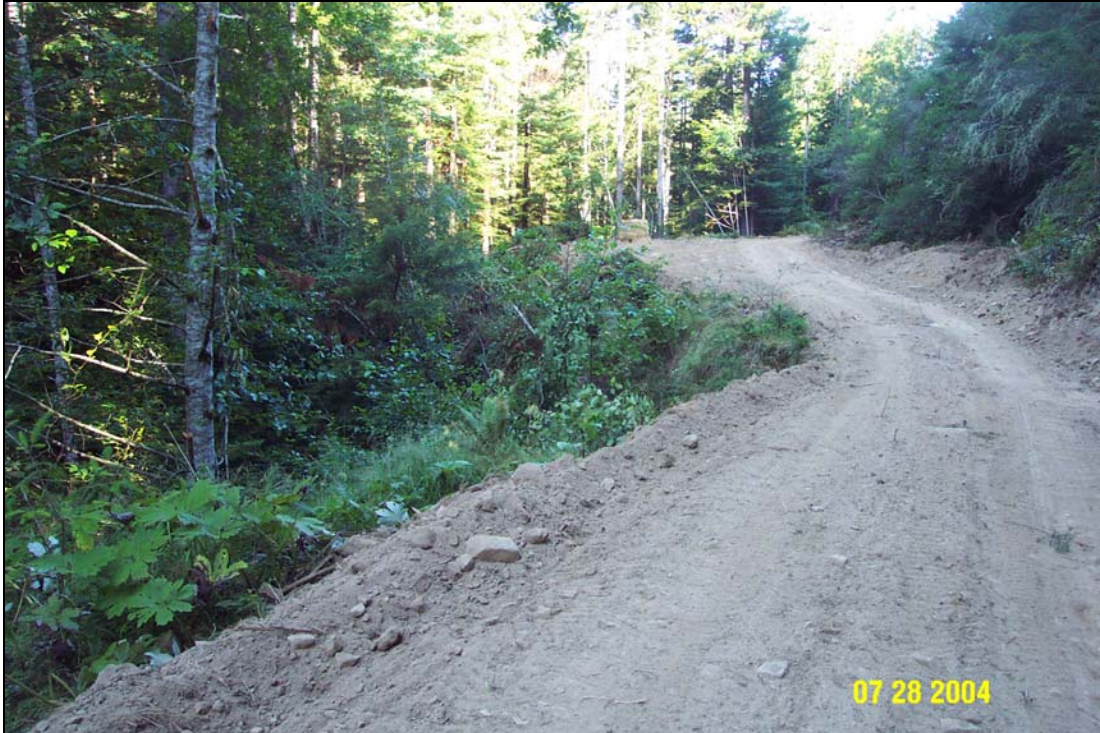
Photo #18A. Site #7, a potential landslide on the U06.6966 Road, pre-treatment. View is from the left side of the site looking beyond across the site toward the right approach. The upper reaches of the north fork of the Little South Fork Elk River is located directly below the site. Note the over-steepened edge of the road at the bend approximately center-right in the photo. A portion of the road bench had already failed and delivered to the creek at the base of the inner-gorge slopes below, but additional unstable material remained perched with potential to deliver additional sediment into the stream.

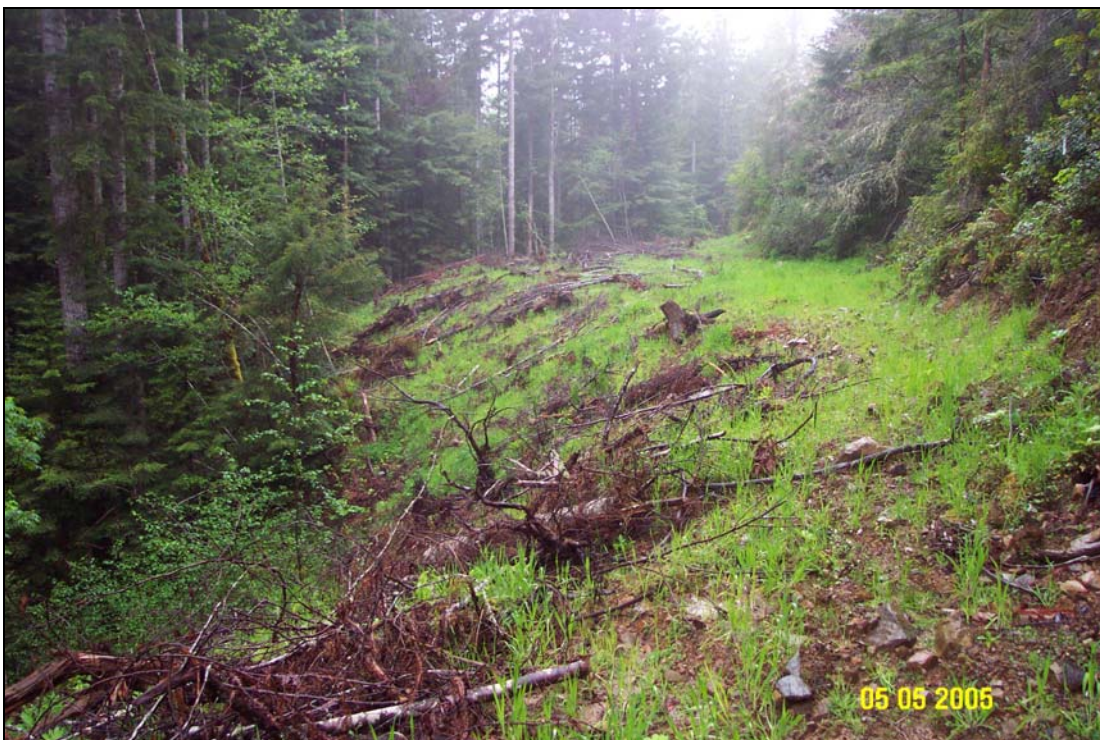
Photo #18B. Site #7, almost one year after treatment. View is similar to the above photo. The edge of the road was pulled back and some of the material was stockpiled upon the cutbank to create a complete outslope.

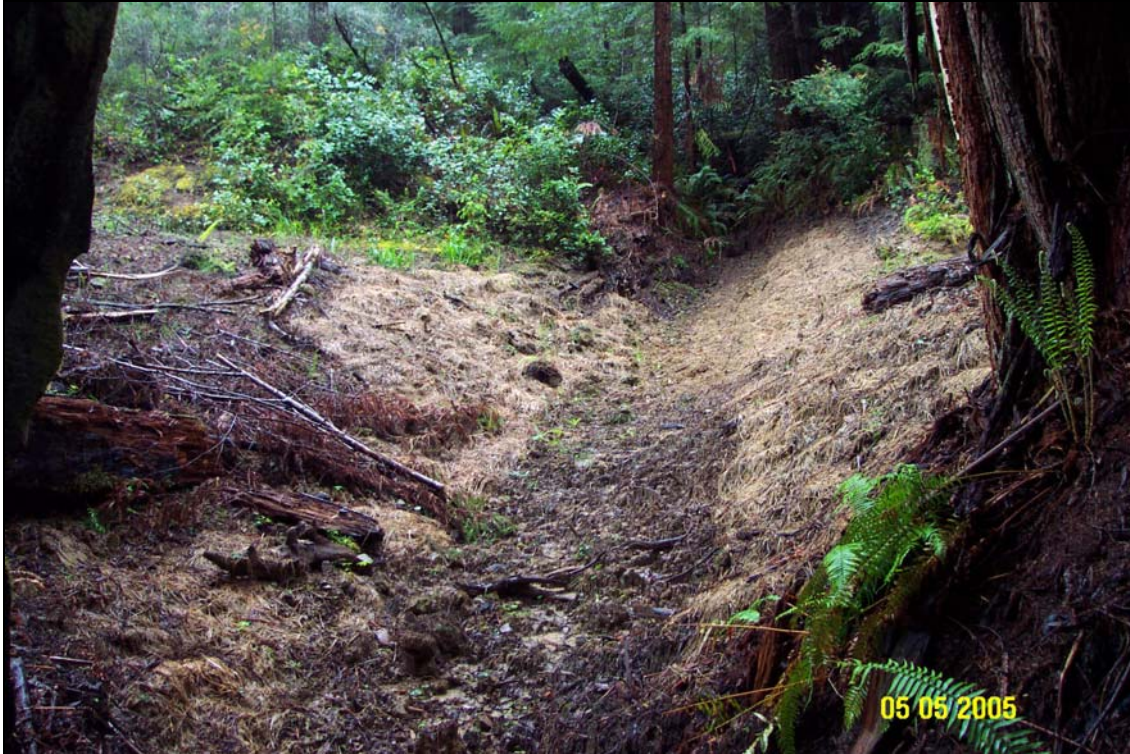
Photo #21. Site #8, stream crossing on the U06.6966 Road, almost one year after treatment. Picture taken from near the bot looking upstream. The new stream channel shows very little signs of adjustments.

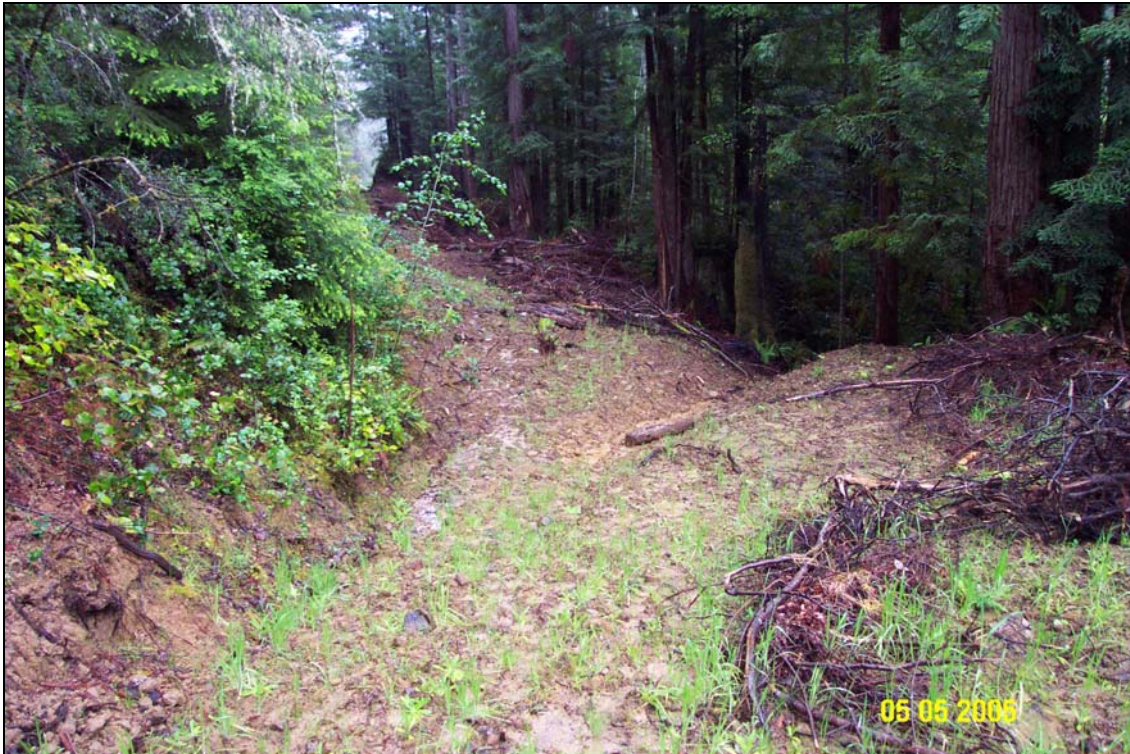
Photo #22. Excavated swale catching spring flow on right approach to site #8., approximately one year after treatment. Site #8 is obscured just beyond the slash pile in the top-center of the photo.

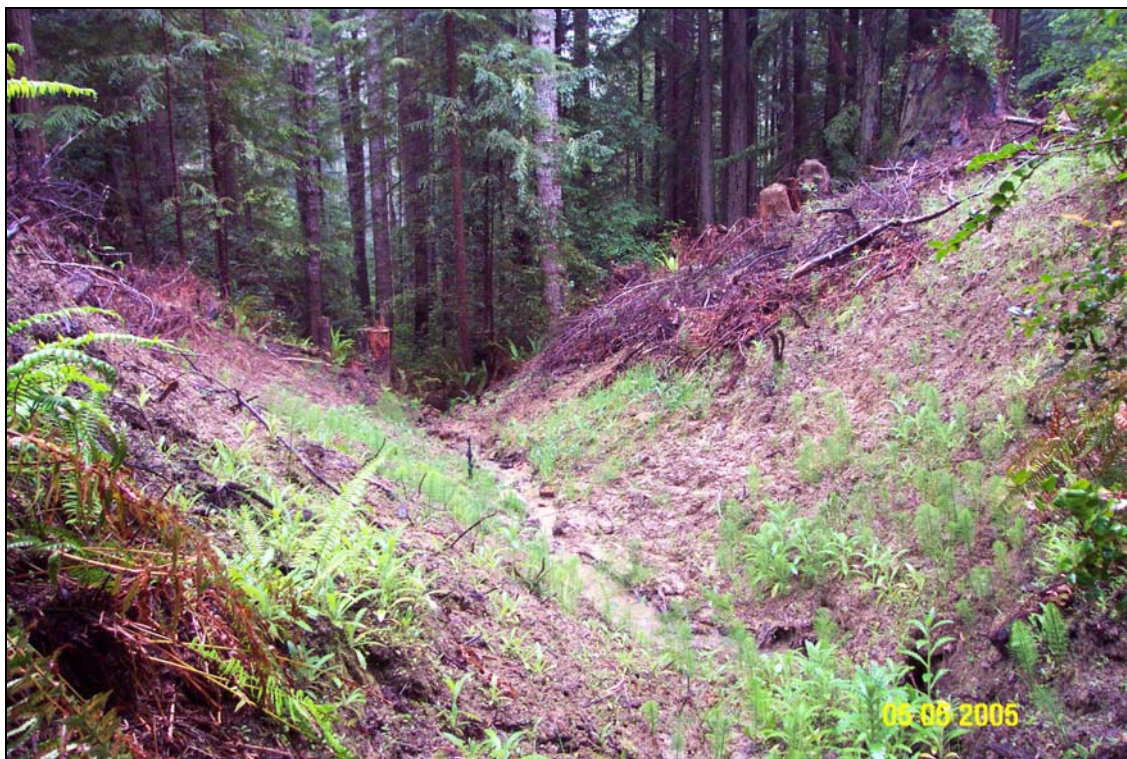
Photo #23. Site #9, almost one year after treatment. Picture taken from the top end of the excavation, looking downstream to the bottom end (bot) of the excavation.

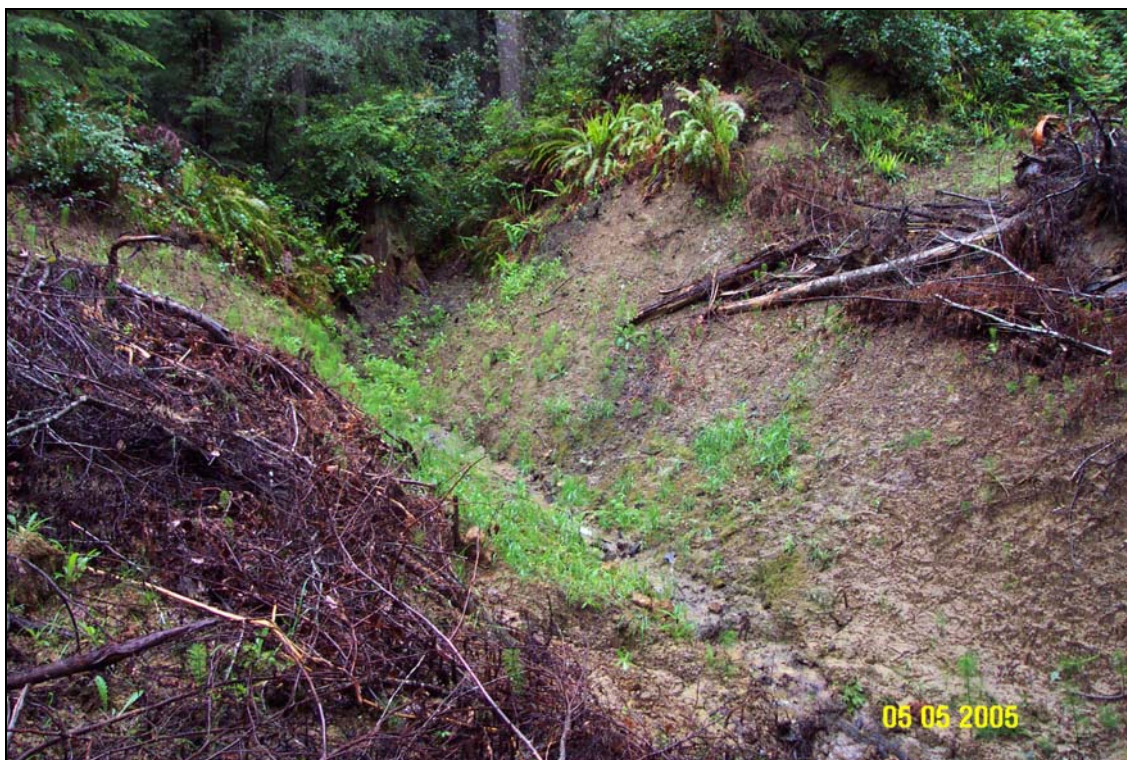
Photo #24. Site #9, almost one year after treatment. Picture taken from the lower end of the excavation above the right side-slope, looking upstream at the top of the excavation.

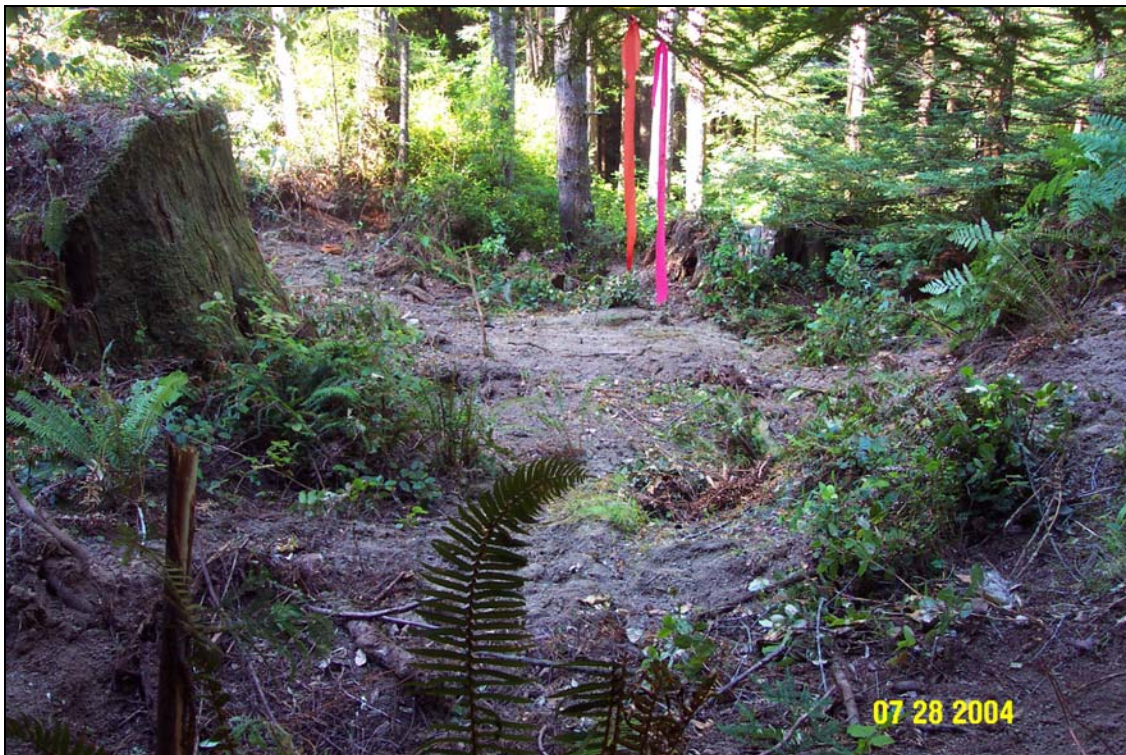
Photos 8A and 8B. U06.6966 Spur 1 Road, Site #16, stream crossing, pre- and post-treatment. The picture was taken from approximately the top, looking downstream. The bottom photo was taken after the site had gone through its first winter post-excavation.

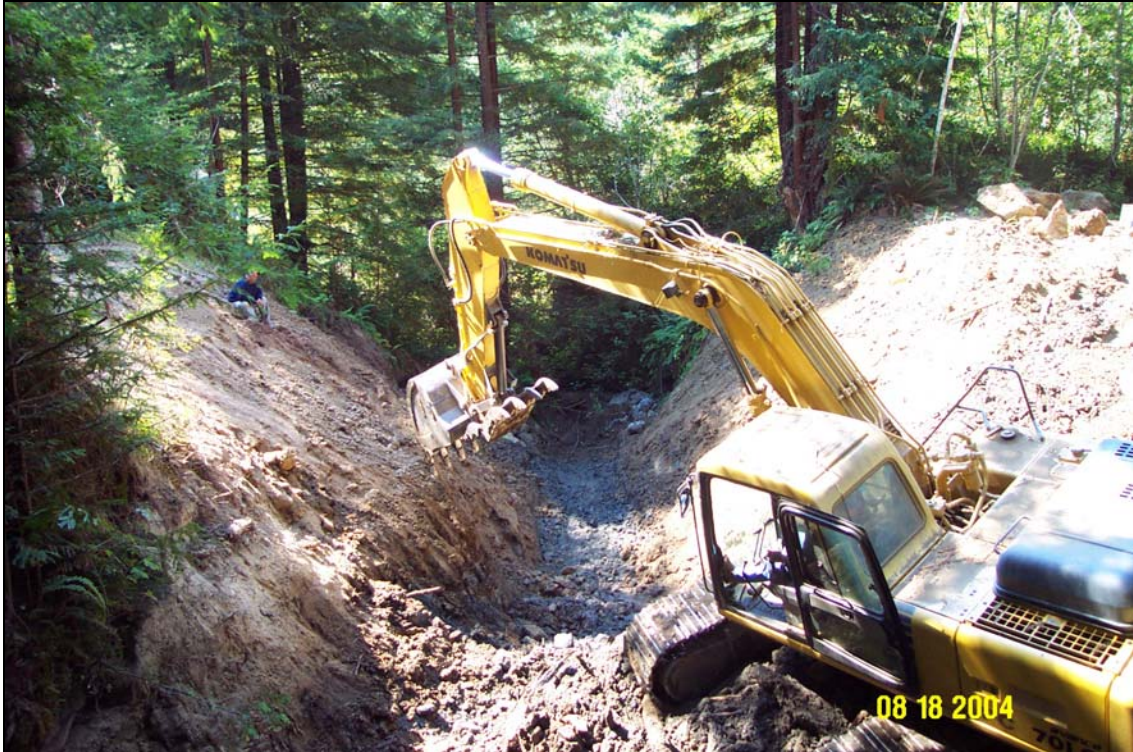
Before moving to the Salmon Creek watershed portion of the Headwaters Forest Reserve, the equipment crew was directed to treat a high priority stream crossing site (#1129) on the U06 Road along the riparian corridor of the mainstem South Fork Elk River (Map 3). This actively failing stream crossing was upgraded by rebuilding the stream crossing, removing over 1,190 yd³ of material from the crossing as well as stored sediment from the stream channel above the crossing. The culvert inlet was wrapped with an expanding clay collar and both the inboard and outboard fillslopes armored with rip rap.

Photo 3. U06 Road, Site #1129, stream crossing, during-treatment. The picture was taken from a stump on the right sideslope of the stream valley upstream of the crossing. The view is looking downstream through the excavated road prism during the last stages of excavating the trench that the culvert was placed in. Note again the gray material in the center of the photo indicating the operator has reached natural bedrock in this area.

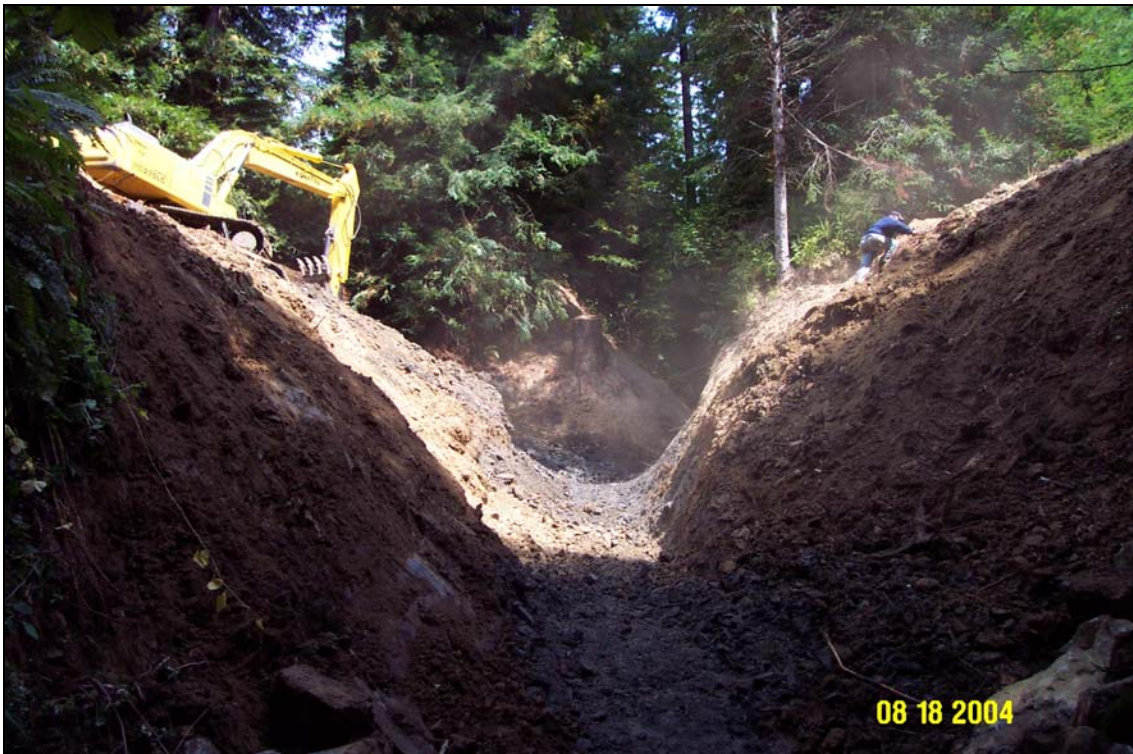
Photo 4. Site #1129 during the crossing upgrade. The excavator has cleaned out the trench to the natural stream grade and is ready for the culvert installation.

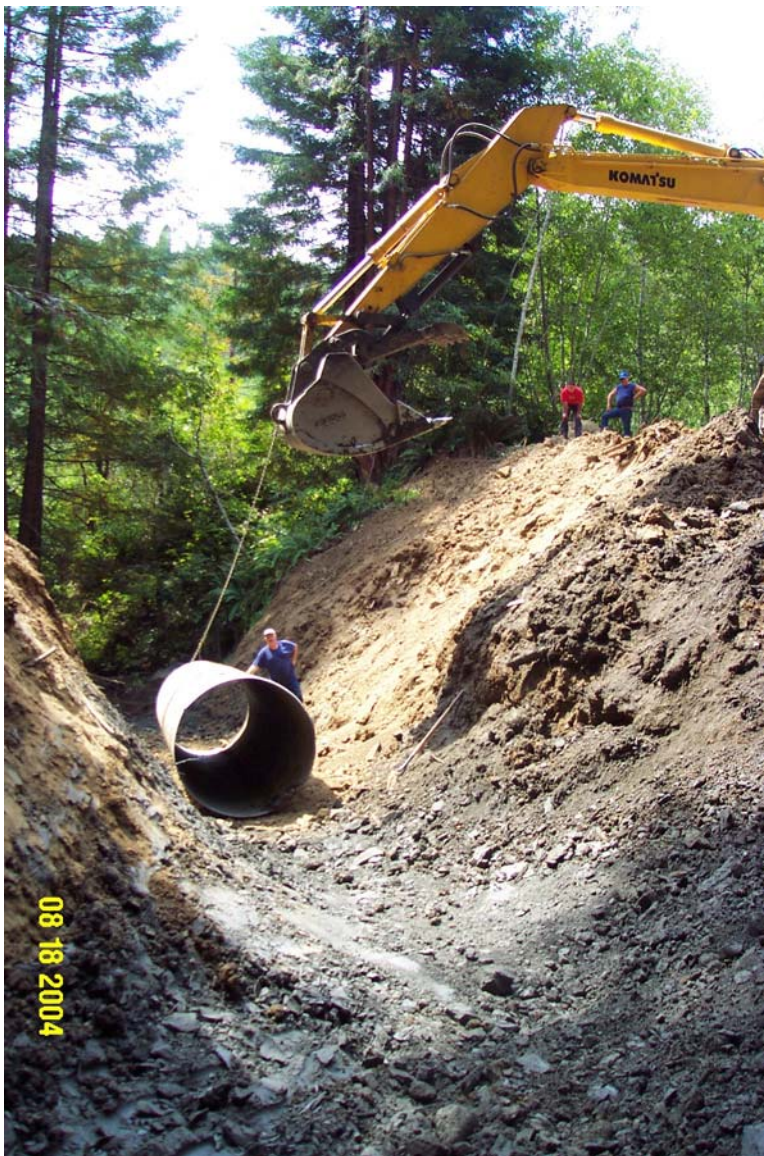
Photo 5. U06 Road, Site #1129 during the crossing upgrade. The excavator is placing the first section of culvert. View looking downstream from approximately the location of the soon to be installed culvert inlet.

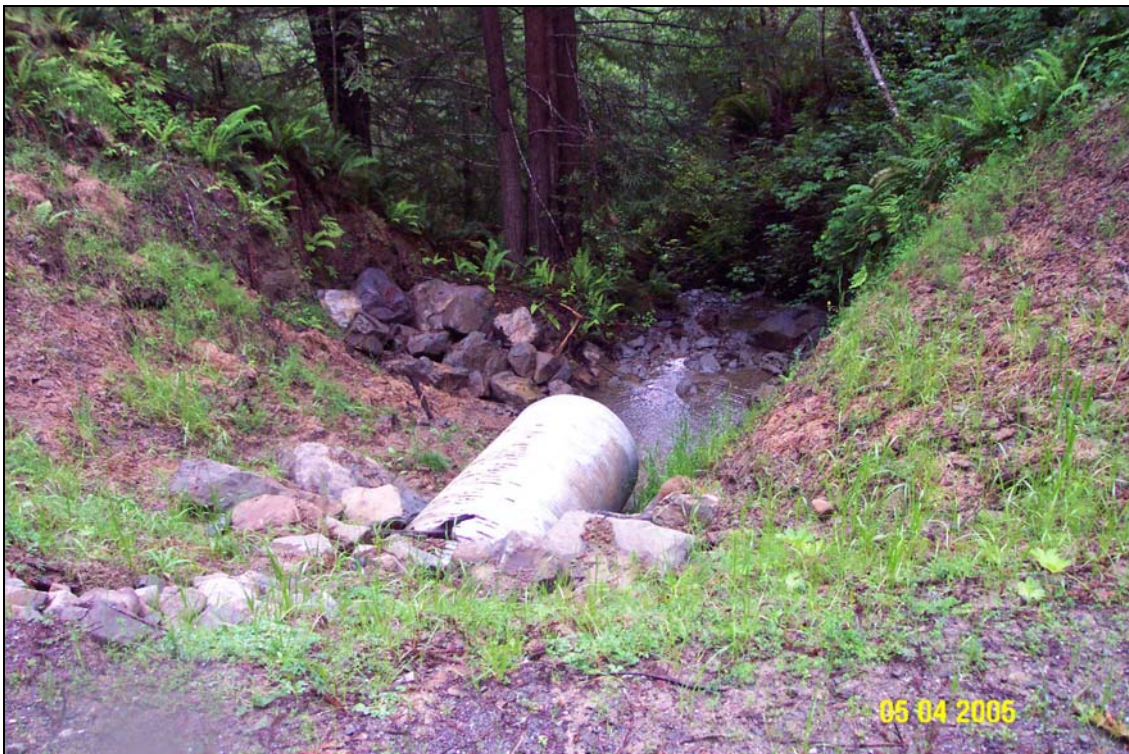
Photo 7. Site #1129, stream crossing, post-treatment. The picture was taken from the outboard edge of the road at the crossing looking downstream toward the outlet. Note how the culvert outlet extends beyond the base of the fillslope to reduce the potential for any material that might slough off the fillslope to come to a rest before reaching the stream. The outlet discharges flow onto bedrock.

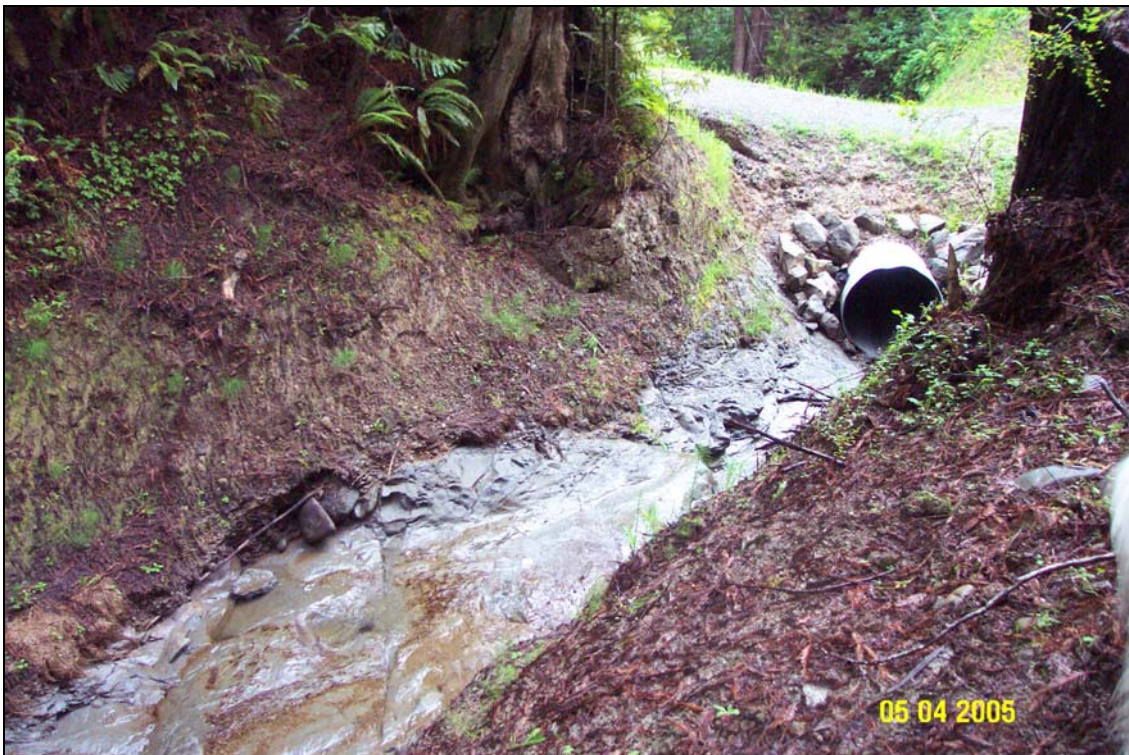
Photos 8 and 9. U06 Road, site #1129, post-treatment. Top photo show picture of the upstream extent of the channel excavation upstream from the crossing. The bottom photo shows part of the excavated channel as well as the new culvert inlet in the upper right of the photo. Both photos show the gray, slick surface of the Wildcat siltstone bedrock which controlled the depth of the channel excavation.

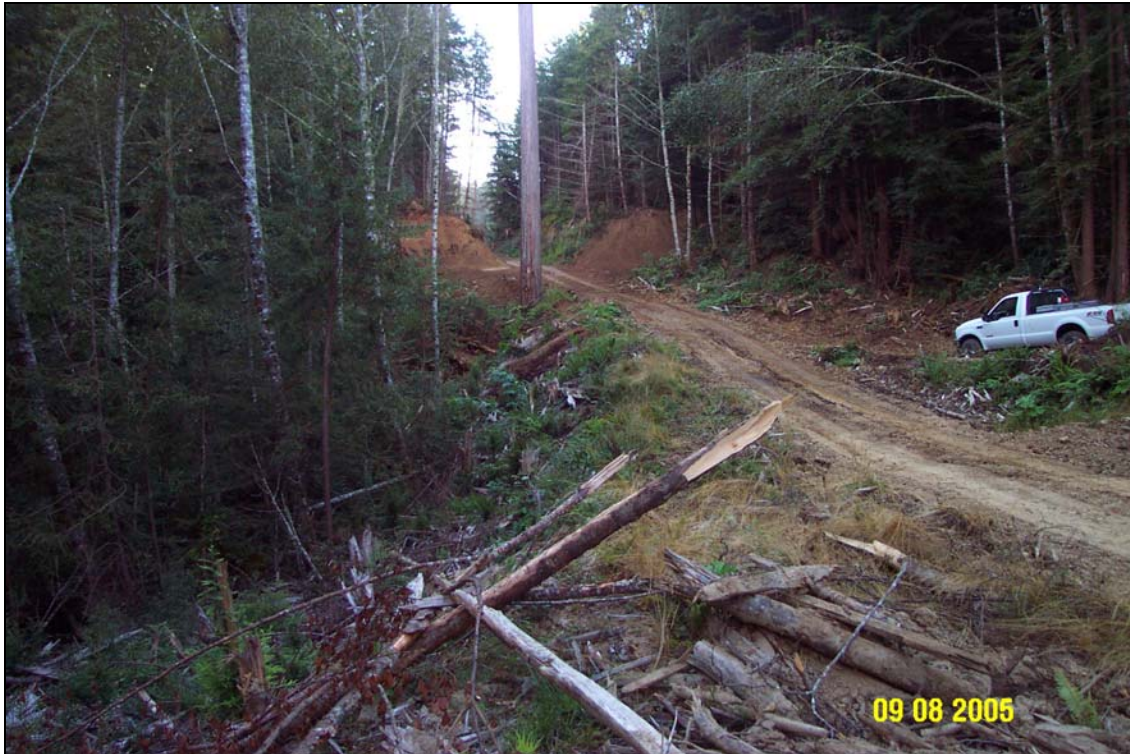
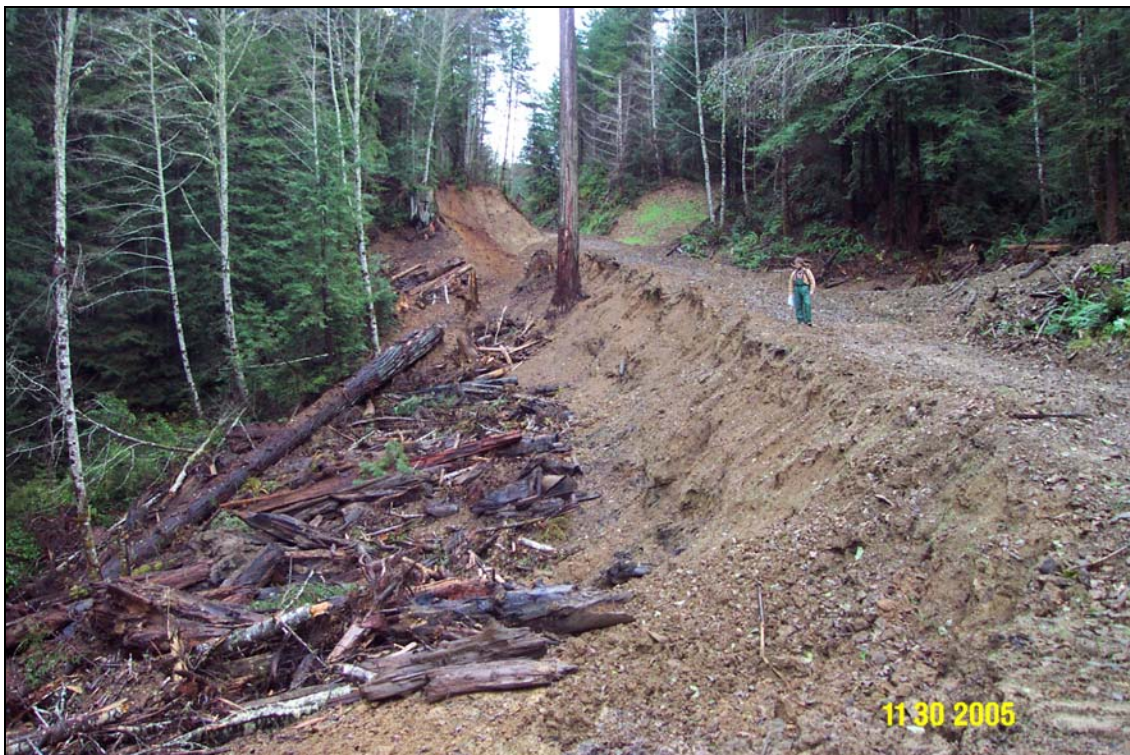
Photos 1A and 1B. R14 Road, site #142.9, landslide, pre- and post-treatment. The picture was taken from a landing on the left side of the site. Road fill, sidecast during road construction activities, was slumping and threatening to deliver to a large Class 2 stream directly down-slope. View is from the left side of the site. Site #143 stream crossing is located near the end of the site at the large Redwood tree in the top-center of the photos.
