**Final Report:
2004 - 2005 South Humboldt Bay Coastal Resources Protection
Project, Salmon Creek and South Fork Elk River Watersheds,
Humboldt County, CA**

**California State Water Resources Control Board
Agreement #03-211-551**

**Pacific Watershed Associates
Arcata, California
(707) 839-5130
December 2005**

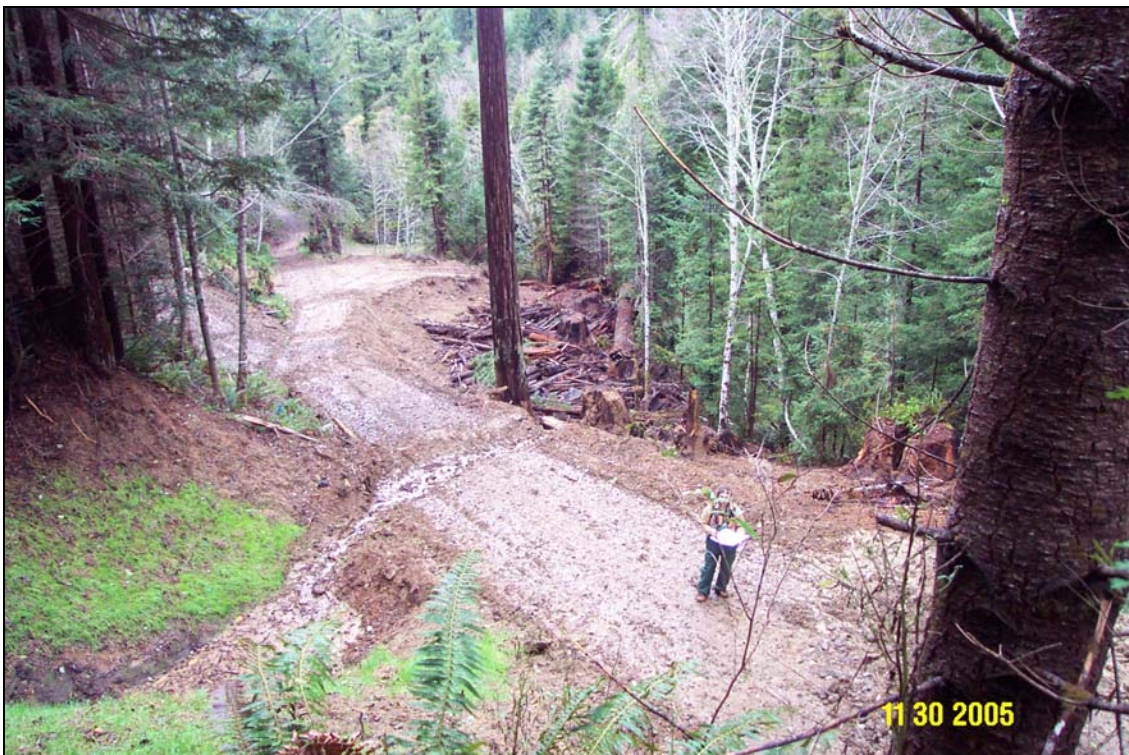
Photos 2A and 2B. R14 Road, site # 143 stream crossing, pre- and post-treatment. The picture was taken from above cutbank immediately to the right of the crossing. Note the lower and upper portions of the stream crossing have been excavated in the lower photo. A small road prism remains to allow future equipment access beyond this site. The remainder of this road is slated for decommissioning in summer 2006. Road fill, sidecast during road construction activities, was slumping and threatening to deliver to a large Class 2 stream directly down-slope. Site #142.9 is visible to the left of the Redwood tree in the top-center of the photo.

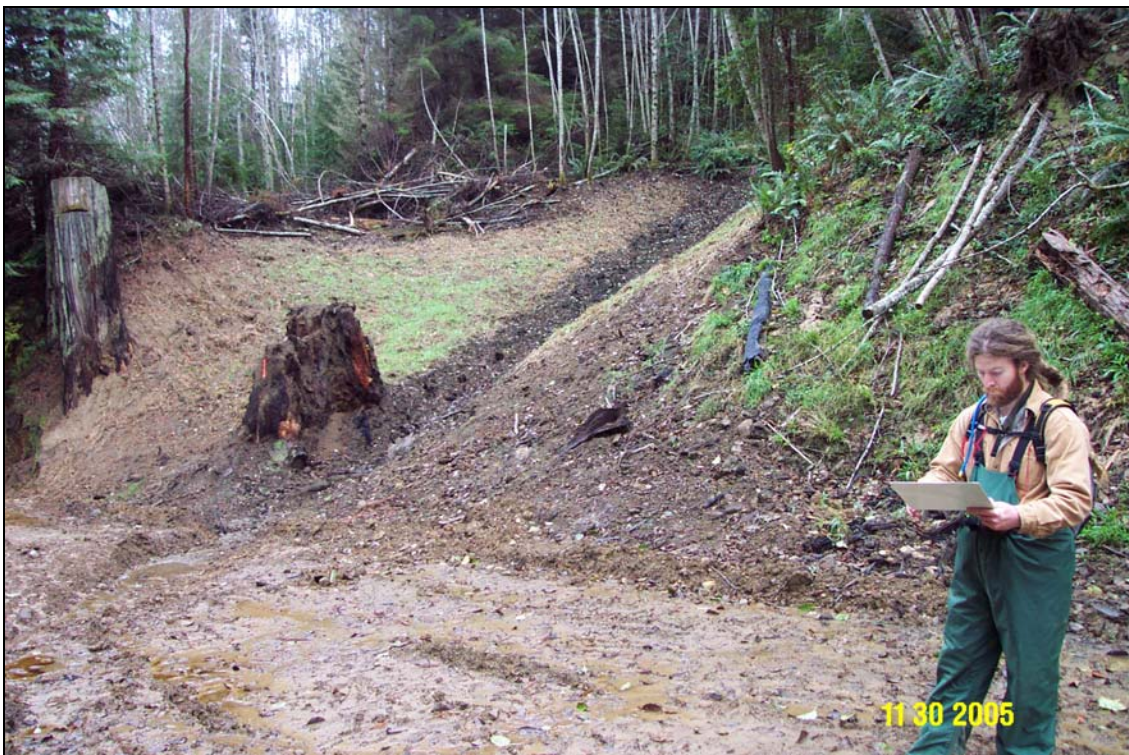
Photos 3 and 4. R14 Road, site #143.2, pre and post treatment. The lower portion of this site had been excavated treated as part of an earlier decommissioning project the previous year. The upper portion of this site had a large break-in-slope with fill over-steepened and saturated above the road. The upstream portion of this site was excavated to the natural channel grade.

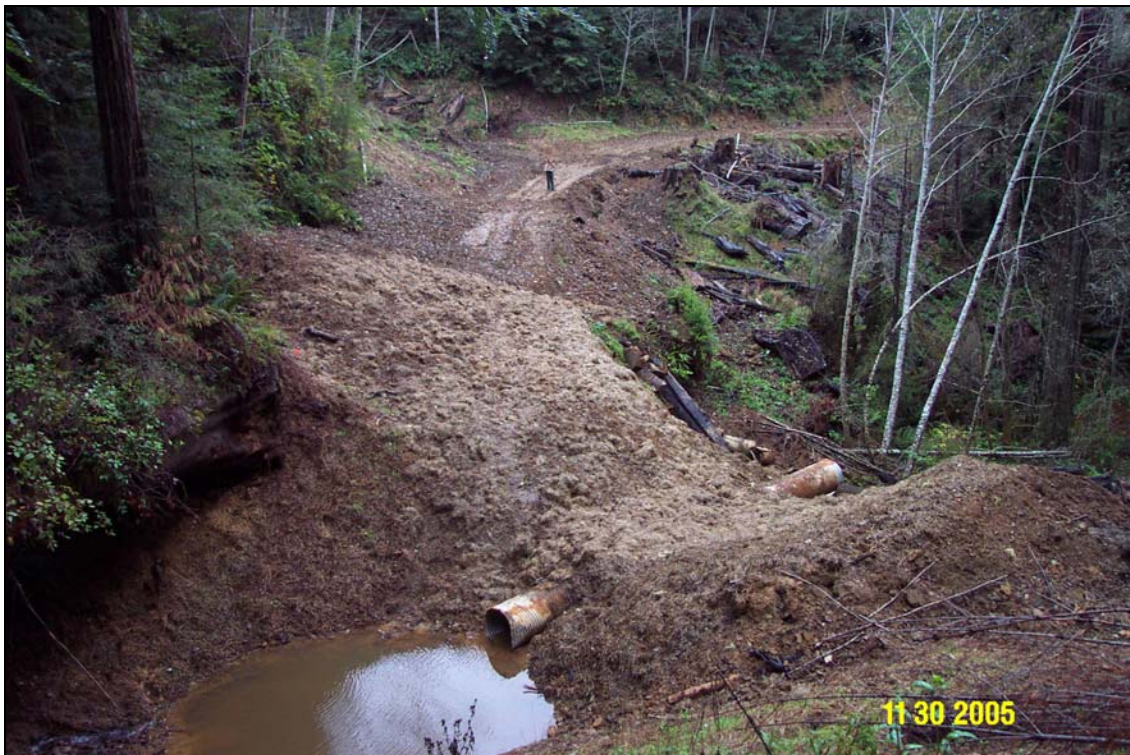
Photos 5A and 5B. R14 Road, site #144, pre and post treatment. This site had also been partially excavated as part of an earlier decommissioning project the previous year. Additional fill was excavated from the crossing and a temporary culvert and downspout installed to pass flow through the crossing. Site #144.2, a small stream crossing site, located in the top center of the photos (where the person is standing in the lower photo) was likewise partially treated with additional fill excavated from the road prism itself through the crossing.

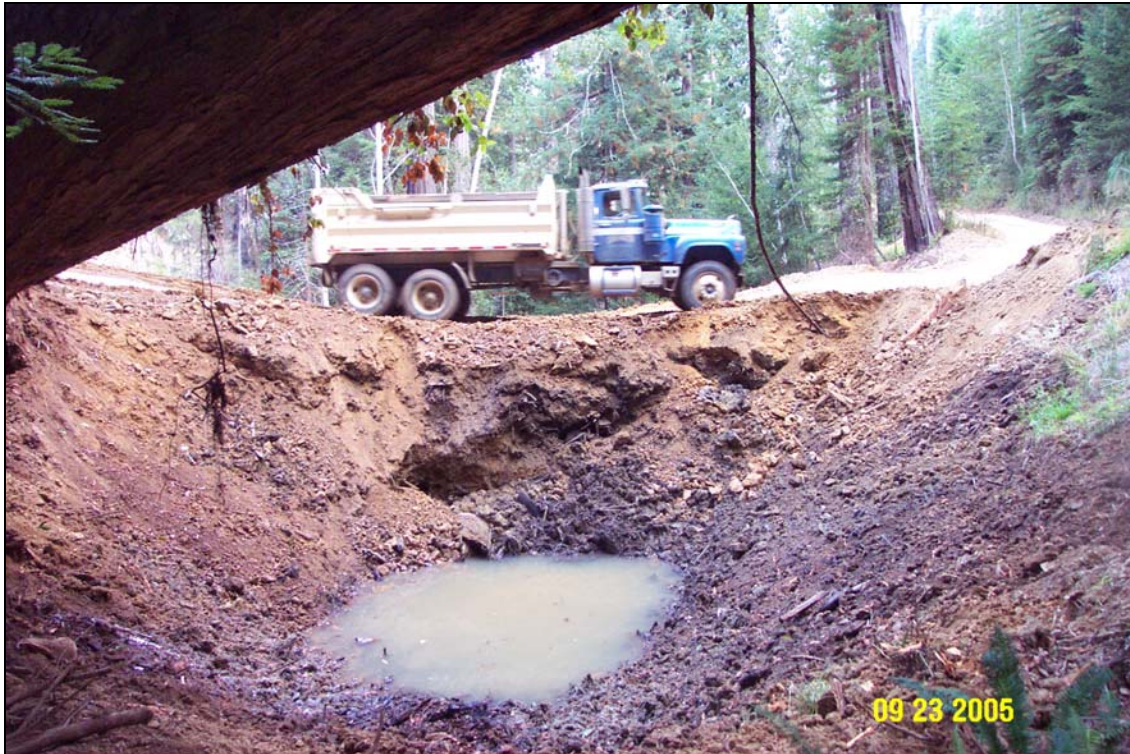
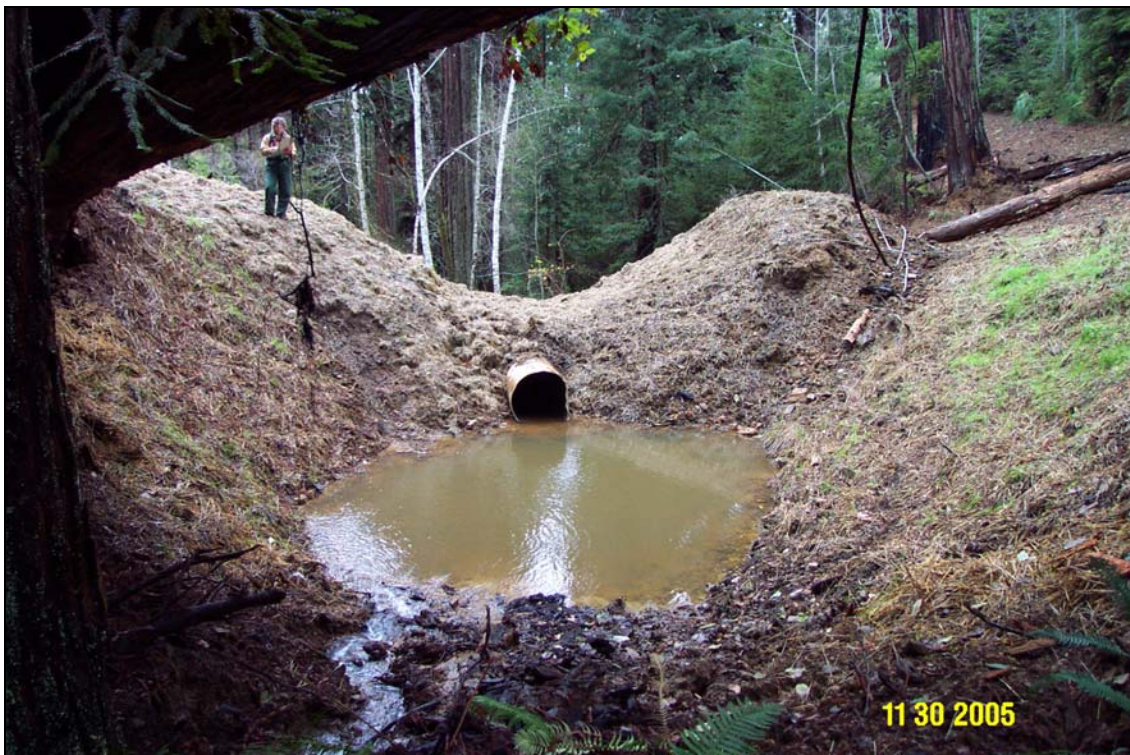
Photos 6A and 6B. R14 Road, site #144, pre and post treatment. View is approximately from the top of the excavation. Note the right road approach has been completely re-contoured in the lower photo. The entire road prism beyond this site was completely re-contoured between sediment delivery sites, funded by the BLM. All sites and road reaches from this site to the beginning of the road, is slated for completion in summer 2006.

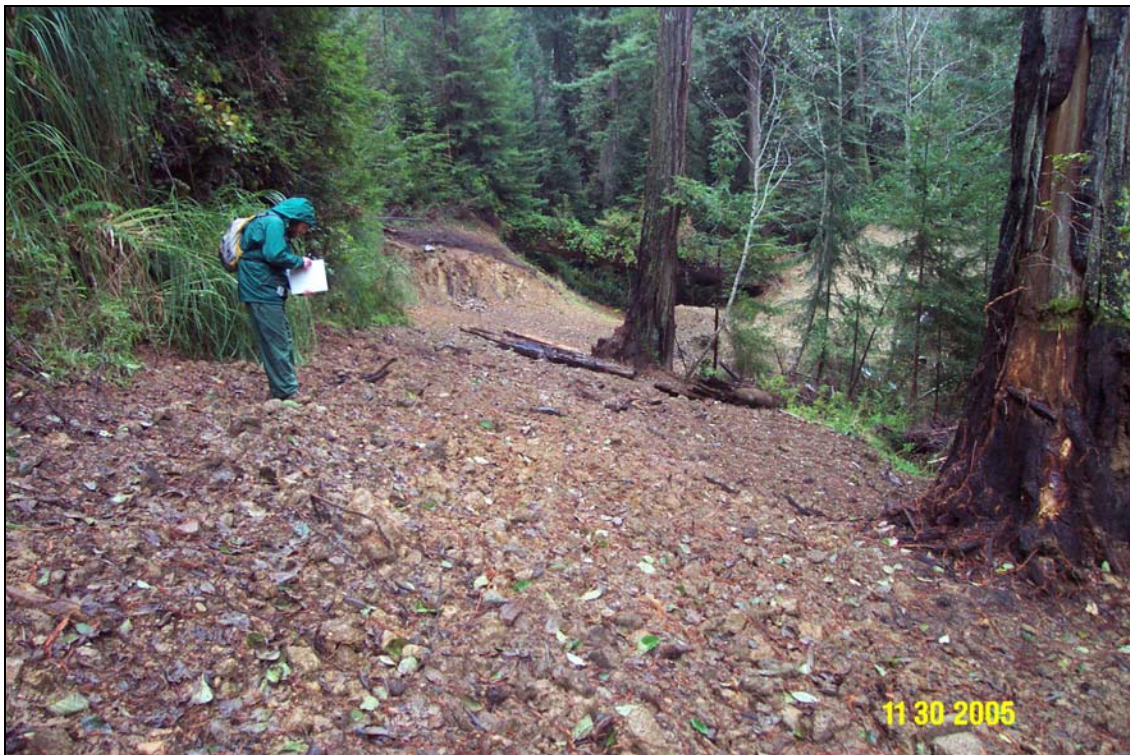
Photos 7A and 7B. R14 Road, site #144.1, landslide, pre- and post-treatment. View is from the right end of the site, looking back towards site #144 stream crossing in the distance. Note the site has been completely outsloped, by placing some of the spoils against the cutbank.

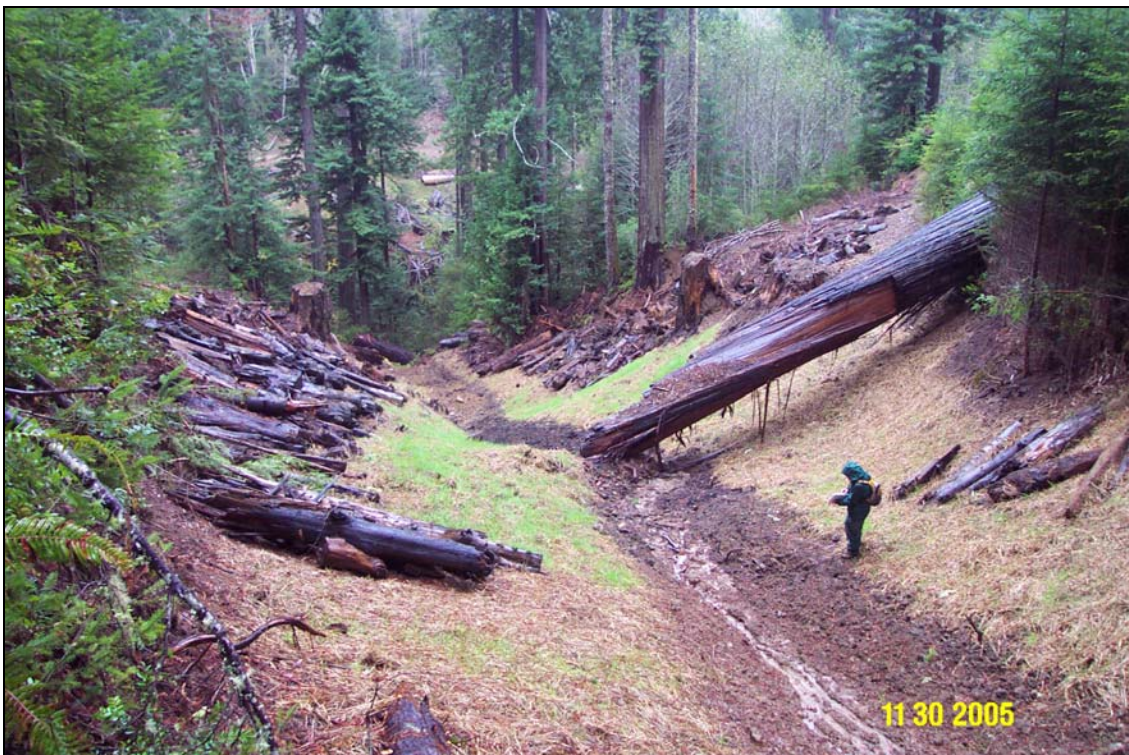
Photos 8A and 8B. R14 Road, site #145, pre and post treatment. View is approximately from the top of the excavation. Note the large woody debris, unearthed during the excavation, was placed upon the side slopes both as a protective layer as well as to catch any material that might slough off. Note the old growth stumps in the lower photo. The previously buried stumps provide guidance to the excavator operator to help locate the original ground surface.

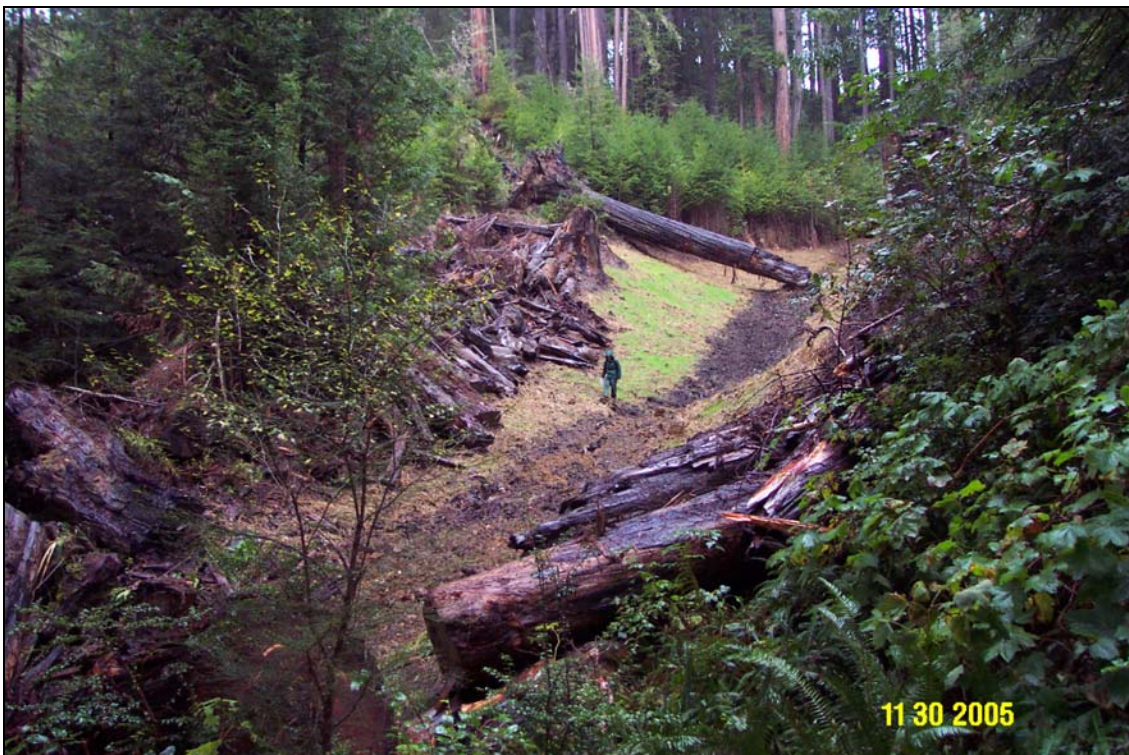
Photos 9A and 9B. R14 Road, site #145, pre and post treatment. View is approximately from the bottom of the excavation. Note the large old growth tree that is resting in the upper portion of the site. The tree had fallen prior to decommissioning activities due to a cutbank slide on the side of the crossing. Note the person, located in the center of the bottom photo, for scale.

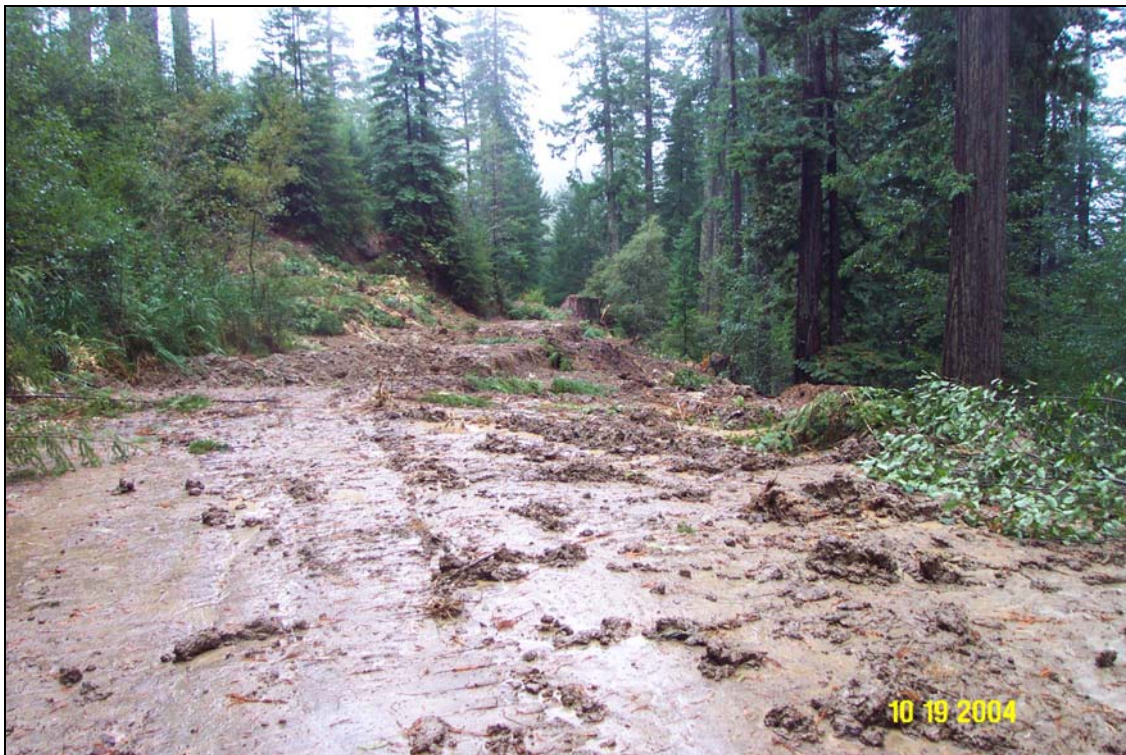
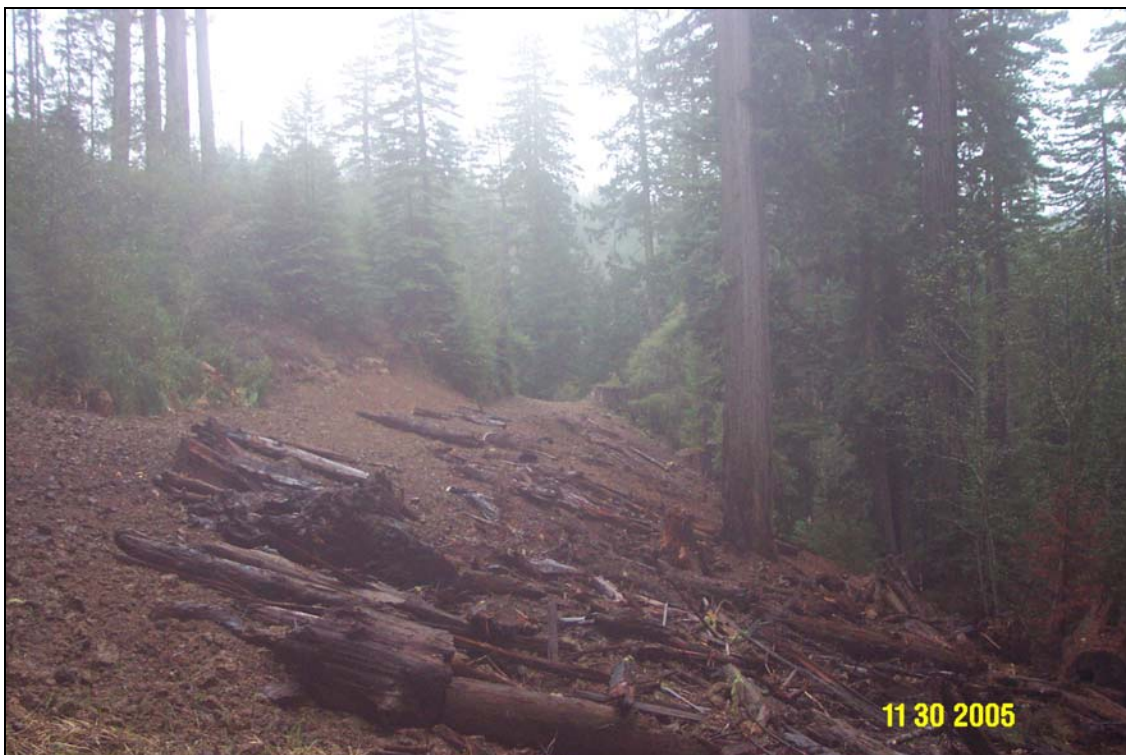
Photos 10A and 10B. R14 Road, site #145.1, another landslide site, pre- and post-treatment. View is from the right end of the site. Again, note the site has been completely outsloped.

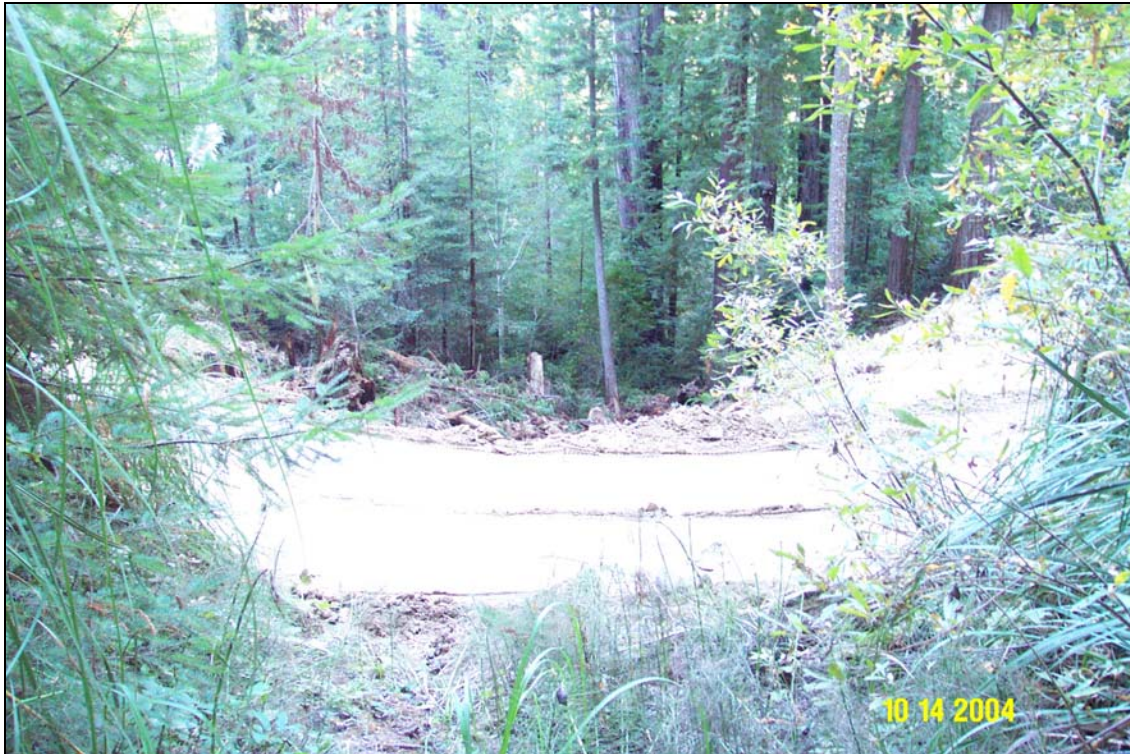
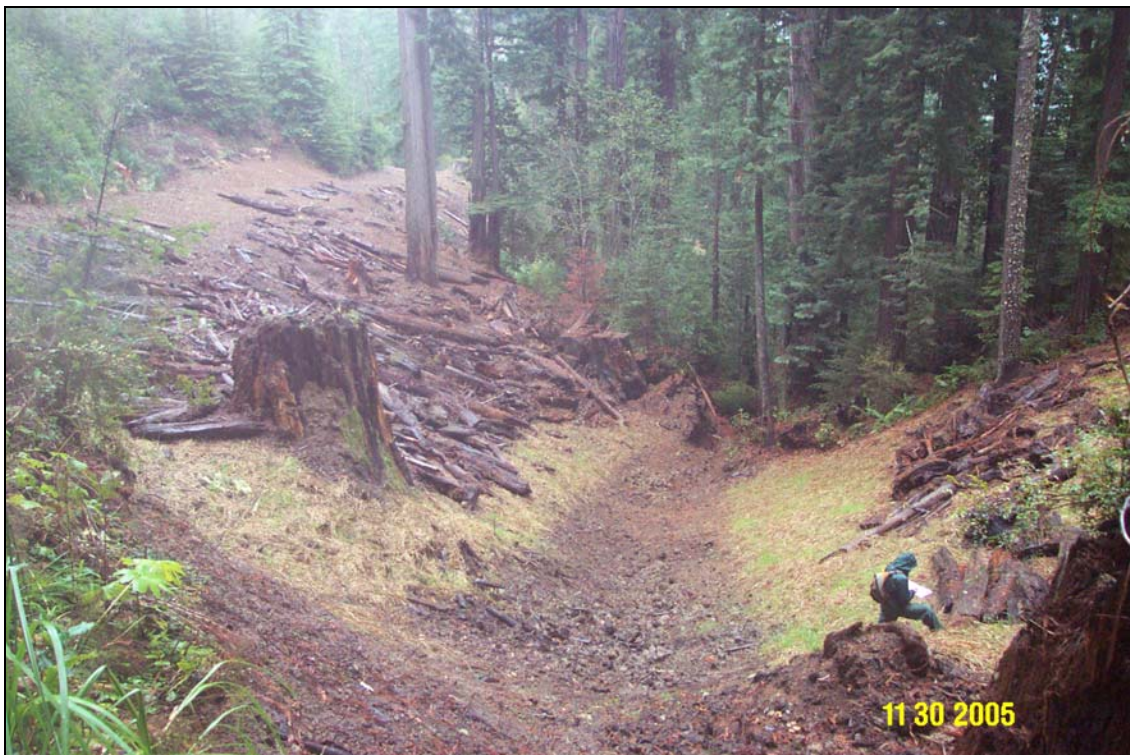
Photos 11A and 11B. R14 Road, site #145.2, pre and post treatment. View is from the top of the excavation. Note the slash and woody debris generated at the site are placed upon the freshly excavated surfaces. Note the person, located in the lower right corner of the bottom photo, for scale. Site #145.1 was located on the left road approach to this site.

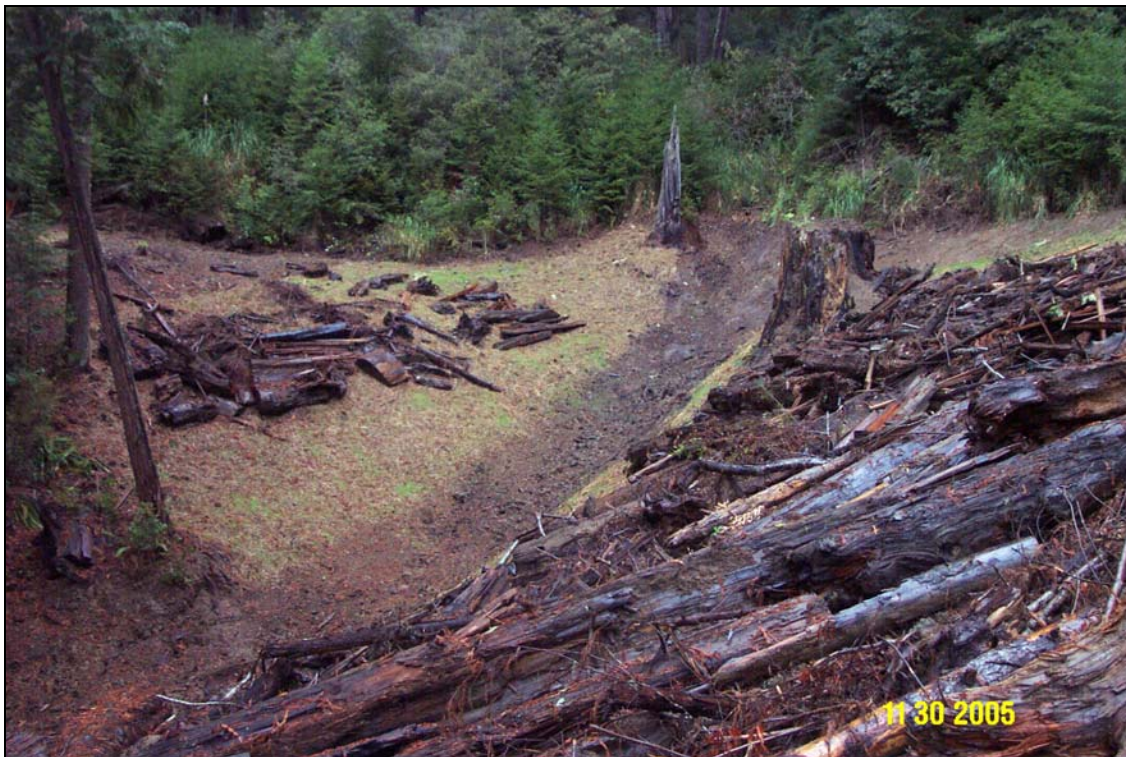
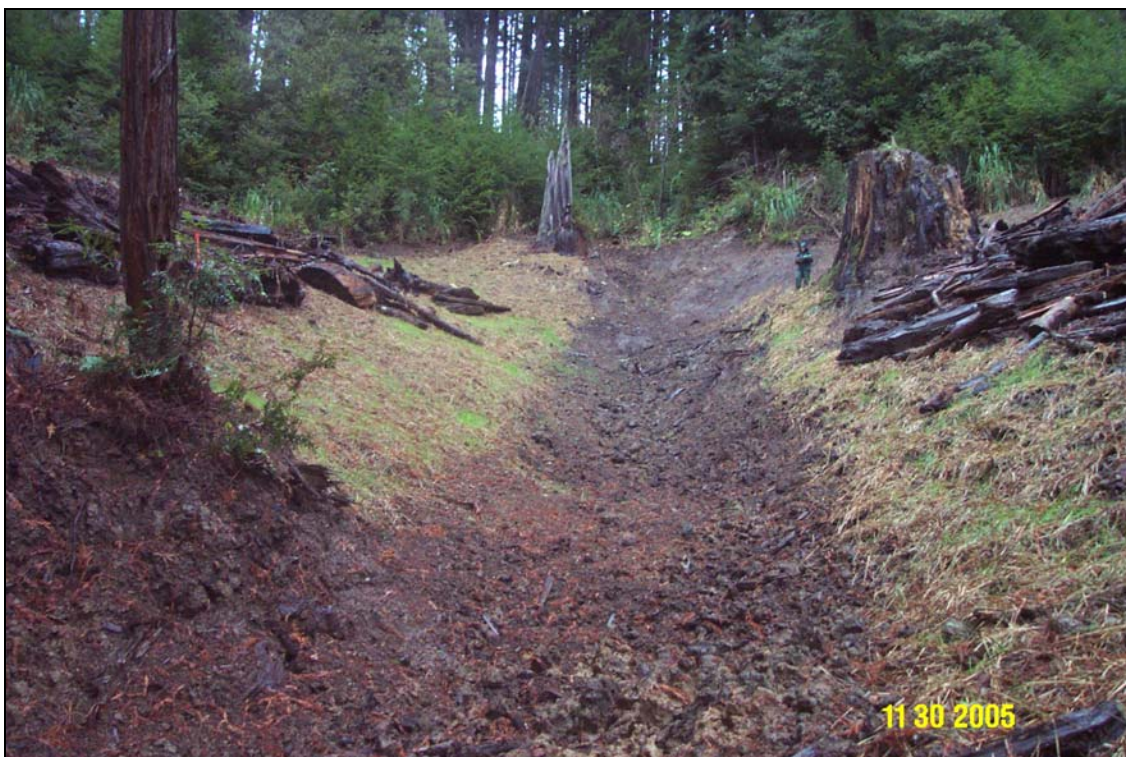
Photos 12 and 13. R14 Road, site #145.2, post treatment. The views are from the lower end of the site, looking up to the top of the excavation.

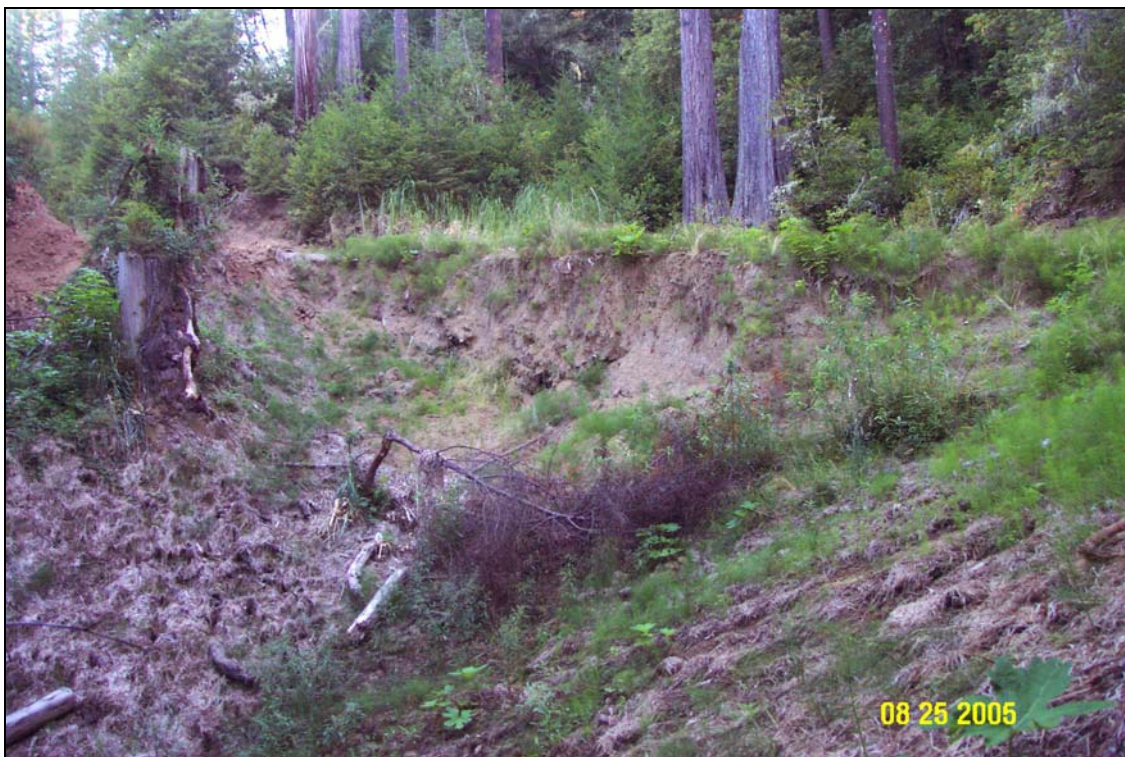
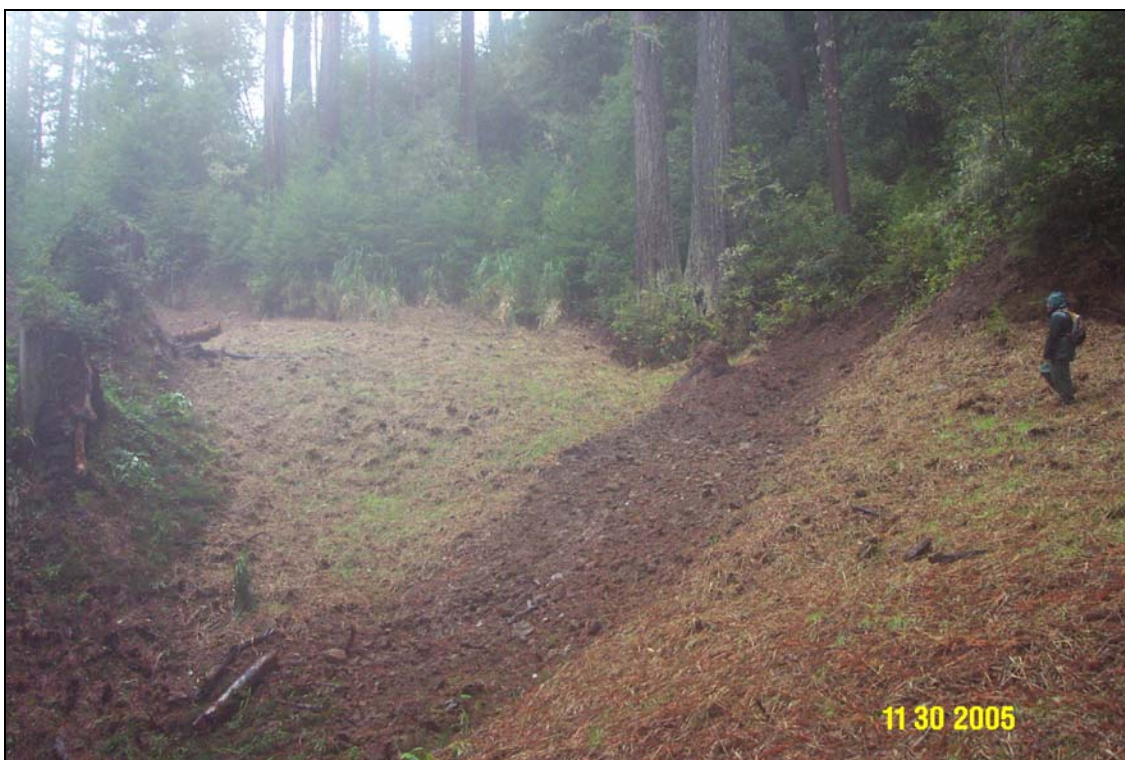
Photos 14A and 14B. R14 Road, site #145.3, pre and post treatment. This was the farthest site out the road, located a short distance before the terminal landing. The lower portion of this site had been partially excavated as part of an earlier decommissioning project the previous year.

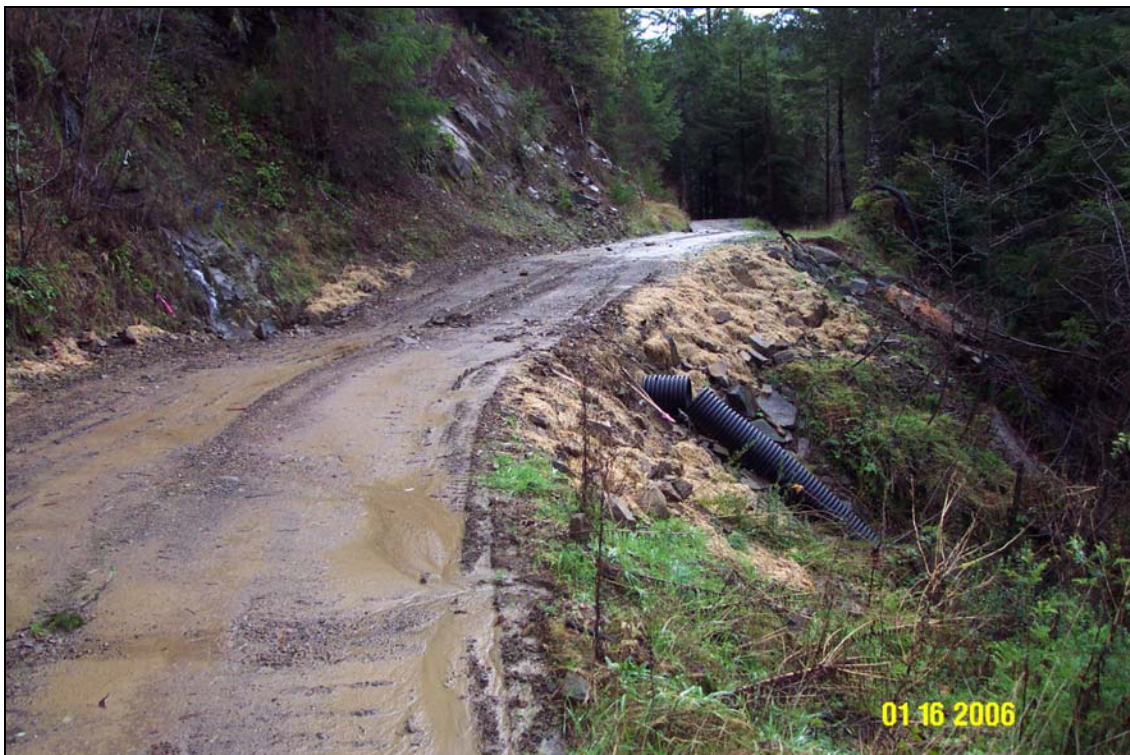
Photos 1A and 1B. R8 Road in the Salmon Creek watershed. Site #121, a stream crossing, pre- and post-treatment. The picture was taken from the right road approach looking across the crossing. Note the new plastic culvert and downspout installed as a temporary crossing until the road can be completed, slated for decommissioning in summer, 2006. This site is located on steep inner-gorge slopes directly above Salmon Creek.

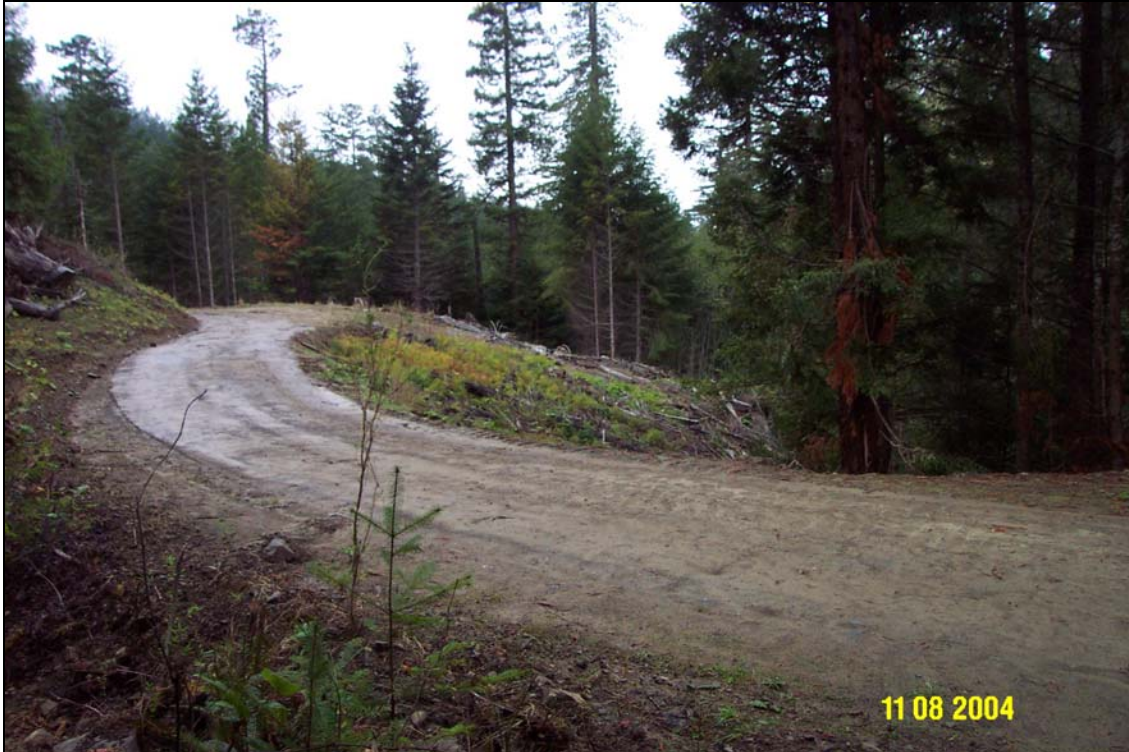
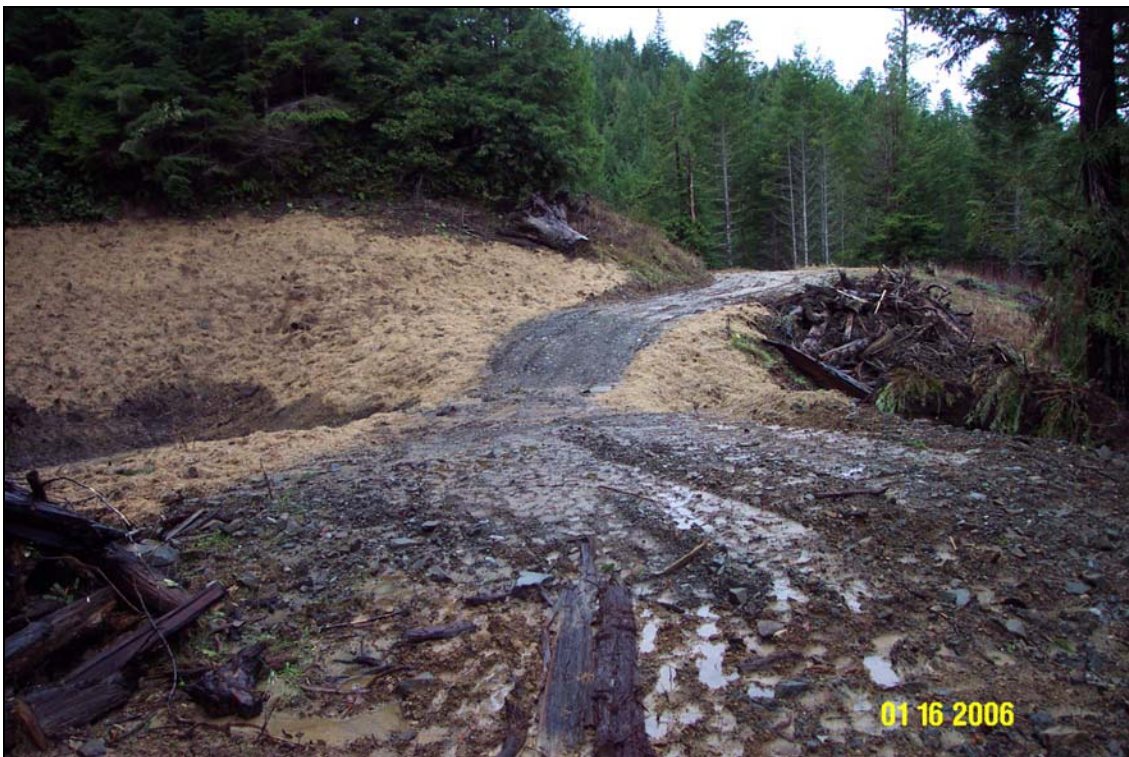
Photos 2A and 2B. R8 Road, site #121.1, a stream crossing, pre- and post-treatment. The picture was taken from the right road approach looking across the crossing. A culvert was installed at this site to pass flow for the winter. This was the last site treated on this road, before the onset of wet weather conditions closed down heavy equipment operations. Most of the work on this site took place above the road.

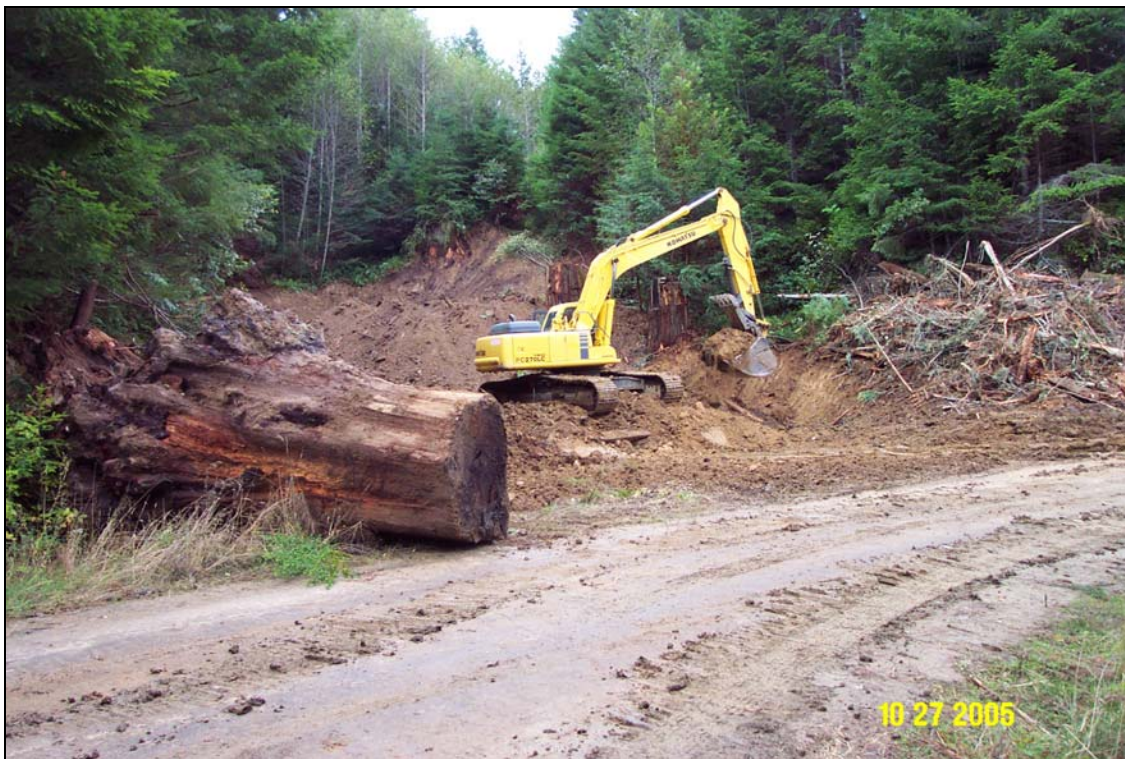
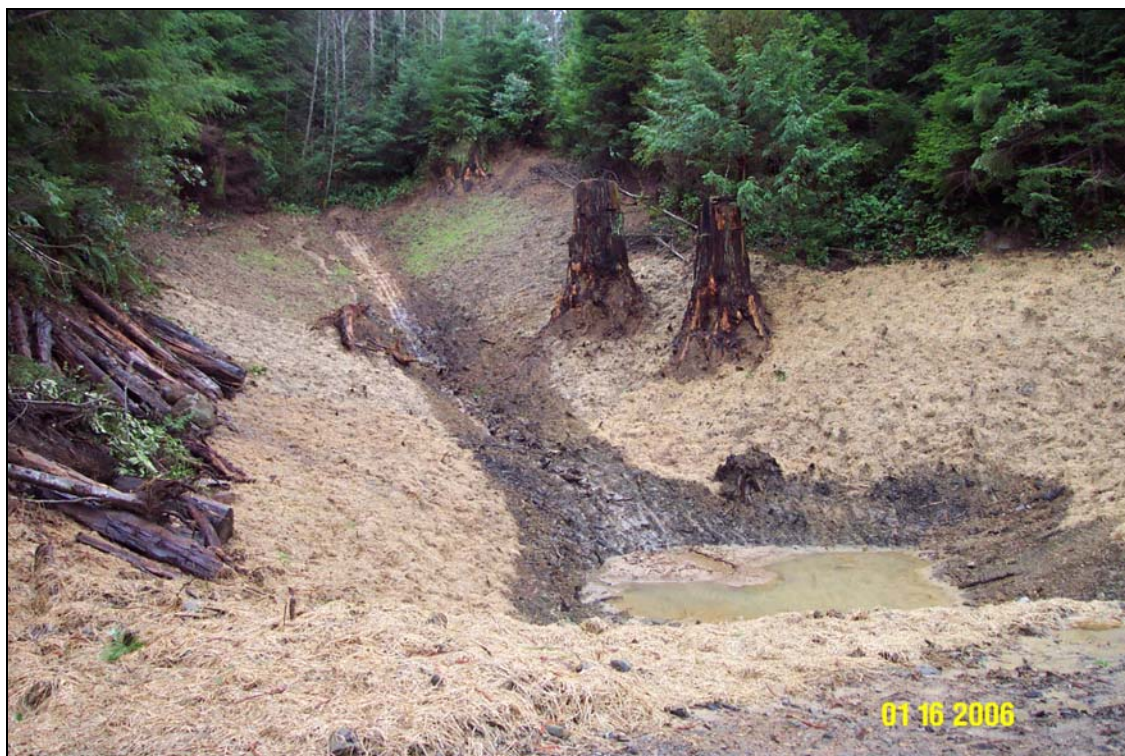
Photos 3A and 3B. R8 Road, site #121.1 during, and post-treatment. The view is from the road looking towards the top of the excavation. Note the large woody debris unearthed during the excavation was placed on the sideslopes to help catch any material that might slough off from an especially springy side slope. The large old-growth Redwood root ball visible in the top photo was unearthed during excavation of fill from the stream valley above the road. These can be used for in-stream fisheries projects incorporating large wood.

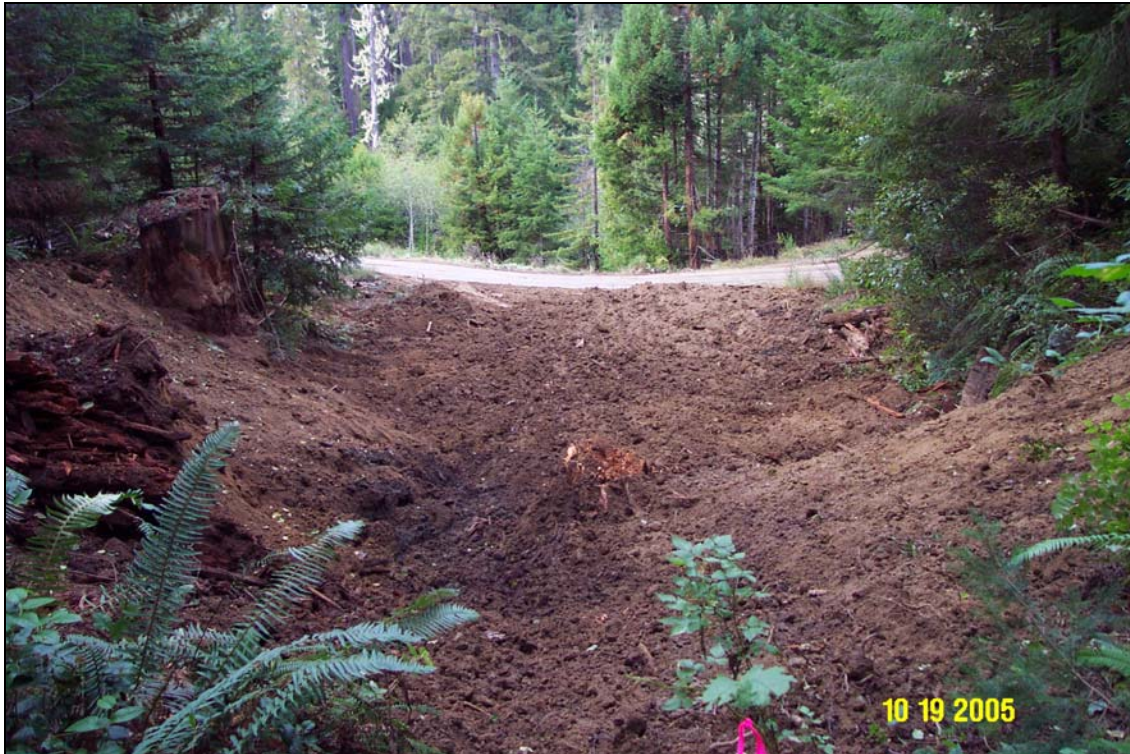
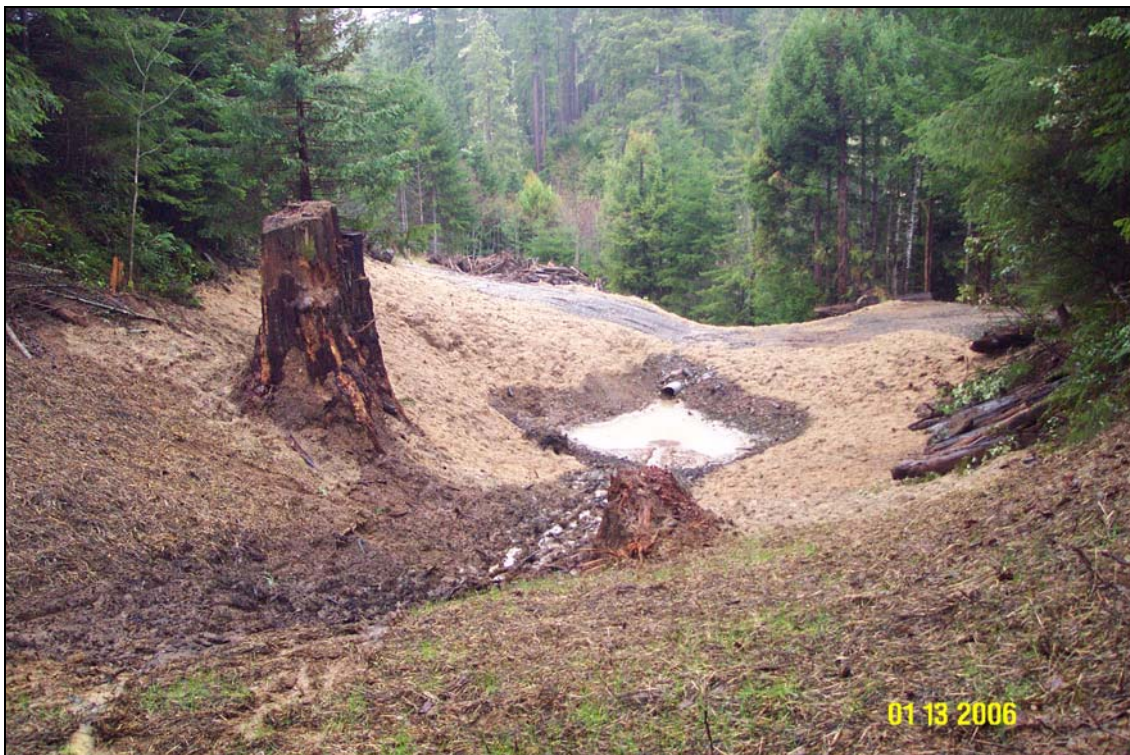
Photos 4A and 4B. R8 Road, site #121.1 during, and post-treatment. The view is from near the top of the excavation looking down to the road. Note the inlet of the new culvert and the large critical dip installed until the crossing can be fully decommissioned

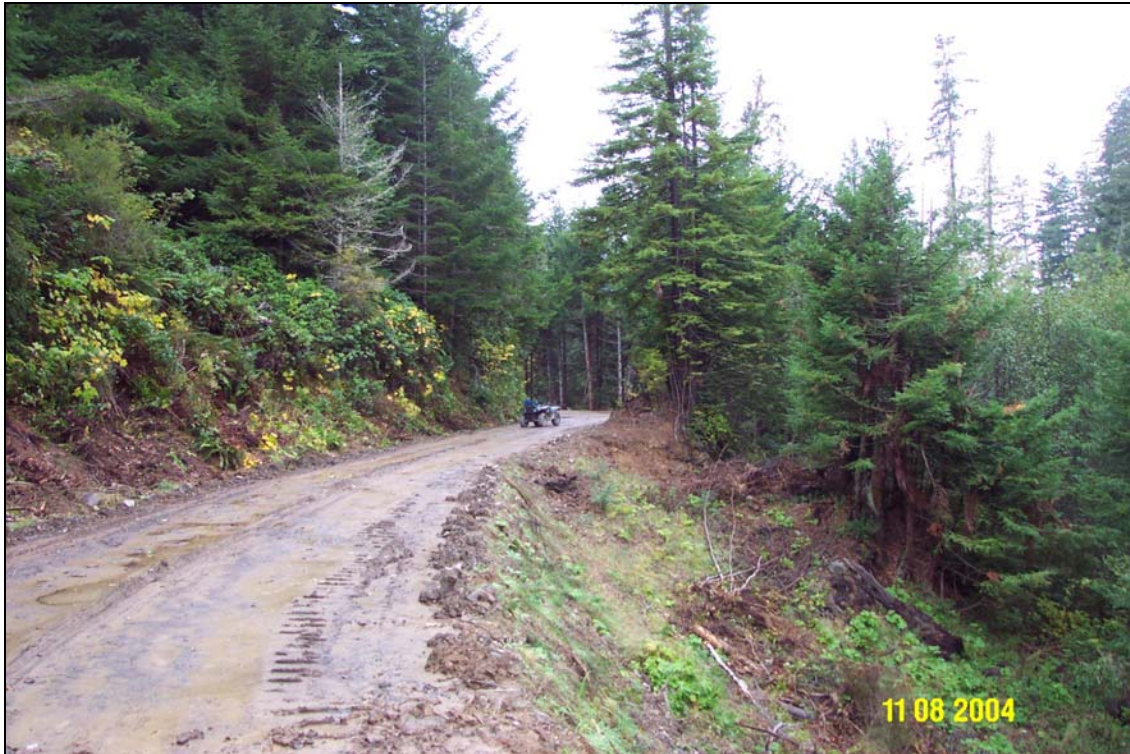
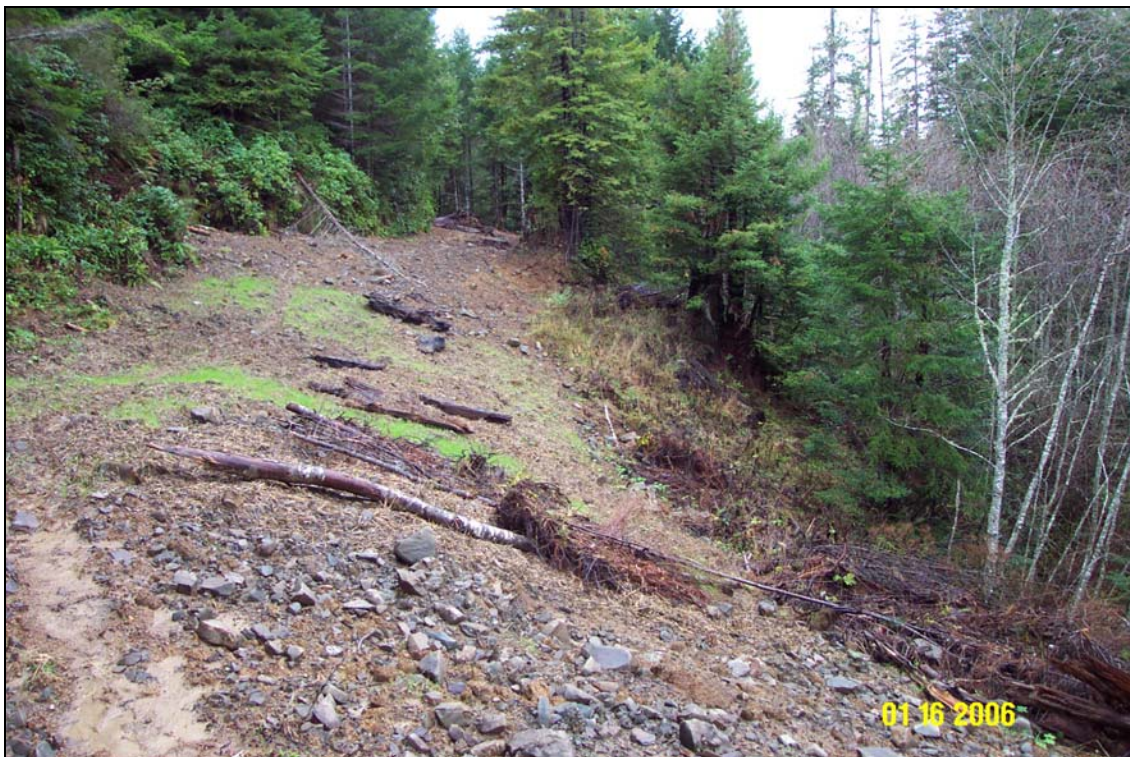
Photos 5A and 5B. R8 Road, site #121.2, a landslide site during, and post-treatment. The view is from near the right end of the site looking back towards the start of the site, located where the quad is sitting in the top photo. This site had been partially treated as part of a different project the previous year. Note the road has been completely outsloped by excavation and endhauling most the material off-site, with a small portion placed upon the cutbank to complete the outslope.
