**Final Report:
2004 - 2005 South Humboldt Bay Coastal Resources Protection
Project, Salmon Creek and South Fork Elk River Watersheds,
Humboldt County, CA**

**California State Water Resources Control Board
Agreement #03-211-551**

**Pacific Watershed Associates
Arcata, California
(707) 839-5130
December 2005**

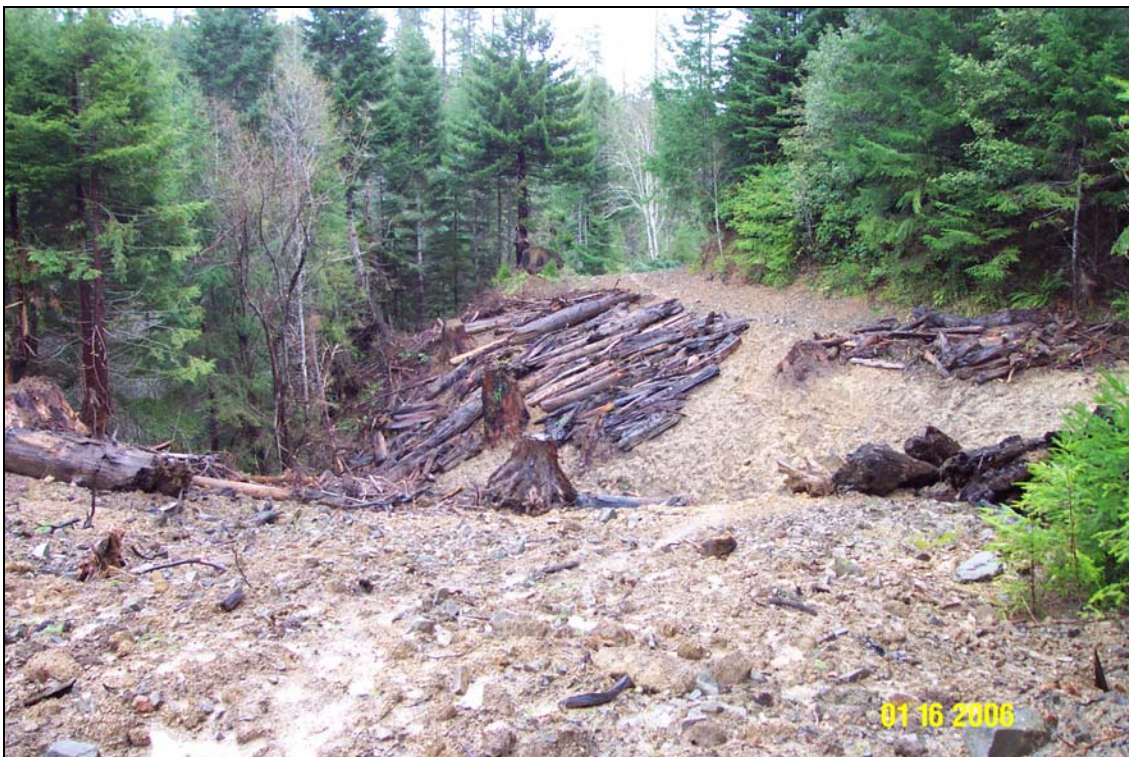
Photo 6A and 6B. R8 Road, site #121.5, a stream crossing, pre- and post-treatment. The picture was taken from the left road approach looking across the crossing. Note the abundance of large woody debris unearthed during the excavation, placed on the newly excavated side slopes.

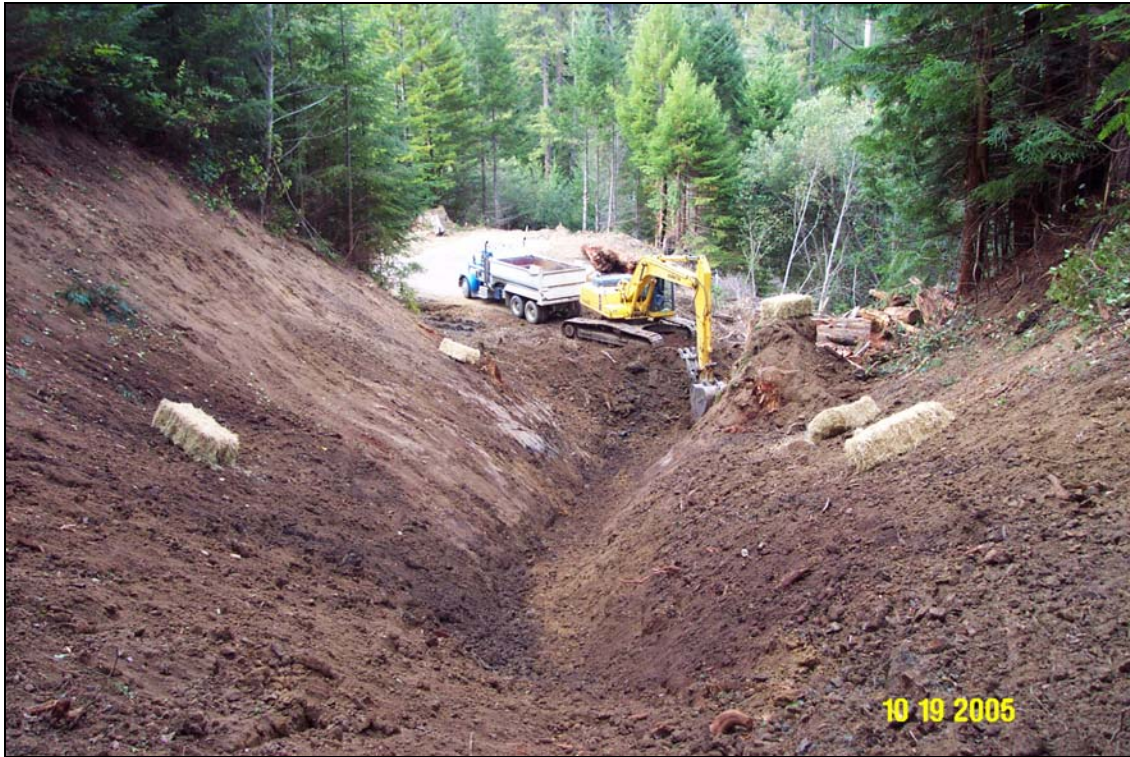
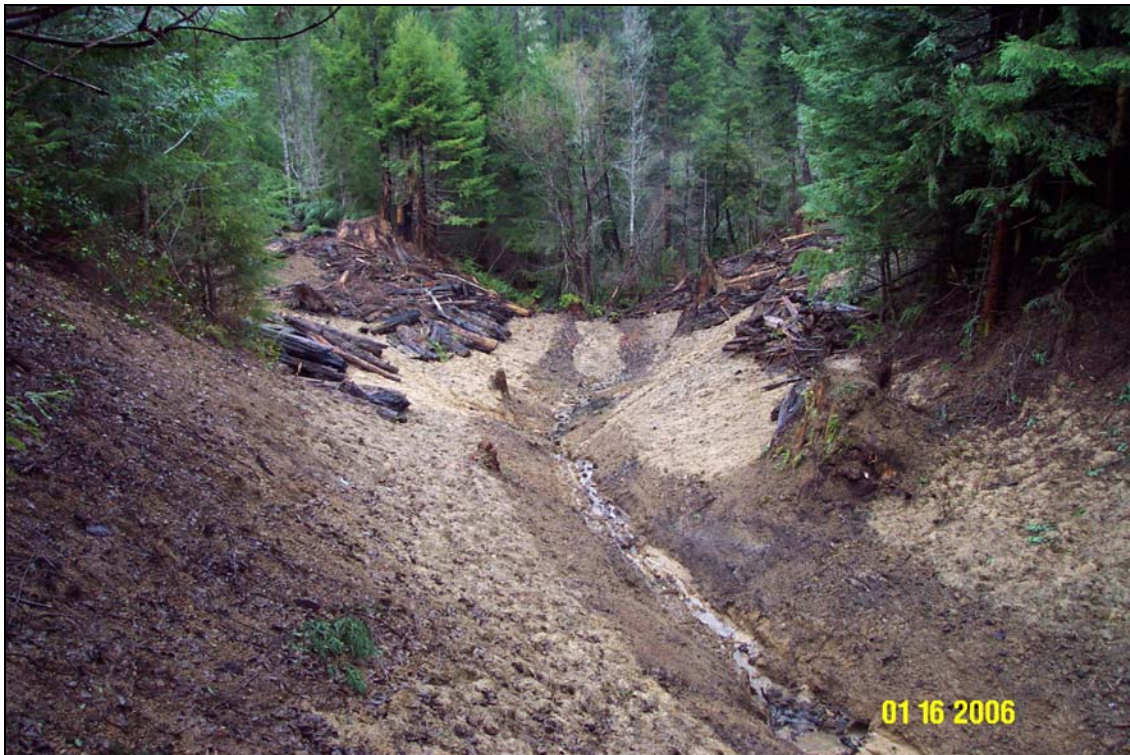
Photo 7A and 7B. R8 Road, site #121.1, during- and post-treatment. The view is from near the top of the excavation looking down to the road.

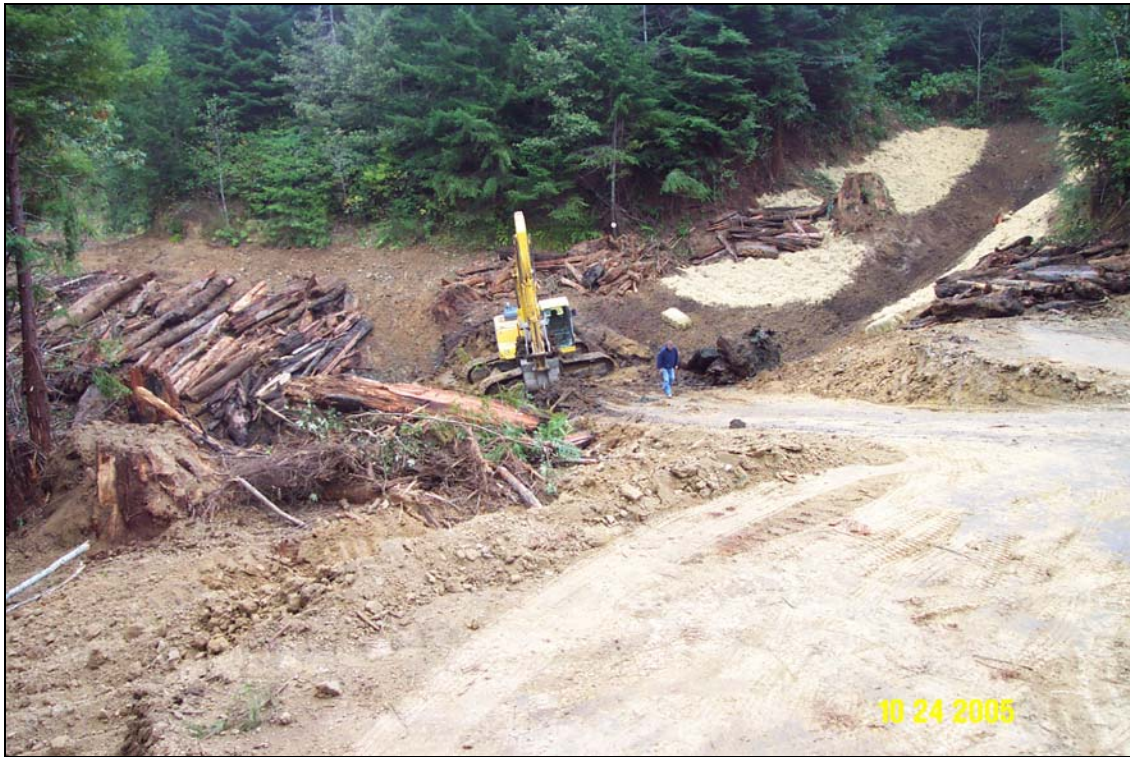
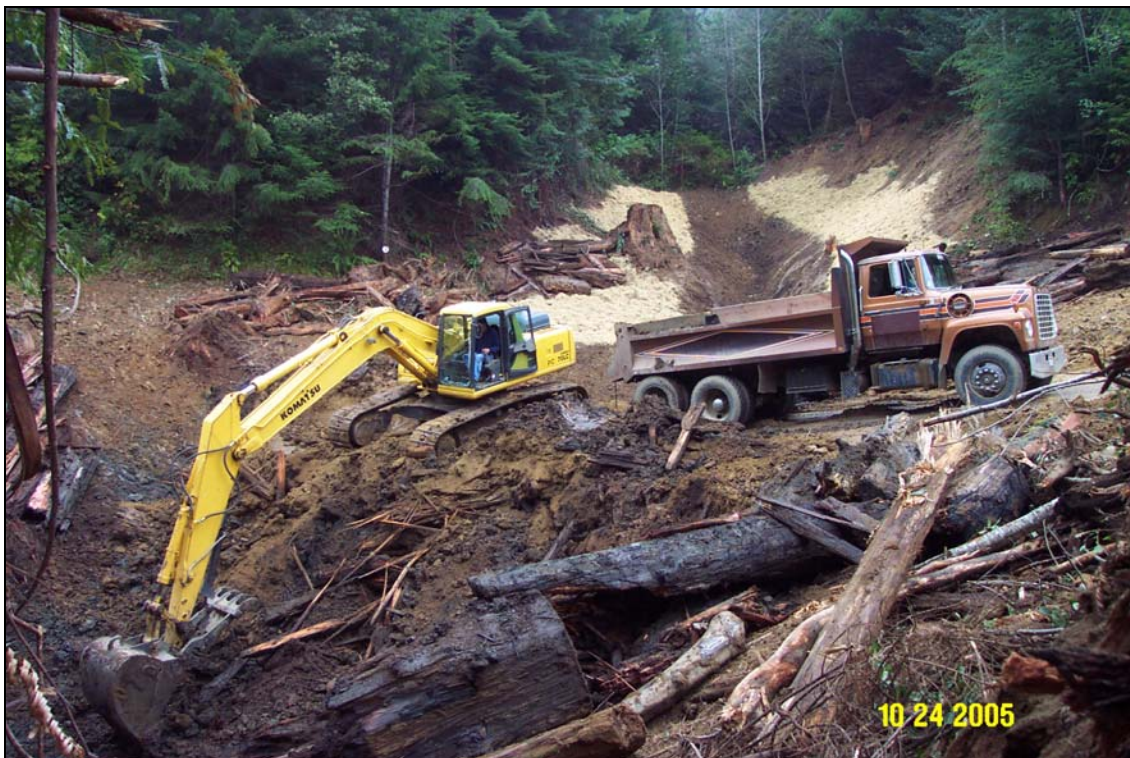
Photos 8 and 9. R8 Road , site #121.5 during-treatment. As the excavation progresses, the excavator gets deeper and more difficult to access by dump truck, so earthen ramps are constructed (top photo) to allow continued access by the dump trucks. On the R8 Road, there was a scarcity of adequate spoil disposal areas on the road itself, so most spoils were endhauled off-site to a stable storage location.

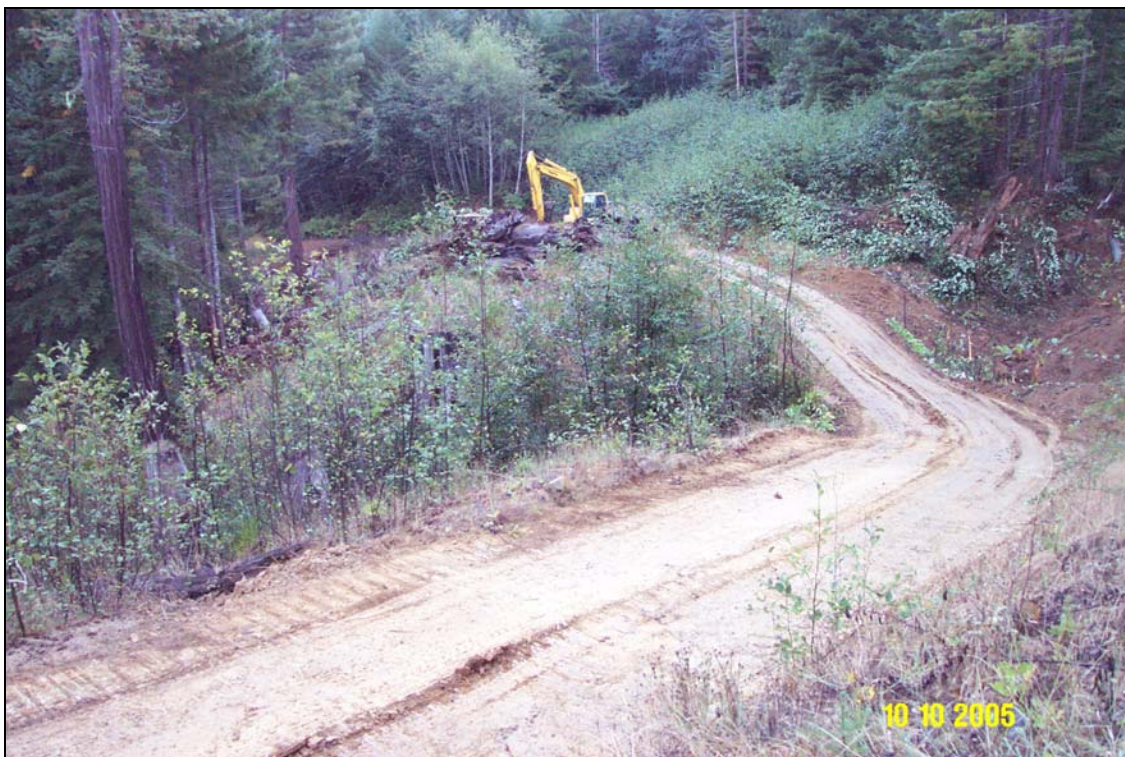
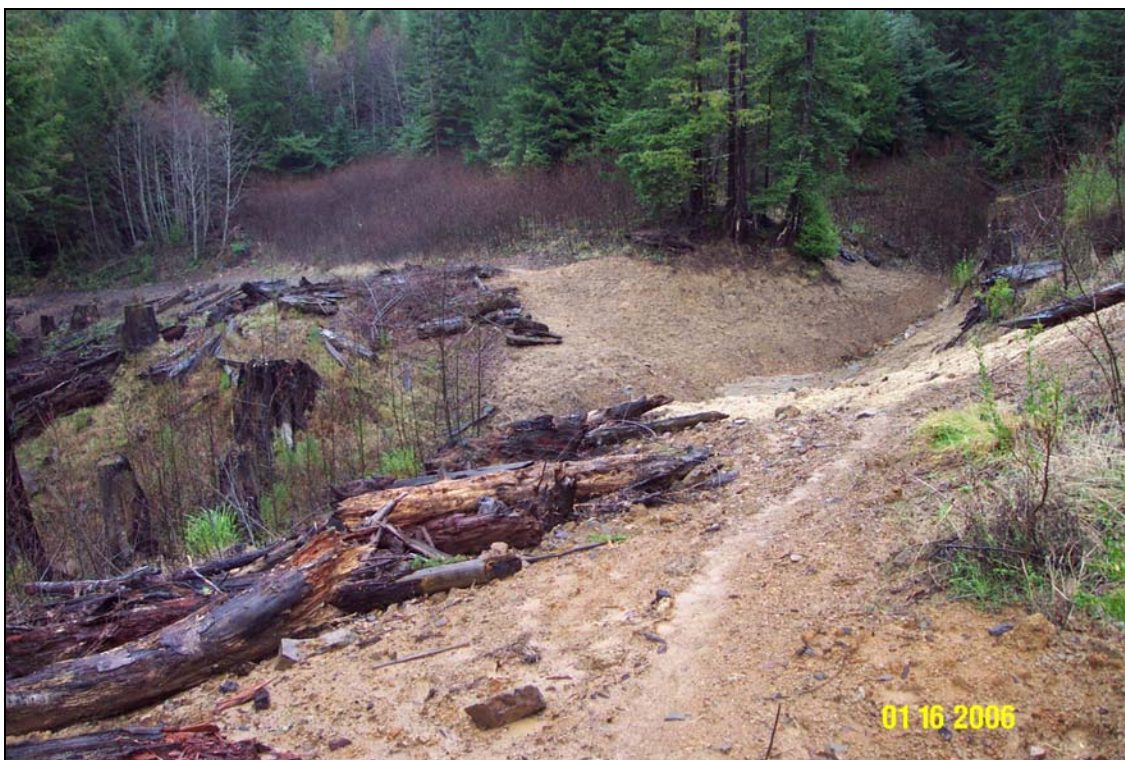
Photo 10A and 10B. R8 Road, site #122, a stream crossing, pre- and post-treatment. The view is from just above a low cutbank on the left road approach near the crossing. Upstream is to the right in the photos.

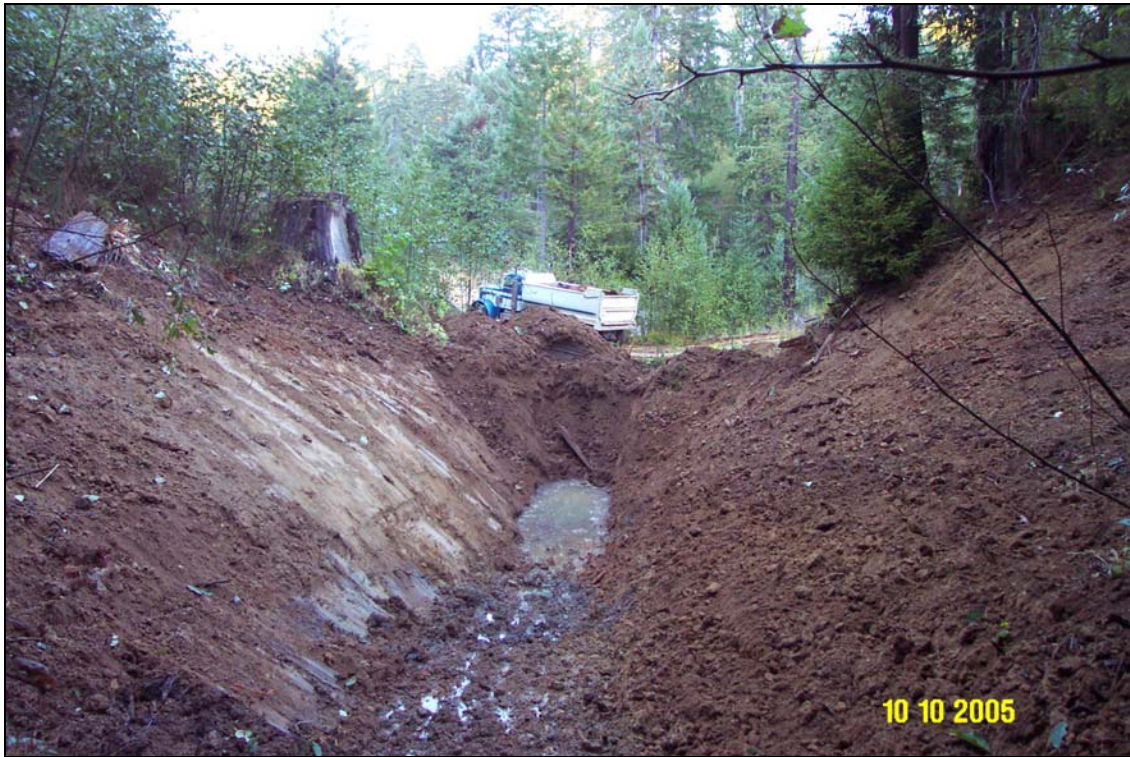
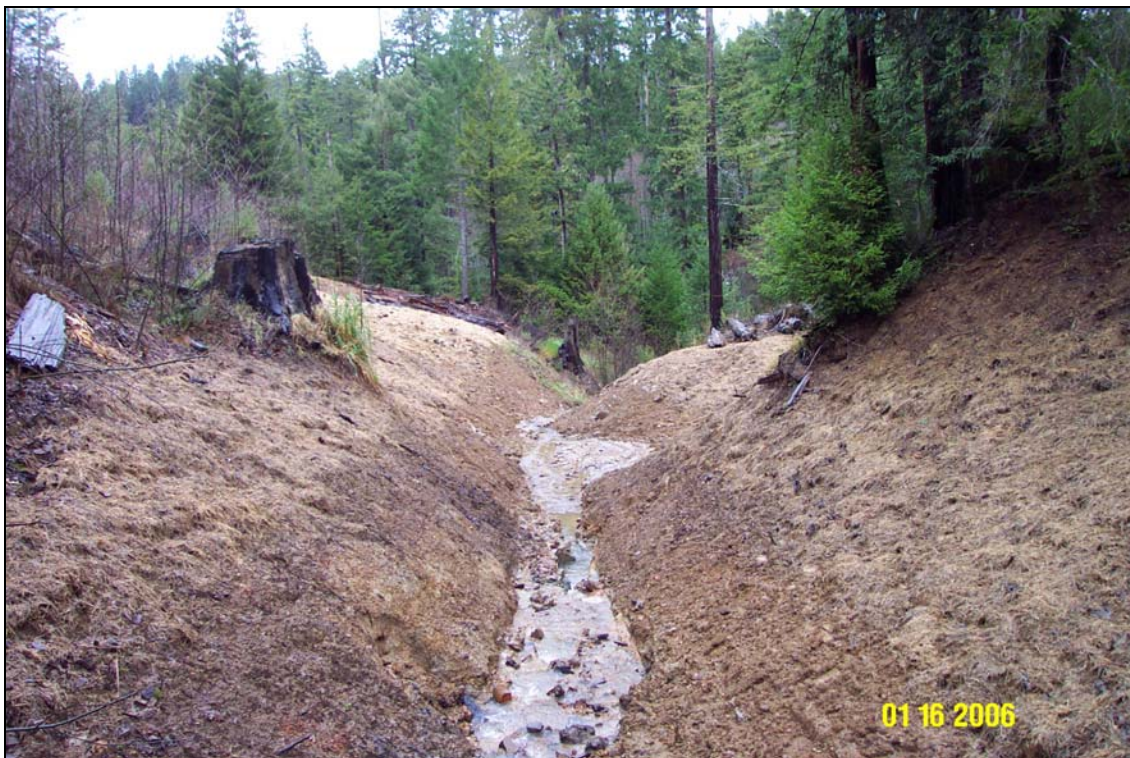
Photo 11A and 11B. R8 Road , site #122, during- and post-treatment. The view looking downstream from just below the top of the excavation. Note the dump truck in the top photo, marking the location of the road prism.

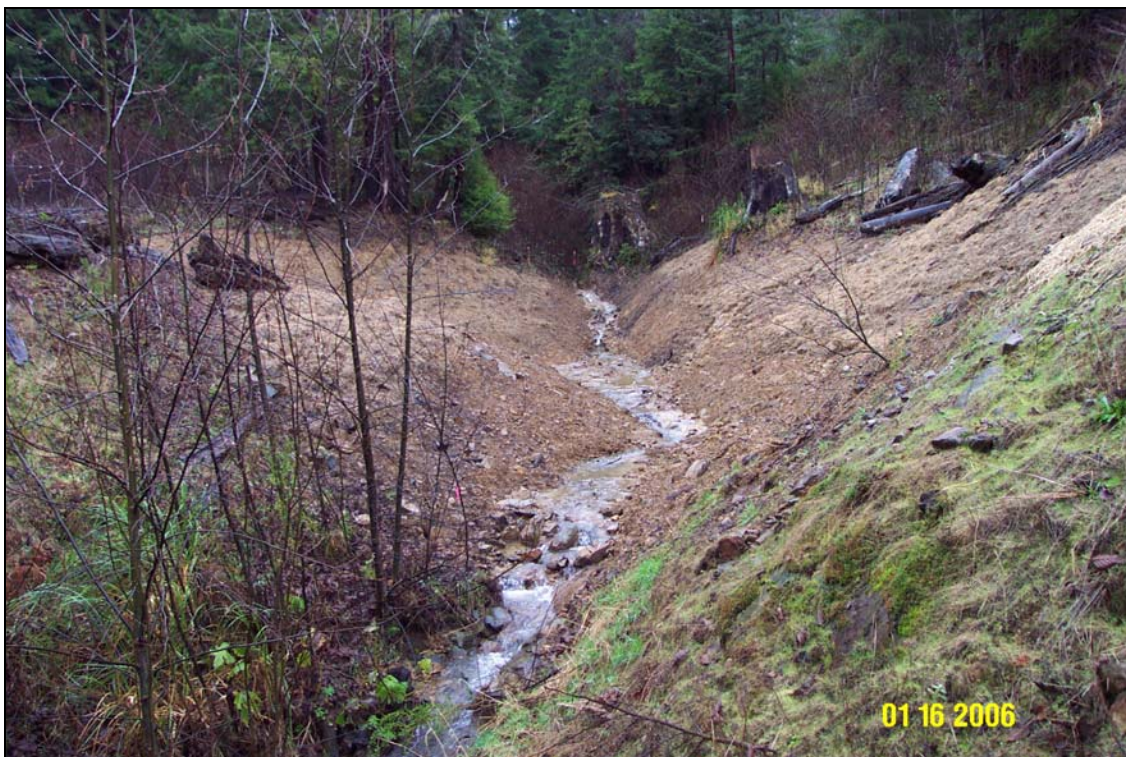
Photos 12 and 13. R8 Road, site #122, post-treatment. The photos were taken from near the bottom of the excavation looking upstream to the top of the excavation. A large hard-rock “knocker” controlled the depth of the excavation near the lower end of the site, creating a

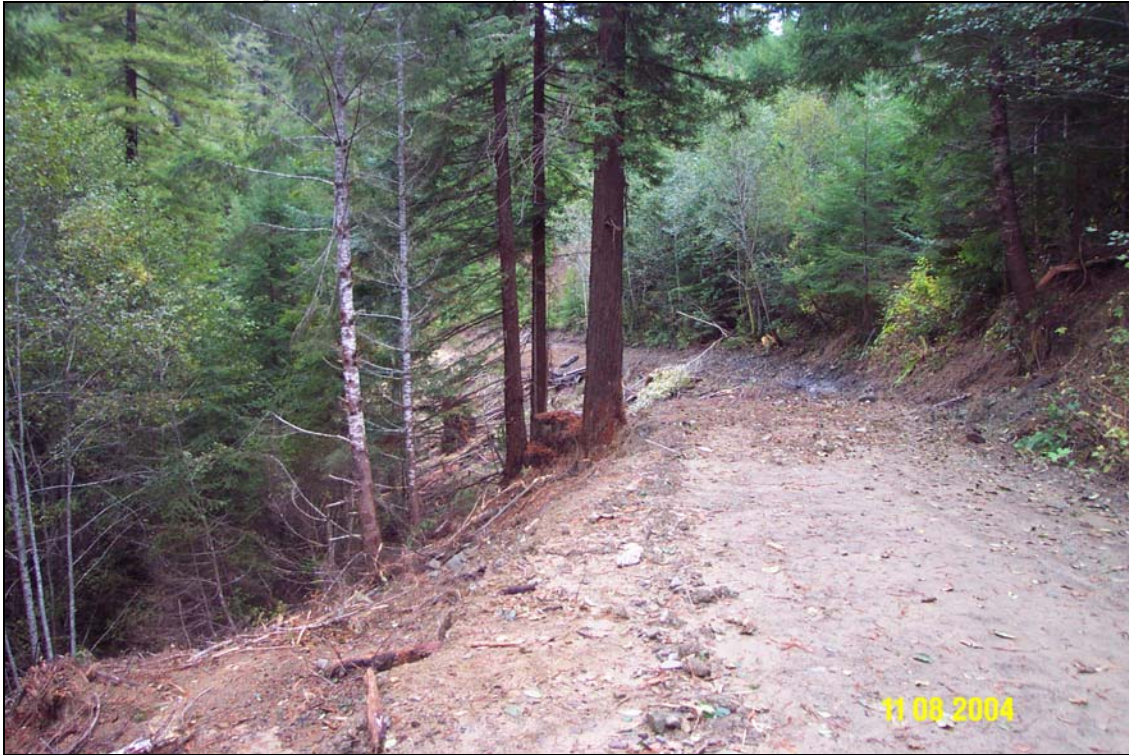
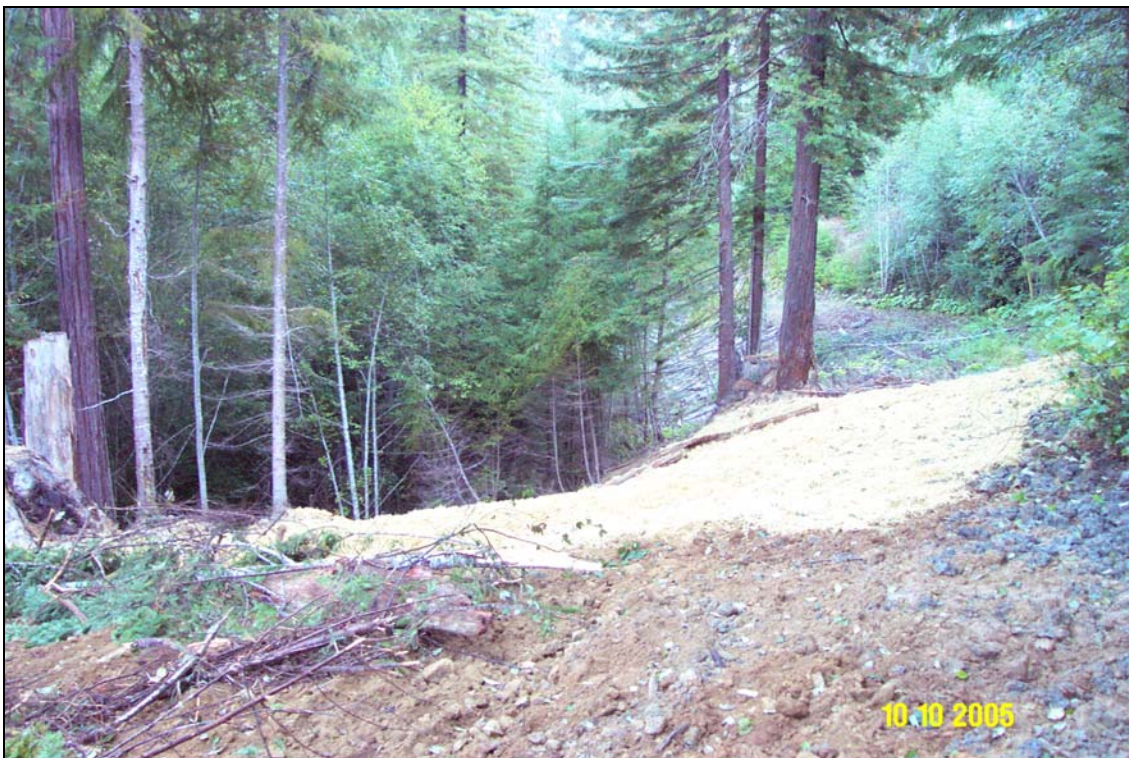
Photo 14A and 14B. R8 Road, site #122.1, a landslide site, pre-, and post-treatment. The view is from the left end of the site looking towards the right end of the site. The site was completely mulched with rice straw due to its proximity to the creek. This site had been partially treated as part of a different project the previous year, but still contained potential to deliver sediment to mainstem Salmon Creek, located immediately below the site. Note the road has been completely outslipped.
