DESIGN EXAMPLES—SECTION 8

8.0 CASE STUDY—LENA GULCH DROP STRUCTURE

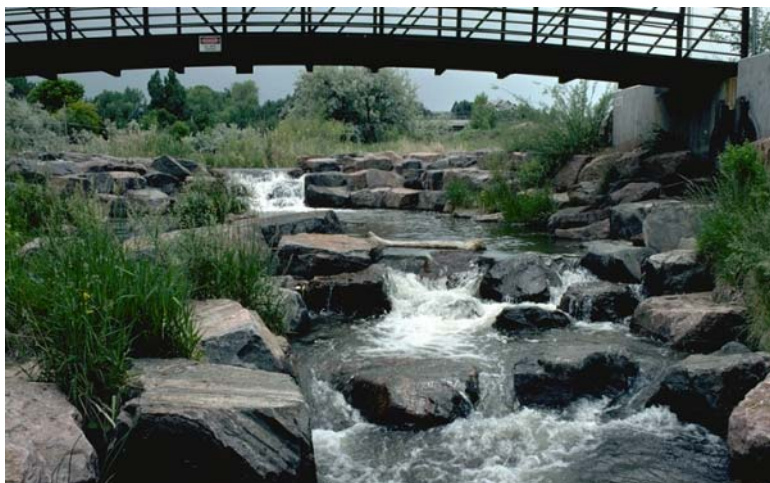
Photo 1.

The existing failing drop structure was situated on a jurisdictional boundary that required the involvement of three different local government sponsors in addition to the District, the City of Lakewood, the City of Wheat Ridge, and the Consolidated Mutual Water Company. The lower end of the drop structure and channel were situated on private property, which required the close involvement of the affected homeowner. The District needed both permanent and temporary

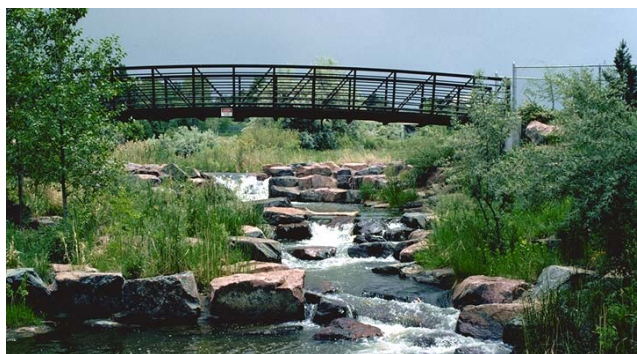
Photo 2

Construction began in the fall of 1997 and was completed in early 1998. The plant material was installed shortly after construction was completed, but before the wet spring season. The homeowners were happy with the appearance and function of the new drop structure. They took real ownership of the completed project and provided all irrigation and maintenance of the newly installed plants, shrubs, and trees. Since the project has been completed, they have installed additional landscaping and plantings to further enhance their backyard habitat.
