CENTRAL VALLEY REGIONAL WATER QUALITY CONTROL BOARD

INSPECTION REPORT

LOCATION & COUNTY: Henry Tosta Dairy

INSPECTION DATE: 1 May 2012

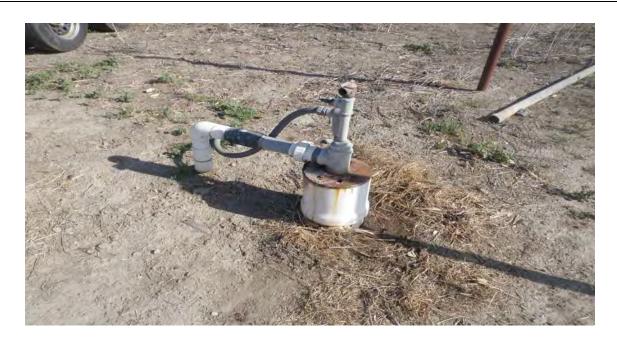
Well #1 had no well-pad and was within 100' of a source of wastewater (Photos 1-3).

Photo 1: Well #1 with no well-pad.

- 2) Install a well-pad at Well #1 and install a control to prevent wastewater from ponding near the well.
- 3) Remove all manure and old feed from the channel located south of the silage pit.

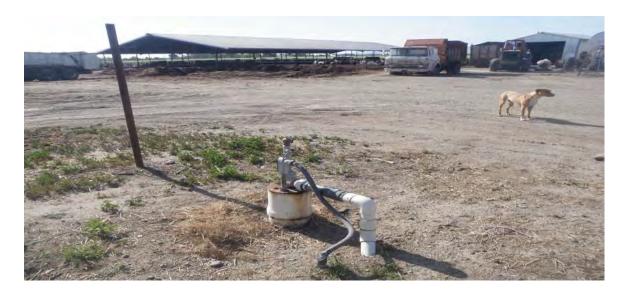
Photo 2: Well #1 with a corral in the background. The corral is approximately 70' from the well. See Photo #3 for a close-up of the corral and the solid manure being stored adjacent to the corral.

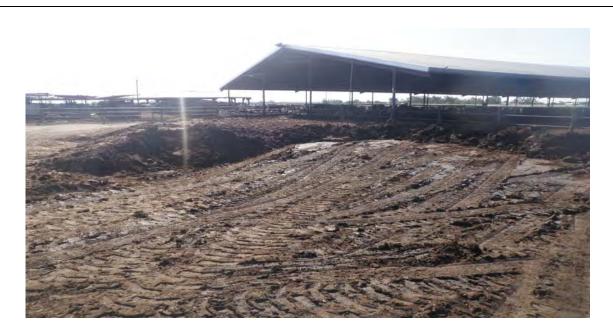
Photo 3: The corral near Well #1 contained significant amounts of solid manure. Additionally there was slurry manure being stored adjacent to the corral (about 70' from Well #1).

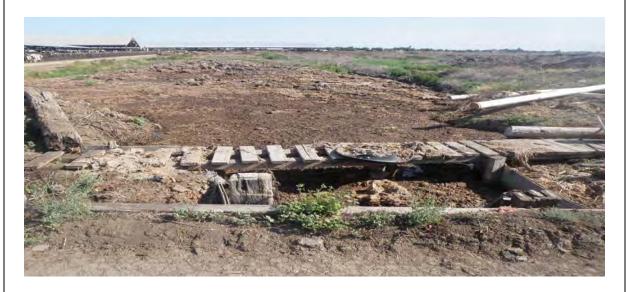
Photo 4: Looking north at Settling Basin #1.

- 4) Remove all weeds from Settling Basins #1 and 2 and Lagoons #1-5.
- 5) Install staff-gauges in Settling Basins #1 and 2 and Lagoons #1-5.
- 6) Reconstruct Settling Basin #2's eastern embankment. The material used to construct the embankment cannot be manure.

- 9) Remove all manure from Settling Basins #1 and 2. All manure should be exported off-site or otherwise managed to mitigate the impact. Provide documentation regarding the amount of manure removed and the destination of manure.
- 10) Locate and sample the three groundwater monitoring wells that are located on the facility property and submit the analysis results to the Central Valley Water Board.

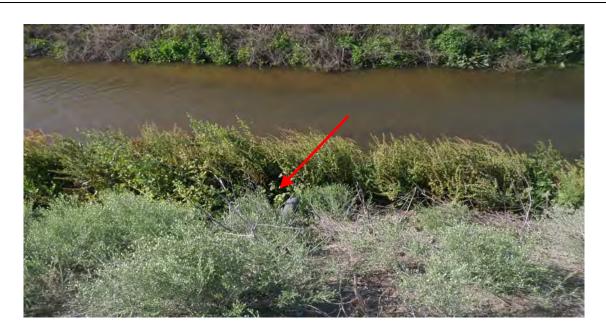
Photo 5: Photo of a black PVC pipe on the bank of the Main Drain Canal of Naglee-Burk Irrigation District; the pipe is connected to Settling Basin #1. Note that the pipe is uncapped.

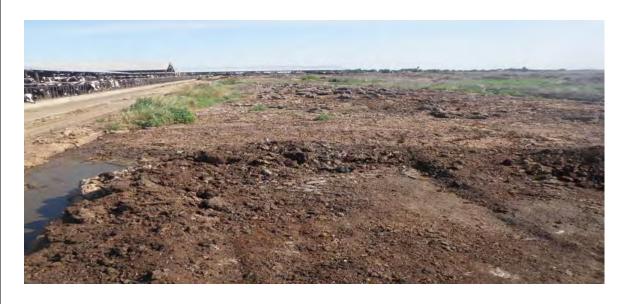
Photo 6: Looking north at the Settling Basin #1 (at capacity).

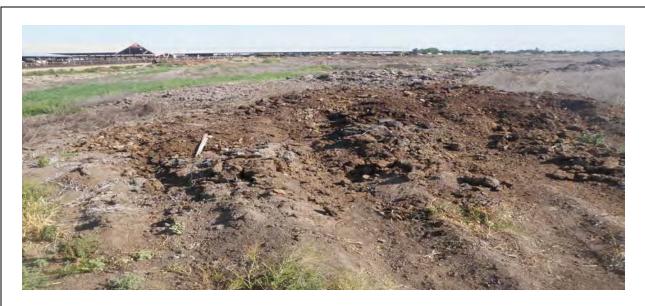
Photo 7: Looking north at the area between the Settling Basin #1 and Settling Basin #2; the pictured area contains a significant amount of solid and slurry manure.

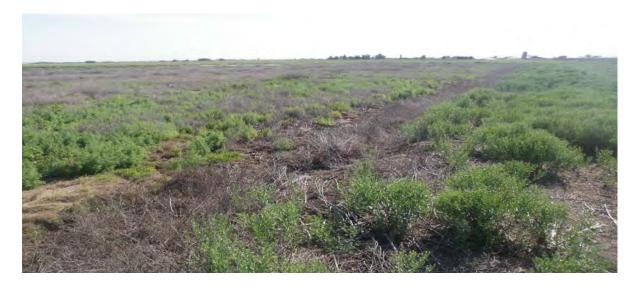
The complex of wastewater impoundments is being poorly managed and showed no staff gauges, excessive vegetation and manure on and adjacent to the embankments, solid manure being used to reinforce embankments at Settling Basin #2, no definition between any of the impoundments, and a PVC pipe connecting Settling Basin #1 to the Main Drain canal of Naglee-Burk Irrigation District (Photo 5). Additionally, it was difficult for staff to determine the lagoon dimensions and embankment integrity of select lagoons due to the amount of solid manure and weeds located on the impoundment embankments (Photo 8,9,11, and 12). Mr. Tosta stated the lagoons were cleaned out approximately 6-7 years ago. No method to move wastewater between the settling basins and lagoons could be observed during the inspection with the exception of the southern settling basin; this basin can transfer wastewater to the wastewater storage lagoon via a loosely defined earthen channel.

Photo 8: Looking northeast at Settling Basin #2. The amount of weeds on the settling basin embankments made it impossible for staff to determine embankment integrity and/or if rodent holes are present.

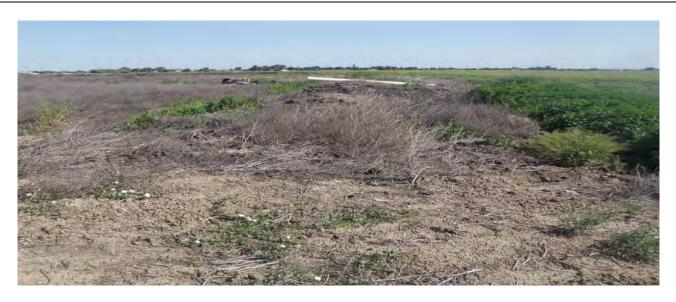
Photo 9: Looking northeast at the eastern end of the Settling Basin #2; the material composing a portion of the eastern embankment appeared to be manure.

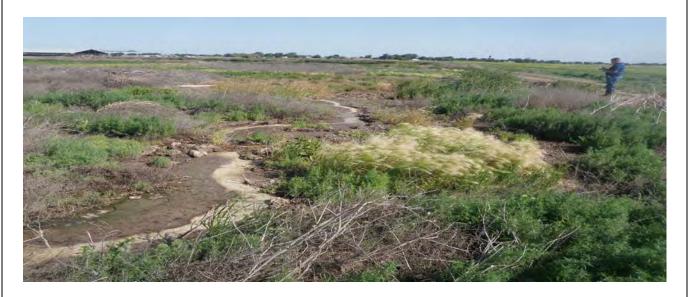
The Waste Management Plan (WMP) is inaccurate regarding silage leachate storage and liquid manure management. According to a map included in the WMP, silage leachate flows into Settling Basin #1; this is not accurate, the conveyance channel routes the leachate through a corral before ponding in an area not designed to store waste located west of the wastewater storage lagoons. While on-site, staff observed a tractor depositing slurry manure into an area not designed to store waste (Photos 31-32); the WMP does not reflect this area as storage. Overall, the WMP indicates that wastewater and manure can be moved between the settling basins and lagoons in the Production Area. Staff observed a loosely defined channel that conveys wastewater from Settling Basin #2 to Wastewater Storage Lagoon #1 (Photo 10) but

Photo 10: Looking north at the conveyance channel that connects Settling Basin #2 to Wastewater Storage Lagoon #1. This is typical of all the lagoons at the facility – channels connecting the lagoons have marginal slope, no definition, and contained excessive weeds.

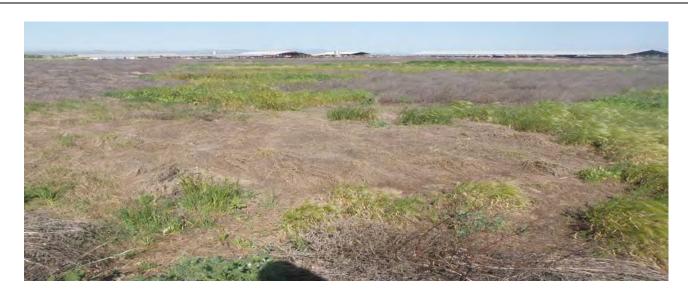
Photo 11: Wastewater Storage Lagoon #1. The embankments contained excessive weeds and there was no staff-gauge.

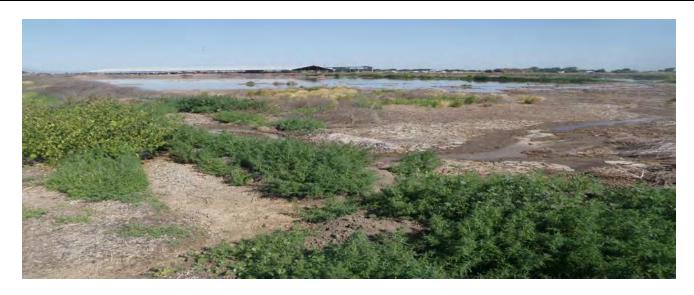
Photo 12: Wastewater Storage Lagoon #2. The embankments contained excessive weeds and there was no staff-gauge.

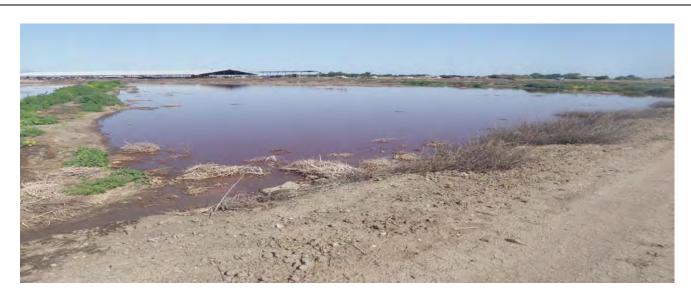
Photo 13: Wastewater Storage Lagoon #3. The embankments contained excessive weeds and there was no staff-gauge.

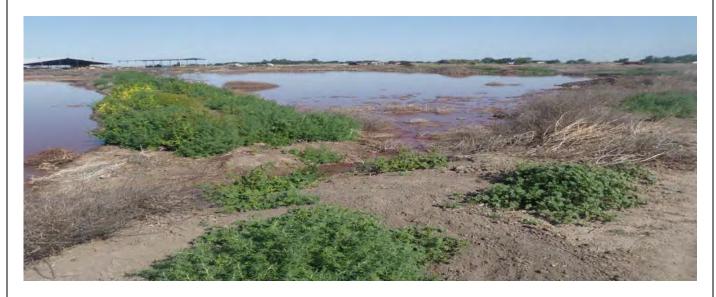
Photo 14: Wastewater Storage Lagoon #4. The embankments contained excessive weeds and there was no staff-gauge.

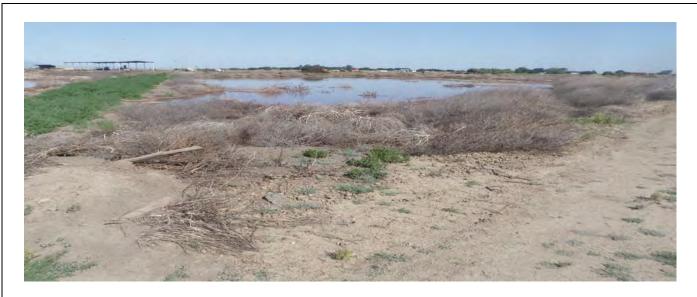
Photo 15: Wastewater Storage Lagoon #5. The embankments contained excessive weeds and there was no staff-gauge. This pond is irregularly shaped containing a small alcove full of weeds in the northeast corner (see Photo 16-17).

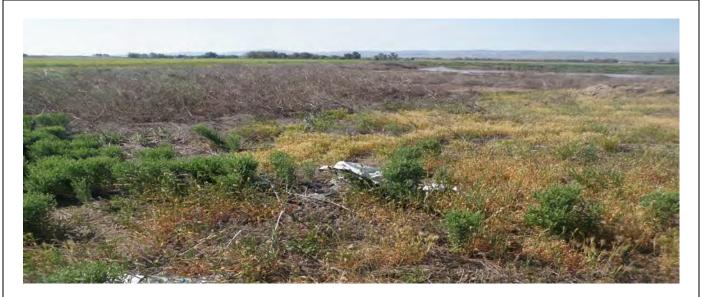
Photo 16: Small alcove in the northeast corner of Wastewater Storage Lagoon #5.

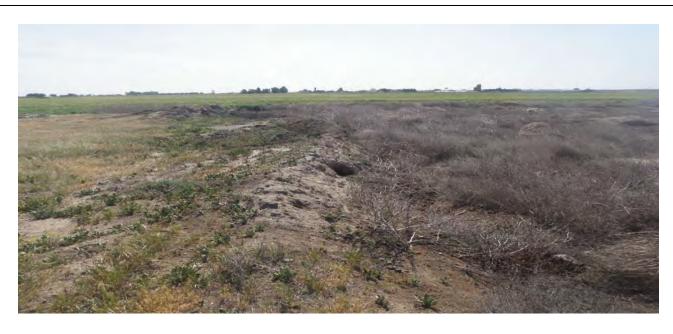
Photo 17: Wastewater Storage Lagoon #5. Note the weeds that extend from the lagoon to the left in the center of the photo (creating the alcove and irregular shape).

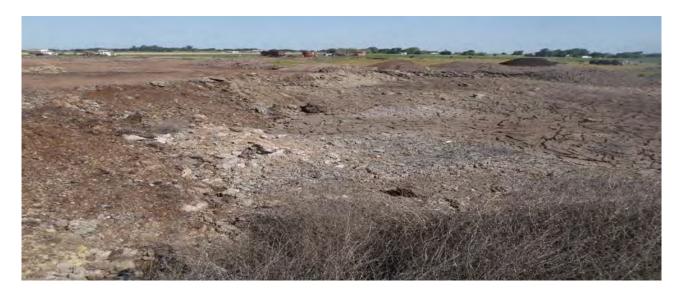
Immediately west of Settling Basin #2 and Lagoons #1-5 is an area of native soil that is used to store liquid wastewater, solid manure, and slurry manure. This area has not been prepared or designed to store waste, and is not contained or graded to prevent ponding of wastewater. Staff estimates this area to be approximately 3-4 acres with manure one to three feet deep in places (Photos 18-26).

Photo 18: Looking north at the area west of the storage lagoons. This area contained massive amounts of solid manure, slurry manure, and liquid wastewater.

- 8) Remove all wastewater, solid manure, and slurry manure from the area located west of the wastewater storage lagoons and northeast of Settling Basin #1 (Photos 18-26). This area must be scraped to native soil. All manure should be exported off-site or otherwise managed to mitigate the impact. Provide documentation regarding the amount of manure removed and the destination of the manure. Groundwater samples should be obtained from the above mentioned area after the manure is removed.

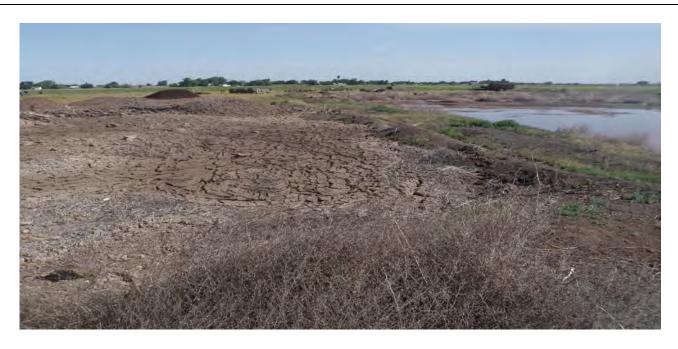
Photo 19: Looking north at the area west of the storage lagoons. This area contained massive amounts of solid manure, slurry manure, and liquid wastewater.

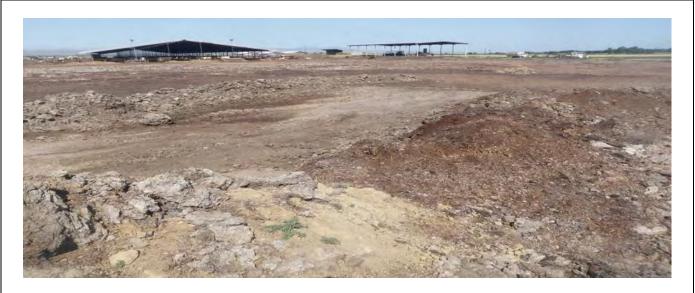
Photo 20: Looking west at the area west of the storage lagoons. This area contained massive amounts of solid manure, slurry manure, and liquid wastewater.

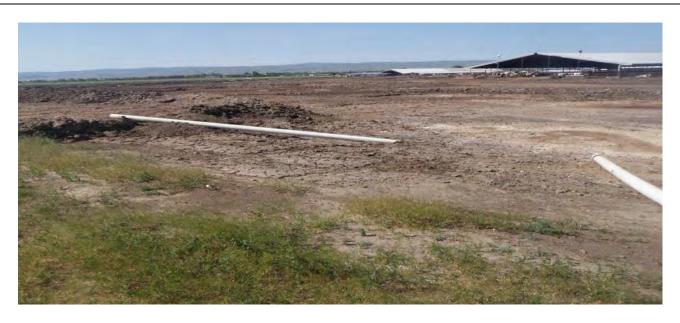
Photo 21: Looking southwest at the area located west of storage lagoons; this area contained massive amounts of solid manure, slurry manure, and liquid wastewater.

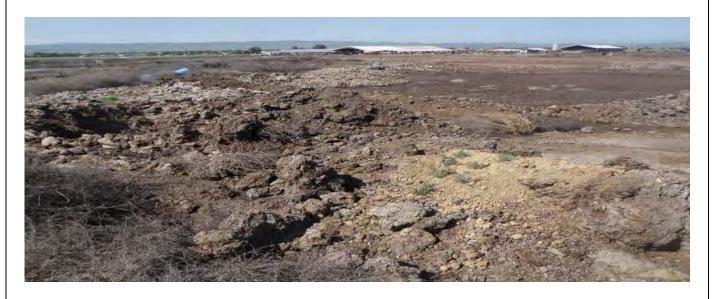
Photo 22: Looking southwest down the western edge of the storage lagoons – note massive amount of solid manure, slurry manure, and liquid wastewater.

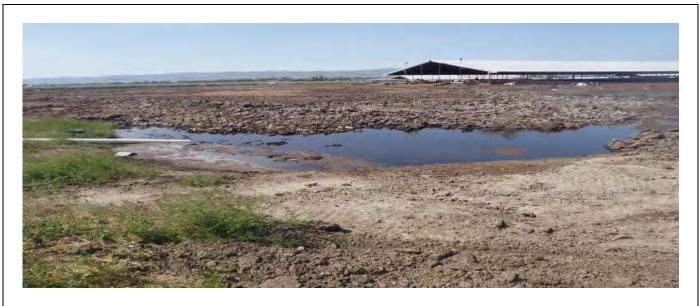
Photo 23: Looking southwest at an area west and northwest of the wastewater storage lagoons – note massive amounts of solid manure, slurry manure, and liquid wastewater. See Photo #24 for a different view.

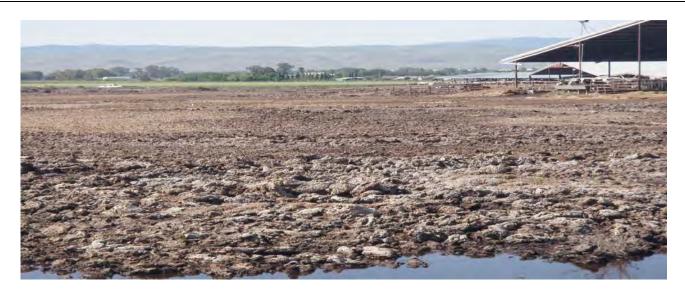
Photo 24: Looking west at an area west and northwest of the wastewater storage lagoons – note massive amounts of solid manure, slurry manure, and liquid wastewater.

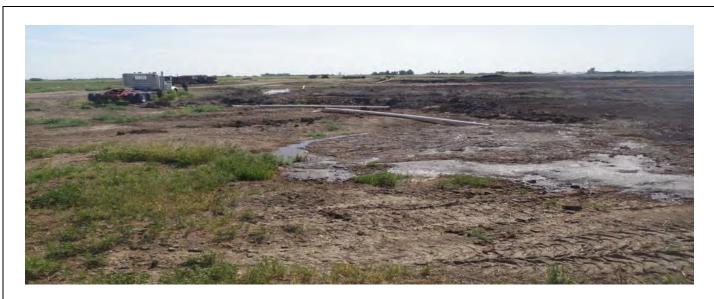
Photo 25: Looking south down the northern edge of the production area.

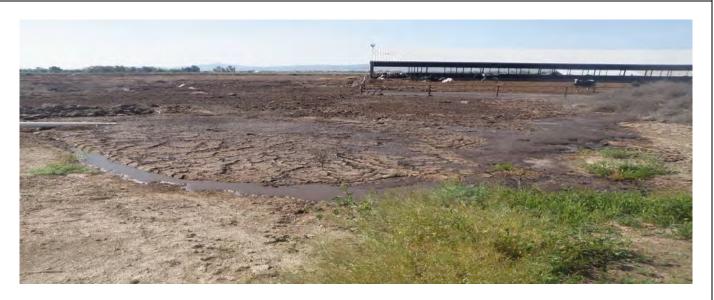
Photo 26: Looking south from the northern perimeter of the production area. Note massive amounts of solid manure, slurry manure, and liquid wastewater.

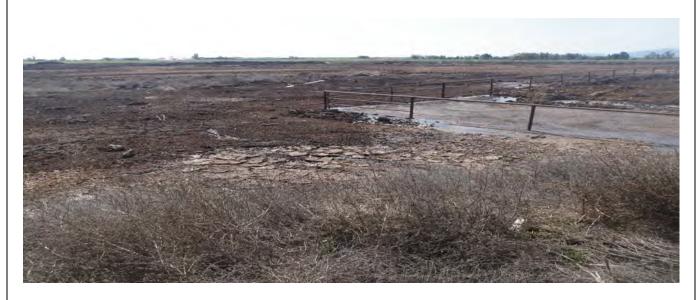
Photo 27: The eastern end of this corral was under wastewater at the time of our visit.

- 7) Remove all manure from the corral in the northeast corner of the production area (Photos 27-29). All manure should be exported off-site or otherwise managed to mitigate the impact. Provide documentation regarding the amount of manure removed and the destination of manure. After the manure is removed, the corral should be graded to prevent ponding.

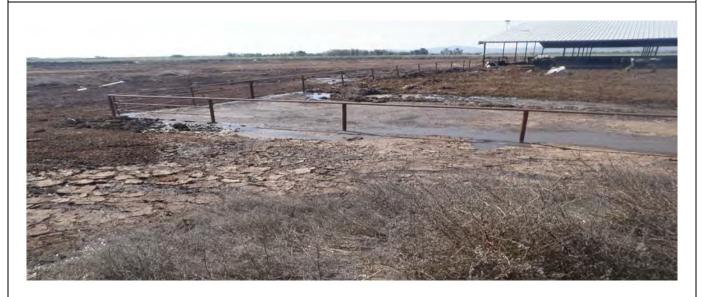
Select corrals contained excessive manure and ponding of wastewater (Photos 28-29). The excessive manure and ponding of wastewater is due to the 3-4 acre slurry area backing up into the corral. The remainders of the corrals were well-graded with all run-off ultimately discharging to Setting Basin #1.

Photo 28: Eastern end of the northern corral was under wastewater at the time of our visit.

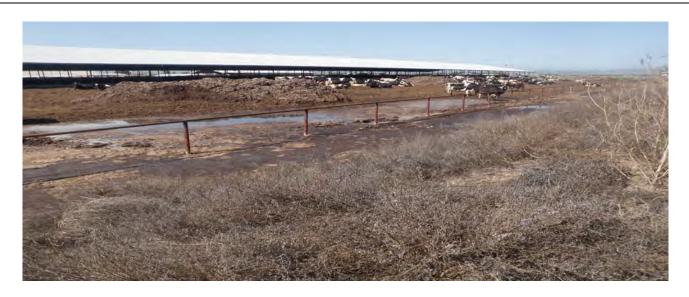
Photo 29: Same corral as pictured in Photos #27 and #28.

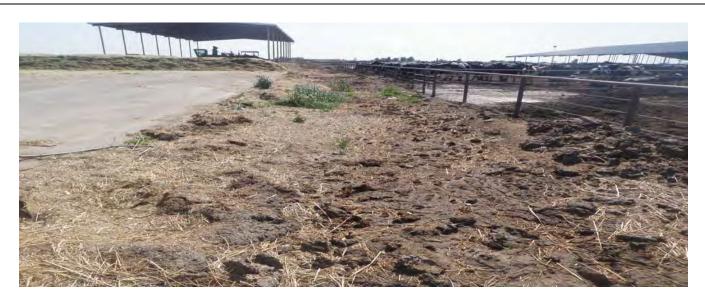
remains ponded in the corral and some continues to flow into the 3 to 4 acre area. The above mentioned channel contains excessive manure and old feed (Photo 30).

Photo 30: Looking east at the channel that is located immediately north of the corral pictured in Photos 27-29; the channel contains a significant amount of solid manure, slurry manure, and old feed.

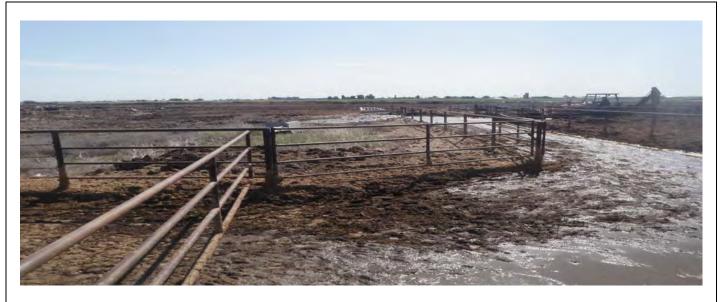
Photo 31: Note tractor pushing slurry manure into an area not designed to store wastewater and/or solid manure. See Photo #32 for a better photo of the area.

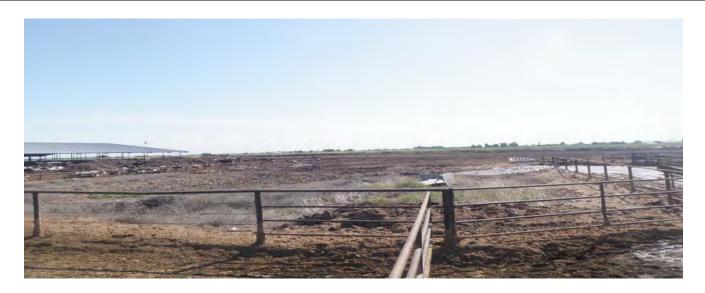
Photo 32: The operator dumps slurry manure and wastewater into this open lot; which is not designed to store wastewater or solid manure.
