FACILITY INSPECTION REPORT

INSPECTION DATE: 10/18/05

FACILITY: Carlsbad Municipal Golf Course

Construction Storm Water Inspection-10/18/05  
Carlsbad Municipal Golf Course, WDID# 937C337203  
Carlsbad, San Diego County

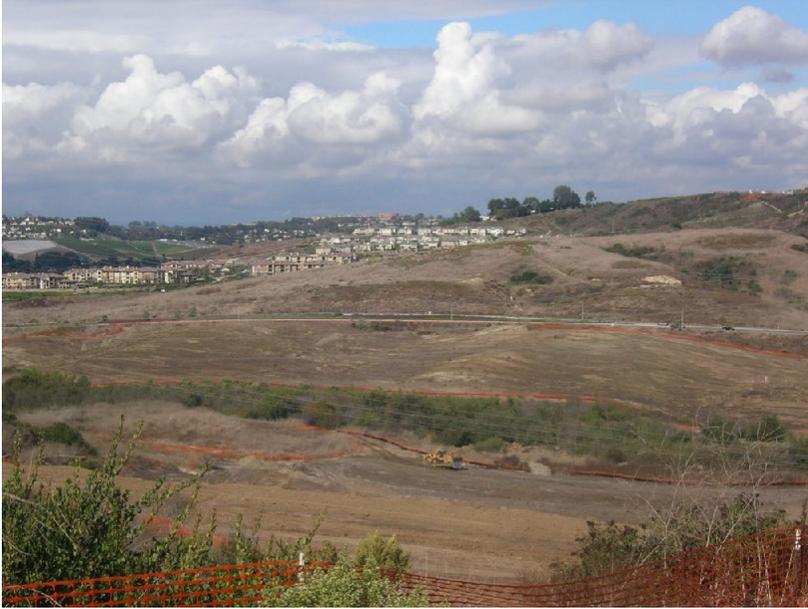
- Approximately 200 acres of the site have been mass graded. (Photo 1)
- Observed uncovered areas throughout the project without adequate BMPs and evidence of sediment discharges onto College Avenue (Photo 2).

Photo 1  
Mass Grading Operations (Facing North)

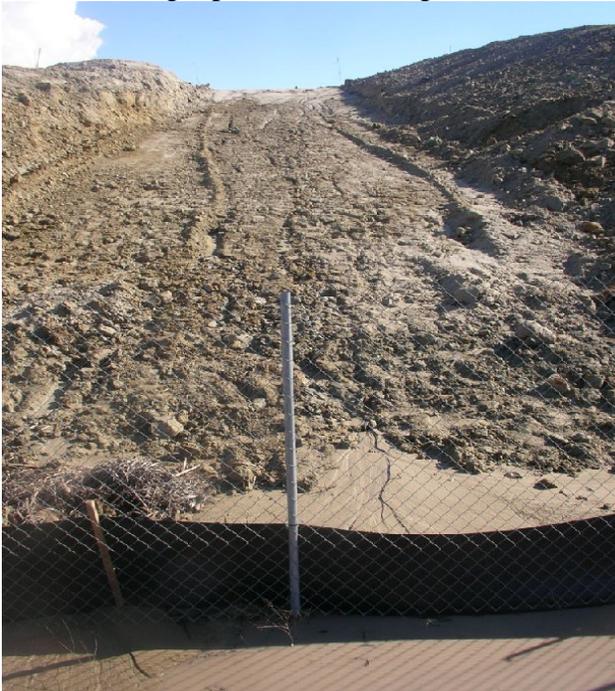
- Site lacks any erosion control BMPs including uncovered, exterior slopes throughout the project (Photos 2-4).
- City or Carlsbad and construction management personnel indicated that sediment basins/traps had been installed at the site. However during the inspection, the location and drainage areas of these sediment basins/traps was not clearly evident. Plastic spillways had been installed at some locations (Photo 5).

Photo 2  
Example of Inadequate BMPs & Evidence of Sediment Discharges Under Silt Fence  
(Facing East on College)

- The site needs to implement sediment and erosion control BMPs on the site to prevent the additional discharges of sediment.
- Silt fence installation needs to be corrected.
- Use of sediment basins should meet the sizing requirements of the General Construction Permit and drainage areas to the basins should be clearly defined.
- The SWPPP needs to be amended to address the deficiencies noted and additional BMP requirements.

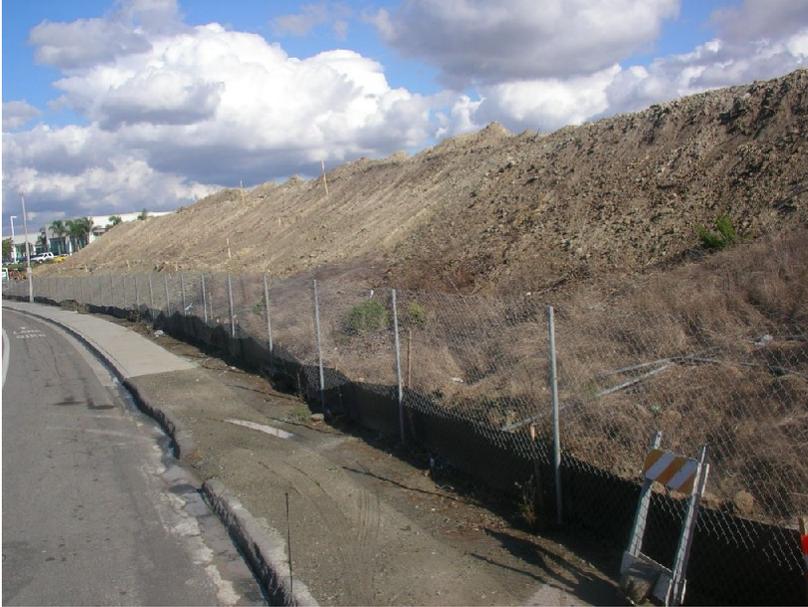
Photo 3  
Example No Erosion Control on Exterior Slopes (Facing Northeast on College Ave)

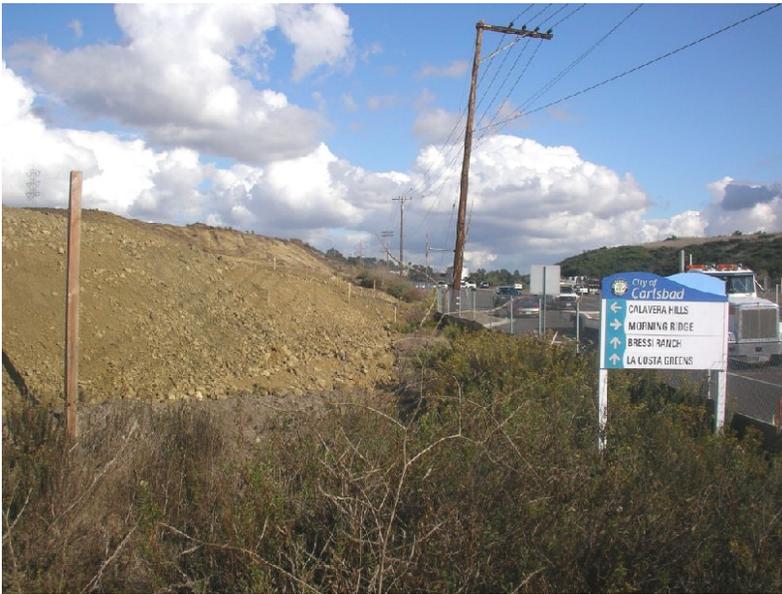
Photo 4  
Uncovered Slopes On Palomar Airport Road (Facing East)

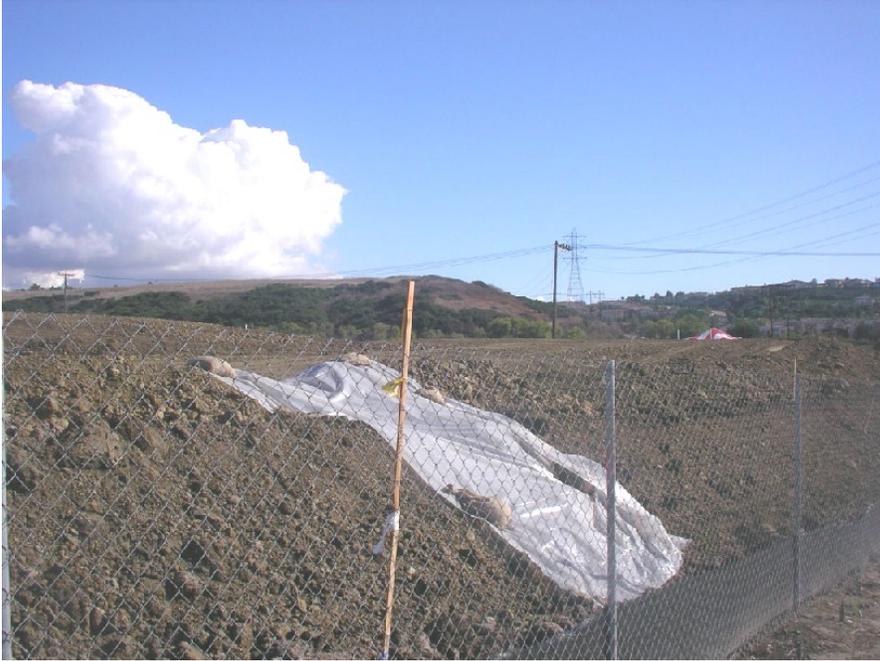
Photo 5  
Plastic Spillway For Sediment Trap (Facing Southeast)

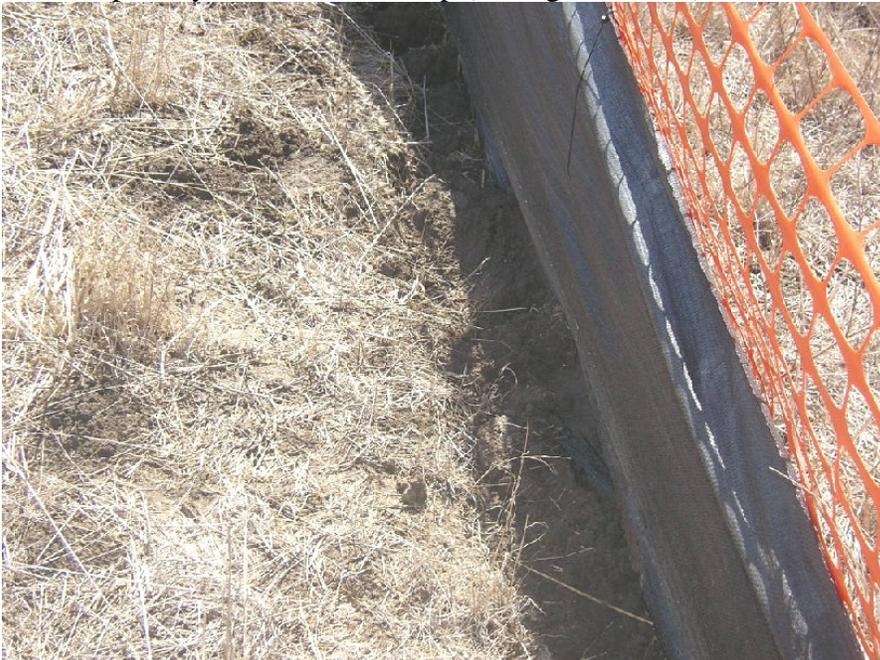
- The site appeared to be relying on silt fence as the main sediment control BMP. The silt fence was installed incorrectly on most of the site perimeter and not trenched into the ground, making it susceptible to undermining (Photo 6).

Photo 6  
Example of Incorrect Silt Fence Installation (Not Trenched In)
