Appendix C

FACILITY: Roripaugh Residential Ranch WDID: 9 00001C091 INSPECTION DATE: August 29, 2006
9 0000512S1
9 33C320657

Introduction

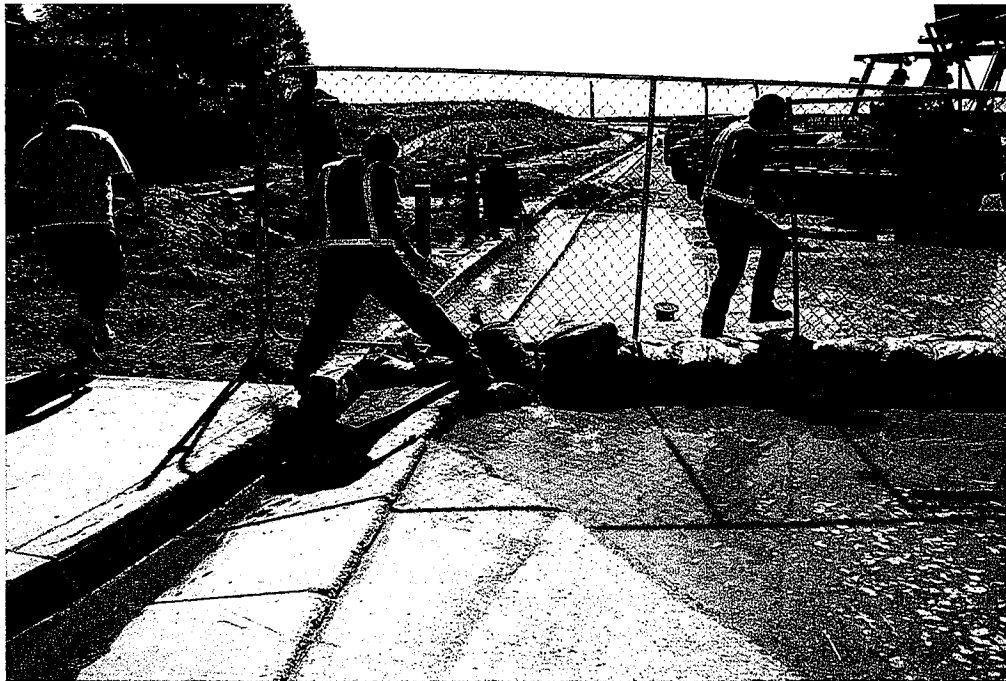
Our 10:00 a.m. arrival at the site was interrupted by a water line break, which occurred at the intersection of Murrieta Hot Springs Road and Pourroy Road (see vicinity map). Gravel bags, which were initially used to contain the pooling sediment-laden water, were being erroneously removed. This allowed the polluted water to flow freely down Murrieta Hot Springs Road (photos 1 and 2).

Photo 01: Ashby, USA workers attending to water line break. Initially, the workers were observed erroneously removing the gravel bags releasing the sediment-laden water along Murrieta Hot Springs Road.

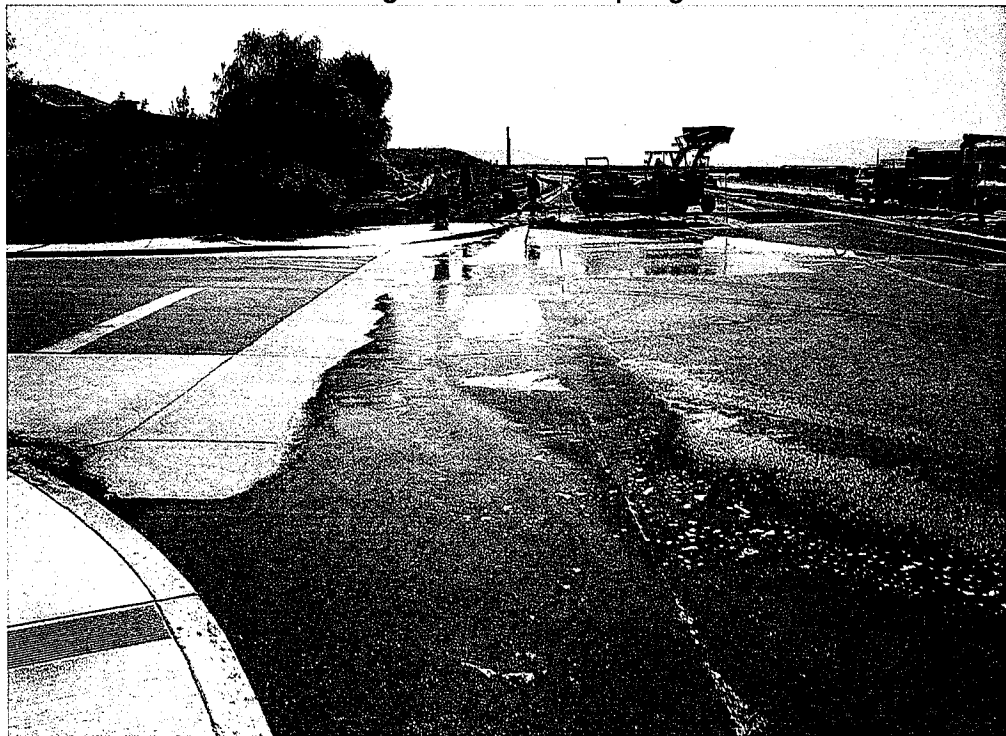
We immediately alerted the Ashby USA workers that the release of sediment-laden water is strictly prohibited under state regulations and city ordinances. Upon recognizing that we were Regional Board employees, the Ashby workers immediately began replacing the gravel bags to contain the flowing water. By that time there was a significant volume of sediment-laden water discharging along Murrieta Hot Springs Road and entering the storm drain inlet at the intersection of Red Bridge Road (photo 2). The discharge along Murrieta Hot Spring Road occurred for about 30 minutes with approximately 10-20 gallons of sediment-laden water entering the storm drain inlet.

Photo 02: Our presence quickly alerted the Ashby works to maintain the BMPs, as sediment-laden water entered the storm drain along Murrieta Hot Springs Road.

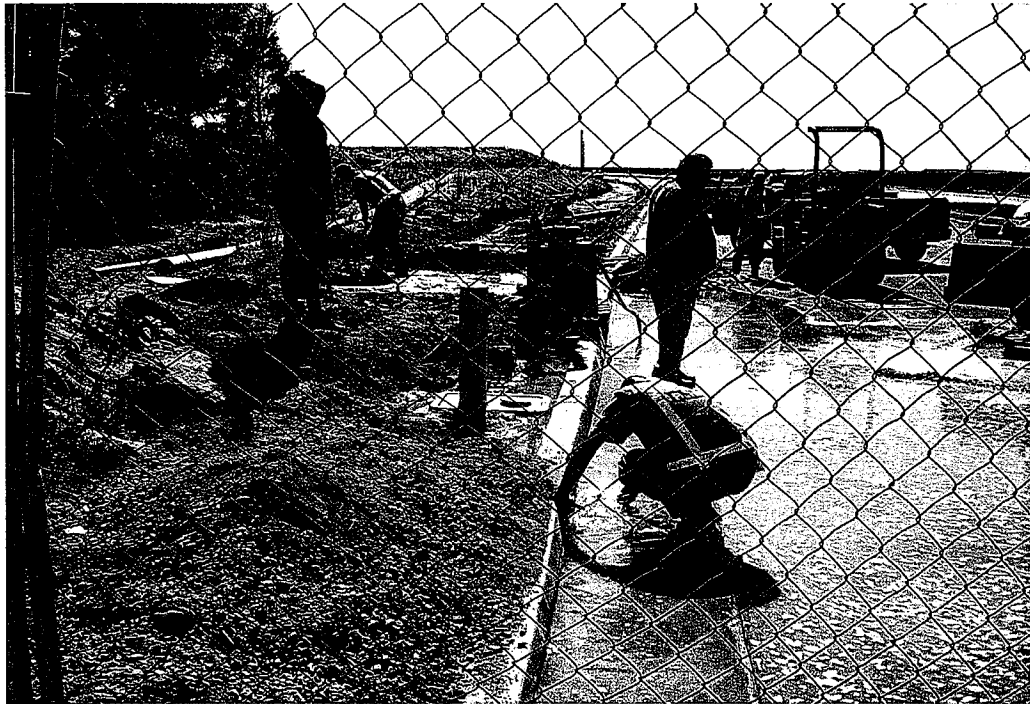
Photo 03: Workers attempting to shut off the water main. The SWPPP person, Mr. Henry Martinez, and his supervisor were present at the time of the incident.

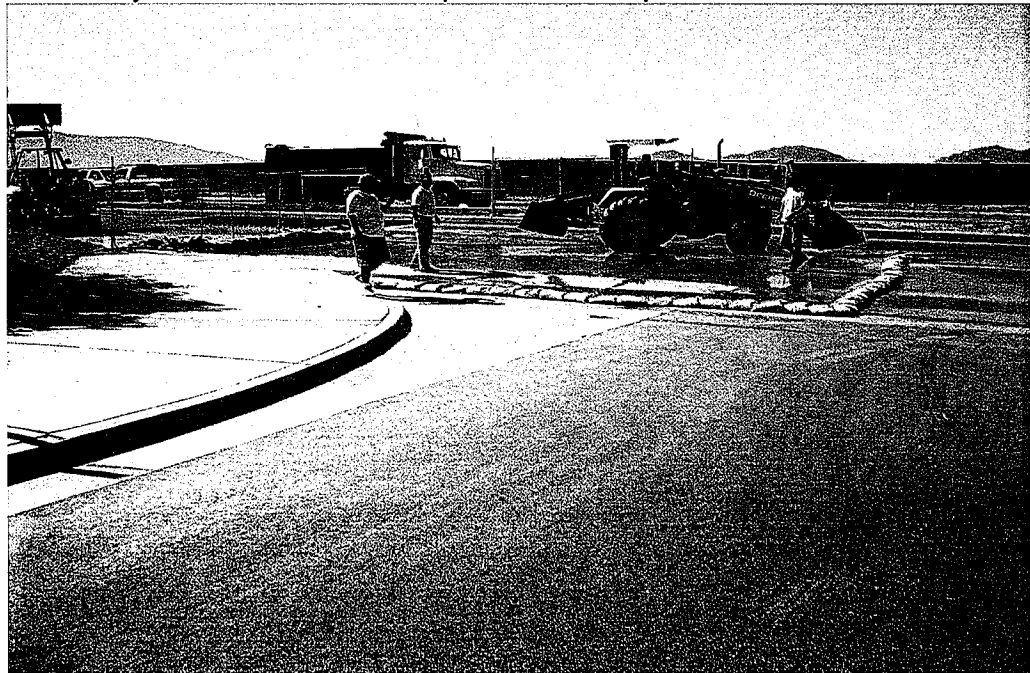
Photo 04: Sediment traps were immediately installed along Murrieta Hot Spring Road to contain and capture the sediment-laden water.

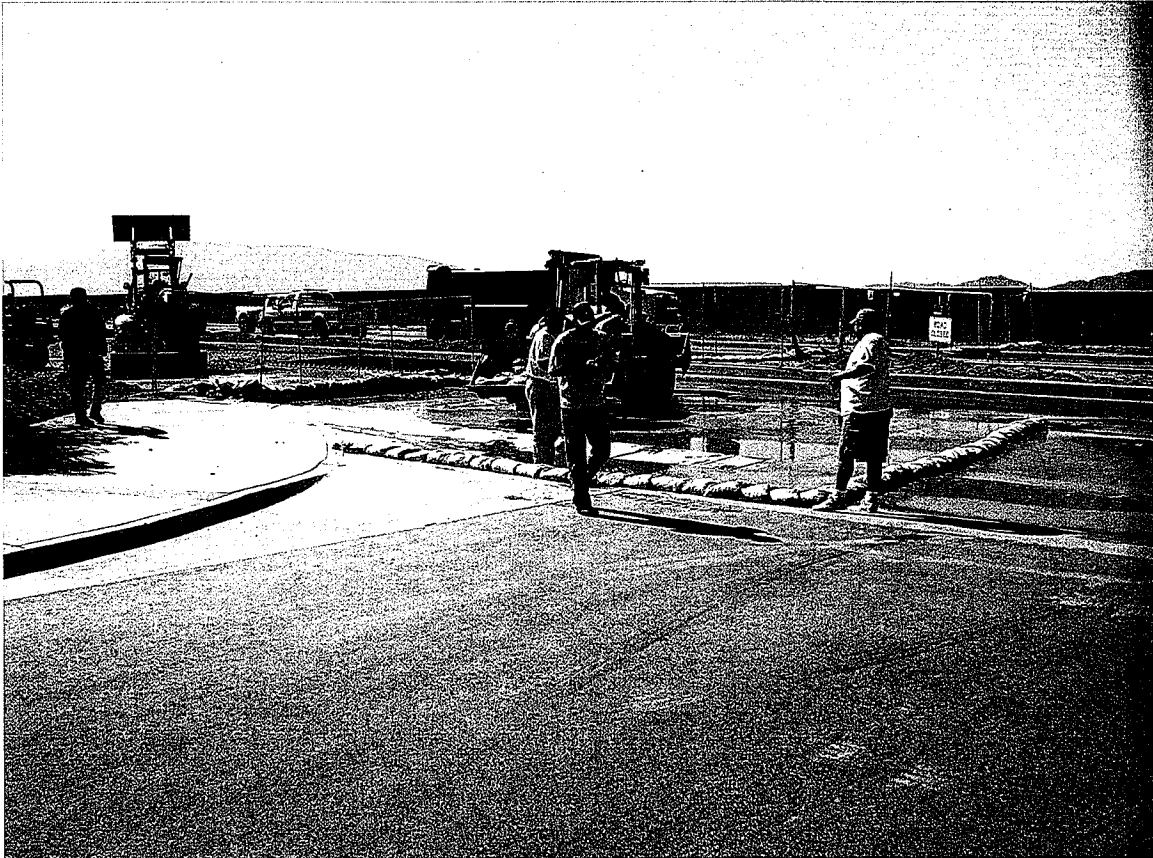
Photo 05: We notified Mr. Aldo Licitra of the City of Temecula of the incident. He proposed to conduct a follow up inspection of the incident to ensure proper clean up of the sediment that was deposited along Murrieta Hot Springs Road. The incident occurred the moment we approach the site entrance on Pourroy Road.

There was discharge into the City's storm drain located at the intersection of Murrieta Hot Springs Road and Red Bridge Road, which is in violation of the City of Temecula's Municipal Separate Storm Sewer Systems (MS₄) permit.

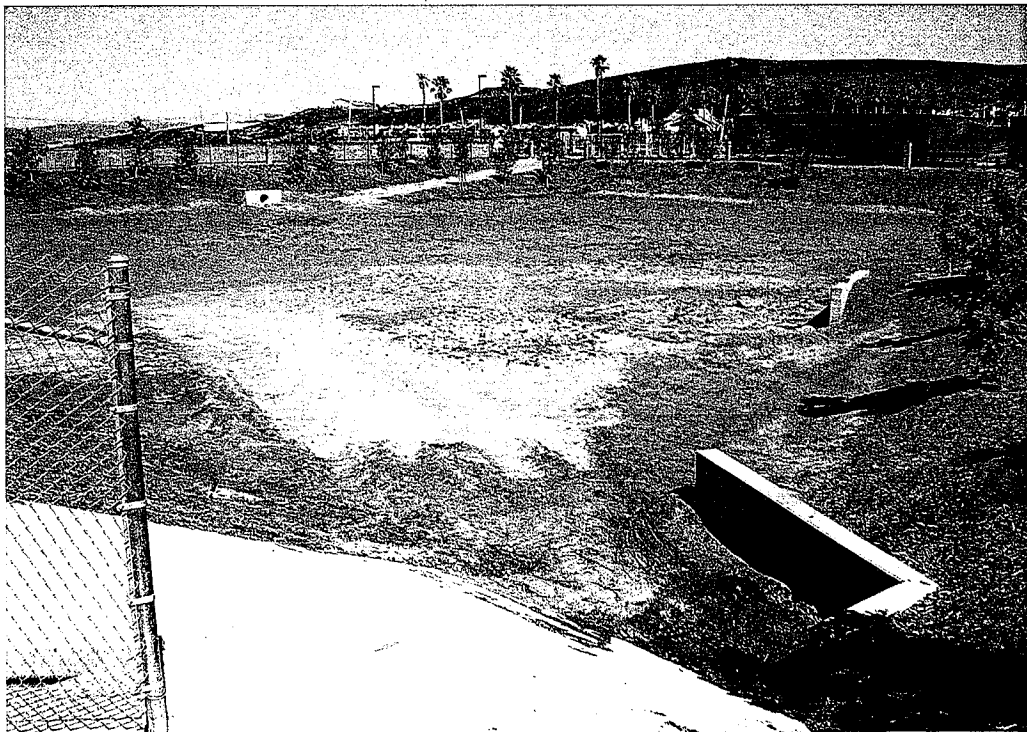
Photo 07: The sediment basin is expected to contain storm water runoff from adjoining east and west graded lots (referred to as the Plateau).

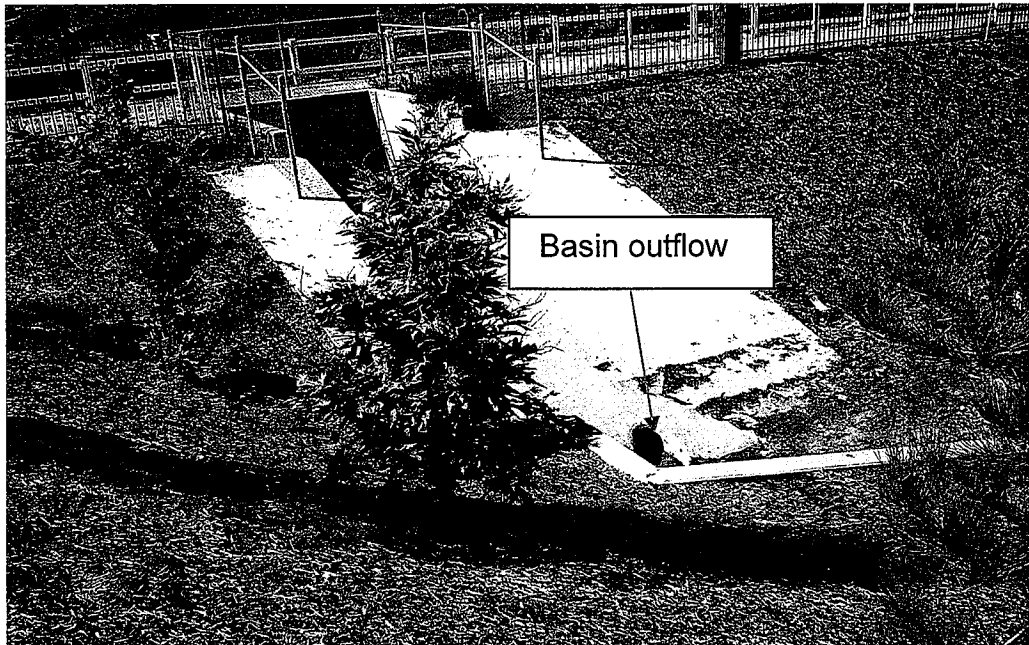
At 10:33 a.m., we entered Roripaugh Ranch to walk the site and to inspect the sediment basin. The basin is at the base of the panhandle of the site, directly behind the club house. The basin, 0.7 acre in size, is designed to capture the stormwater runoff from the "plateau" and the surrounding areas (photos 7 and 9). Close inspection of the basin shows the outlet is level with the base of the basin, making the basin a flow-through system (see photo 8). The basin lacks

The basin outlet design is causing erosion in the creek downstream from the outlet as shown in photos 8, 10, and 11. Ashby USA is in violation of Condition 16 of 401 Certification No. 01C-091 for failing to implement BMPs as described in the WQMP.

Photo 08: Placement of the basin outflow indicates the design is a flow-through system, eliminating settling time.

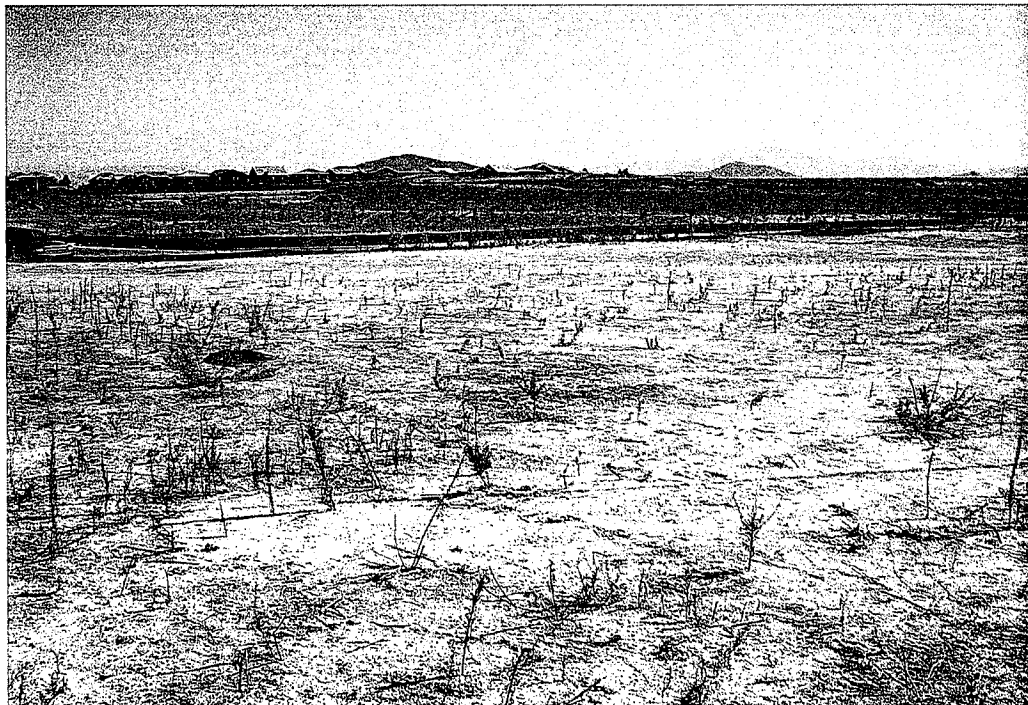
Photo 09: Most of the storm water runoff to the sediment basin comes from the 'plateau' portion of the site and the adjoining graded parcel (west).

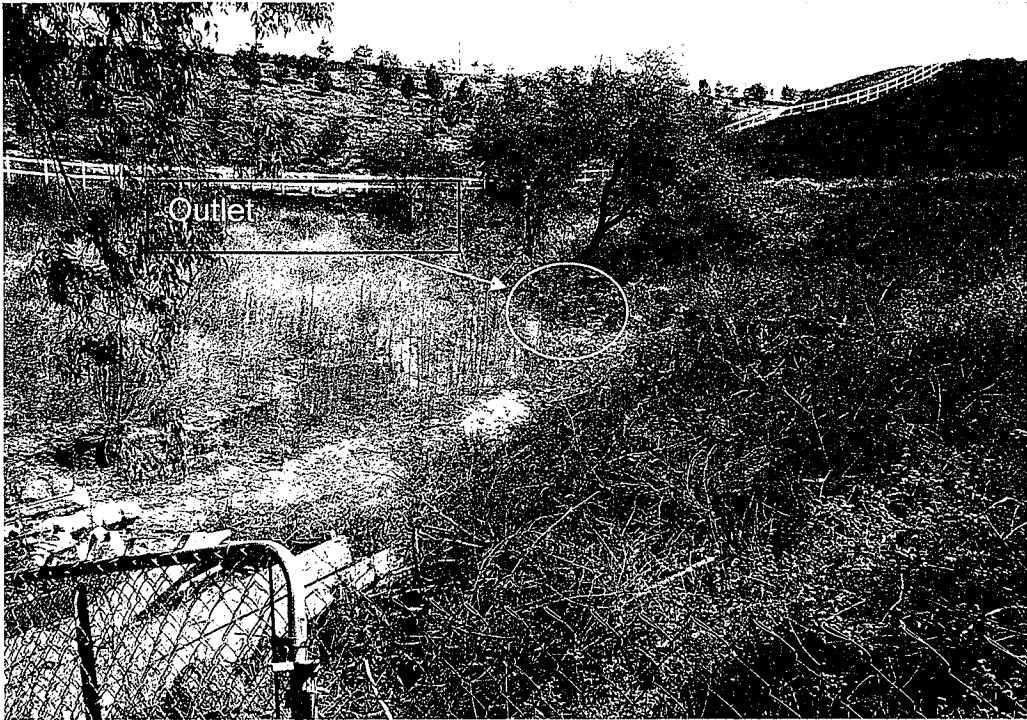
an anchored-riser that would facilitate sediment desilting time. The basin's 6-inch outlet pipe continues through an eighteen-inch pipe and daylight through the headwall located down gradient from the plateau (photo 10). Storm water runoff discharges through riprap, placed at the headwall, to diffuse the high velocity flows from the sediment basin (photo 10). We observed most of the riprap was covered with sediment and therefore, not expected to provide much velocity reduction. In response to the complaints, the City of Temecula had requested more riprap placed at the outlet to further reduce flow velocities from the sediment basin.

Photo 10: Insert shows outlet of sediment basin with velocity diffuser (barely visible because it is covered with sediment). Subsequent photos will trace the path of discharge from the sediment basin to the complainant's property.

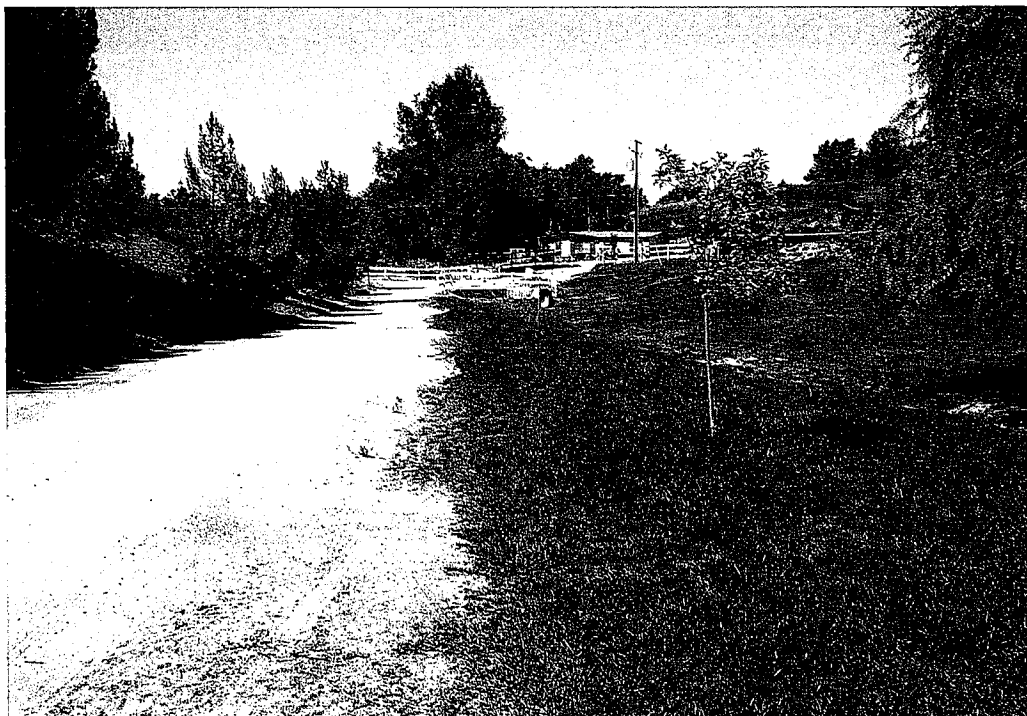
We traced the path of storm water discharge from the sediment basin's headwall through various private properties to the complainant's property. From the headwall the discharge continues through a grassy swale of a neighbor's backyard through a culvert pipe fitted with riprap at the inlet (photos 11 and 12). The complainant's property begins down gradient, at the intersection of the culvert pipe outlet and Kimberly Lane.

Photos 11, 12, 13, and 14 show illegal fills of waters of the US downstream of the detention basin. The complainant said that these fill areas were placed to address the erosion from the detention basin discharge.

Photo 11: Runoff from the sediment basin continues through this grassy swale exiting through the culvert pipe (seen in background).

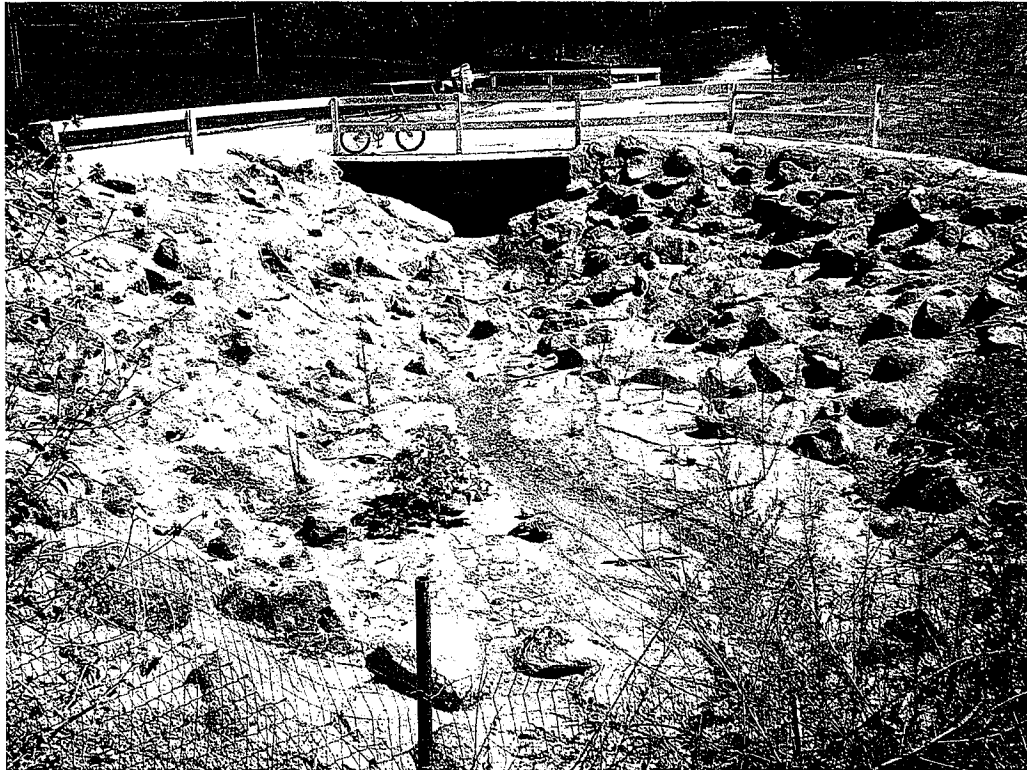
Photo 12: Culvert pipe-shows buildup of sediment deposit from discharges from sediment basin.

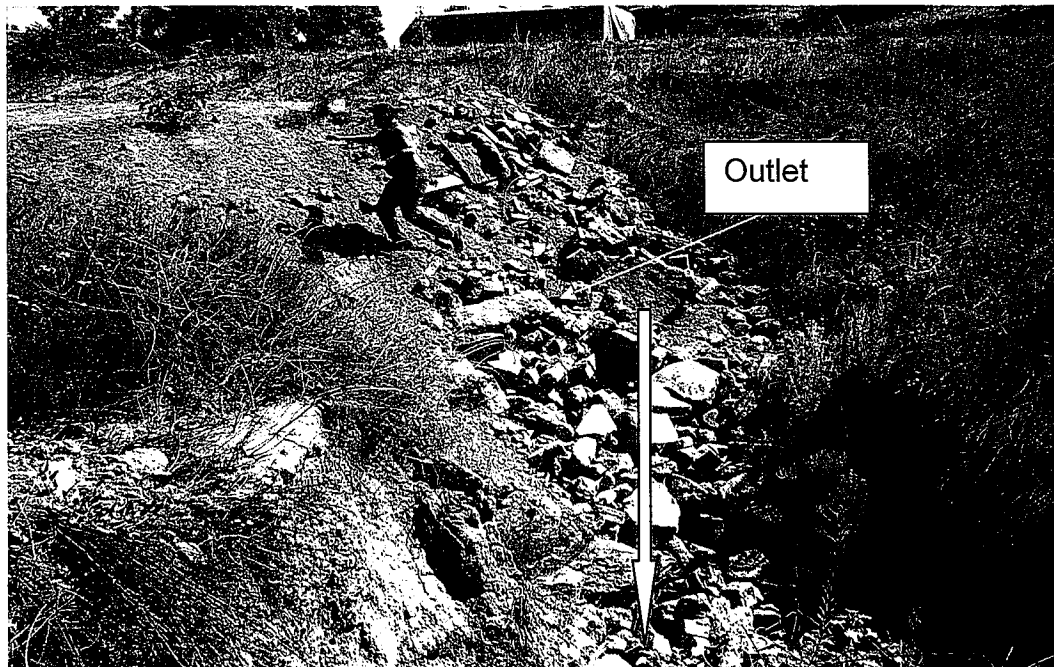
At the culvert pipe outlet, where storm water discharges enter the complainant's property, we observed severe erosion and sediment deposits within the natural waterway. The erosion effects and sediment deposits were more pronounced in areas along the complainant's property (photos 13 and 15). The natural waterway was scoured in some areas up to about 6 feet high (photo 15). The complainant recalled, "...as a child I could easily walk across the natural waterway." Getting across the tributary is now difficult or impossible because of the depth of erosion gullies that are formed from storm water discharges.

Photo 13: Insert shows culvert pipe's outlet. This natural waterway is a tributary to Santa Gertrudis Creek. Complainant states that the creek bed was at the level of the outlet pipe before the upstream Roripaugh basin was constructed.

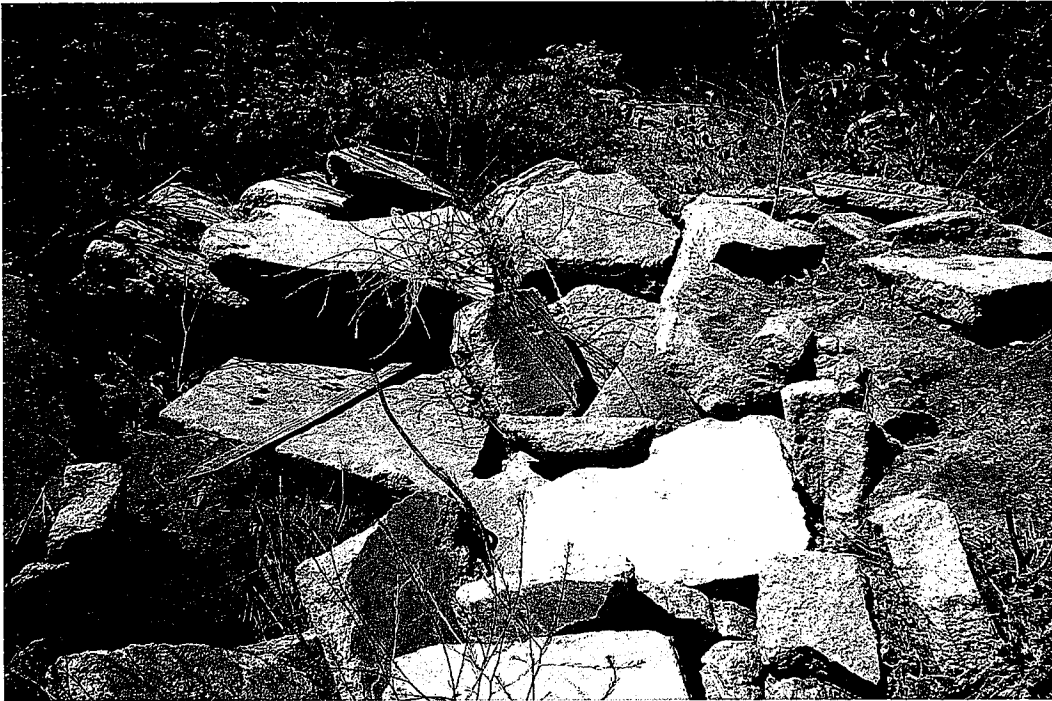
Photo 14: Complainant filled natural waterway with waste concrete blocks to serve as velocity diffuser. More of this can be seen in previous photo.

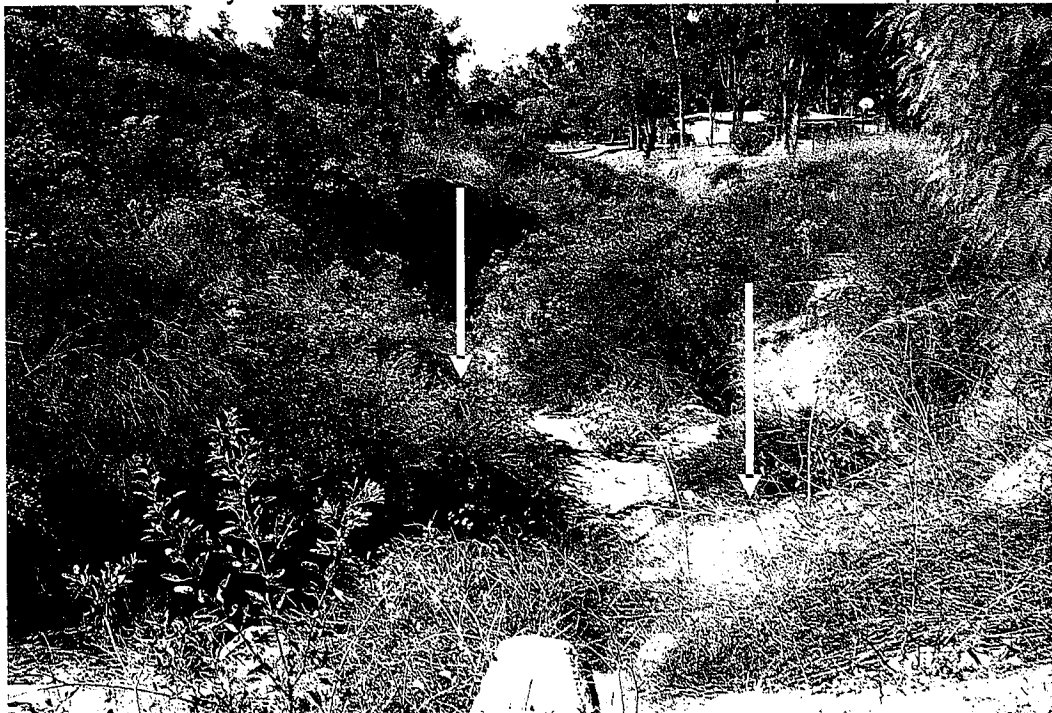
Photo 15: Complainant claims that high velocity and long duration discharges from the sediment basin has created deep gullies within the natural waterway. Note the depth of erosion from top of bank to bottom of creek bed shown with white arrows. Erosion was generally 3 to 4 feet, and up to 6 feet deep, in this area.

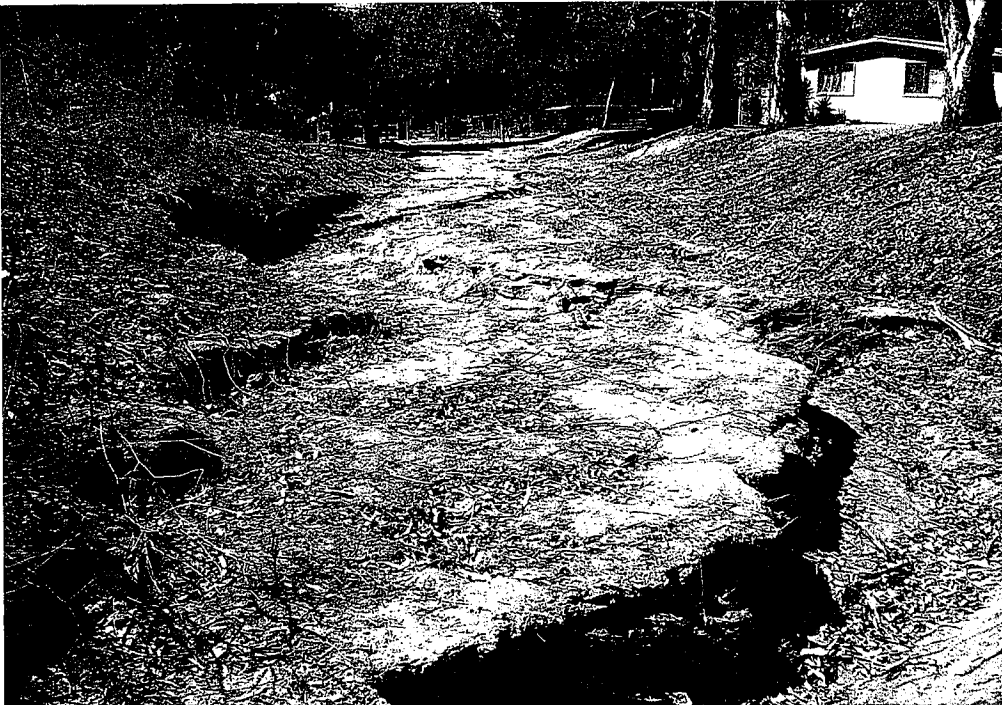
We observed significant amount of erosion, scouring of the embankment, and sediment buildup within the unnamed tributary that abuts the complainant's property and Liefer Road (see photos 16 and 17).

Photo 16: Complainant's property (5 acres) is to the left. Scouring of the embankment from erosion from low drainage flows. Per the complainant, during the wet season the erosion effects and sediment deposits are more pronounced in this area.

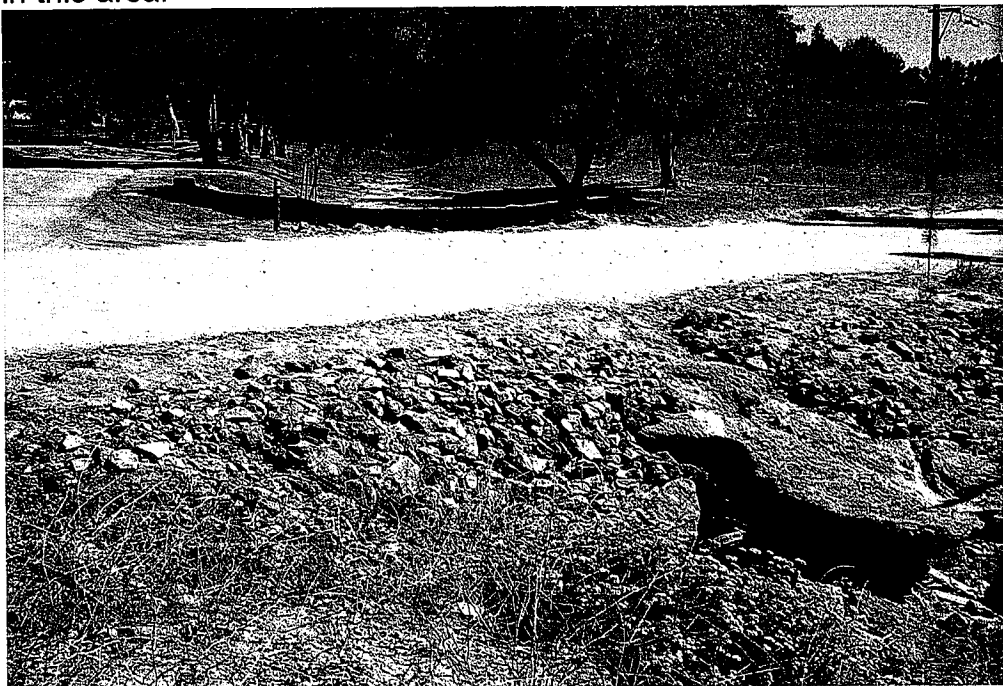
Photo 17: Facing upstream of natural waterway across Liefer Road. Storm water discharges continues through pipe underneath Liefer Road.
