CALIFORNIA REGIONAL WATER QUALITY CONTROL BOARD - SAN DIEGO REGION

FACILITY INSPECTION DATA ENTRY FORM

INSPECTION DATE: November 15, 2006 TIME: 9:00 WQID: 9 00001C091 ORDER NO. 01C-091 FILE 18-2001091.02  
9 33C320657 99-08-DWQ 10-3020657.02

Roripaugh Ranch Tract 29353  
 FACILITY OR DEVELOPER NAME (if different from owner)

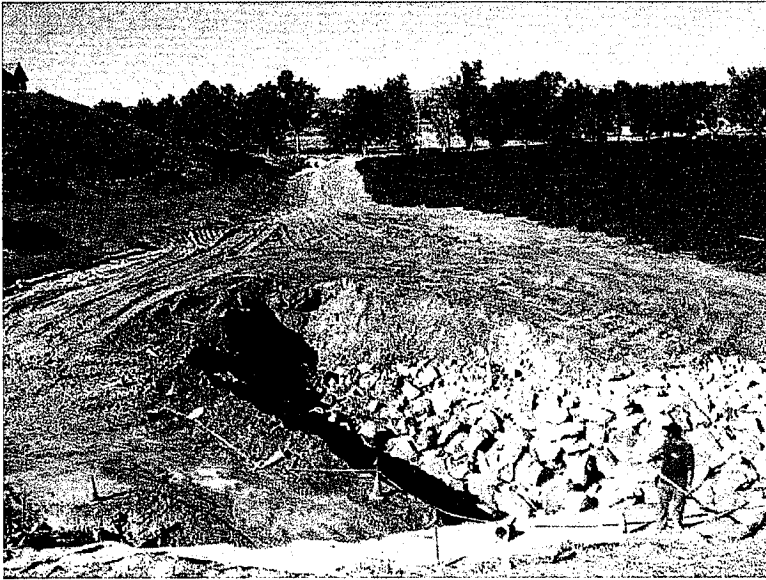
Photo 1. Bridge crossing at Butterfield Stage Road over Long Valley Wash looking downstream. Bridge is complete, but work is needed to finalize the riprap and downstream creek area shown here. Dirt obstructions in the creek bed as seen here need to be removed.

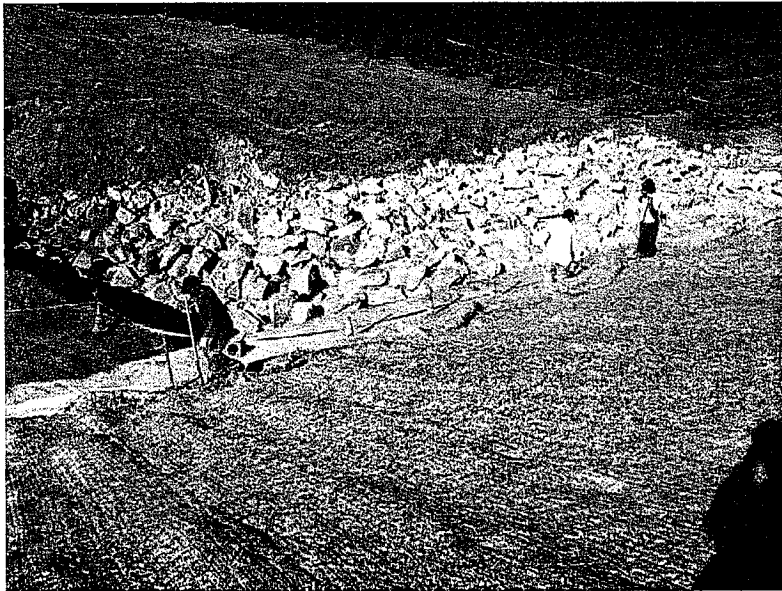
Photo 2. Same bridge as photo 1. Slopes have been covered with matting.

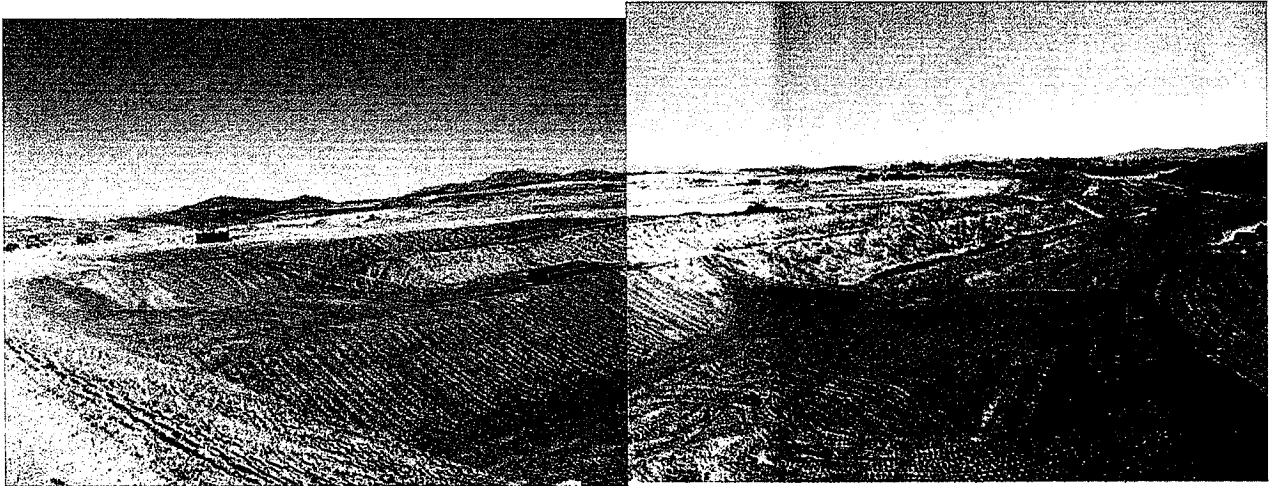
10. Long Valley Wash has been disturbed from its natural condition as shown in photos 3, 4, 7, 8, 15, 16, and 18. The wash should be returned to a natural condition as soon as possible.
11. There is little vegetation in Long Valley Wash between the bridges at Butterfield Stage Road and the Loop Road as shown in photos 3 and 4. There is more vegetation upstream of the Loop Road crossing as shown in photos 7 and 8. Long Valley Wash seems to

Photo 3 & 4. From the bridge in photo 1 facing upstream. An earthen dike has been constructed in the channel. This dike should be removed and the soil stabilized so water can flow over it. Slopes should be stabilized.

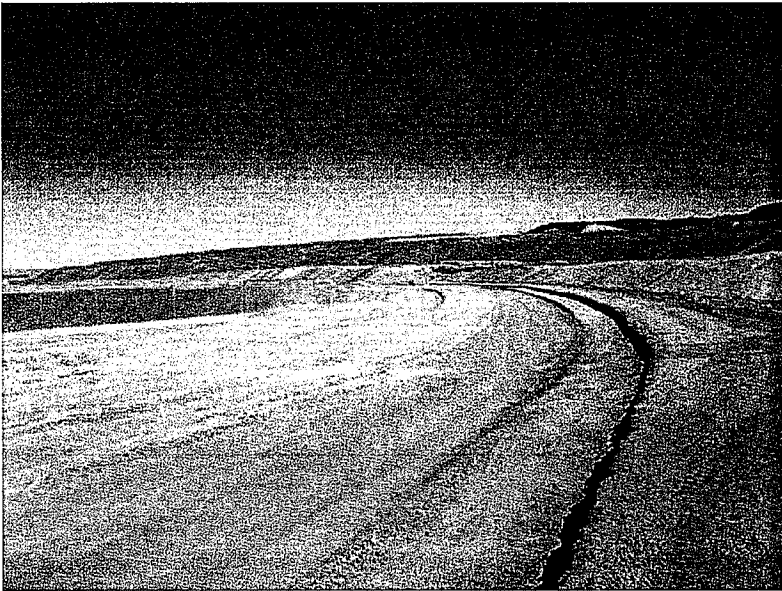
Photo 5. Top of completed bridge at Loop Road over Long Valley Wash. Bridge is a low point for water to accumulate. Additional BMPs are needed to prevent concentrated flow along road from causing erosion.

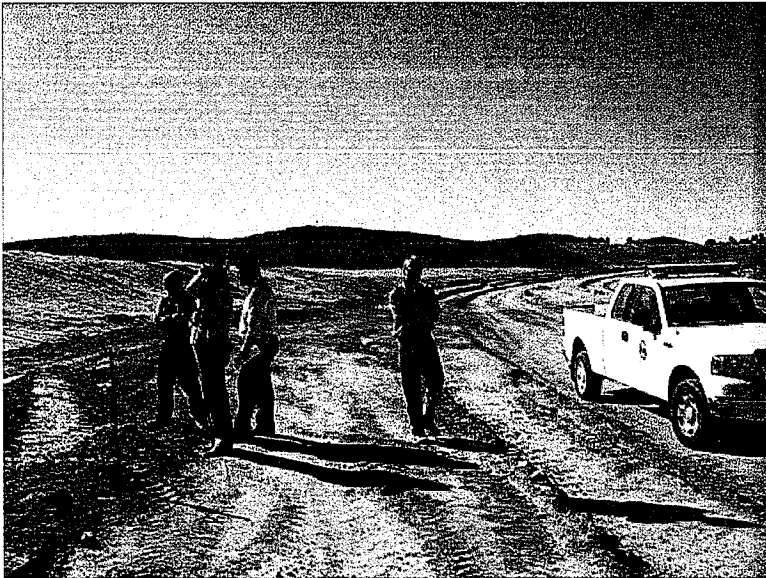
Photo 6. Loop Road bridge looking south. Additional BMPs are needed along road and at toe of slopes. Any unstabilized slopes should be stabilized.

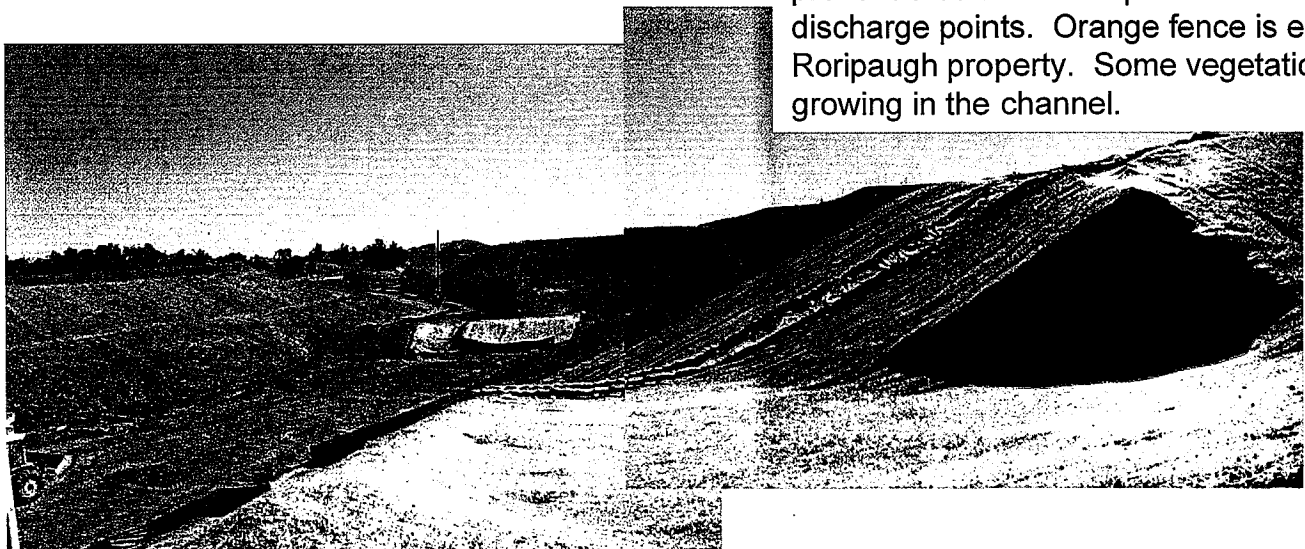
Photo 7 & 8. Loop Road bridge looking upstream. A dike has been constructed in the channel. The dike should be removed. Any concentrated flow spillways should be fully stabilized to prevent erosion at flow paths and discharge points. Orange fence is end of Roripaugh property. Some vegetation is growing in the channel.

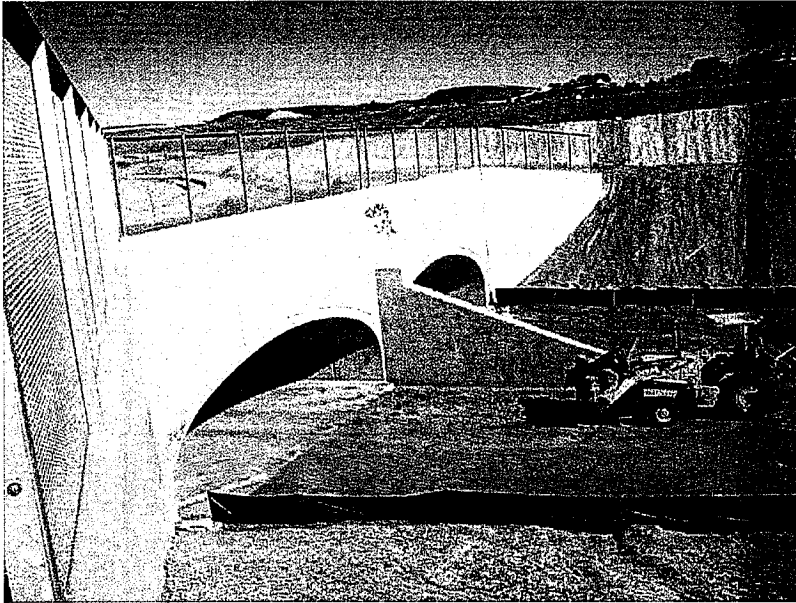
Photo 9. Upstream bridge entrance is almost complete.

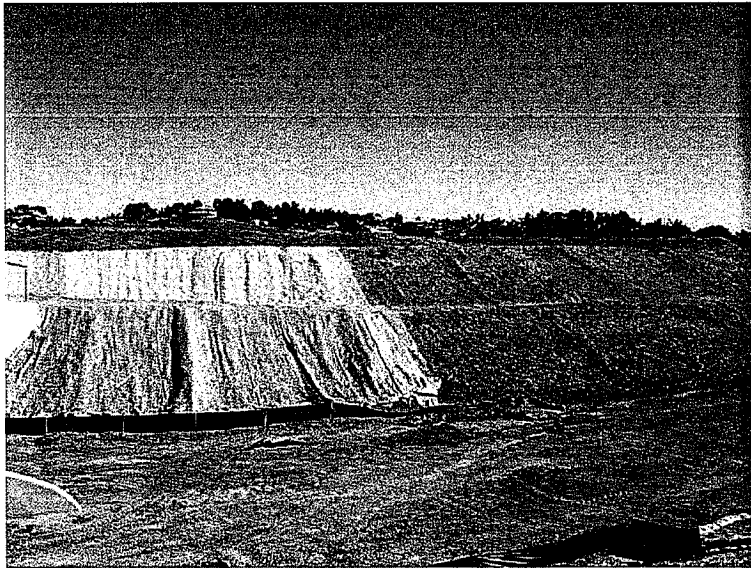
Photo 10. North bank upstream of Loop Road bridge. Some slopes have matting places and some slopes need to be stabilized.

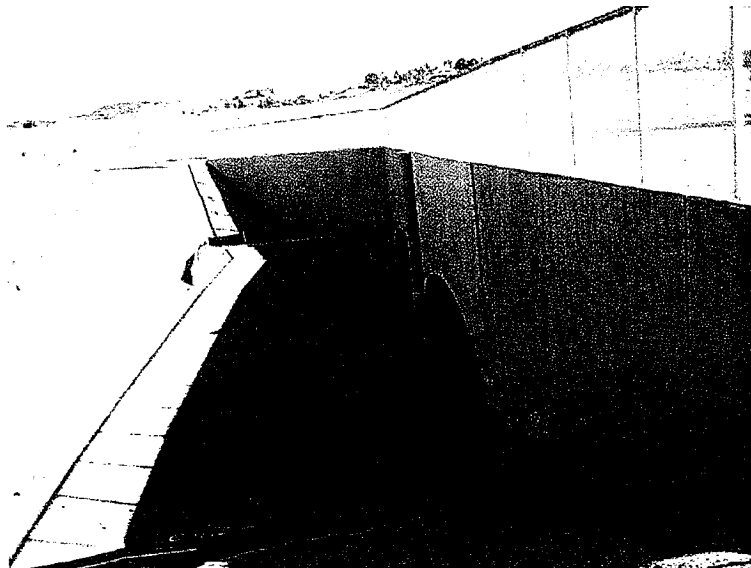
Photo 11. Loop Road bridge downstream. Riprap is not installed yet.

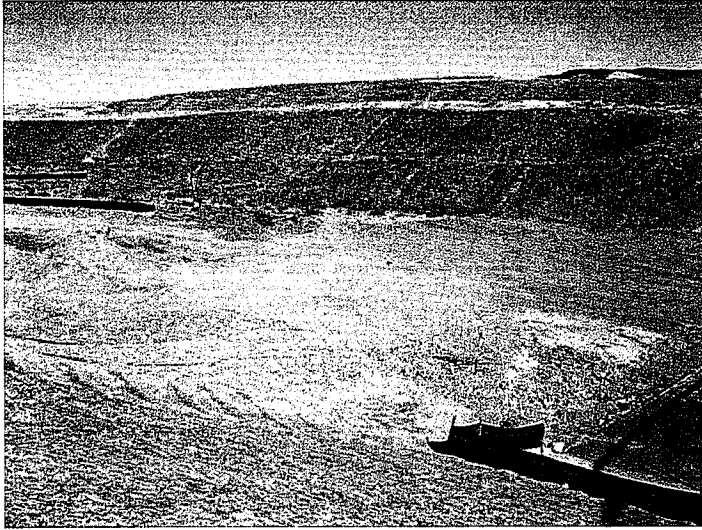
Photo 12. Unstabilized dirt in the channel downstream of the Loop Road bridge.

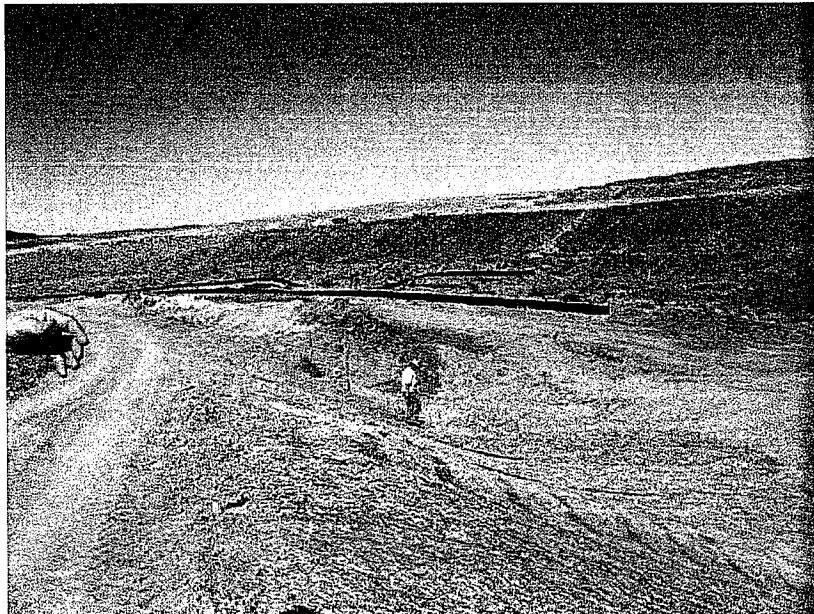
Photo 13. Access road into channel needs stabilization before a storm.

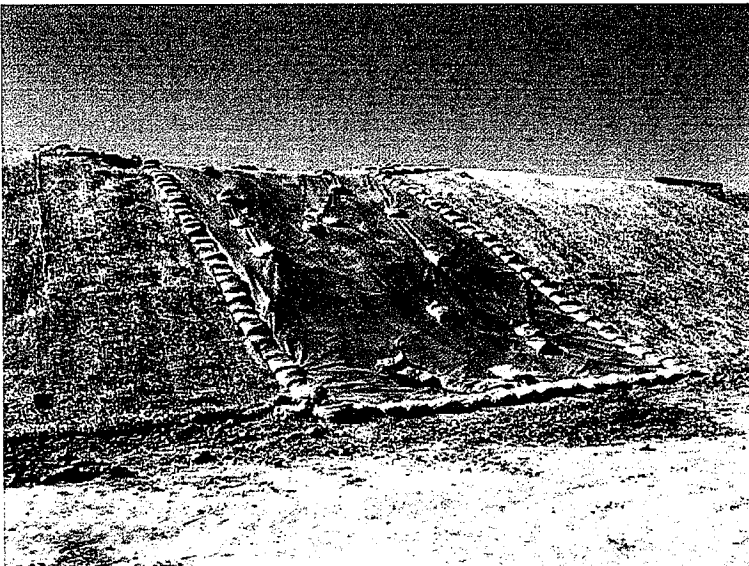
Photo 14. Stabilized spillway needs additional BMPs at the bottom of the slope and to get the water to the channel without causing erosion.

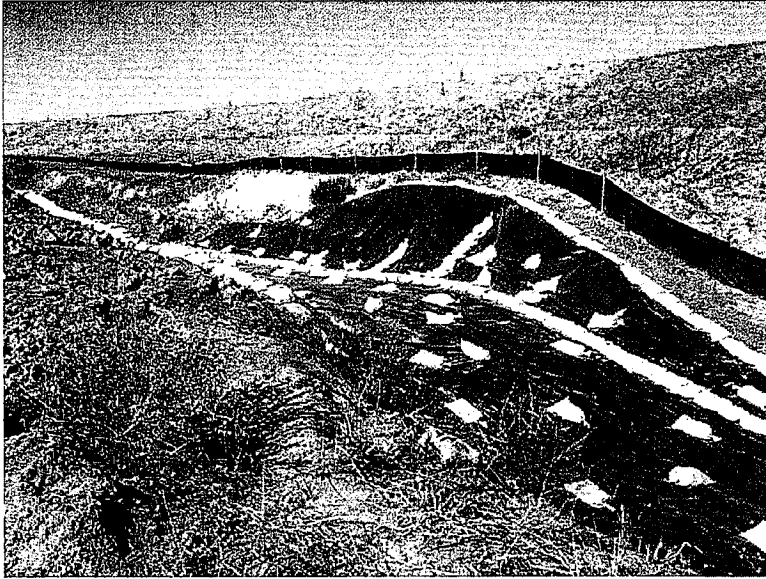
6. There were several berm/ dikes in Long Valley Wash. These berm/ dikes need to be removed for many reasons including the Wash is not to be used as a BMP, the 401 Certification requires that Long Valley Wash be maintained in its natural state, and if there is a big storm the berms will wash away.

Photo 15. Visqueen lined berm in Long Valley Channel downstream of Loop Road bridge should be removed. Long Valley Wash is to remain in its natural state and the creek should not be used as a BMP.

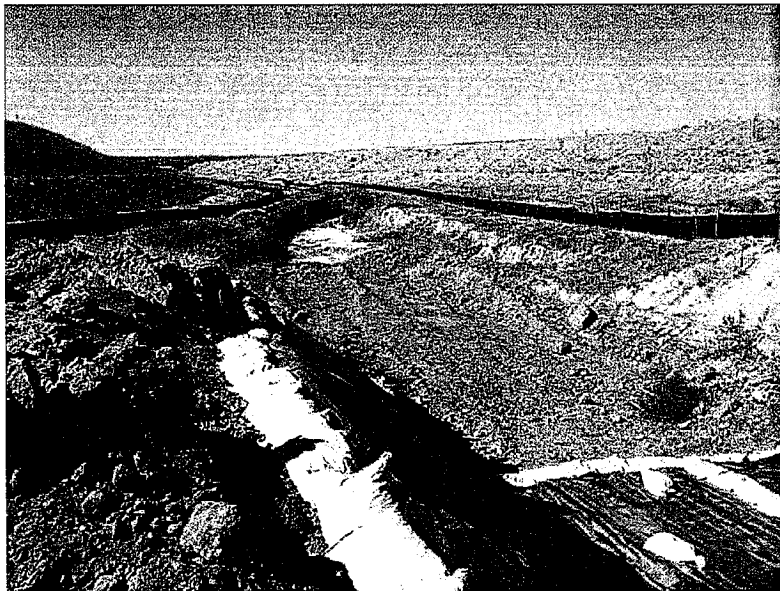
Photo 16. Long Valley Wash downstream of the berm in photo 15. Channel should be returned to its original state.

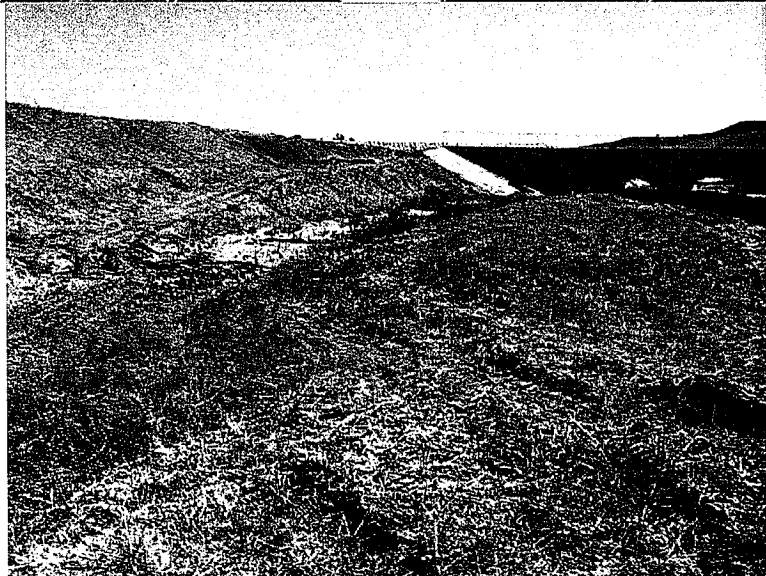
Photo 17. Long Valley Wash looking upstream of the berm in photo 15.

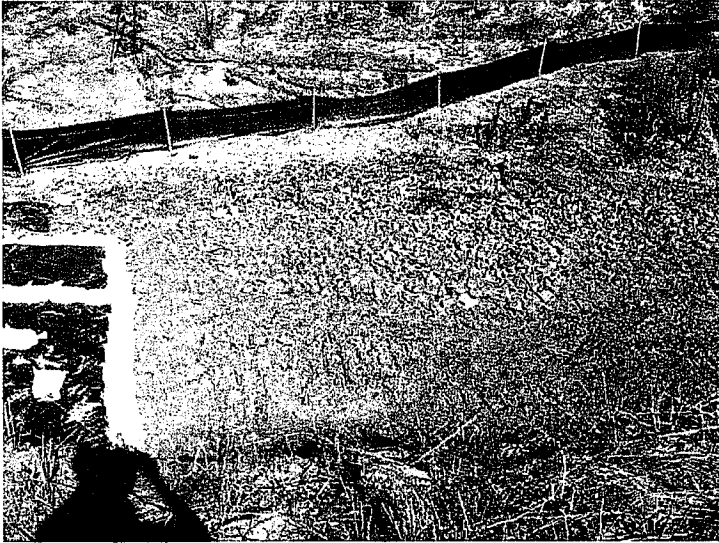
Photo 18. Upstream of the berm in photo 15. Channel was disturbed here.

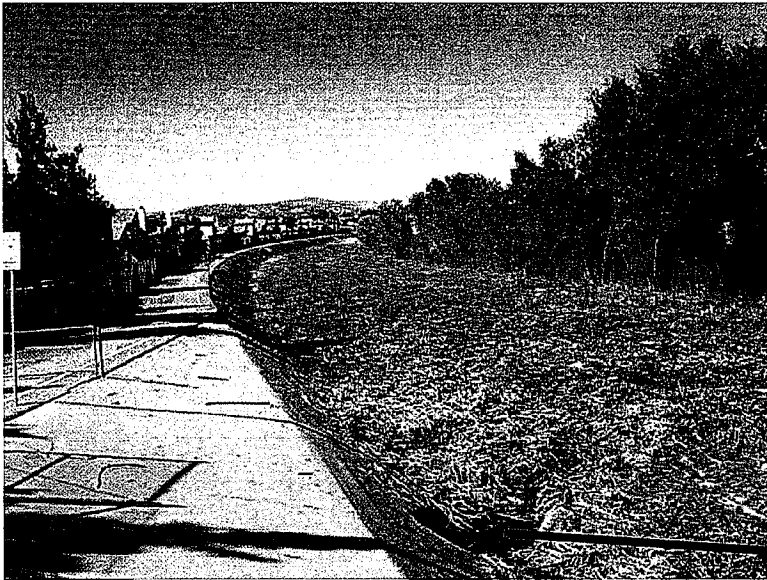
Photo 21. Santa Gertrudis Creek downstream of photo 19 and 20 facing downstream at General Kearny Road. This section of the creek had recently been mowed. The large amount of vegetation is likely due to a storm drain discharge. The trees on the right are in a park adjacent to the creek behind a chain link fence.

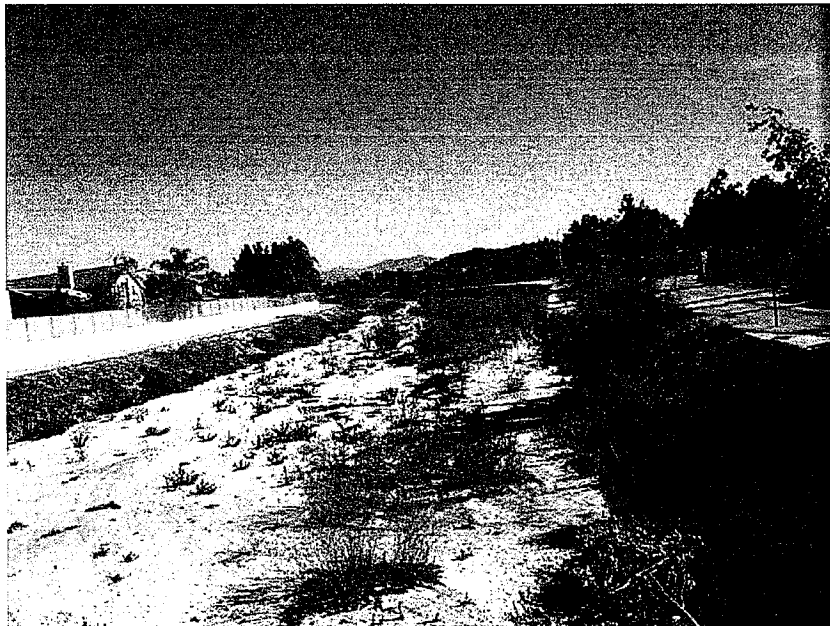
12. Riverside County Flood Control and Water Conservation District wants to be able to mow the channels on Roripaugh annually as needed. They generally don't mow all channels each year, but perform an assessment to determine which channels need mowing. Santa Gertrudis Creek was mowed downstream of General Kearny Road due to excessive vegetation growth as shown in photo 21. Upstream of General Kearney Road was not mowed because there is little vegetation as shown in photo 22.

Photo 22. Santa Gertrudis Creek looking upstream at General Kearny Road. This section of creek was not mowed because there was not much vegetation.
