CALIFORNIA REGIONAL WATER QUALITY CONTROL BOARD - SAN DIEGO REGION

FACILITY INSPECTION FORM

DATE: February 20, 2007 TIME: 09:50 AM WDID: 9 33C320657 FILE NO. 10-3020657

Roripaugh Ranch
FACILITY OR DEVELOPER NAME

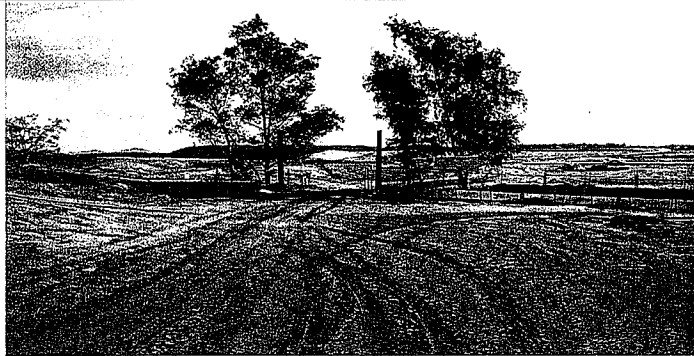
Photo 01: Site entrance at the Liefer Road junction.

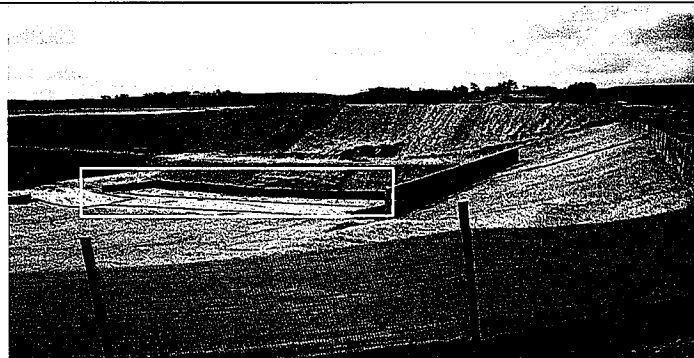
The natural waterway, Long Valley Wash, was cited in the November 2006 inspection for Construction Storm water and 401 Certification 01C-091 non-compliances (Violation No. R9-2006-0135, Construction Permit Findings # 6 and Certification Findings # 10, respectively). The violations noted the installed berms and dykes in Long Valley Wash would impede the natural flow of water in the natural waterway. The noted violations stated that the berms and dykes are to be removed and not use Long Valley Wash as a BMP. The berms and dykes continue to be there (see photo # 3). Long Valley Wash must be maintained in its natural state as much as possible.

Ashby USA, LLC continues to be in violation of the construction storm water permit for failure to implement and maintain best management practices pursuant to Water Quality Order No. 99-08, Section A.5.a.2(c). The previous Notice of Violation (R9-2006-135) requested the removal of the earthen-dyke which was constructed in the channel. Long Valley Wash has been disturbed from its natural condition.

Photo 03: Long Valley Wash bridge (right). Insert shows earthen berm/dyke constructed in natural water way which is a violation of the construction storm water permit. Natural water way is used as a BMP.

1. The immediate removal of the earthen dyke in the channel.
2. Stabilization of the soil in the area to maintain the natural drainage course.
3. The channel must not be used as a BMP.
4. Long Valley Wash must remain in its natural condition.

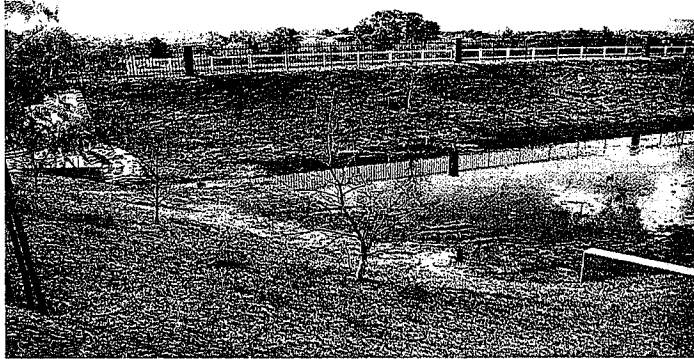
There was no observable discharge of storm water from the sediment basin located at the panhandle. Previous complaints from down gradient neighbors stated that concentrated storm water discharges from the basin deposited large quantities of sediment onto their properties and severely eroded the banks of the natural water causing it to encroach onto a neighbor's property. Inspection of one of the neighbor's property showed no deposition of sediment nor recent impacts to the natural waterway which abuts the property.

Photo 04: Runoff from recent rain event (not enough for offsite discharge) settles in basin at panhandle.

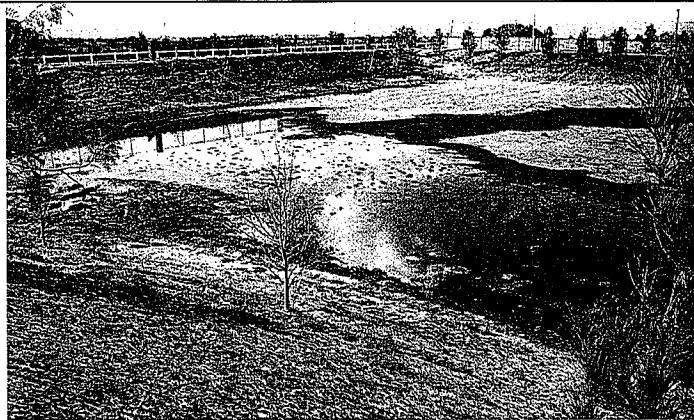
Photo 05: Looking northeast-extent of sediment basin with ponded water from runoff.
