CALIFORNIA REGIONAL WATER QUALITY CONTROL BOARD - SAN DIEGO REGION

FACILITY INSPECTION DATA ENTRY FORM

Sprinter Rail Proj
FACILITY OR DEVELOPER NAME (if different from owner)

FACILITY: NCTD Sprinter Rail (WDID) 9 37C322900 INSPECTION DATE: 02/20/07

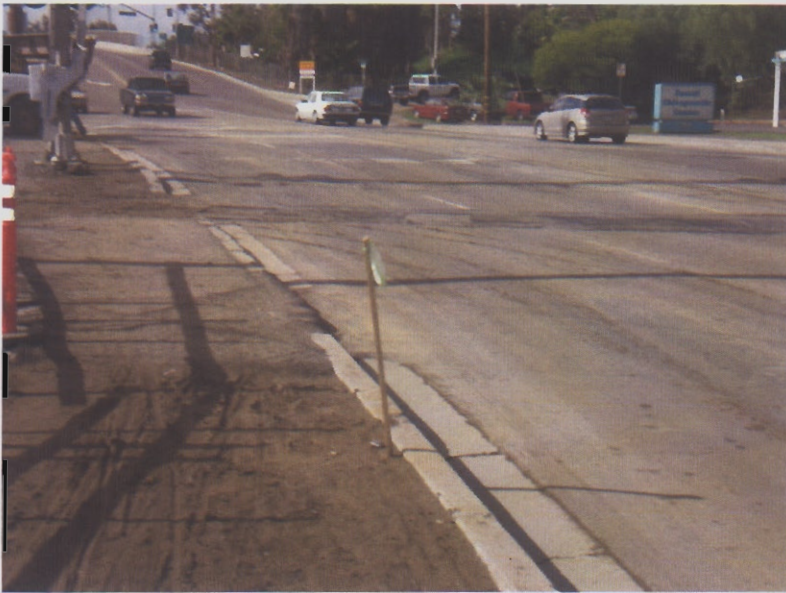
At approximately 10:30 am, We drove past the intersection of the Sprinter Rail construction and Escondido Avenue in Vista, CA. I immediately noticed excessive sediment tracking from the construction site onto Escondido Avenue, photo 001. A street sweeper was slowly sweeping Escondido Avenue. We parked at a local strip mall and proceeded to the construction trailers at the site. We talked with the electrical contractor who instructed us to check in at the general contractor's trailer in San Marcos. As we walked back to vehicle, we saw inadequate construction material and trash storage, Photos 002,003, and 004. A gas can was stored outside without cover or containment to prevent storm water pollution. Trash bins have lids but the lids were not being used. The trash inside was soaked and water was pooled in the bottom of the trash bin. Although the trash bins were mostly empty, a large pile of construction trash was next to a storage container.

001. Excessive sediment tracking onto Escondido Avenue.

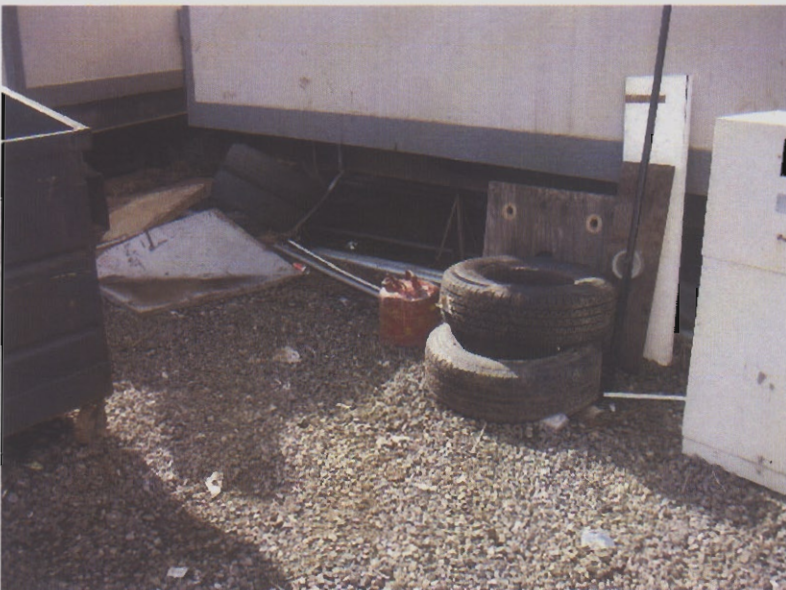
002. Inadequate material storage of a gasoline can.

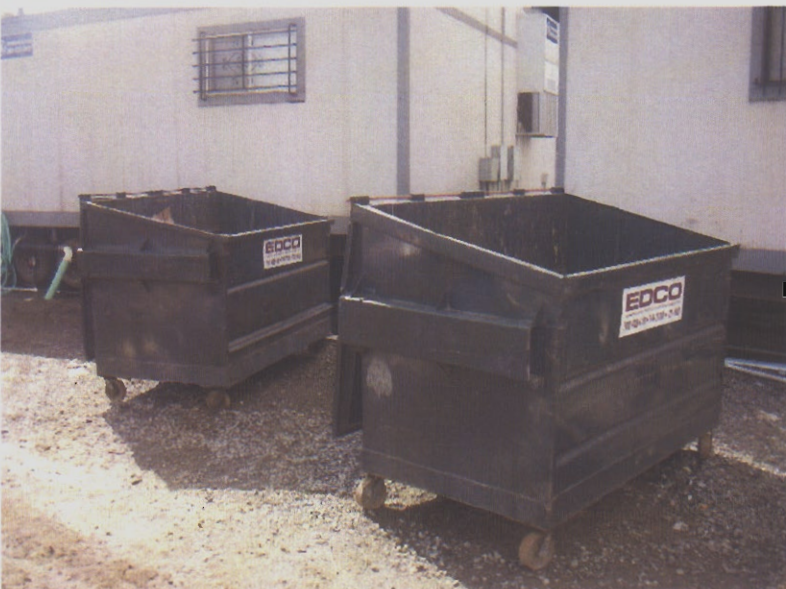
003. Although the trash cans do have lids they have not been used. Pooled water and soaked trash was observed inside the trash cans.

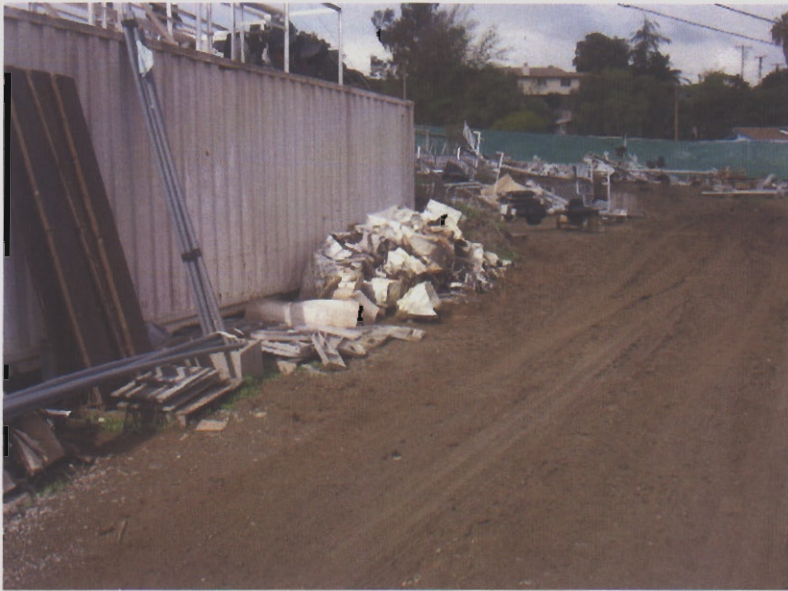
004. Although the trash containers were mostly empty in photo 003, trash is stored outside without cover or containment.

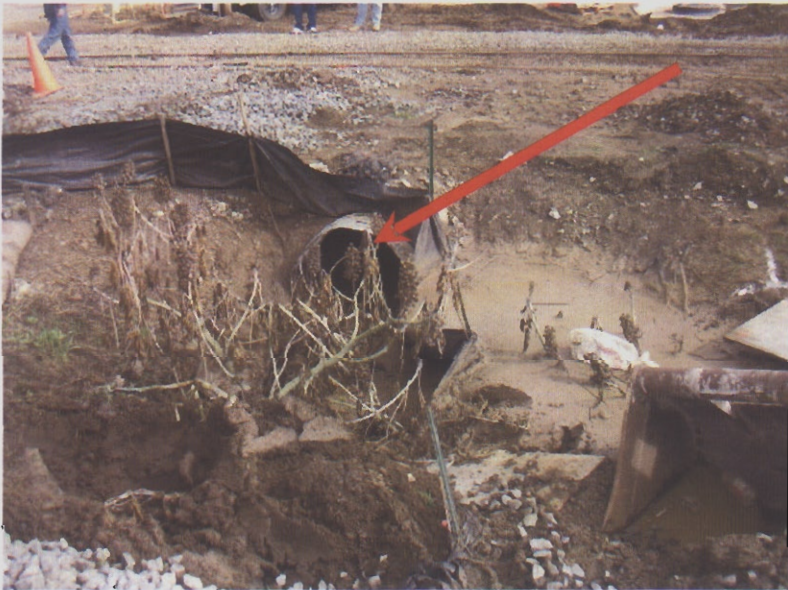
005. Storm drain inlet is without adequate protections. Silt fence is completely overwhelmed and failing resulting in a discharge of sediment into the storm drain inlet.

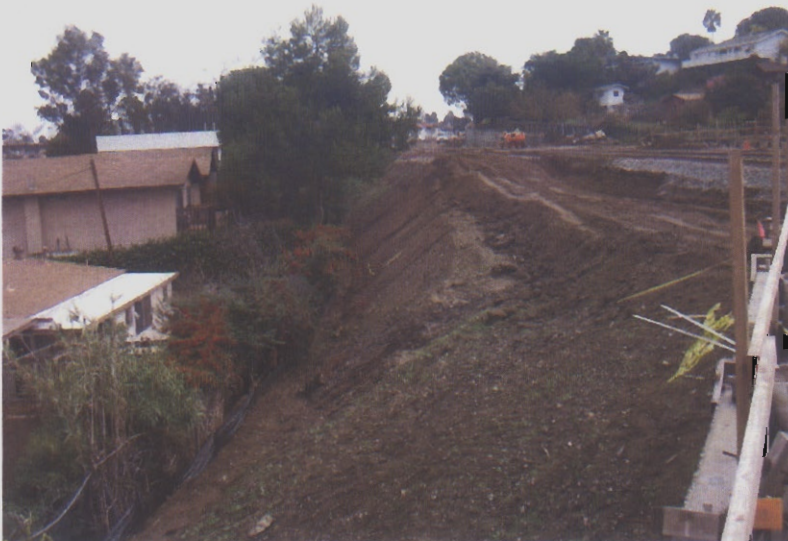
006. A large slope without erosion control measures.

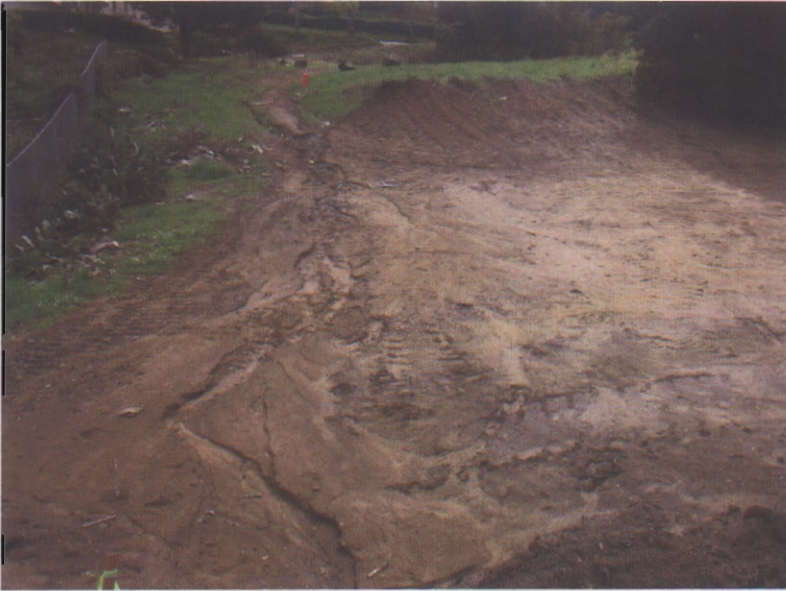
007. Erosion gully in a disturbed area without sediment or erosion controls.

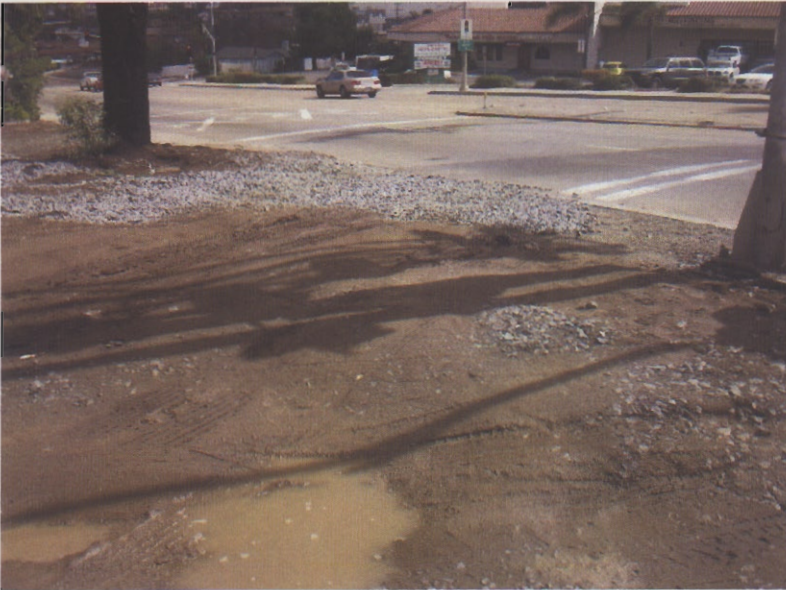
We then proceeded to the west side of Escondido Avenue. The construction exit has too little gravel to prevent sediment tracking onto Escondido Avenue, photo 010. Farther west, were two large concrete wash water spills on the ground, photos 011 and 012. A plastic lined concrete washout pit is available on the east side of Escondido Avenue but was not used in these instances. The construction area was littered with construction related trash throughout the site, photo 013. Trash containers were not readily available. The only trash containers seen were those in photo 003 near the trailers. Slopes along the sides of the railroad tracks did not have any erosion control BMPs such as mulch, hydroseed, or blankets, photos 014, 015, and 018. A storm drain outfall did not have any rock energy dissipater to prevent erosion, photo 016. Steve Hoyle and Keith Kranda departed the inspection at this time. For the remainder of the inspection, we were accompanied by Bill O'Sullivan, West Coast Rail Constructors; and Ken McGrath, NCTD.

010. Inadequate gravel to prevent sediment tracking onto the adjacent Escondido Avenue.

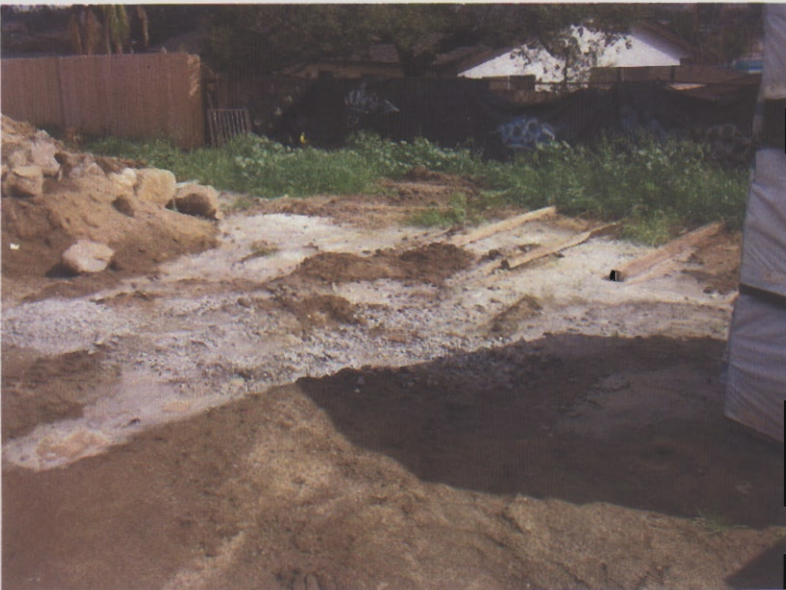
011. A concrete slurry spill on the ground. A washout was available across the street.

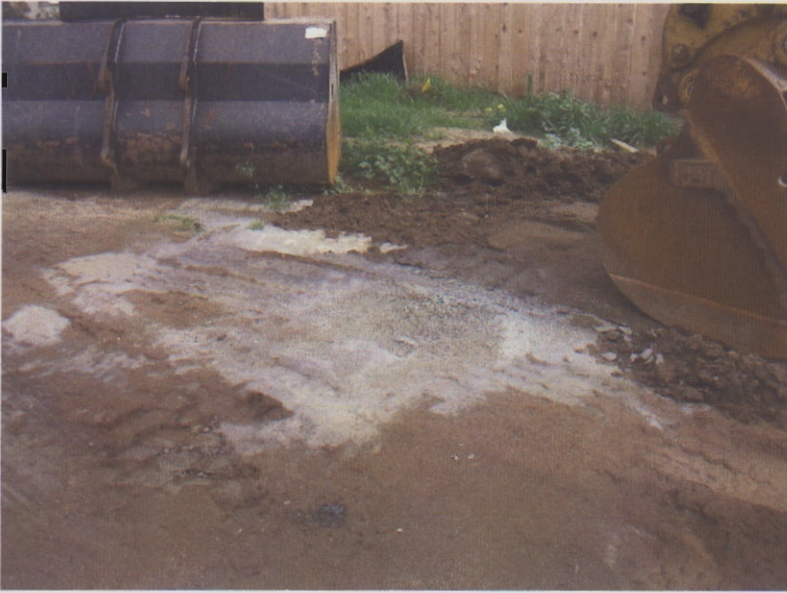
012. Another concrete slurry spill not far from the one in photo 011.

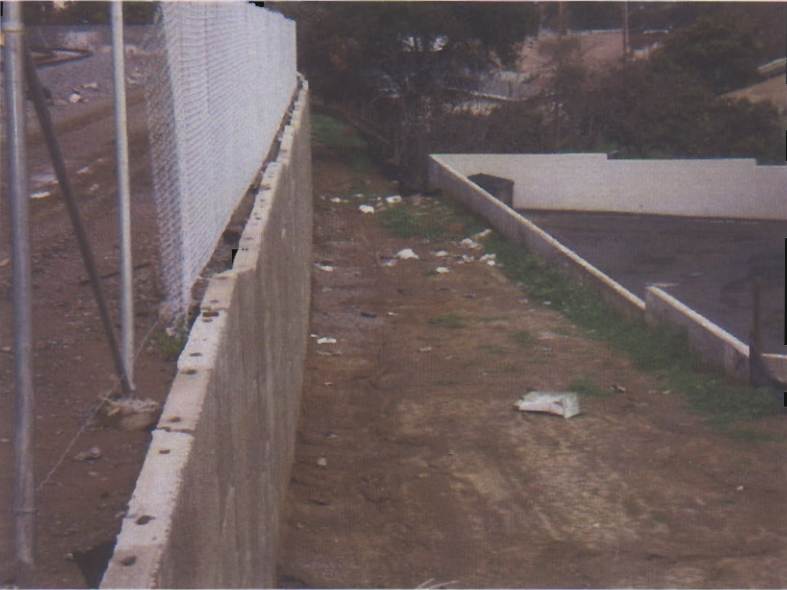
013. Excessive trash on the construction site.

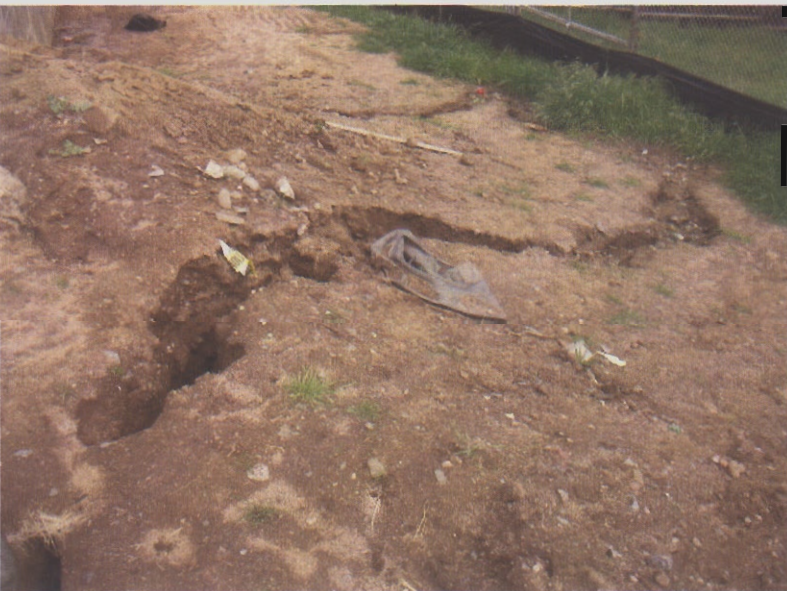
014. Erosion gully down a slope with no erosion controls.

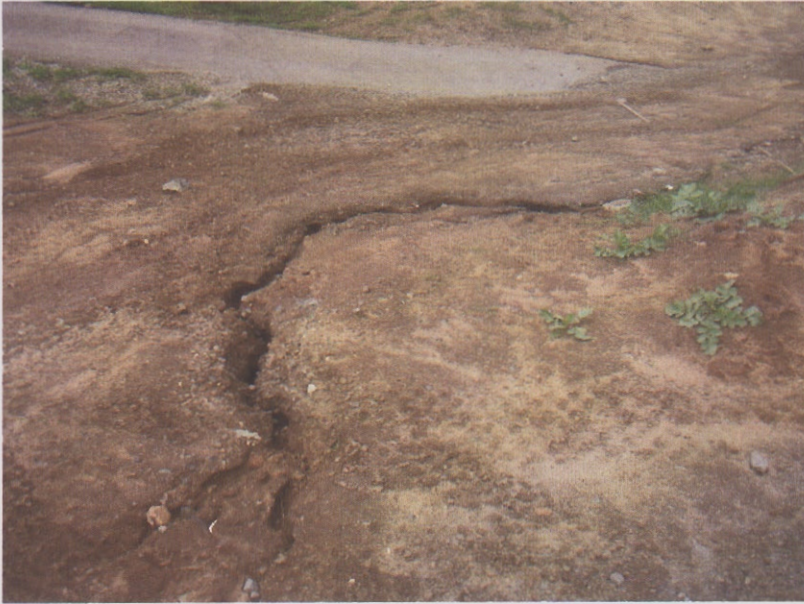
015. Another erosion gully in an area without erosion controls.

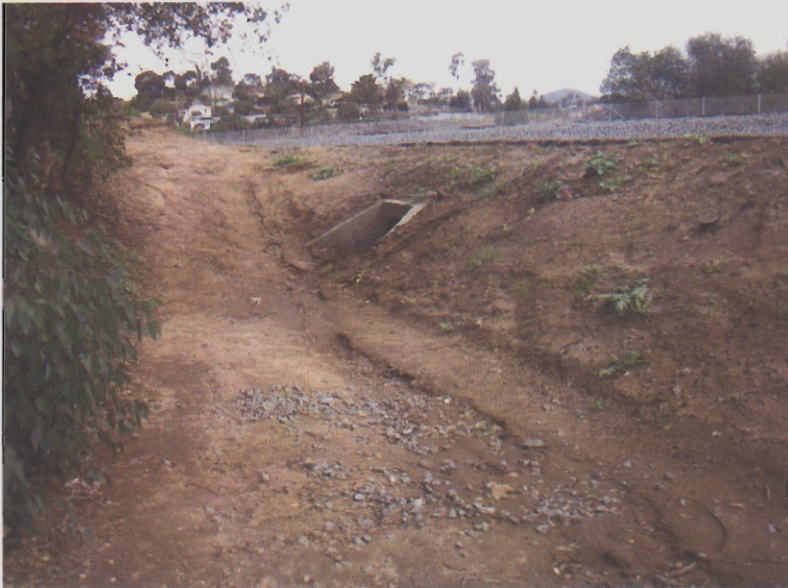
016. Storm drain discharge point with no energy dissipation.

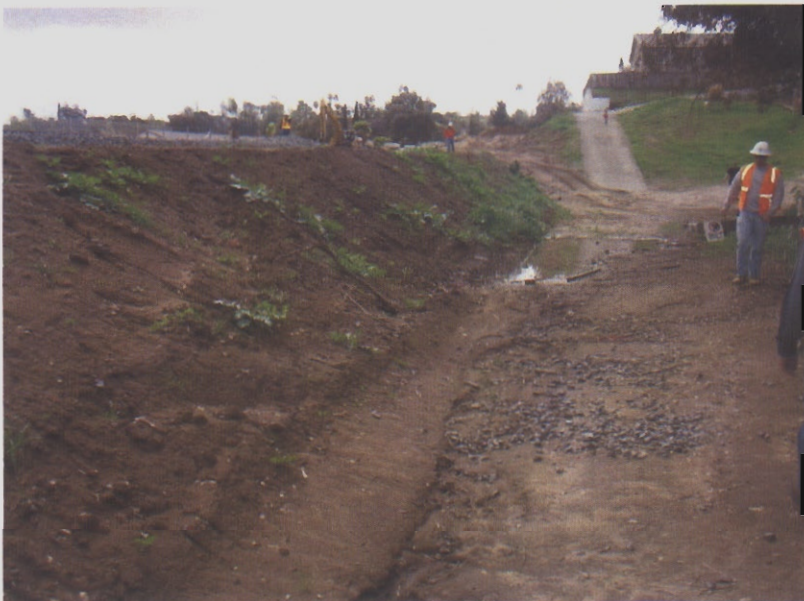
018. A long slope with no erosion or sediment controls.

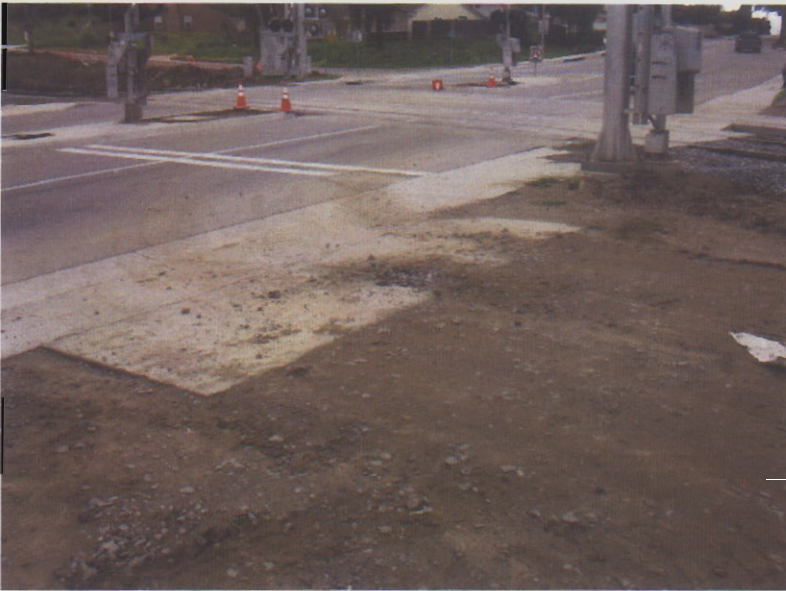
019. Sediment tracking onto the adjacent paved surface due to a total lack of BMPs.

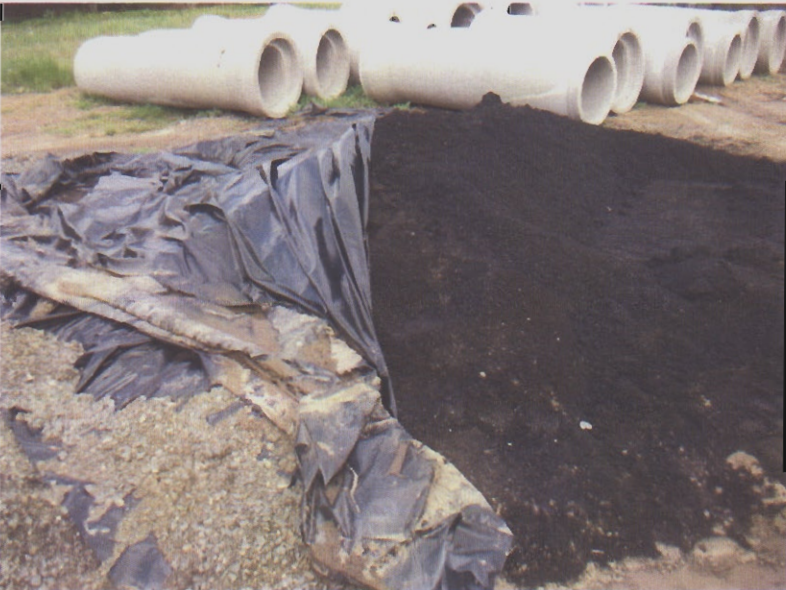
021. Although this asphalt stockpile does have plastic to cover it in case of rain, site personnel did not cover the stockpile. Puddles of water are seen on top of the folded up plastic.

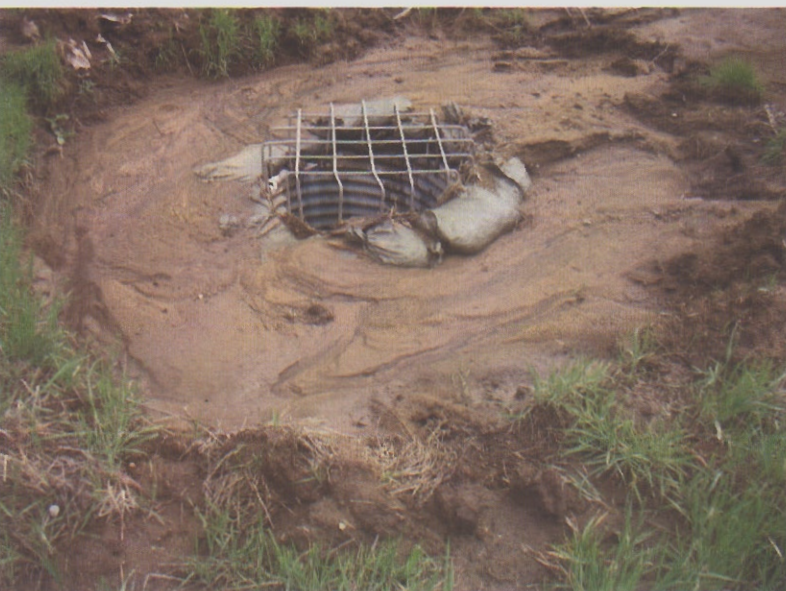
Following the inspection of construction at Escondido Avenue, we drove to the construction storage yard at Mar Vista Drive in Vista. We parked the car just to the south of the railroad tracks and walked across them to the storage yard. The entrance/exit does not have any BMPs (Large gravel rock, shaker plates) to prevent sediment tracking onto Mar Vista Drive, photo 019. Significant tracking was observed onto the paved street. A storage stockpile of asphalt was uncovered, photo 021. A black plastic tarp was folded back and was intended to cover the stockpile. Puddles of water were pooled on top of the folded back, black, plastic tarp. At the northeast corner of the storage yard is a large storm drain collecting runoff from the entire yard. The inlet had inadequate gravel bag BMPs. Sediment had collected around the inlet and overtopped the gravel bags entering the storm drain, photo

022. Sediment discharge at a storm drain inlet that is completely overwhelmed from sediment flows. This inlet received runoff from the material storage yard that has soil stabilization and sediment controls.

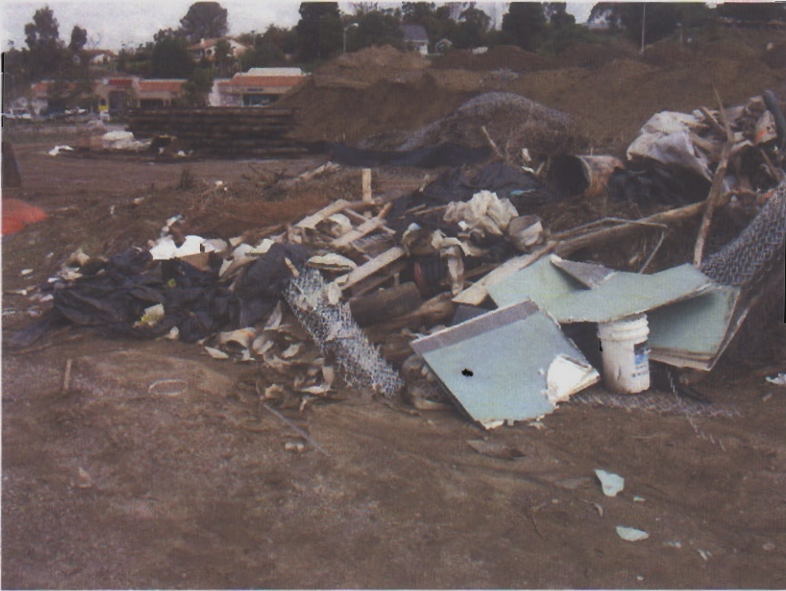
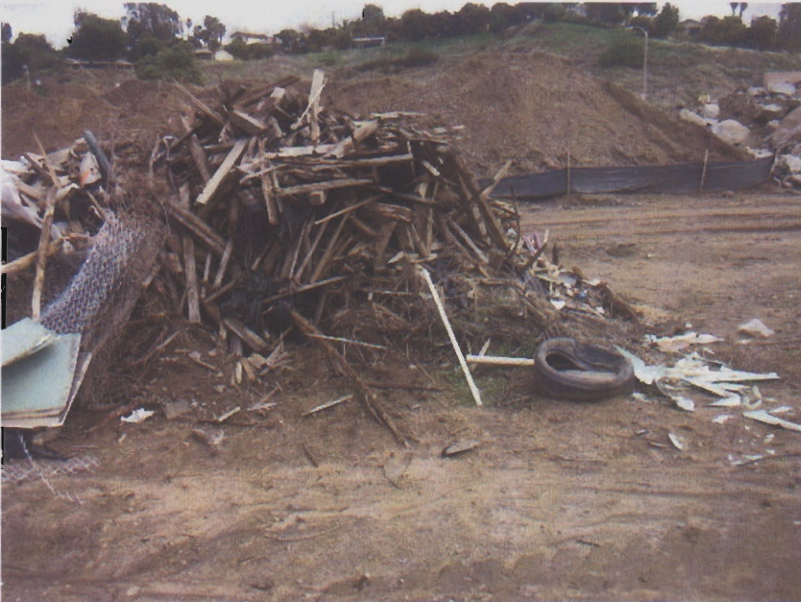
022. The construction yard had very little sediment controls throughout the yard to prevent the sediment transport. A large pile of construction trash was stored in the yard with no BMPs to cover or contain the trash, photos 023 and 024. The slope from the railroad tracks to the construction yard did not have any erosion control BMPs, photo 025. A silt fence below the slope was not maintained and failing under the sediment load.

023. Construction trash storage is inadequate with no containment or coverage.

024. Construction trash storage is inadequate with no containment or coverage.

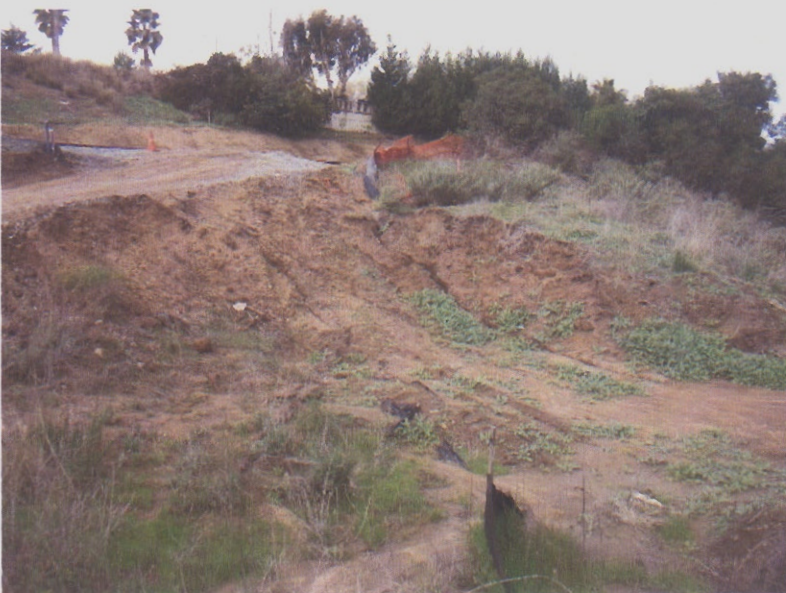
025. A slope is without adequate erosion or sediment controls is eroding away. Silt fencing is inadequate, not maintained and overwhelmed.

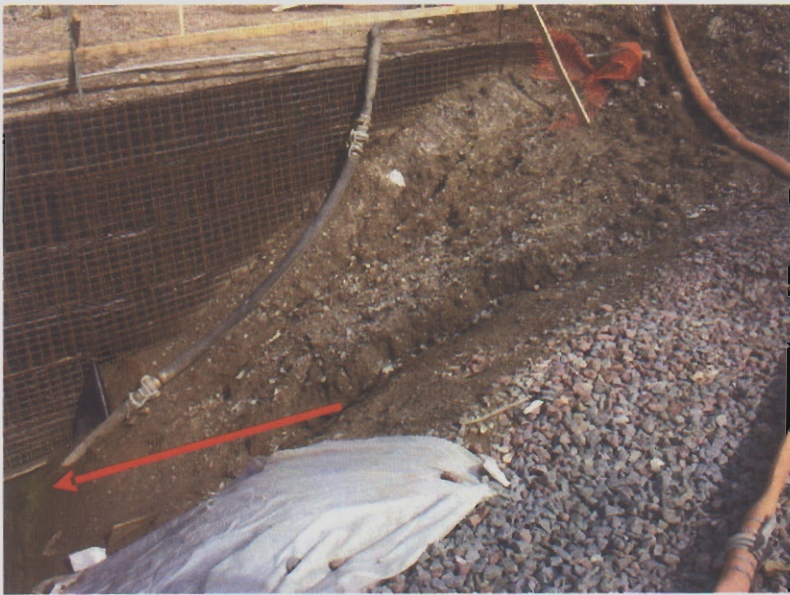
The next stop on the railroad inspection was the bridge crossing Buena Creek. In addition to the bridge construction, a construction storage yard is next to the creek. The bridge construction lacked erosion controls on either side of the bridge abutments, photo 026. The bare dirt had erosion gullies leading to the creek. The site is currently dewatering for the bridge construction, photo 027. The construction yard had a large pile of construction trash with inadequate cover or containment, photo 028. The construction yard's exit was inadequate to prevent sediment tracking onto the adjacent Buena Creek Road, photo 029.

026. Bare dirt next to the bridge abutments is eroding away and discharging into Buena Creek. The arrow points to the edge of the creek.

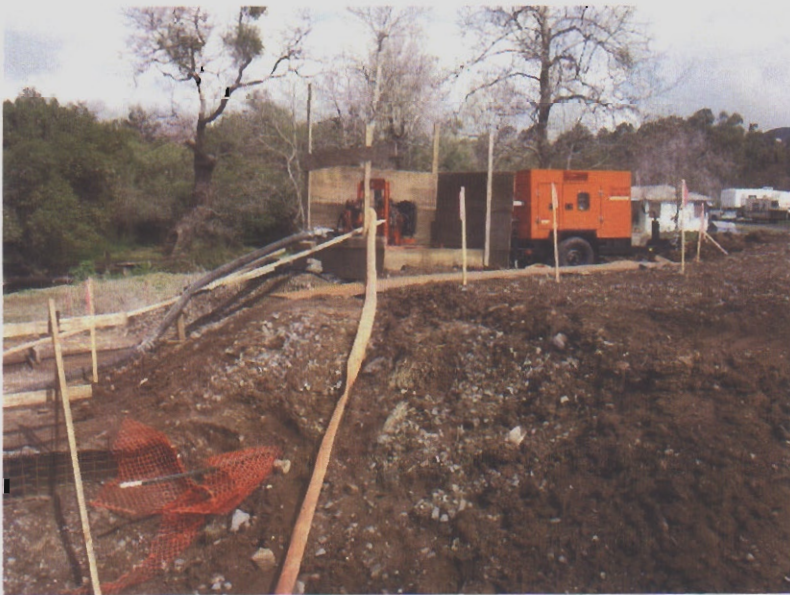
027. Groundwater dewatering for bridge work.

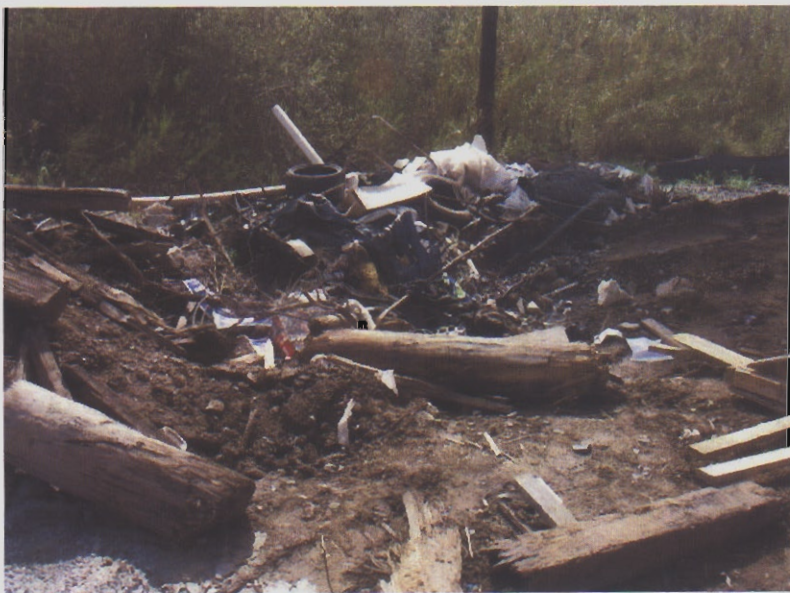
028. Inadequate trash containment without cover or containment.

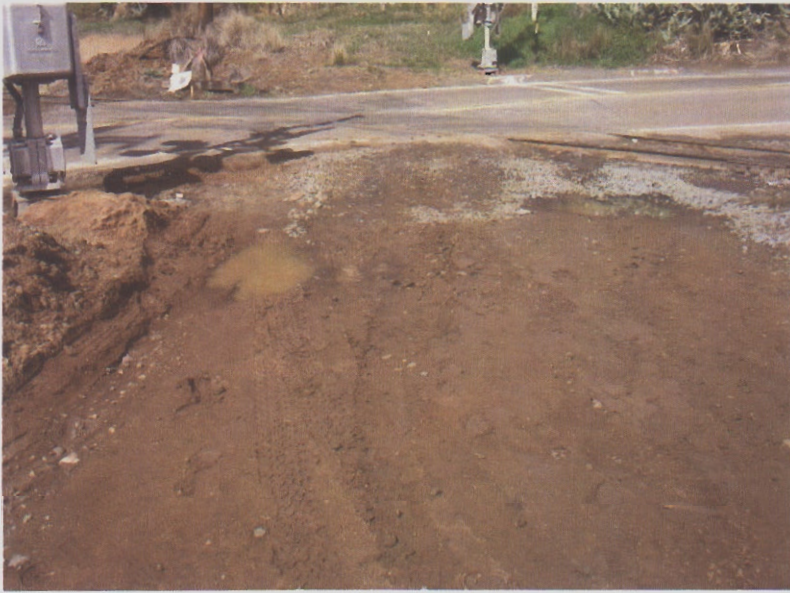
029. Inadequate gravel to prevent sediment tracking onto the adjacent street.

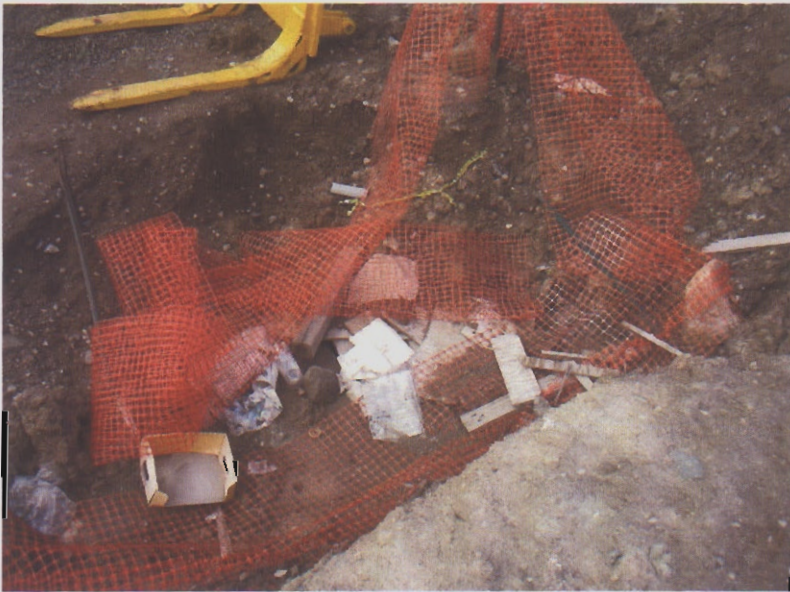
We continued east and briefly stopped at the main construction yard and offices, located south of Palomar College in San Marcos, between Mission Road and Armorlite Drive. The construction yard was fairly trash free except for a storm drain inlet, photo 030. The inlet did not have any BMPs. Rather, the inlet was blocked off by a wooden pallet with large gaps between the slats. Sediment had collected on top of the slats, and entered the storm drain between the slats.

030. Sediment discharge at a storm drain inlet without adequate inlet protection provided by a wooden slats with large gaps. The wooden slats appear to have held back the trash.

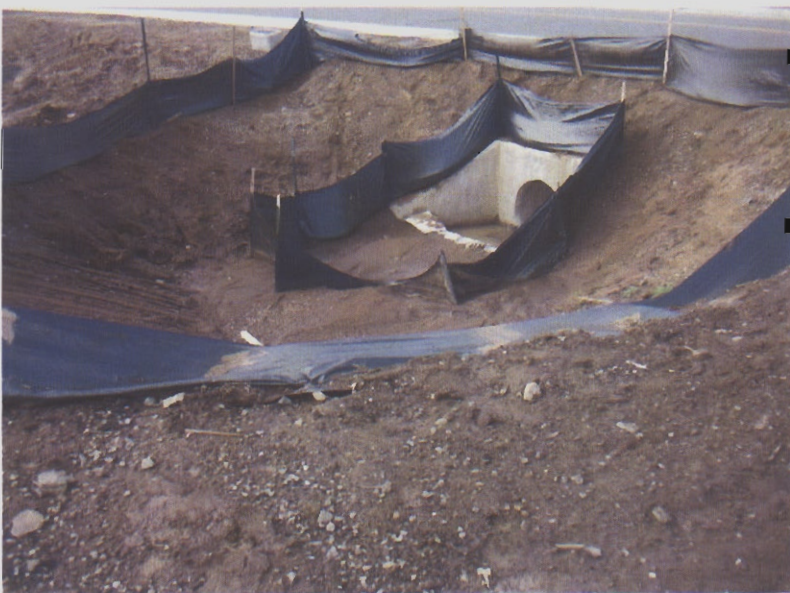
031. Sediment discharge at a storm drain inlet with inadequate inlet protections. A lack of source controls resulted in sediment flows that overwhelmed the silt fencing.

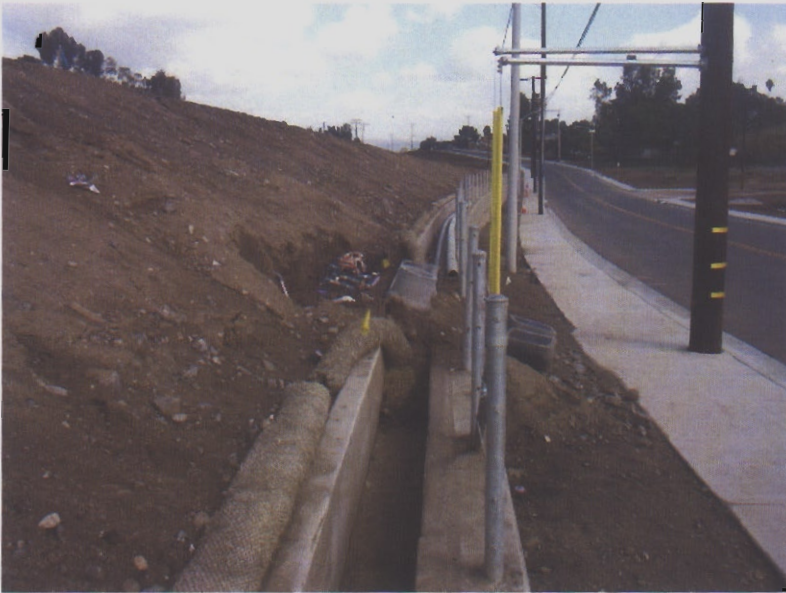
032. A large slope is without any erosion control protections. Dirt is stockpiled in the storm drain ditch.

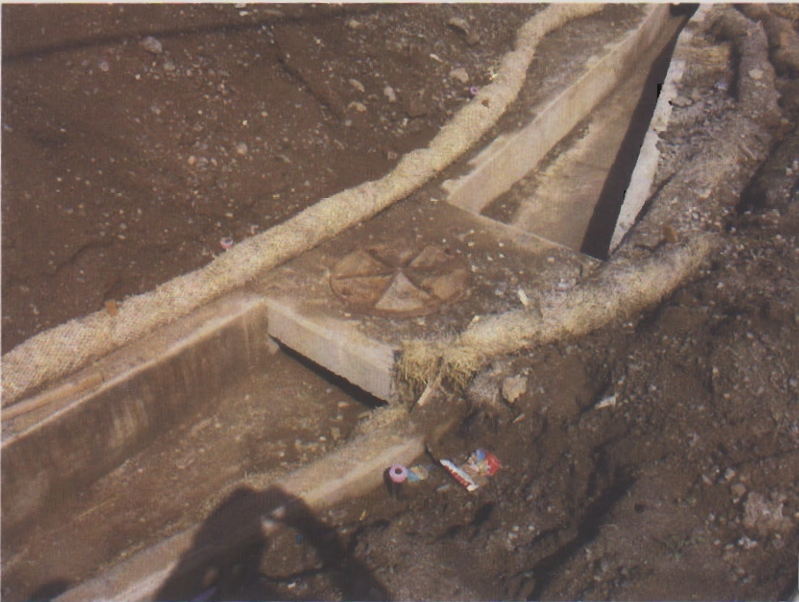
033. Sediment discharge into a storm drain inlet without any inlet protections. Fiber rolls are deteriorated and not placed properly. Slope is without erosion controls.

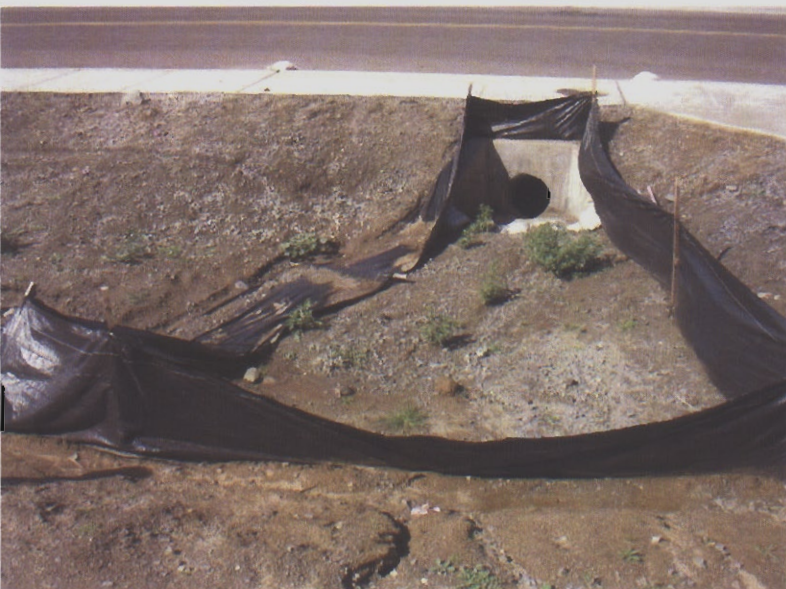
034. Sediment discharge at a storm drain inlet without adequate protections. Silt fence has been overwhelmed due to a lack of upstream source control measures.

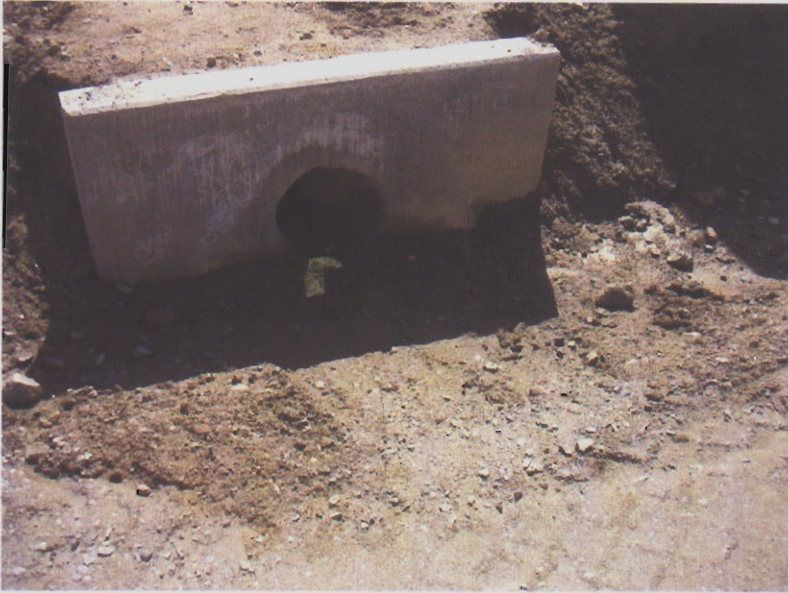
035. Sediment discharge at a storm drain inlet without any inlet protections.

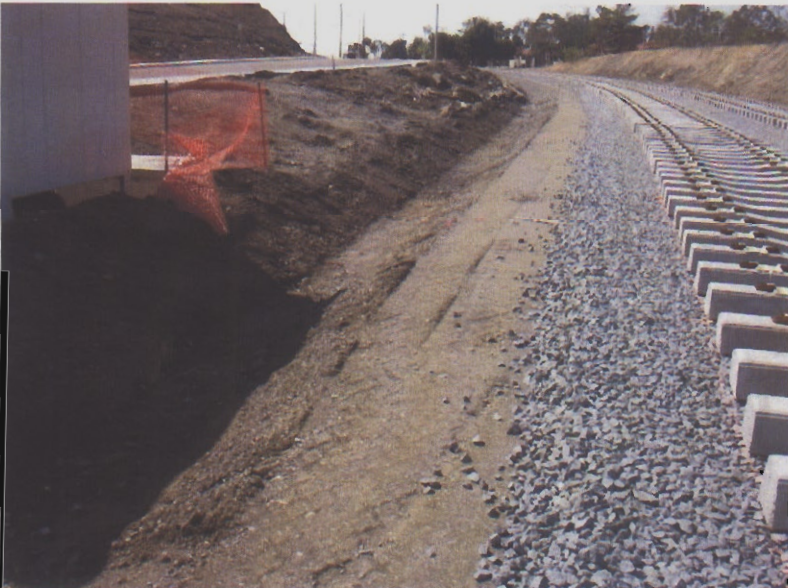
036. Upstream of photo 035 there is a lack of sediment or erosion control BMPs.

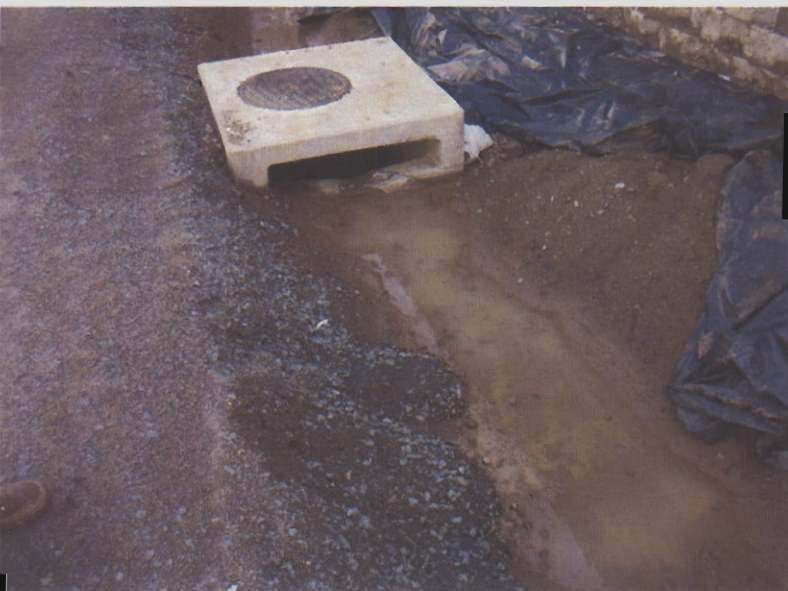
037. Sediment and sediment laden water discharge at an unprotected storm drain inlet.

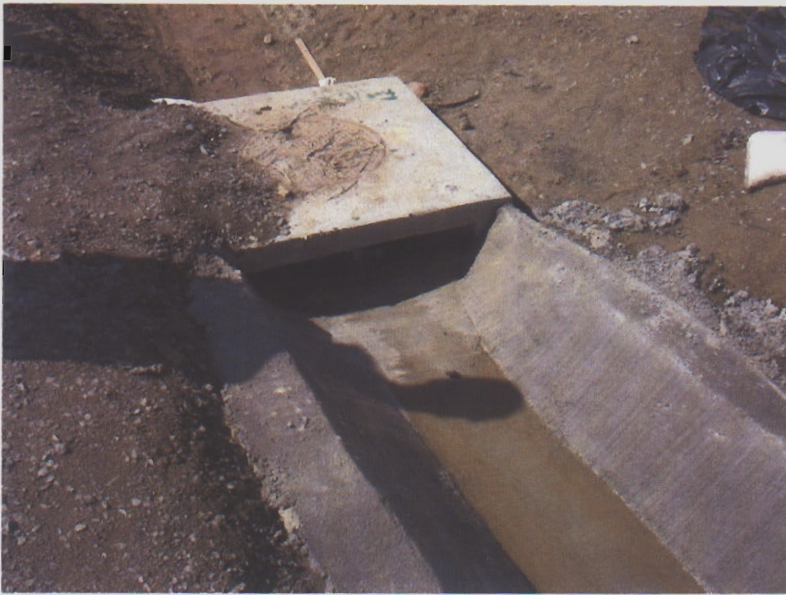
038. Sediment and sediment laden water discharge into a storm drain inlet without any inlet protection. This inlet is across the rail road tracks from the inlet in photo 037.

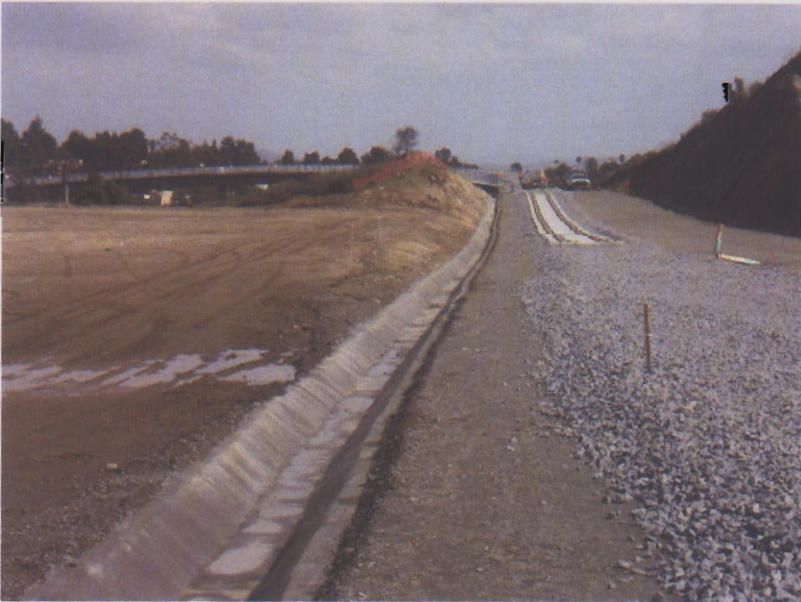
039. Storm drain channel without any perimeter sediment controls.

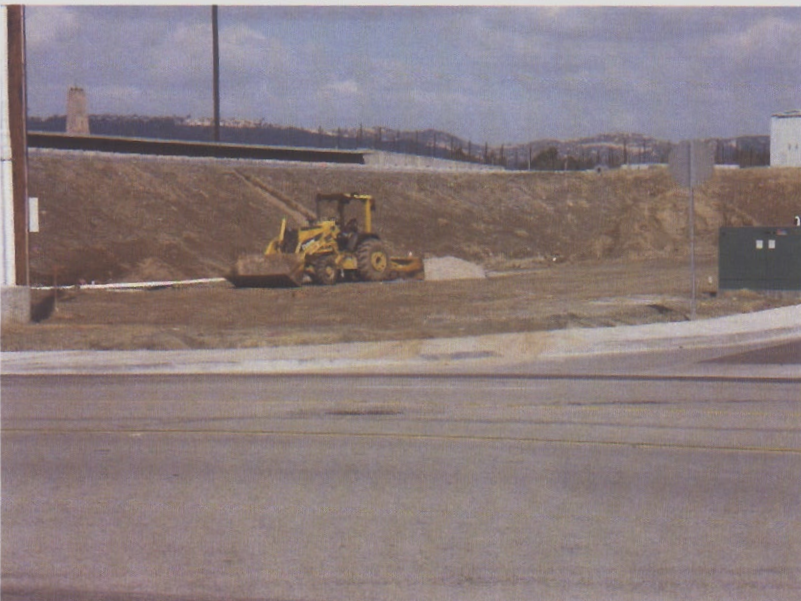
040. Sediment tracking onto the pavement. Slope behind the front loader is without erosion or sediment controls. No sediment controls behind the curb.
