CALIFORNIA REGIONAL WATER QUALITY CONTROL BOARD - SAN DIEGO REGION
WATERSHED MANAGEMENT PROGRAM

FACILITY INSPECTION REPORT

INSPECTION DATE: March 21, 2007 TIME: 10 am WDID: 9 37C322900

Sprinter Rail Proj
FACILITY OR DEVELOPER NAME (if different from owner)

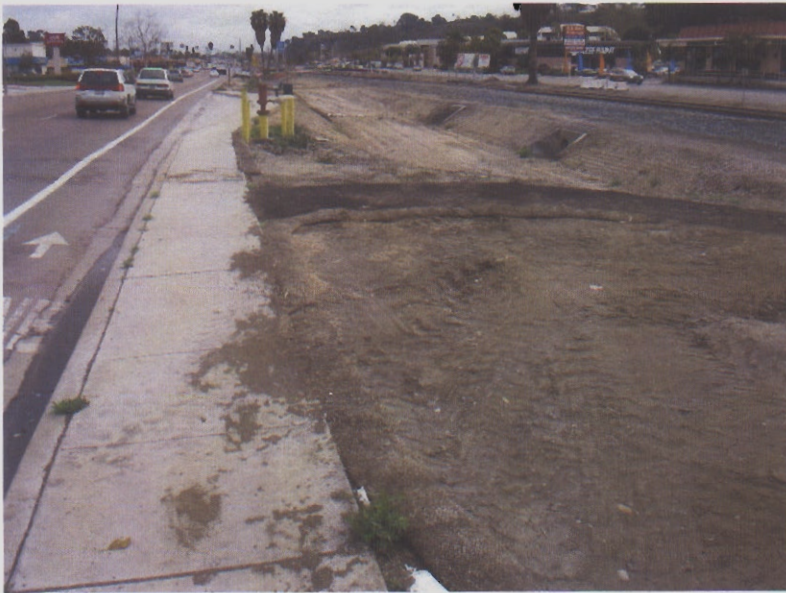
The inspection started along South Oceanside Boulevard, just east of Interstate 5. Rail track construction appeared to be complete with some final landscaping and finish grading still needed along the sides of the track. A few silt fences and fiber rolls were implemented along the perimeter. Fiber rolls were flattened and ineffective after repeatedly being run over by vehicle traffic (Photo 1). Other disturbed areas were without any sediment control BMPs such as fiber rolls or silt fencing (Photo 2). One storm drain inlet did not have adequate inlet protection (Photo 3). Gravel bags were broken and inadequate to prevent sediment from entering the inlet. A temporary construction access road was built over the corner of the storm drain inlet.

1. Fiber rolls are rendered ineffective due to frequent vehicle traffic over them.

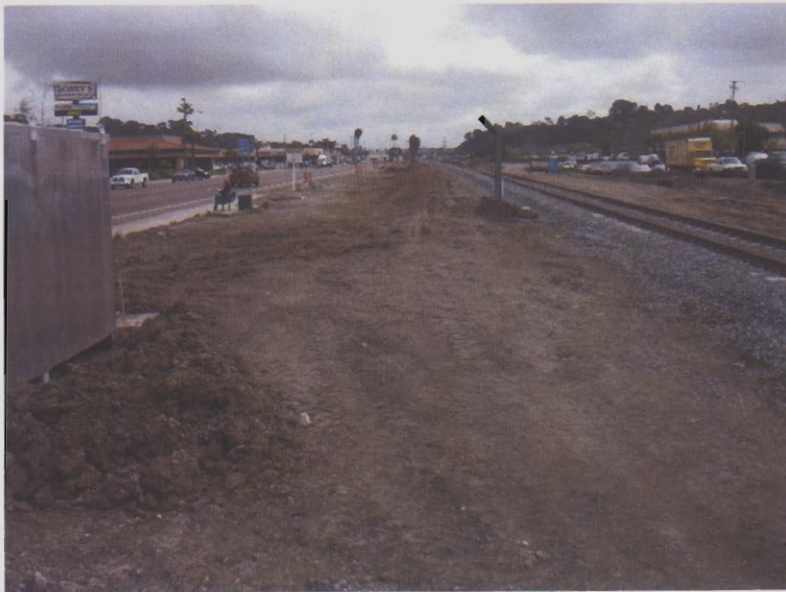
2. A large area of disturbed dirt with no sediment controls.

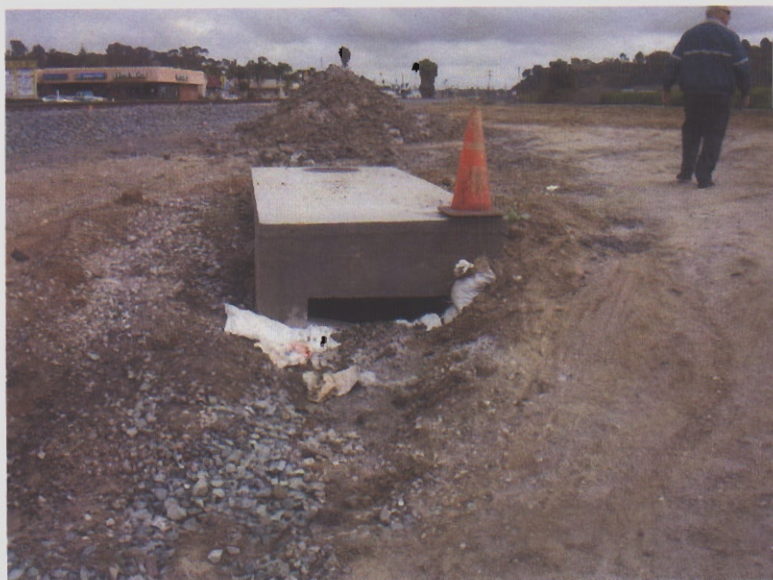
3. A storm drain inlet with inadequate sediment control protections.

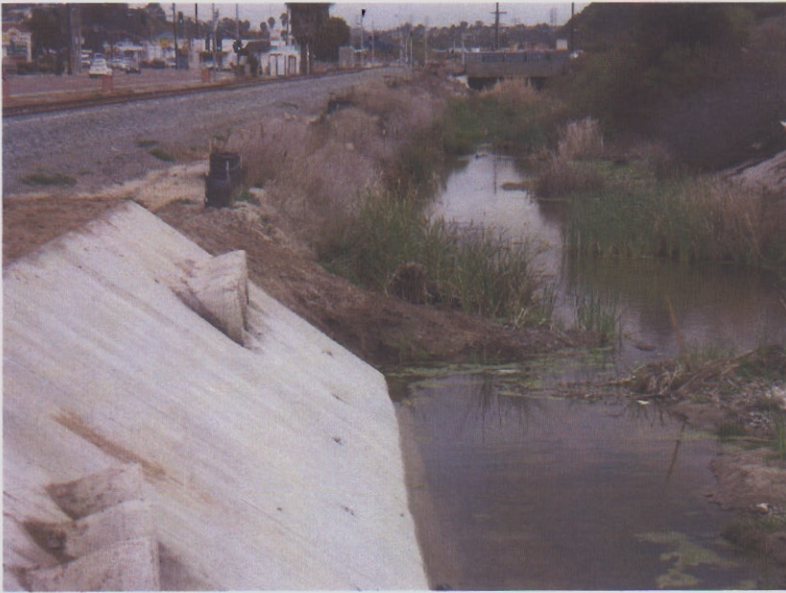
Farther east, the railroad tracks begin to parallel Loma Alta Creek. At the point where the concrete lined channel ends, a large pile of sediment had been pushed into the creek (Photo 4). Silt fencing at the top of the creek bank ends where the sediment was pushed into the creek (Photo 5). Downstream of the sediment, gravel bags were in the creek bottom (Photo 6).

4. Sediment discharge to Loma Alta Creek.

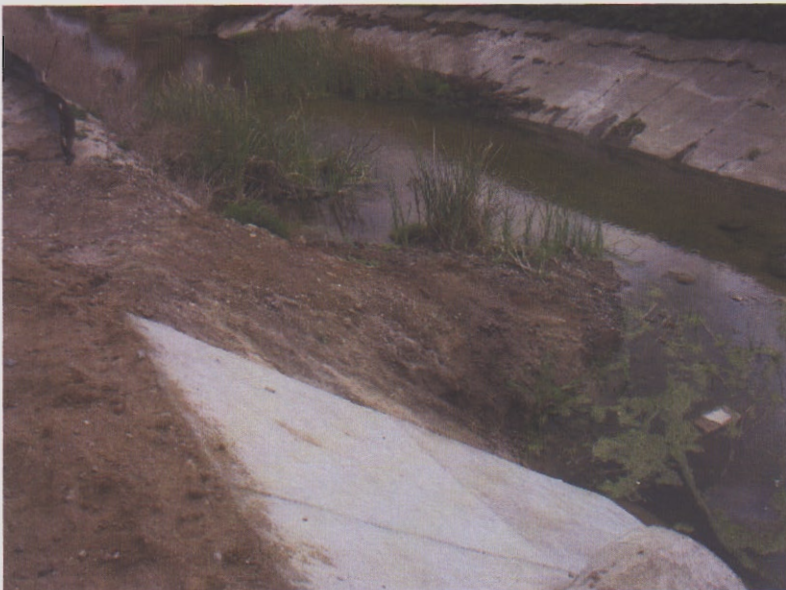
5. A closer look at the sediment discharge. Silt fence at the top of the bank stops right at the sediment discharge.

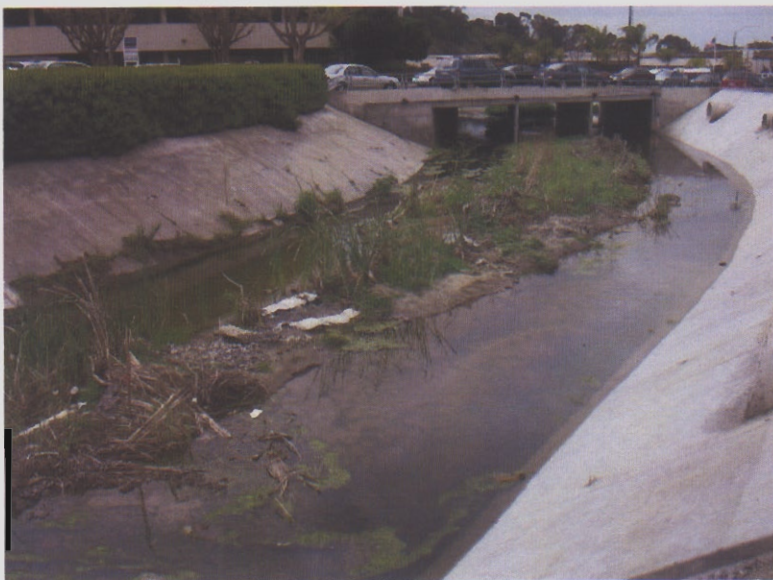
6. Looking downstream from the sediment discharge, gravel bags are in the creek.

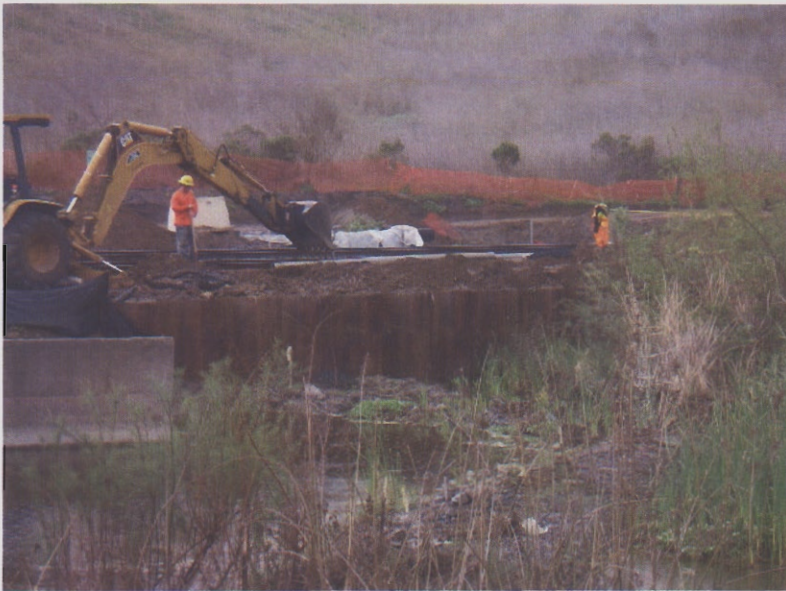
The next stop on the inspection was the intersection of the sprinter rail line and El Camino Real. This construction work is directly adjacent to Loma Alta Creek. No sediment controls such as silt fencing were next to the creek where an excavator was working (Photo 7). Sediment had fallen over the retaining wall into the creek from the excavator's work. A soil stockpile at the construction site had no BMPs to contain runoff or cover to minimize contact with storm water. A large pile of construction waste also had no cover or containment (Photo 8).

7. Construction work next to Loma Alta Creek causes sediment to spill into the creek. No sediment controls are at the top of the wall.

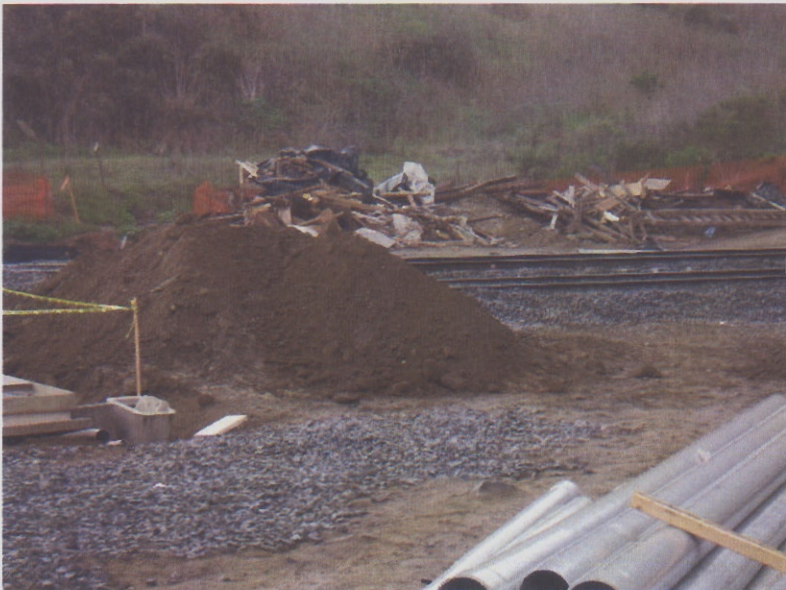
8. Soil stockpile has no cover or perimeter protection. Construction waste in the background has no cover or containment to minimize exposure to storm water.

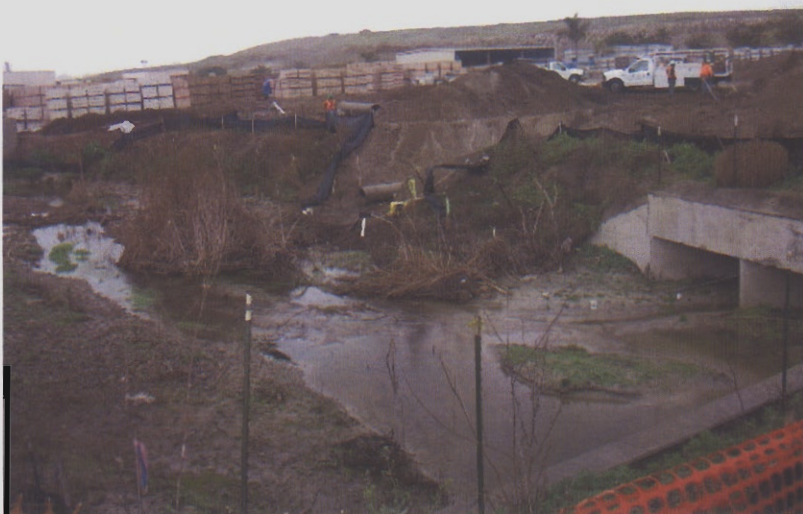
The last area inspected was the construction at the Rancho del Oro crossing. This construction area is directly adjacent to Loma Alta Creek. Pipe construction had cut the north bank of the creek. Silt fence around the cut bank was pulled back and not protecting the receiving waters from any potential runoff from the construction site (Photo 9). A large area of soil stockpiles had no cover or containment to minimize contact with storm water runoff (Photo 10). The construction exit onto Oceanside Blvd. was inadequate to prevent sediment tracking (Photos 11 and 12). Construction site personnel purposefully avoided driving over the rock and instead drove over the soil thereby tracking sediment onto the paved street.

9. Construction work near the creek with inadequate sediment controls. Silt fence was removed around the pipe construction.

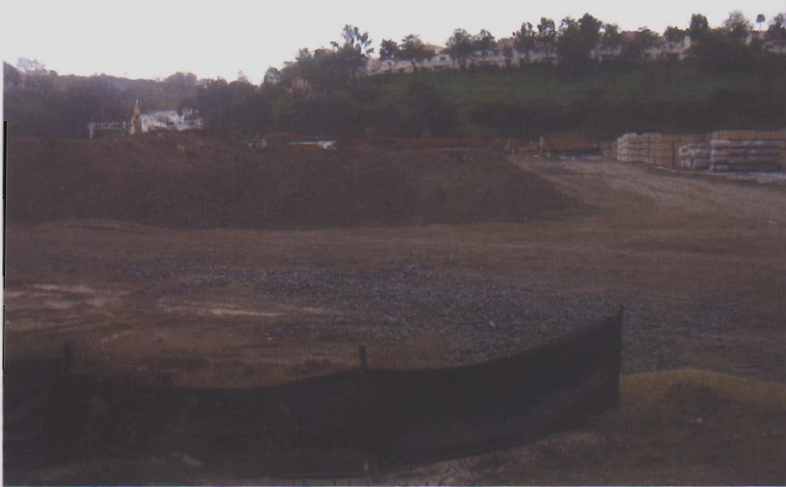
10. Soil stockpiles with no cover or containment.

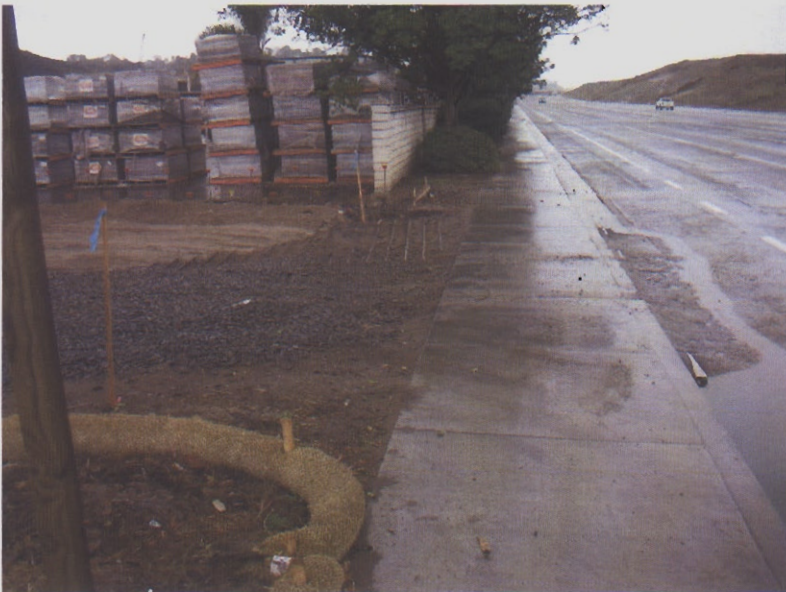
11. Construction exit with inadequate gravel to prevent sediment tracking.

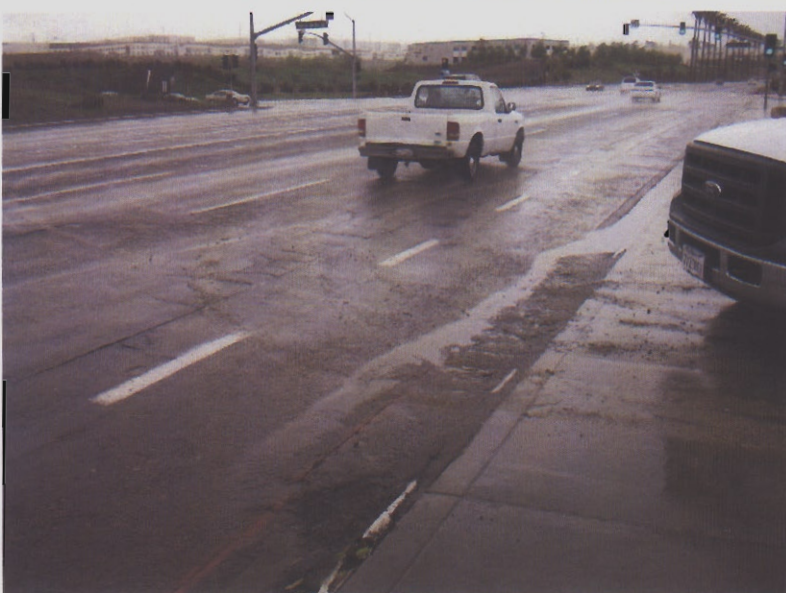
12. Sediment tracking onto Oceanside Blvd.
