**CALIFORNIA REGIONAL WATER QUALITY CONTROL BOARD
SAN DIEGO REGION**

STAFF REPORT

**Proposed Administrative Civil Liability
Contained in Complaint No. R9-2009-0040
City of Laguna Beach
Sewage Collection System**

August 18, 2009

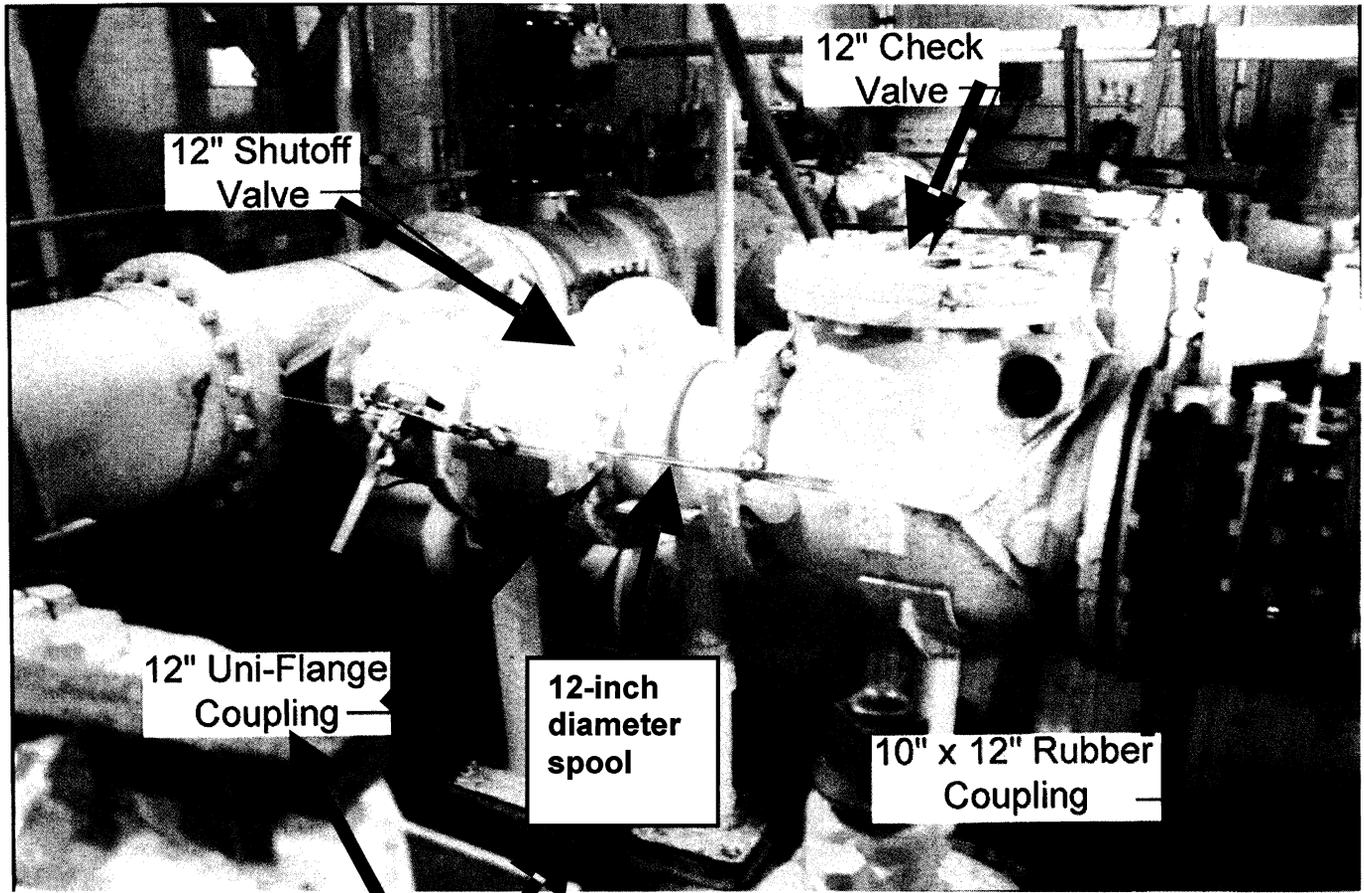
Figure 1: Dry Well – typical layout of the discharge side of each pump

NOTE 2: On October 29, 2008, the SSO flowed out of a crack between the coupling and spool.

10" x 12" Rubber Coupling
NOTE 1: October 28, 2008, this coupling was not yet installed for Pump No. 1, creating a gap here, between the new Pump No. 1 and the check valve on the discharge side of Pump No. 1.

As a result, the sewage seeped through the shutoff gate valve and pushed on the check valve. This caused lateral movement of the check valve and spool, away from the improperly installed Uni-Flange and the shutoff gate valve. The sewage spilled out of the crack between the spool and the Uni-Flange. (See Figure 1 above)

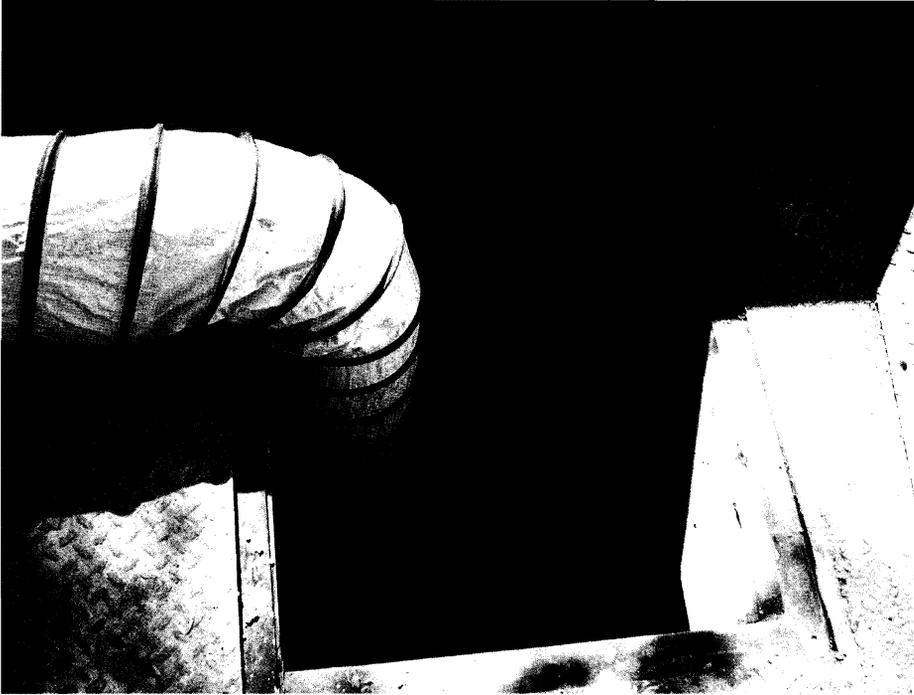
- The sewage spill was a result of a discharge from the manifold that separated in the dry well at Birdbird Lift Station (figure 1), possibly due to a water hammer. The sewage spill flooded the dry well and caused all the pumps to stop.

Figure 1 - view of dry well from outside

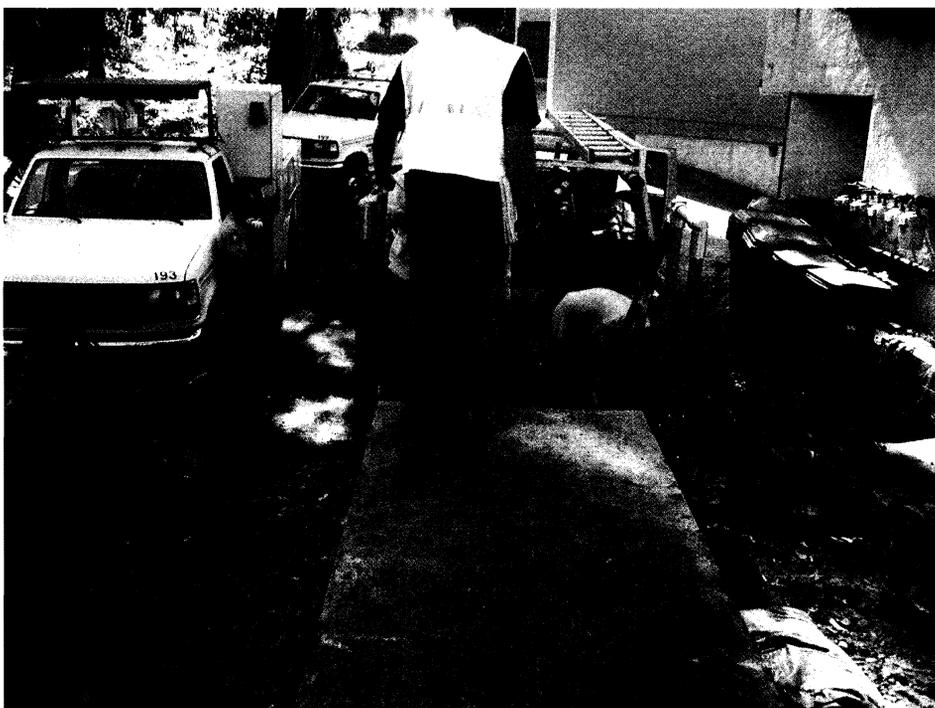
Figure 4 - Lift station and dry well is to the right. The sewage flowed down the landscape, into the storm drain in this alleyway.

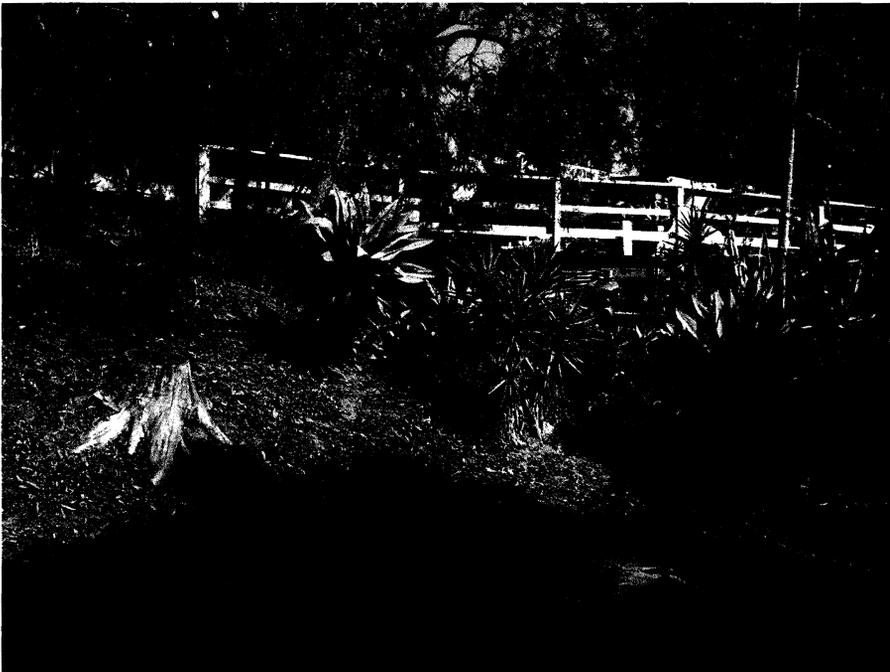
Figure 8 - The sewage from the wet well was pumped to this storm drain, upstream from the alleyway/ storm drain shown in figure 4.

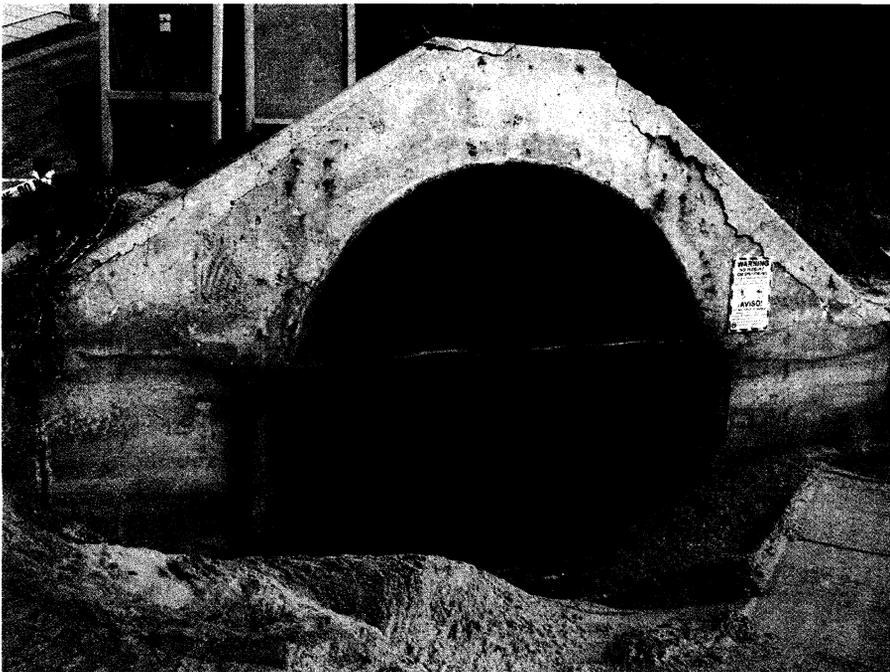
Figure 10 - The outlet to the storm drain is partially blocked by wood.

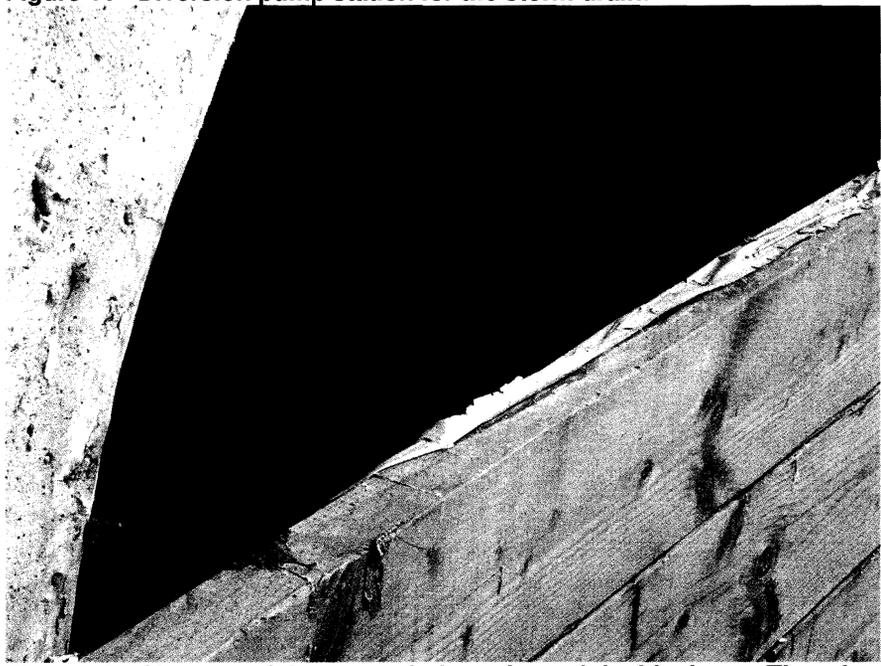
- During the inspection, some sewage was still standing in the storm drain and leaking a little from the bottom of the blockage (figure 12 and 13).
- The beach was closed from Crescent Bay to Carmel Point, which includes the Area of Special Biological Concern. Water samples are being taken.

Figure 12 - Close up of the storm drain outlet and the blockage. There is still some water inside.

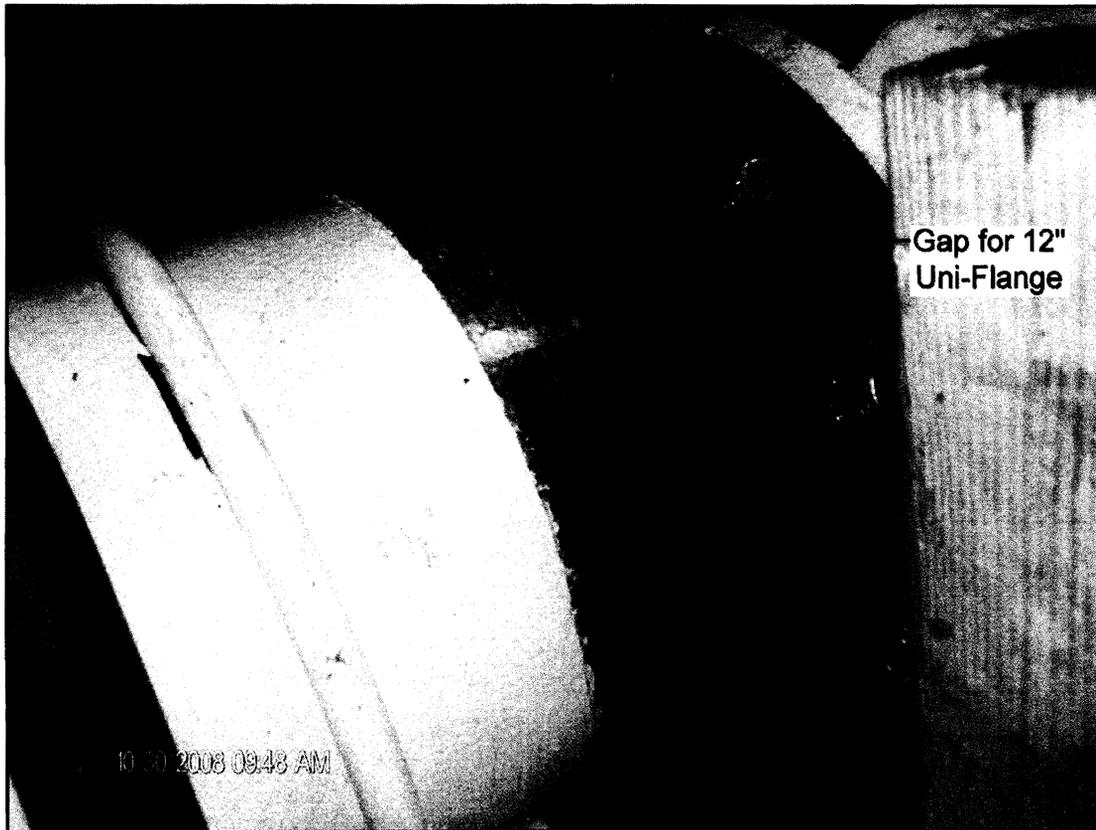
The Uni-Flange coupling for Pump #1 had been removed by City Staff prior to Dudek arriving onsite on October 30. This coupling had been removed because it interfered with installing the blind flange on the upstream side of the shutoff valve. We noted that only two significant “scratches” on the outside of the ductile iron pipe spool that had been stabbed into this Uni-Flange Coupling, and those scratches were not as deep as we would have expected if the set screws had been properly installed. City Staff informed us that they had not changed how the set screws were installed; they had simply placed the already dislodged coupling, on the floor. We noted that most of the set screws (10 of 12 set screws) had not been screwed down sufficiently to even touch the outside of the pipe that they were intended to restrain. The remaining two set screws had very limited extension past the coupling collar. The set screws had been previously painted, and because that paint was not broken, we concluded the set screws had not been adjusted (tightened or loosened) by City Staff or by the Contractor.

Photos #12 through #15 show the “failed” Uni-Flange coupling after it was taken off the end of the pipe spool for Pump #1. This removal occurred after the Dry Well had flooded, as part of the City’s efforts to stop inflow through the dis-lodged spool where it fit into the Uni-Flange coupling. We understand none of the set screws were adjusted to allow the coupling to be removed. The coupling was simply slid off the end of the pipe spool by City Staff.

Photo #12: Gap where Uni-Flange Coupling would be for Pump #1 Discharge Piping

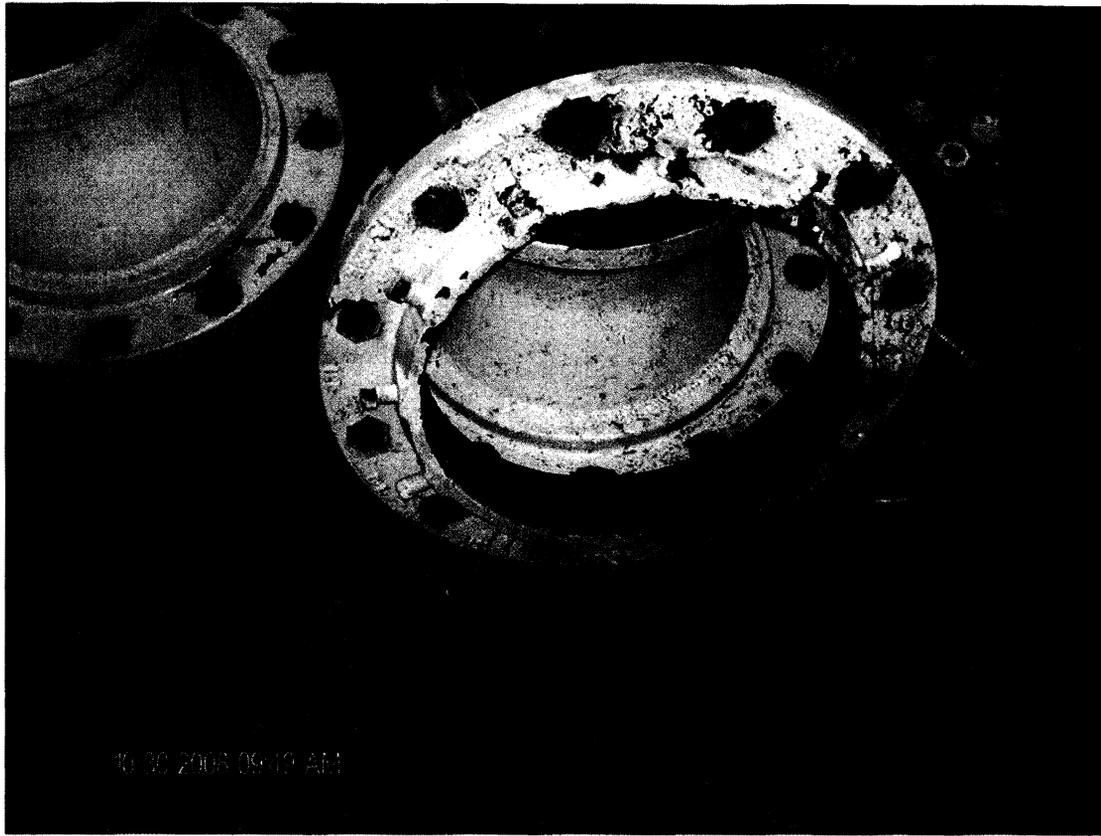
The fact that this Uni-Flange had been improperly installed would not have caused that pipe spool to separate, except for the fact that the shutoff valve was found to be leaking.

Photo #13: Pump #1 Uni-Flange Coupling

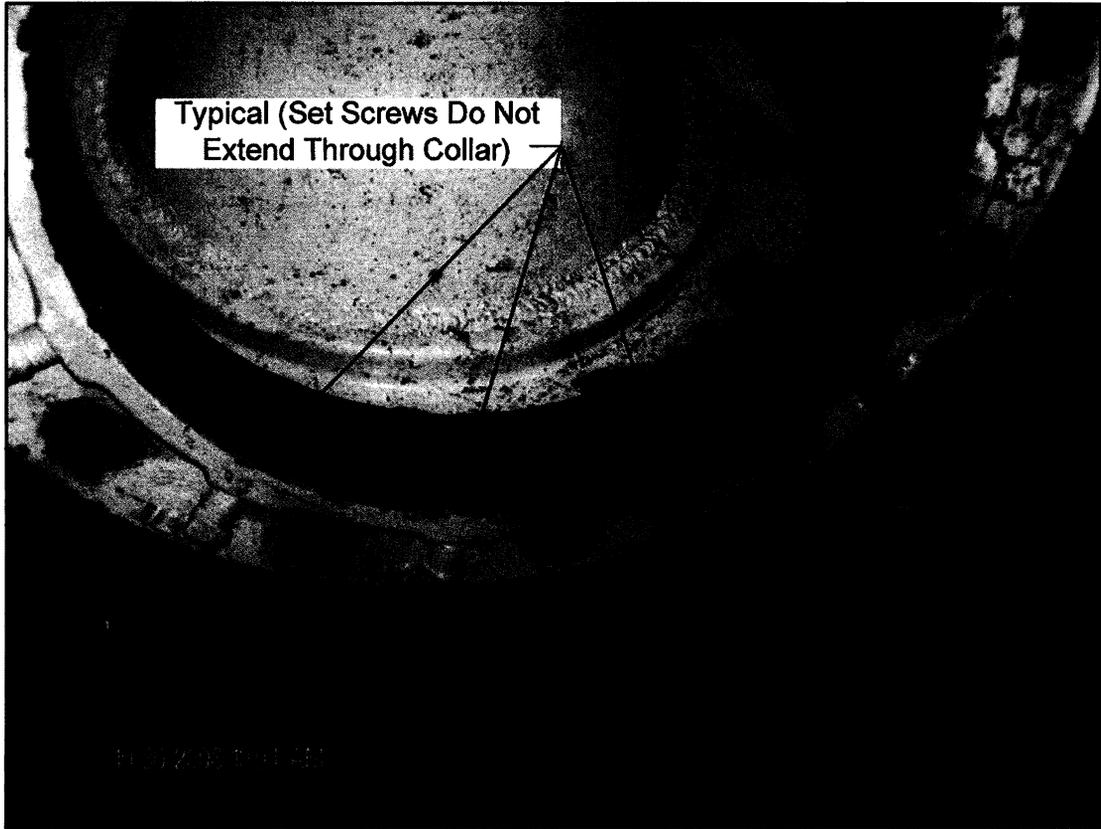
Uni-Flange coupling set screws, which extend above the coupling collar, are properly installed when torqued to a force recommended by the coupling manufacturer. Once they are so torqued, the coupling is properly installed, and the outside appearance of the set screws would not be noticeably different than if they had not been properly torqued. Neither City Staff nor the Contractor could have been expected to know that the set screws were not sufficiently torqued by visual observation alone. This condition would have been confirmed only by using a torque wrench to check the setting of each set screw.

Photo #14: Pump #1 Uni-Flange Coupling (Set Screws Do Not Extend Through Collar of Coupling)

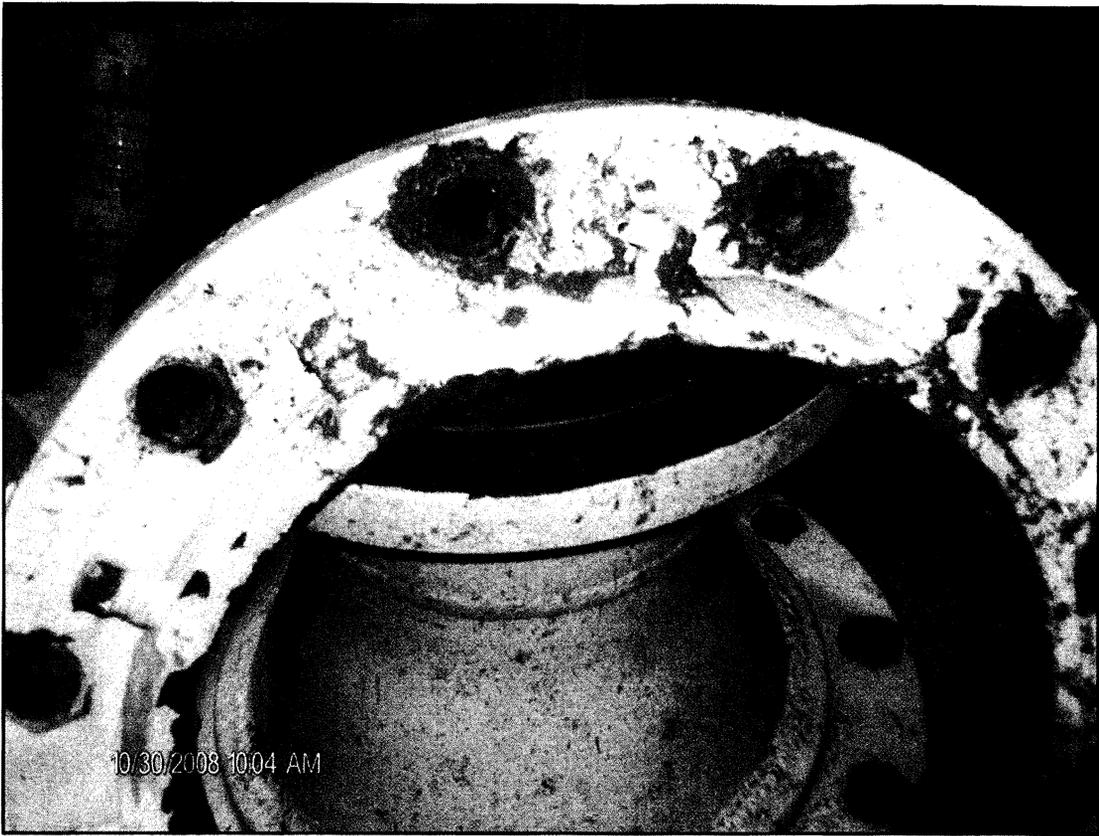
Photo #15: Pump #1 Uni-Flange Coupling (Paint on Set Screws Is Not Disturbed)

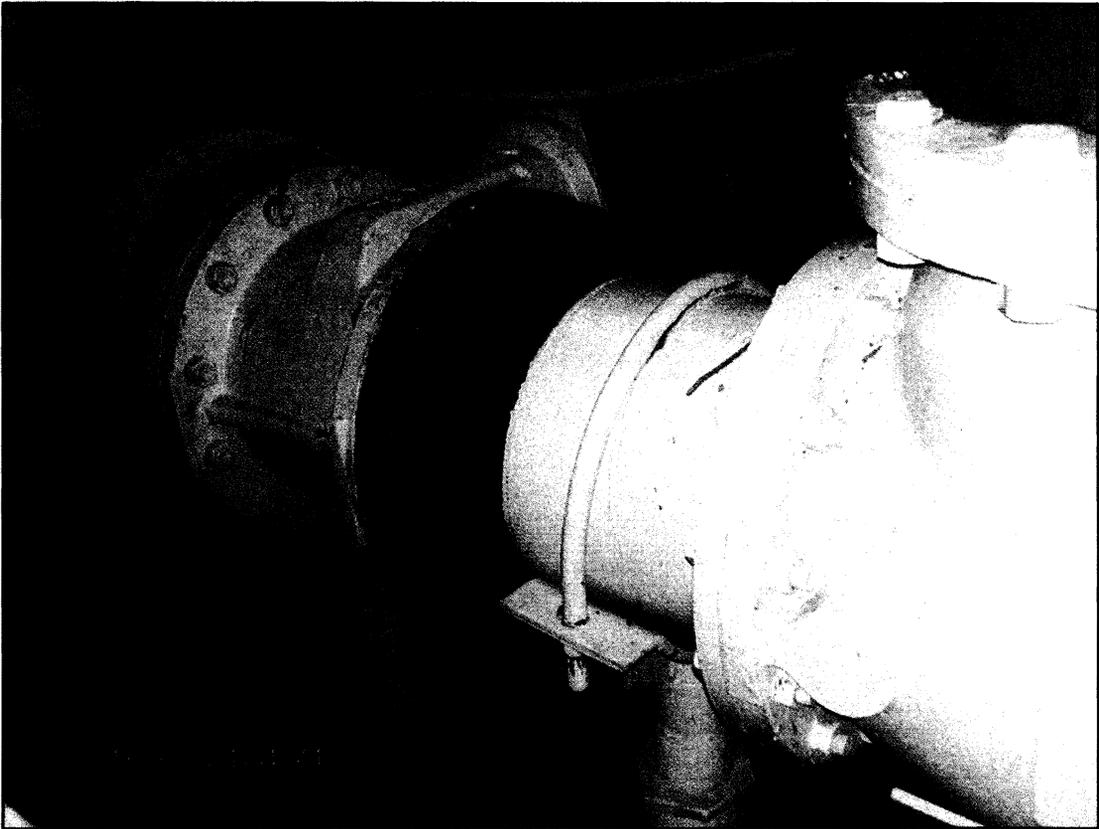
Photo #16: Pump #1 Discharge Piping (With Uni-Flange Coupling Removed and Blind Flange Temporarily Installed on Shut-Off Valve)

Once the bypass pumping system was hooked up, and the blind flange installed at the upstream end of the Pump #1 shutoff valve, inflow to the Dry Well was stopped, and repairs could commence.
