San Diego Regional Water Quality Control Board

Subject: Mission Avenue Inspection Summary

Mission Avenue Landfill Inspection Summary
Enclosure (1): Inspection Report No. 24732046

Mission Avenue Landfill Inspection Summary
Enclosure (2): Facility Inspection Photographs

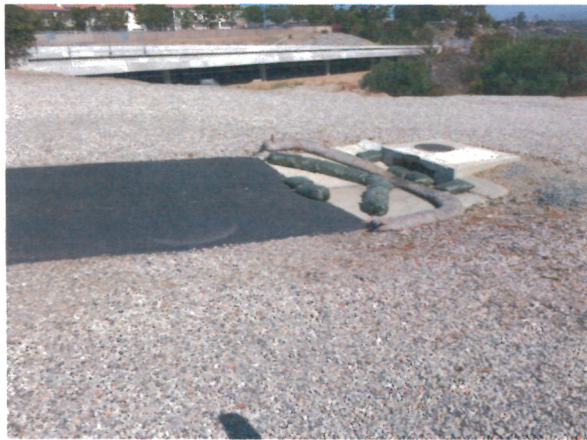
Photograph 1: Storm Water BMPs.

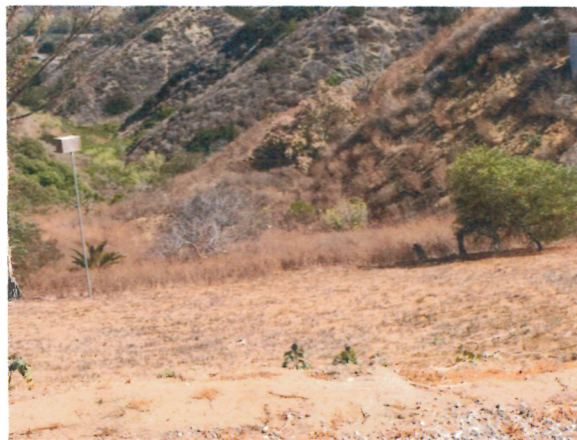
Photograph 2: Landfill face, and owl box

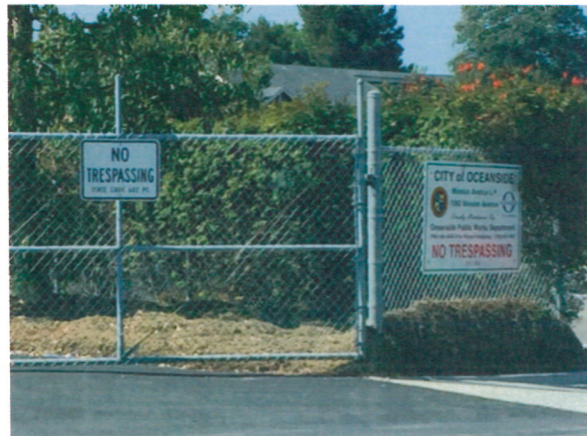
Photograph 3: Landfill signage.

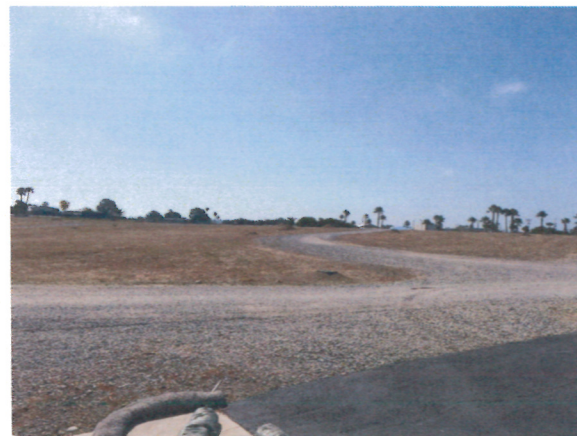
Photograph 4: Landfill cover.
