CALIFORNIA REGIONAL WATER QUALITY CONTROL BOARD - SAN DIEGO REGION
WATERSHED MANAGEMENT PROGRAM

FACILITY INSPECTION REPORT

INSPECTION DATE: January 7, 2008 TIME: 10 AM WDID: 9 37C322900

Sprinter Rail Project
FACILITY OR DEVELOPER NAME (if different from owner)

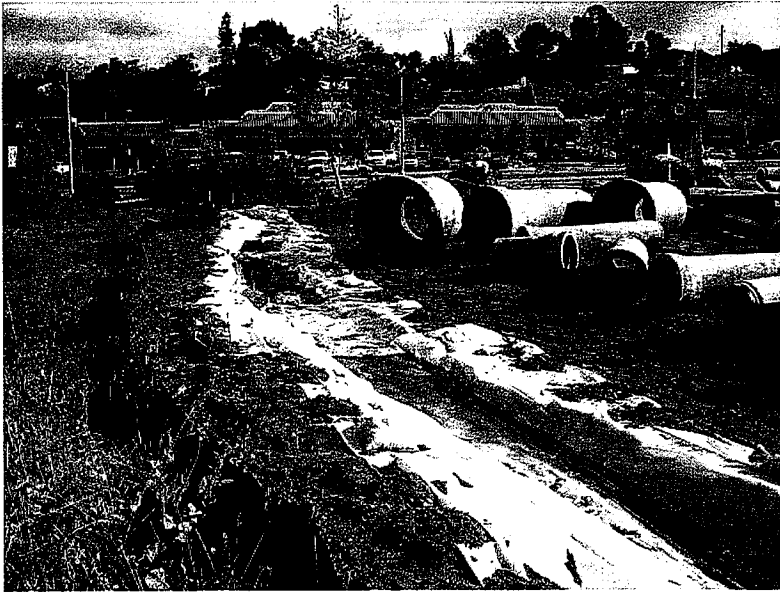
1. Runon from offsite coming through the Mar Vista Storage Yard was conveyed through a plastic lined channel. Turbid sheet flow from the yard was entering the plastic lined channel. Photo looking North.

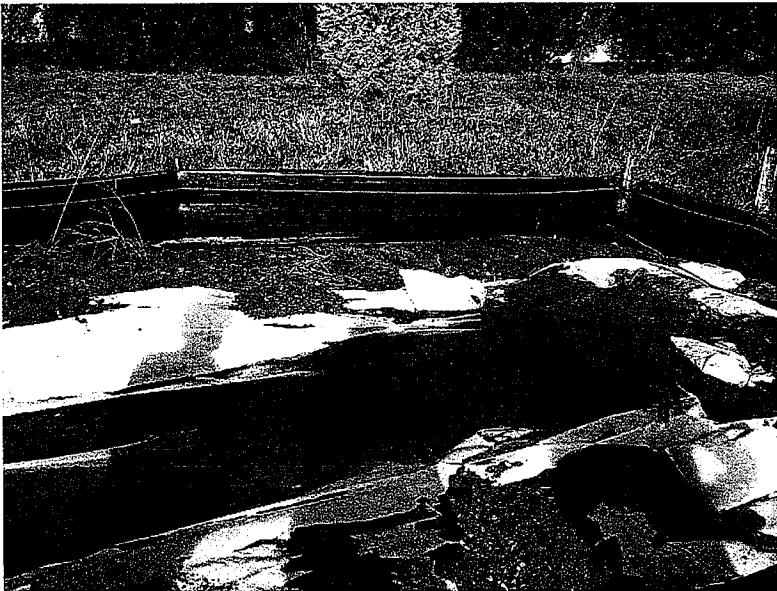
2. The plastic lined channel was full of sediment from the construction yard. Photo looking West.

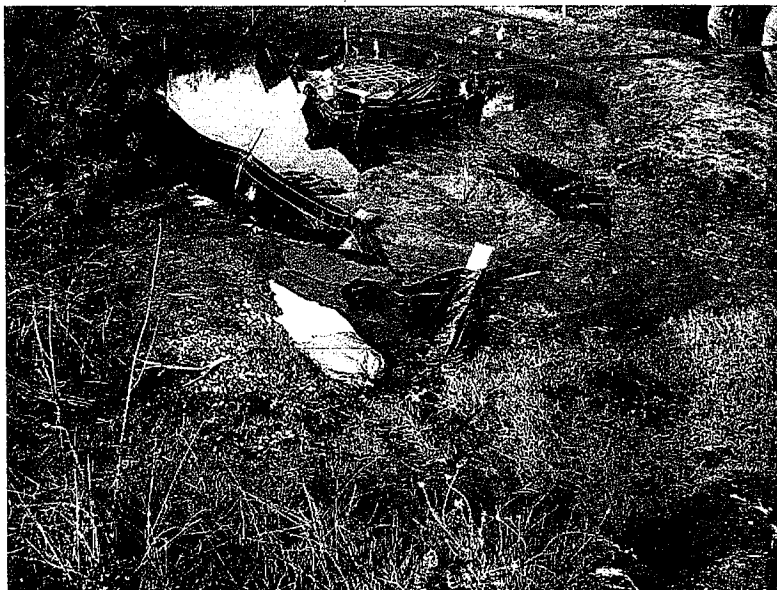
3. The plastic lined channel drained to this inlet highlighted by the arrow. Silt fence has failed and mud fans out around the inlet. Photo looking West.

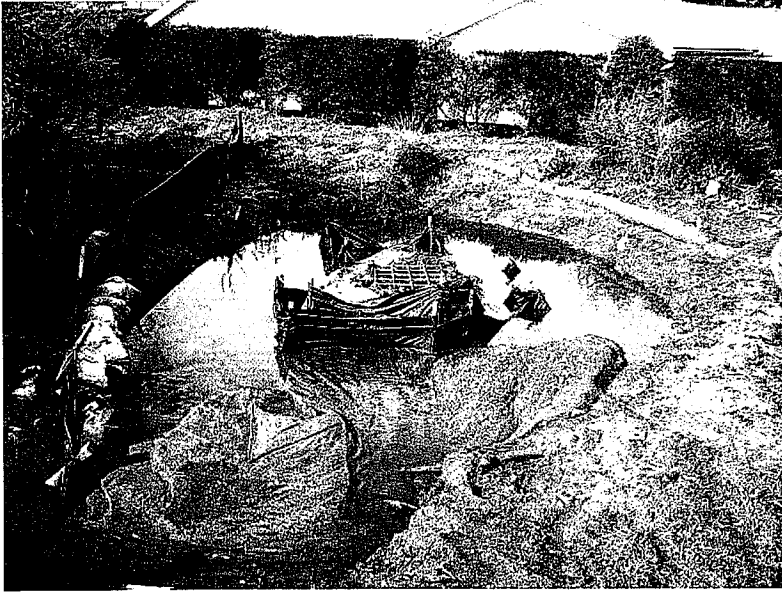
4. Another view of the storm drain inlet in photo 3 and the fan of mud. Photo looking West.

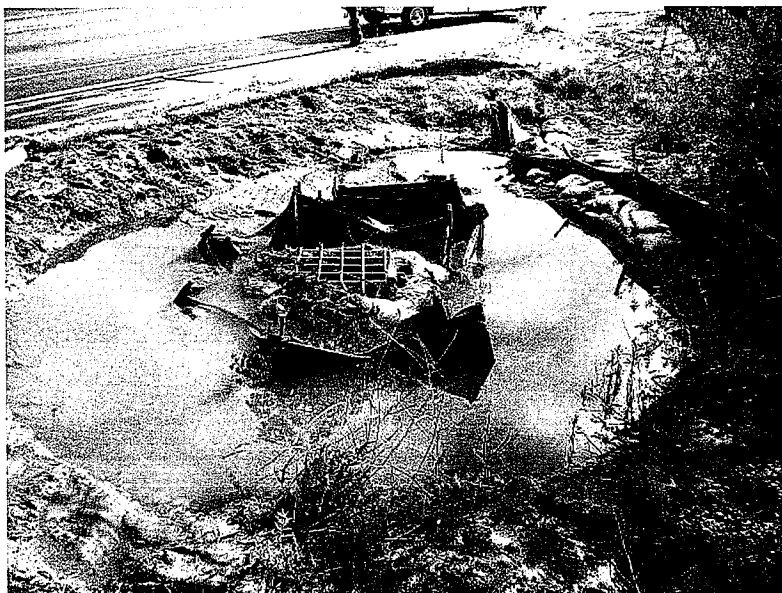
5. Another view of the storm drain inlet in photos 3 and 4. Turbid water was discharging into the storm drain inlet. The wire rack on top was choked with debris. Photo looking East.

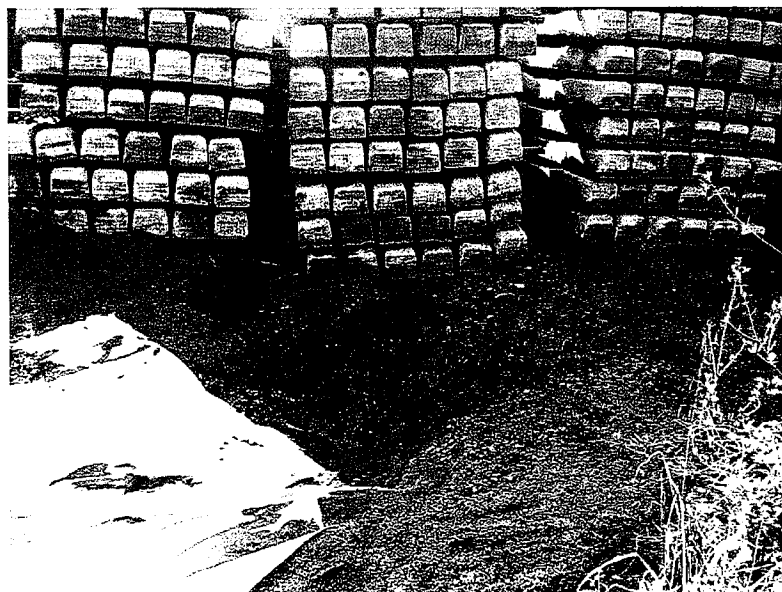
6. The plastic lined channel begins at this point receiving storm water flowing beneath the stockpile of concrete railroad ties. Photo shows channel erosion occurred beneath the railroad ties. Photo looking South.

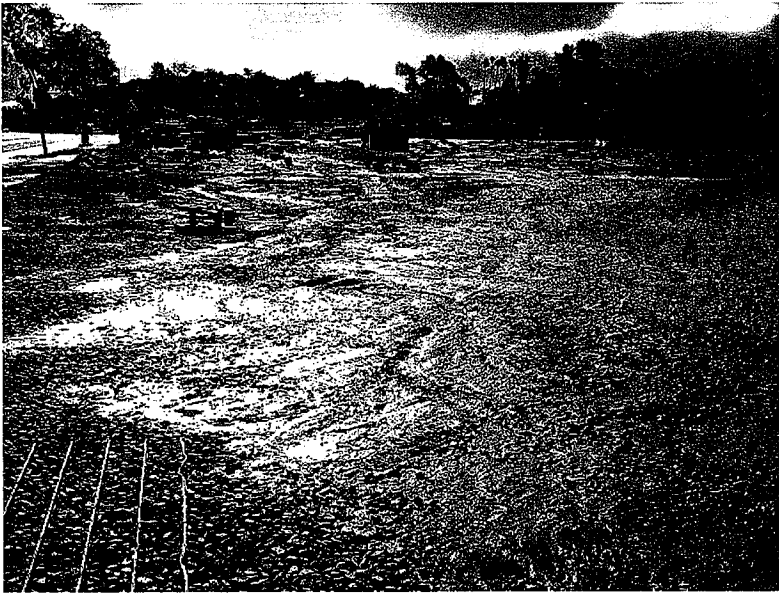
7. An example of the muddy sheet flow of storm water flowing across the construction storage yard and then entering the plastic lined channel in photo 1. The yard had no erosion or sediment controls to stabilize the soil and prevent sediment transport. Photo looking East.

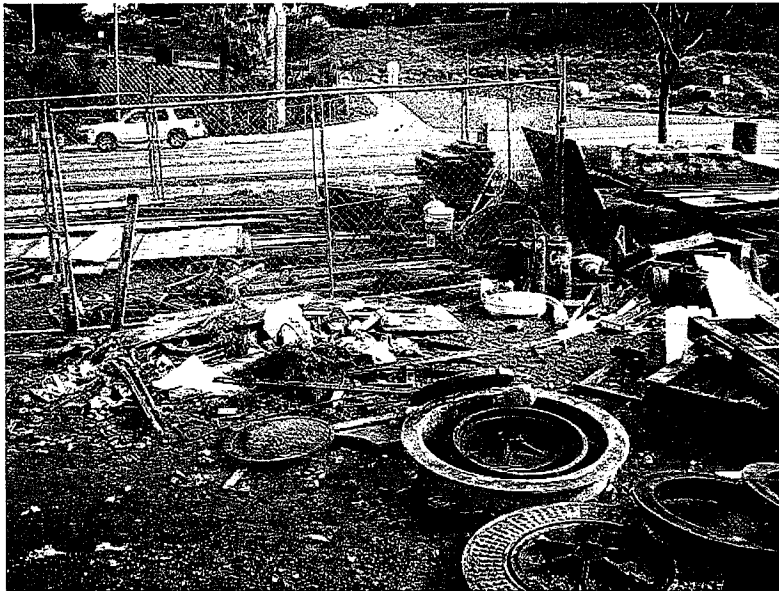
8. Construction trash left out at the yard without cover or containment to prevent contact with storm water. Photo looking North.

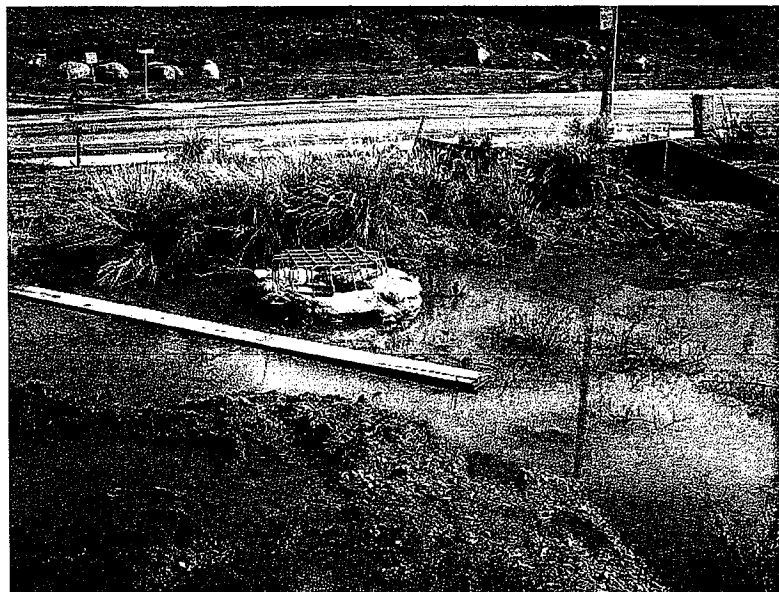
9. Second inlet within Mar Vista Storage Yard. Water did not appear to flow into this inlet but rather pooled here and then flowed across the construction yard to the inlet in photos 3, 4, and 5. Photo looks North.

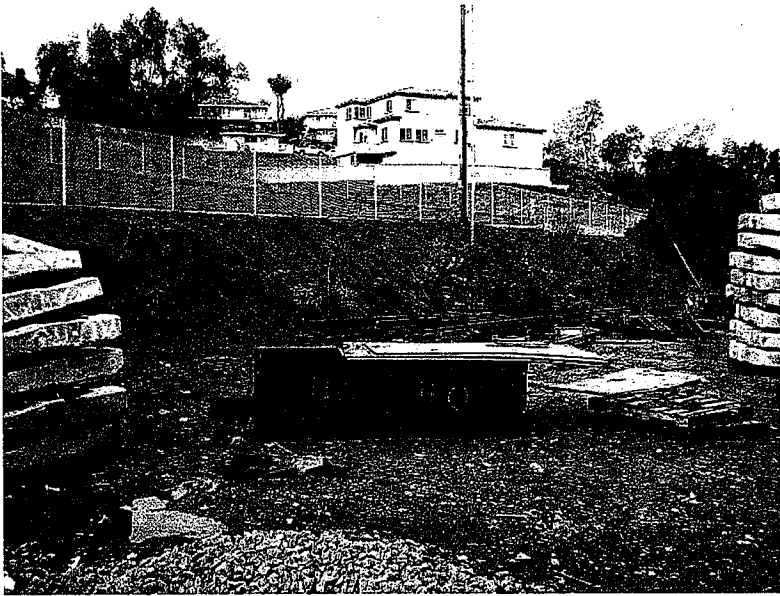
10. Erosion gullies are on the slope. The slope did not have sediment or erosion controls. Photo looks South west.

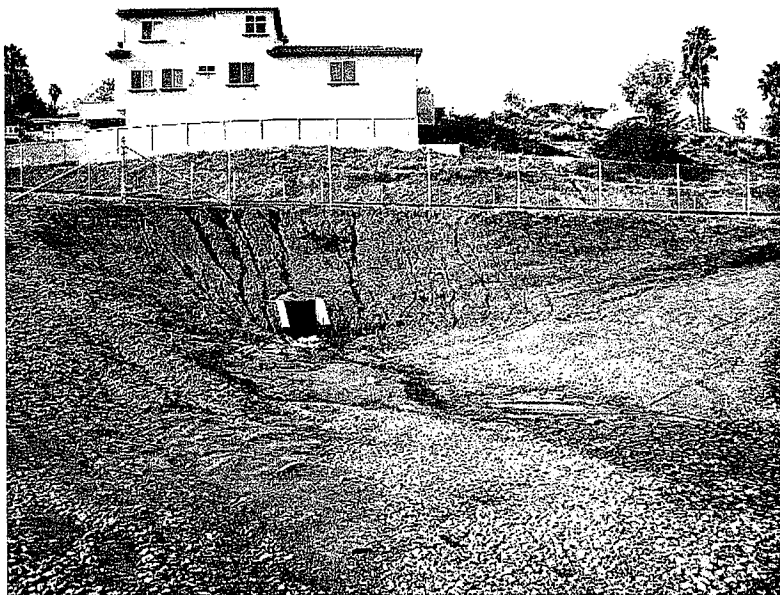
11. Another slope with erosion gullies has no erosion controls. Concentrated storm water runoff from the culvert flows through the construction yard. Photo looks South.

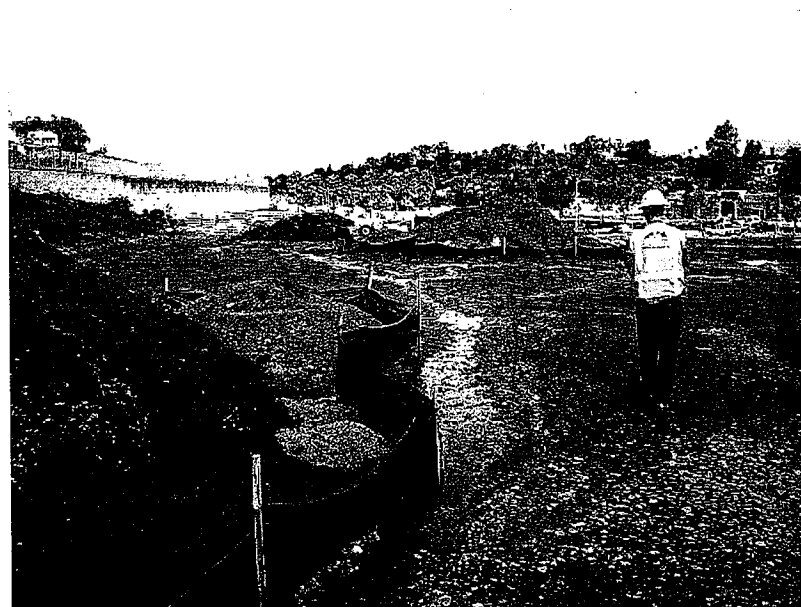
12. Runoff from the culvert in photo 11 flows through the bare dirt in the construction yard to the plastic lined channel in photo 1. Photo looks West.

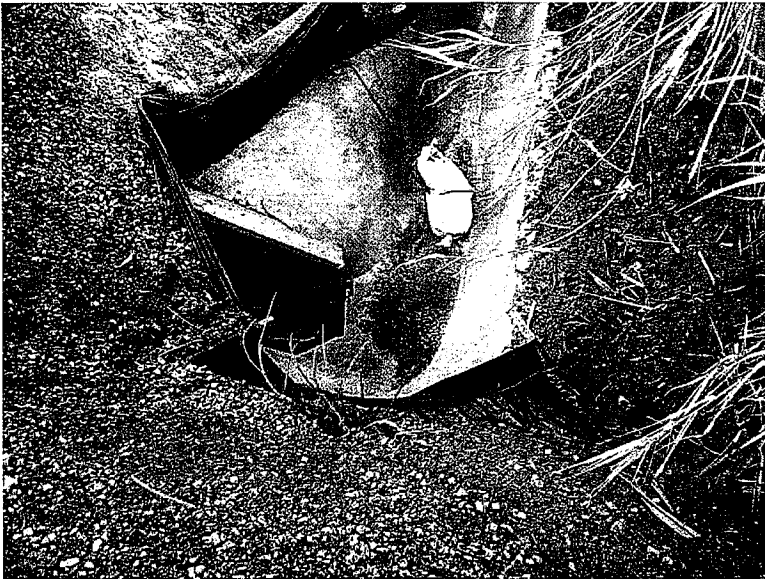
13. This photo was taken at the Escondido Avenue Station in the City of Vista. Silt fence has failed around this inlet at the north east corner of the station. Sediment and off color water was observed in the storm drain culvert. Photo looking east.

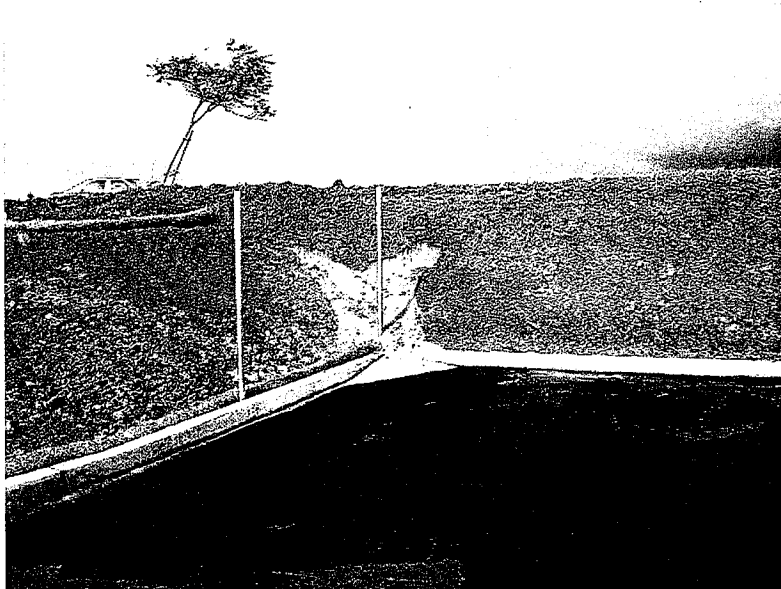
14. A slope failed at the north west corner of the parking lot. Fiber roll does not continue behind the curb. Photo looks north.

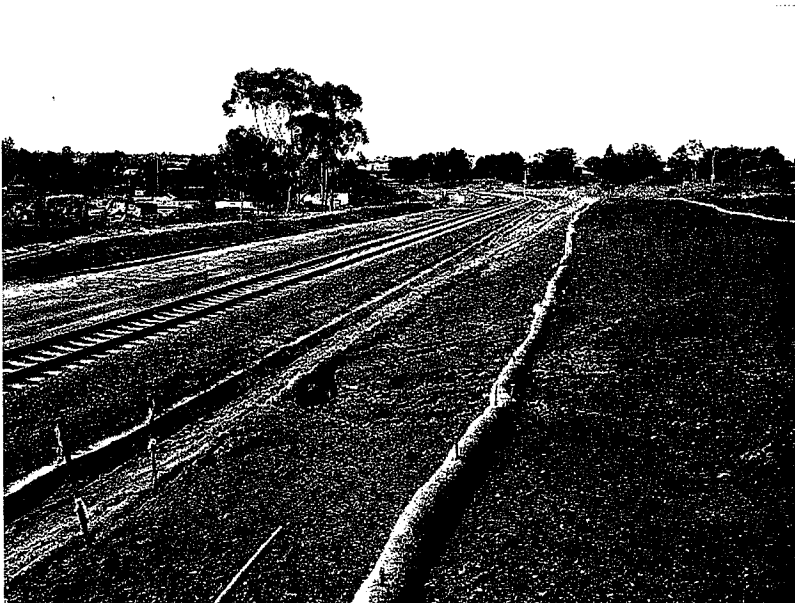
15. The slope has eroded due to concentrated runoff flowing down the slope at the south west corner of the parking lot. Photo looking west.

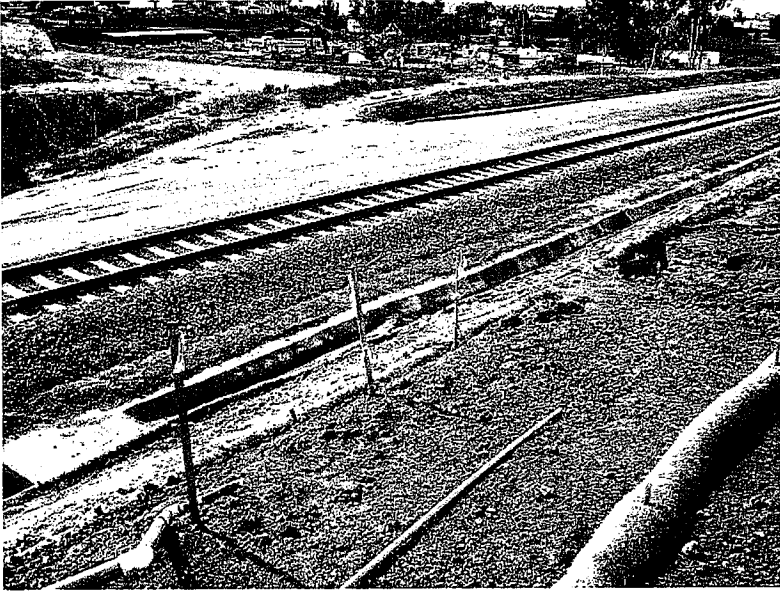
16. Mud from the erosion in photo 15 has entered the storm drain channel. Photo looking south west.

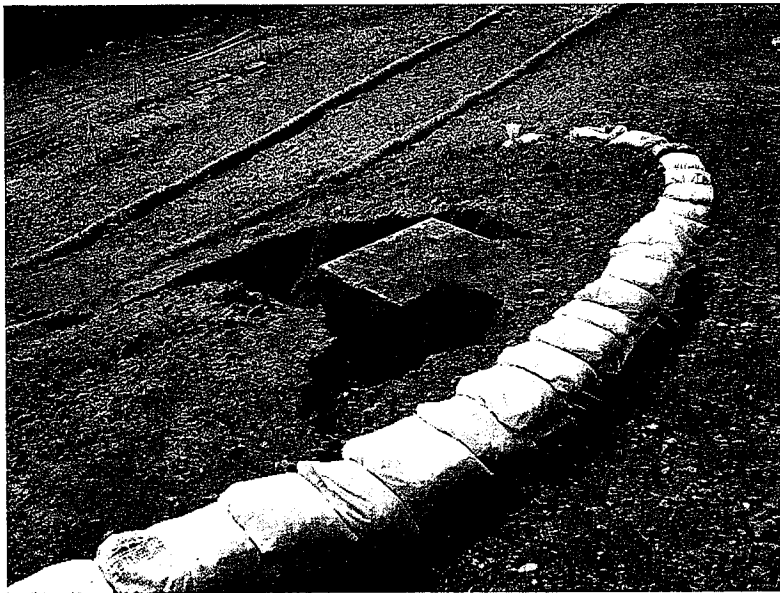
17. Gully erosion on a slope south of the train tracks next to Loma Alta Creek. Photo looking south west.

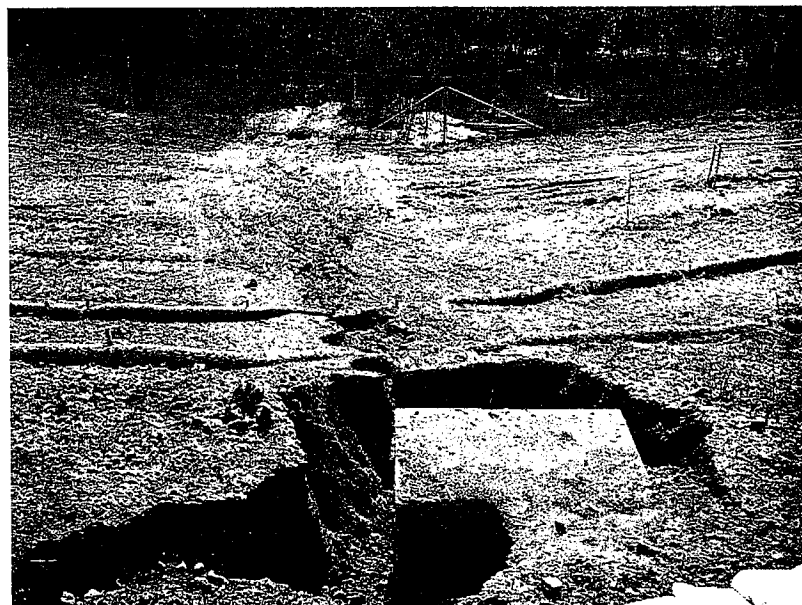
18. Another view of the gully in photo 17 shows the large fan of sediment entering Loma Alta Creek.

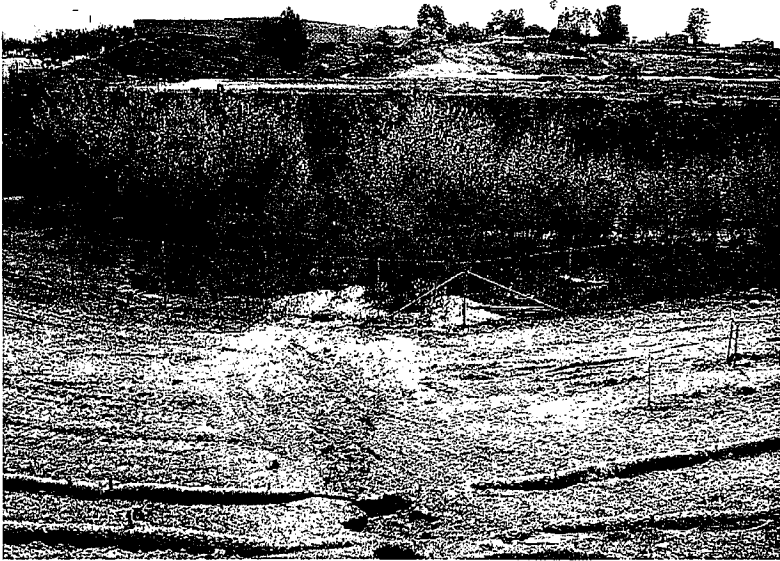
19. Another view of the fan of sediment entering Loma Alta Creek. Photo looking South.

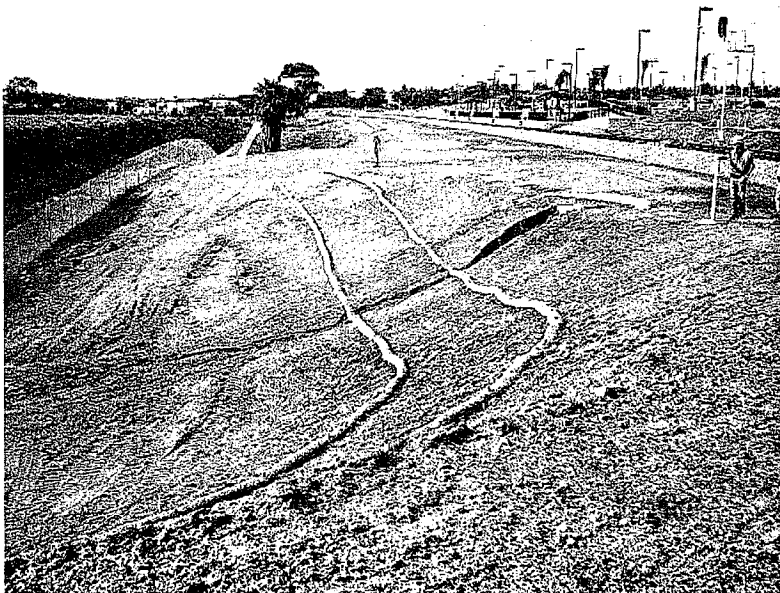
20. A side view of the gully erosion in photo 17. The erosion was caused by concentrated storm water runoff flowing down the slope. Photo looking West.

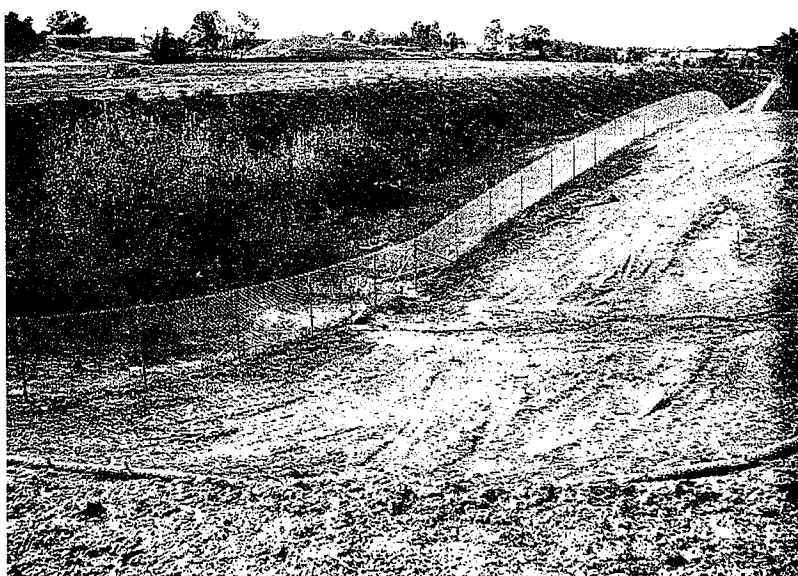
21. A side view of the sediment plume entering Loma Alta Creek in photo 18. Photo looks south west.

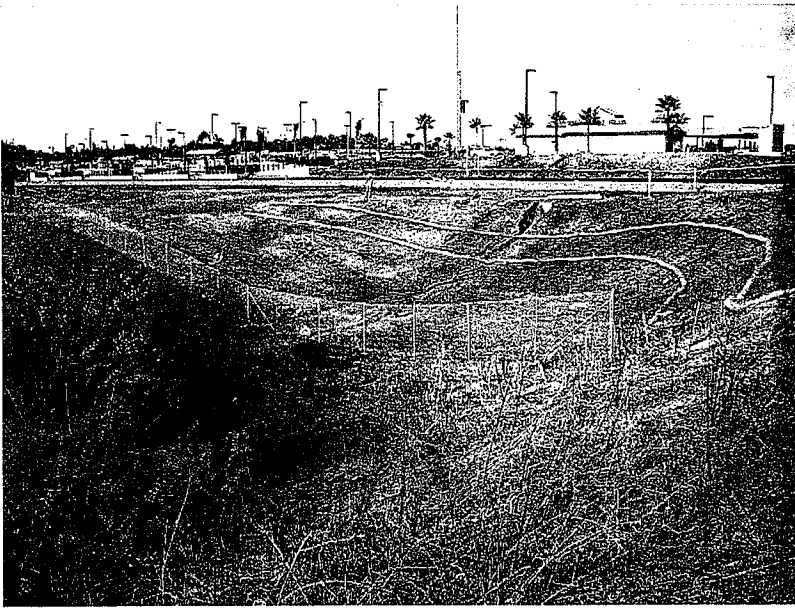
22. A view of the erosion gully from a distance and the sediment plume at the bottom of the slope entering Loma Alta Creek. Photo looking North.

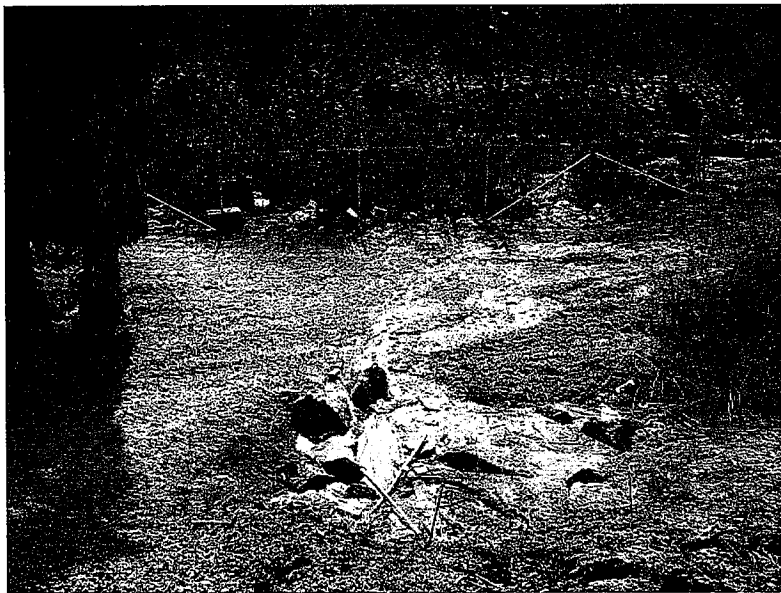
23. A storm drain outfall farther west from the gully in photo 17. This outfall shows evidence of sediment discharged from the Melrose Station to Loma Alta Creek. Photo looking South.

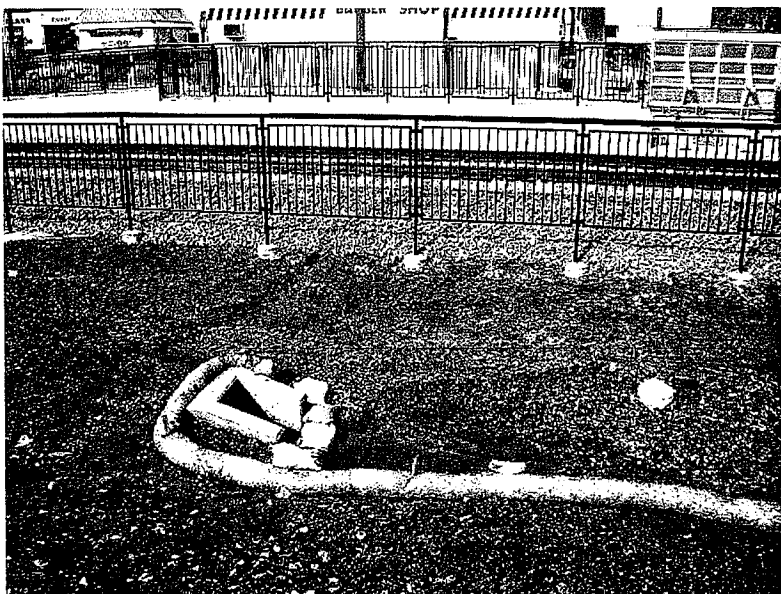
24. A storm drain inlet has inadequate protections. The soil and slope around the inlet did not have erosion controls or soil stabilization. Photo looking North.

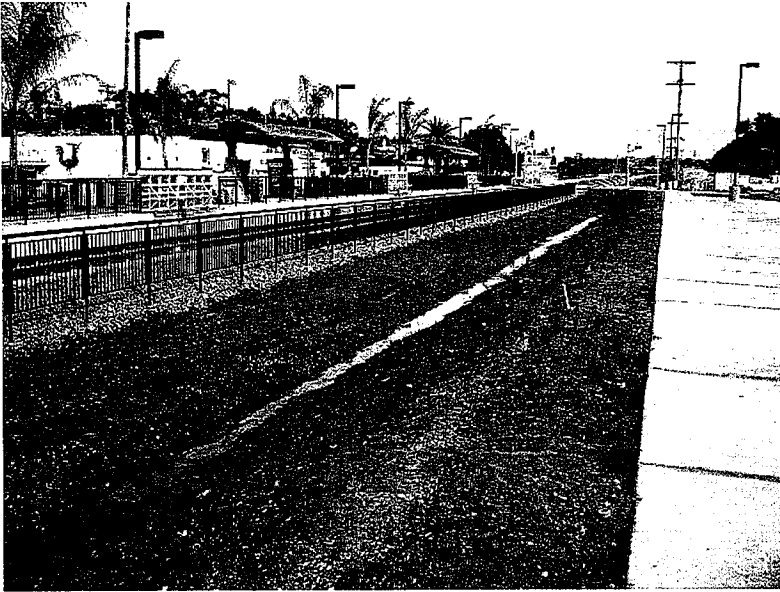
25. Photo shows the unstabilized soils surrounding the inlet in photo 24. Photo looking East.

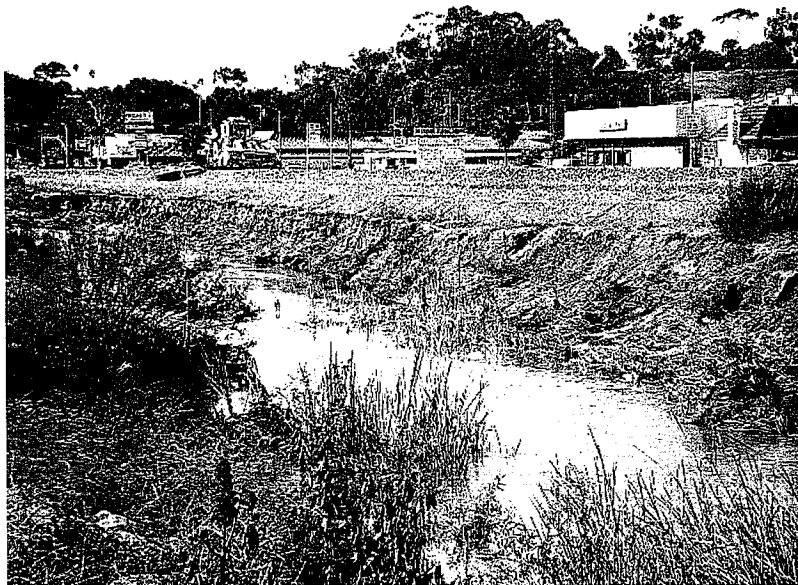
26. Loma Alta Creek has eroded away on the north bank threatening the tracks. A sediment discharge occurred. Workers were moving the tracks away from the eroded embankment. Photo looks Northwest.

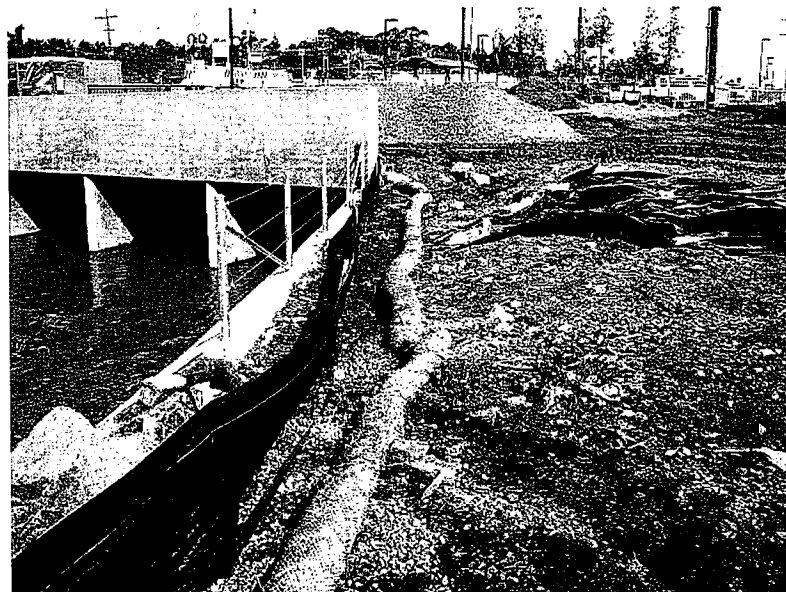
27. Sediment flows between the fiber roll and the silt fence were not held back. Silt fence is not properly implemented. Photo looking east.

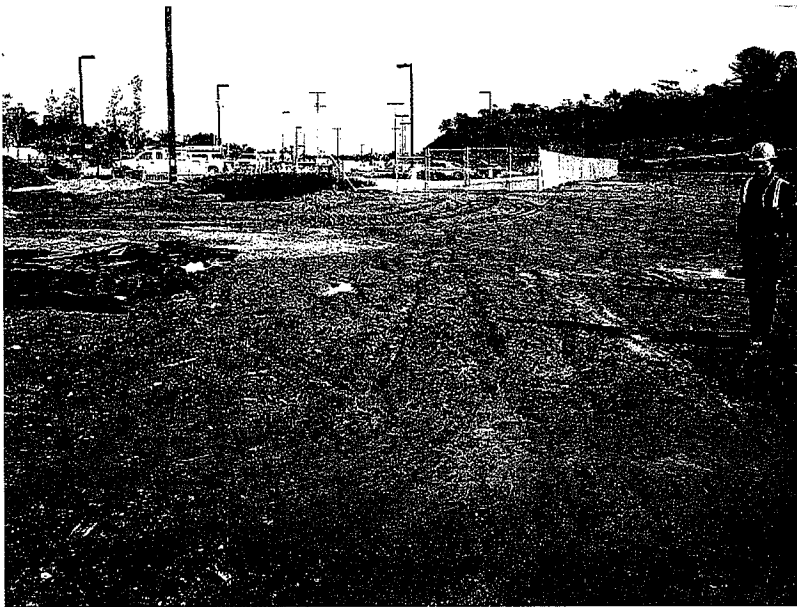
28. Storm water sheet flowing across unstabilized soils without any sediment controls. This area is south west of the parking lot. Photo looking east.

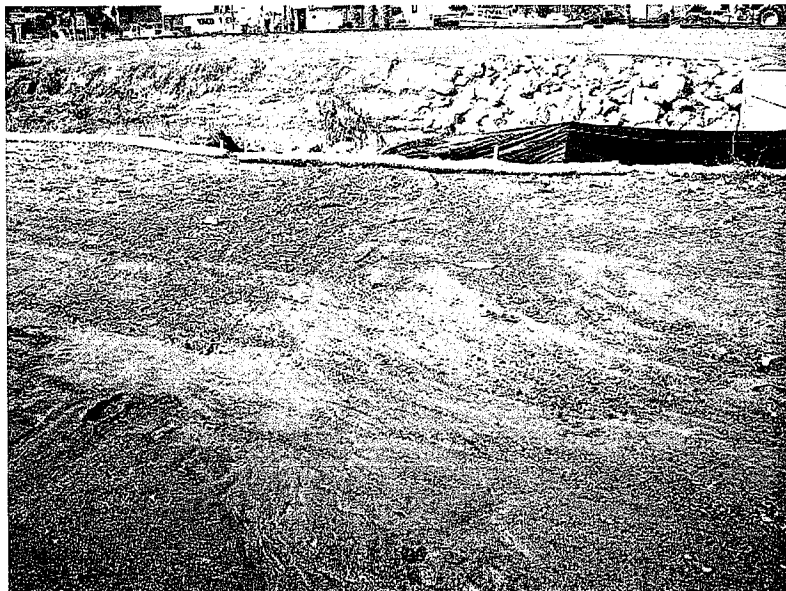
29. The sheet flow in photo 28 flows toward Loma Alta Creek. Photo looking North.

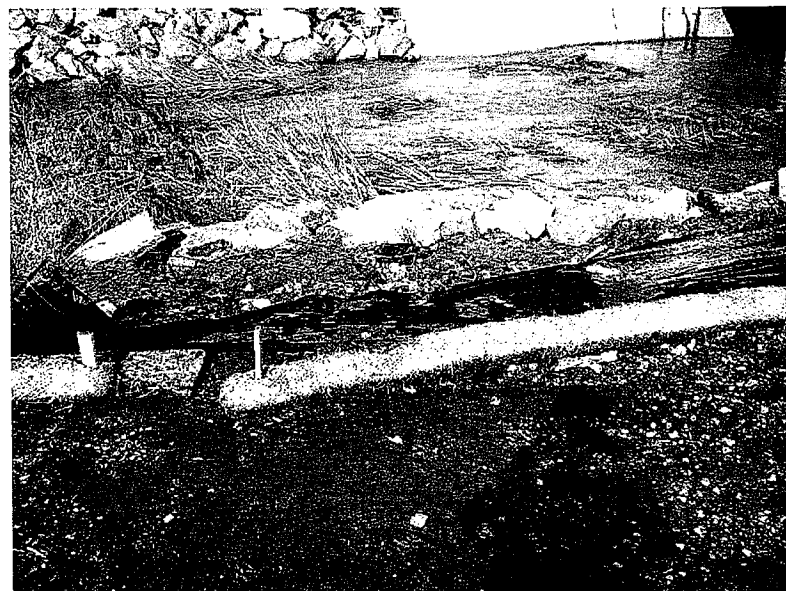
30. The sheet flow in photo 27 carries sediment and overwhelms the improperly implemented and maintained fiber rolls and silt fencing. Sediment discharged to Loma Alta Creek. Photo looking North.

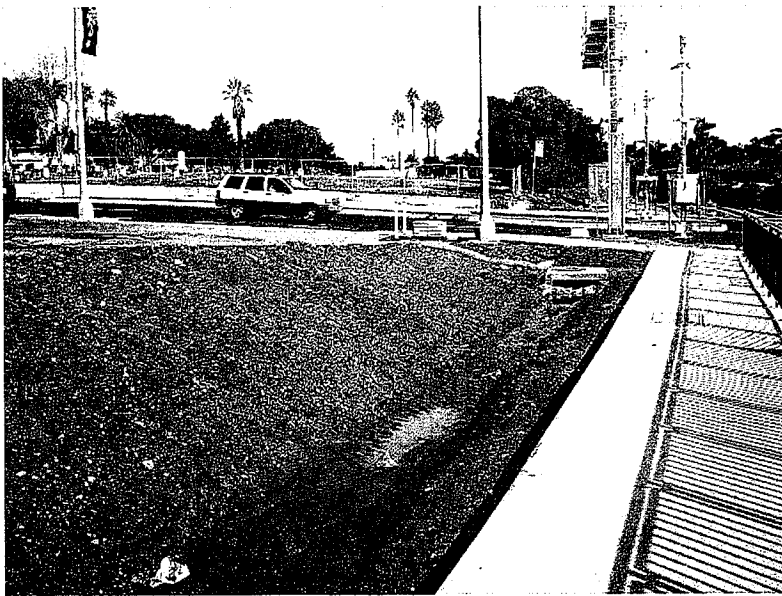
31. Exposed soils with no erosion or sediment control lead to a storm drain inlet. This was located north of the tracks next to South Coast Highway. Photo looks East.

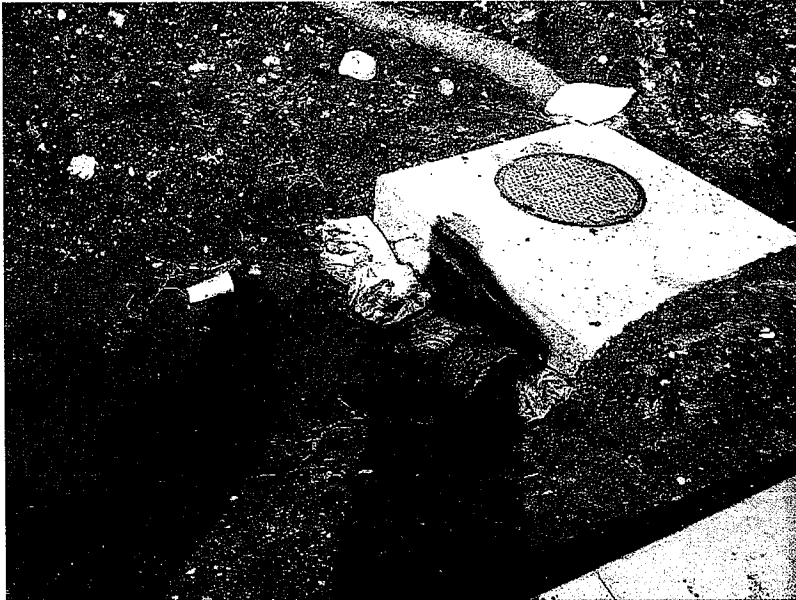
32. A closer view of the inlet in photo 31 shows that storm water flows had previously overtopped the gravel bags resulting in a discharge of sediment. Photo looks North east.

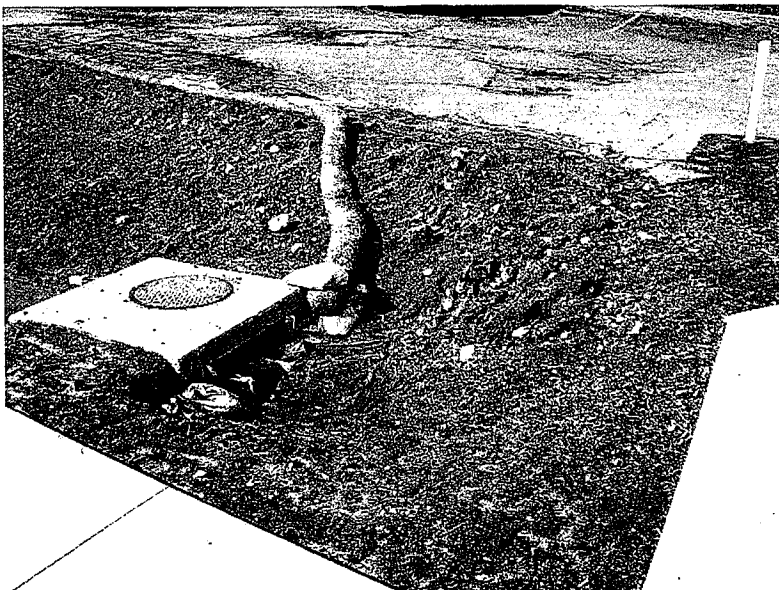
33. Another view of the inlet in photo 31 shows the opposite side of the inlet. The slope has erosion gullies. Sediment has overtopped the gravel bags resulting in a sediment discharge. Photo looks North west.

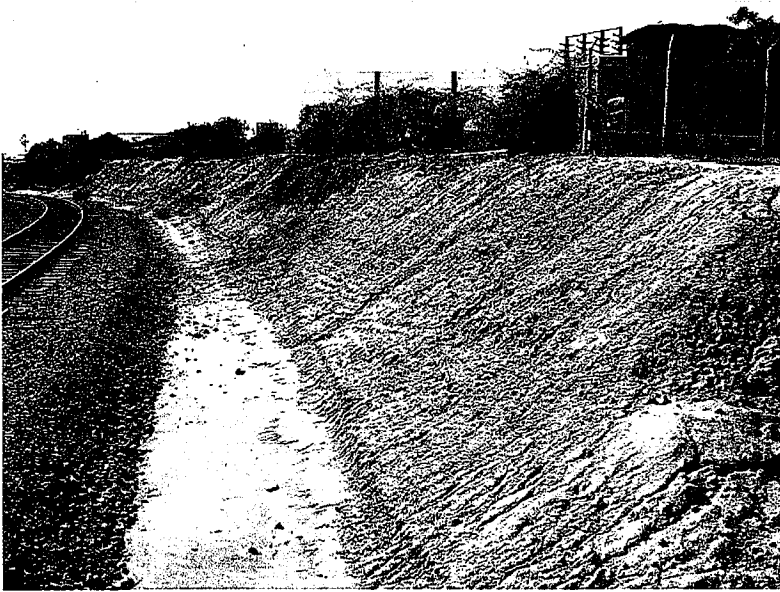
34. Slopes are without sediment or erosion controls. This area is south west of the parking lot. The slope is north of the track going southwest to intersect the Coaster track. Photo looking West.

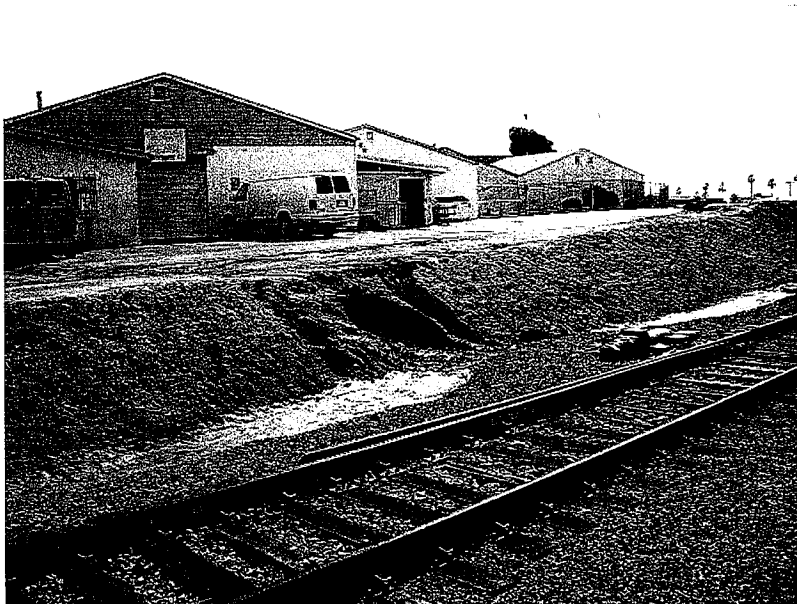
35. Slope with significant erosion has exposed the underground utilities.

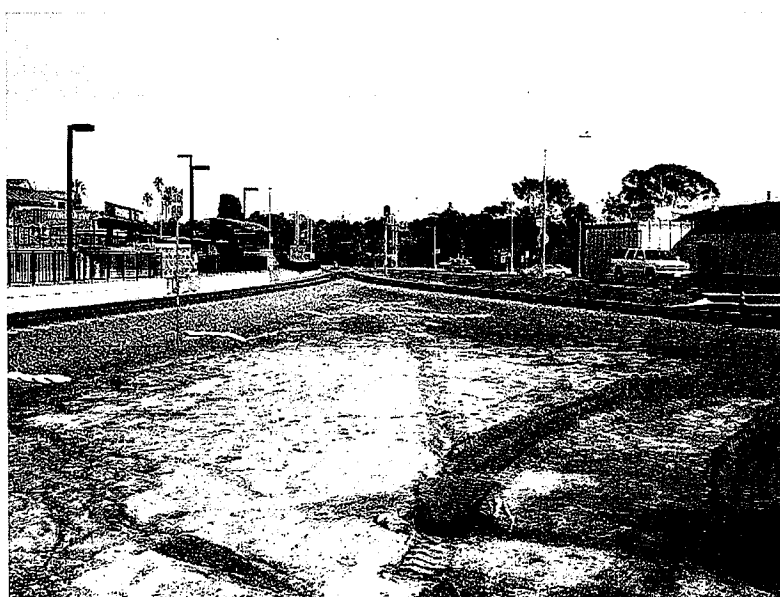
36. The area between the tracks has some chevrons of gravel bags implemented. Photo looks east.

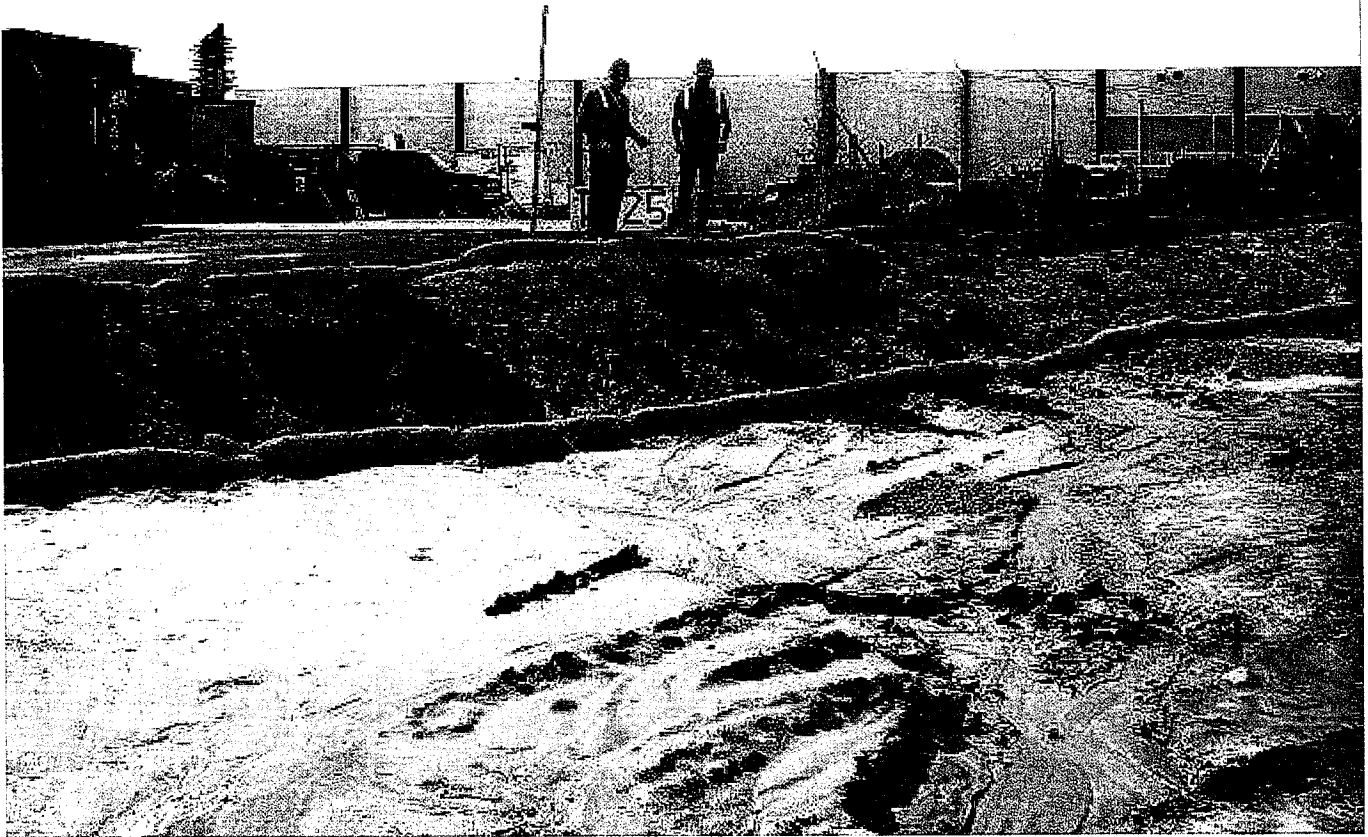
37. Significant erosion on a slope with no erosion controls. Although the ground was muddy in this area, the top fiber roll was completely dry suggesting it's implementation following the rainstorms. Not shown, the erosion had undermined a light pole and a portion of the driveway. Photo looking west.
