CALIFORNIA REGIONAL WATER QUALITY CONTROL BOARD - SAN DIEGO REGION
WATERSHED MANAGEMENT PROGRAM

FACILITY INSPECTION REPORT

INSPECTION DATE: January 22, 2008 TIME: 9 am WDID: 9 37C322900

Sprinter Rail Project
FACILITY OR DEVELOPER NAME (if different from owner)

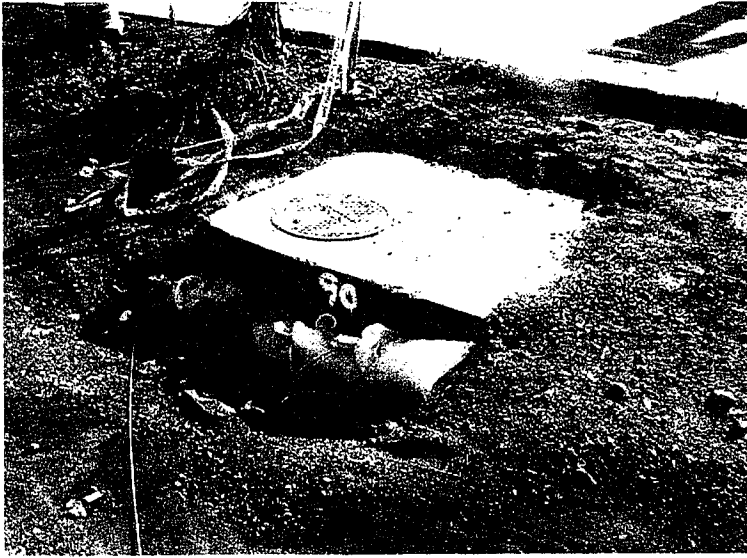
1. Nordahl Road Station in Escondido - This station is located at the intersection of Barham Drive and Mission Avenue. Photo 1 shows a drain inlet which historically has not been adequately protected. Inlet protection has improved at this location. Outside this inlet, there is a shallow channel that directs flow toward the inlet. Gravel bags placed across this channel act as check dams to trap sediment. Photo 2 shows an area between gravel bags where concrete washout was improperly dumped. On the west side of Nordahl Station, the street was stained with sediment in an area where previous inspections noted turbid discharges. Fiber rolls placed along the site boundary have not prevented these discharges (Photo 3).

1. Improved inlet protection.

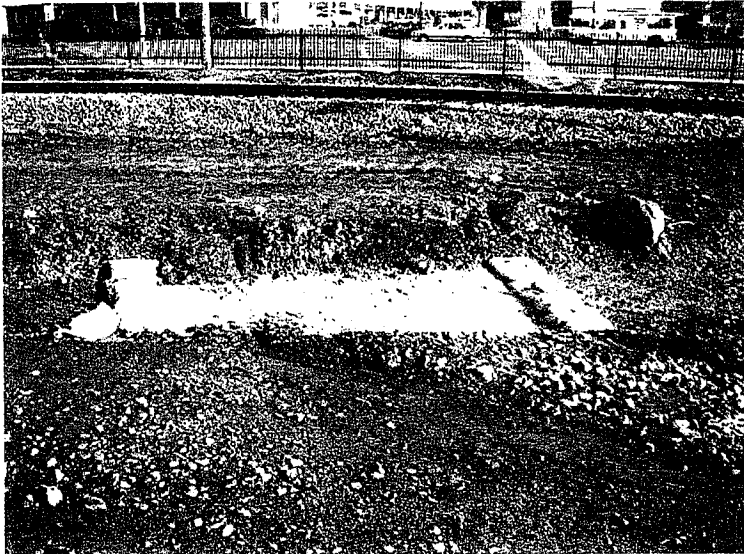
2. Sandbag checkdams outside of
inlet shown in Photo 1. White
material is concrete washout.

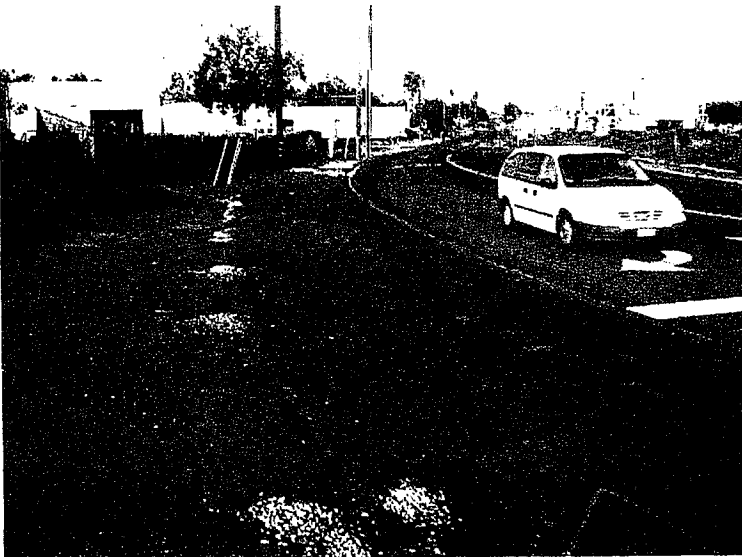
3. Area on west side of Nordahl
Road Station where pavement is
stained by sediment.

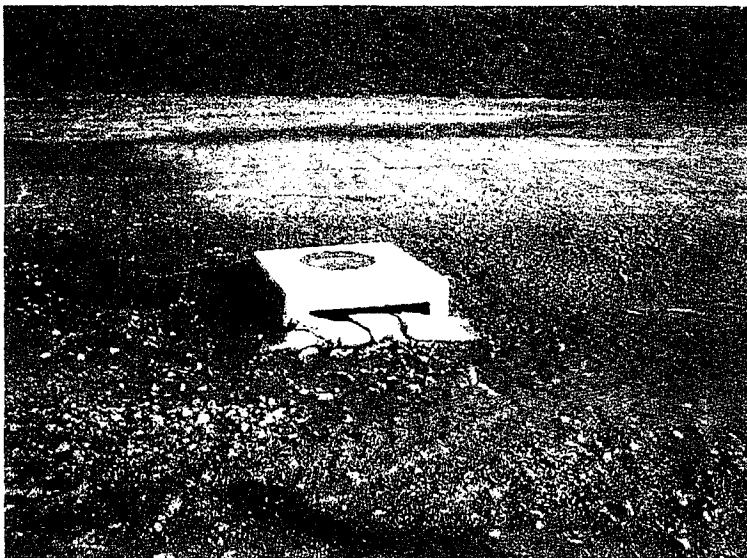
4. Inlet protection does not appear to have failed, however gravel bags show some overtopping. Protection is not likely to be adequate for a larger storm.

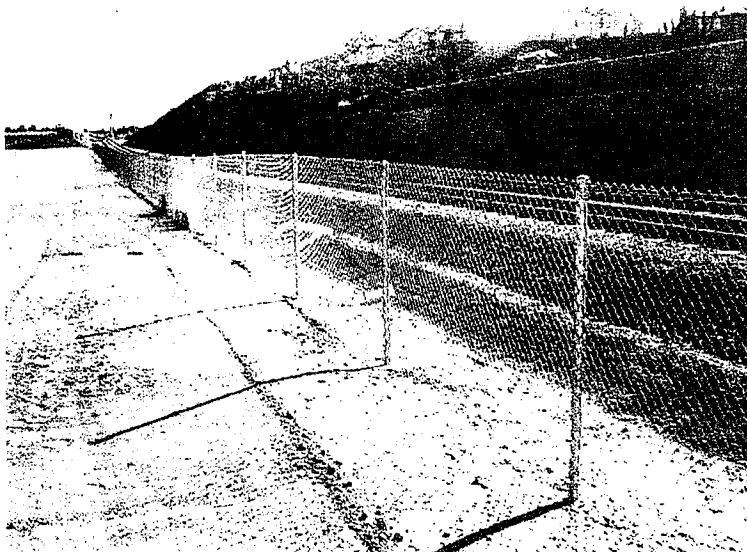
5. Channel next to tracks is unstabilized although gravel bag sediment controls have been placed in channel.

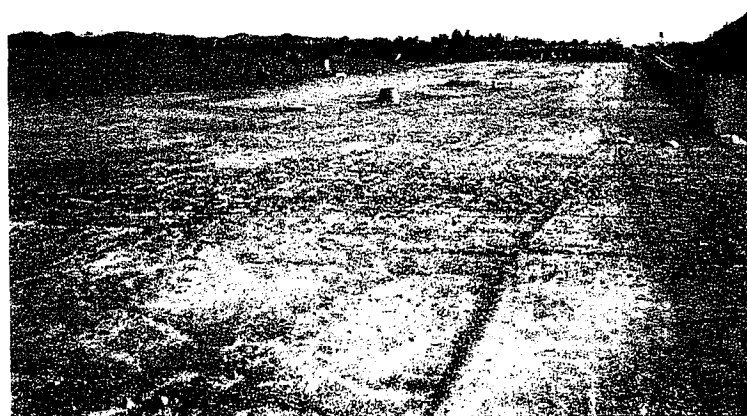
2. Near the intersection of Barham Drive and Shelly Drive in San Marcos - This is a location near a stretch of tracks that run along Barham Drive. Prior inspections have identified inadequate protection of the storm drain inlet at this location. The lack of adequate protection has resulted in discharges of sediment to the MS4 (noted during an inspection on December 19, 2007). The protection still appears to be lacking (Photo 4). Photo 5 shows an earthen channel running along the tracks that lacks stabilization. The large expanse of unstabilized soil found in past inspections (e.g., on November 30, 2007, December 7, 2007 and December 19, 2007) persists at this location (Photo 6).

6. Field north of tracks previously used to store equipment continues to lack erosion controls.

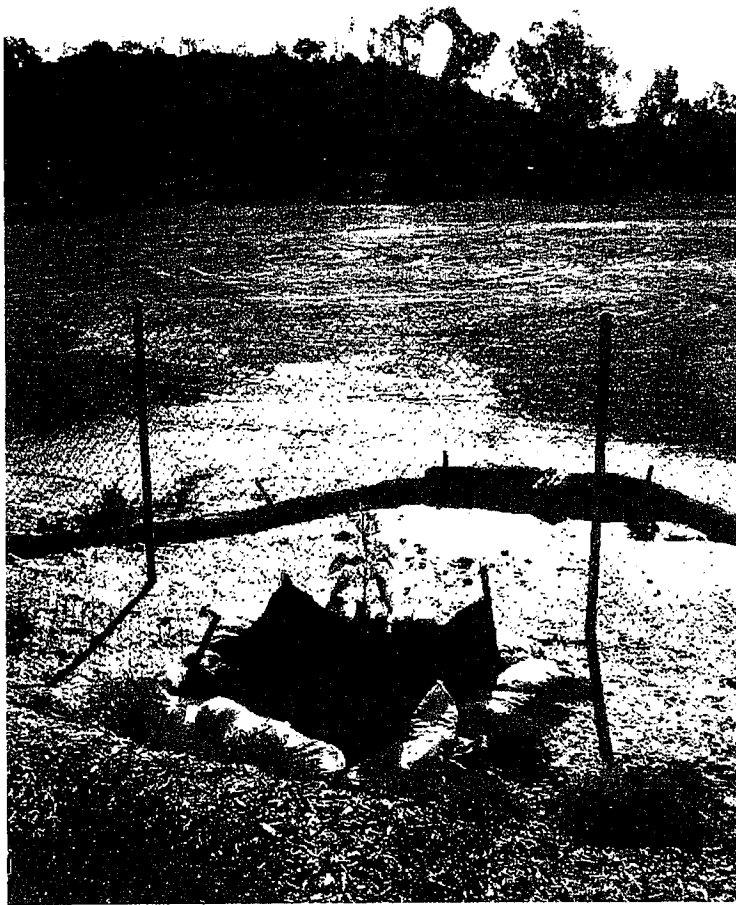
7. Continued lack of erosion controls in field previously used to store equipment.

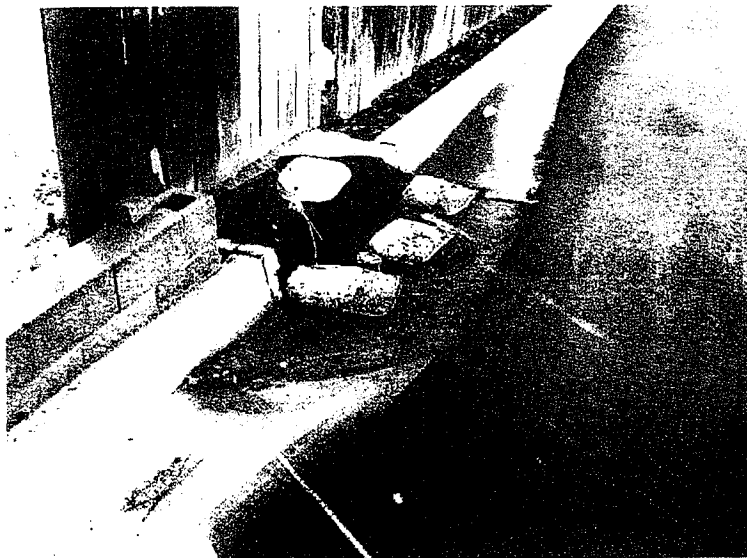
8. Inlet needs maintenance.

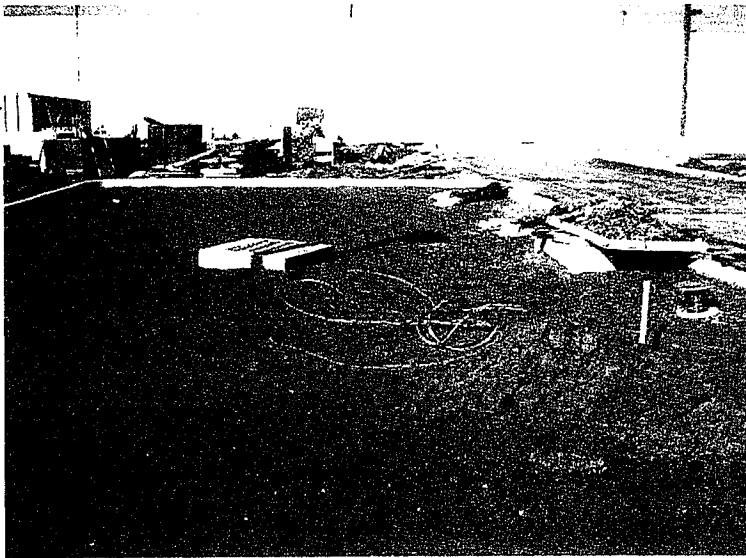
9. Bioretention cell being constructed in parking area.

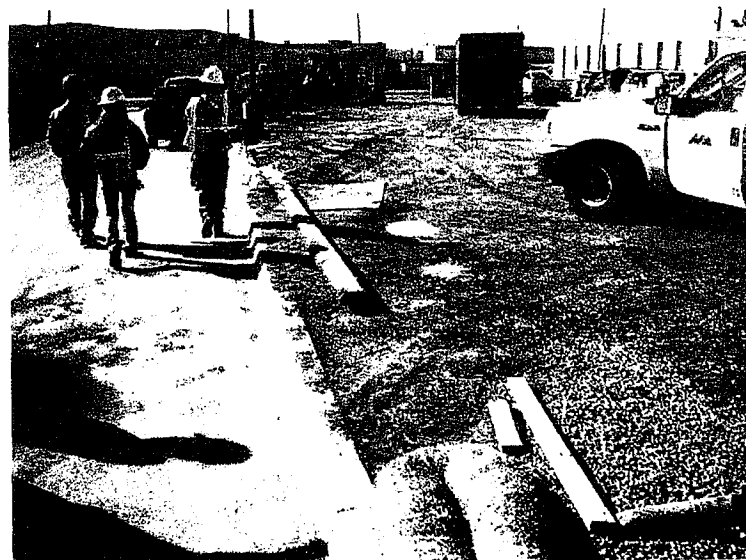
11. Sediment tracking in parking lot.

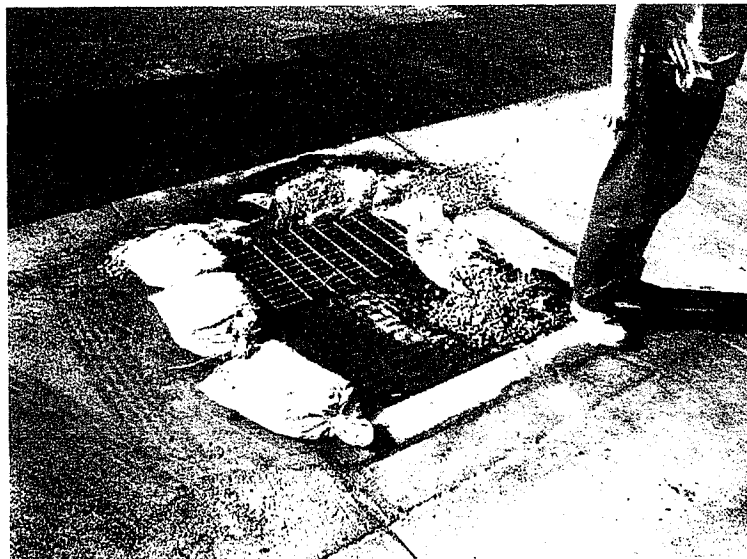
13. Gravel bags around inlet are not properly maintained.

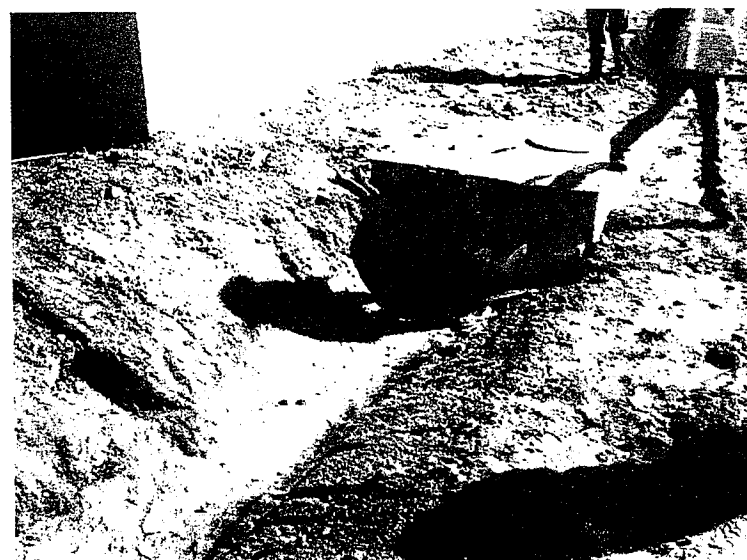
14. Earthen channel lacks erosion controls.

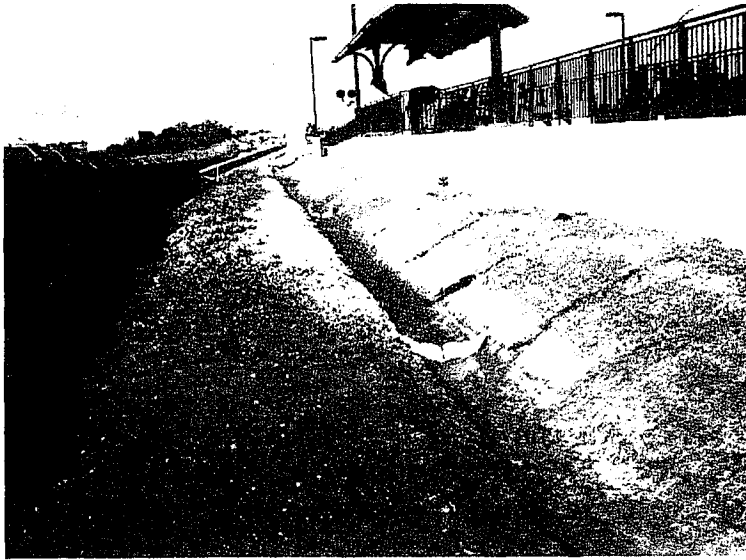
15. Another view of channel that lacks erosion controls.

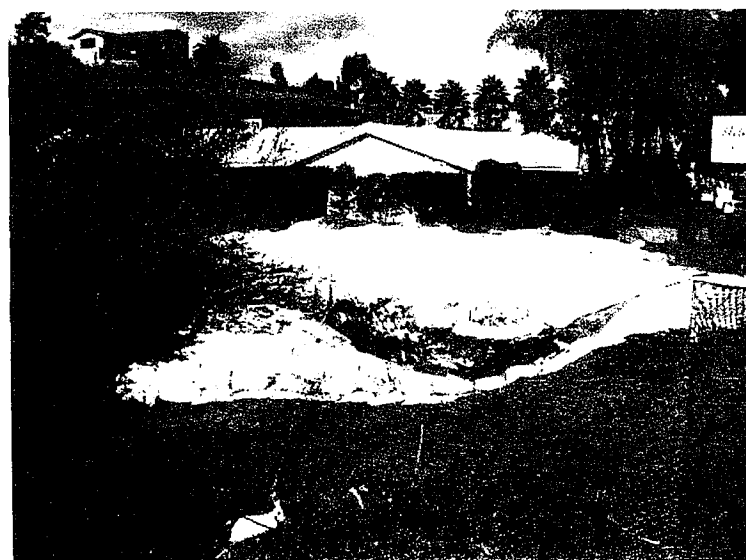
17. Another view of the detention basin.

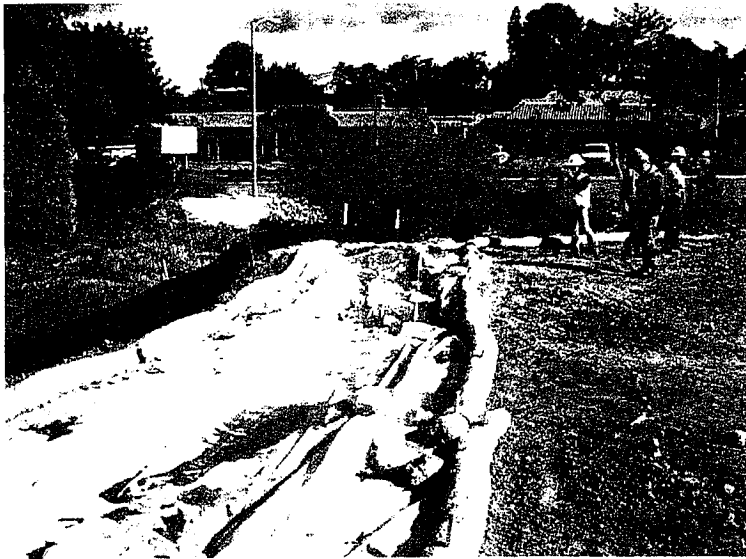
18. Earthen channel leading from outfall at the south property boundary to the detention basin.

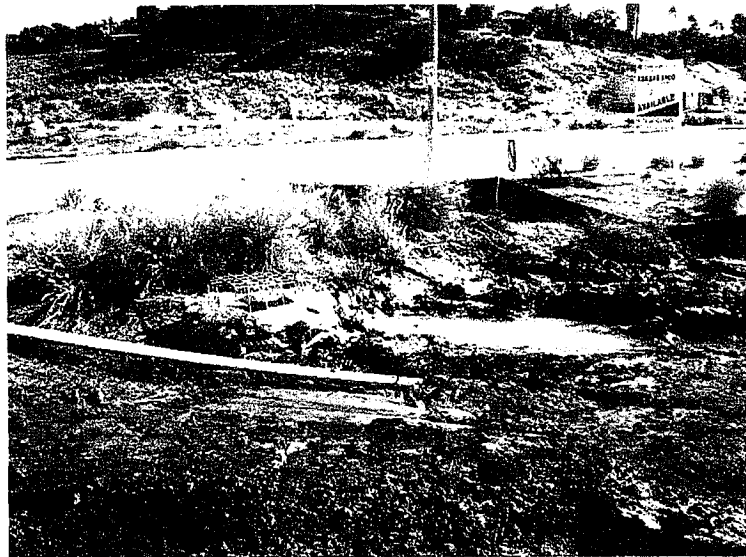
19. Storm drain inlet east of the inlet shown in Photo 16 appears to be adequately protected.

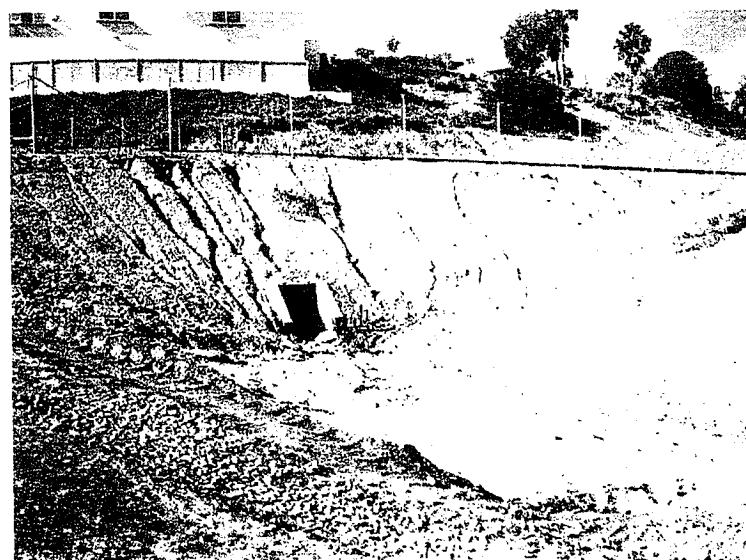
further to the east. The other outfall that enters the property at the south boundary is shown in Photo 20. There is a need for erosion controls in the unprotected channel below this outfall.

20. Outfall on south side of property leads to a channel that lacks erosion controls.

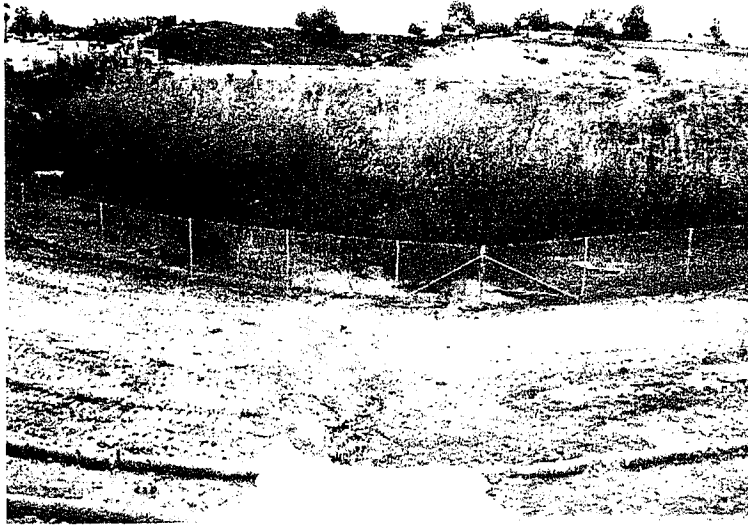
21. Plastic sheet covers recently formed gully. Residual sediment below the sheet leads to Loma Alta Creek.

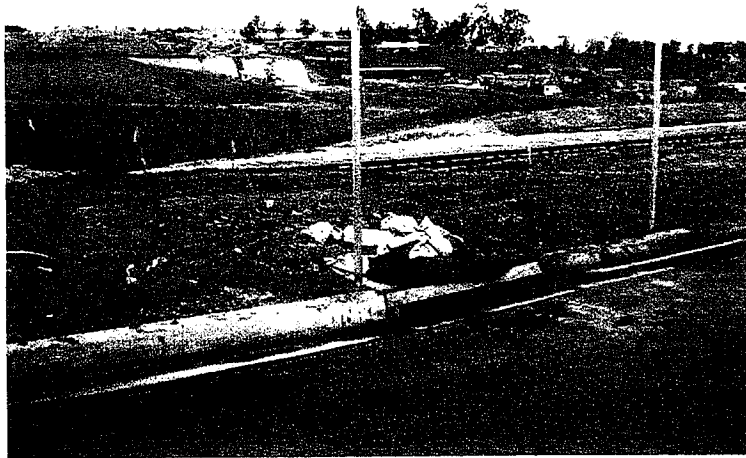
22. Inlet protection has been pulled up leaving the inlet unprotected.

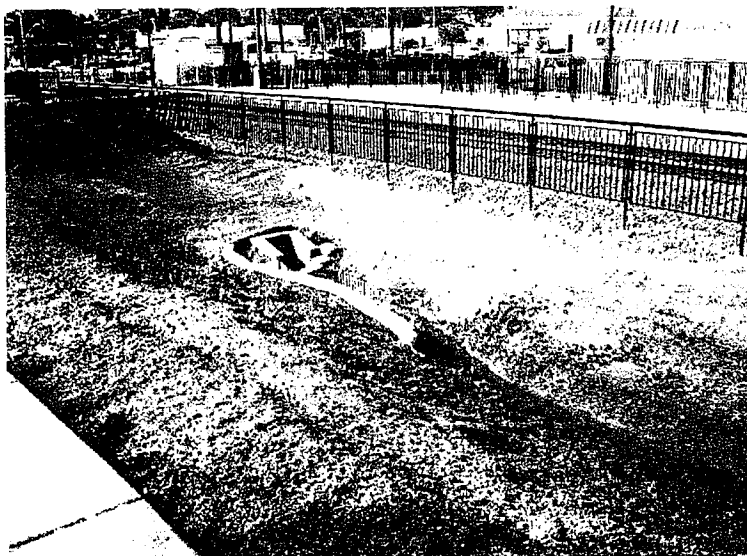
23. Incomplete stabilization along an earthen channel.

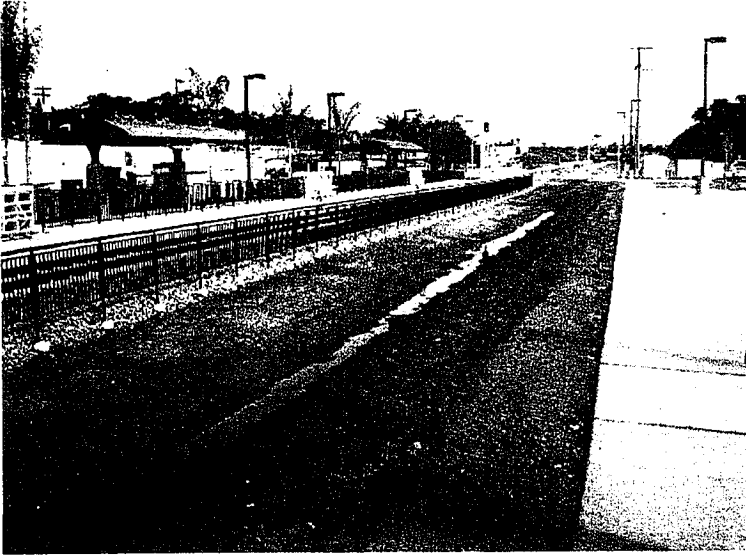
24. Another view of the unstabilized slope and channel shown in Photo 23.

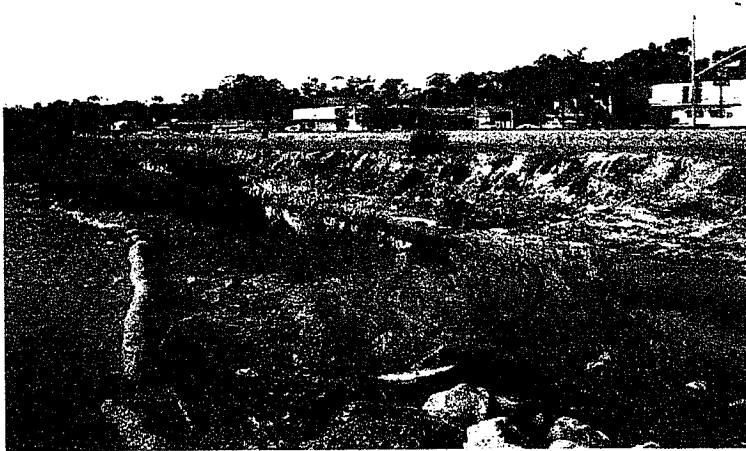
7. Crouch Street Station in Oceanside. Photos 23 and 24 show a channel which lacks stabilization on one side. A fiber roll on top of the south bank of Loma Alta Creek which had been allowing rills to form under it during prior rainfall events still has not been staked in. The fiber roll is shown in Photo 25. The area around the fiber roll has been sprayed with a stabilizer.

25. Fiber rolls still not trenched in. Previously, water has formed rills below untrenched fiber rolls.

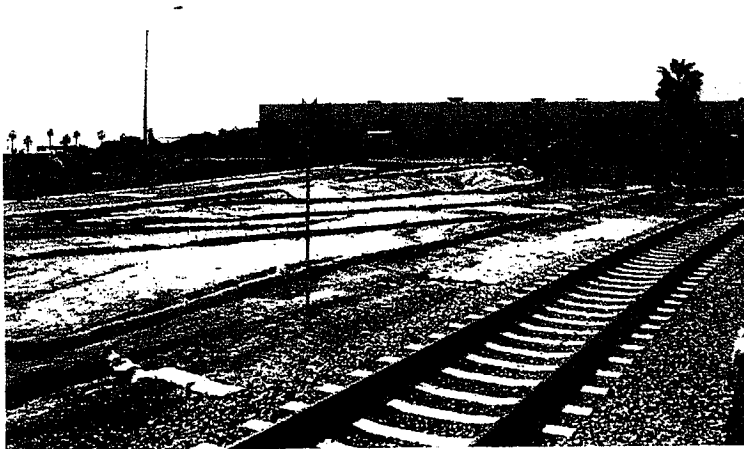
26. Improvements in this area include use of plastic sheeting, more fiber rolls and additional gravel bags.

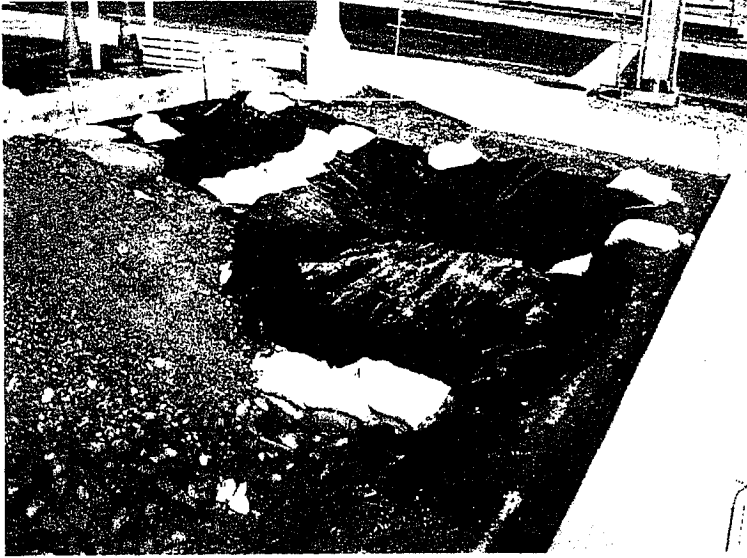
27. Inlet protection has improved at this location.

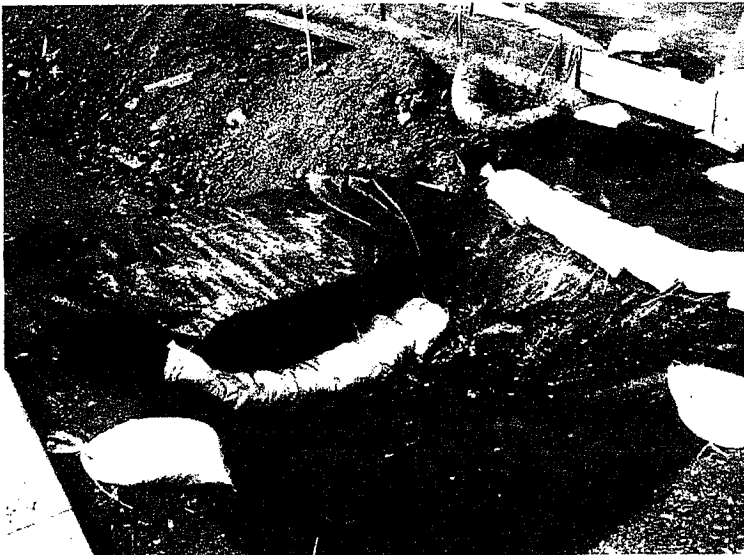
28. Another inlet with improved protection.

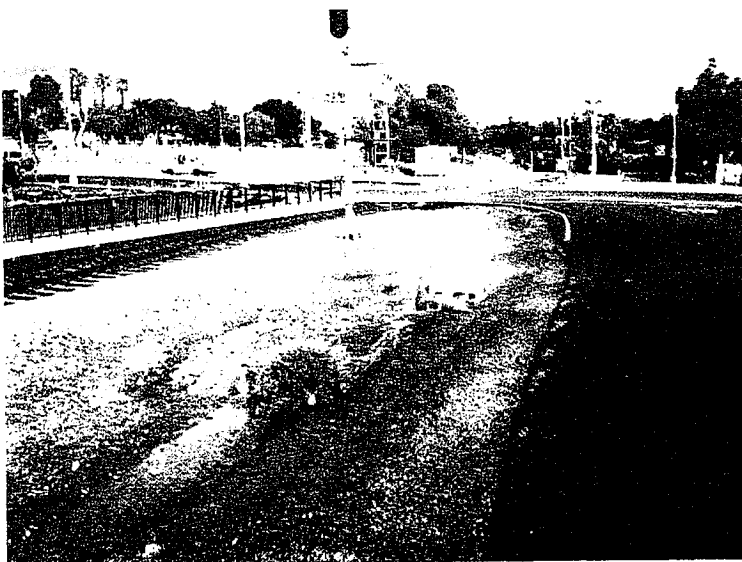
29. Lack of stabilization on one side of channel leading to storm drain.

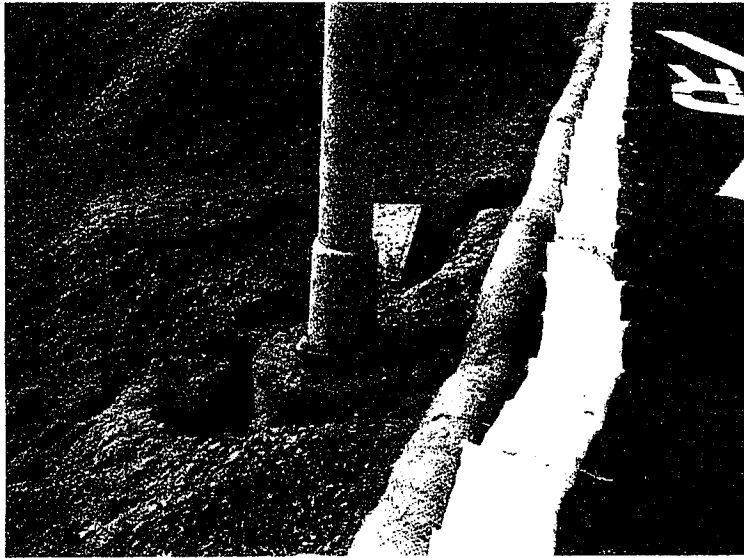
30. Gully undermining a light pole.

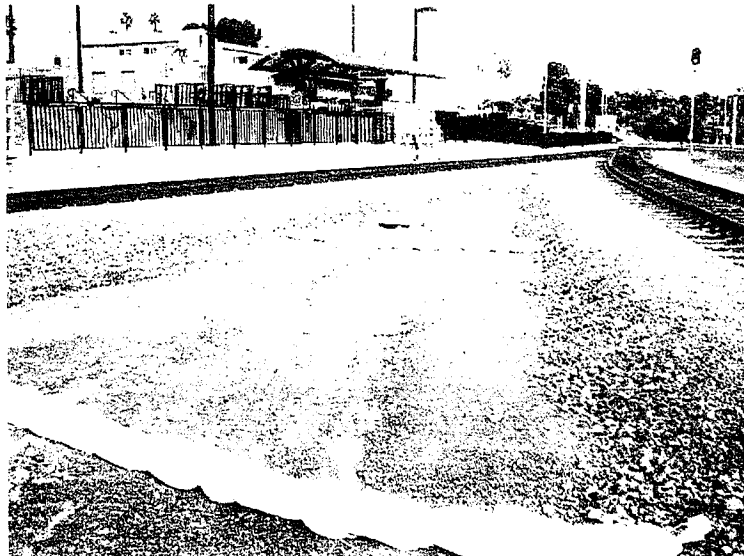
31. Exposed soil in front of inlet lacks erosion controls.

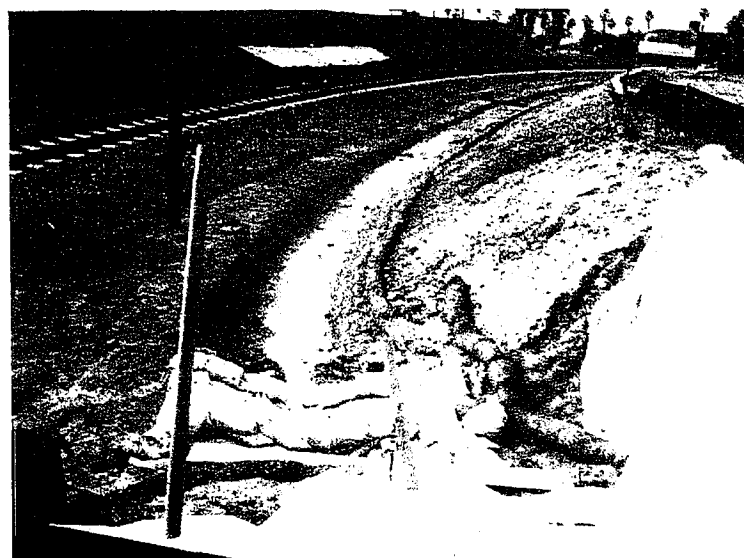
32. Inlet protection has been upgraded but channel still lacks erosion controls.

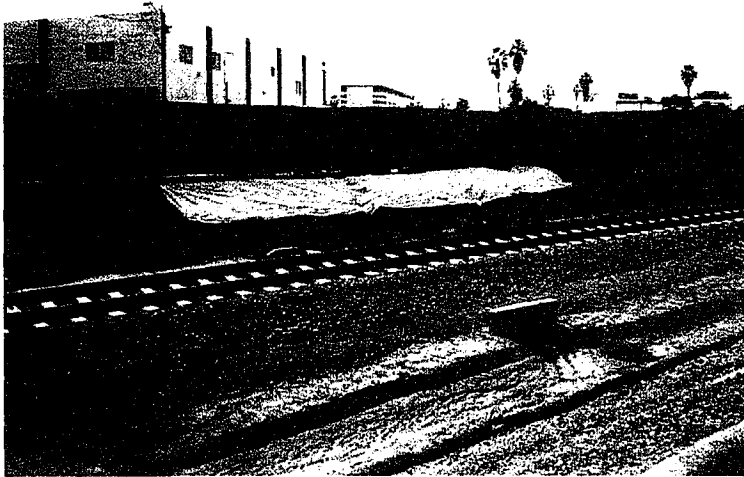
33. Slope is only partially covered with plastic.

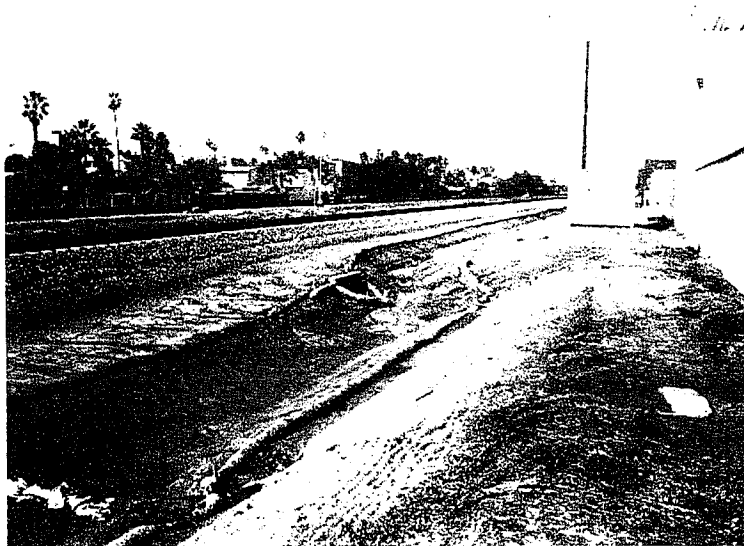
34. Partial stabilization on one side of the channel.

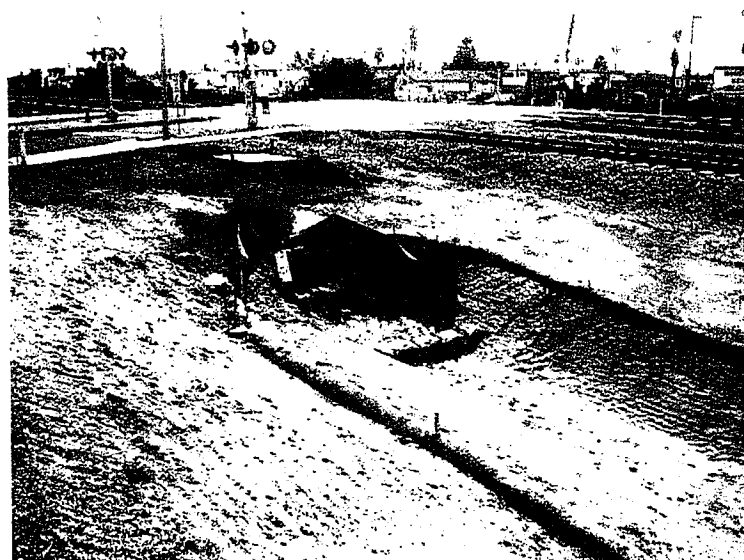
35. Another view of the channel in Photo 37 which lacks adequate stabilization.

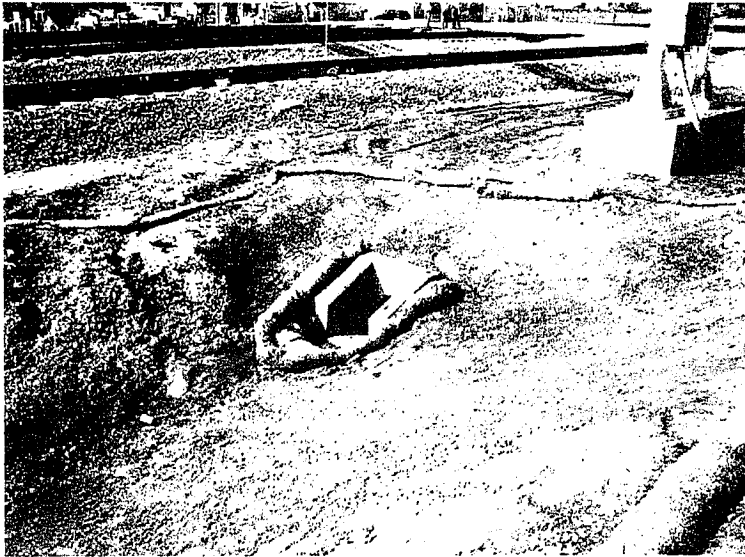
36. Inadequate inlet protection and no erosion controls.

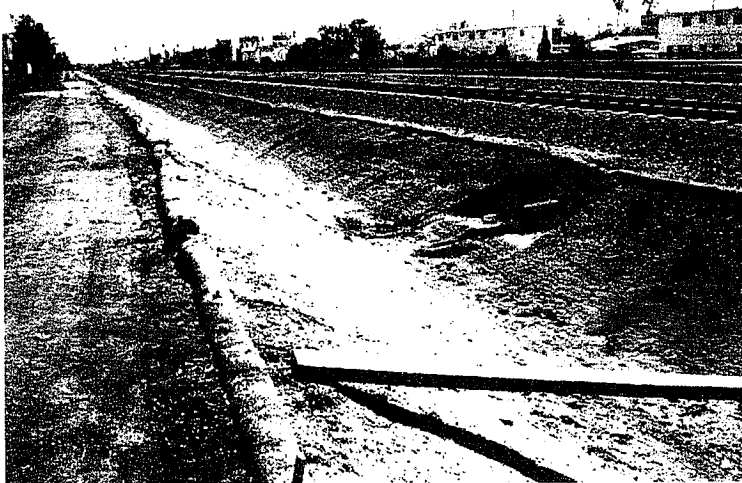
37. Only one side o this channel is stabilized. Channel leads to inlet shown in Photo 39.
