**CALIFORNIA REGIONAL WATER QUALITY CONTROL BOARD - SAN DIEGO REGION
WATERSHED PROTECTION PROGRAM**

FACILITY INSPECTION REPORT

FACILITY: Estates at Costa del Mar

INSPECTION DATE/TIME: 01/07/14; 10:30 am

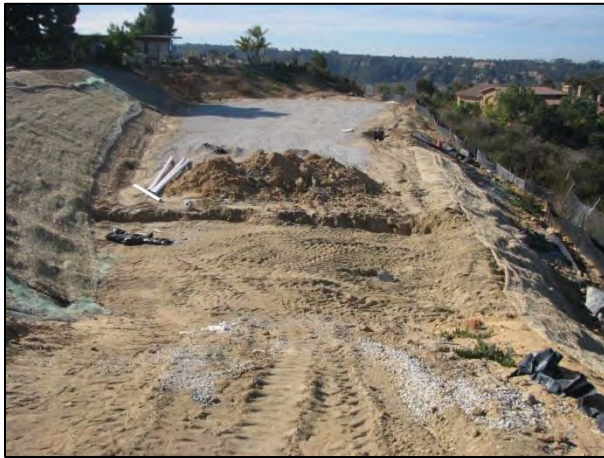
Photo 1

- a. Several slopes located in the interior and exterior of the site appeared to be inactive and had inadequately implemented, inadequately maintained, or did not have erosion control BMPs to provide effective soil cover and stabilization (see Photos 1-4);

- b. Most of the building pads appeared to be inactive and had a layer of gravel, but no erosion control BMPs (e.g. soil binder, bonded fiber mulch) providing effective soil cover were observed (see Photos 1, 5 and 6);

- d. Linear sediment controls were not observed along the toe of slopes and grade breaks of exposed slopes, as required for Risk Level 2 sites (see Photos 1-4)

10. BMPs that had been implemented throughout the site were not being adequately maintained (see Photos 1-4).
11. The QSP is not implementing the housekeeping BMPs and erosion and sediment control BMPs in accordance with the BMPs that are specified in the SWPPP provided by Mr. Cooper on January 13, 2014.

Photos 1-4 show lack of erosion and sediment control BMPs required to be implemented by Risk Level 2 dischargers for slopes throughout the site.

4. The site requires adequate erosion control and sediment control BMPs. All slopes require soil stabilization such as hydroseed, bonded fiber matrix, or erosion control blankets.

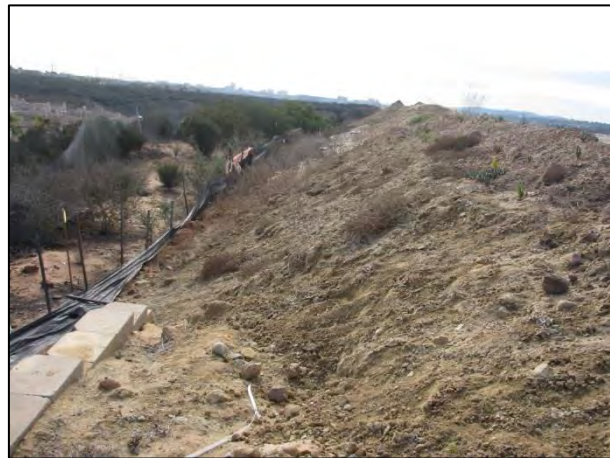
Photo 4

- e. Silt fence was observed around the perimeter of the site, but did not appear to be adequately maintained to sufficiently control erosion and sediment discharges from the site (see Photos 4 and 7); and

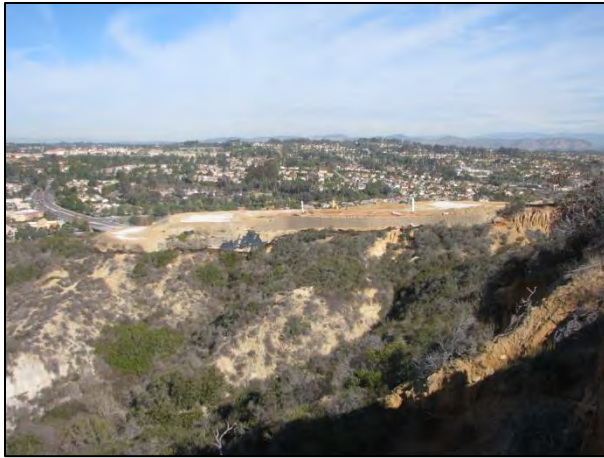
Photo 5

Photos 5-6 show lack of erosion control BMPs implemented to provide effective soil cover for building pads that appears to be inactive at the site (also see Photo 1).

6. Stabilization is required for inactive (i.e. not scheduled to be re-disturbed for at least 14 days) open spaces, utility backfill, and completed lots.

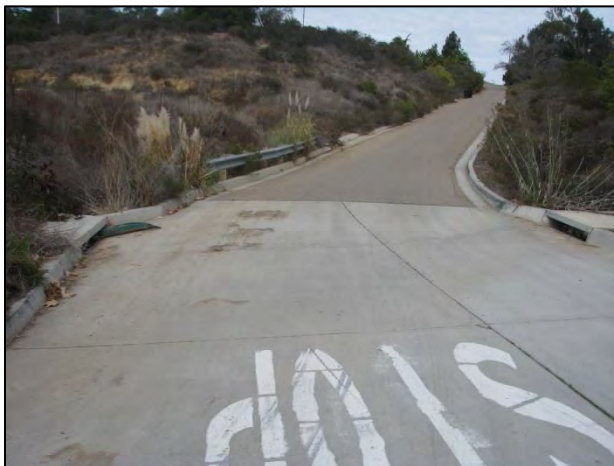
9. Storm drain inlets were inadequately protected, and evidence of sediment in surface runoff discharged from the site leading to the inlets was observed (see Photos 8).

Photo 8 shows lack of BMPs to protect storm drain inlets, with evidence of sediment in surface runoff discharged from the site leading to the inlets.
