California Regional Water Quality Control Board, San Diego Region

SUBJECT: SAN MARCOS II LANDFILL INSPECTION REPORT

Landfill Inspection Report

Name of Facility: San Marcoss II Landfill
Owner: County of San Diego
Operator: County of San Diego
Facility Address: San Elijo Road
RB Inspector: Sean McClain

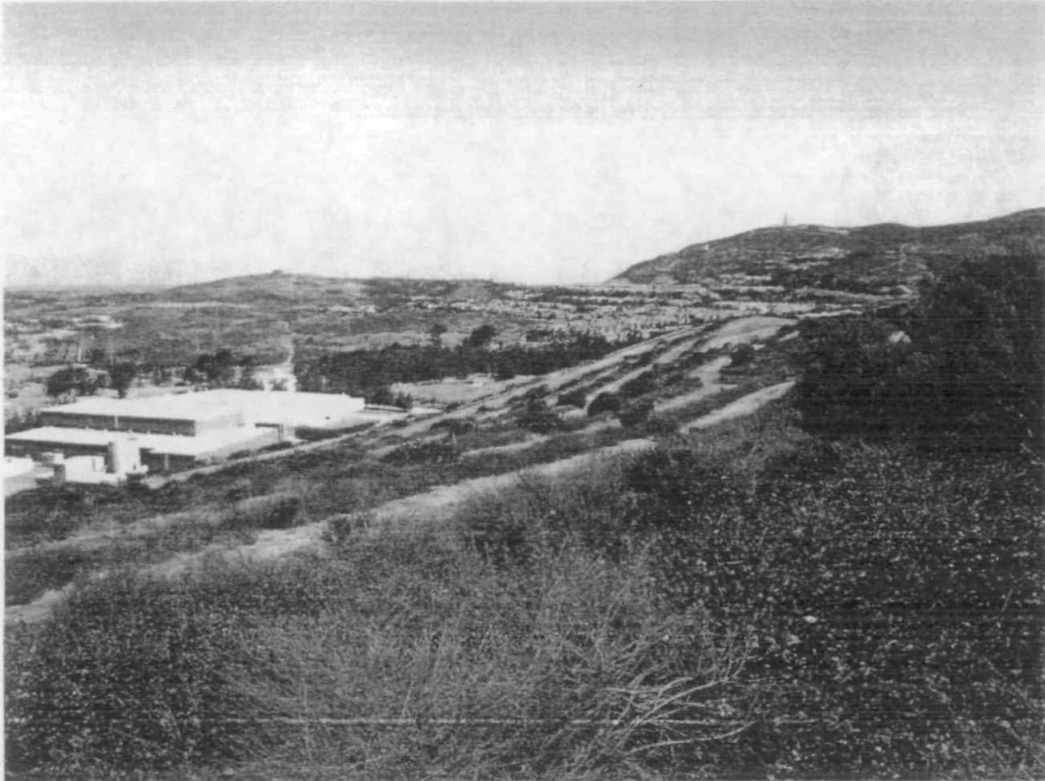
Photo 1 – Looking North West, bench roads and side slopes.

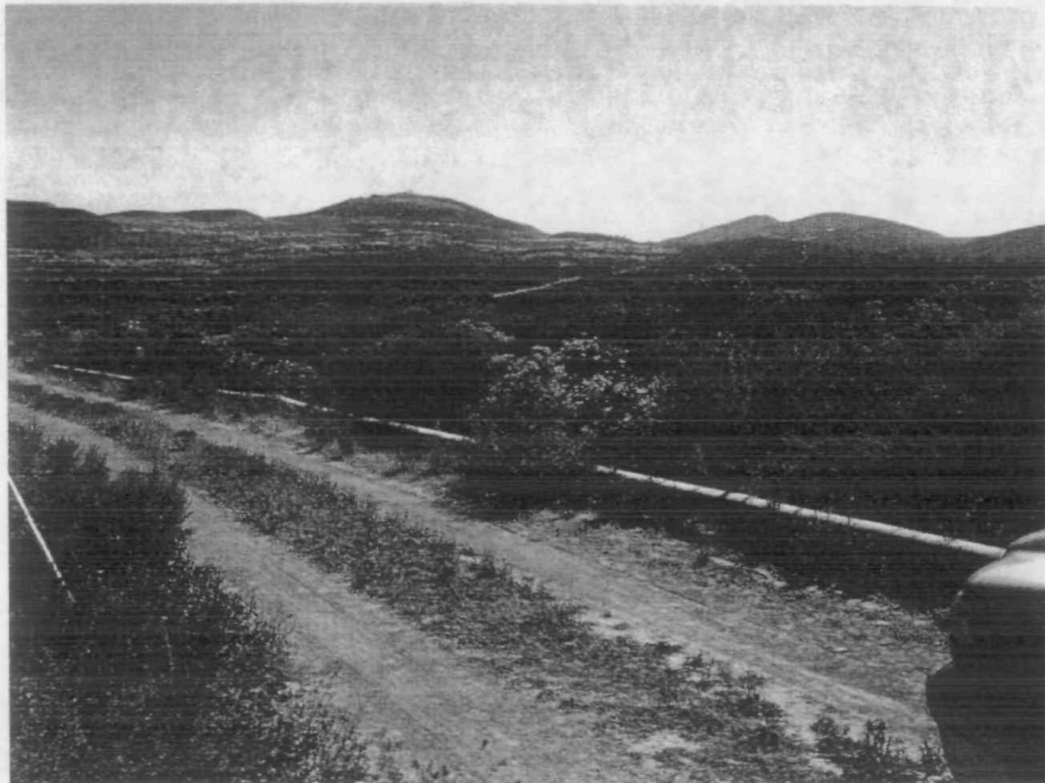
Photo 2 – Top Deck, looking North East.

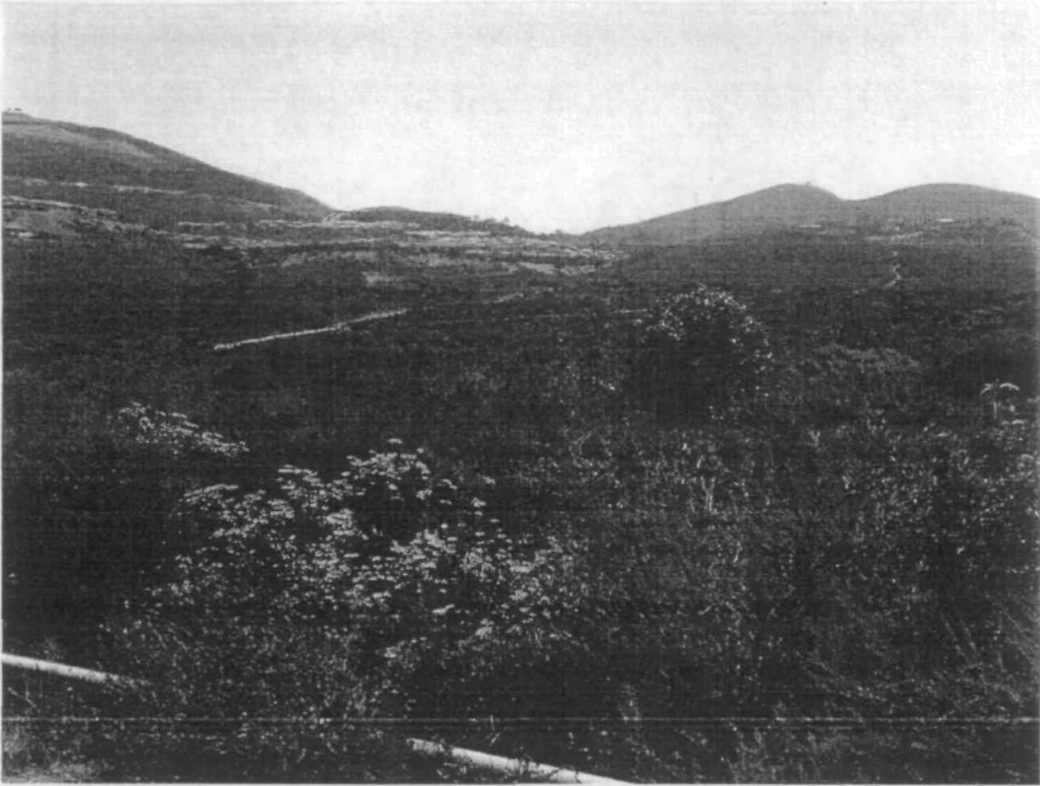
Photo 3 – Top Deck, looking East

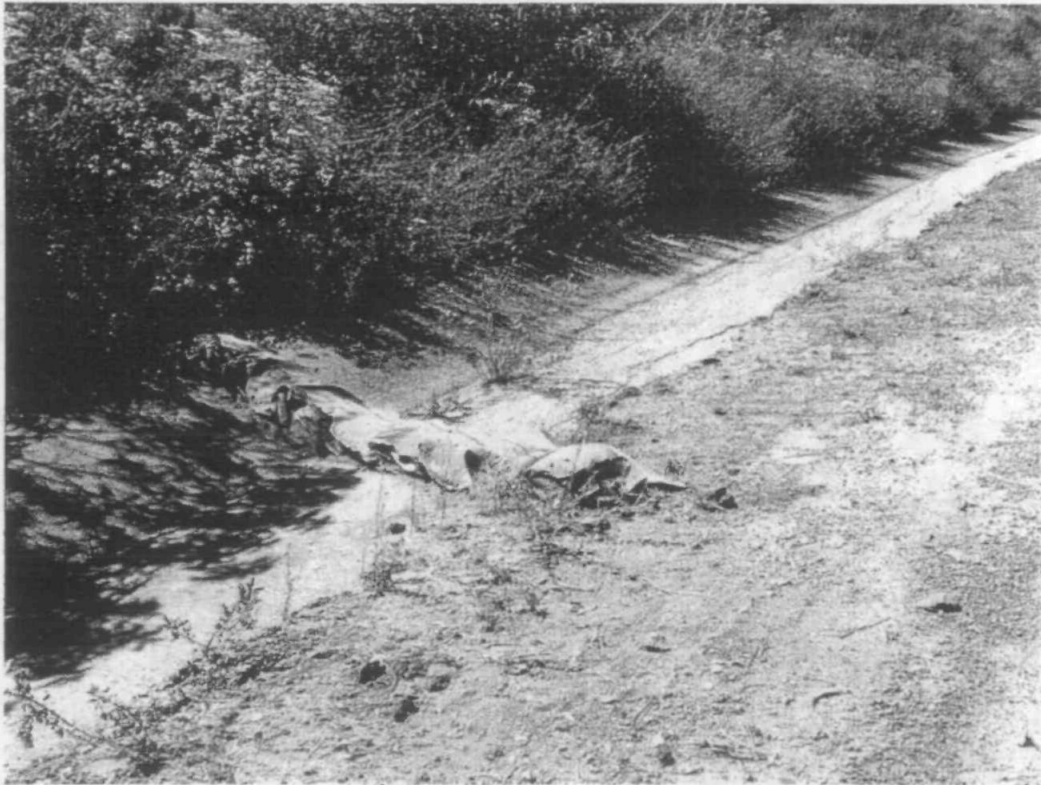
Photo 4 – Drainage channel on 2nd Bench road from top deck.

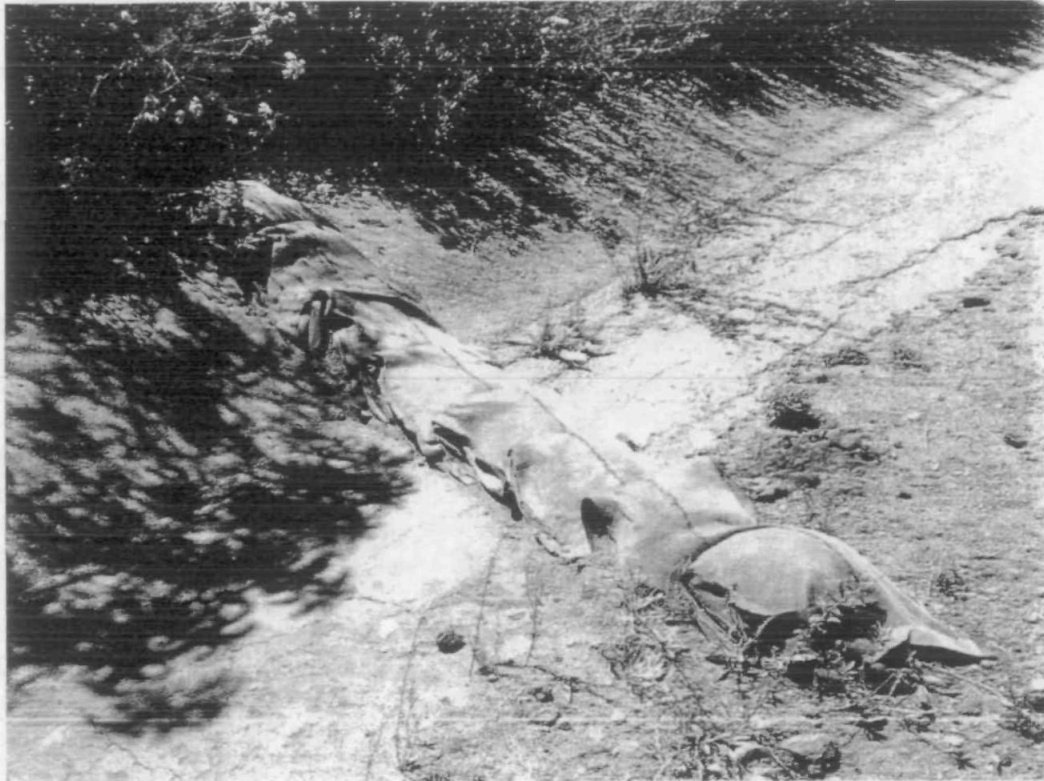
Photo 5 – Same as Photo 4

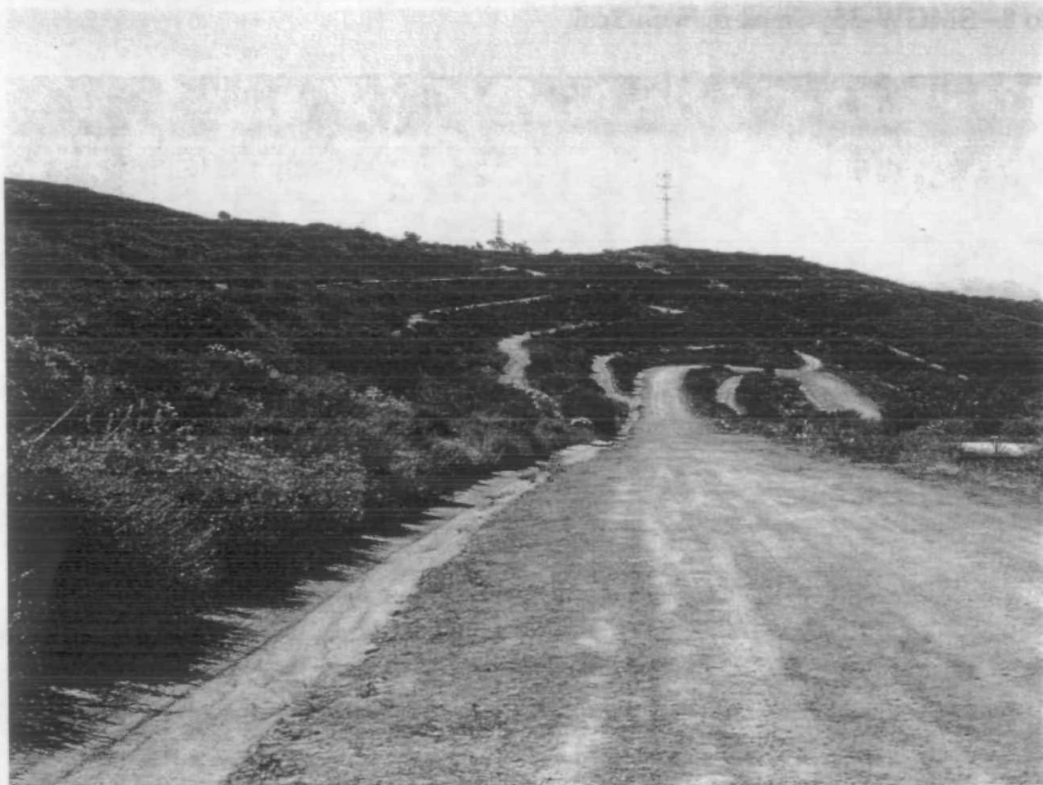
Photo 6 – Looking South, Main Road to top and bottom of Landfill.

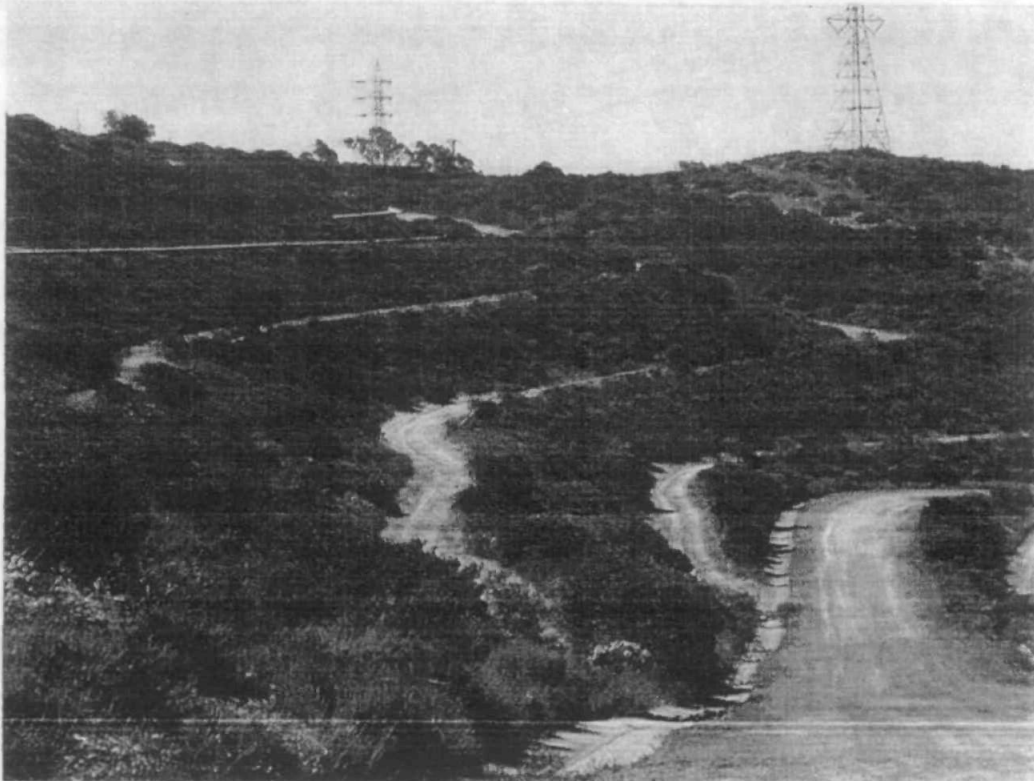
Photo 7 – Same as Photo 6.

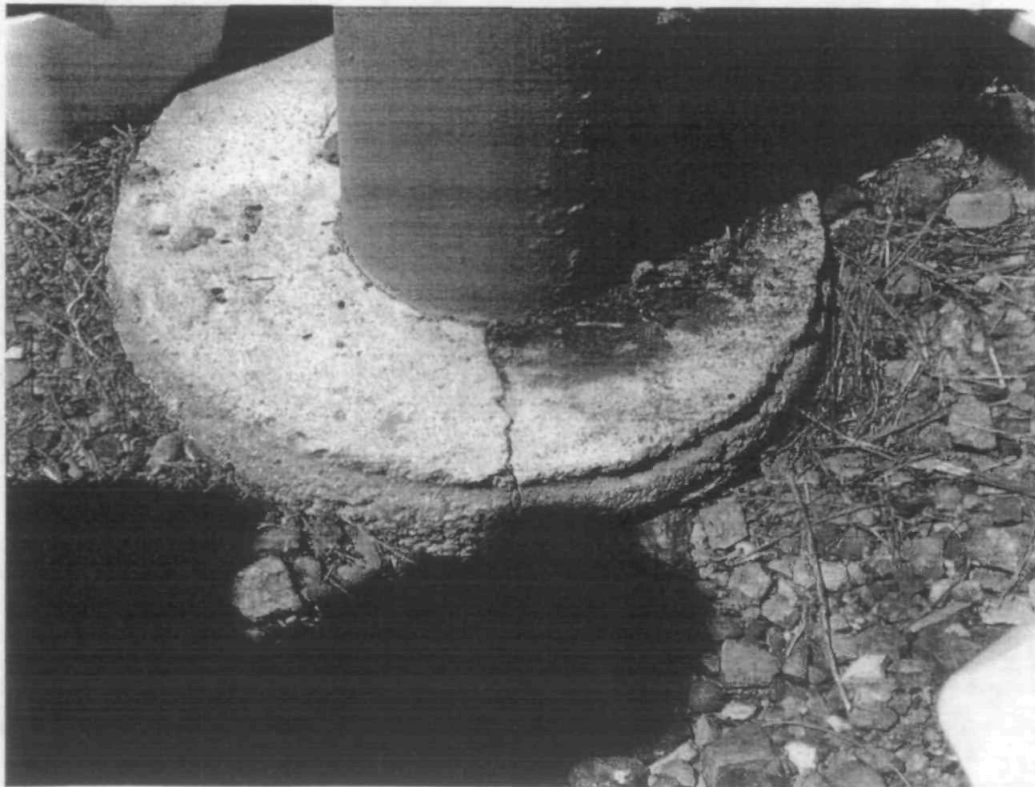
Precipitation/Drainage Controls	
Yes	Is Drainage System Adequate?*	Yes
	*If no, identify: Erosion, Downcutting, Flooding, Ponding, Does Not Control Peak Flows	
	Water Quality Monitoring Program	
	Type of Monitoring Program: Surface Water, Groundwater, Unsaturated Zone, Condensate, Leachate, Other	Surface water, groundwater, vapor probes, landfill gas.
Yes	Is Monitoring Program Adequate?*	Yes
	Wells secured, construction Problem, Broken, Could Not Find, Unknown	Cracked concrete well seal for SMGW-36. This well seal is inadequate.
No	Samples Collected? (sample no. & location)

- Cracked concrete well pad for SMGW-35 (Attachment 1, Photo 8 and 9).

Photo 8 – SMGW-35, Crack in Well Seal.

The violation cited in the Inspection Report must be repaired by August 30, 2012. Once the violation has been addressed, please send me documentation of the repair.

Please take steps to correct this violation, no later than August 30, 2012. Contact me at 858-627-3988 if you have any questions.

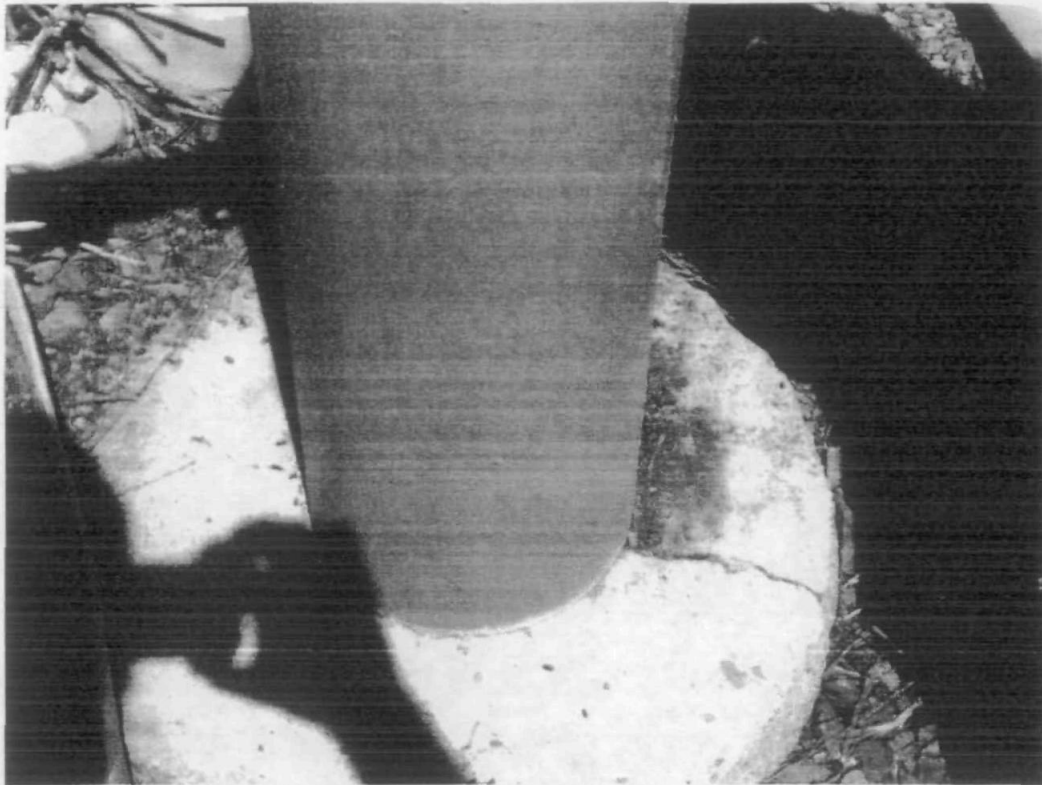
Photo 9 –SMGW-35, Crack in Well Seal.

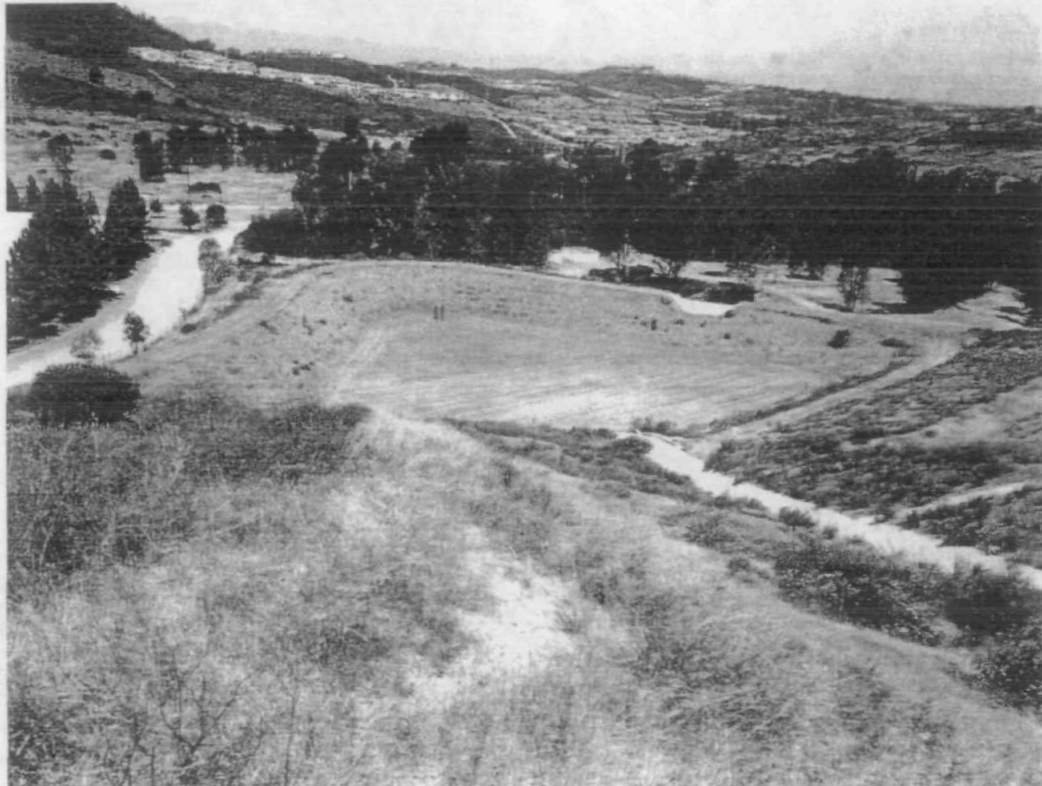
Photo 10 –North West Detention Basin

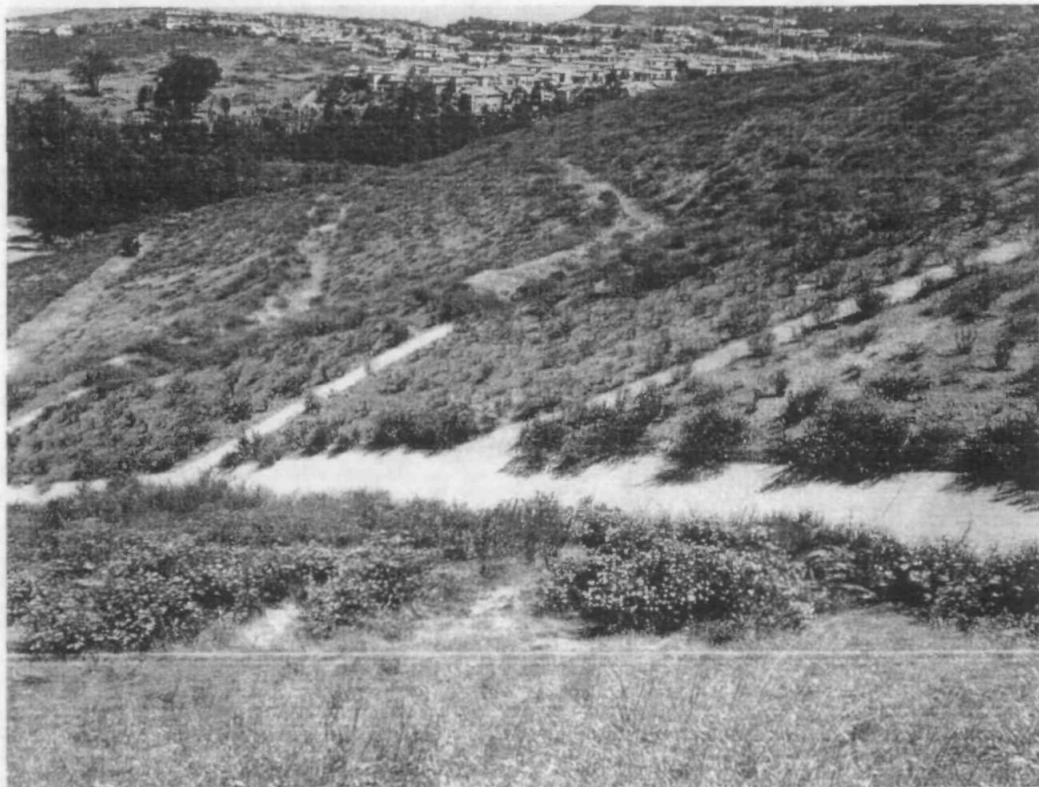
Photo 11 – Northern Slope

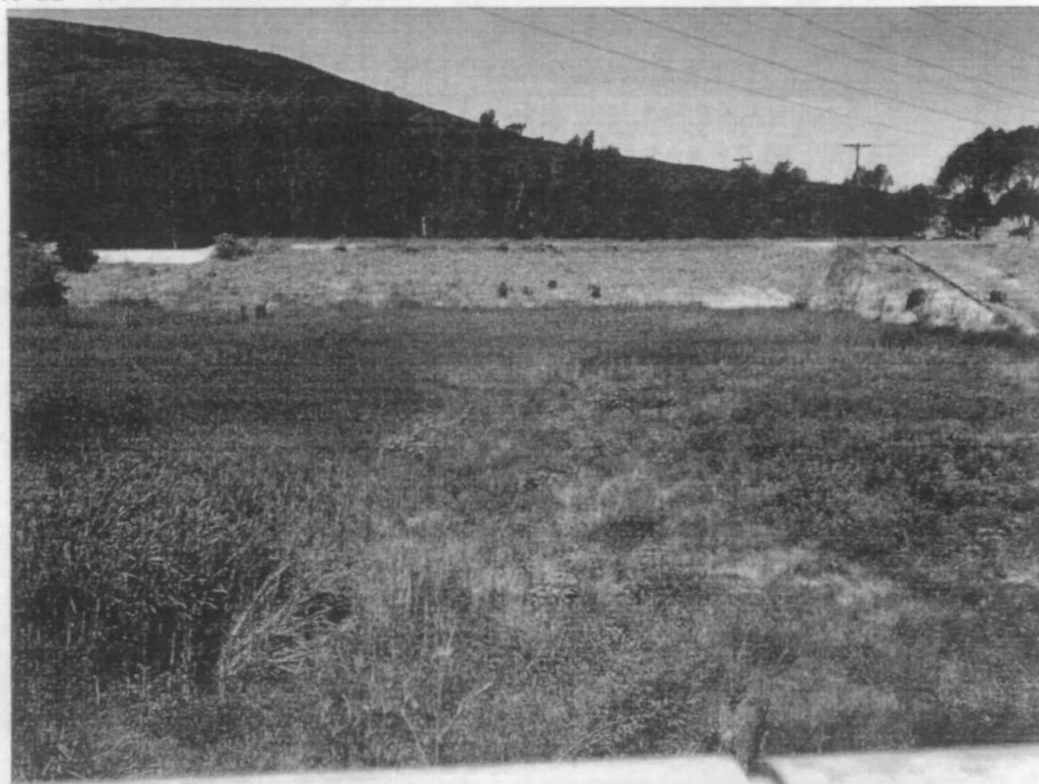
Photo 11 – Western Detention Basin

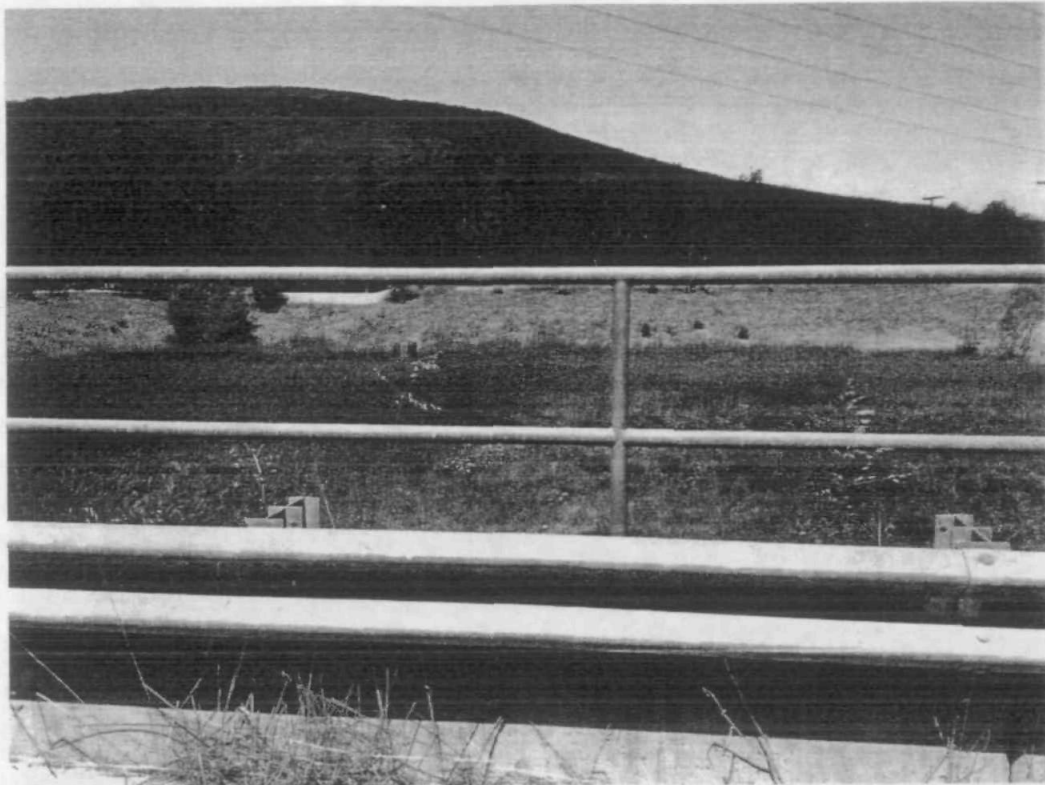
Photo 12 – Same As Photo 11.

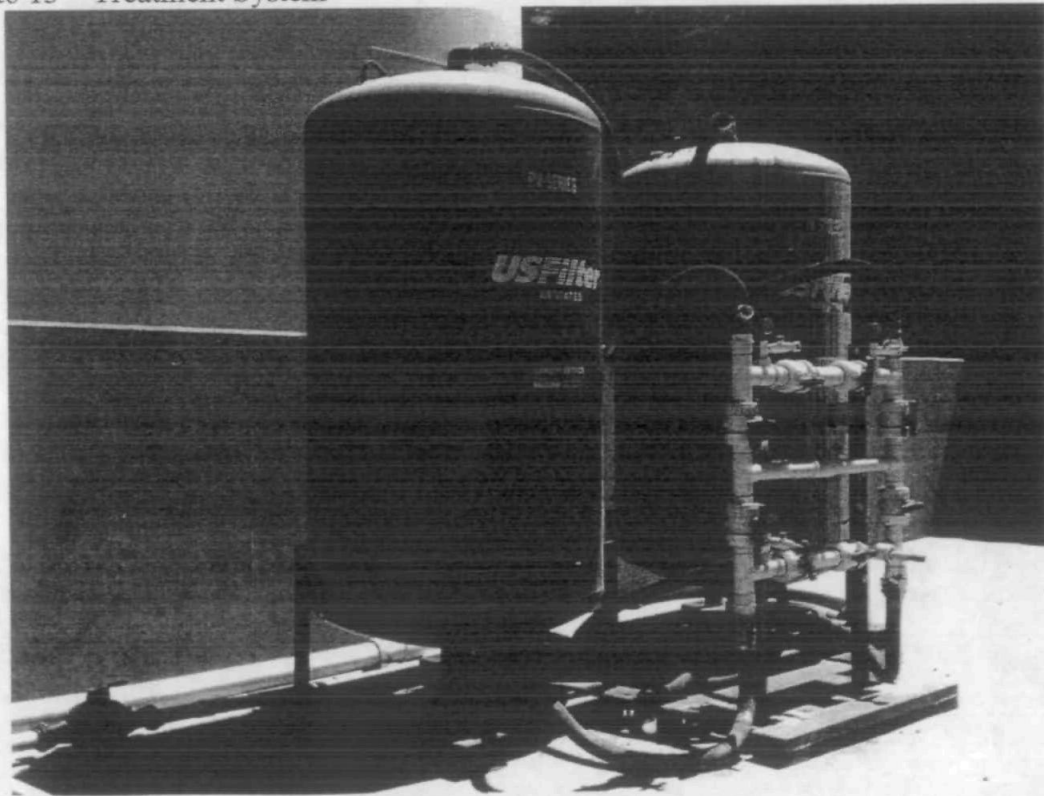
Photo 13 – Treatment System

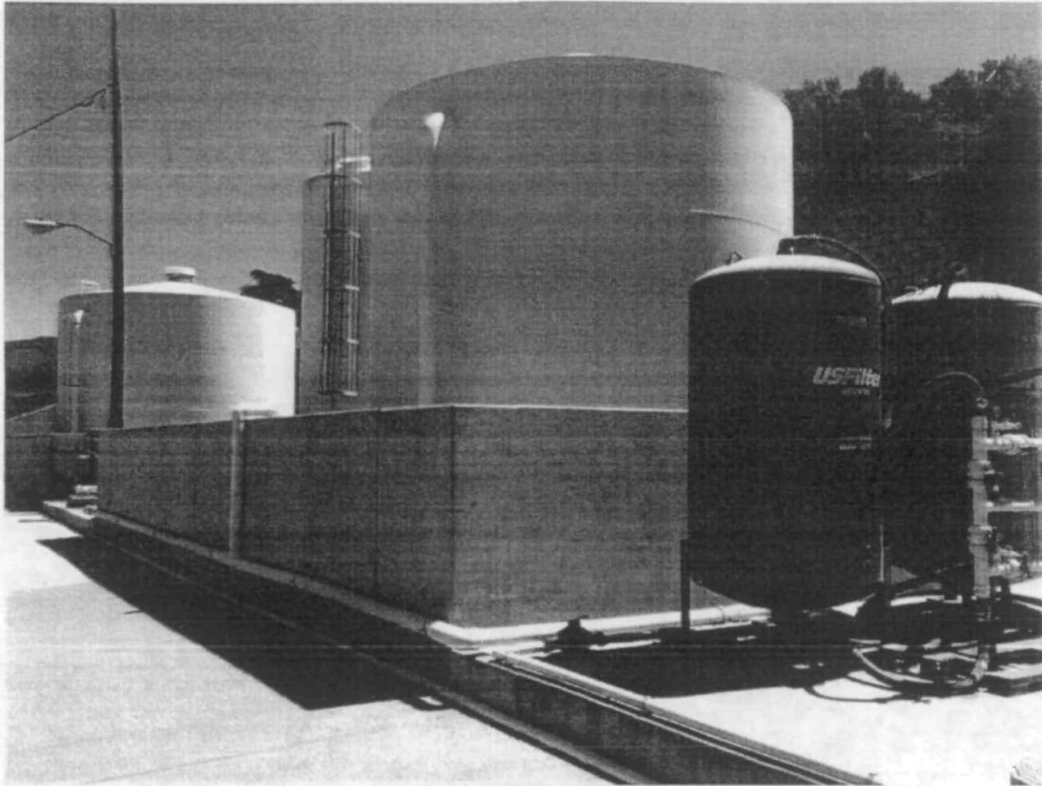
Photo 14 – Treatment System

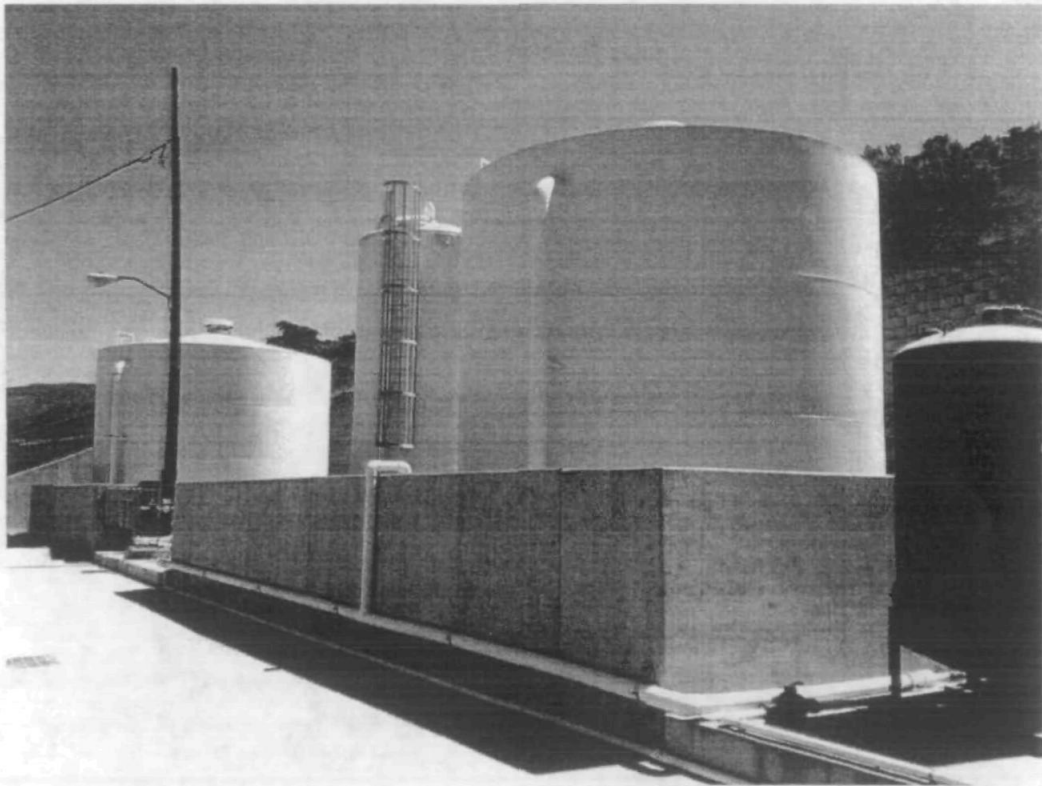
Photo 15 – Leachate Collection Tanks.

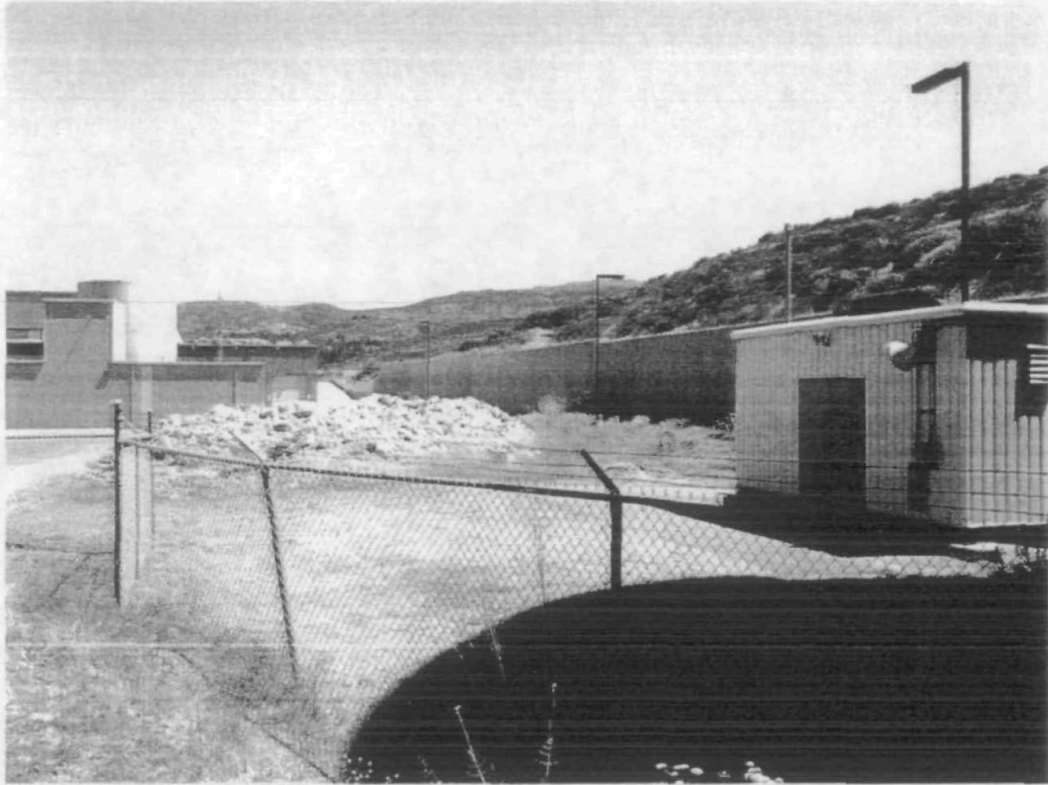
Photo 16 – Landfill retaining wall.

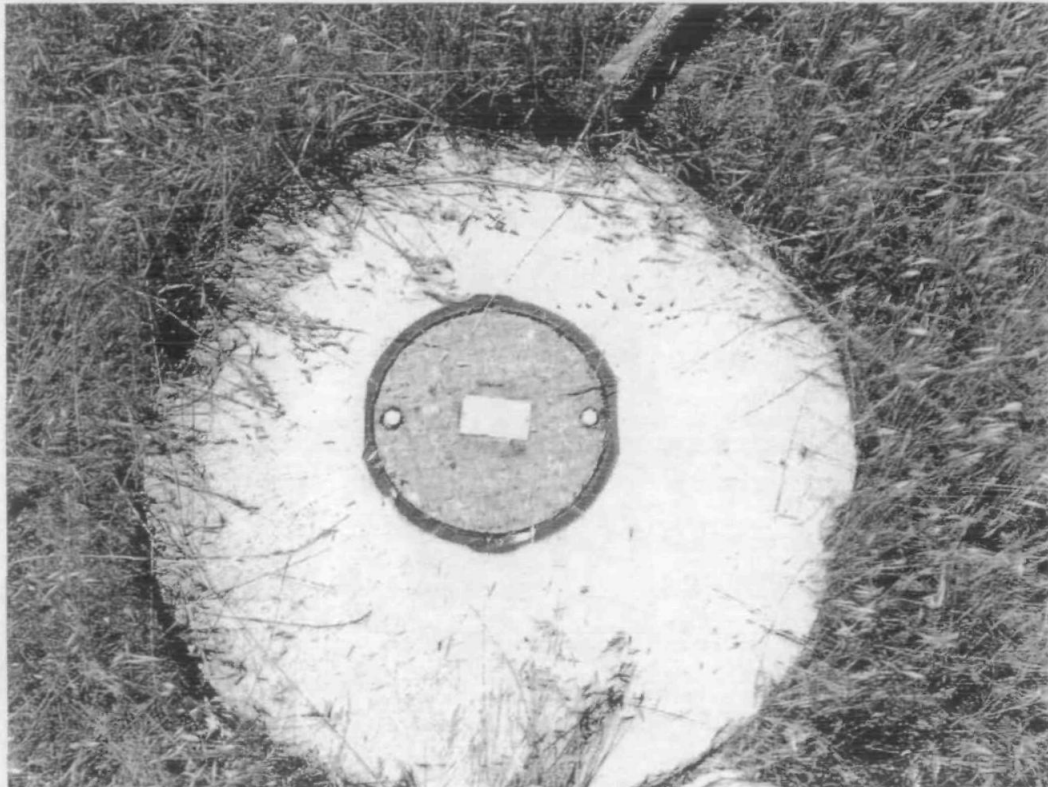
Photo 17 – SMGW-40
