Subject: Notice of Violation No. R9-2014-0033, Airport Construction Storm Water Management Program, Order No. R9-2007-0001, NPDES Permit No. CAS0108758, AND Rental Car Center, Order No. 2009-0009-DWQ, NPDES Permit No. CAS000002

**NOTICE OF VIOLATION
No. R9-2014-0033**

Facility: San Diego International Airport MS4
Inspection Date: 2/27/2014

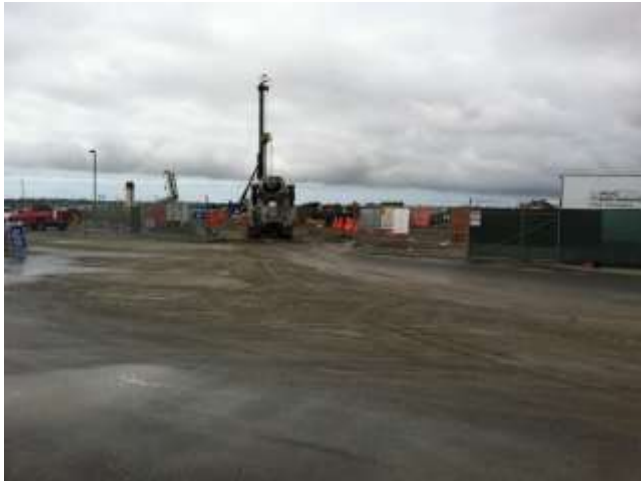
- c. **Observation:** During the February 27, 2014 inspection, the San Diego Water Board inspector observed significant off-site tracking of sediment originating from the site, constituting an unauthorized non-storm water discharge from the site. The off-site tracking was the result of construction traffic to and from the site. The construction traffic caused the unauthorized non-storm water discharge into the Airport's MS4. See attached February 27, 2014 Facility Inspection Report Photos 1 through 3.

Photo 1 shows a cement truck entering the Rental Car Center construction site when the San Diego Water Board inspector arrived on site. Significant off-site tracking of sediment can be observed outside the entrance/exit of the site on Sassafras Street.

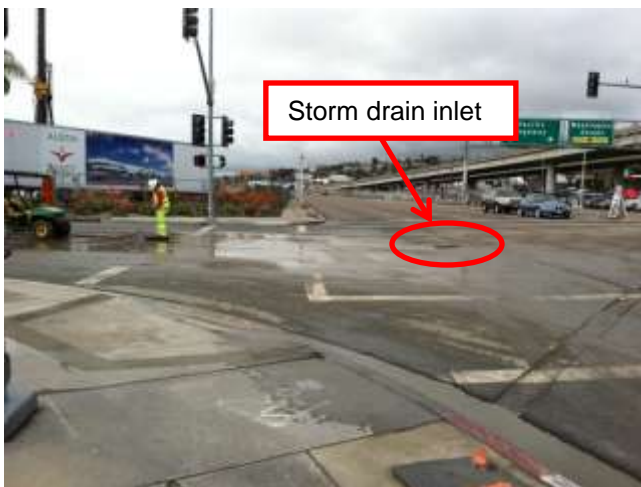
3. At the intersection of Pacific Highway and Sassafras Street, the San Diego Water Board inspector observed highly turbid ponded water very close to an unprotected storm drain inlet located near the center of the intersection, coming from Sassafras Street, which is part of the Airport's MS4. Vehicles driving through the ponded water and through the intersection were causing the water to enter the storm drain inlet. (See Photos 2-3). A person that appeared to be from the Rental Car Center construction site was observed by the San Diego Water Board inspector to be attempting to clean up the turbid ponded water (See Photo 2).

Photo 2 shows turbid ponded water on Sassafras Street that can be discharged into the storm drain inlet in the intersection with Pacific Highway when vehicles drive through ponded water. Significant off-site tracking of sediment can be observed in the intersection of Sassafras Street and Pacific Highway.

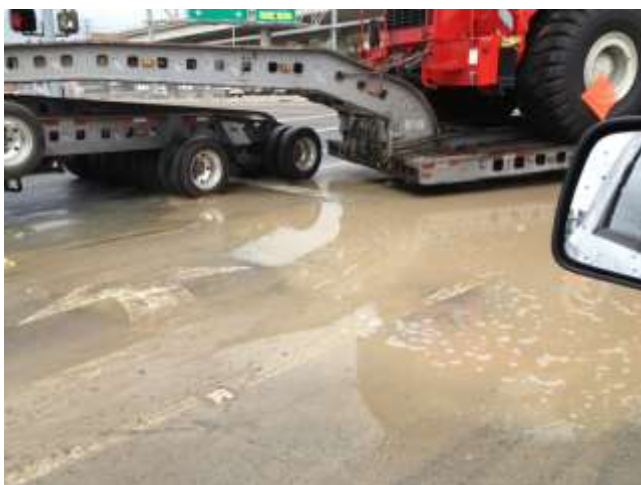
4. The ponded water observed on Sassafras Street appeared to be the remnants of the rainfall from earlier in the day. The source of the turbidity in the ponded water appeared to be due to the off-site tracking of sediment by the cement trucks and other vehicles leaving the Rental Car Center construction site via Sassafras Street. Tracking control BMPs were in place, but were obviously inadequate and ineffective at preventing sediment from being discharged from the site. Significant tracking of sediment was observed in Sassafras Street and into the Pacific Highway intersection (See Photos 2-3).

Photo 3 shows a large vehicle driving through turbid ponded water over the storm drain inlet shown in Photo 2.

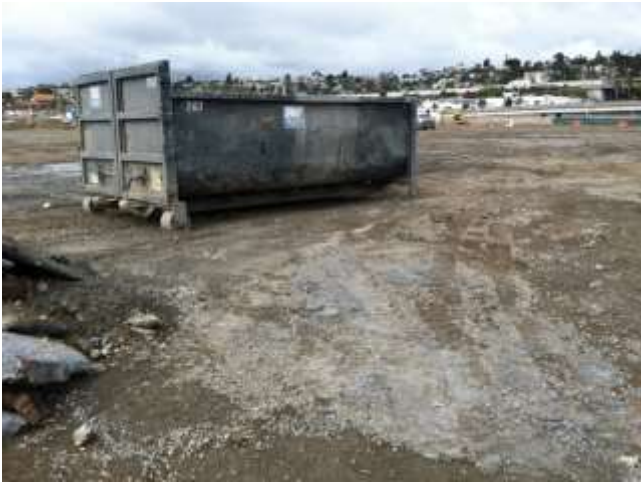
Photo 4 shows concrete waste materials that have been discharged to a pervious surface on the site. The waste container in the picture does not have a cover, or evidence that a cover was in place during the rainfall that occurred earlier in the day.

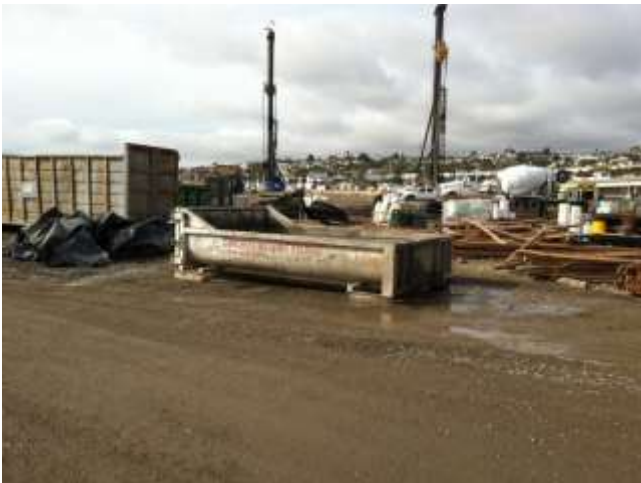
- b. Inadequate concrete waste management BMPs were observed during the inspection (See Photos 4-5).
 - c. Construction waste containers were observed to be inadequately covered, and there was no evidence that the containers were covered during the rainfall that occurred earlier in the day (See Photo 4-6).

Photo 5 shows a concrete washout that has been placed on a pervious area of the site, without any BMPs to contain potential spills. There also appeared to be concrete waste spillage around the concrete washout. The concrete washout and the waste container in the picture do not have covers, or evidence that any covers were in place during the rainfall that occurred earlier in the day.

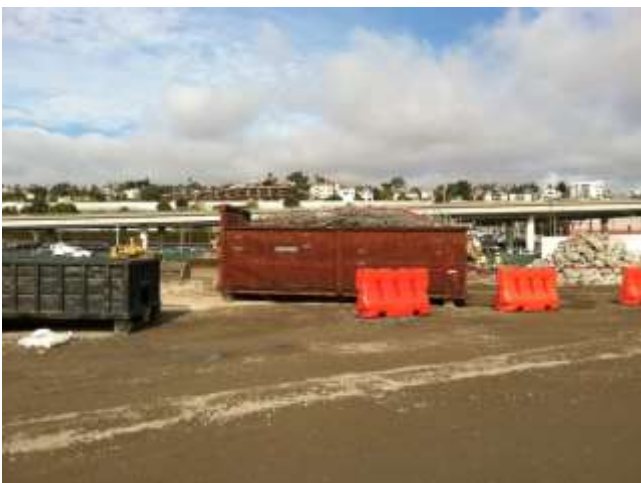
Photo 6 shows two waste containers that do not have covers, or evidence that any covers were in place during the rainfall that occurred earlier in the day. The picture also shows a construction waste stockpile without cover or containment, or evidence that any cover or containment were in place during the rainfall that occurred earlier in the day.

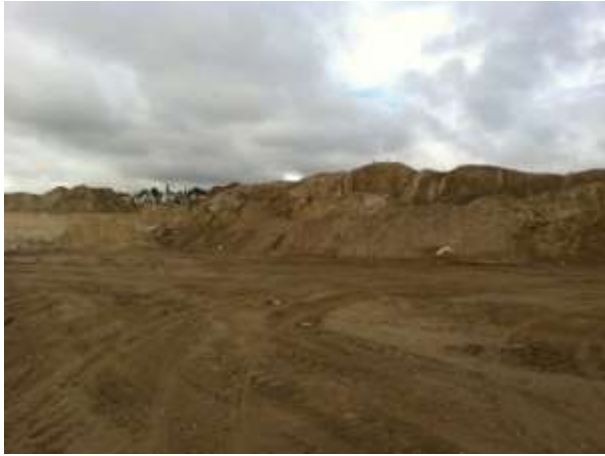
- d. Construction waste and soil stockpiles were observed throughout the site without adequate cover or containment, and there was no evidence that cover or containment had been provided during the rainfall that occurred earlier in the day (See Photos 6-8).

Photo 7 shows soil stockpiles without cover or containment, or evidence that any cover or containment were in place during the rainfall that occurred earlier in the day.

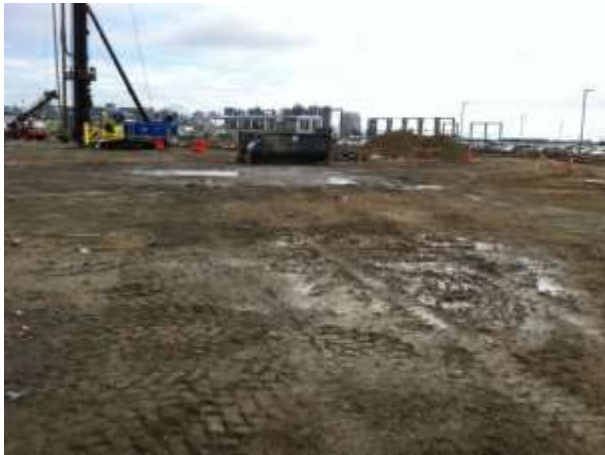
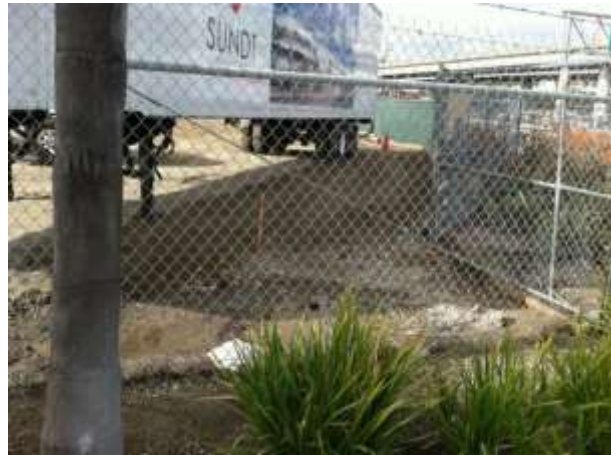
- e. Several areas of the site were observed to be inactive, or could be scheduled to be inactive, without effective soil cover or other BMPs that could prevent erosion (See Photos 8-9).

Photos 8 and 9 shows areas of the site without any effective soil cover or other BMPs to prevent erosion that do not appear to have any construction activity that is necessary and could be considered inactive, or scheduled to be inactive. Photo 8 also shows a soil stockpile without cover or containment, or evidence that any cover or containment were in place during the rainfall that occurred earlier in the day. Photo 8 also shows concrete waste materials that have been discharged to a pervious surface on the site.

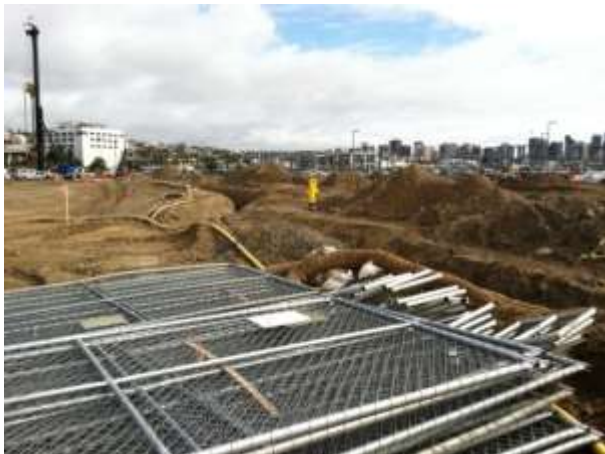
- a. **Pursuant to Provision E.1 of Attachment C to State Water Board Order No. 2009-0009-DWQ:** Risk Level 1 dischargers shall establish and maintain effective perimeter controls and stabilize all construction entrances and exits to sufficiently control erosion and sediment discharges from the site.
- b. **Observation:** During the February 27, 2014 inspection, the San Diego Water Board inspector observed significant off-site tracking of sediment originating from the site, due to ineffective perimeter controls. In addition, at least one section of the perimeter controls was observed to be missing, thus inadequate and ineffective. See attached February 27, 2014 Facility Inspection Report Photos 1 and 10.

Photo 10 shows a gap in the perimeter sediment controls that would potentially allow run-on to or run-off from the site.
