**NOTICE OF VIOLATION  
No. R9-2014-0145**

Northwest Village Creek Construction Project  
PIN No. SM-828254:wchiu

**FACILITY INSPECTION REPORT**

**FACILITY:** Northwest Village Creek (Walgreens)      **INSPECTION DATE/TIME:** 12/4/2014; 11:30 am

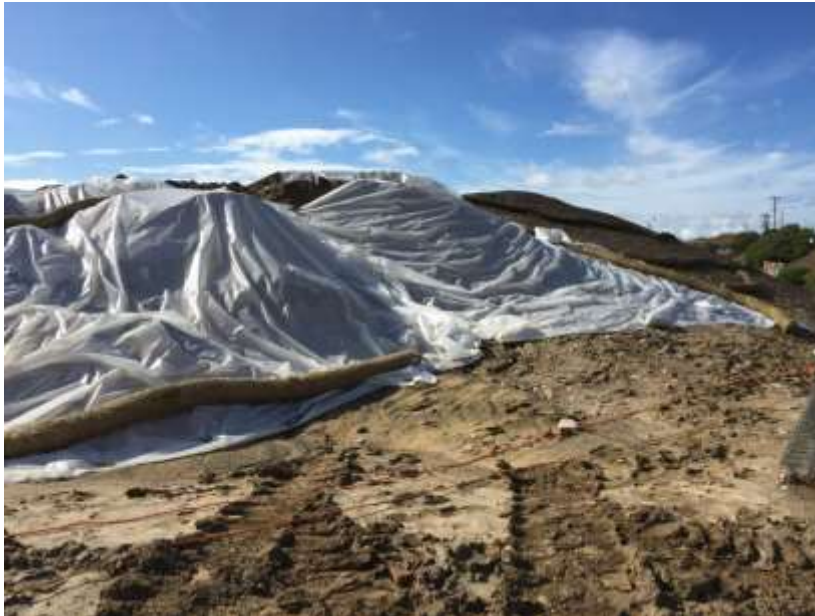
- c. Observation:** During the December 4, 2014 inspection, the San Diego Water Board inspector observed soil stockpiles that appeared to be inactive, or could be scheduled to be inactive without adequate cover, berm, containment or protection, resulting in erosion and sediment transport. See attached December 4, 2014 Facility Inspection Report Photos 1 and 4 through 8.

**Photo 1** show soil stockpile without adequate cover or containment. Evidence of erosion and sediment transport along that base of the stockpile. Photo taken by San Diego Water Board inspector on December 4, 2014.

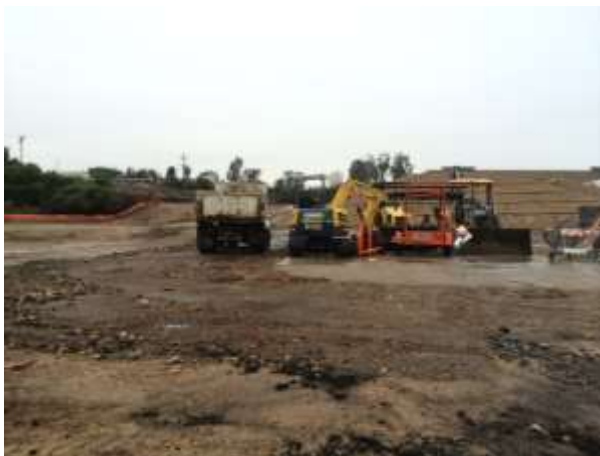
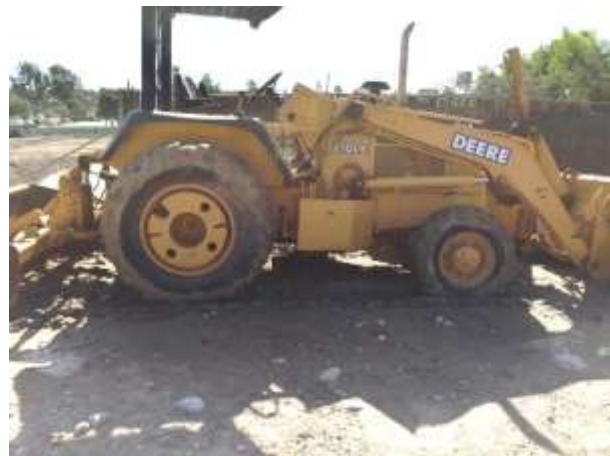
- a. Pursuant to Provision IX and Section B.3.a of Attachment C of State Water Board Order No. 2009-0009-DWQ:** Risk Level 1 dischargers are required to prevent oil, grease, or fuel to leak in to the ground, storm drains or surface waters.
- b. Pursuant to Provision IX and Section B.3.b of Attachment C of State Water Board Order No. 2009-0009-DWQ:** Risk Level 1 dischargers are required to place all equipment or vehicles, which are to be fueled, maintained and stored in a designated area fitted with appropriate BMPs.
- c. Observation:** During the December 4, 2014 inspection, the San Diego Water Board inspector several construction equipment and vehicles stored without appropriate BMPs to prevent oil, grease or fuel to leak in to the ground, storm drains or surface waters. See attached December 4, 2014 Facility Inspection Report Photos 2 and 3.

3. Several construction equipment and vehicles observed without appropriate BMPs (e.g. drip pans) to prevent oil, grease, or fuel to leak in to the ground, storm drains, or surface waters (See Photos 2-3). All construction sites are required to prevent oil, grease or fuel to leak in to the ground, storm drains, or surface waters, and to place all equipment and vehicles, which are to be fueled, maintained and stored in a designated area fitted with appropriate BMPs.
4. Several areas were observed to be inactive, or could be scheduled to be inactive, without effective soil cover to control potential erosion. All construction sites are required to provide effective soil cover for inactive (i.e. areas that have been disturbed and not scheduled to be re-disturbed for at least 14 days) areas and all finished slopes, open space, utility backfill, and completed lots.

**Photos 2 and 3** show construction equipment and vehicles without appropriate BMPs (e.g. drip pans) to prevent oil, grease, or fuel to leak in to the ground, storm drains, or surface waters. Photo 2 provided by concerned citizen, taken in the morning on December 3, 2014. The same vehicles were observed by the San Diego Water Board inspector on December 4, 2014, also without appropriate BMPs. Photo 3 taken by the San Diego Water Board inspector on December 4, 2014.

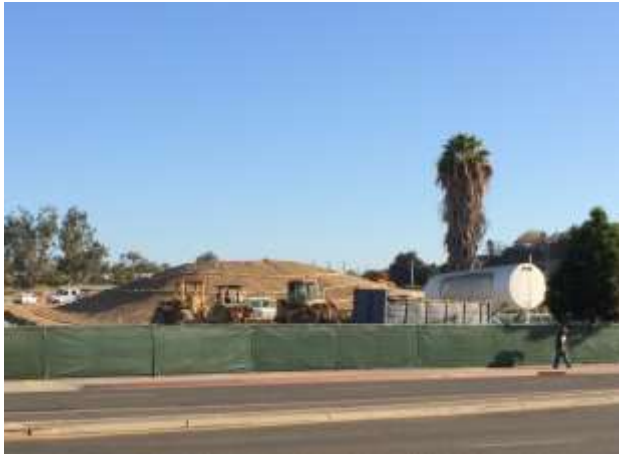
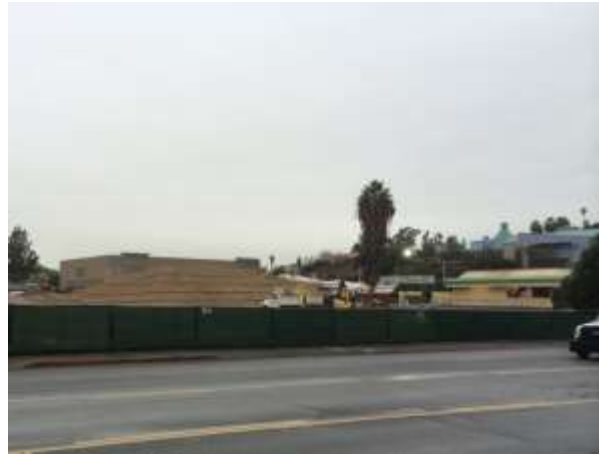
prevent erosion. In particular, a large topographic feature (claimed to be a stockpile by the site superintendent) documented by a concerned citizen from as early as September 30, 2014 to the date of the inspection (December 4, 2014), lacked any effective soil cover for erosion control. Evidence of erosion and sediment transport due to lack of erosion control measures were observed throughout the site during the inspection. See attached December 4, 2014 Facility Inspection Report Photos 4 through 8.

In particular, a large topographic feature (claimed to be a stockpile by Mr. Dipalma) documented by a concerned citizen from as early as September 30, 2014 to the date of the inspection (December 4, 2014), lacked any effective soil cover for erosion control. Evidence of erosion and sediment transport due to lack or erosion control measures were observed throughout the site during the inspection (See Photos 4 through 8).

**Photos 4 and 5** show the large topographic feature without any erosion controls. Linear sediment controls can be observed. Photo 4 provided by concerned citizen, taken in the morning on September 30, 2014. Photo 5 provided by concerned citizen, taken in the morning on December 3, 2014. Approximate size and shape of the topographic feature has not changed.

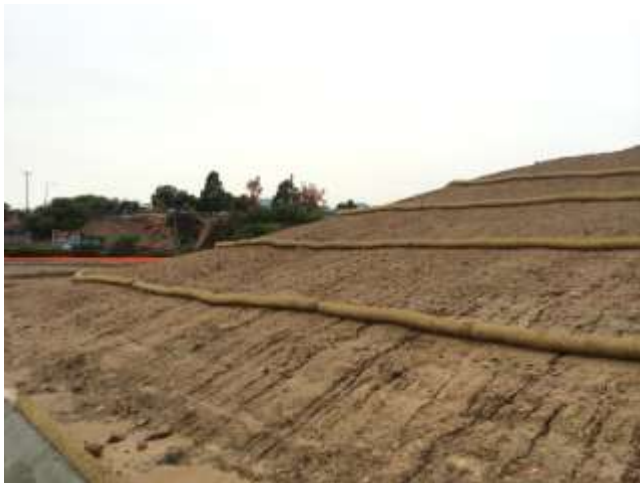
**Photo 6** shows the evidence of erosion and sediment transported to the base of the slope. Photo 6 also shows the linear sediment controls were not properly installed, as the fiber rolls are not overlapped and properly trench into the slope. Photo 6 provided by concerned citizen, taken in the morning on December 3, 2014.

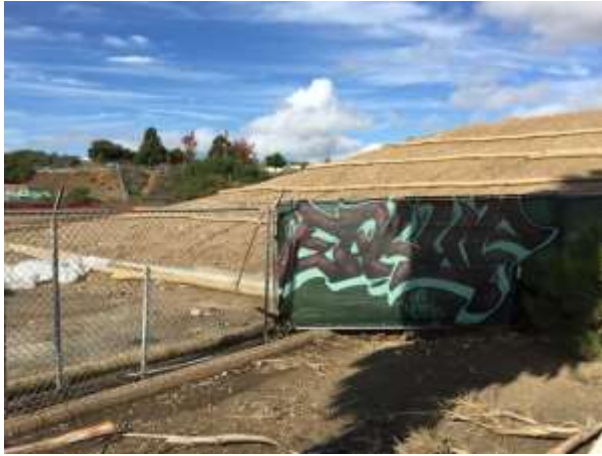
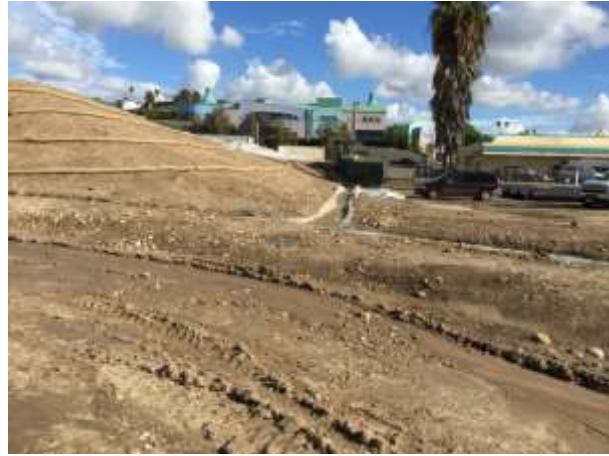
**Photos 7 and 8** show evidence of erosion, in the form of rills on the slope. Photo 7 also shows evidence that erosion has resulted in sediment transport to v-ditch at base of the topographic feature, which drains to a post-construction BMP basin. Photos 6 and 7 taken by San Diego Water Board inspector on December 4, 2014.

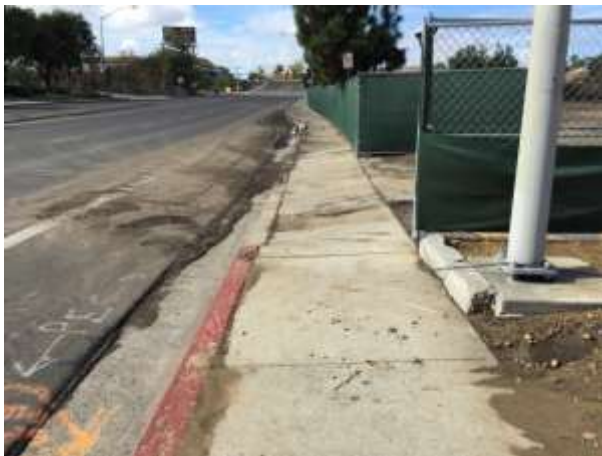
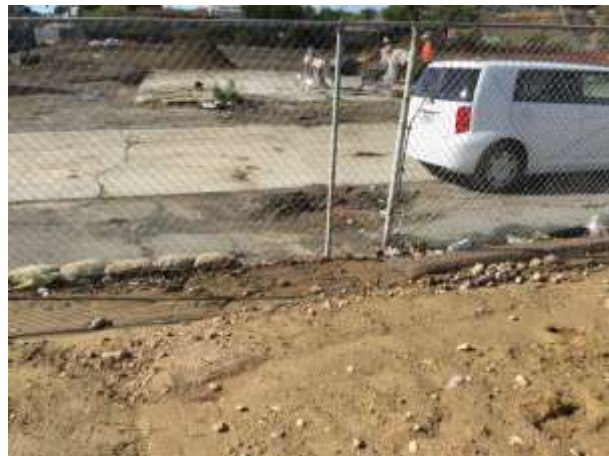
5. Lack of effective perimeter sediment controls observed in several locations of the site (See Photos 9 through 11). One construction entrance/exit was not adequately controlled which resulted in sediment discharges from the site. All construction sites are required to establish and maintain effective perimeter controls and stabilize all construction entrances and exits to sufficiently control erosion and sediment discharges from the site.

6. Lack of effective run-on controls observed which resulted in sediment discharges to the site, and contributed to sediment discharges from the site (See Photo 10). All construction sites are required to effectively manage run-on, all runoff within the site and all runoff that discharges off the site. Run-on from off site must be directed away from all disturbed areas or collectively be in compliance with the effluent limitations of the CGP.

**Photos 9 and 10** show factors that contributed to uncontrolled sediment discharges from the site. Photo 9 shows lack of perimeter sediment controls or tracking controls at an entrance/exit to the site. Significant offsite tracking of sediment can be seen in Photo 9. Photo 10 shows a missing section of the perimeter controls allowing offsite sediment to run-on to the site, which contributed to the sediment discharges from the site shown in Photo 9. Photos 9 and 10 taken by the San Diego Water Board inspector on December 4, 2014.

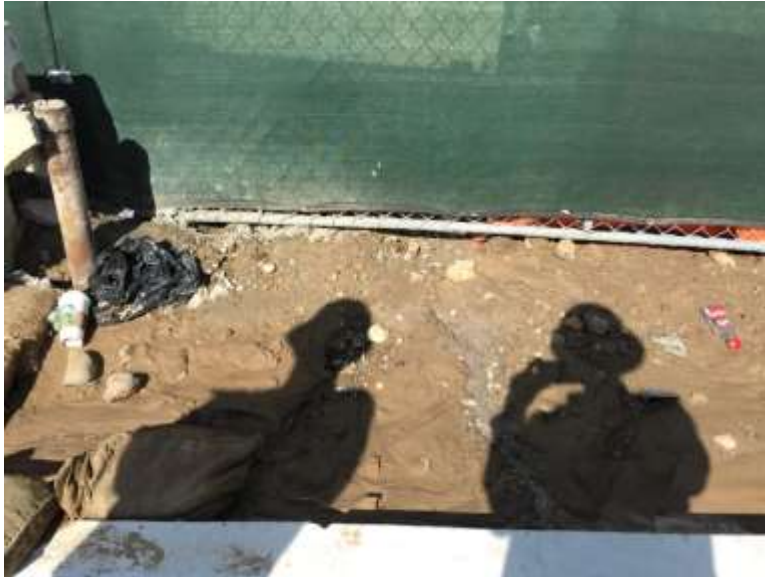
**Photo 11** shows an additional location where perimeter sediment controls were not established, resulting in a discharge of sediment from the site. Photo 11 taken by the San Diego Water Board inspector on December 4, 2014.

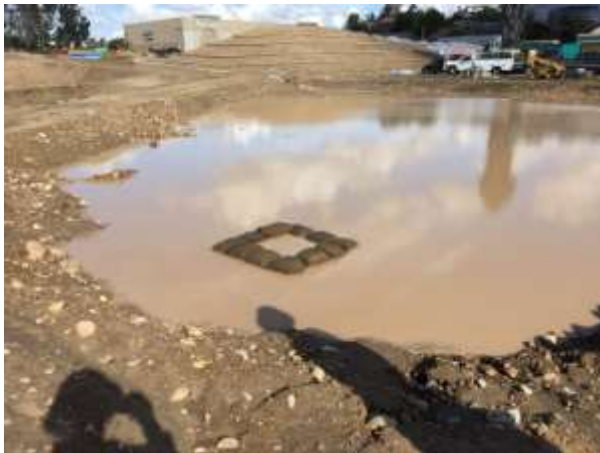
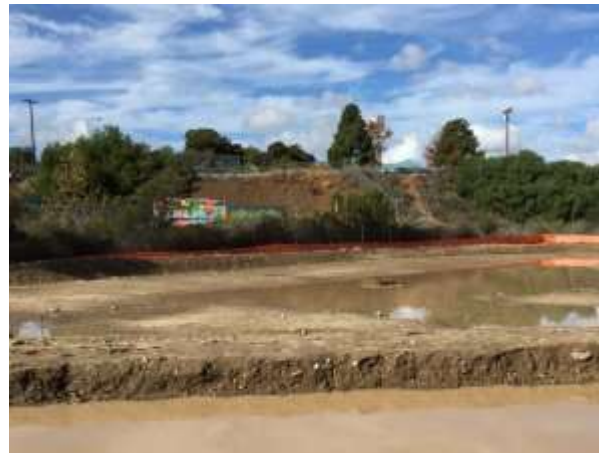
The unauthorized discharge originated from the two basins that appeared to be constructed to be post-construction BMPs, and were not appropriately modified to be sediment traps (or sediment basins) during the construction phase as the outlets (or storm drain inlets) are located on the bottom of the basins without any

risers or spillways (See Photos 12 and 13). In addition, erosion controls were not implemented to reduce the potential for sediment to be transported to the sediment traps (or sediment basins). The outlets from the post-construction BMPs are connected to a six-inch pipe outfall that discharges directly to Chollas Creek (See Photos 14 through 16).

**Photos 12 and 13** show the post-construction BMP basin that were inappropriately used and/or designed for the construction phase. Photo 12 shows the eastern basin, which collects runoff from the topograph feature seen in the background. Photo 13 shows the western basin. In both photos, the outlets (or storm drain inlets) can be seen surrounded by gravel bags. According to the superintendent, the outlets are covered with filter fabric. Photos 12 and 13 taken by the San Diego Water Board inspector on December 4, 2014.

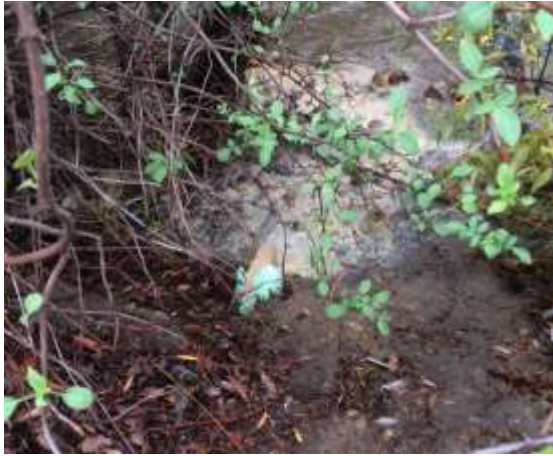
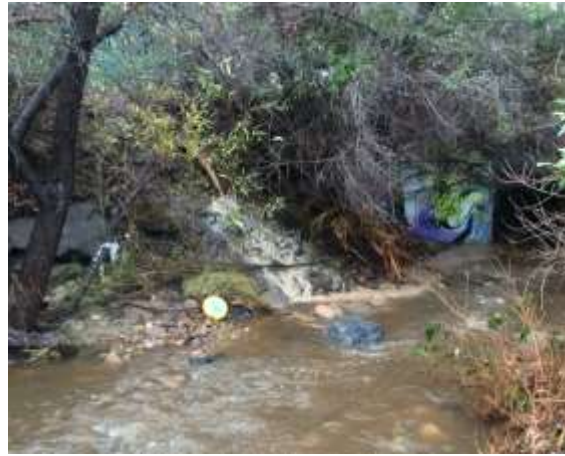
**Photos 14 and 15** show the 6-inch pipe outfall connected to the post-construction BMP basins on the site discharging sediment-laden storm water directly to Chollas Creek. Photo 15 also shows a plume of sediment-laden storm water traveling downstream in Chollas Creek. Photos 14 and 15 provided by concerned citizen, taken in the morning on December 4, 2014.

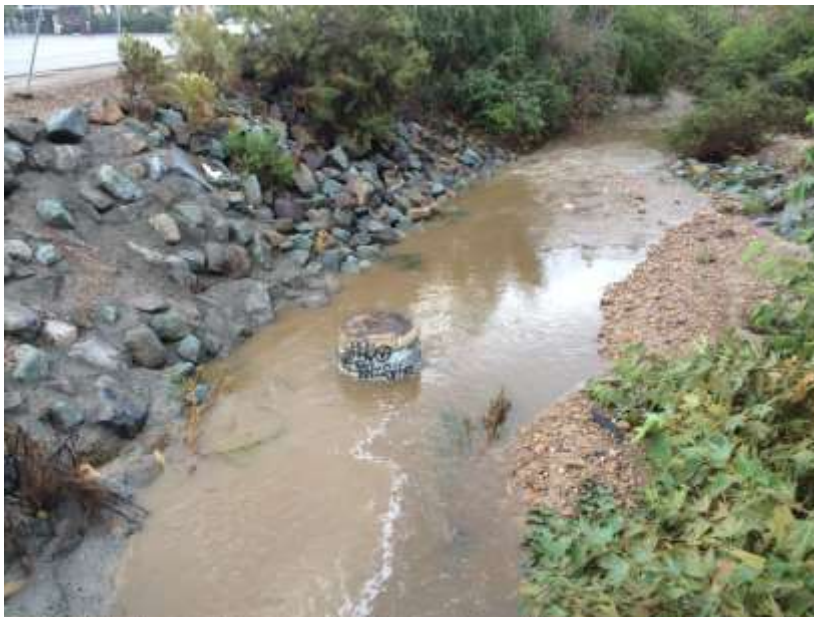
**Photo 16** shows plume of sediment-laden storm water downstream from discharge point shown in Photos 14 and 15. Photo 16 provided by concerned citizen, taken in the morning on December 4, 2014.
