California Regional Water Quality Control Board, San Diego Region

Subject: Notice of Violation No. R9-2014-0148, La Jolla Del Rey Phase 1 Construction Project, Order No. 2009-0009-DWQ, NPDES Permit No. CAS000002, Construction General Permit

**NOTICE OF VIOLATION
No. R9-2014-0148**

Facility: La Jolla del Rey Phase 1
Inspection Date: 12/4/2014

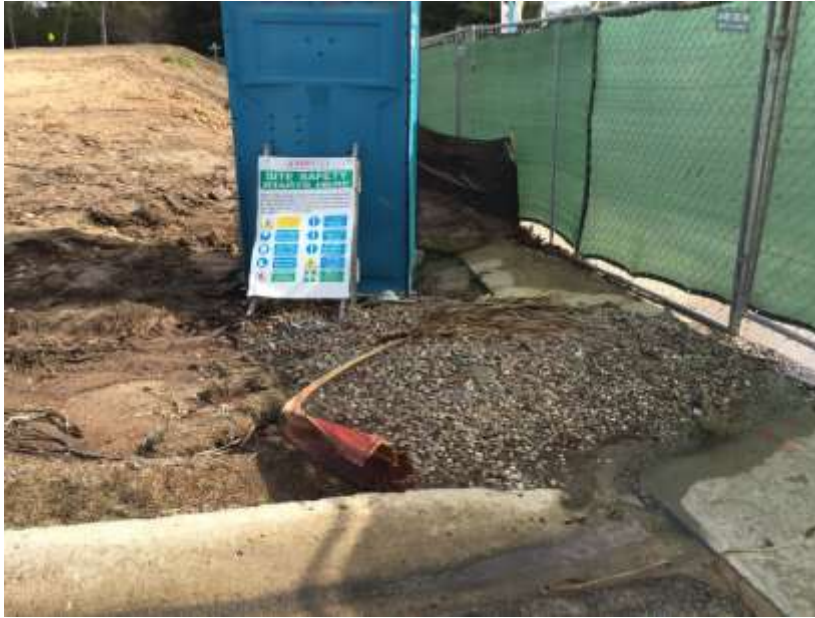
- a. **Pursuant to Provision IX and Section B.1.b of Attachment C of State Water Board Order No. 2009-0009-DWQ:** Risk Level 1 dischargers are ensure containment of sanitation facilities (e.g. portable toilets) to prevent discharges of pollutants to storm water drainage systems and receiving waters.
- b. **Observation:** During the December 4, 2014 inspection, the San Diego Water Board inspector observed a portable toilet located next to site boundary with evidence of runoff flowing through location and offsite into the storm water drainage system. See attached December 4, 2014 Facility Inspection Report Photo 1.

4. Sanitation facilities placed in runoff flow lines and in front of a discharge point from the site with inadequate protection or containment to prevent runoff from transporting pollutants from sanitation facilities offsite (See Photo 1). All construction sites are required to ensure containment of sanitation facilities to prevent discharges of pollutants to the storm water drainage system or receiving water.

Photo 1 shows sanitation facilities (i.e. portable toilet) located next to site boundary with evidence of runoff flowing through location, and lack of perimeter sediment controls. Evidence of erosion and sediment transport through location and discharge of sediment and storm water from area without perimeter controls.

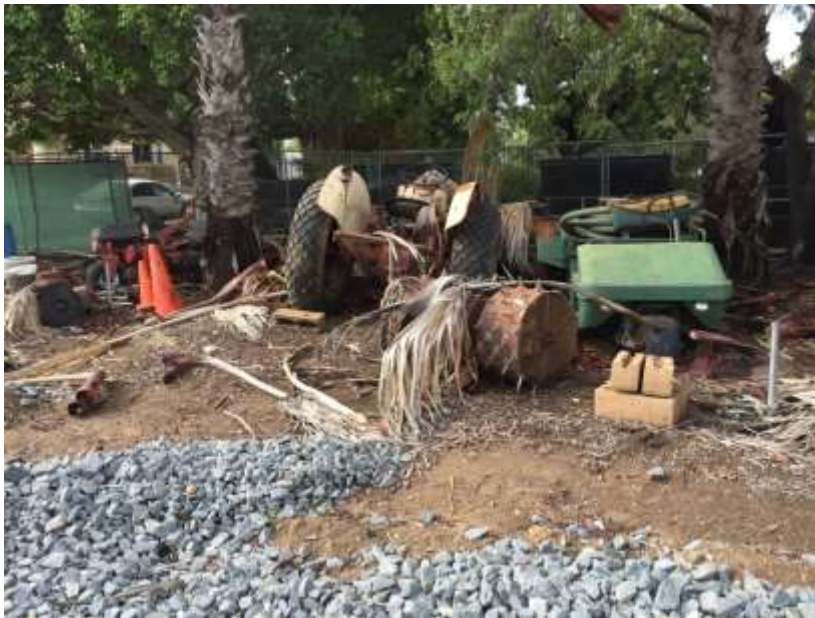
- c. Observation:** During the December 4, 2014 inspection, the San Diego Water Board inspector equipment and vehicles stored without appropriate BMPs to prevent oil, grease or fuel to leak in to the ground, storm drains or surface waters. See attached December 4, 2014 Facility Inspection Report Photo 2.

5. Equipment and vehicles observed without appropriate BMPs (e.g. drip pans) to prevent oil, grease, or fuel to leak in to the ground, storm drains, or surface waters (See Photo 2). All construction sites are required to prevent oil, grease or fuel to leak in to the ground, storm drains, or surface waters, and to place all equipment and vehicles, which are to be fueled, maintained and stored in a designated area fitted with appropriate BMPs.

Photo 2 shows equipment and vehicles stored on site lacking appropriate BMPs to prevent oil, grease, or fuel to leak in to the ground, storm drains, or surface waters.

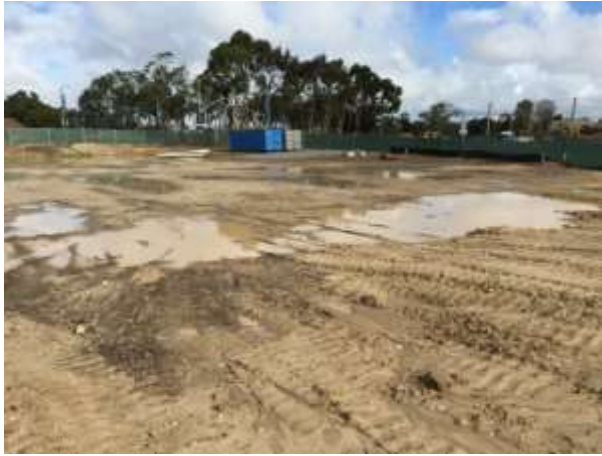
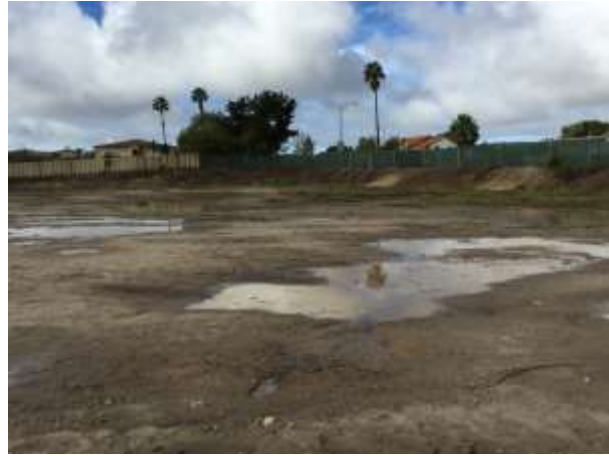
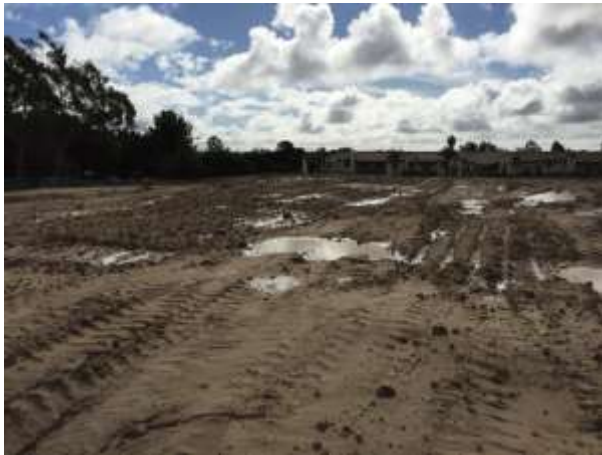
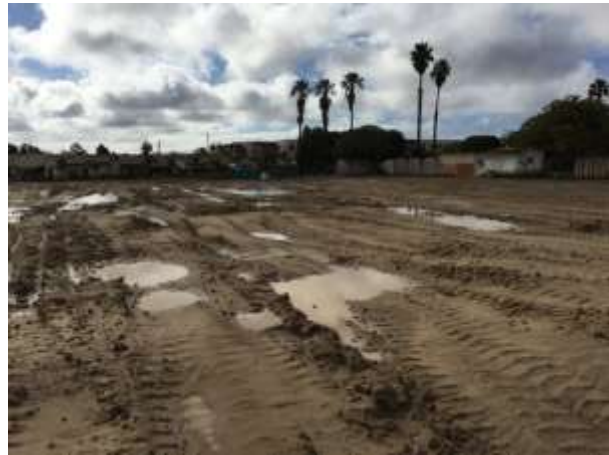
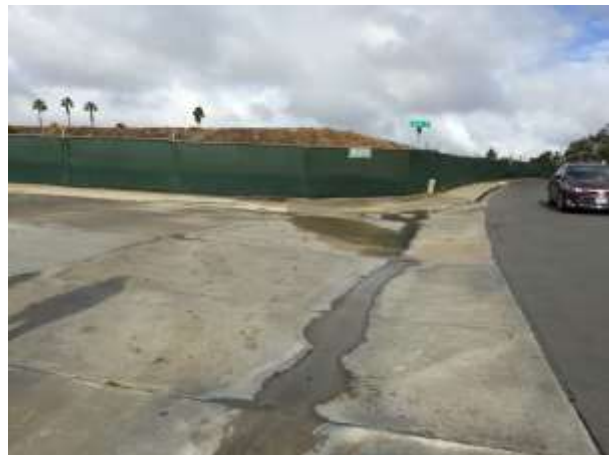
- 5. Failure to Implement Adequate Erosion Controls for Inactive Areas:**
 - a. Pursuant to Provision IX and Section D.2 of Attachment C of State Water Board Order No. 2009-0009-DWQ:** Risk Level 1 dischargers shall provide effective soil cover for inactive areas and all finished slopes, open space, utility backfill, and completed lots.
 - b. Observation:** During the December 4, 2014 inspection, the San Diego Water Board inspector was informed that the site had been inactive for several months. The entire site lacked effective soil cover or other BMPs that could prevent erosion. Evidence of erosion and sediment transport due to lack or erosion control measures were observed throughout the site during the inspection. See attached December 4, 2014 Facility Inspection Report Photos 3 through 7.

6. The entire site was observed to be inactive, or could be scheduled to be inactive, without effective soil cover to control potential erosion (See Photos 3 through 7). All construction sites are required to provide effective soil cover for inactive areas (i.e. areas that have been disturbed and not scheduled to be re-disturbed for at least 14 days) and all finished slopes, open space, utility backfill, and completed lots.

8. Lack of effective runoff controls observed within and around the site which contributed to sediment discharges from the site (See Photos 3 through 11). All construction sites are required to effectively manage run-on, all runoff within the site and all runoff that discharges off the site.

Photos 3 through 7 show lack of erosion controls for areas that are considered inactive, which is the entire site. Photo 3 shows the site looking toward the northeast corner. Photo 4 shows the site looking toward the northwest corner. Photo 5 shows the site looking toward the southeast corner. Photo 6 shows the site looking toward the southwest corner. Photo 7 is looking northwest toward the southeast corner of the site showing the slopes that lack any erosion controls.

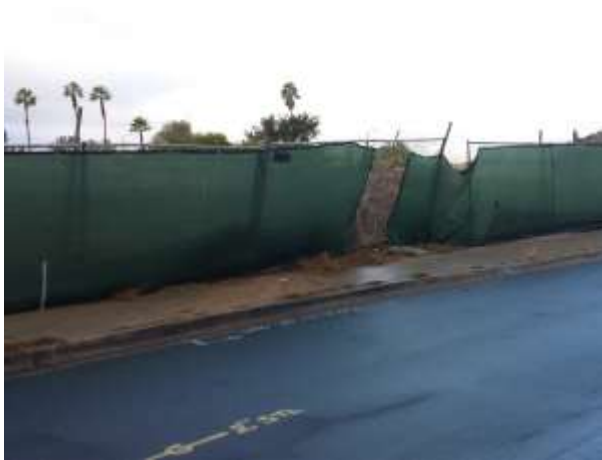
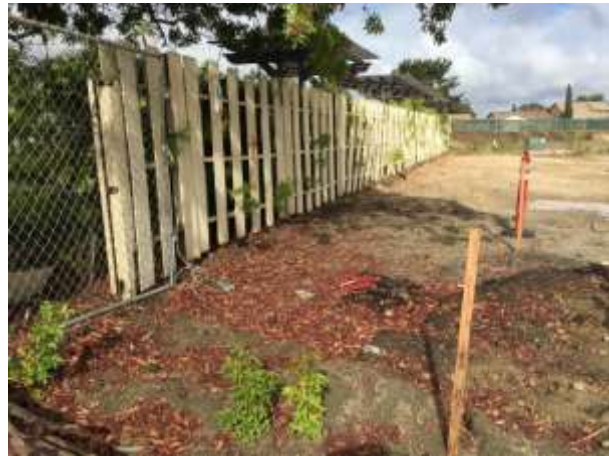
- 6. Failure to Implement Adequate Perimeter Sediment Controls:**
 - a. Pursuant to Provision IX and Section E.1 of Attachment C of State Water Board Order No. 2009-0009-DWQ:** Risk Level 1 dischargers shall establish and maintain effective perimeter controls and stabilize all construction entrances and exits to sufficiently control erosion and sediment discharges from the site.
 - b. Observation:** During the December 4, 2014 inspection, the San Diego Water Board inspector observed several areas of the site where perimeter controls were not established or maintained to sufficiently control erosion and sediment discharges from the site. See attached December 4, 2014 Facility Inspection Report Photos 8 and 9.

- a. **Pursuant to Provision IX and Section F.1 of Attachment C of State Water Board Order No. 2009-0009-DWQ:** Risk Level 1 shall effectively manage all run-on, all runoff within the site and all runoff that discharges from the site. Run-on from off site shall be directed away from all disturbed areas or shall collectively be in compliance with the effluent limitations in the CGP.
- b. **Observation:** During the December 4, 2014 inspection, the San Diego Water Board inspector observed no runoff controls within the site, and at least one area of the site where perimeter controls were not established or maintained to prevent runoff from the site, resulting in sediment being allowed to be discharged in runoff from the site. See attached December 4, 2014 Facility Inspection Report Photo 8.

7. Lack of effective perimeter sediment controls observed in several locations of the site which resulted in unauthorized sediment discharges from the site (See Photos 8 through 11). All construction sites are required to establish and maintain effective perimeter controls and stabilize all construction entrances and exits to sufficiently control erosion and sediment discharges from the site.

Photos 8 and 9 show two locations along the boundary of the site where there is an obvious lack of perimeter sediment and run-on/runoff controls. Photo 8 also shows evidence of sediment discharged from the site due to lack of erosion and perimeter sediment controls.

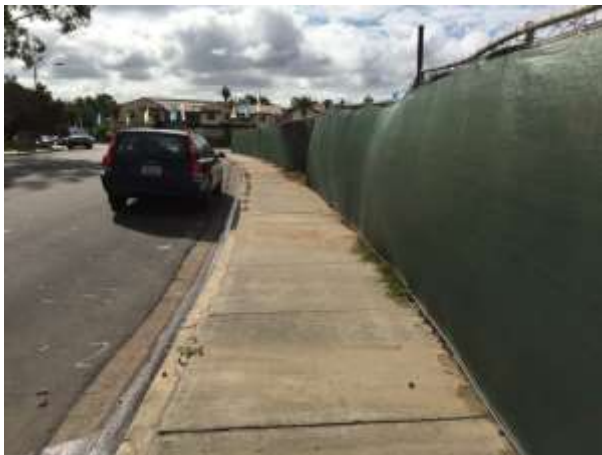
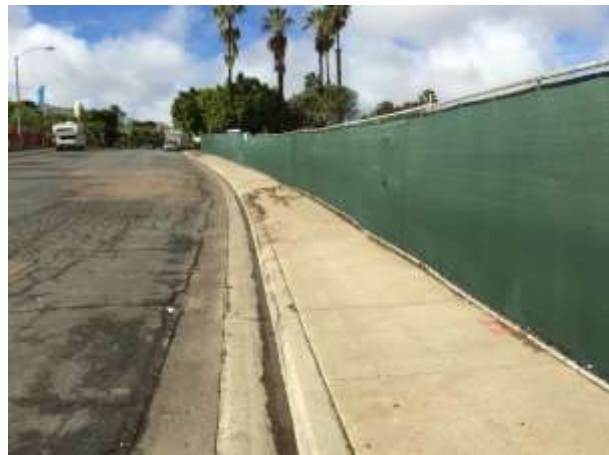
Legally Responsible Person (LRP) enrolled under the Construction General Permit (CGP) for the site. On December 4, 2014, the San Diego Water Board inspector observed evidence of sediment discharged from the site due to inadequate and ineffective implementation of best management practices (BMPs), constituting an unauthorized discharge of sediment from the site. See attached December 4, 2014 Facility Inspection Report Photos 8, 10, and 11.

Photos 10 and 11 show evidence of sediment discharges from the site due to lack of erosion and perimeter sediment controls. Photo 10 is looking south along the eastern boundary of the site. Photo 11 is looking west along the southern boundary of the site.
