From: Chiu, Wayne@Waterboards
Sent: Friday, January 08, 2016 4:01 PM
To: 'John La Raia'
Cc: 'Rob Furey'; Walsh, Laurie@Waterboards; Julie Ballesteros (BallesterosJ@sandiego.gov); Clemente, Chiara@Waterboards
Subject: WDID 937C374691 (The Boulevard): 6 January 2016 Inspection
Attachments: 2016-0106 Inspection Photos (The Boulevard).pdf

I conducted an inspection of your site on January 6, 2016 following a storm event, and before another predicted storm event. As there was no one on the site, I inspected the site from the perimeter and publicly accessible locations. Based on my observations, several requirements for a Risk Level 2 construction site were not implemented or inadequately implemented in compliance with the CGP.

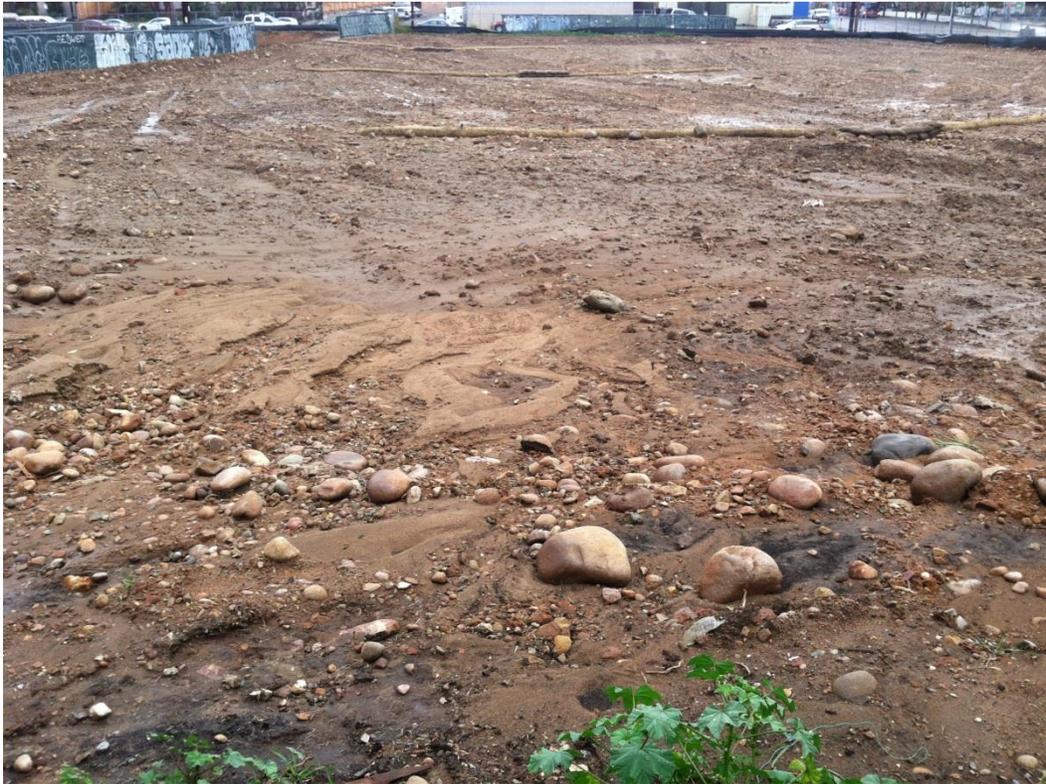
Photo 1

1. All Risk Level 2 sites are required to implement effective soil cover for inactive areas. All Risk Level 2 sites are required to implement appropriate erosion control BMPs (runoff control and soil stabilization) in conjunction with sediment control BMPs. Areas that were inactive should have had already had effective soil cover or soil stabilization implemented before the storm event. Runoff controls and soil stabilization is expected to be implemented prior to a predicted rain event for all active areas. Photos 1 and 2 show evidence of significant sediment transport, which is a clear indication that the site lacked appropriate erosion control BMPs to prevent erosion for inactive or active areas.

3. All Risk Level 2 sites are required to effectively manage all run-on, all runoff within the site and all runoff that discharges from the site. Photos 1, 2, 4 and 5 show a lack of controls to manage run-on (Photo 4), all runoff within the site (Photos 1 and 2) and runoff that is discharging from the site (Photo 5).

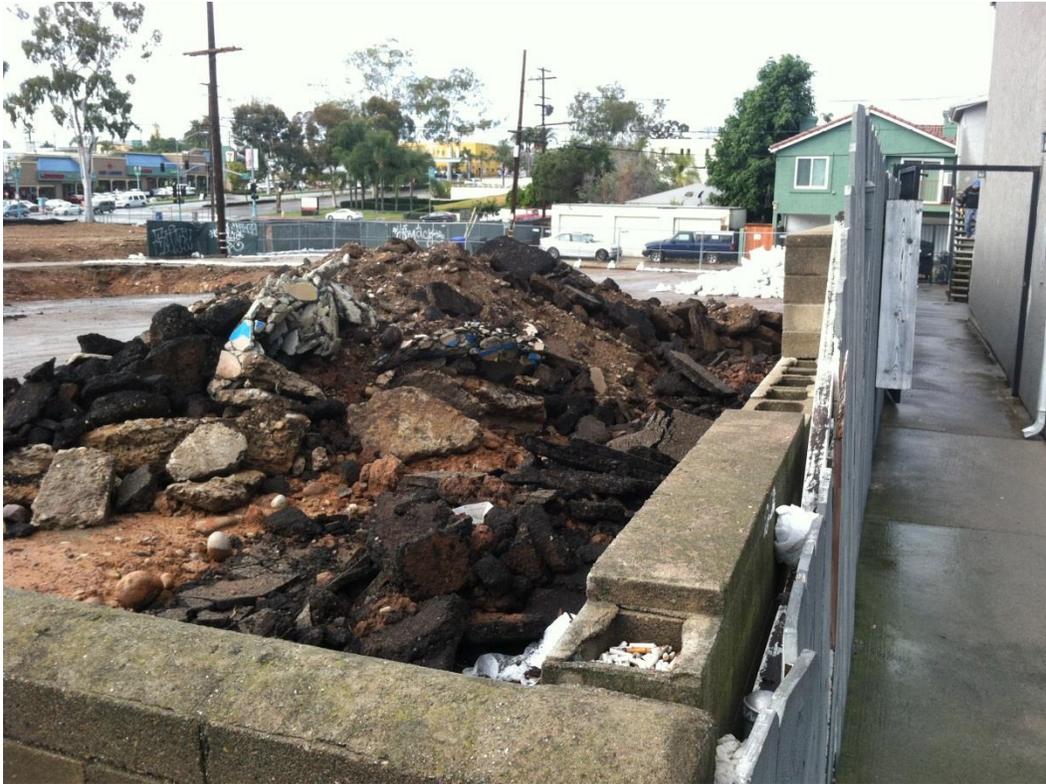
2. All Risk Level 2 sites are required to contain and securely protect stockpiles waste material from wind and rain at all times unless actively being used. Photo 3 shows what appears to be a waste stockpile that evidently is not being used as there is no activity on the site, and does not have and protection from rain or containment.

5. All Risk Level 2 sites are required to minimize or prevent pollutants in storm water discharges through the use of controls, structures, management practices that achieve BCT for conventional pollutants. Photo 5 shows discharges from storm water runoff with visible sediment being discharged to a storm drain inlet. The sediment in the discharge was observed to originate from runoff that flowed through the unprotected stockpile in Photo 3 and the unstabilized and unprotected soil berm in Photo 2.

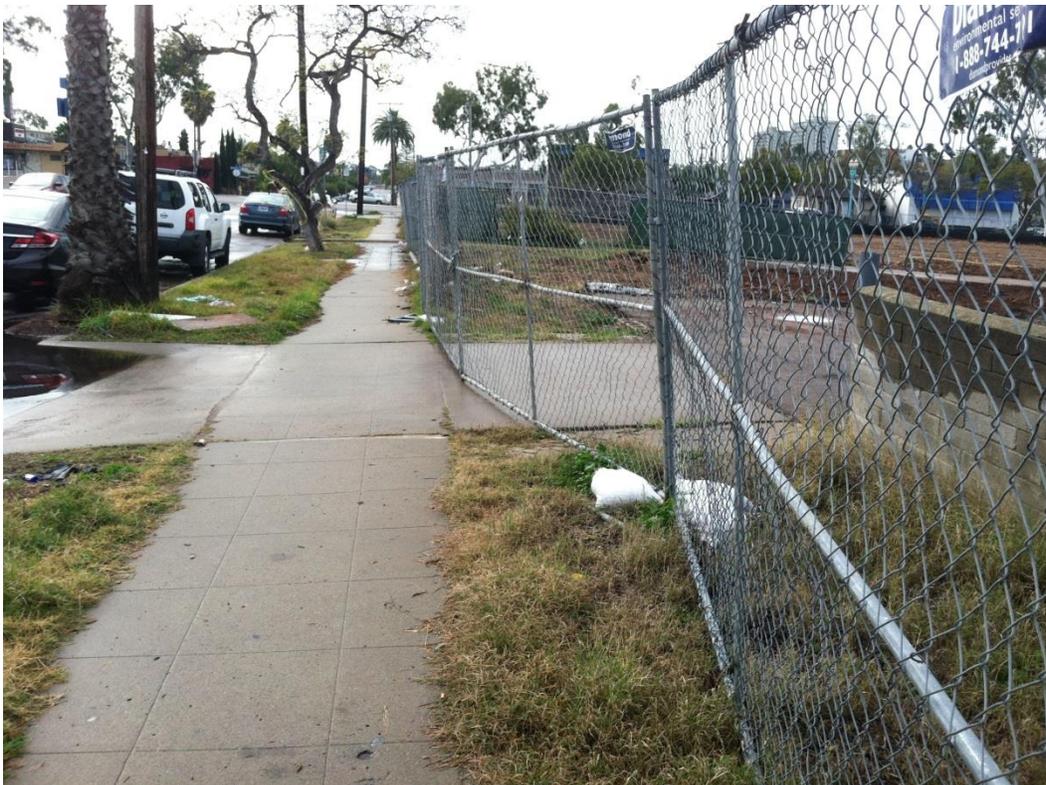
4. All Risk Level 2 sites are required to establish and maintain effective perimeter controls to sufficiently control erosion and sediment discharges from the site. Photo 4 shows a lack of perimeter controls to prevent runoff that can cause erosion on the site and result in discharges of sediment from the site.
