California Regional Water Quality Control Board, San Diego Region

NOTICE OF VIOLATION No. R9-2016-0036

URBAN VILLAGES SAN MARCOS

University District Student Housing **Construction Project** PIN No. SM-741872

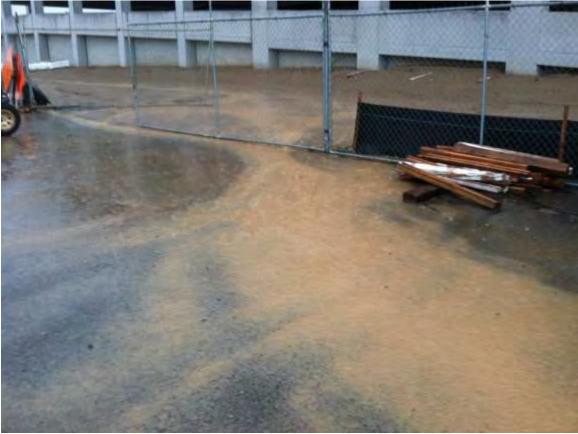
Photo 5 Photo 6

- 5. Risk Level 2 construction sites are required to cover and berm loose stockpiled construction materials unless actively being used. San Diego Water Board inspectors observed at least one stockpile of loose construction material with inadequate cover and berm (see Photo 5).

Photos 5 through 7 show examples of areas where there was inadequate implementation of controls to manage runoff within the site. Photos 5 and 6 show areas where runoff through the site has resulted in significant amounts of sediment being transport through the site from areas without erosion control BMPs. Photo 7 shows sediment-laden runoff from the areas shown in Photos 3 and 4 as a result of inadequate erosion controls and runoff controls.

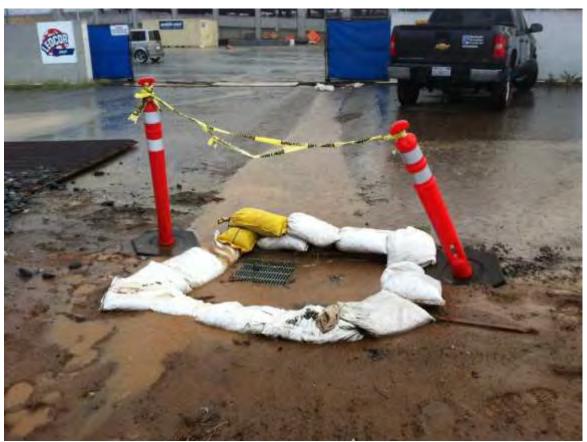
Photo 8 Photo 9

- 4. Risk Level 2 construction sites are required to effectively manage all run-on, all runoff within the site and all runoff that discharges from the site. Risk Level 2 construction sites must direct run-on from off site away from all disturbed areas or the run-on that is discharged from the site must collectively be in compliance with the effluent limitations of the CGP (see Finding 8). San Diego Water Board inspectors observed inadequate implementation of controls to effectively manage all runoff within the site (Photos 1 through 7), and all runoff that discharges from the site (Photos 8 through 10).

Photos 8 through 10 show where there was inadequate implementation of controls to manage runoff discharge from the site. Photo 8 shows a storm drain inlet at the beginning of the inspection and significant amounts of sediment around the inlet. Photo 9 shows that the filter fabric placed inside the inlet has a large hole exposing the drain pipe. Photo 10 shows the same storm drain inlet at the end of the inspection after raining for about 20 minutes. Runoff shown in Photo 7 drains to this storm drain inlet.

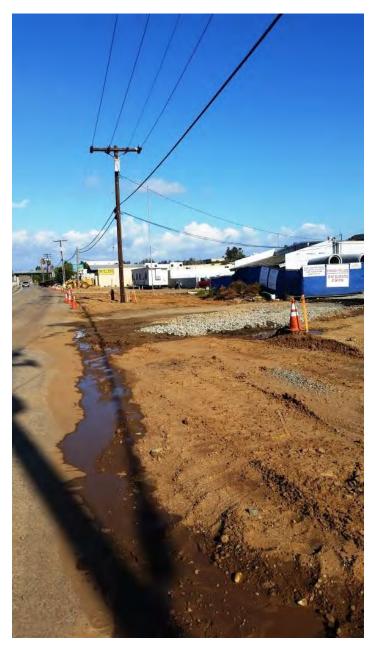
Carmel St – on 10/6/2015

Missing BMPs on Carmel St and improperly maintained construction entrance
