**Subject: Notice of Violation and Investigative Order No. R9-2016-0067, Otay Landfill, San Diego County**

**NOTICE OF VIOLATION AND  
INVESTIGATION ORDER  
No. R9-2016-0067**

**FACILITIES INSPECTION REPORT**

# Otay Landfill

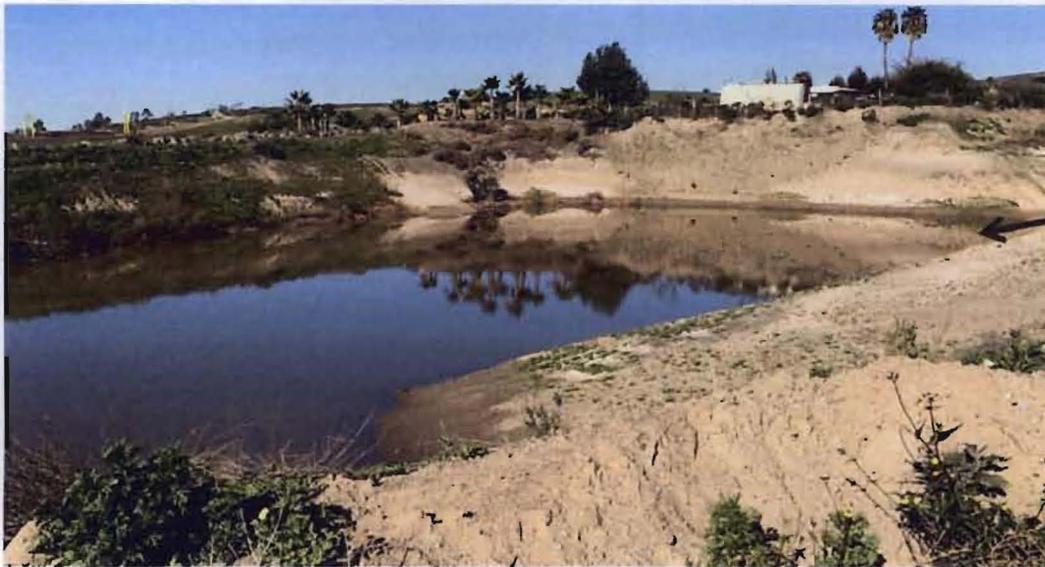
Figure 2- West Storm Water Basin

North portion of West Basin was excavated prior to rainy season with intention to keep storm water onsite for reuse for dust control.

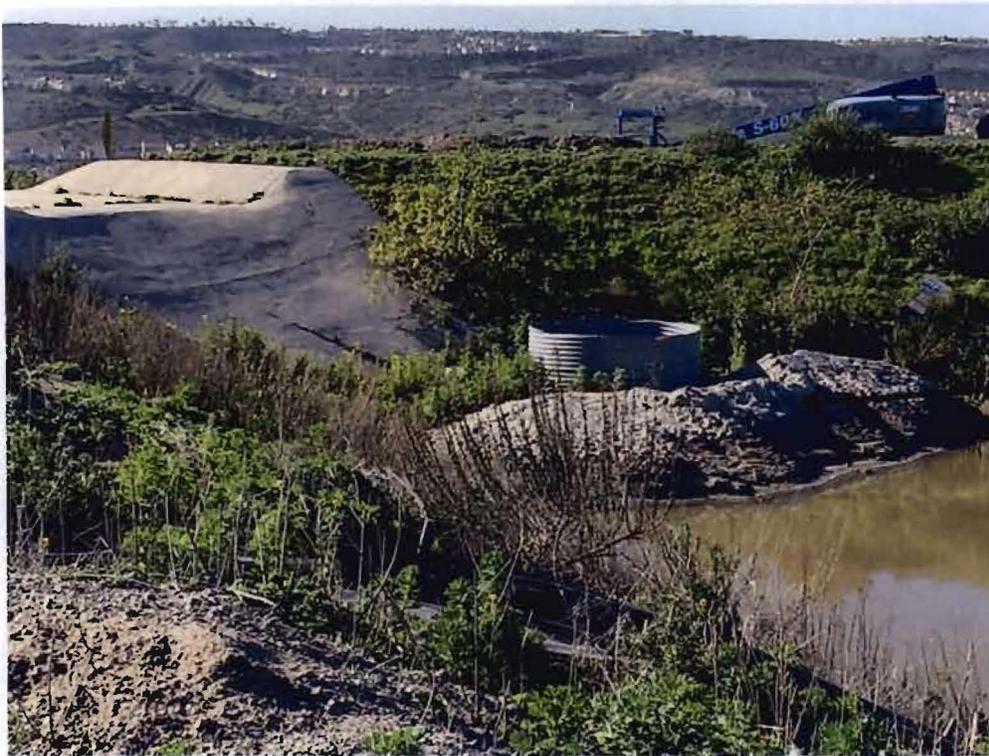
Figure 3- West Storm Water Basin Outlet

Sediment accumulated during rain events.

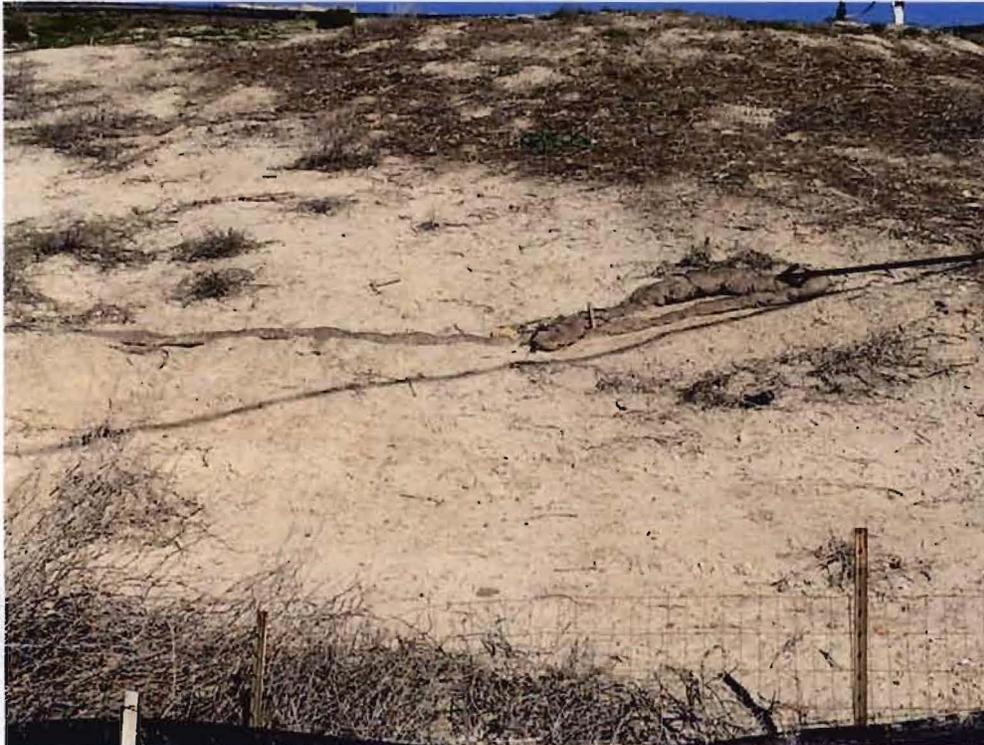
Figure 4- Southwest Side Slope

Failure to properly maintain the Site constitutes a violation of Order No. 90-09 Provision C.5, and IGP sections X.H.1 and X.H.1.e. Order No. 90-09 requires the Discharger to properly operate and maintain all facilities and systems of treatment and control which are installed or used by the Discharger to achieve compliance with the conditions of this Order. These include all storm water and surface water control systems used to prevent run-on and runoff, and to maintain positive drainage away from wastes, and all erosion control measures. During the November 13, 2014 and February 4, 2016 inspections, staff observed that the Discharger had failed to maintain best management practices (BMPs) to control or prevent erosion (Figures 4, 5 and 9).

Straw wattles are no longer functioning as intended for erosion control. Straw wattles need to be replaced.

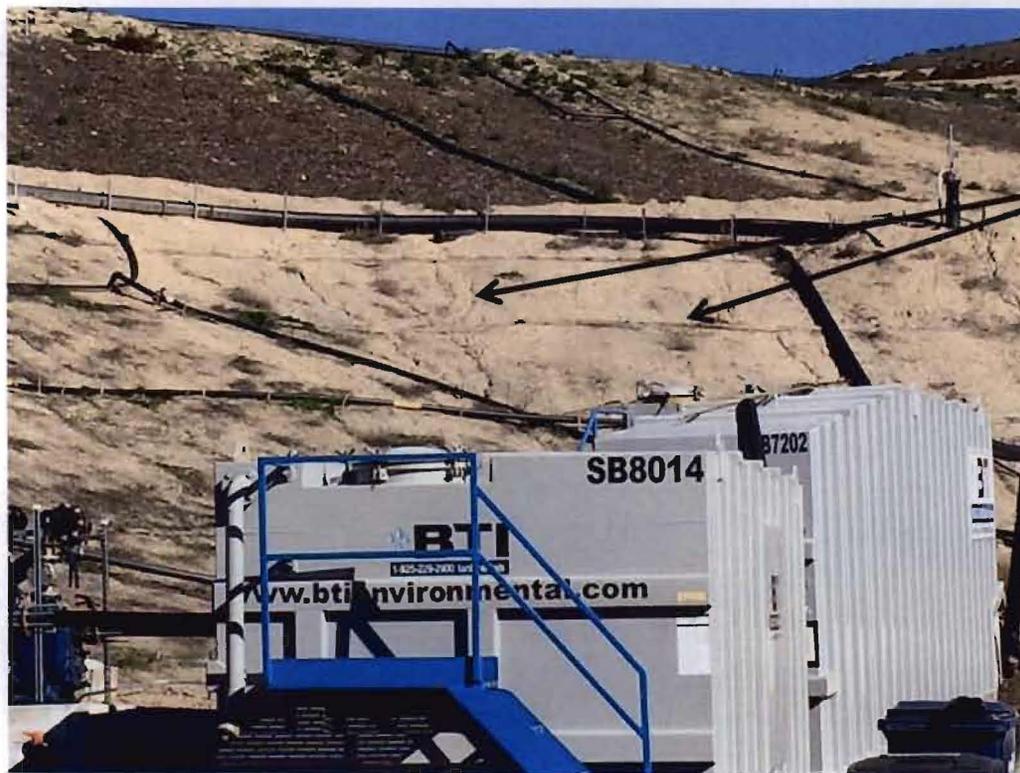
Figure 8- South Side Slope

Signs of erosion evident on the side slopes. BMPs are no longer functioning.

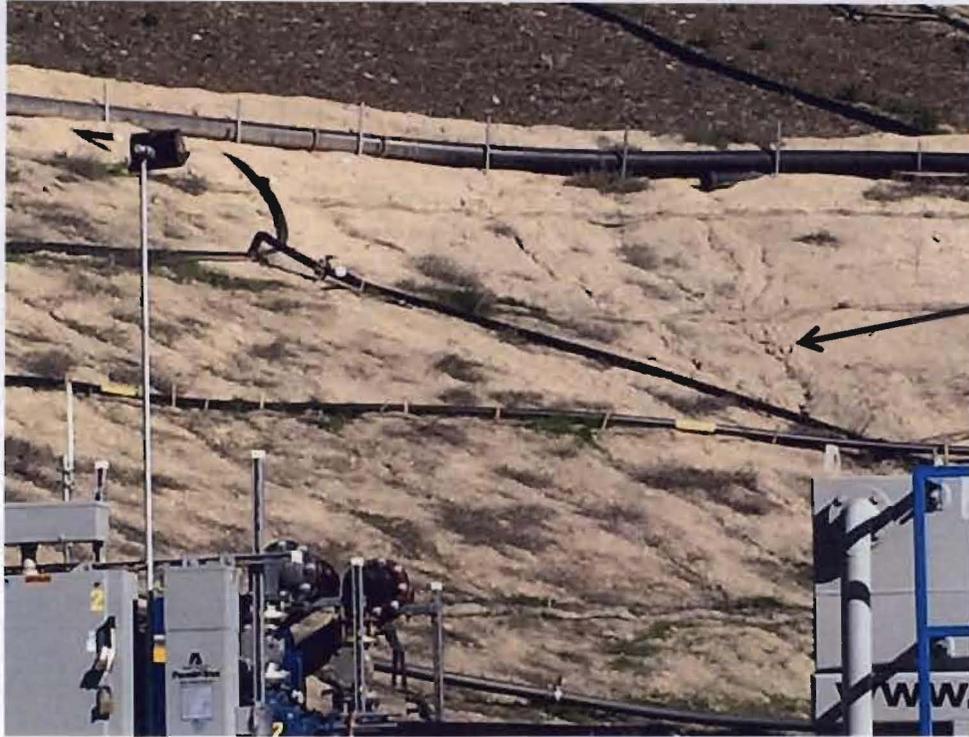
Figure 9- Side Slope Adjacent to South Basin

Signs of erosion  
evident on the  
side slopes.

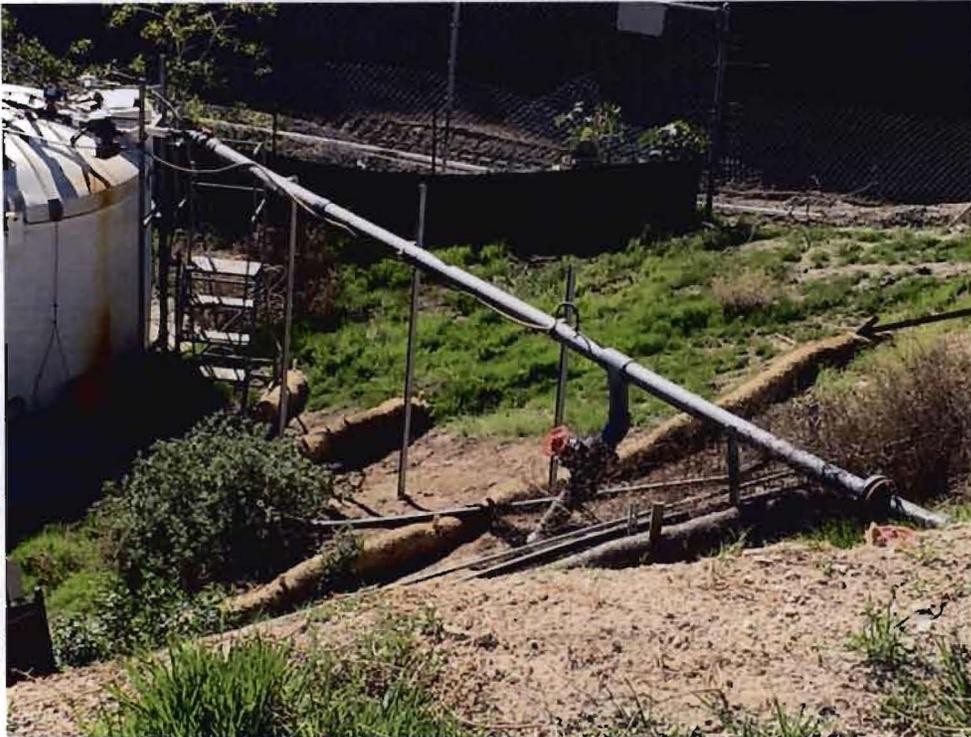
Figure 11- Near Southwest Property Line

New straw wattles implemented in a lower risk area. While high risk erosion areas have failed or poorly implemented BMPs.

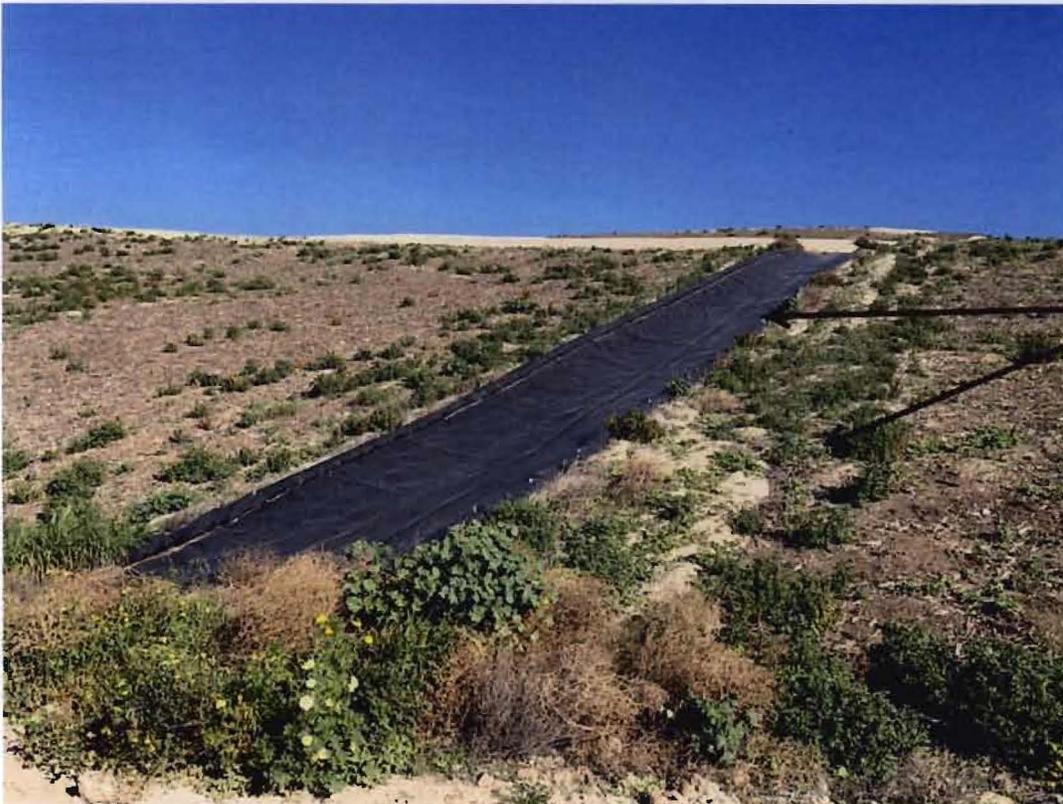
Figure 12- Southwest Side Slope

Side slope adequately vegetated. Drainage feature clear of any debris.

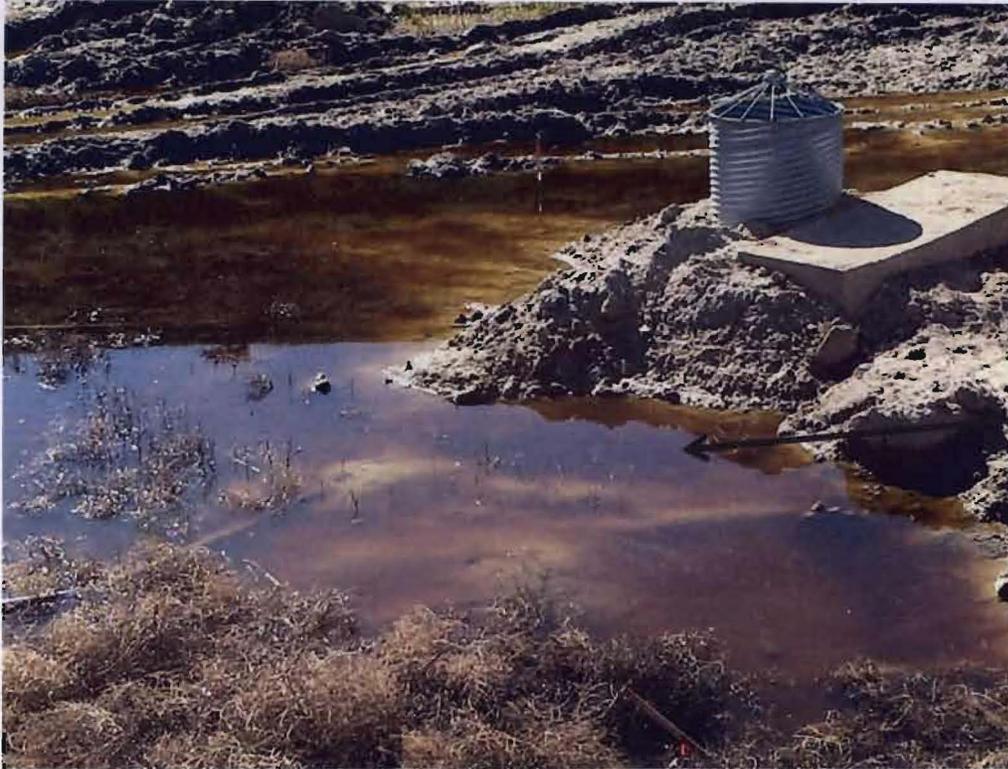
Figure 13- East Storm Water Basin

The IGP prohibits discharges of liquids or other materials, other than storm water, either directly or indirectly to waters of the United States. The East Storm Water Basin has the potential to discharge waste to waters of the United States that could cause or threaten to cause pollution, contamination, or nuisance as defined in section 13050 of the Water Code. During the February 4, 2016 inspection, staff observed leachate runoff from the up gradient composting, and chip and grinding operations in the East Storm Water Basin (Figures 13, 14, 15 and 16). Rainfall after coming into contact with compost piles constitutes a waste

The east storm water pond was observed to have a brown sheeny color.

Leachate or wastewater runoff from the composting working surface must be conveyed to a detention pond. The leachate or wastewater can be reapplied to the compost piles as needed.

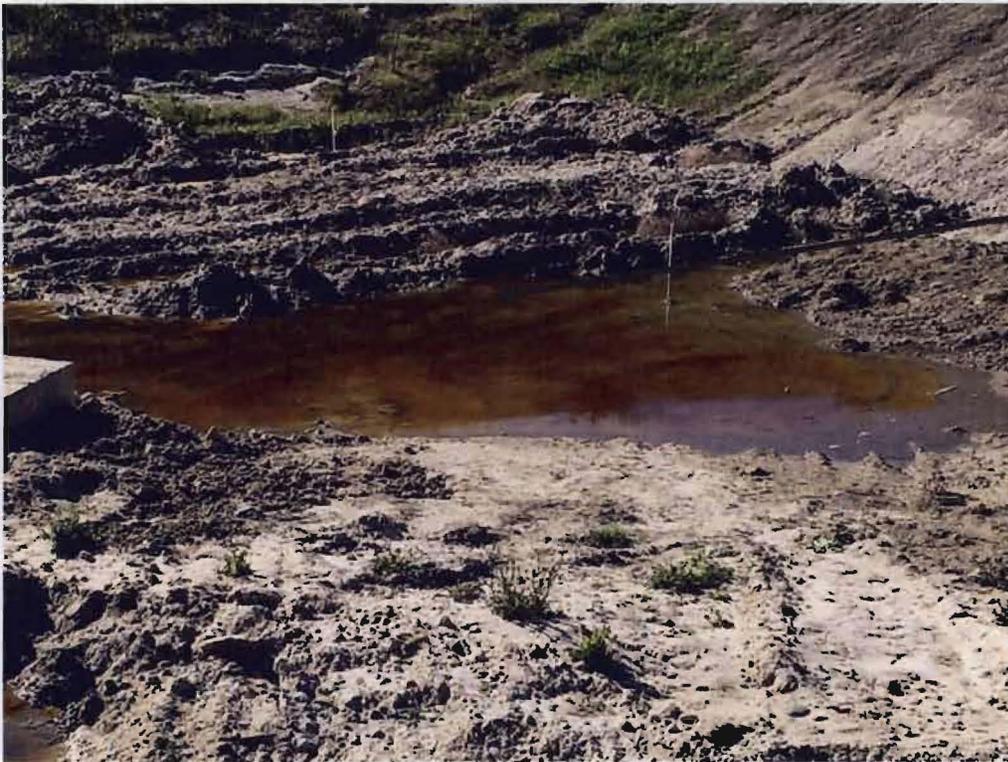
Figure 14- East Storm Water Basin

The east storm water pond was observed to have a brown sheeny color.

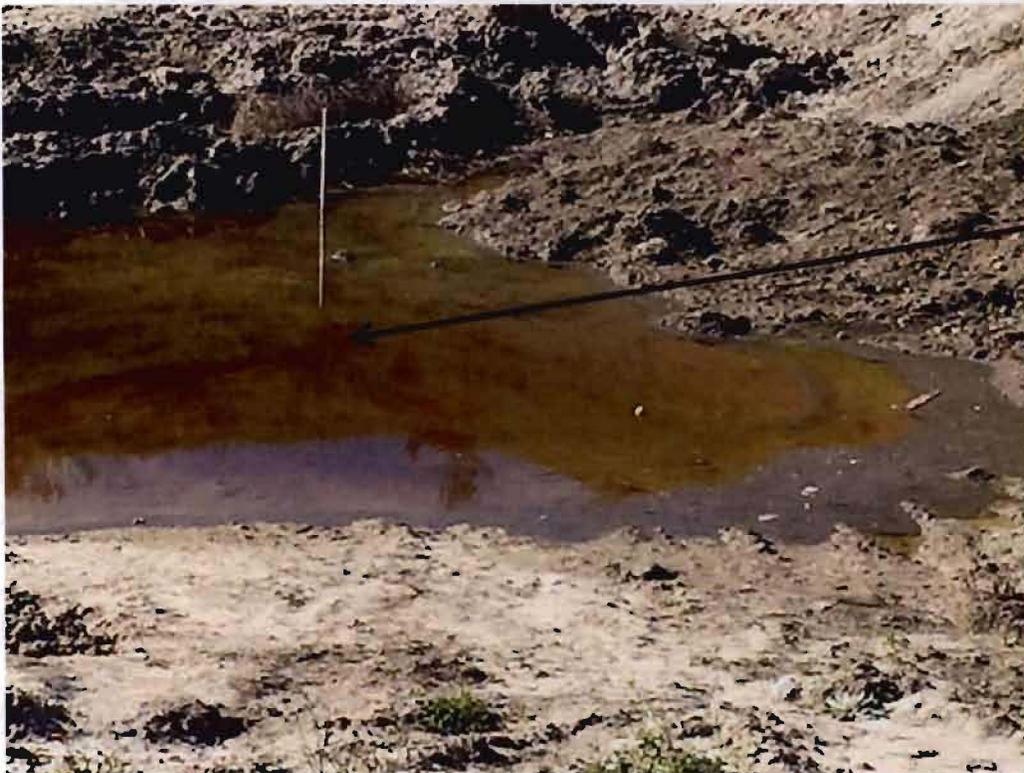
Figure 16- Zoomed Image of East Storm Water Basin

The east storm water pond was observed to have a brown sheeny color.

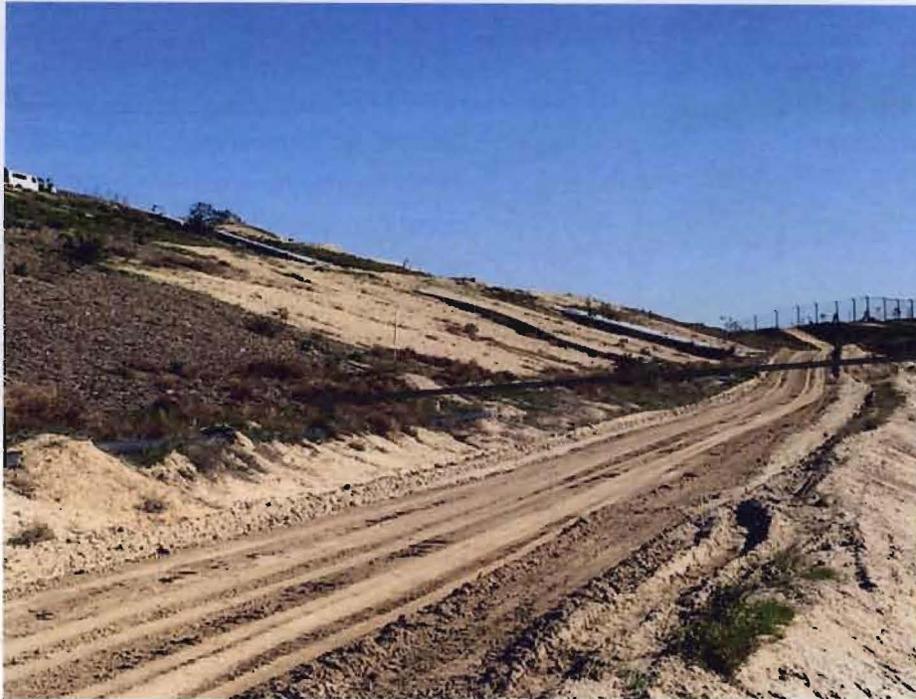
Figure 17- Side Slope Adjacent to East Basin

Mulch applied to side slopes for erosion control.

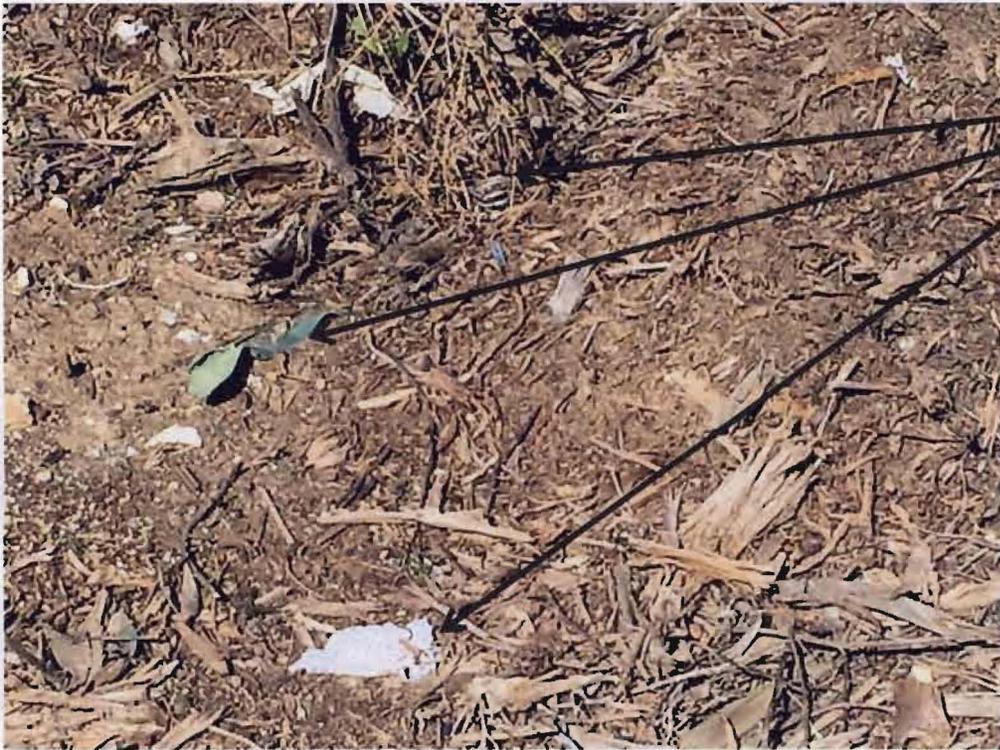
Figure 18- Mulch Applied to Side Slope Adjacent to East Basin

Mulch observed with contamination.

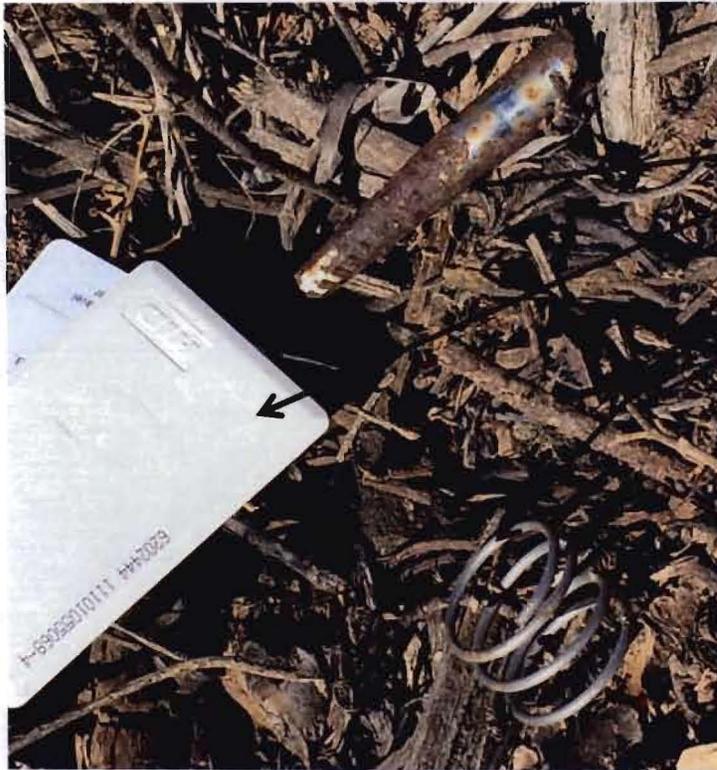
Figure 19- Zoomed Image of Contaminants Observed in Mulch

Contaminants observed in mulch applied for erosion control on side slopes. Water Board staff access card show for size comparison.

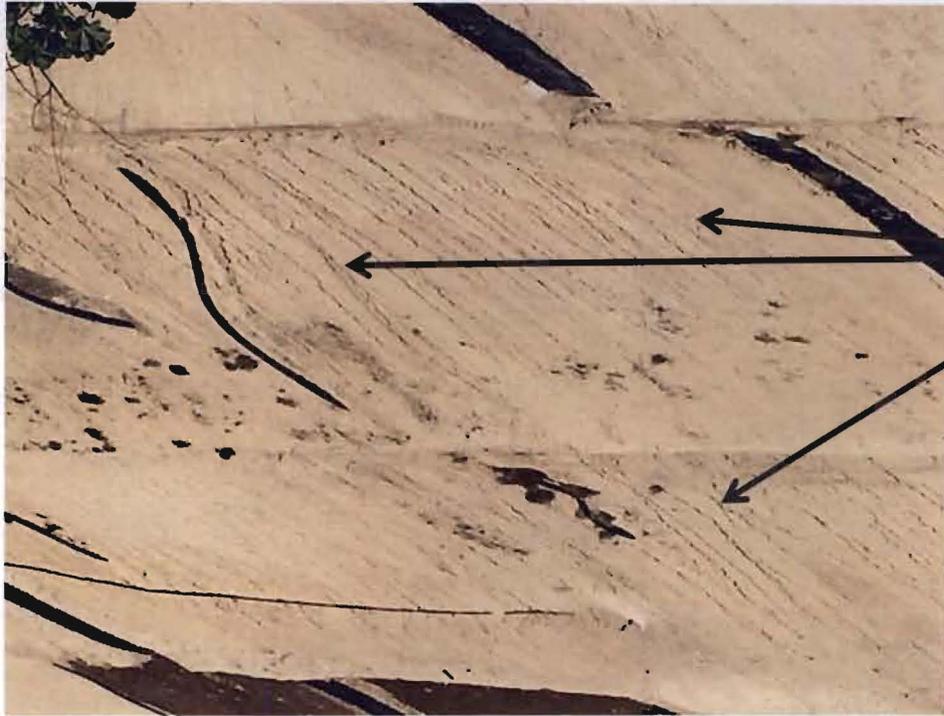
Figure 21- Southeast Side Slope

Failure to implement appropriate erosion control measures constitutes a violation of Order No. 90-09, section B.15, IGP sections X.H.1.b and X.H.1.e, and title 27, Cal. Code Regs., section 20365(f). Order No. 90-09 requires the Discharger to implement erosion control measures, and complete any necessary construction, site maintenance, or repairs to those measures prior to the start of the rainy season. The implementation and maintenance of control measures is necessary to adequately protect the site from erosion, ponding, and infiltration, and to prevent surface water from coming into contact with wastes. As observed during the February 4, 2016 inspection, the southern side slopes did not have adequate vegetation to prevent erosion, and did not have erosion control BMPs (Figures 21, 22 and 23).

Signs of erosions evident all over the side slope. No vegetation observed on the side slopes. The side slope is not implemented with erosion BMPs.

1. Implement effective BMPs and storm water control systems to prevent erosion, manage and direct surface water flows, promote positive drainage, and prevent ponding, washout, and infiltration of surface water into wastes during the rainy season.
2. Implement effective stabilization for inactive areas, finished slopes, and other erodible areas prior to the next storm event.
3. Implement effective perimeter controls and stabilize all site entrances and exits to sufficiently control discharges of sediment from discharging offsite.
4. Implement measures to divert storm water run-on and runoff generated from within the landfill footprint, away from all erodible materials.
5. Implement measures to prevent leachate or wastewater runoff from the composting working surface from discharging into the East Storm Water Basin.

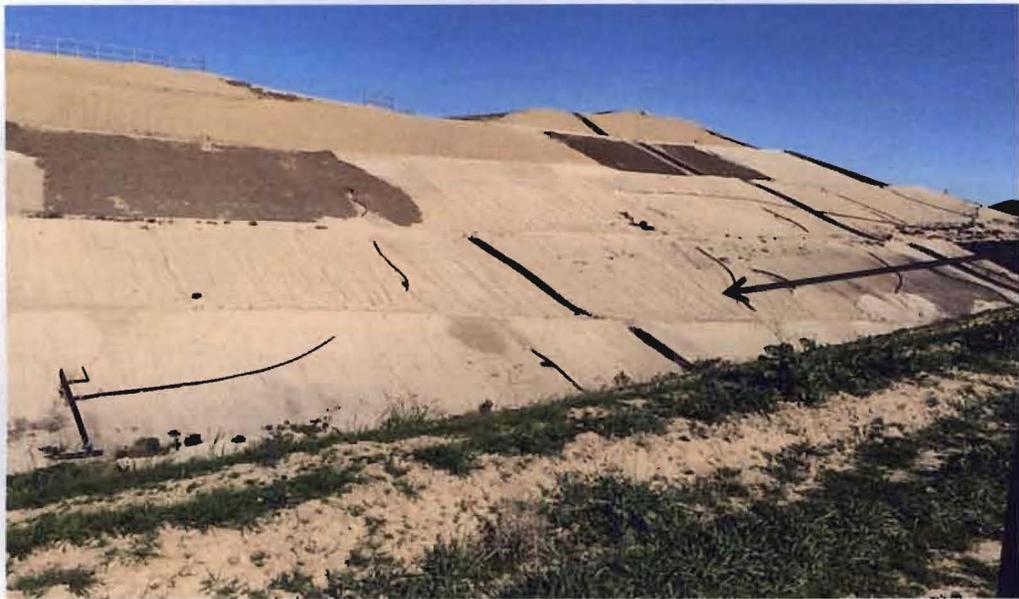
Figure 22- Zoomed Out Image of Southeast Side Slope

Signs of erosions evident all over the side slope. No vegetation observed on the side slopes. The side slope is not implemented with erosion BMPs.

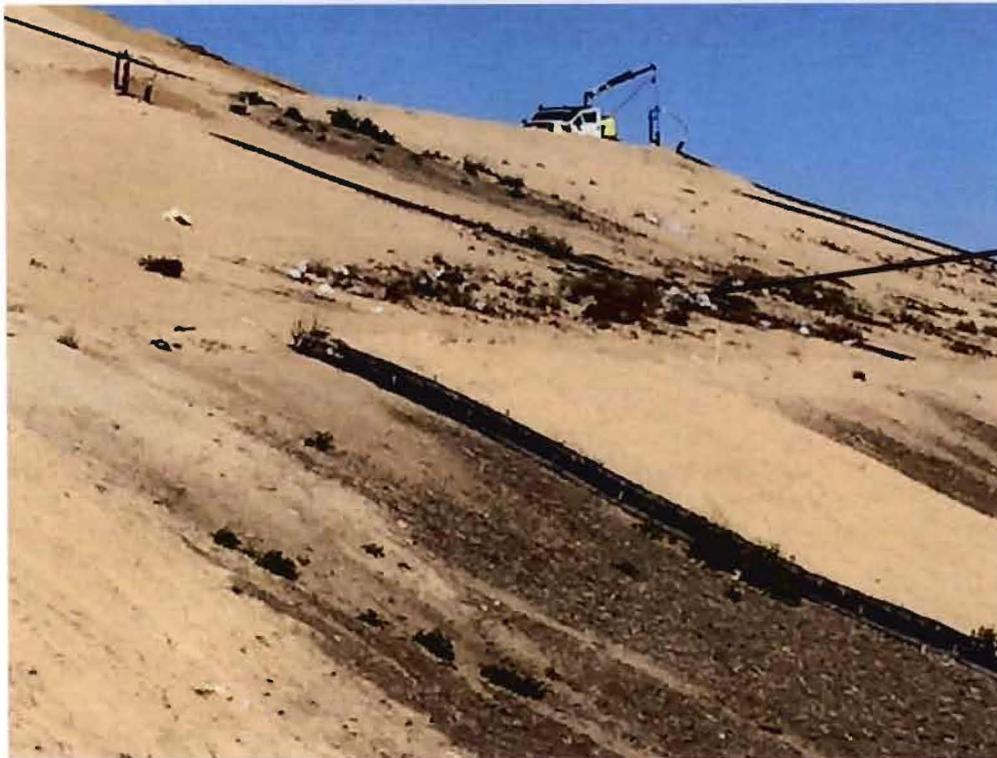
Figure 23- East Side Slope

Trash observed on the east landfill side slope, down gradient from the active portion.

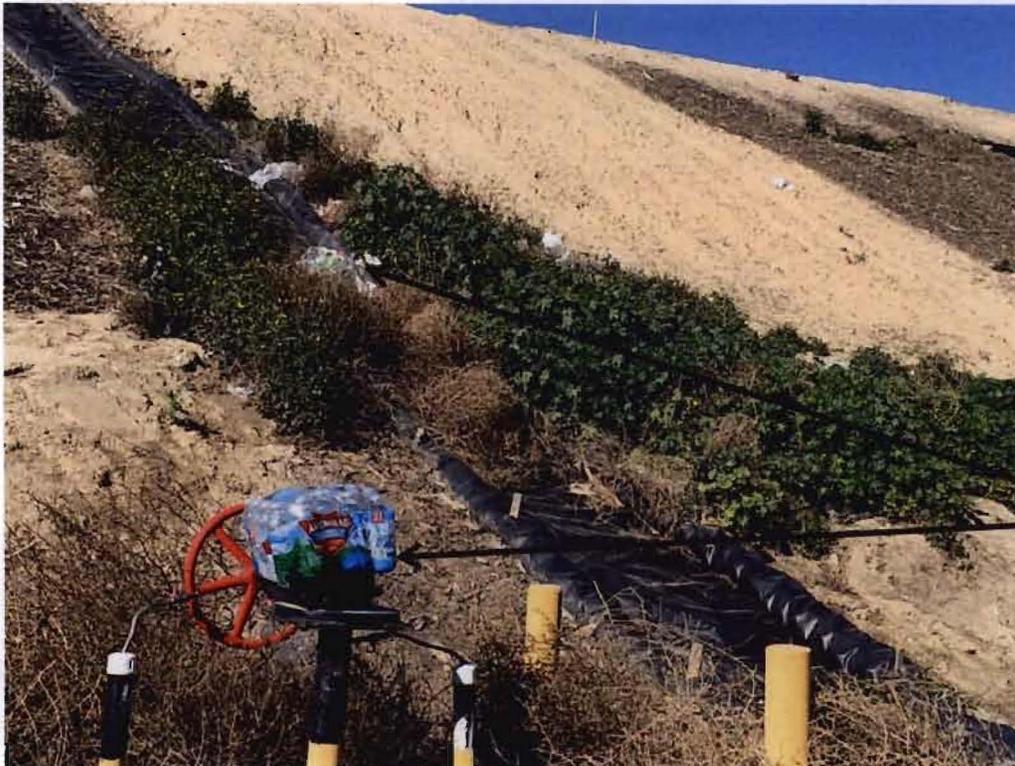
Figure 24- East Side Slope

Unopened bottled water left on gas probe. Trash observed.

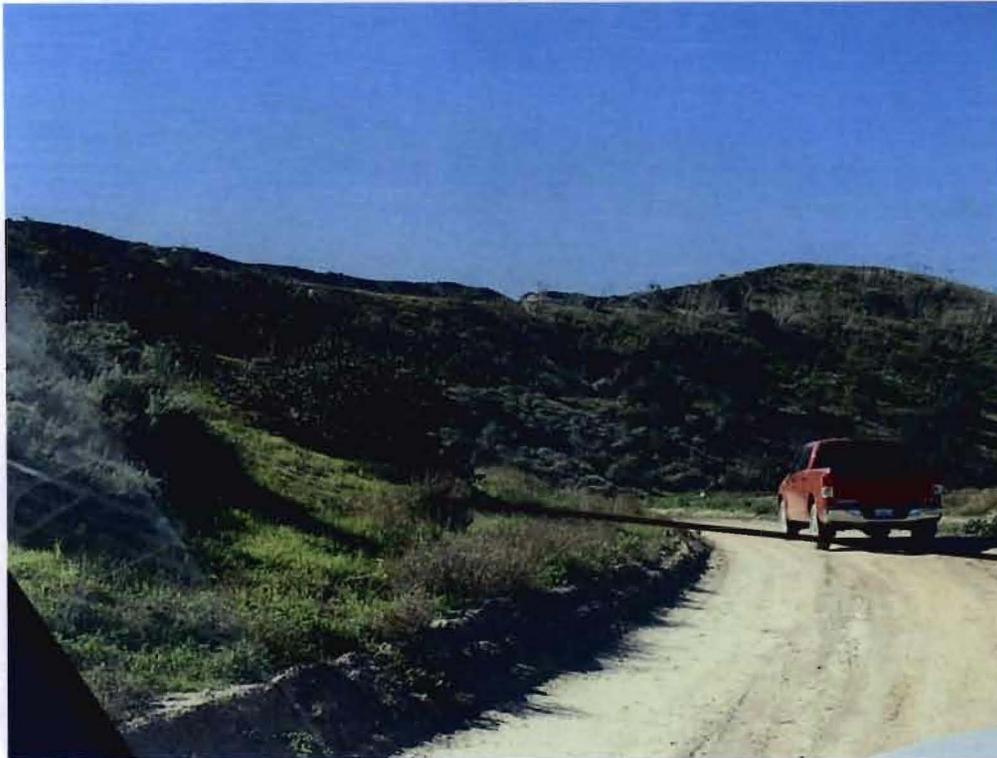
Figure 27- North Side Slope

North side slopes were observed with established vegetation.

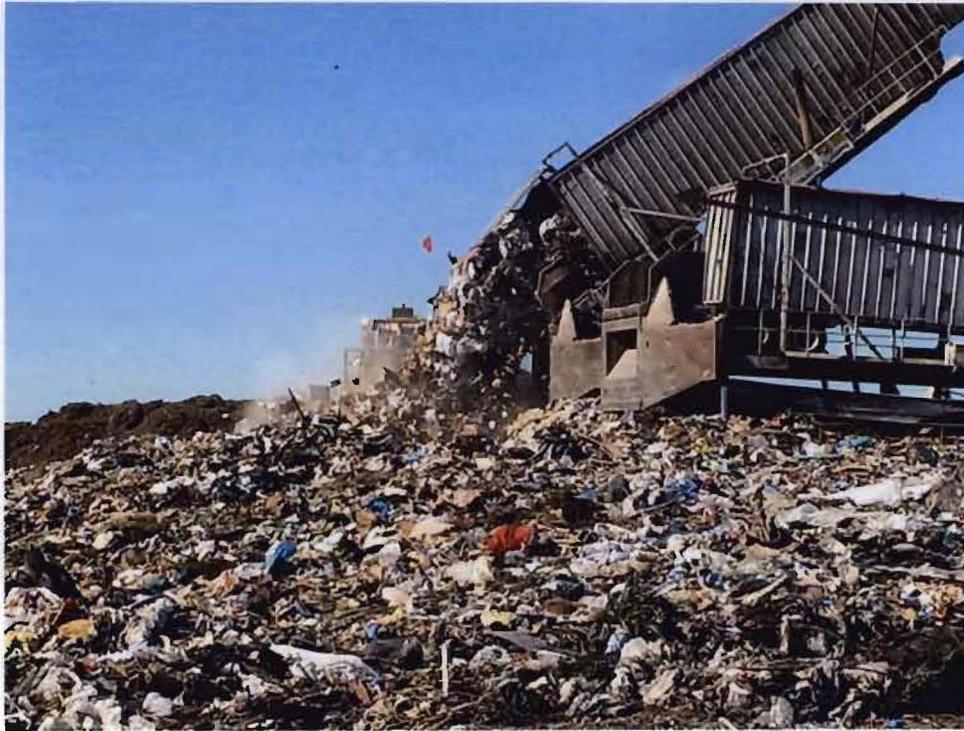
Figure 29- Active Portion of Landfill

Three tons of municipal solid waste being dumped in active portion of landfill from transfer station.
