Report of Transboundary Bypass Flows into the Tijuana
River

Minute 320 Binational Technical Team

Final Report

April 2017

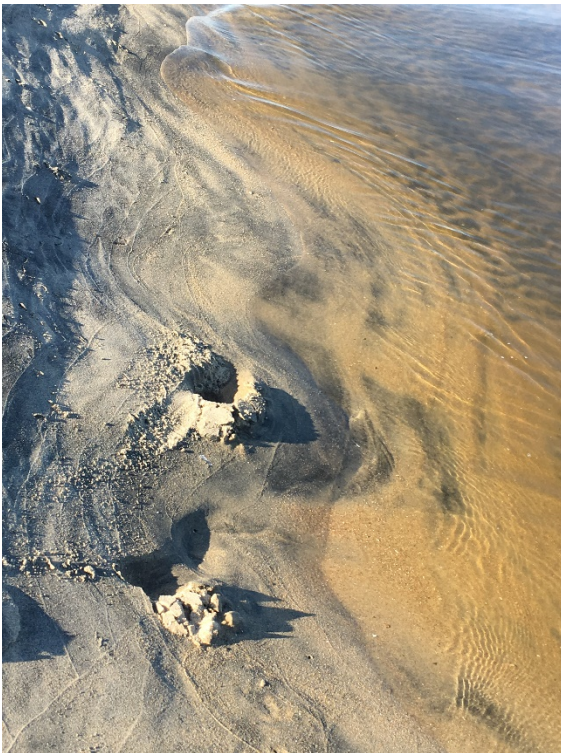
Figure 3 Tijuana River at confluence with Pacific Ocean, dark material present -March 8, 2017

There was the presence of black organic material in the sands. USIBWC interviewed personnel at the Tijuana River National Estuarine Research Reserve and at Border Field State Park, located near the river's mouth. Those personnel noted that the odor of wastewater is consistent when there are flows in

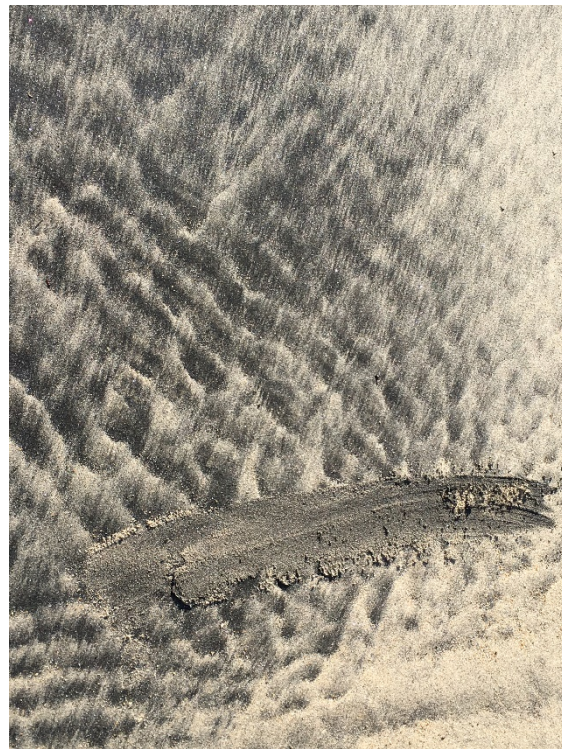
Figure 4 Close up of sand material – March 8, 2017

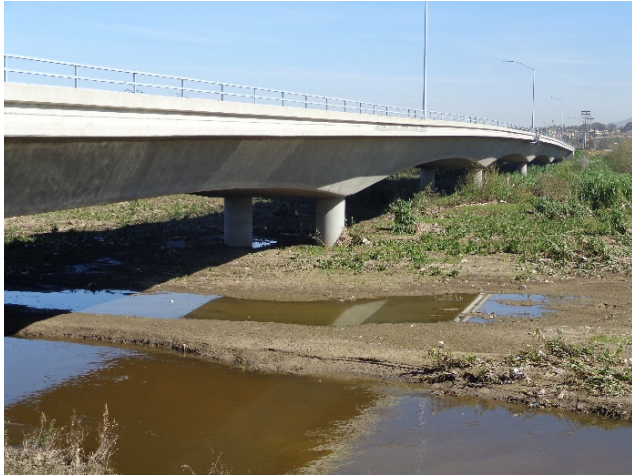
the river and that odors were noticeably higher during early February. Park service personnel noted the increase in odors but they indicated the odors are normally present when the river is flowing. They did not associate the increase with increased wastewater discharges. Park personnel take water quality readings on a routine basis. The Tijuana River flow at Dairy Mart Road Bridge, San Diego California, was slow moving and contained litter but did not smell of wastewater nor have any dark discoloration.

Figure 5 Tijuana River at Dairy Mart Bridge

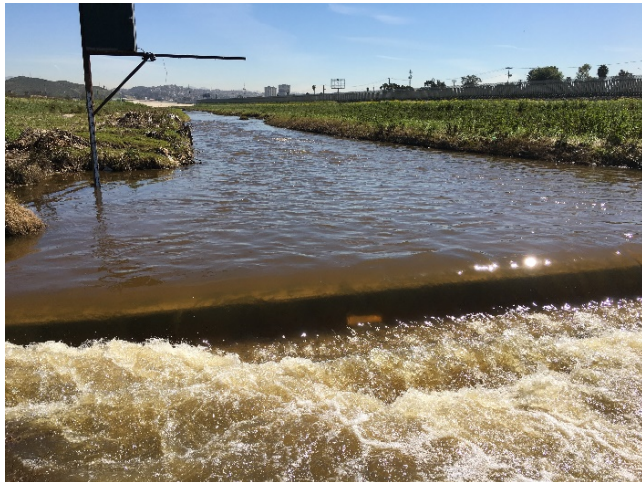
Figure 6 Tijuana River at IBWC gaging station, March 8, 2017

Further upstream at the USIBWC gaging station located in the pilot channel of the flood control project, immediately downstream of the international border, flow of the Tijuana River was fast moving and approximately two cubic meters per second (cms). The flood plain on either side of the pilot channel contained large amounts of trash and debris such as plastic bottles and tires. The water did not smell of wastewater but was slightly brown in color.

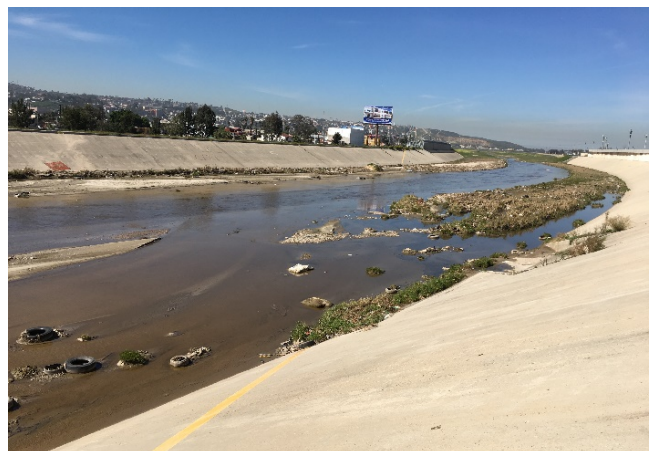
Water in the concrete lined portion of the channel was constant and did not have any smells or stagnant locations. The Tijuana River includes a 2-mile long concrete-lined channel near the international boundary as part of the IBWC's Tijuana River Flood Control Project.

Figure 7 Tijuana River at international boundary- March 8, 2017

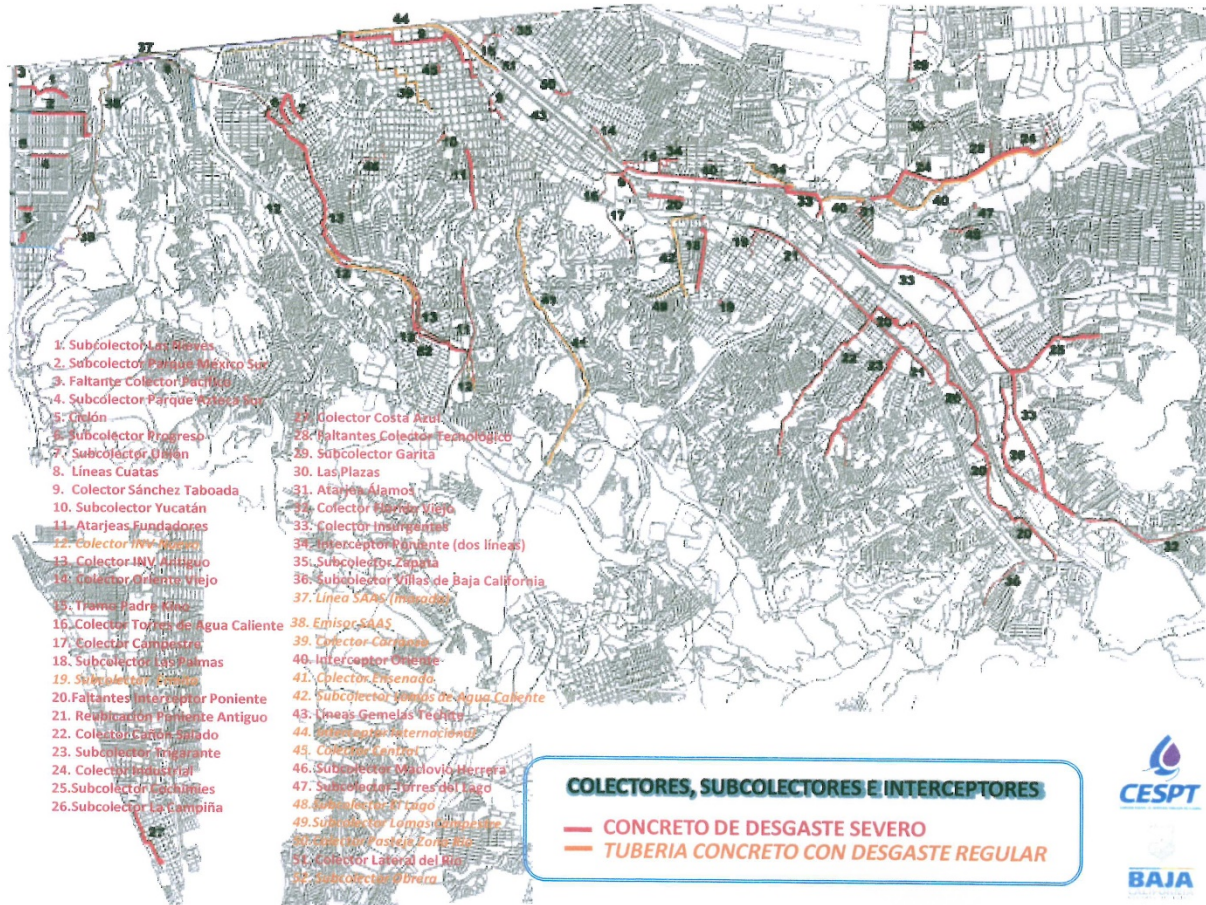
Figure 9 Location map of critical collectors

CESPT noted that they have a 2012 master plan for infrastructure improvements however it needs to be updated as Tijuana has grown significantly. A CESPT consultant will provide the updated 2012 plan with actions and a schedule. CESPT is working with CONAGUA and the governor of Baja California to financially assist in replacing some of the wastewater lines. The following are a location map and two tables showing the immediate needs and near term needs for Tijuana sewerage:

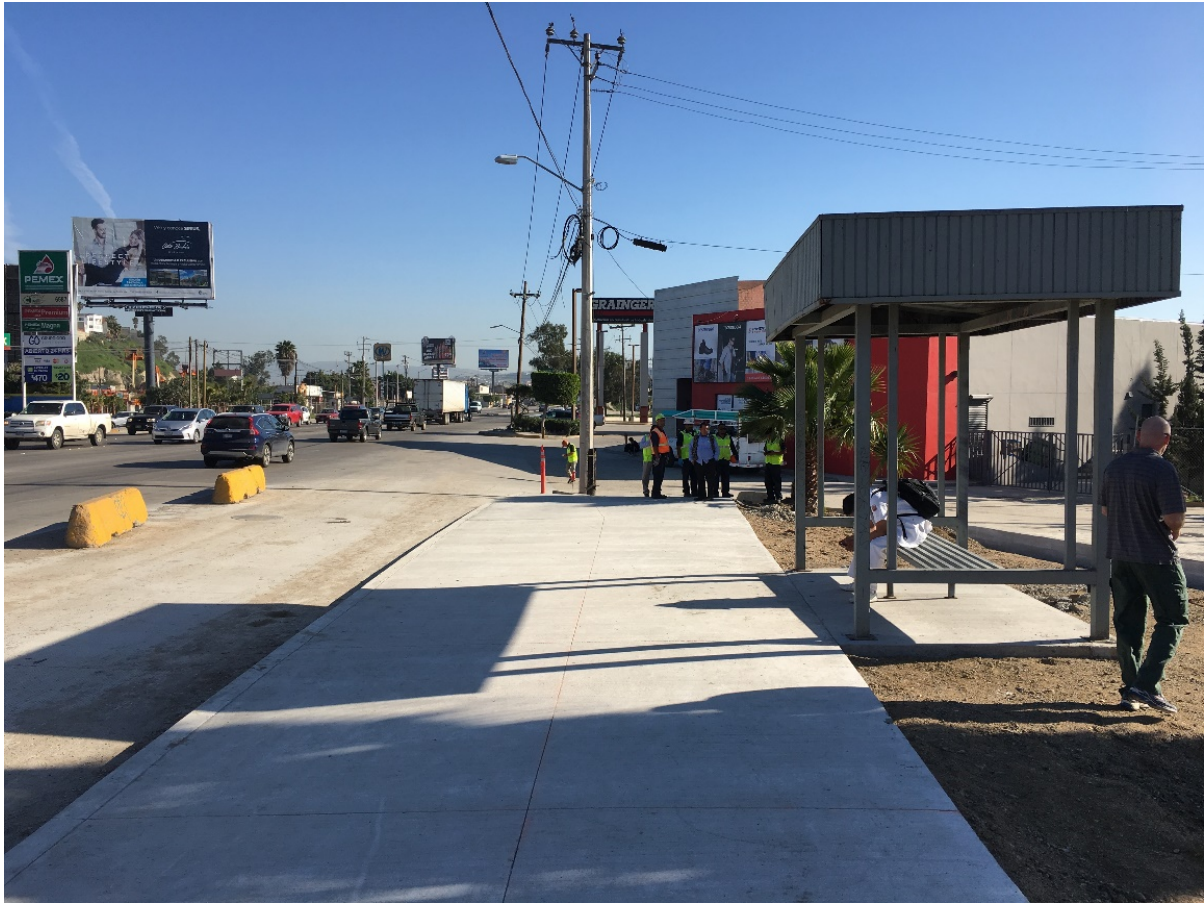
Figure 11 Final repairs to road and bus stop and location of Insurgentes/Oriente collector repair- - Blvd Lazaro Cardenas, Colonia Los Pirules, Tijuana, B.C. - March 9, 2017

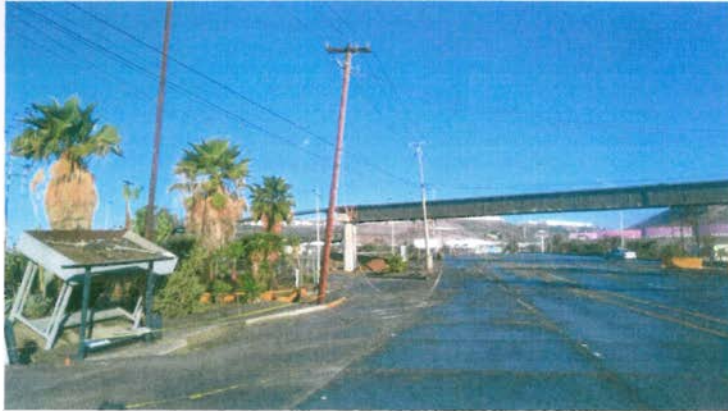
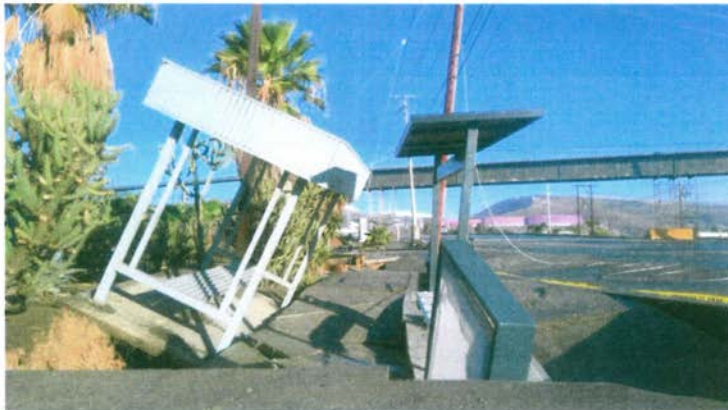
ANTES DEL INICIO DE LA OBRA

Este fue un evento extraordinario, generado por la saturación del colector con agua de lluvia, debido principalmente a las tormentas atípicas en la zona, lo que provocó que la tubería de concreto (ya con vida útil avanzada) trabajara a presión, lo cual dañó en los costados. La tubería fallada tendió a compactarse, reduciendo su área hidráulica e iniciando el arrastre de sólidos del relleno.
