San Diego Regional Water Quality Control Board

SUBJECT: OFFER TO SETTLE ADMINISTRATIVE CIVIL LIABILITY FOR ALLEGED VIOLATIONS OF THE CONSTRUCTION GENERAL STORM WATER PERMIT, ORDER R9-2018-0072, CASTLEROCK WESTON CONSTRUCTION SITE, WDID 9 37C374922

Attachment 2 – Castlerock Inspection Report Photo Log
Photos from January 19, 2017

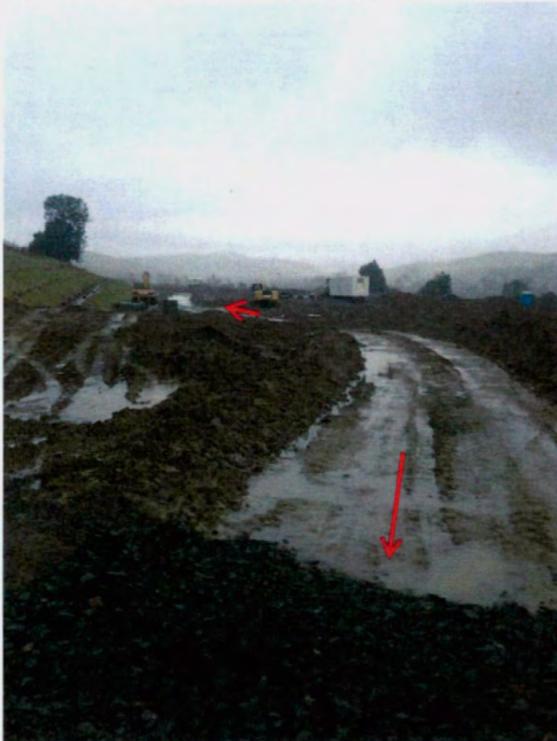
Figure 1.
Construction access road in site interior, looking North. No erosion controls BMPs in the form of bonded fiber matrix, soil tackifier or sediment control BMPs in the form of fiber rolls, gravel bag chevrons, or silt fencing implemented

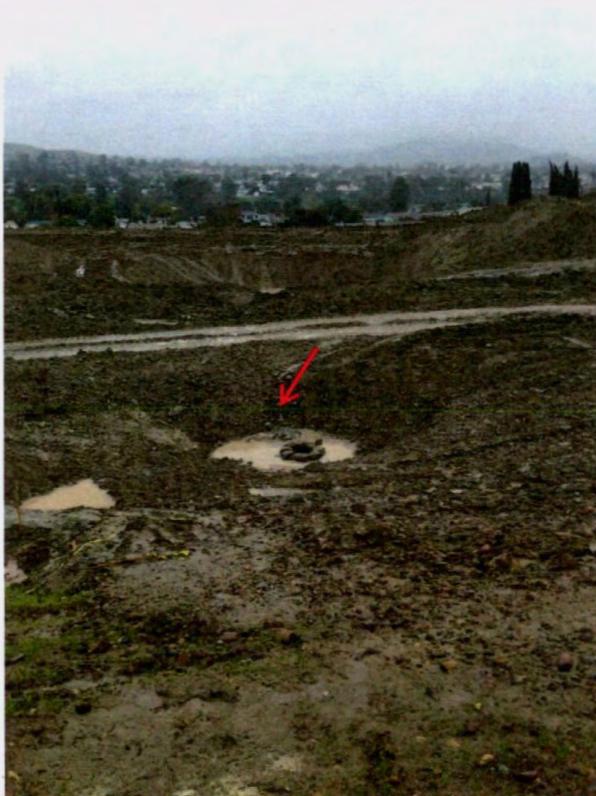
Figure 2.
Discharge point (open pipe connected to MS4) within construction site. Photo taken facing east. Turbid water was flowing into pipe but this discharge point had not been sampled for discharge quality per CGP.
No erosion/sediment BMPs implemented on disturbed soil surrounding this discharge point.

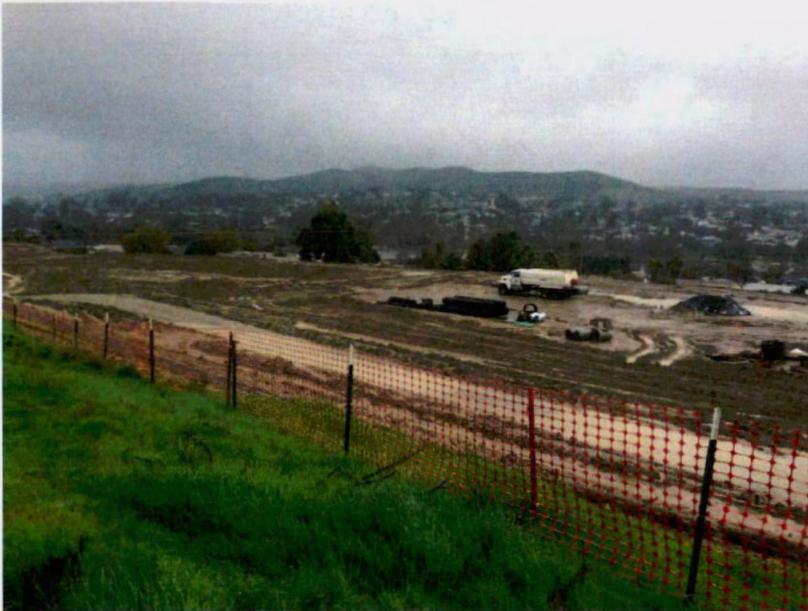
Figure 3.

Photo looking northeast from construction site service road. Several acres of area were disturbed. No erosion controls BMPs in the form of bonded fiber matrix, soil tackifier or sediment control BMPs in the form of fiber rolls, gravel bag chevrons, or silt fencing implemented.

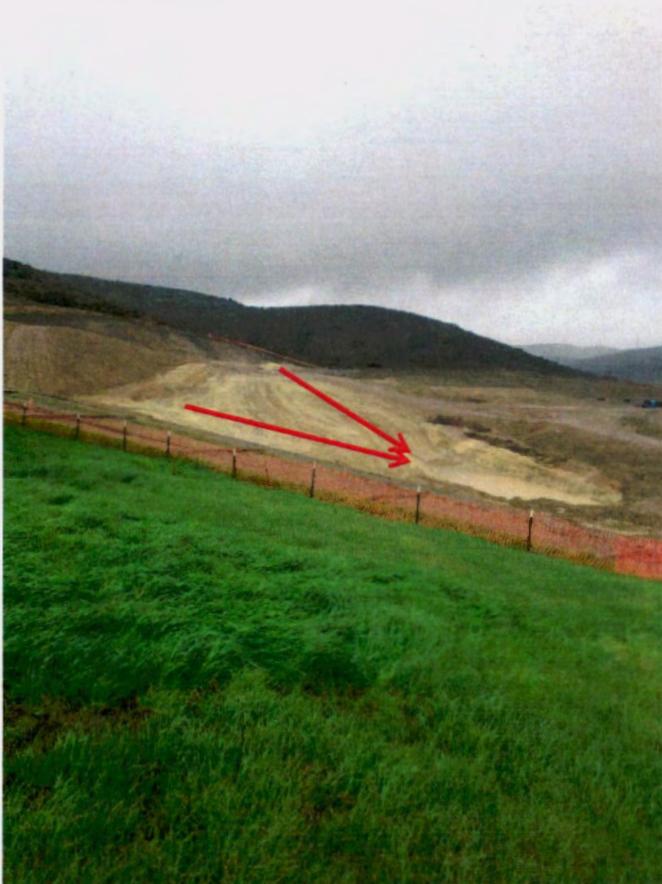
Figure 4.

Photo looking north at northern area of construction site. Area had been rough graded. Storm water run-on from open space area, as well as runoff generated onsite, are directed into depressions throughout the site. No erosion control BMPs in the form of bonded fiber matrix, soil tackifier or sediment control BMPs in the form of fiber rolls, gravel bag chevrons, or silt fencing implemented.

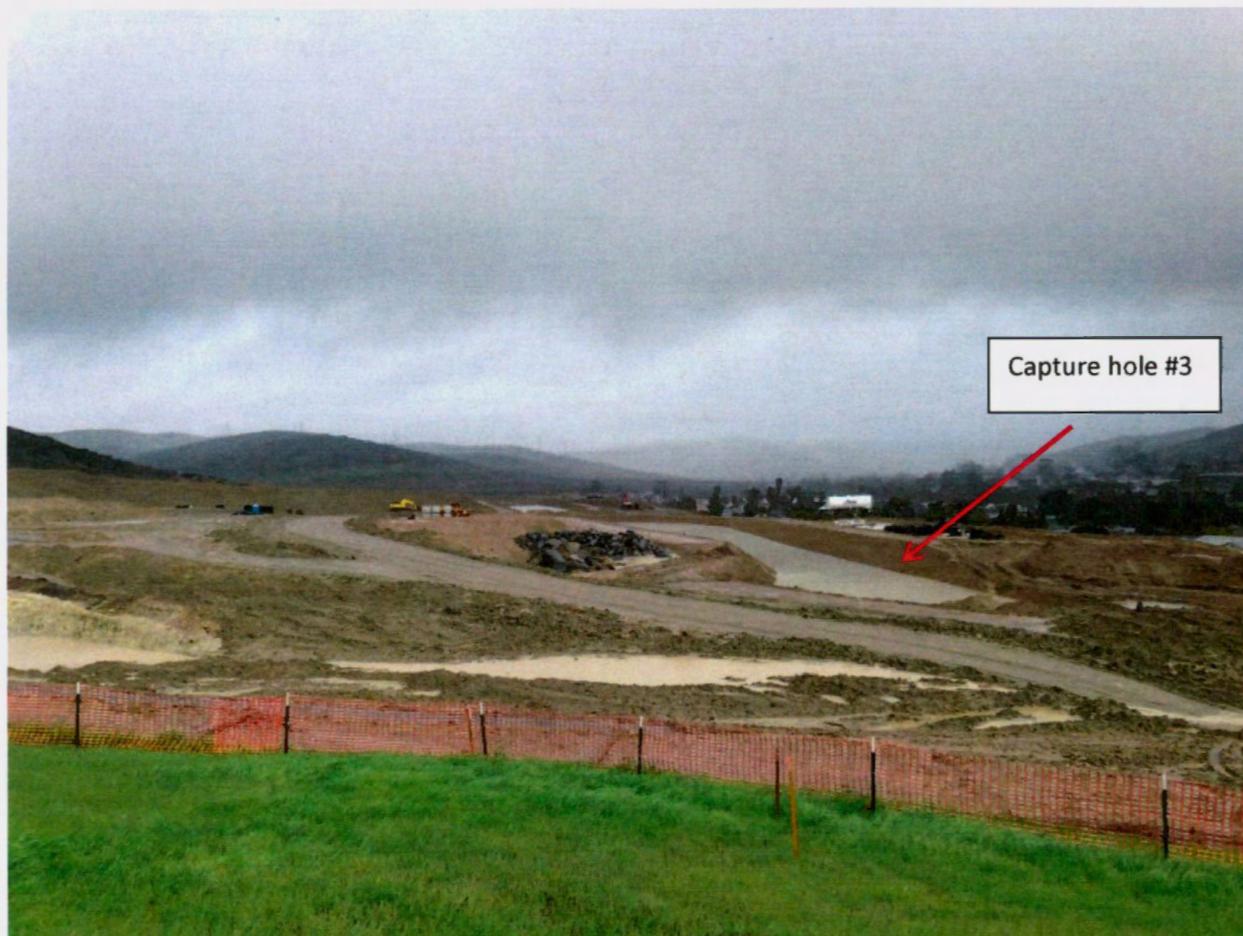
Figure 5.

Photo looking north at capture hole #3 and construction service road. Capture hole has standing water. No erosion control BMPs in the form of bonded fiber matrix, soil tackifier or sediment control BMPs in the form of fiber rolls, gravel bag chevrons, or silt fencing implemented.

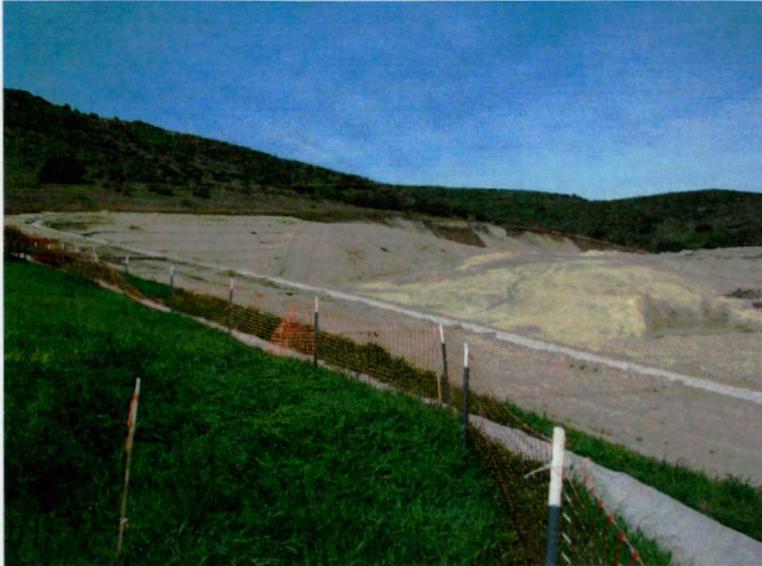
Figure 6.

Photo looking North at northern area of construction site (same angle as Figure 4). . No erosion control BMPs in the form of bonded fiber matrix, soil tackifier or sediment control BMPs in the form of fiber rolls, gravel bag chevrons, or silt fencing implemented. Erosion rills are visible.

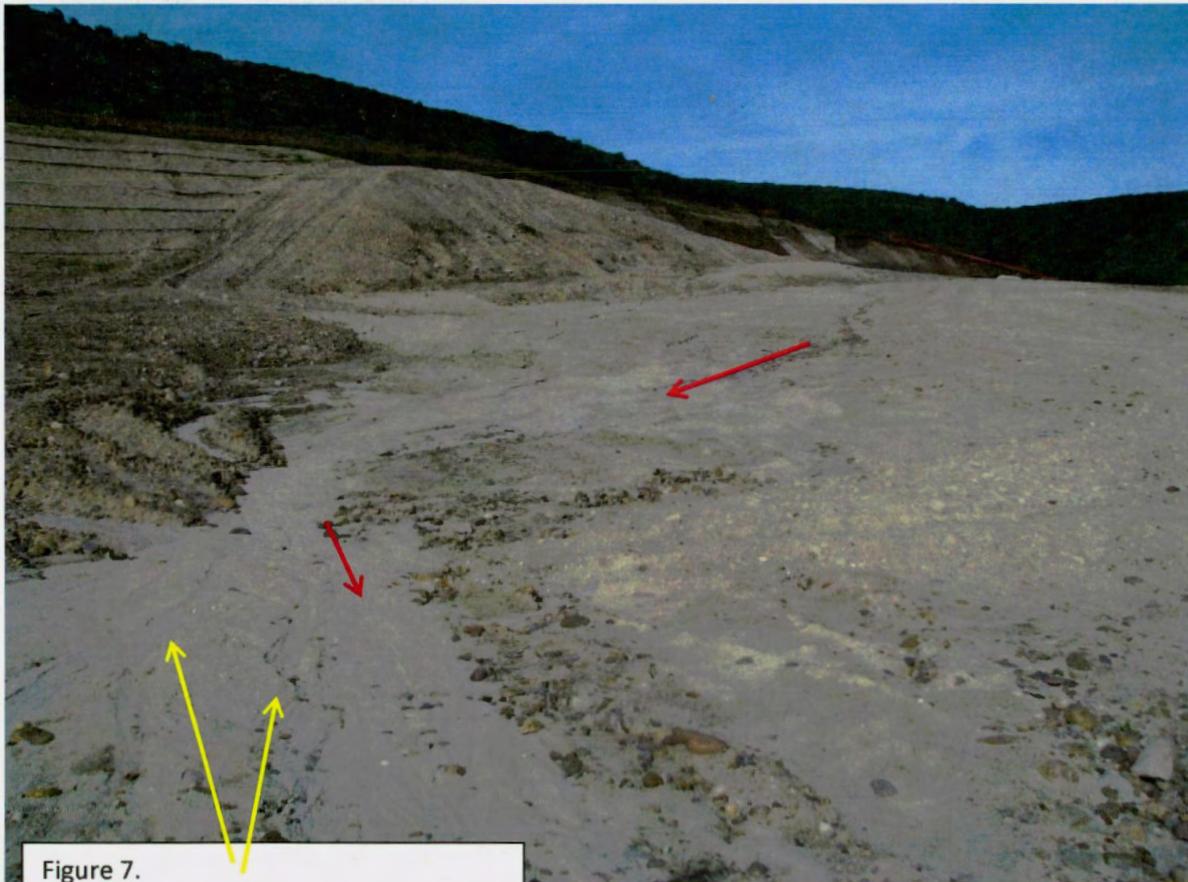
Figure 7.

Close-up of rills shown in Figure 6.

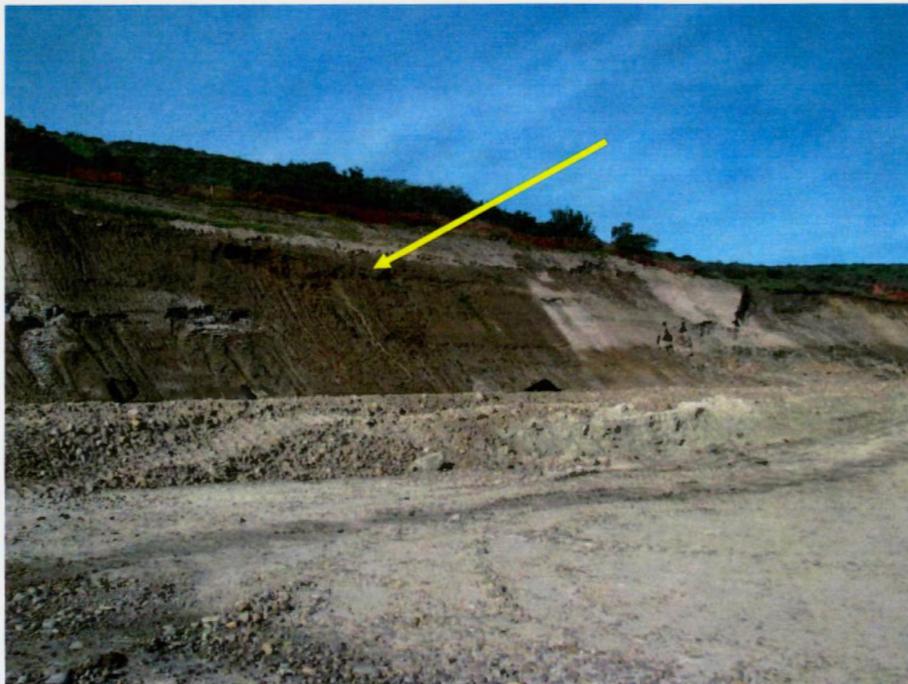
Figure 8.
Photo looking at western boundary of construction site. Days after rain occurring on January 20, 2017 ceased, hillsides were weeping water onto construction site (run-on). Erosions rills are visible despite this finished slope having been sprayed with soil tackifier several weeks before.

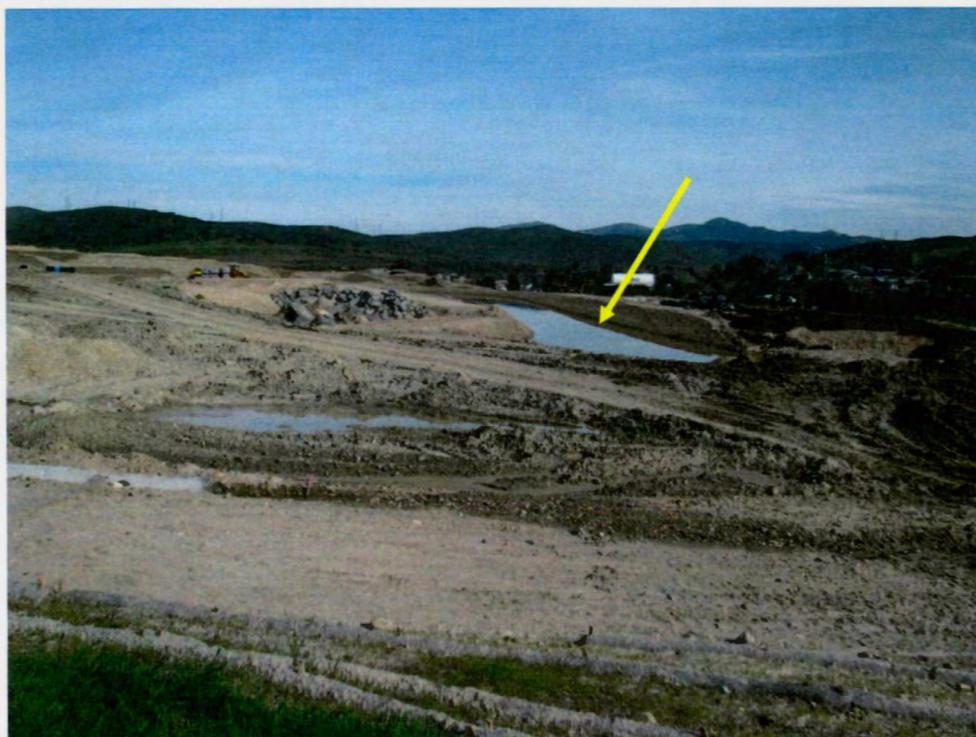
Figure 9.
Photo looking at capture hole #3 shown in Figure 5. This hole receives the drainage from the areas shown in Figures 7 and 8.

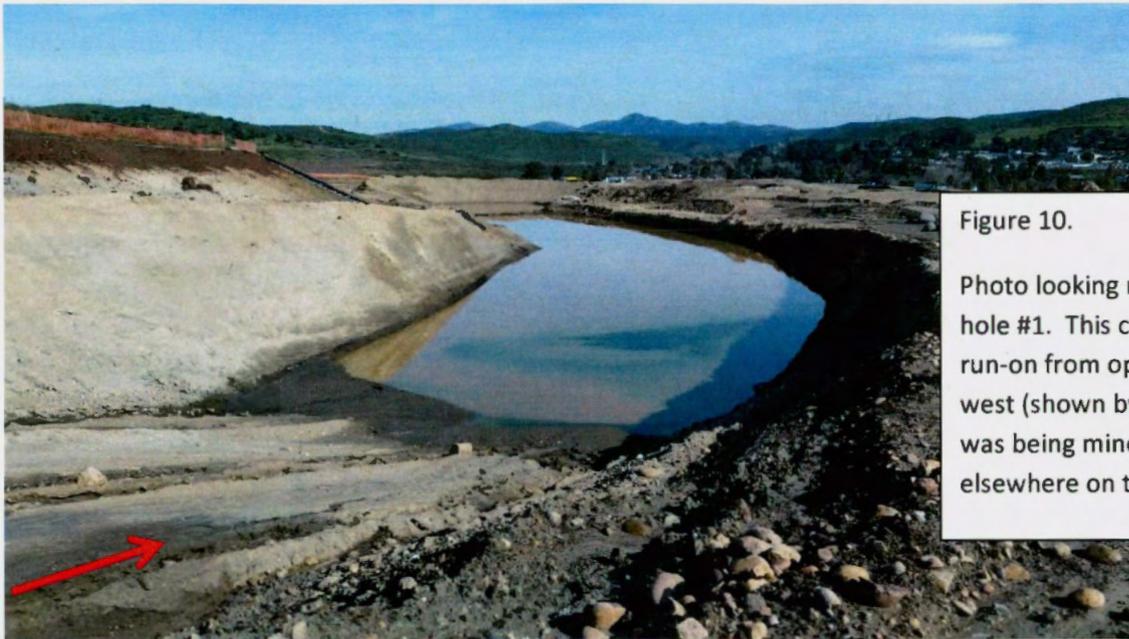
Figure 10.
Photo looking northeast at capture hole #1. This capture hole receives run-on from open space area to the west (shown by red arrow). This area was being mined for material used elsewhere on the site.

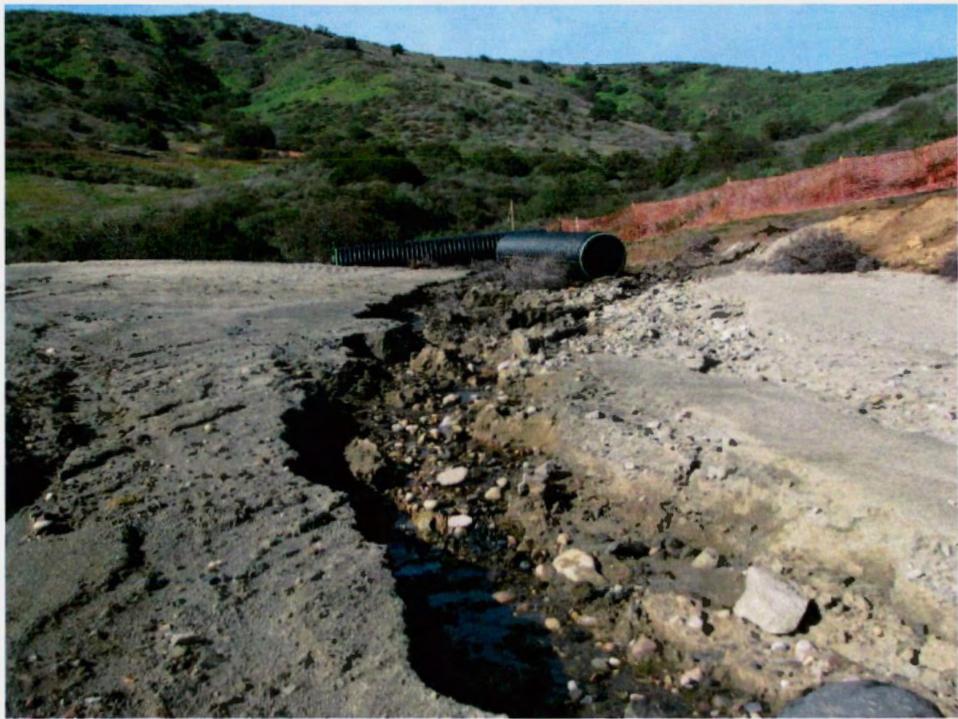
Figure 11.
Photo looking upstream at source of run-on into capture hole #1 shown in Figure 10. No erosion control BMPs in the form of bonded fiber matrix, soil tackifier or sediment control BMPs in the form of fiber rolls, gravel bag chevrons, or silt fencing implemented.

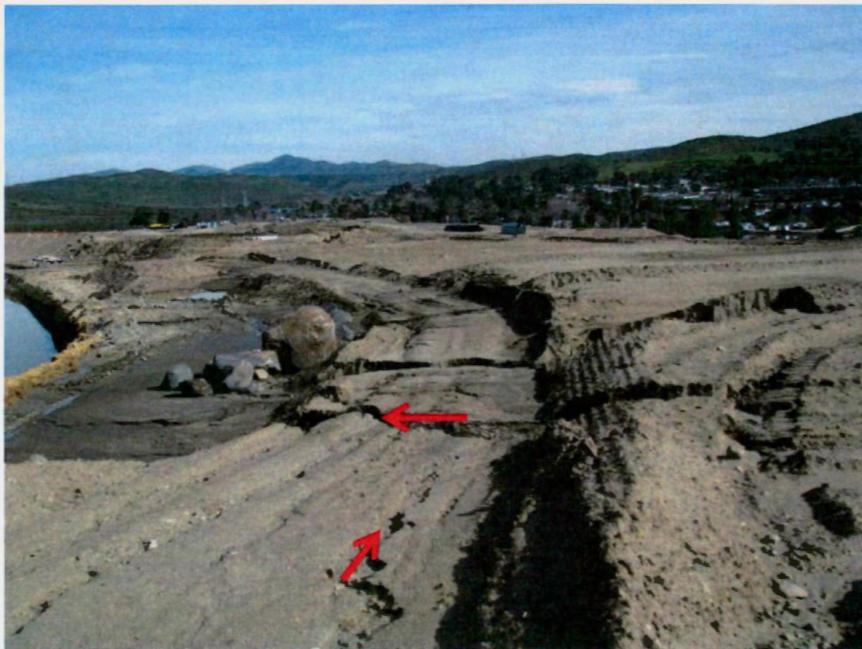
Figure 12.

Photo looking northeast at construction site. Rough graded area drains to the left to capture hole #1 pictured in Figure 10. No erosion control BMPs in the form of bonded fiber matrix, soil tackifier or sediment control BMPs in the form of fiber rolls, gravel bag chevrons, or silt fencing implemented.

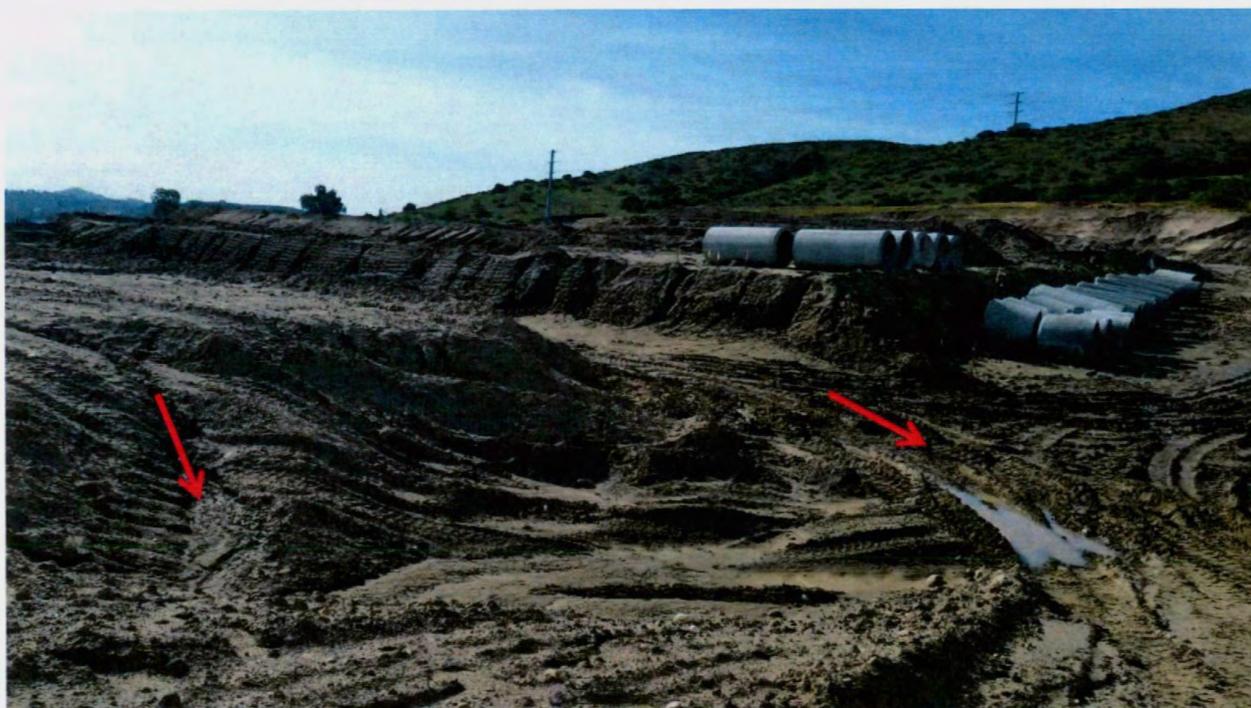
Figure 13.

Photo looking southwest towards open space area. This area drains to the capture hole #1 shown in Figure 10. No erosion control BMPs in the form of bonded fiber matrix, soil tackifier or sediment control BMPs in the form of fiber rolls, gravel bag chevrons, or silt fencing implemented.

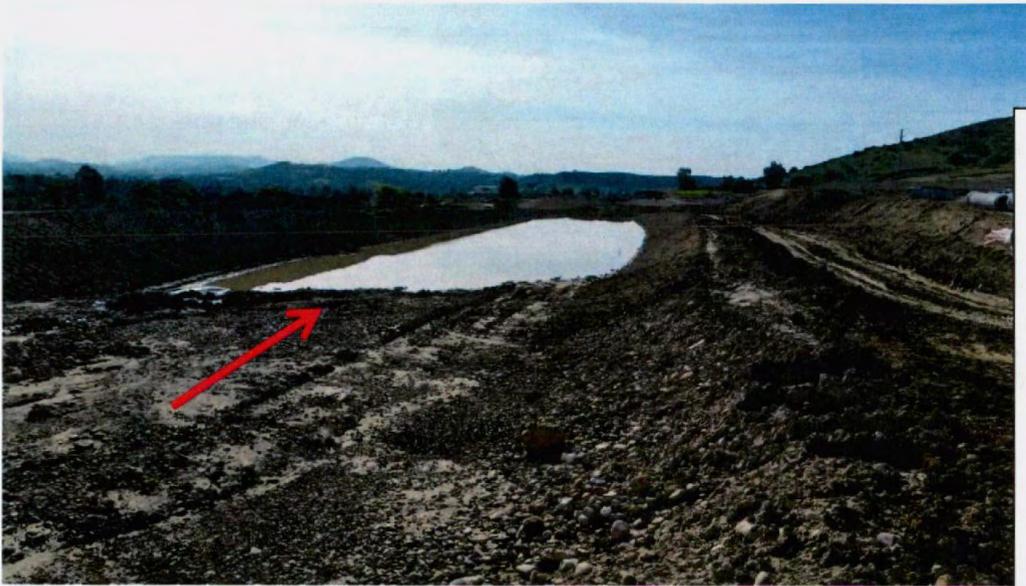
Figure 14.
Capture hole #2 located east of capture hole #1. This photo is facing south. No erosion control BMPs in the form of bonded fiber matrix, soil tackifier or sediment control BMPs in the form of fiber rolls, gravel bag chevrons, or silt fencing implemented.

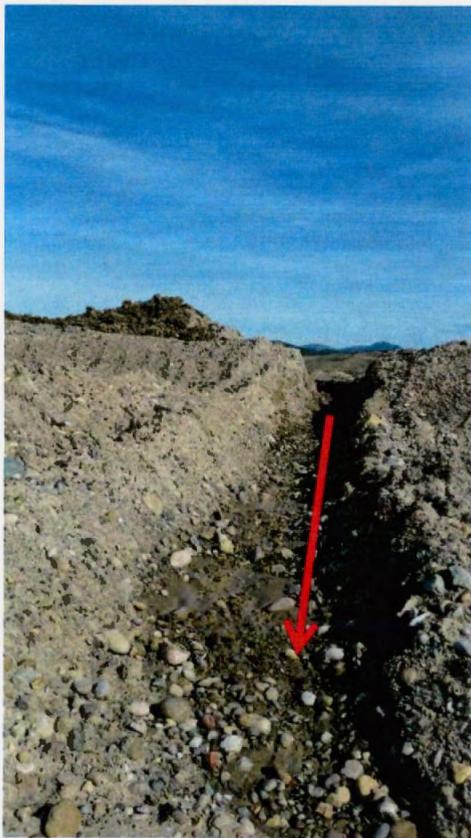
Figure 15.
Runoff from north eastern area of construction site mesa is directed into capture hole # 2 shown in Figure 14 via this channel.

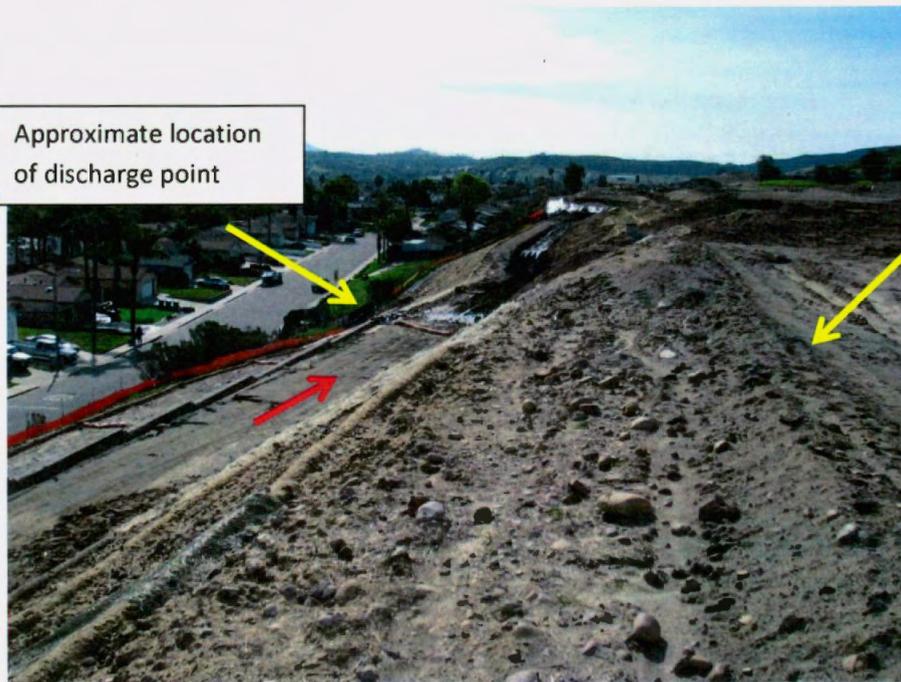
Figure 16.
Photo at edge of fill slope and eastern boundary of site, looking South at Medina Dr. The terraced area had erosion and sediment control BMPs (bonded-fiber matrix, fiber rolls); however, the road/ trail area that was graded towards the discharge point (along the retaining wall) only had one line of gravel bag chevrons. Linear sediment control BMPs are required at least every 20 feet.

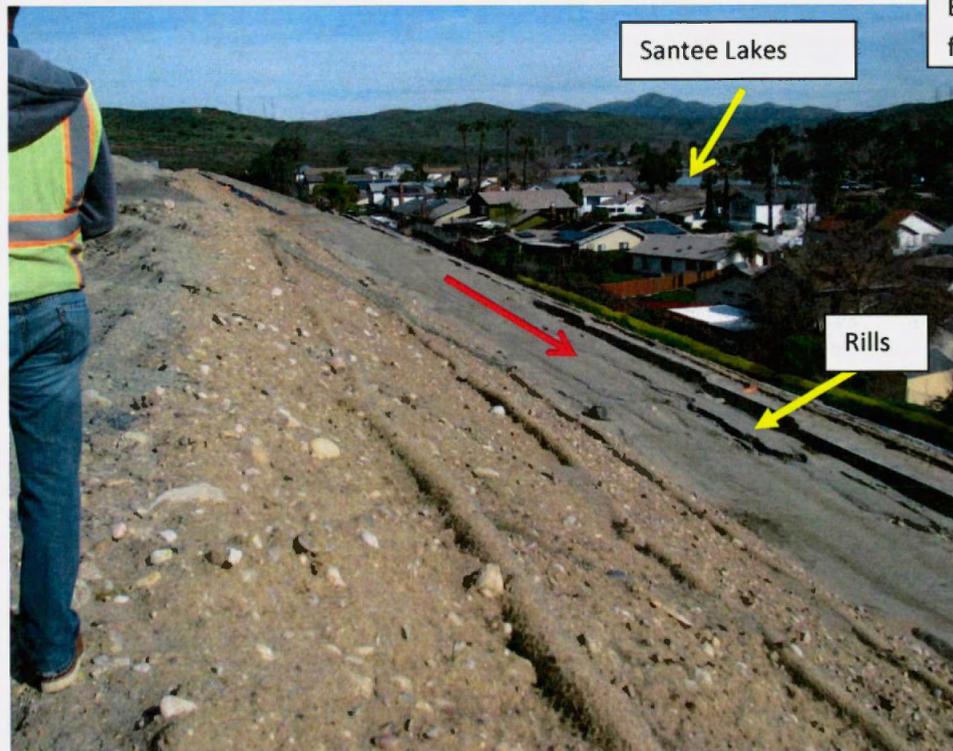
Figure 17.
Photo at edge of fill slope and eastern boundary of site, looking north. The terraced area had erosion and sediment control BMPs in the form of bonded fiber matrix and fiber rolls; however, the road/trail area that was graded towards the discharge point (direction of flow indicated by red arrow) did not have adequate BMPs. Linear sediment control BMPs are required at least every 20 feet. Rills are evident on this trail.

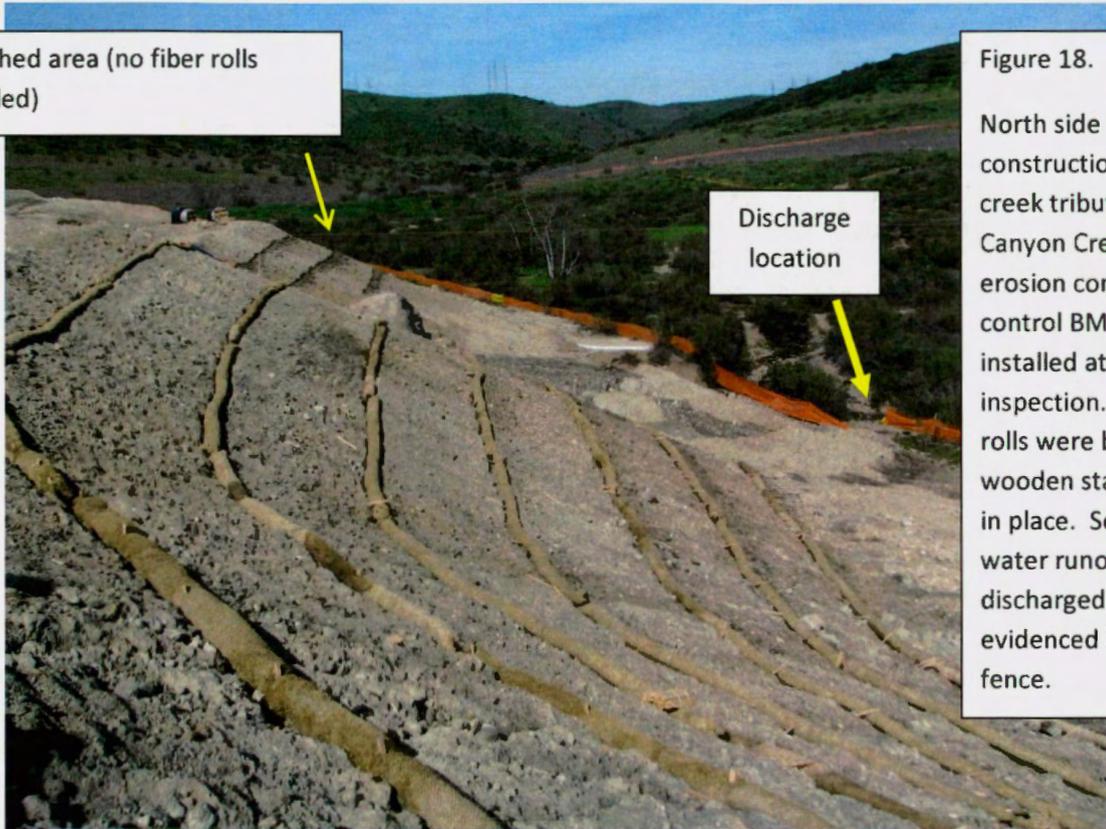
1. In regards to the slope failure that San Diego Water Board inspectors Ms. Ryan and Ms. Arias observed on the north side of the construction site during the inspection occurring on February 2, 2017 (see Attachment 2, Figures 18, 21), Ms. Arias asked Mr. Nichols to verify that BMPs had not been in place at that location. Mr. Nichols verified that erosion and sediment control BMPs on the north side of the disturbed area had not been installed immediately upon completion of rough grading. According to an email to Ms. Arias from Ms. Horn dated February 10, 2017, the fill slope on the north side was completed on December 9, 2016 to a slope height of 21 feet, and BMP repair and installation in the area was completed on February 8, 2017.

Figure 18.
North side (boundary of work) of construction site, adjacent to creek tributary to Sycamore Canyon Creek. There were no erosion controls, and sediment control BMPs were being installed at the time of inspection. Locations for fiber rolls were being trenched, and wooden stakes are not yet staked in place. Sediment-laden storm water runoff was illegally discharged at this area, evidenced by the collapsed silt fence.

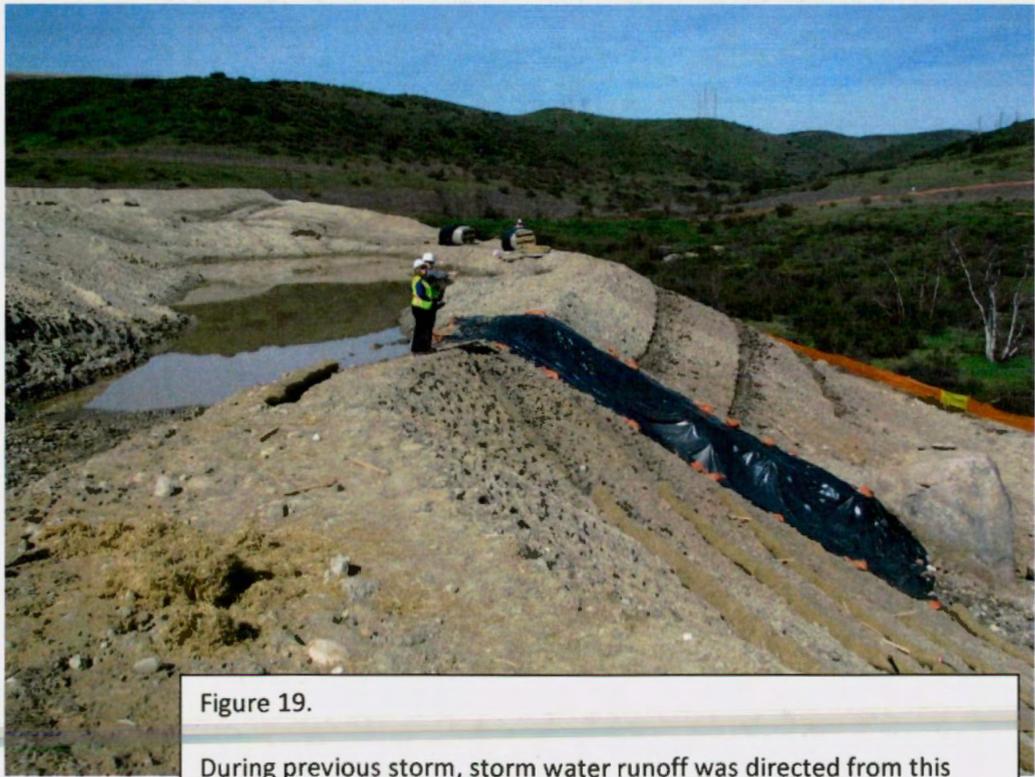
Figure 19.
During previous storm, storm water runoff was directed from this area of ponded water at the top of the fill slope down sheet plastic towards the creek. The plastic was placed to prevent collapse of the slope.

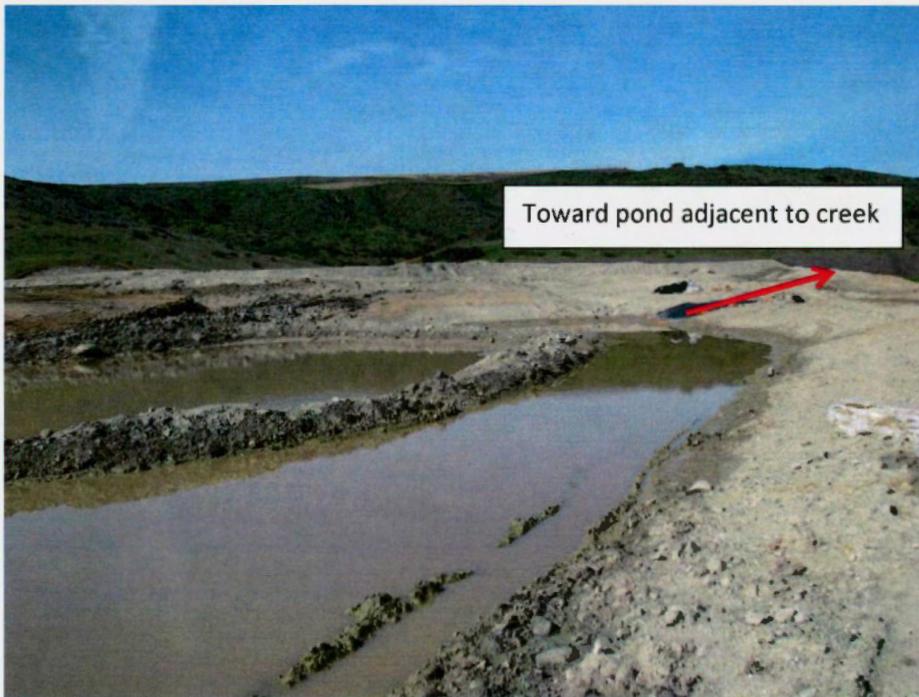
Figure 20.

Pond near northern boundary of construction site. In previous storms, runoff was diverted from this pond via sheet plastic into pond shown in Figure 19.

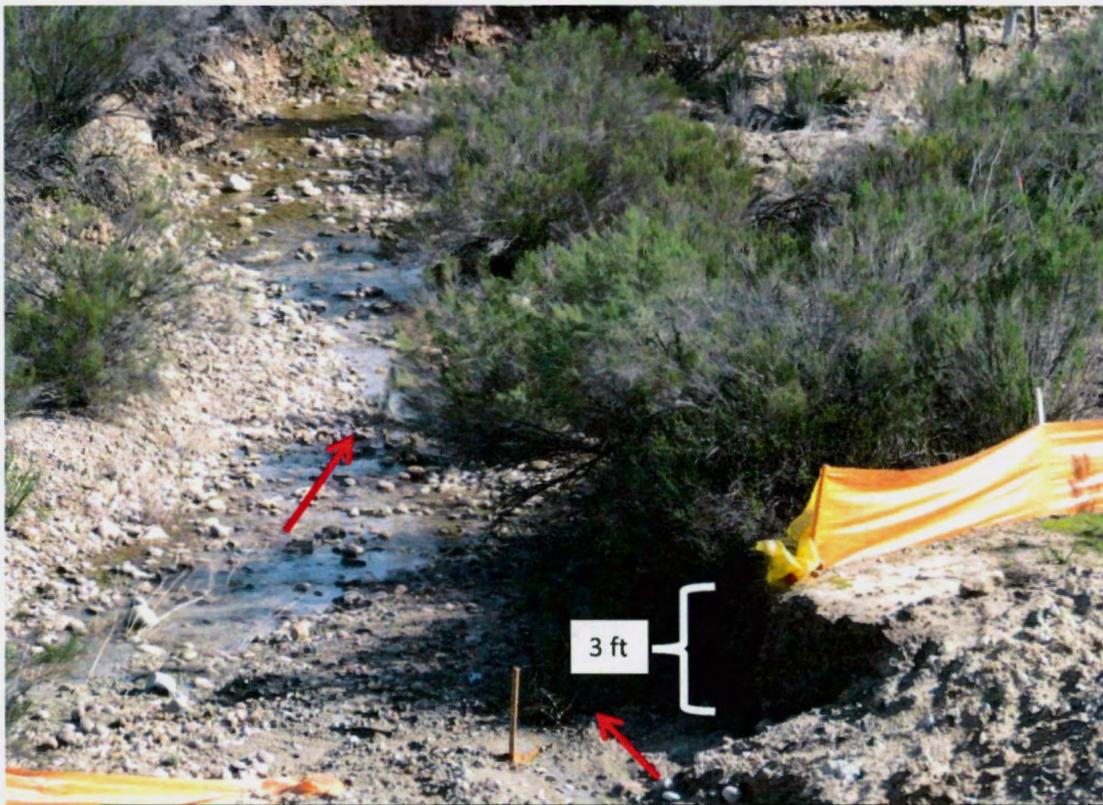
Figure 21.

Close up of perimeter breach shown in Figure 18. During previous storm, storm water was diverted to this area causing erosion of the slope and an illegal discharge into the creek (unnamed tributary to Sycamore Canyon Creek). Vertical drop where fence is torn is approximately 3 feet.

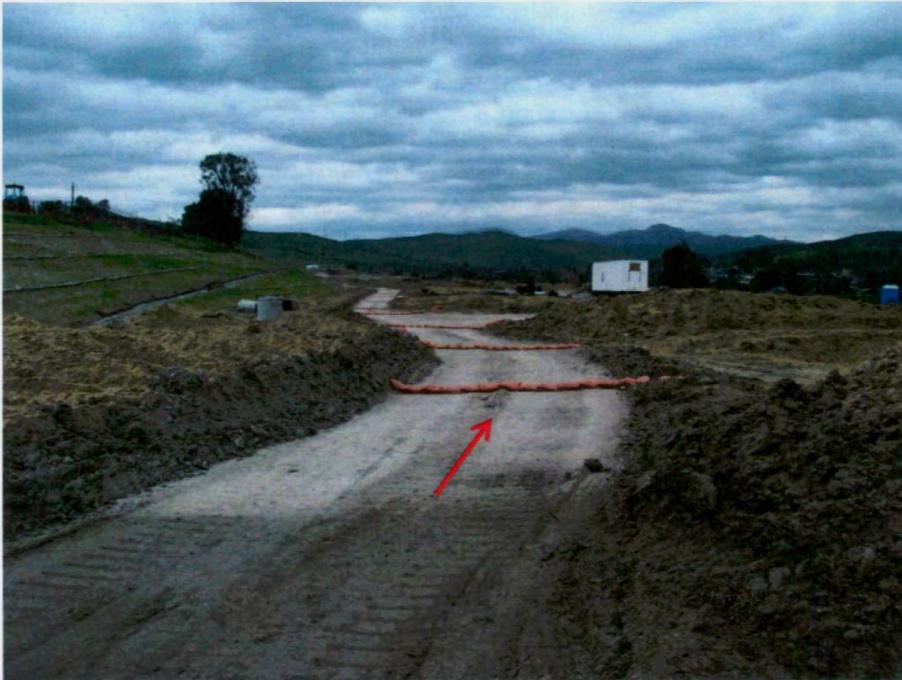
Figure 24.

Photo showing road depicted in Figure 1. In preparation for the oncoming storm, construction site personnel had placed temporary sediment controls in place, and the disturbed areas had been sprayed with soil tackifier (erosion control). Some areas had also been sprayed with hydromulch (slopes with tan-colored bonded fiber matrix).

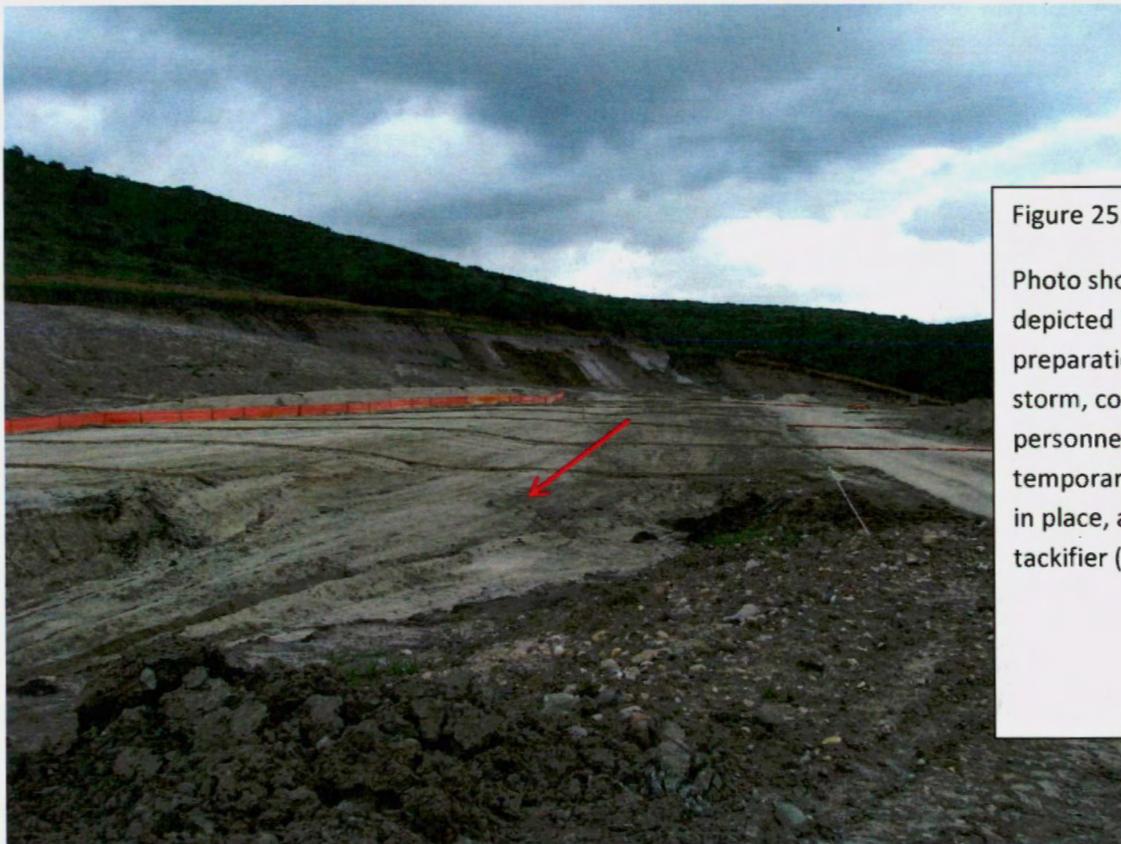
Figure 25.

Photo showing disturbed area depicted in Figure 7. In preparation for the oncoming storm, construction site personnel had placed temporary sediment controls in place, and a non-visible soil tackifier (erosion control).

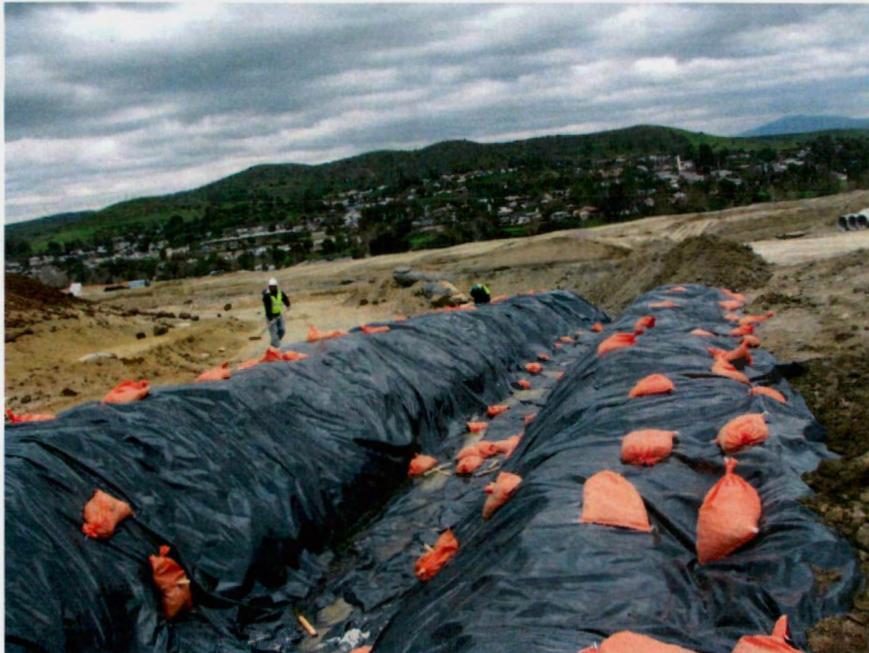
Figure 26.

Photo showing spillway to direct run-on from open space area into capture hole #1. This is a retrofit of drainage pathway shown in Figure 11.

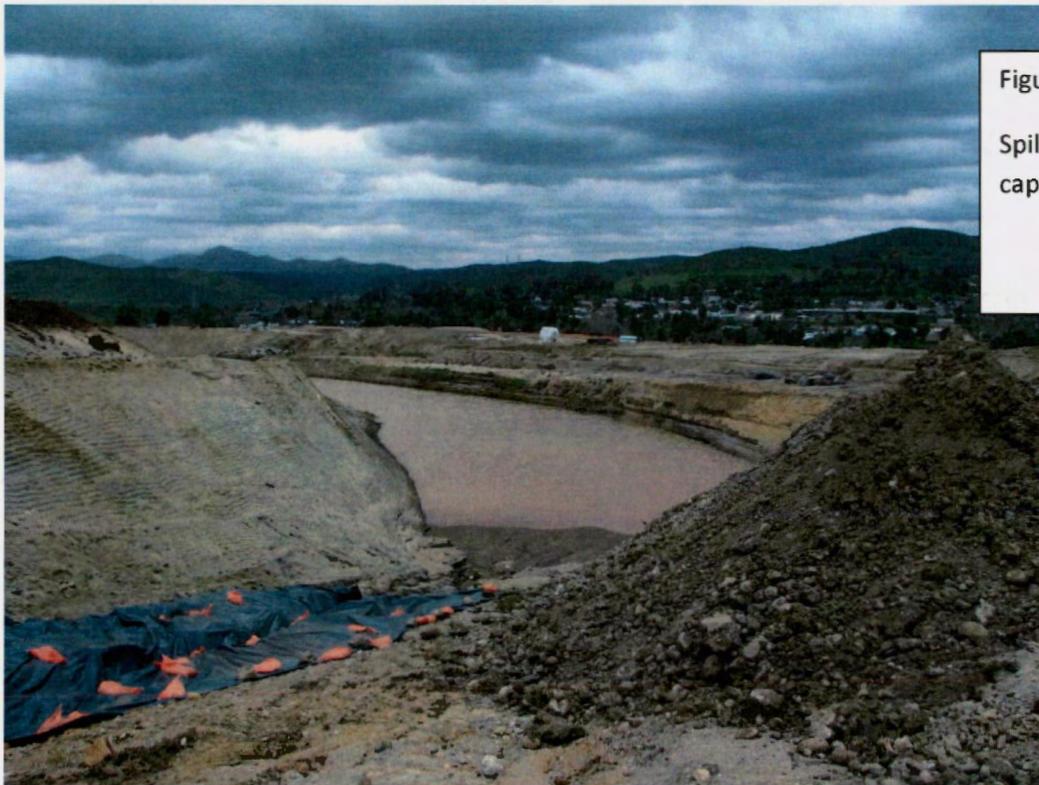
Figure 27.

Spillway discharge point into capture hole #1.

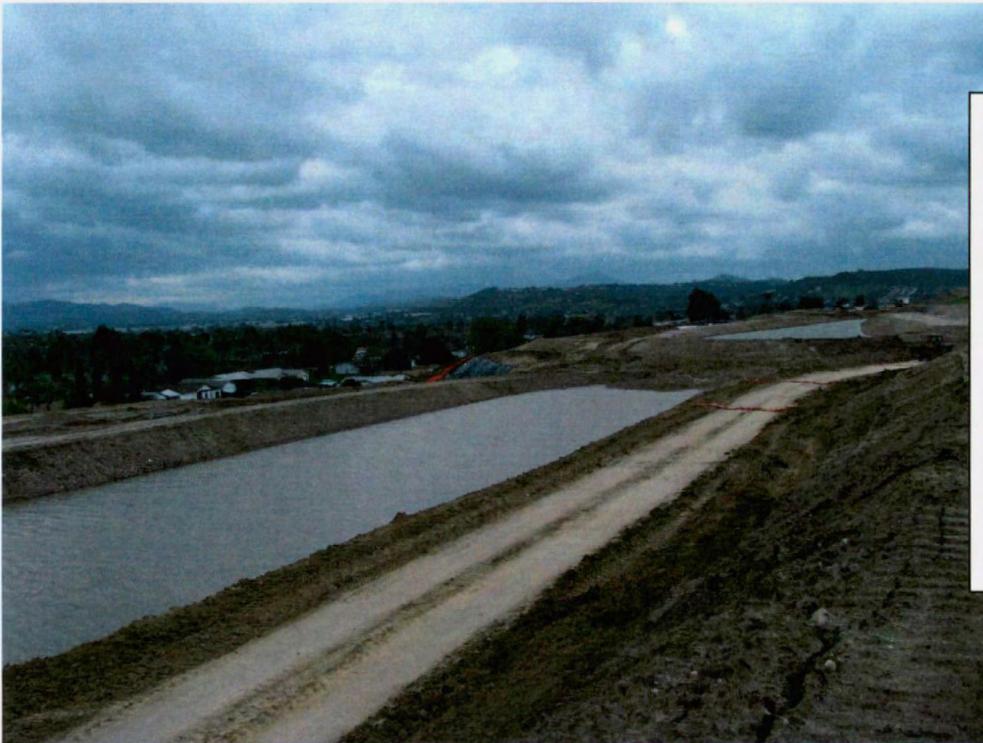
Figure 28.
Photo showing capture holes #2 (foreground) and #3 (background). Note the capture holes in this photo have been dug to a depth of 12 feet, approximately 3 feet of freeboard is visible. A storm was approaching at the time of inspection.

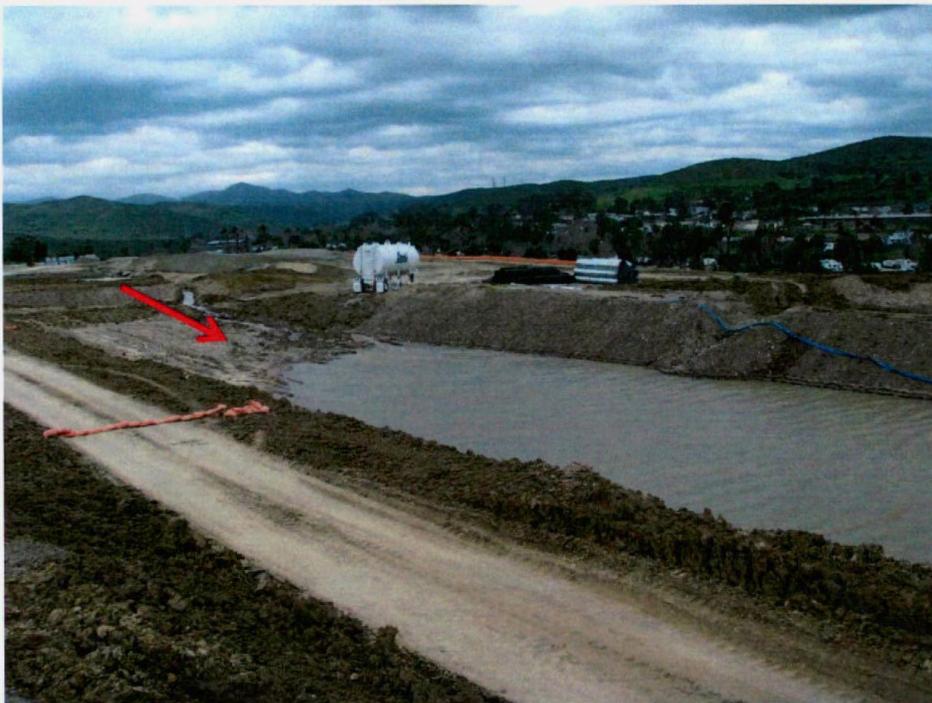
Figure 29.
Photo showing north side of capture hole #2. The area had been graded so that water drained from pools on the north side of the property into this capture hole. A hose was also used to pump water from the pools on the north side into this capture hole.

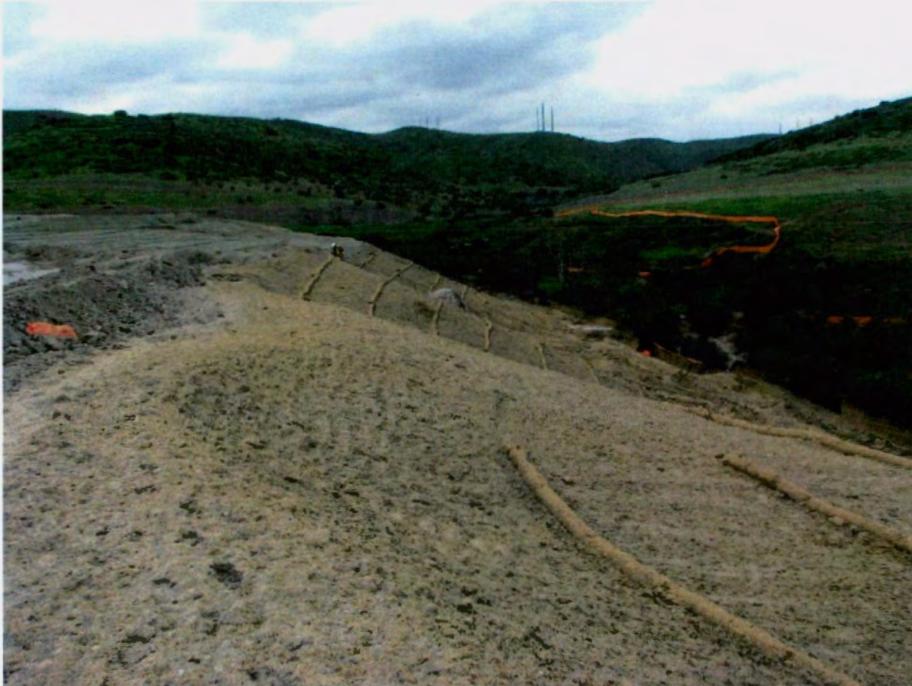
Figure 30.

Photo showing north boundary of construction site disturbed area (facing west). The slope had been repaired from previous storms and erosion control BMPs in the form of bonded fiber matrix and sediment control BMPs in the form of fiber rolls had been implemented.

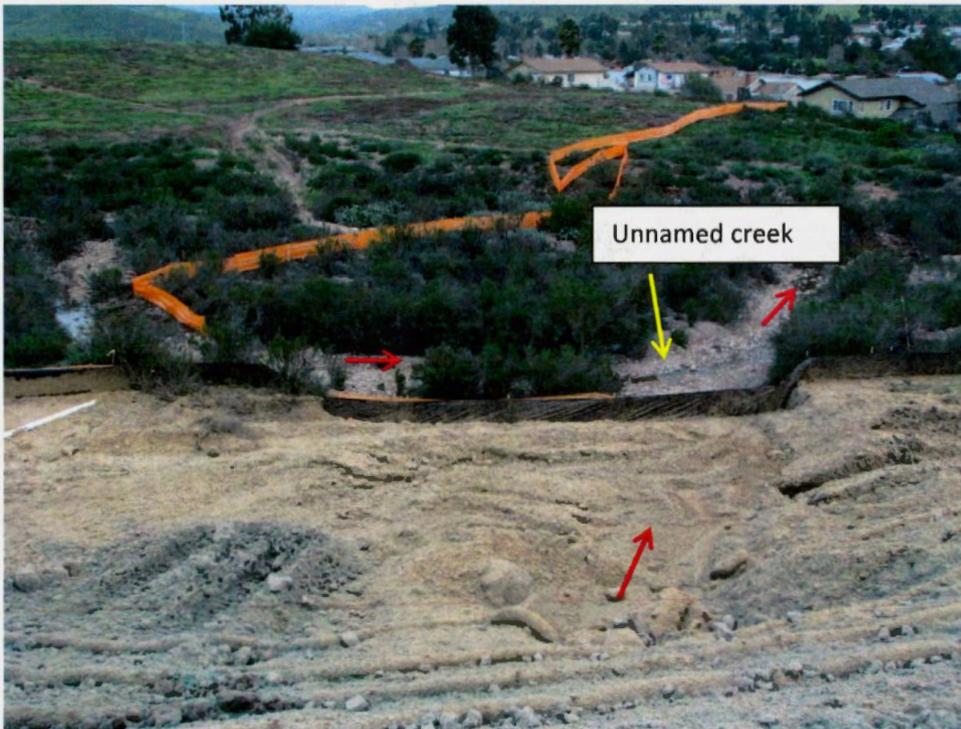
Figure 31.

Photo showing north boundary of construction site disturbed area (facing north). The perimeter silt fence had been repaired from previous storms and bonded-fiber matrix and fiber rolls had been implemented.

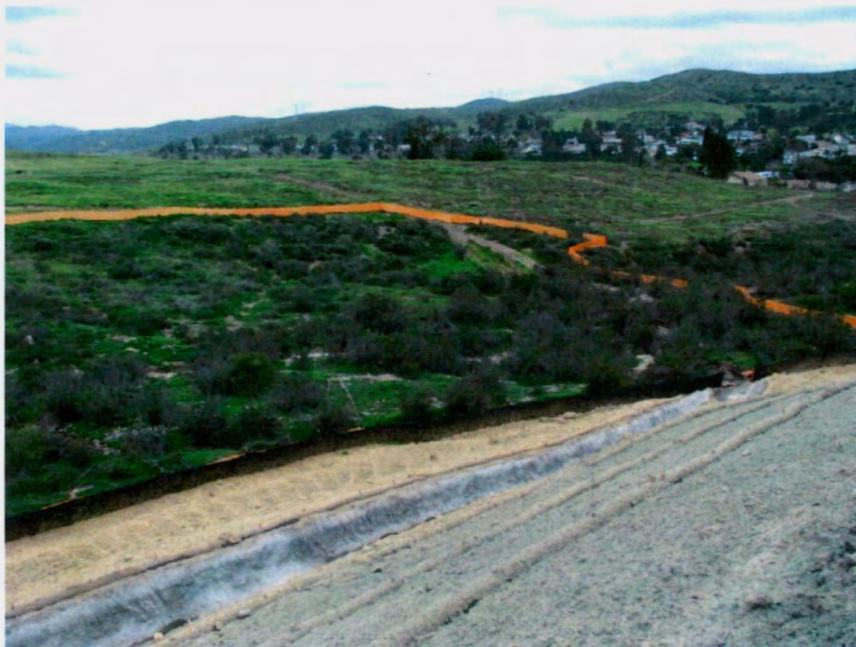
Figure 32.

In addition to making repairs on the slope, construction site personnel installed a temporary gunnite channel to route run-on from the open space areas to the unnamed creek, without collecting disturbed sediment from the construction site itself.
