San Diego Regional Water Quality Control Board

SUBJECT: OFFER TO SETTLE ADMINISTRATIVE CIVIL LIABILITY FOR ALLEGED VIOLATIONS OF THE CONSTRUCTION GENERAL STORM WATER PERMIT, ORDER R9-2018-0072, CASTLEROCK WESTON CONSTRUCTION SITE, WDID 9 37C374922

Attachment 2 – Castlerock Inspection Report Photo Log
Photos from January 19, 2017

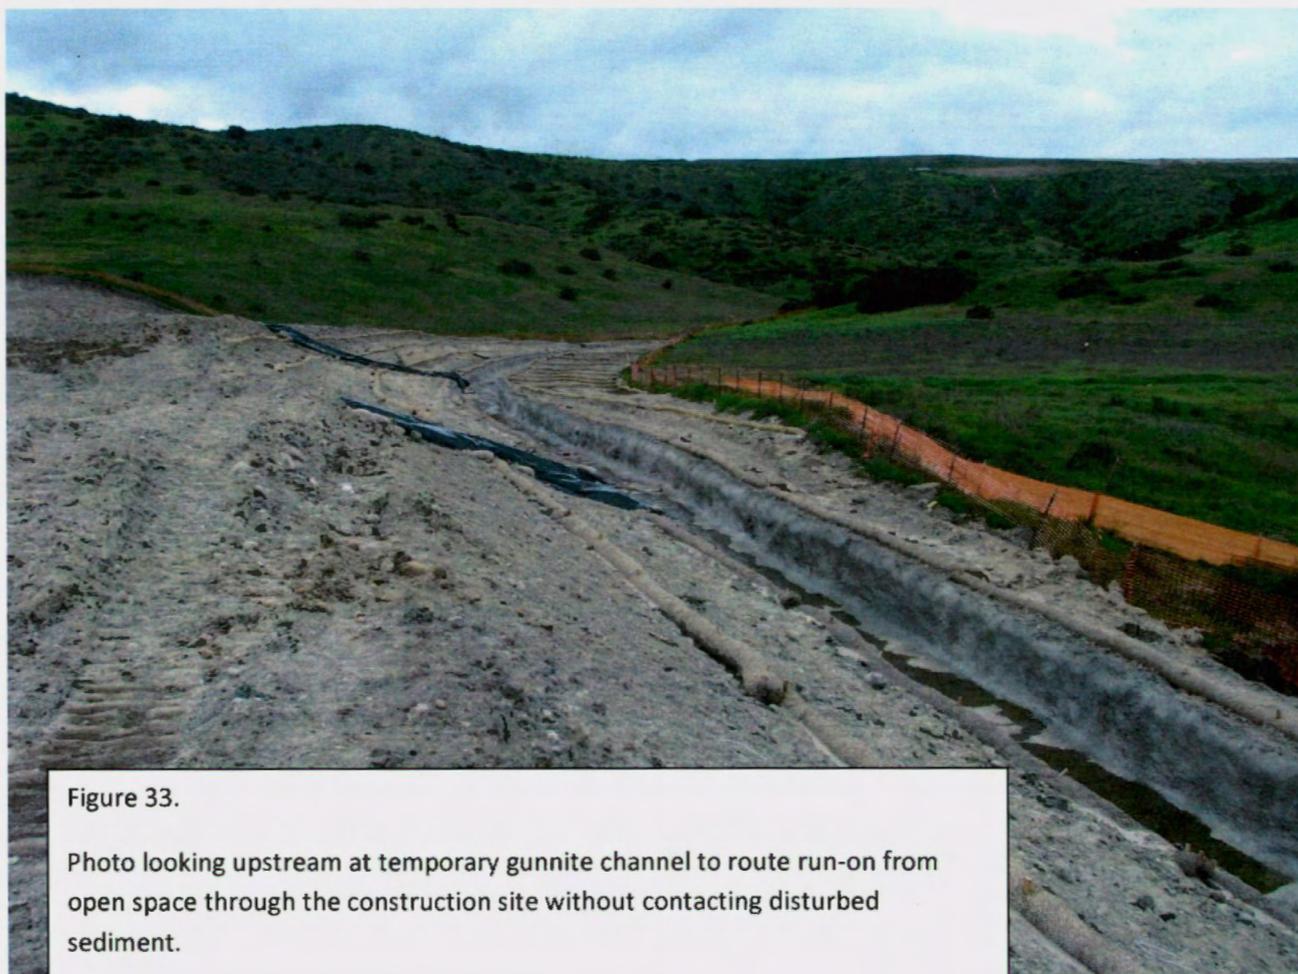
Figure 33.

Photo looking upstream at temporary gunnite channel to route run-on from open space through the construction site without contacting disturbed sediment.

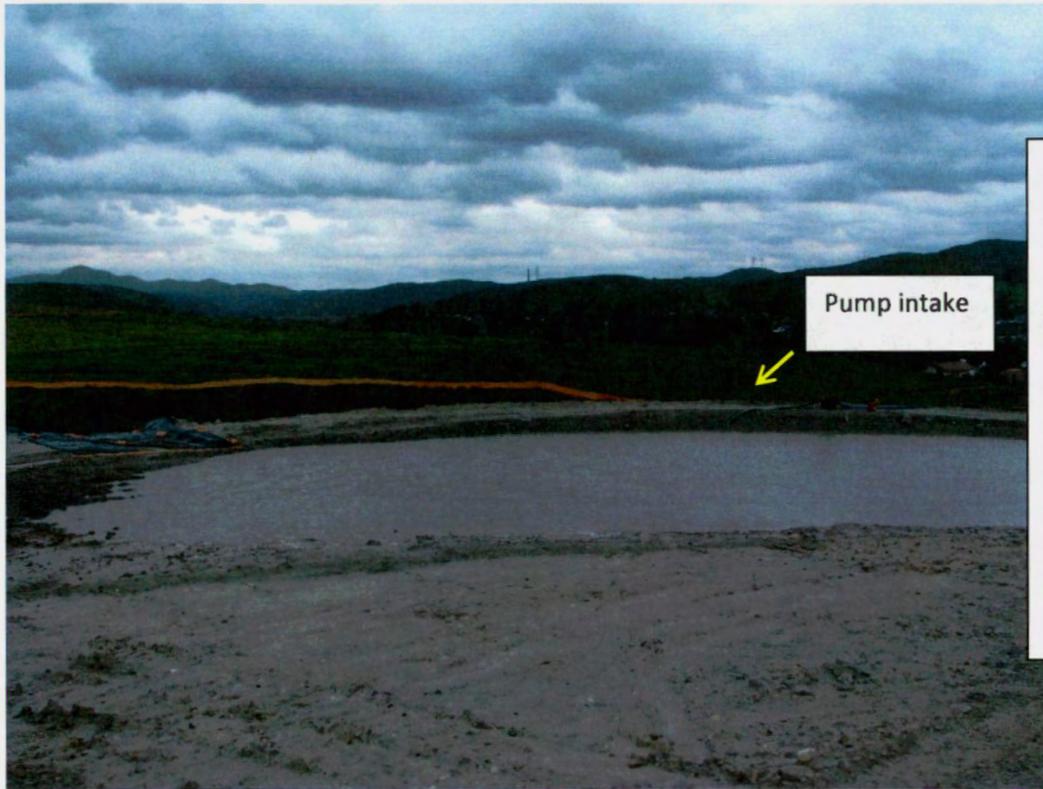
Figure 34.
Photo showing one of several pooled areas that had collected water from previous storms. At the time of the inspection, a pump was being used to transfer water from this area to the capture hole shown in Figures 28-29.

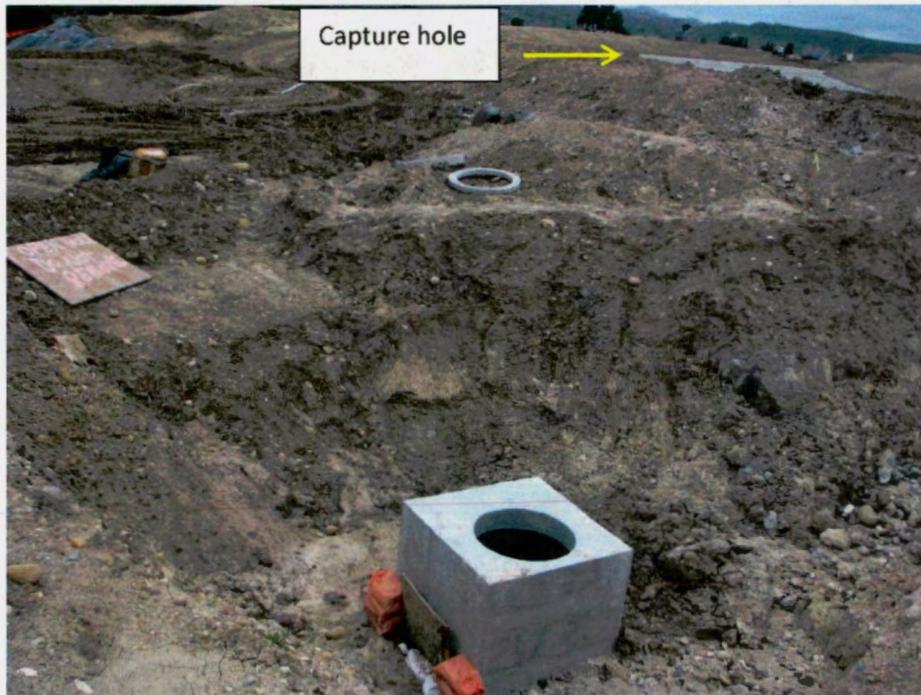
Figure 35.
Photo showing one of several “emergency overflows” for capture holes. This inlet is connected to the City of Santee MS4 and is intended to prevent flooding should the capture holes reach capacity. Note erosion control consists of soil tackifier only, no linear sediment controls such as fiber rolls or gravel bag chevrons in place.

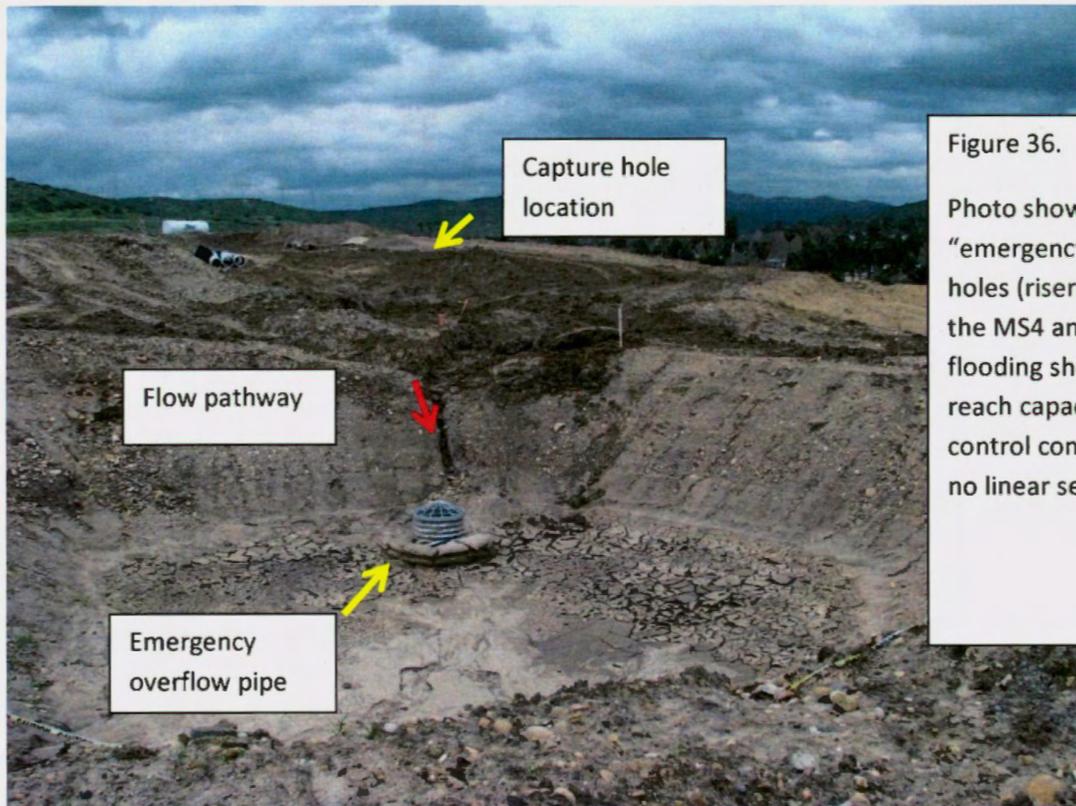
Figure 36.

Photo showing one of several “emergency overflows” for capture holes (riser pipe that is connected to the MS4 and is intended to prevent flooding should the capture holes reach capacity). Note erosion control consists of soil tackifier only, no linear sediment controls in place.

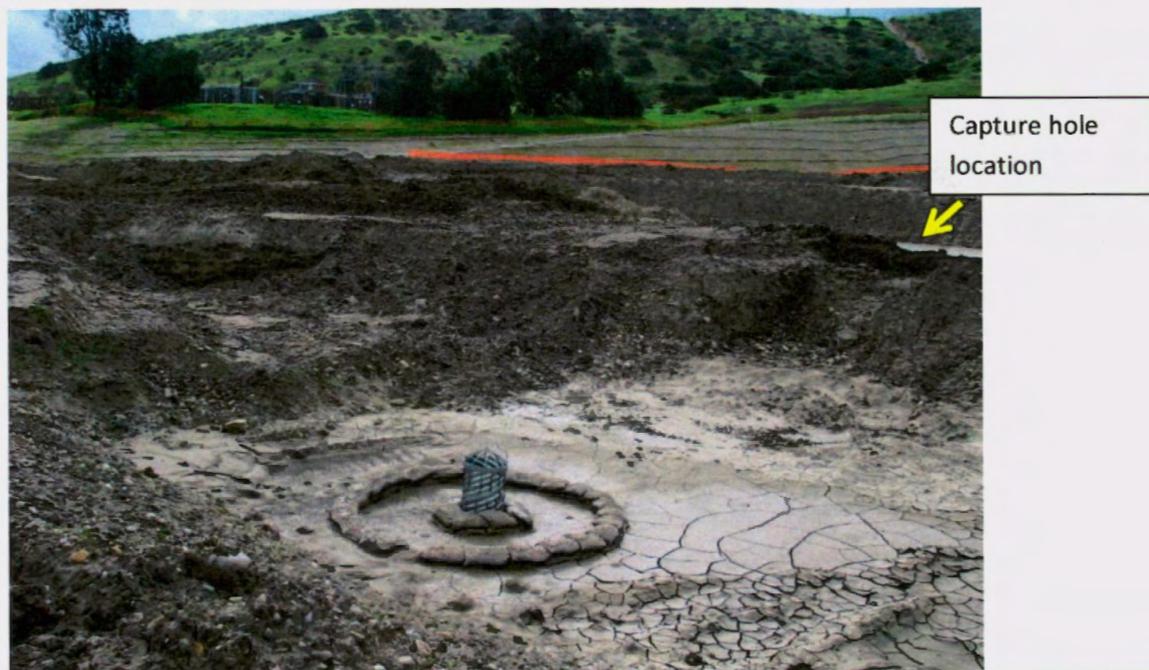
Figure 37.

Photo showing one of several “emergency overflows” for capture holes. This inlet is connected to the City of Santee MS4 and is intended to prevent flooding should the capture holes reach capacity. Note erosion control consists of soil tackifier only, with a few gravel bags (sediment control BMPs) around the riser pipe.

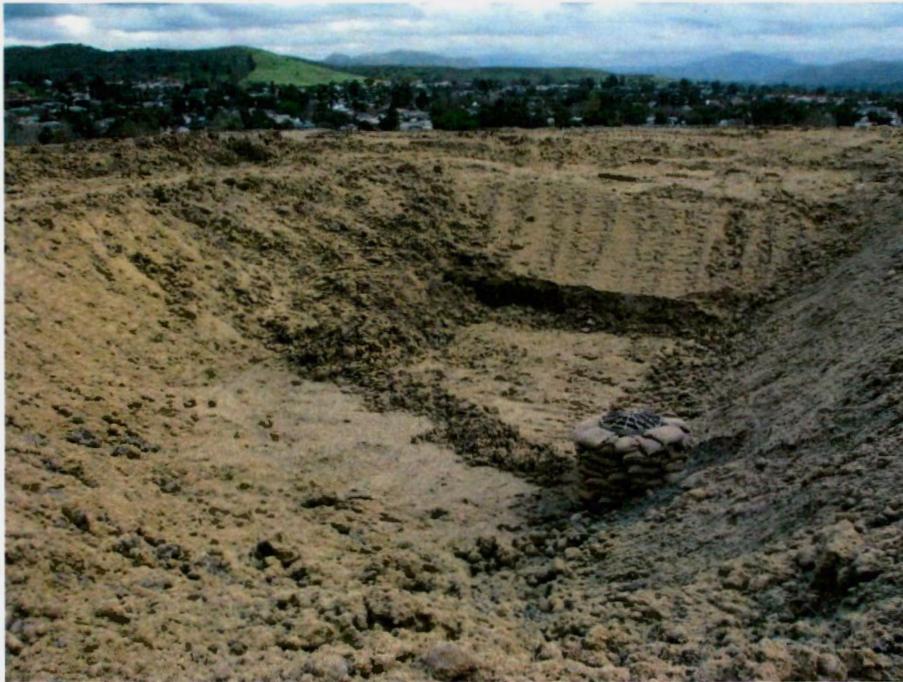
Figure 38.
Photo showing one of several “emergency overflows” for capture holes. This inlet is connected to the City of Santee MS4 and is intended to prevent flooding should the capture holes reach capacity. This one had hydromulch in addition to soil tackifier as erosion control BMPs, but no linear sediment control BMPs along the walls.

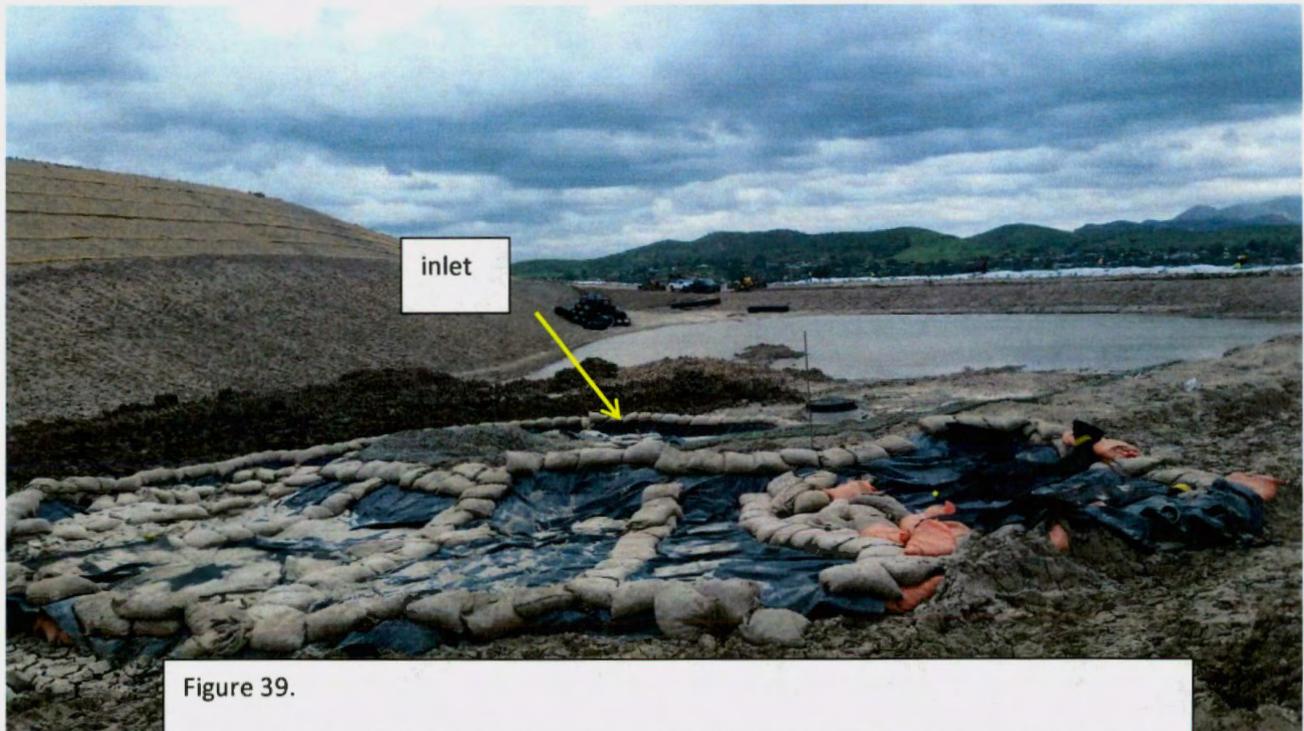
8. The inspection concluded with observations of capture hole #4 (see Attachment 2, Figure 39). This capture hole is situated on a fill slope erected above several houses on Medina Dr. Mr. Nichols stated that he had previously used a pump to dewater the capture hole into the MS4 inlet, and that the water was visibly clear. This was done out of concern for possible slope failure due to the volume of water being stored on the fill slope. We discussed that the CGP

Figure 39.
Photo showing capture hole #4 located on southeast area of construction site. Plastic is used as spill way to route runoff to the inlet, in the event that the capture hole reaches capacity. Check dams are used to settle out particulates.
